Property of  
Flood Control District of MC Library  
Please Return to  
2801 W. Durango  
Phoenix, AZ 85009

Rittenhouse Flood Retarding Structure - Tuesday, April 26, 1977

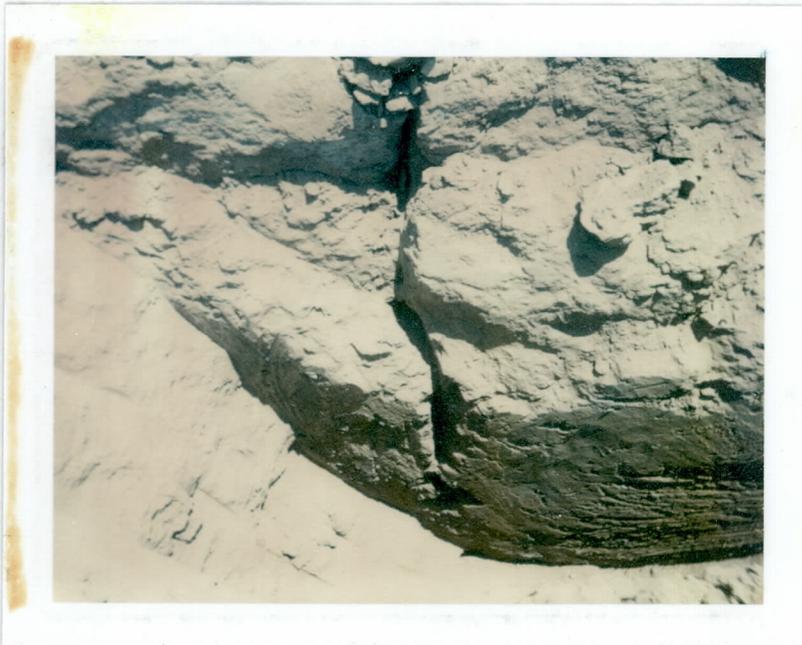
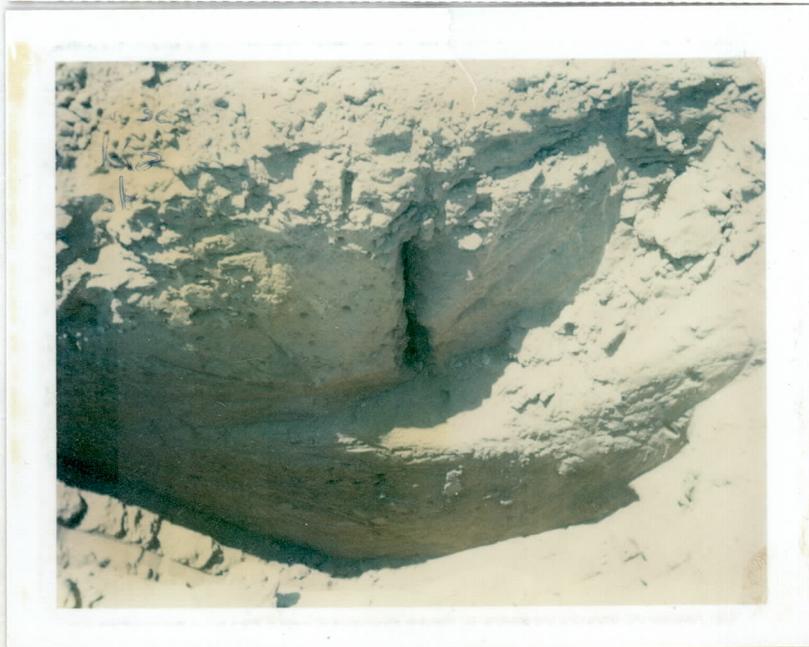
Station 98+38 - Excavation started in the centerline of the dam. The depth of the cut is  $5\frac{1}{2}$ ' , width  $3\frac{1}{2}$ ' , length 11' . We found transverse crack. Determined that the crack goes down 4' below the crest and was about  $\frac{1}{4}$ " wide. There was another transverse crack in this excavation 3' north of the crack just described. This crack we determined goes down 2' below the crest and is about  $\frac{1}{4}$ " wide. A longitudinal crack exists in the north wall of excavation,  $\frac{1}{4}$ " wide. Another cut was made at this same Station, but on the downstream hinge point. This cut is 9' deep, 5' wide and 18' long. Transverse crack was traced down 5' on both ends of the cut. This crack ranged in width from  $\frac{1}{4}$ " to  $\frac{1}{2}$ " . The moisture is still present below the point where we lost evidence of the crack.

In summary, in both excavations at this Station, the transverse crack discontinued at 4' from the cut in the centerline. In the cut on the downstream hinge point the crack discontinued at 5' below the crest. Moisture still present in the bottom of both excavations.

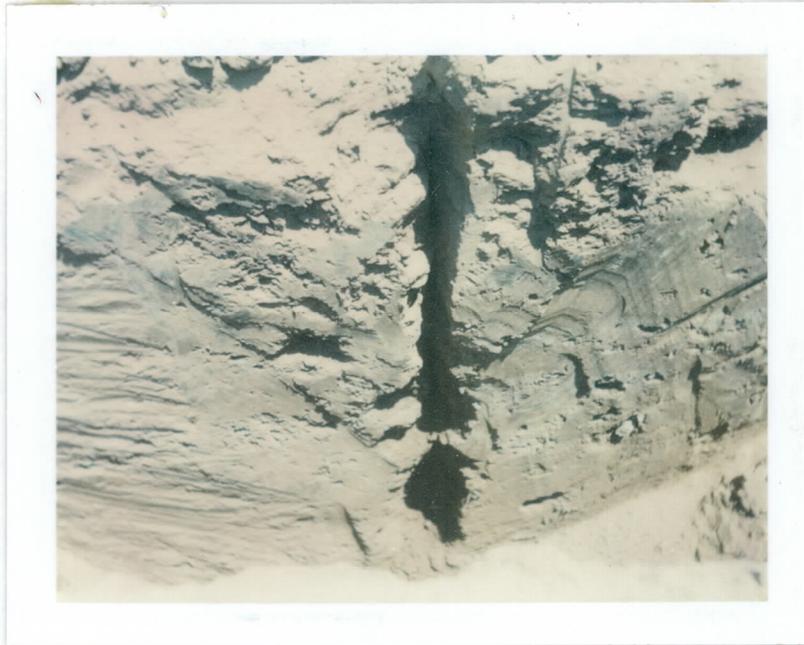
Rittenhouse Flood Retarding Structure - April 26, 1977  
Station 97+20

Excavation on centerline of dam crest. The cut is 4' wide, 12' long and 7½' deep. From the top of the crest to 4' below, crack is about ½" wide; below 4' the transverse crack is full of silt but still present and turns into a hairline that I was able to trace down 6' below the crest. Moisture still present in the bottom of excavation.

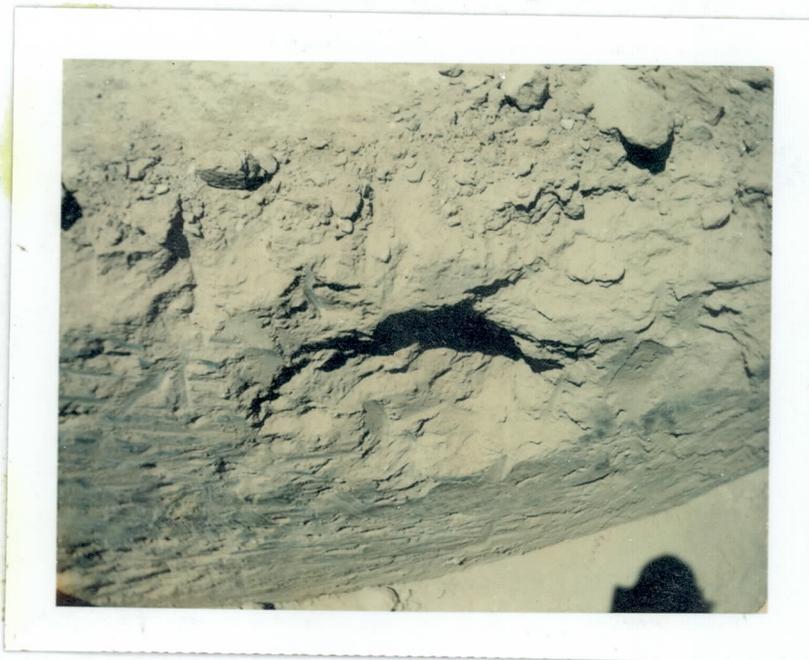
Rittenhouse Flood Retarding Structure - Thursday, April 28, 1977  
Station 89+93 - Digging started at centerline of the dam. On the downstream side of the cut transverse crack was traced down 2' and then discontinued. This crack is just a hair line. On the upstream side of the cut transverse crack was traced down 5' before it discontinued. At 2' down below the crest crack is  $\frac{1}{4}$ " wide. Below that the crack is just a hair line. The excavation goes as follows: 13' long, 3' wide,  $6\frac{1}{2}$ ' deep.

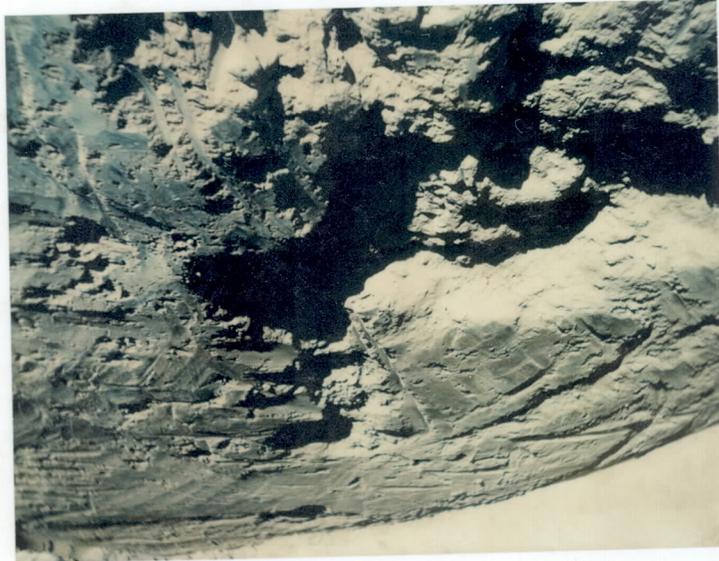
Downstream side

Station 91+67 - Digging started at centerline of the dam. Transverse crack on both upstream and downstream sides of the cut. On the downstream side of the cut crack is a  $\frac{1}{4}$ " wide with voids 3" wide on the upper half. On the lower half transverse crack is a hair line. On the upstream side of the cut transverse crack goes down 10' and is between an  $\frac{1}{8}$ " and  $\frac{1}{16}$ " wide crack which has silt deposits in it in places. One other thing about the downstream side of the cut is that at 4' down, transverse crack changes direction and runs longitudinally. The excavation goes as follows: 14' long, 4' wide and 10' deep. Moisture is present in bottom of this excavation.

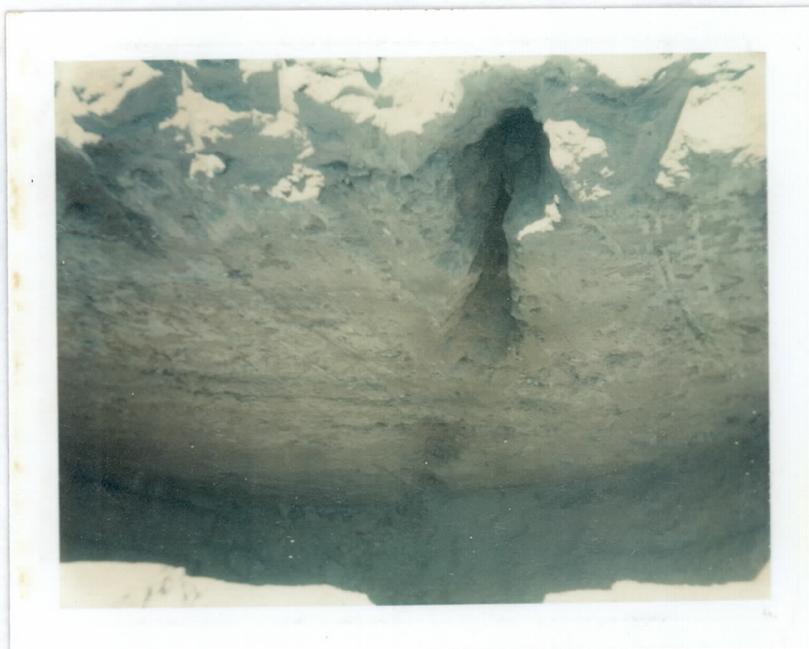
Downstream side

Rittenhouse Flood Retarding Structure - April 28, 1977  
Station 93 + 83 - Digging started at centerline of the dam. Cut is 14' long,  
3½' wide and 10' deep. Transverse crack runs down 9' on both upstream and  
downstream sides of cut before it discontinues. At 2' down from the crest  
crack is ¼" wide; below 2' down crack is a hair line with silt deposits in  
it. Moisture is present in the bottom of the cut.

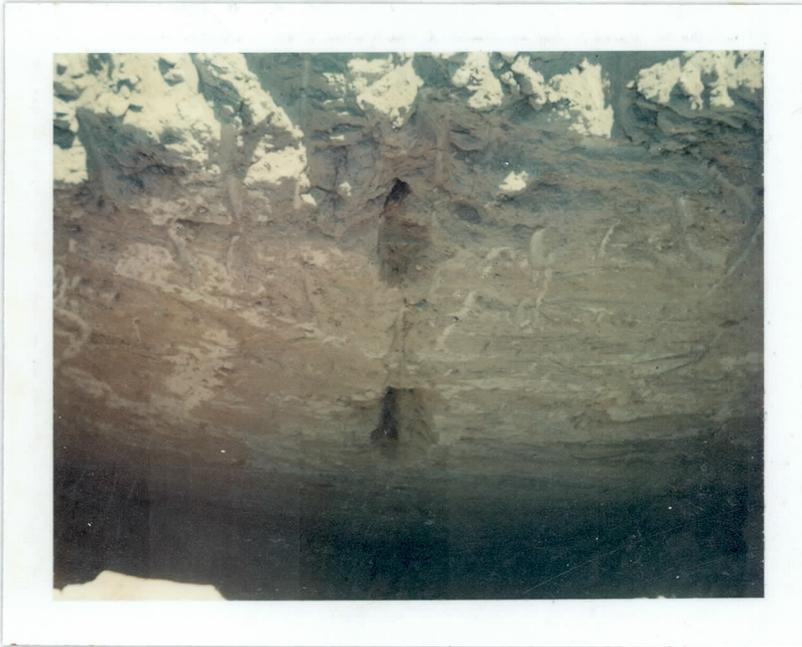
Downstream side

Station 95+07 - Digging started at the centerline of the dam. From top of crest to 2' below, crack is  $\frac{1}{4}$ " wide; after that level, crack closes into a hair line that runs 7' down on both the upstream and downstream sides of the cut. The excavation is 14' long, 3' wide and 9' deep. Moisture present in the bottom of this cut.

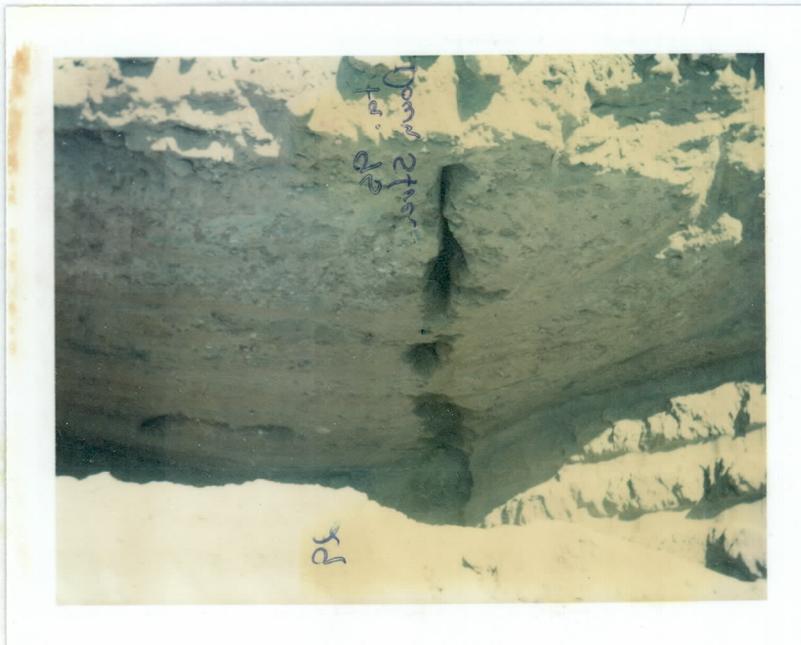
Upstream side

Station 95+50 - Digging started at the centerline of the dam. On the upstream side of the cut transverse crack goes down 6' before it discontinues. On the downstream side of the cut, crack goes down 4' before it discontinues. On both the upstream and downstream sides of the cut, transverse crack is a hair line. Excavation is 14' long, 3' wide. Moisture present in the bottom of this cut - 7' deep.

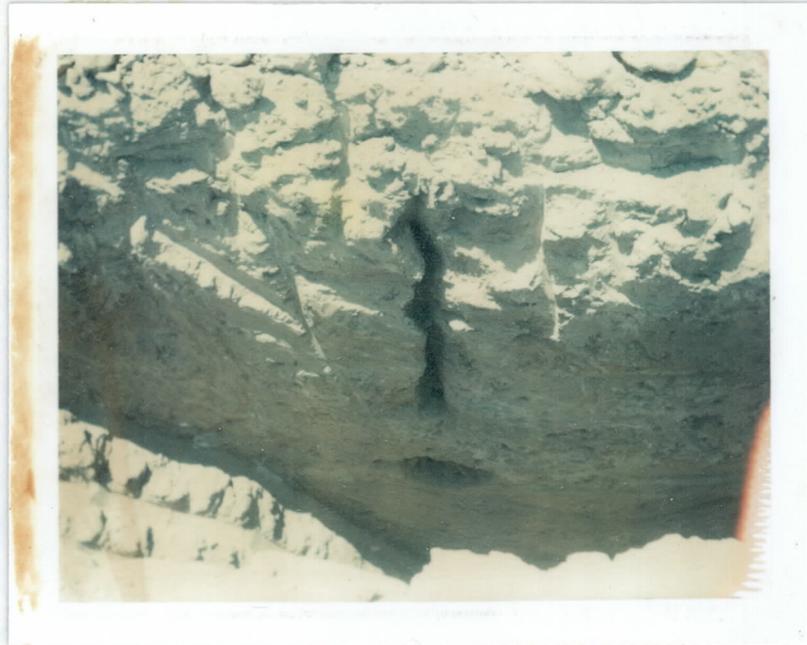
Downstream side

Station 98+82 - Diggings started at the centerline of the dam. On the upstream side of the cut, transverse crack was traced down 6' before it discontinued. This crack is  $\frac{1}{4}$ " wide in places along its length. On the downstream side of the cut, transverse crack discontinued at 4' down from the top. Moisture present in the bottom of this excavation. Excavation is 13' long,  $7\frac{1}{2}$ ' deep, 3' wide.

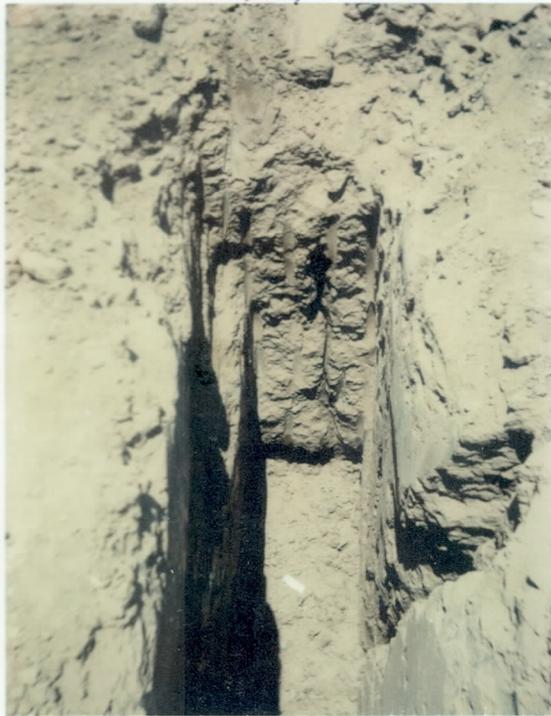
North End

Excavated a cut on centerline and parallel to centerline 9 feet deep and 9 feet long. The transverse crack opening to a one inch width on the upstream face of the excavation extended down to a five foot depth from crest elevation. A second transverse crack on the upstream face was observed beginning three feet below crest and extended another three feet and discontinuing in a small sandy-gravelly layer toward bottom of excavation. Both transverse cracks terminated near bottom of hole at  $5\frac{1}{2}$  feet below crest elevation. The transverse crack on the downstream face of the excavation was not definitely defined and appeared to discontinue in sandy-gravelly pockets and layers above and below a  $3\frac{1}{2}$  foot layer of compacted heavy clay. A longitudinal crack in the end of the centerline excavation was observed opened up to a width of  $\frac{1}{2}$ - $\frac{3}{4}$  inch. This crack was evident in starting three feet below crest and extended another three feet in length along the end face of the excavation.

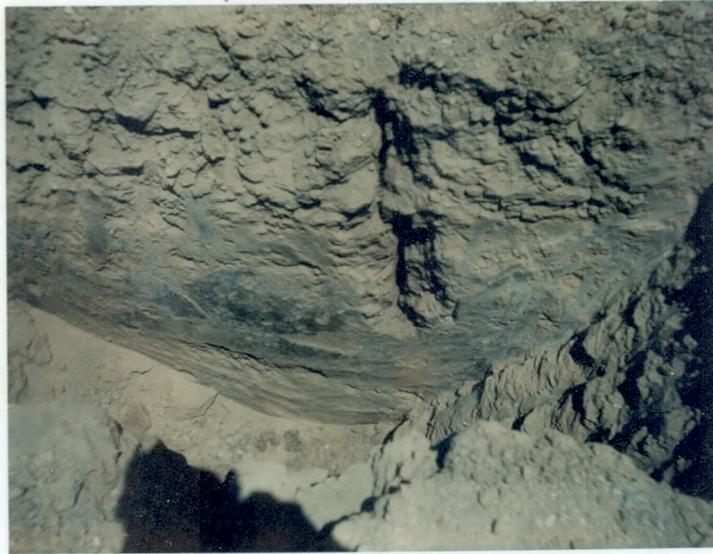
*Downstream face*

Excavated a cut 8 feet long and 6 feet deep. Found transverse crack extended through to downstream face of this excavation measuring 4 feet in length from surface of slope. Crack observed in the upstream face for a length of 2 feet and continued beyond.

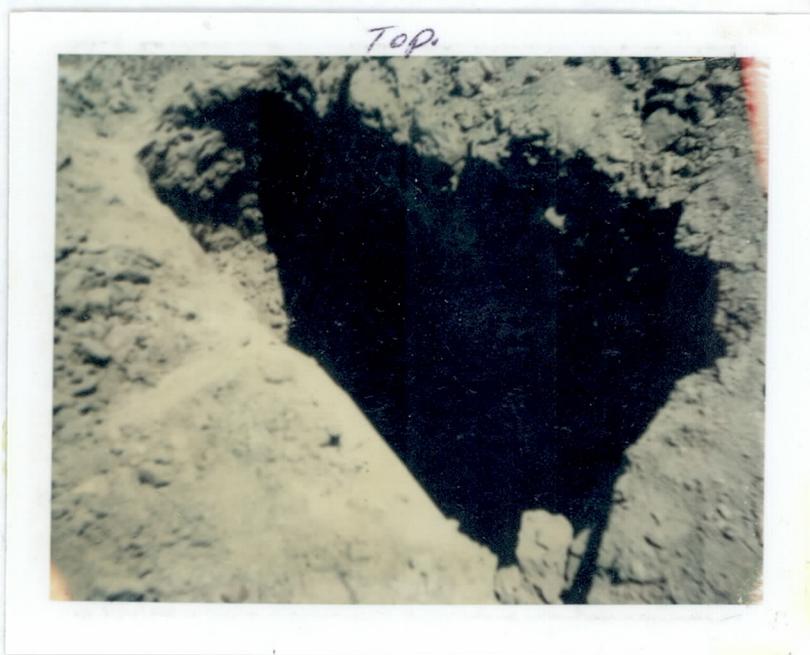
Rittenhouse FRS - May 18, 1977  
Station 100 + 51

An excavation 8 feet long and 6 feet deep was made transverse and immediately upstream of centerline on the crest in an attempt to intercept longitudinal crack observed in the end of the excavation. This proved unsuccessful; no crack could be uncovered.

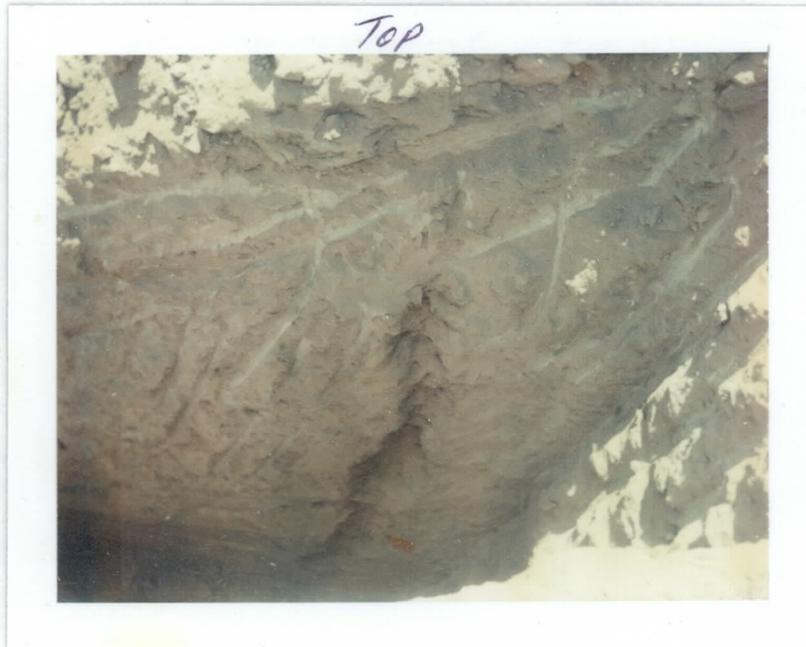
Station 91 + 67 - Work started on centerline of the dam. Made a cut 13' deep, 14' long and 3½' wide. Found transverse crack on both sides of the cut. Crack goes down 11½' before it ends in a sand pocket. The crack ranges from a hair line to 1/8" wide. In places along its length, crack has material washed down into it.

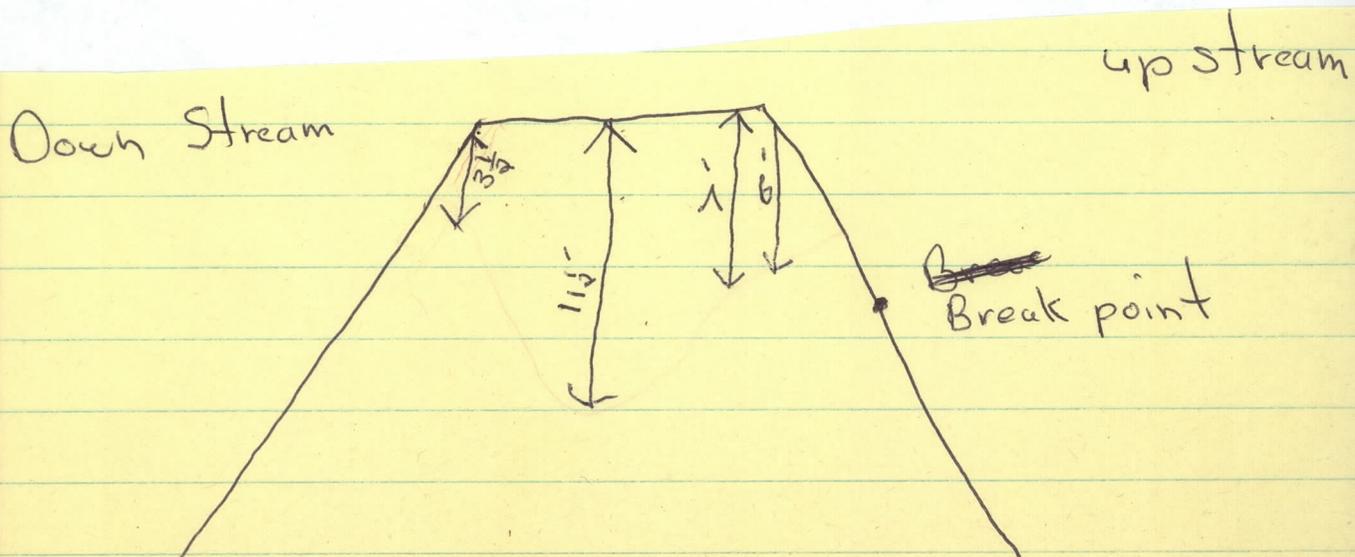
Cut on the upstream hinge point - upstream side of cut.

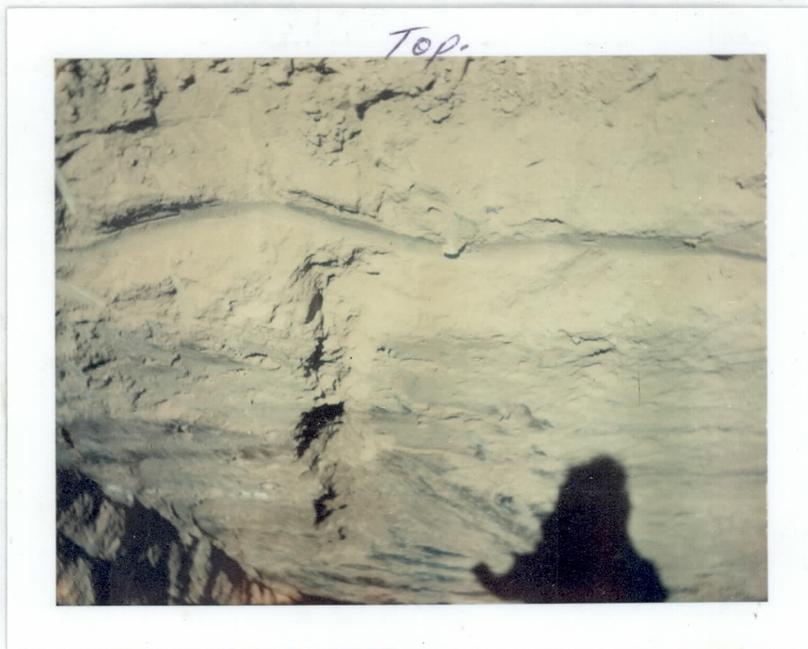
Station 91 + 67 - Downstream hinge point. Length of cut 12', width 3', depth 7'. Found transverse crack on the upstream side of the cut. On the downstream side of the cut no crack could be located.

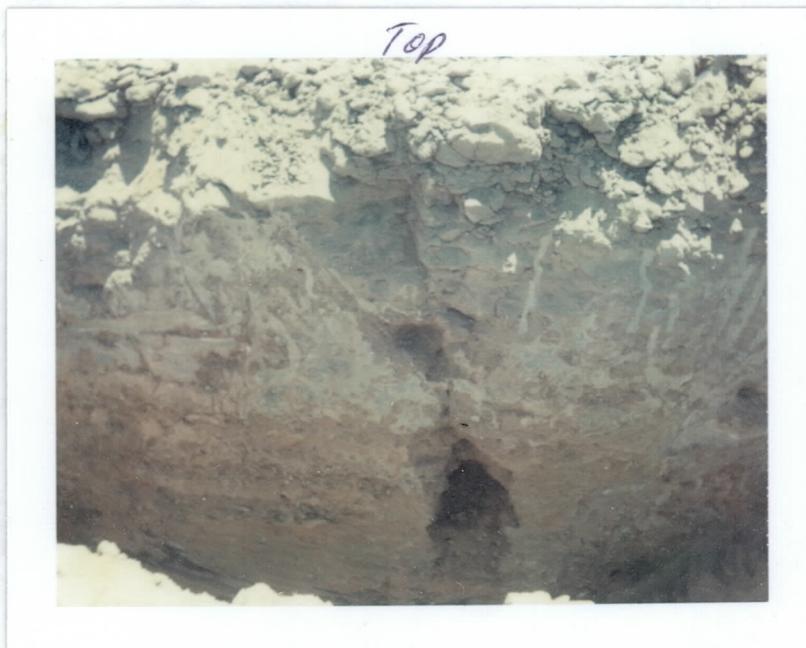
Upstream hinge point. Excavation 12' long, 3½' wide, 10' deep. Found transverse crack on both upstream and downstream sides of the cut going down 7' on the downstream side and 6' on the upstream side. Crack ranged in width from a hairline to 1/8" wide. This crack also had silt and sand deposits in it.

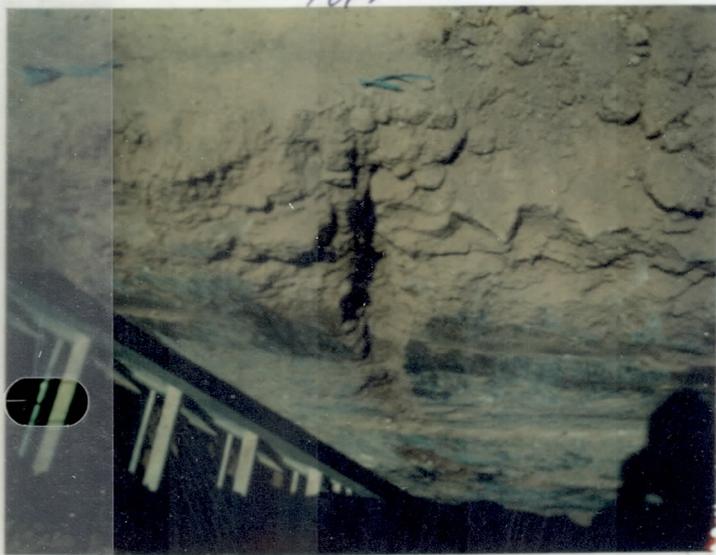
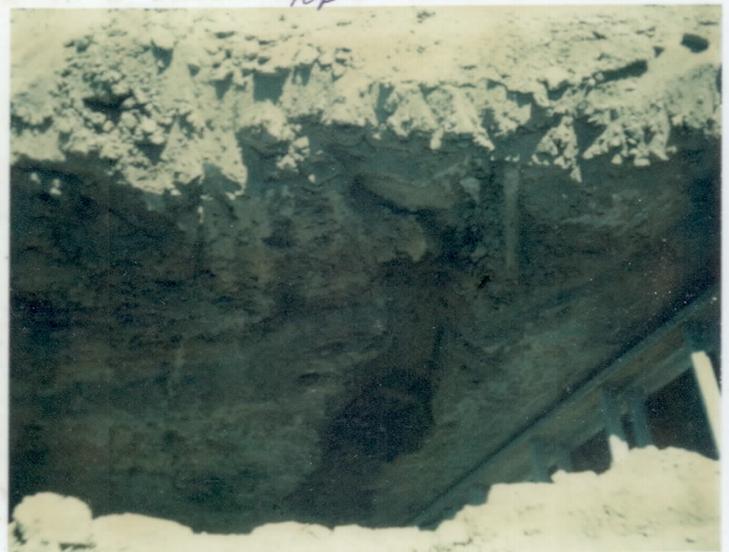
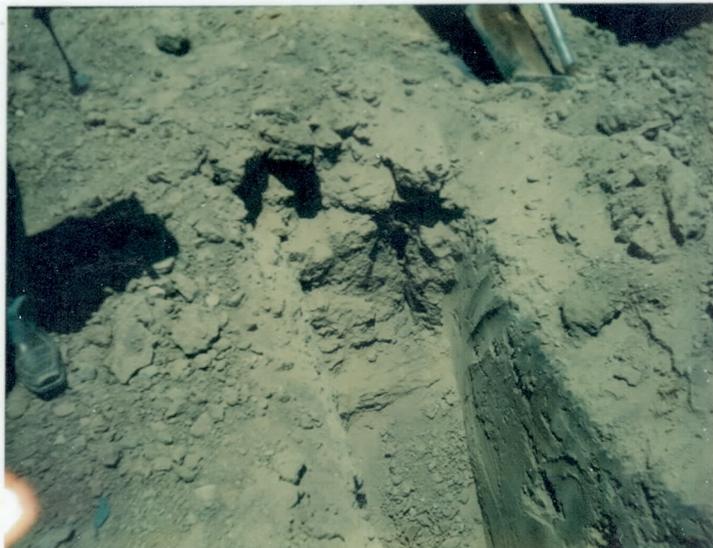
Station 105 + 10 - 105 + 22

Also cut made on centerline of the dam between Station 105 + 10 and 105 + 22. Here hair line transverse crack was found. The depth was 4' on the upstream face and 3' down on the downstream face. We also found a longitudinal crack at 2' below crest. There was moisture evident on all sides of this cut.
