Various Project Photos of Maricopa County Flood Control Projects 1970 thru 1977

Various Project Photos of Maricopa County Flood Control Projects

1970 thru 1977

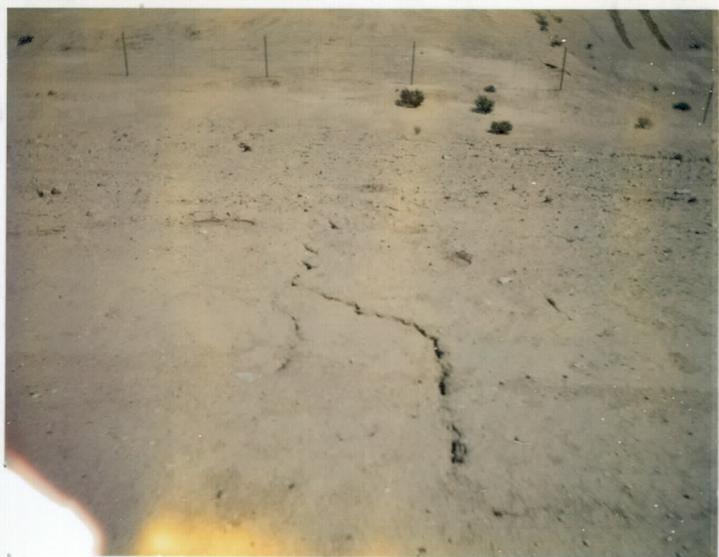
Buckeye #1. View of tranverse cracking on upstream slope. Crack continues through on downstream face and through fill at toe of embankment. 8-4-76

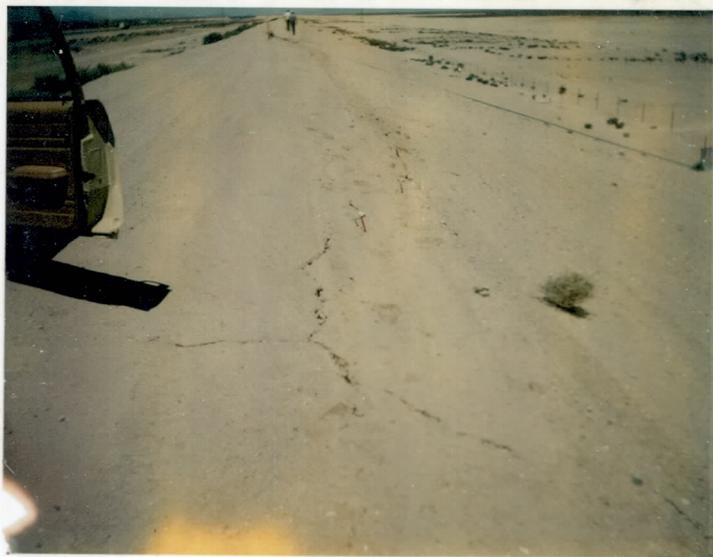
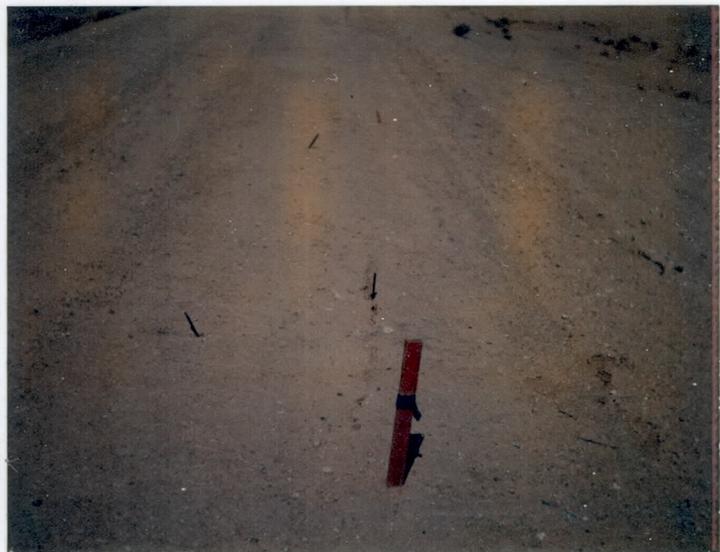
Buckeye # 1. Longitudinal fracture along crest near gate operator. 8-4-76

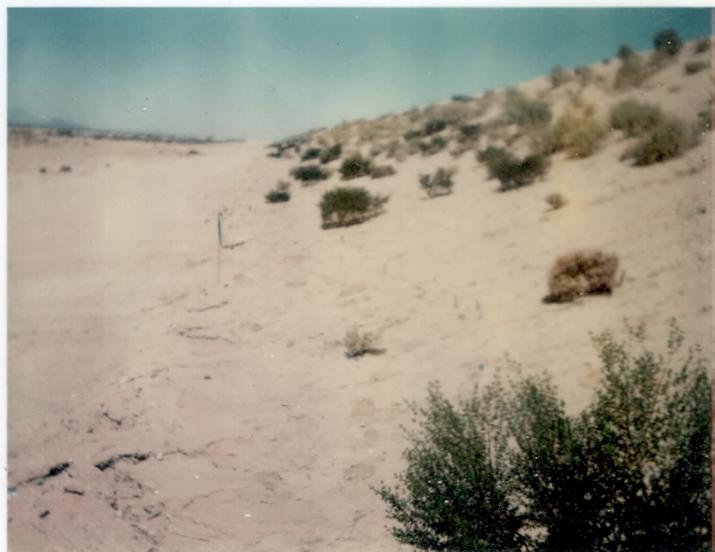
Buckeye #1. 1st fracture west of Palo Verde Gate. 8-4-76

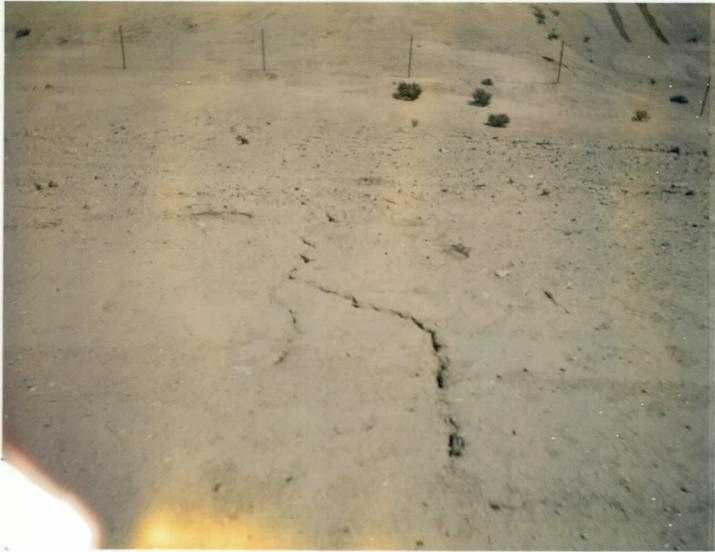
Buckeye #1. View of tranverse cracking on upstream slope. Crack continues through on downstream face and through fill at toe of embankment. 8-4-76

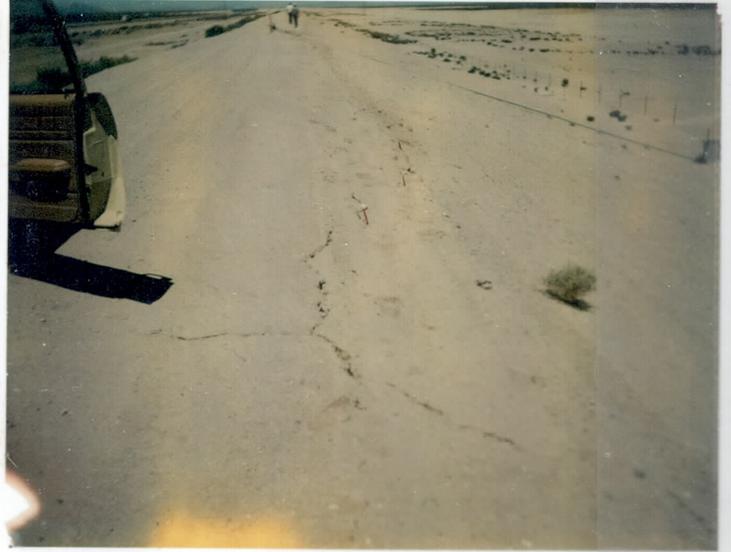
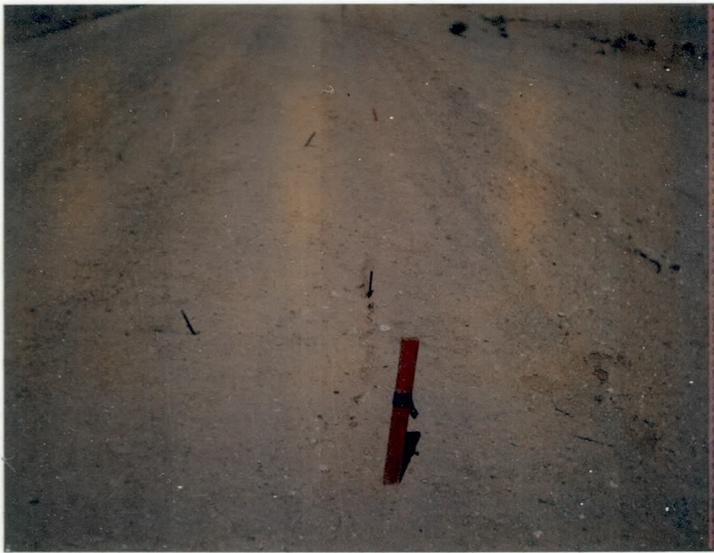
Buckeye # 1. Longitudinal fracture along crest near gate operator. 8-4-76

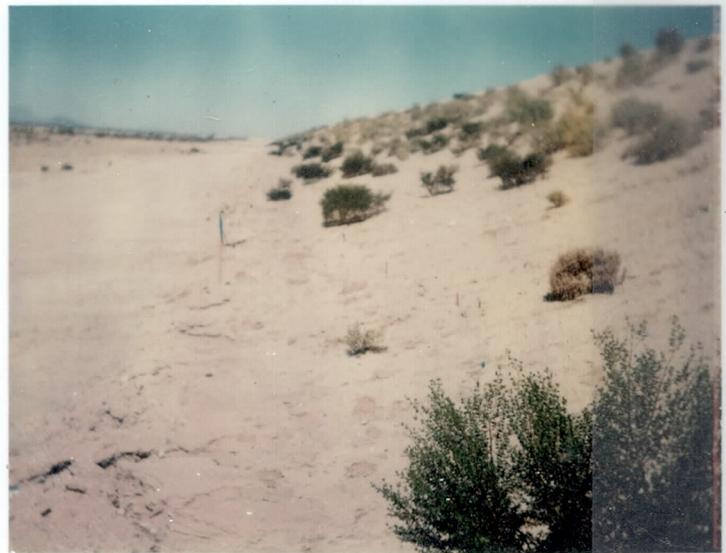
Buckeye #1. 1st fracture west of Palo Verde Gate. 8-4-76

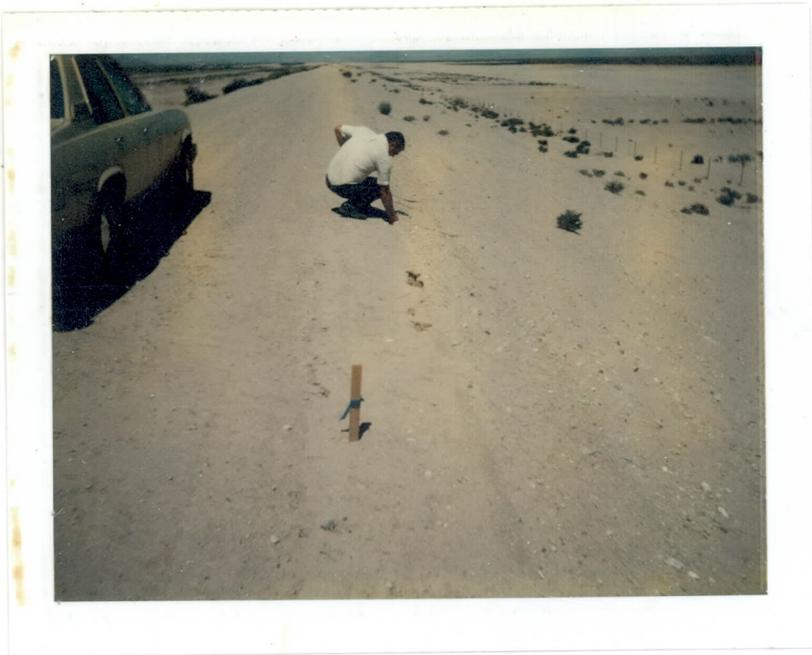
Leavitt examining cracks on Buckeye
FRS #2.

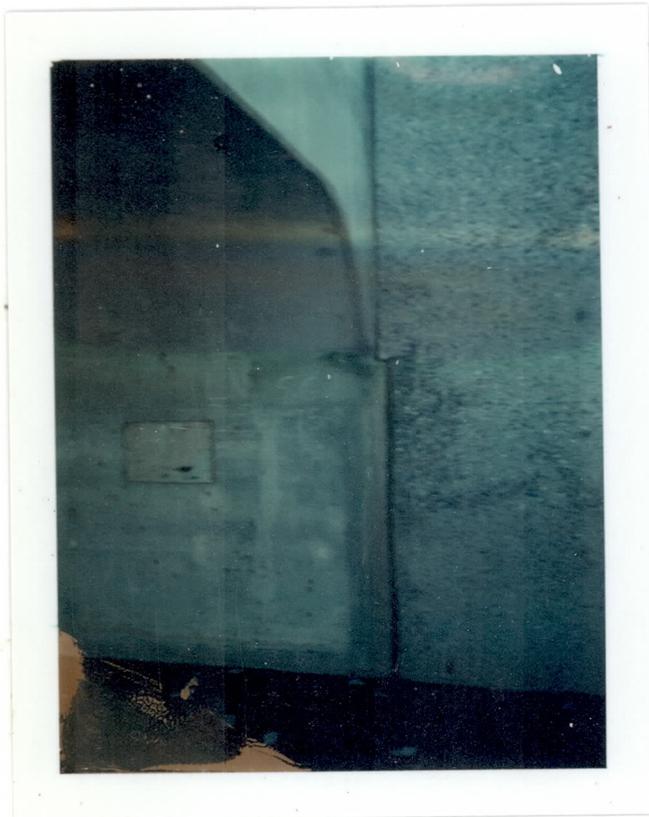
Indian Bend Wash. Vertical joint.
East abutment, south side of
McKellips Rd. Bridge over Indian
Bend Wash. (ABOVE) 3-9-76

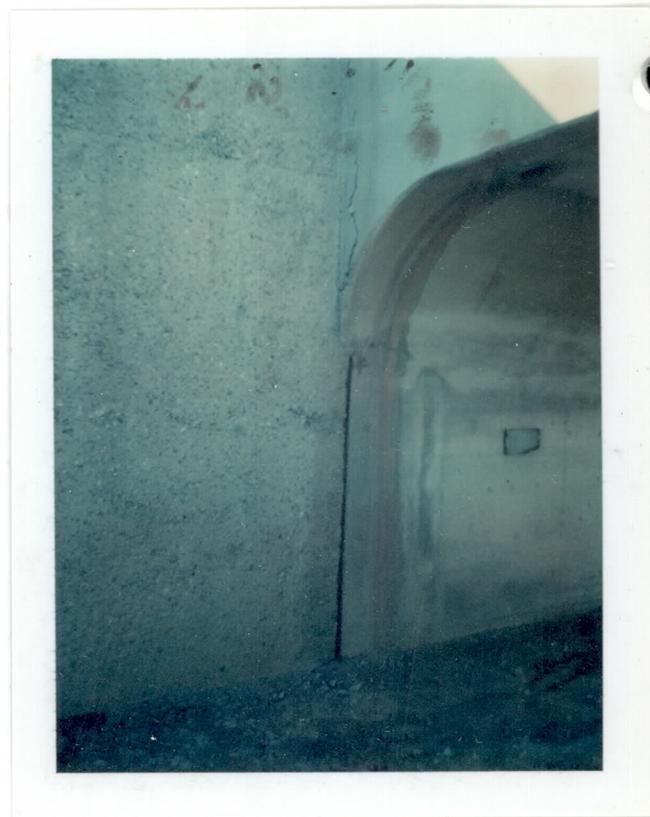
Vertical joint- west abutment-
south side McKellips Rd. Bridge
over Indian Bend Wash. 3-9-76

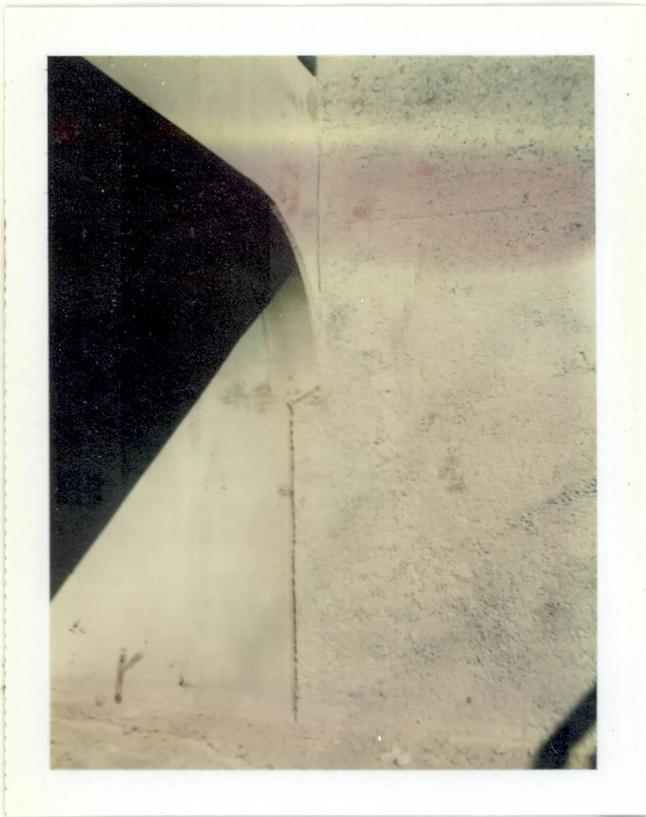
Vertical joint- west abutment-
north side McKellips Rd. Bridge
over Indian Bend Wash. 3-9-76

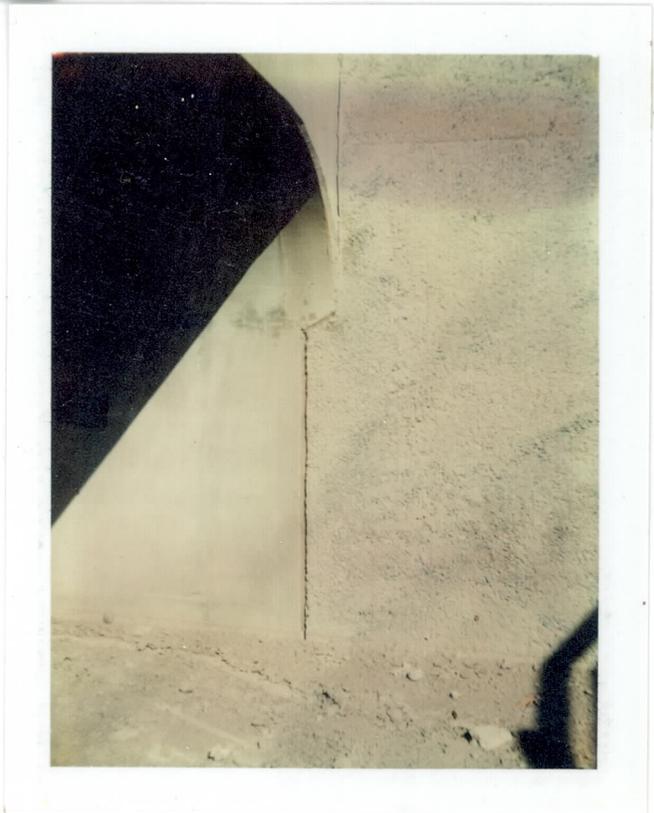
Vertical joint east abutment,
north side, McKellips Rd. Bridge
over Indian Bend Wash. 3-9-76
(Both pictures)

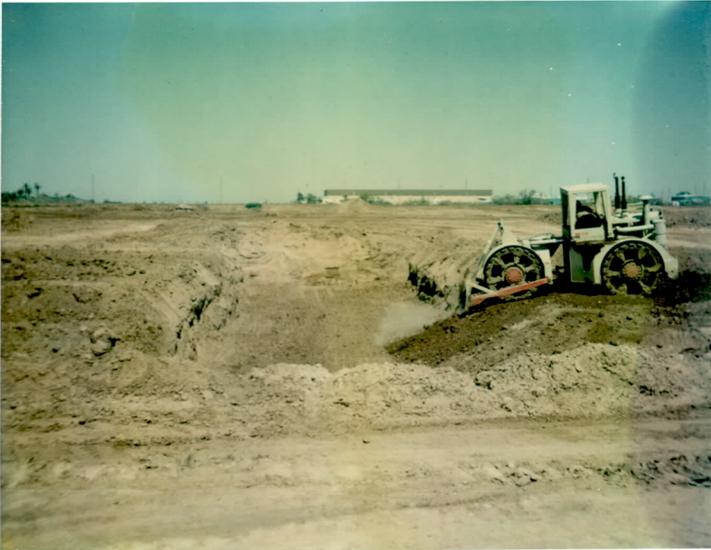
Indian Bend Wash. View of telephone cable crossing 18" storm drain from catch basin in corner of Princess & Miller- Cable covering damaged during initial excavation & cut into during 2nd Excavation shown in this photo. 6-8-76

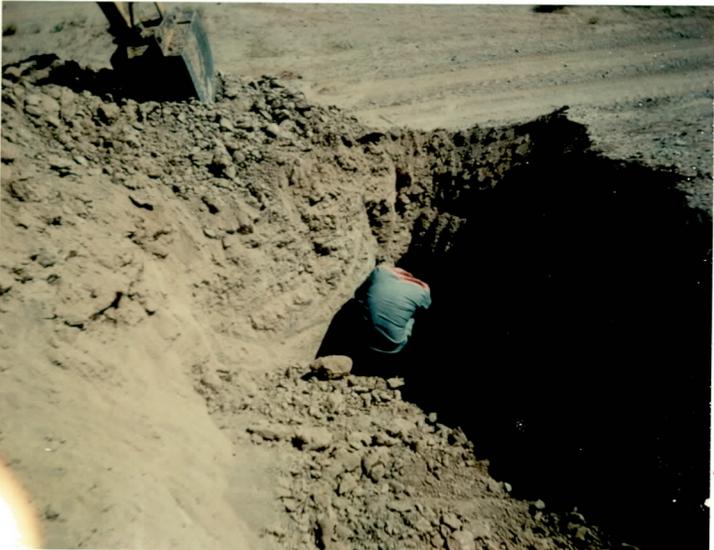
McMicken Dam. Station 456+10.
View looking downstream to
upstream showing Eric inspecting
cracking on upstream slope
just over upstream shoulder.
4-4-77

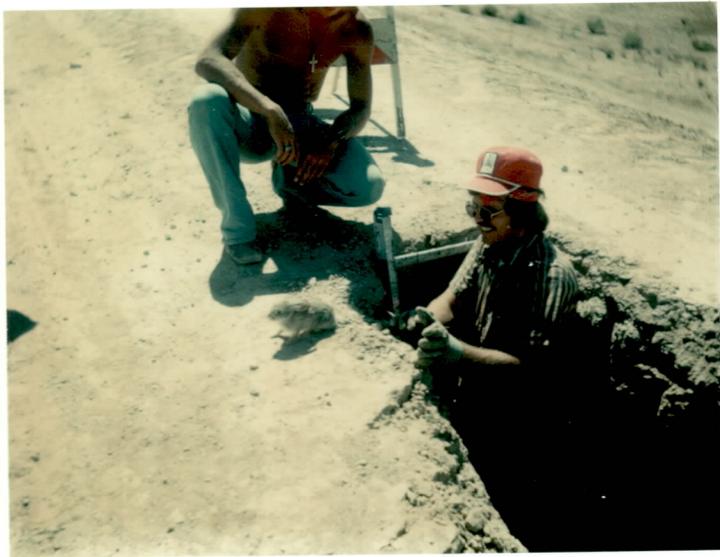
McMicken Dam. Station 465+88.
View of downstream side of
diminished cracking. 4-5-77

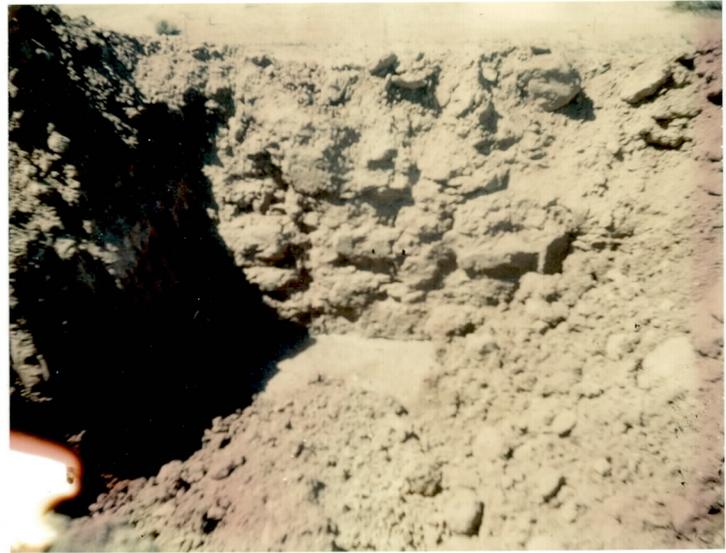
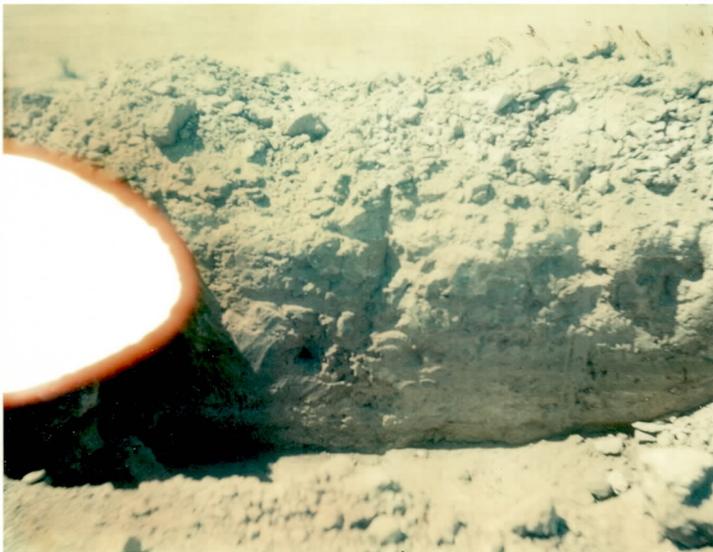
McMicken Dam. Station 465+79.
View of excavation showing
crack character. Excavation
5 ft. by 7 ft. by 3 ft. deep.
4-5-77

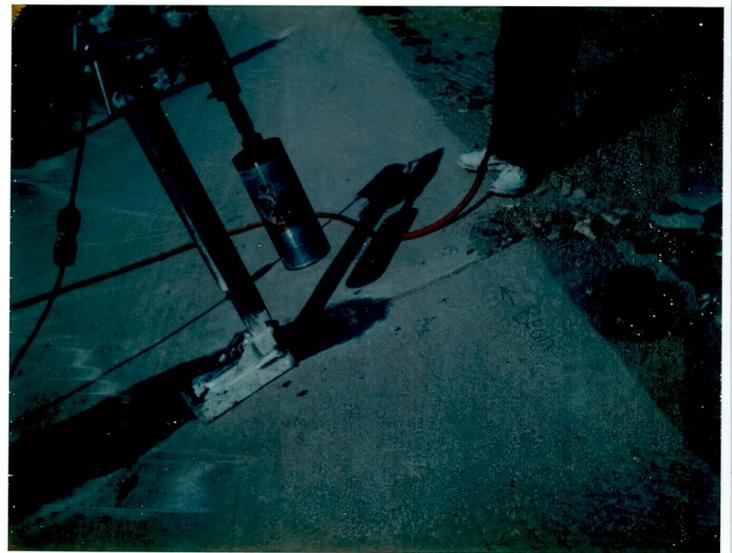
Rittenhouse. View of fracture on upstream
face of cut made in line with downstream
shoulder. Station 98+38. 4-26-77

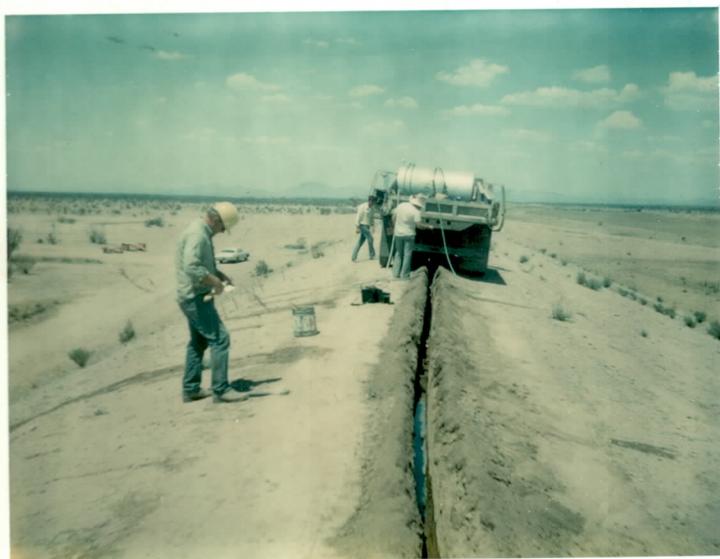
Rittenhouse. View of watering crew testing trench for cracks vicinity of station 93+15.
4-26-77

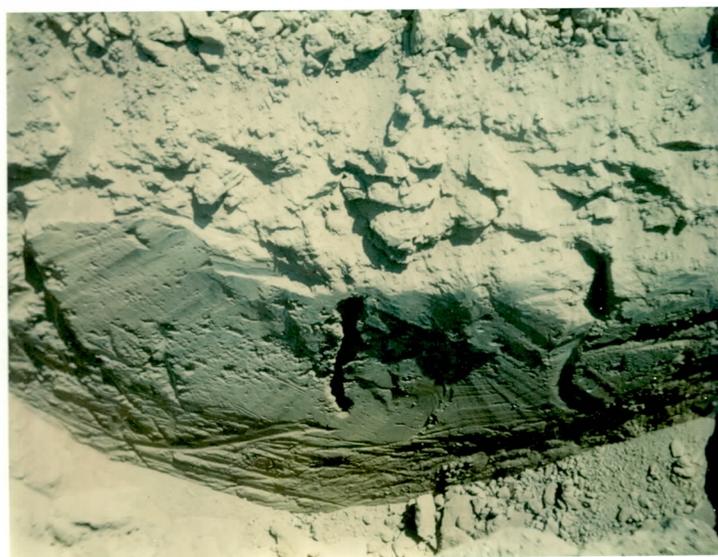
Rittenhouse. View of fracture on
upstream face of cut made on centerline
of crest. Station 98+38. 4-26-77
