FINAL REPORT TO CONGRESS

**THE STREAMBANK EROSION CONTROL
EVALUATION AND DEMONSTRATION ACT OF 1974
SECTION 32, PUBLIC LAW 93-251**

Appendix F - Yazoo River Basin Demonstration Projects

A COMPREHENSIVE SUMMARY REPORT ON STREAMBANK
EROSION CONTROL DEMONSTRATION PROJECTS CONSTRUCTED
IN EIGHT WATERSHEDS OF THE YAZOO RIVER BASIN

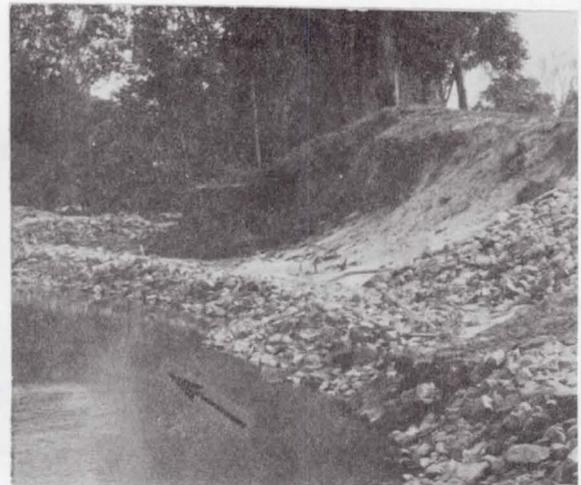
Perry Creek
Reach 16
April 1979

Figure 22. Reaches damaged, Perry Creek

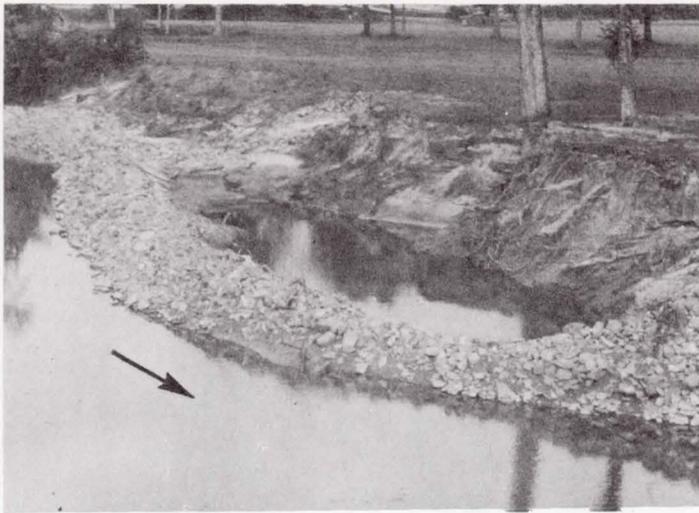
Perry Creek
Reach 19
April 1979

Figure 23. Reaches damaged, Perry Creek

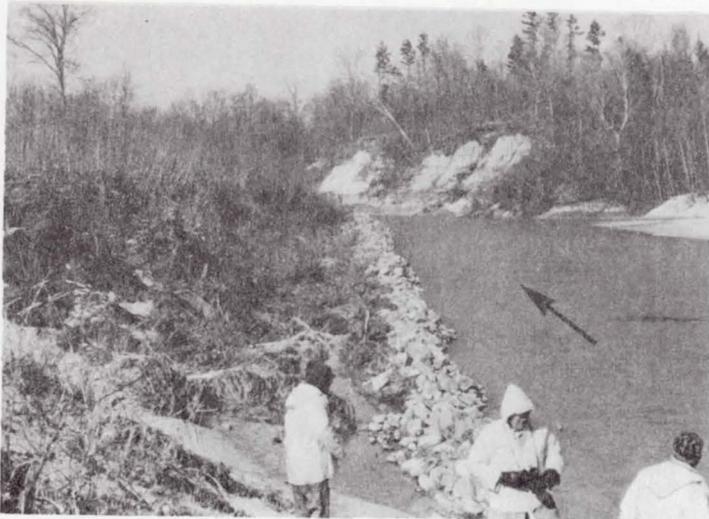
After Construction
Jan 1979

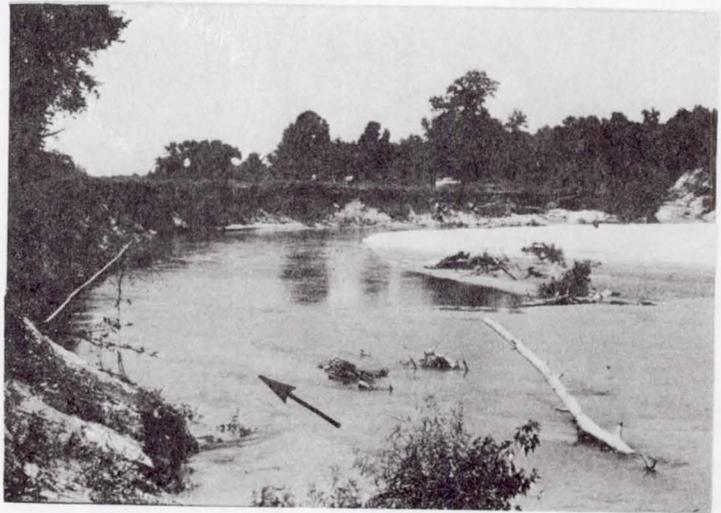
After Damage
Looking Downstream
Along Old Dike Alignment
July 1980

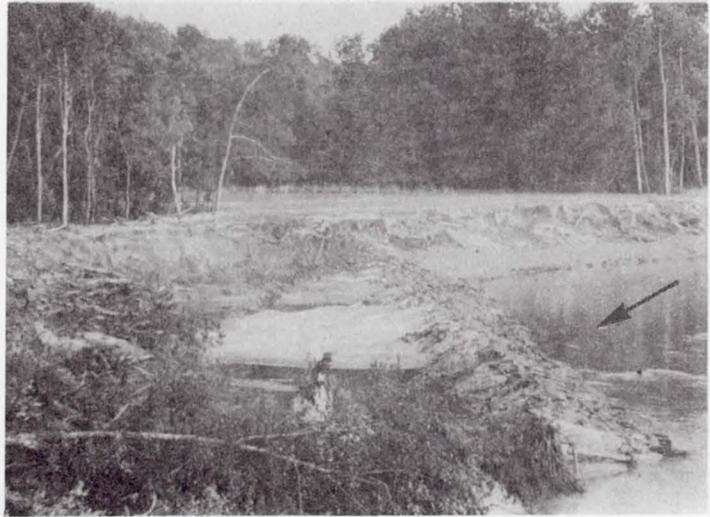
After Damage
May 1978

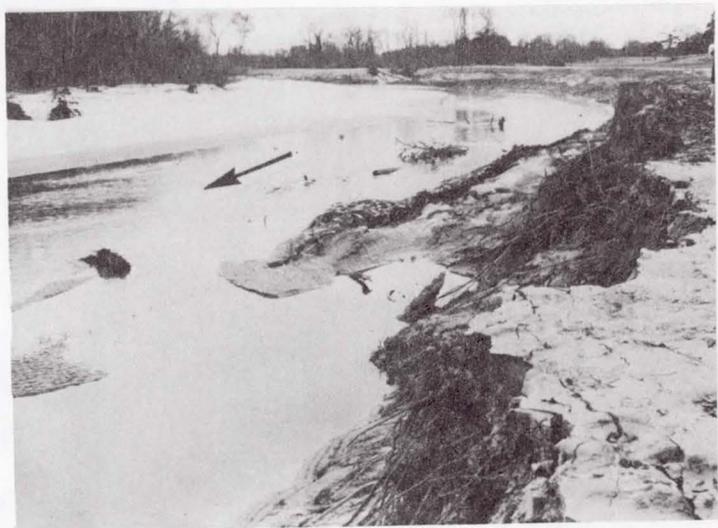
After Damage
Nov 1977

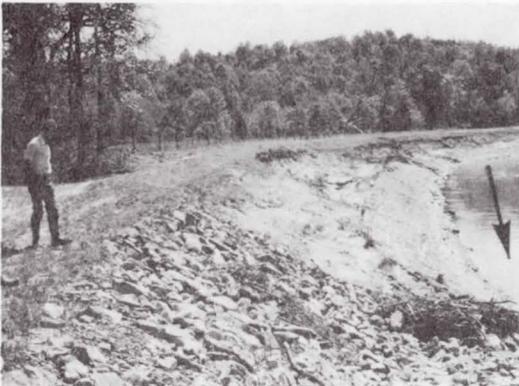
After Damage
Item 4A
Dec 1977

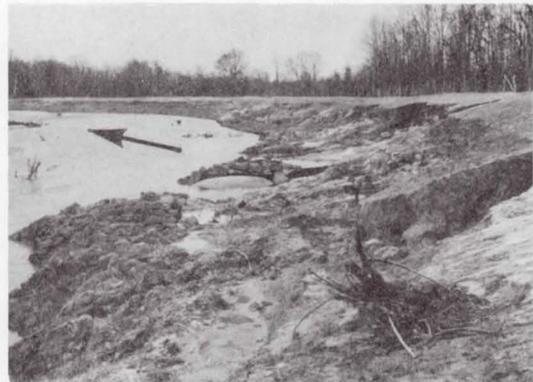
After Initial Rehab
Item 4A-1
27 April 1979

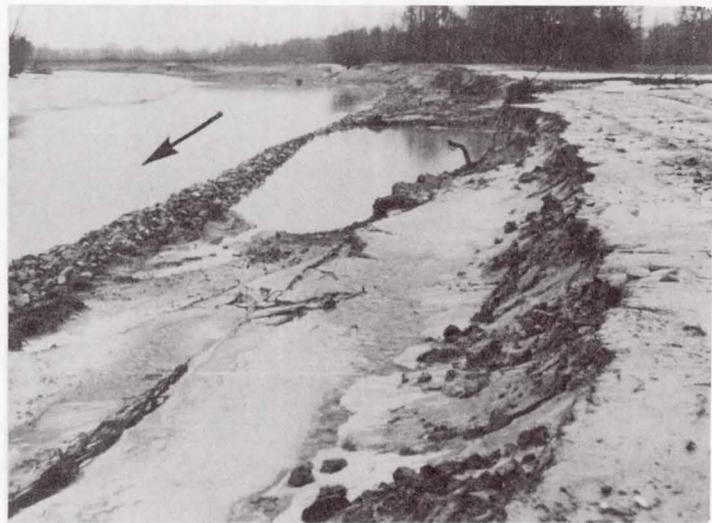
After Damage in Late
Nov 1977

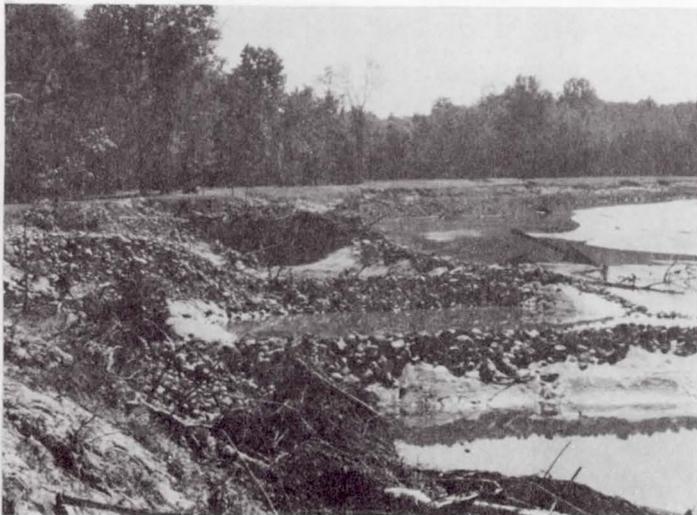
After Damage
July 1978

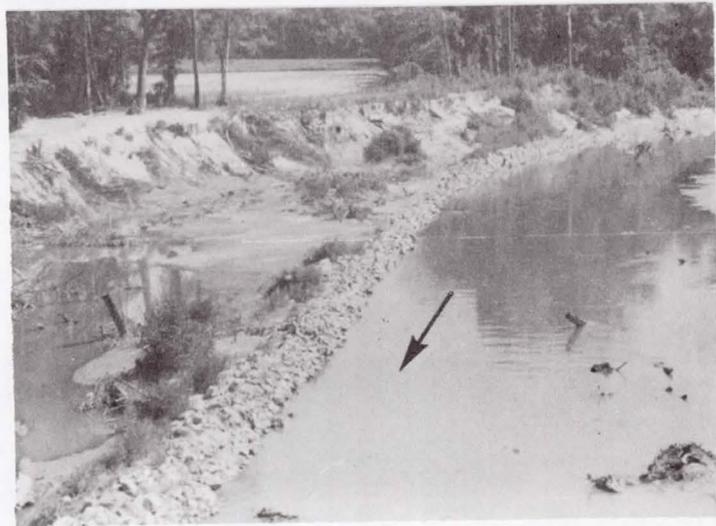
After Damage in 1977
July 1978

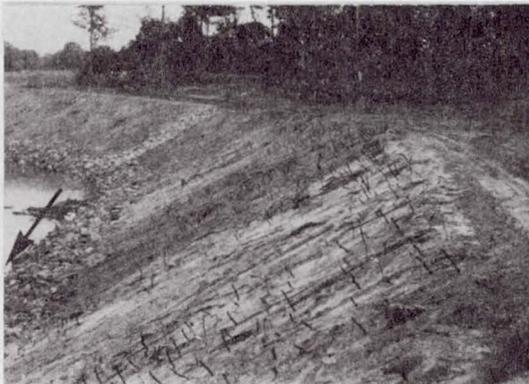
Tire Revetment
After Damage
Mar 1978

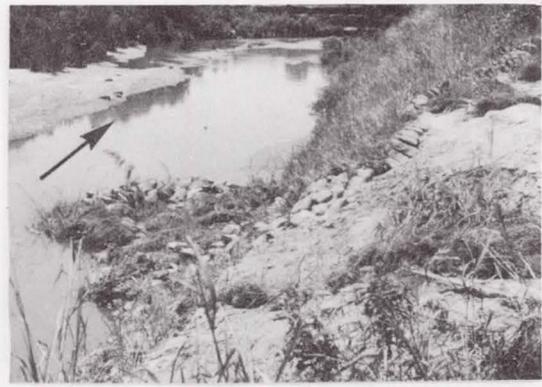
Looking Downstream After
Damaging Overbank Flows
and Slip Failure
Sand Cement Bag Revetment
July 1980

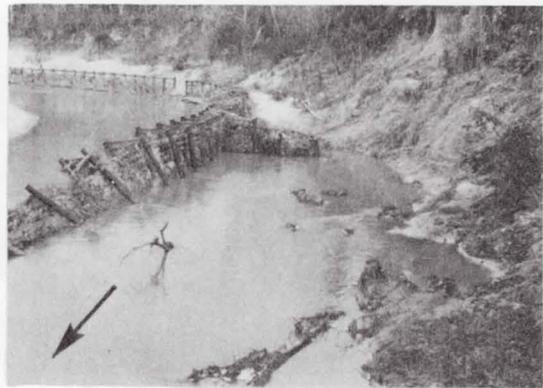
Bank Failure Behind Empty
Hay Crib Retards
Feb 1979

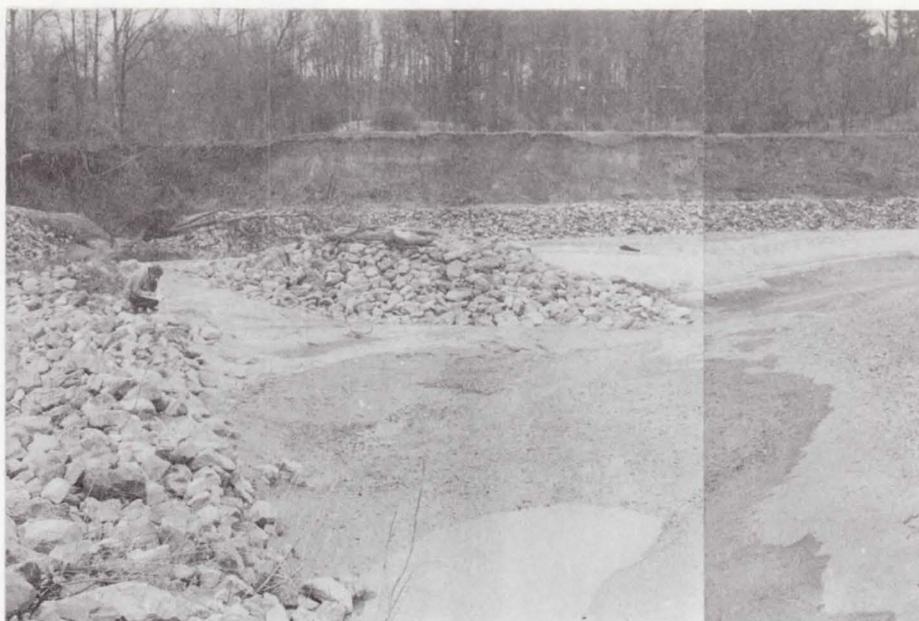
Failure, Dike 36; Item 1
North Fork Tillatoba Creek

Figure 99. Flanked dike failures, North Fork, Tillatoba

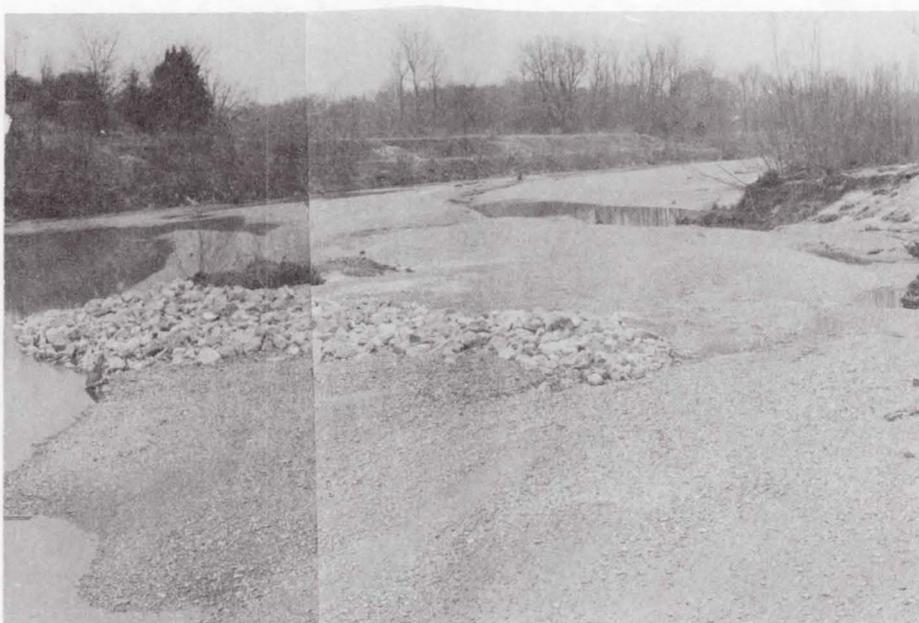
Failure, Dike 30; Item 1
North Fork Tillatoba Creek
