FINAL REPORT TO CONGRESS

**THE STREAMBANK EROSION CONTROL
EVALUATION AND DEMONSTRATION ACT OF 1974
SECTION 32, PUBLIC LAW 93-251**

Appendix G - Demonstration Projects on Other Streams, Nationwide Volume 2 of 2

APPENDIX G DEMONSTRATION PROJECTS ON OTHER STREAMS, NATIONWIDE

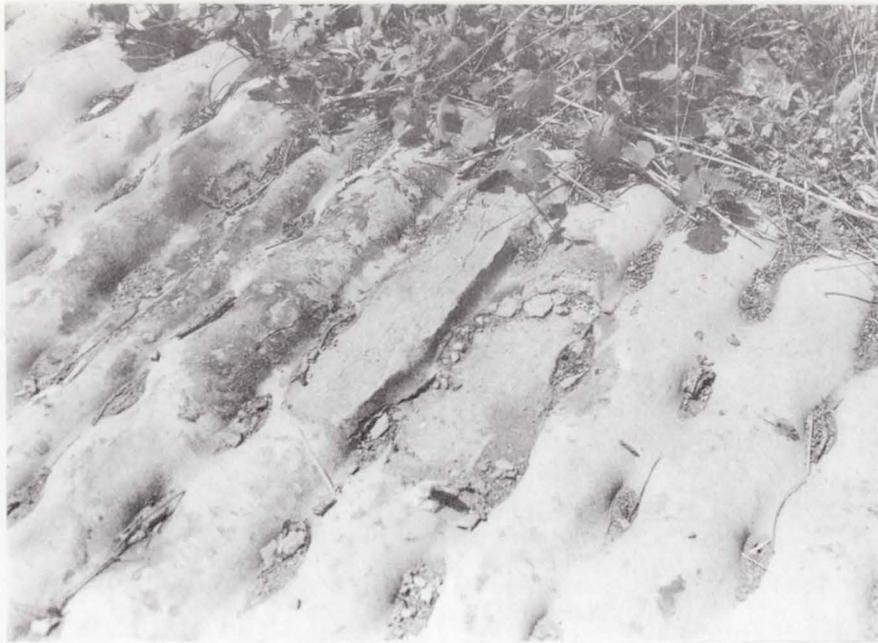
PHOTO 11. CONCRETE SPALLING OF THE EROSION CONTROL MAT. 1980.

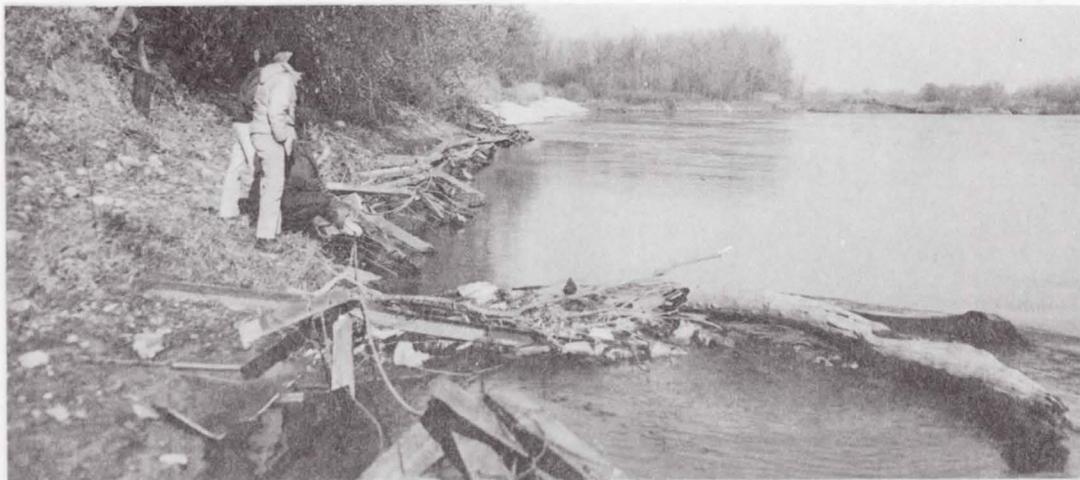
11. Rock Island District is now monitoring this project four times a year, including yearly surveys. Photo 10 is an example of the damage to the timber jetties. Some panels are bent or missing. Some panels were probably lifted off by ice action. Photo 11 illustrates some spalling on the surface of the erosion control mat, apparently the aftermath of a fisherman's campfire. The fabric covering of the erosion control mat has been cut by the jacks or cables in a few places. A break in the concrete erosion control mat was noted in April of 1981. The break is about 3 to 5 feet long. A knife blade could penetrate the break to about 1/2 inch, although the break is obviously the total depth of the mat. See photo 14. However, other than these minor problems, the fabric is in good condition. Photo 12 illustrates the damage to the steel jacks on the upstream end. The anchor cable securing these upstream jacks was broken during ice flow conditions.

12. Evaluation of Protection Performance. Flooding in the spring of 1979 resulted in some damage to timber jetties and to the steel jacks. This damage is shown in photos 10 and 12 as mentioned previously.

The erosion control mat and timber jetties protection has been effective in reducing additional bank erosion. The steel jacks, however, were not as effective as planned. This is probably due to two conditions. One, water and ensuing debris are moving too fast when they strike the steel

PHOTO 12. STA 6+00 LOOKING UPSTREAM AT DAMAGED STEEL JACKS.
14 NOVEMBER 1979.

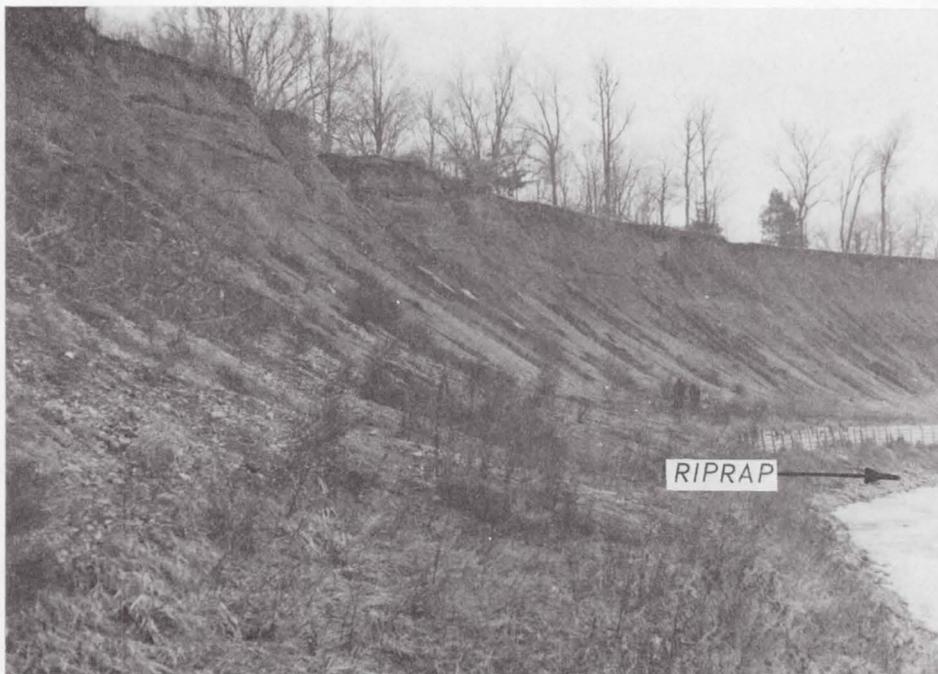
b. Sloughing of the upper slope should be slowed by continued growth of weeds and grasses. However, the slope will continue to flatten toward its natural angle of repose (1.5H to 1V). Condition of the upper slope is the responsibility of the locals and they are aware of that.

PHOTO NO. 4. Completed project showing unstable condition of upper bank. This bank is expected to gradually stabilize at its natural angle of repose.

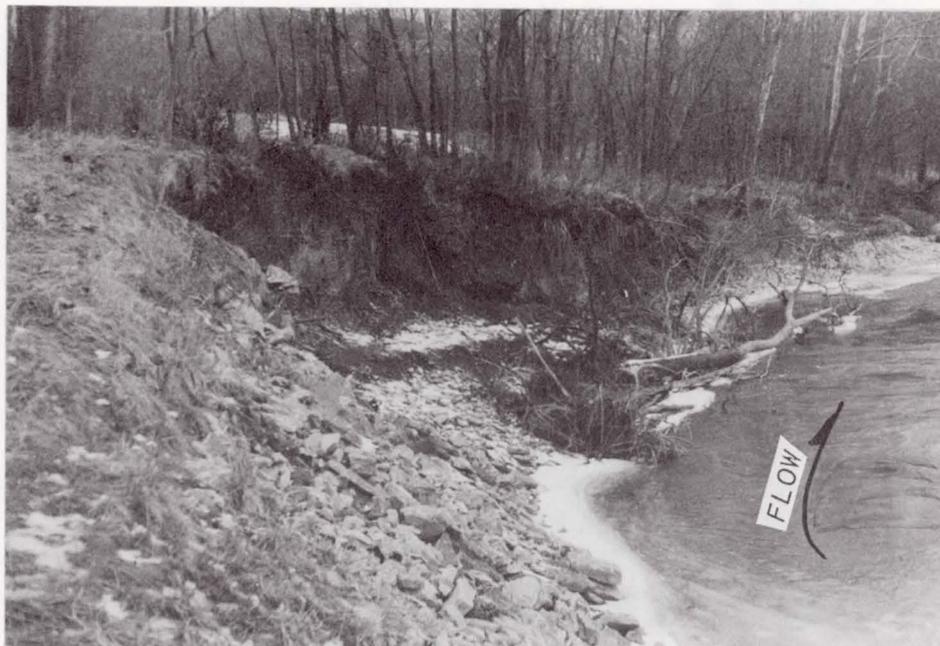
PHOTO NO. 5. 5 Jan. 81. Erosion downstream end of project. Repair of this transition to natural section will be required.

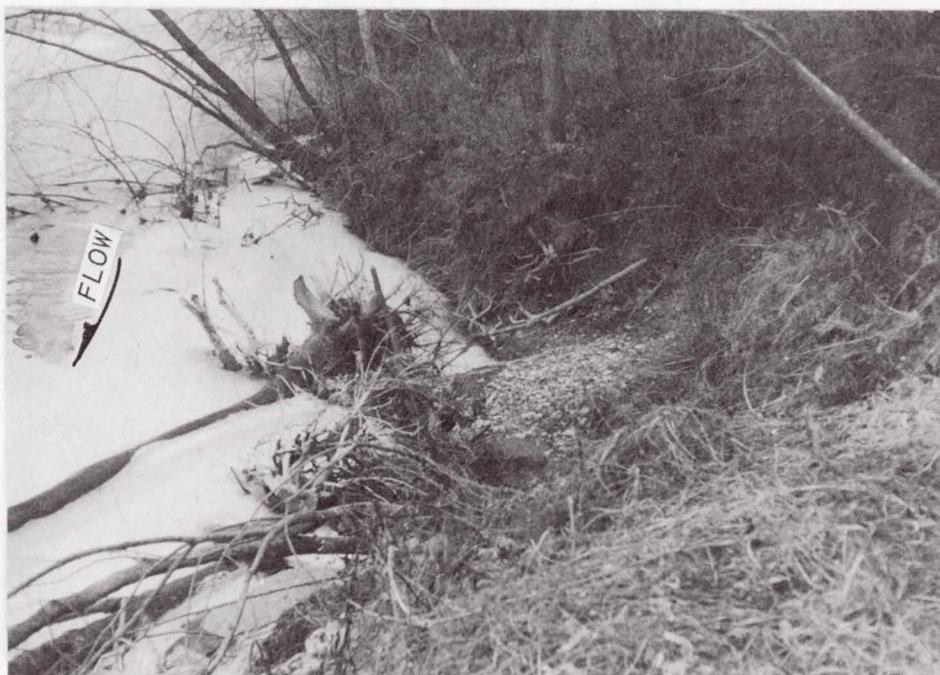
PHOTO NO. 6. Jan 81. Erosion upstream end of project. Transition repair will be required here also.

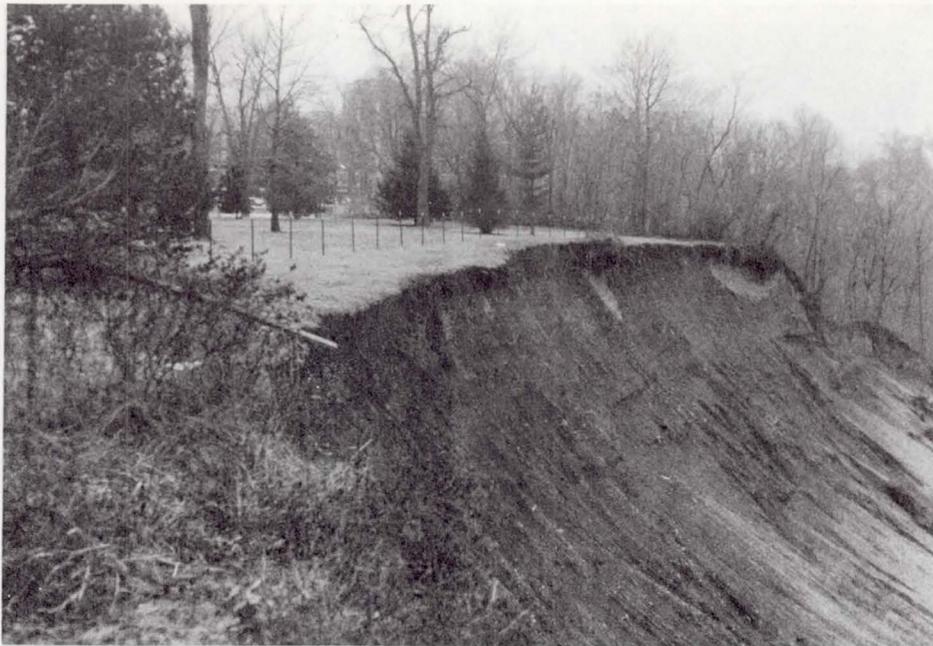
PHOTO NO. 7. Jan. 81. Very steep upper bank. Bank will continue to recede until stable slope is reached.

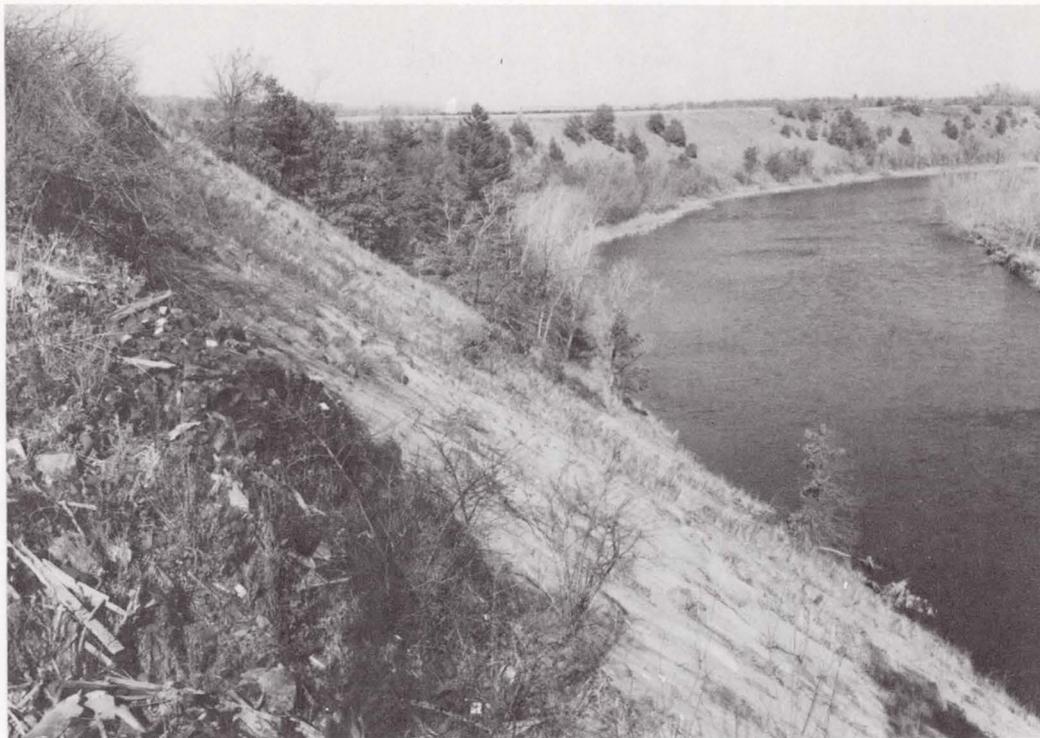
4. Problem Resume. Erosion along the Lower Chippewa River is of two types: (1) high bank erosion and (2) low bank erosion. The high bank chosen for protection is more than 100 feet high and is being eroded by undermining of the bank below the normal water surface which causes the material to slide. See photo 1 for typical high bank erosion. Low bank erosion occurs on banks generally 5 to 15 feet high. These banks are eroded in the same manner. Undermining beneath the water surface causes the material to slide while ground cover reinforces the soil at the top of the bank. This soil becomes cantilevered as erosion progresses and eventually breaks away. See photo 2 for typical low bank erosion.

PHOTO 1. SITE NO. 3 - HIGH, LOOKING UPSTREAM, BANK ABOUT 100 FEET HIGH, 30 OCTOBER 1980.

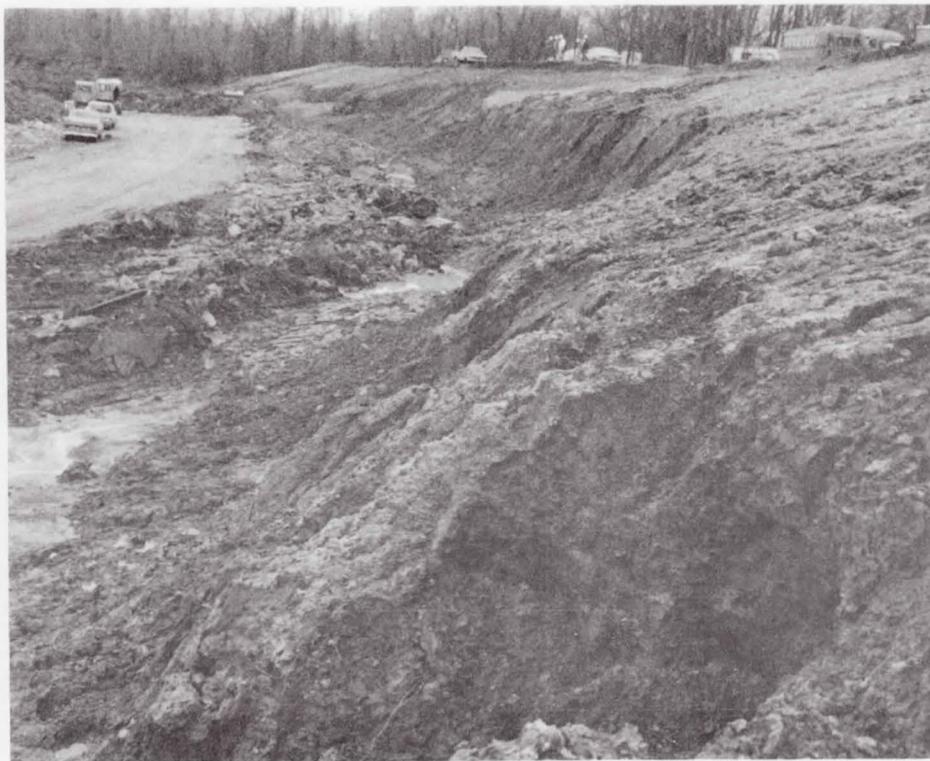
PHOTO 6

VIEW DOWNSTREAM
BANK FAILURE AFTER GRADING

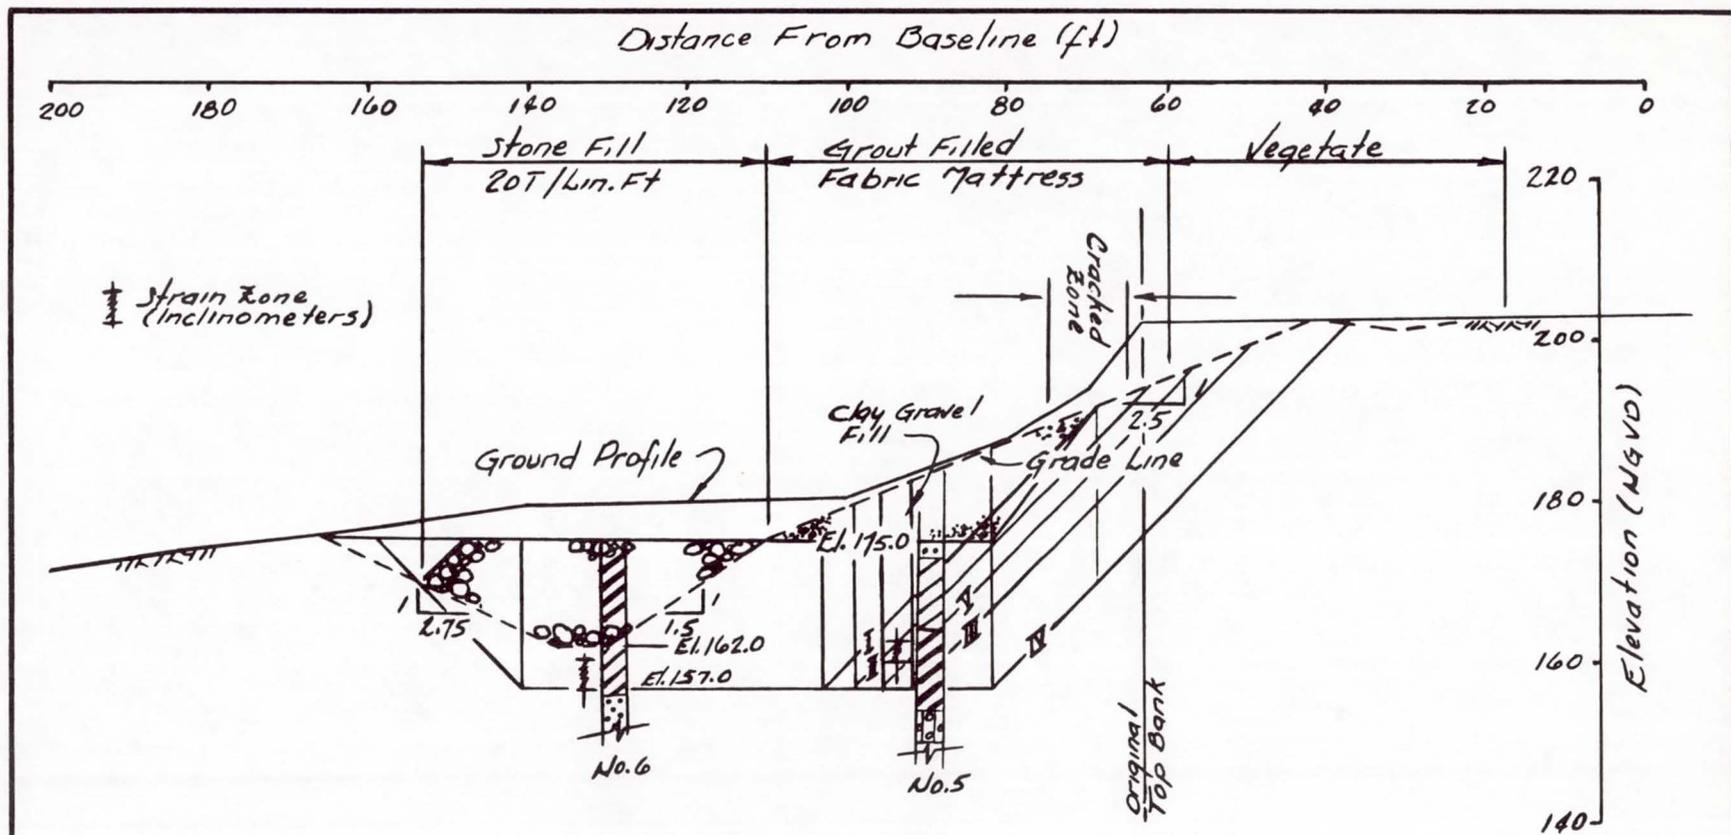
recession of the next highwater against the banks. The rock filled toe trench lacks adequate depth and mass to be effective in halting failure and may be expected to be carried out with the failing embankment. Following the occurrence of the expected failure it may be anticipated that a mechanism of failure similar to that described in the Memo for Record attached to the Bank Stability Study (Appendix A) will again develop within the bluffs. It is further concluded that the developing failure may be attributed to the failure to construct the rock filled toe trench to adequate depth and section and to the failure to set the grading limits back sufficiently to assure all of the graded bank landward of the toe trench would be in undisturbed material.

h. Recommendations. Since the program under which the project was constructed is experimental in nature, it is recommended that the monitoring of the instrumentation be continued with significant occurrences being evaluated and documented. Due to the experimental nature of the program, funds should be made available to rectify problem areas which develop or rehabilitate the project in the event of a general failure of the soil mass.
