Report on FLOODING IN EASTERN MARICOPA COUNTY JULY 17-18, 1984

prepared by

Timothy E. Sutko, Hydrologist

November 15, 1984

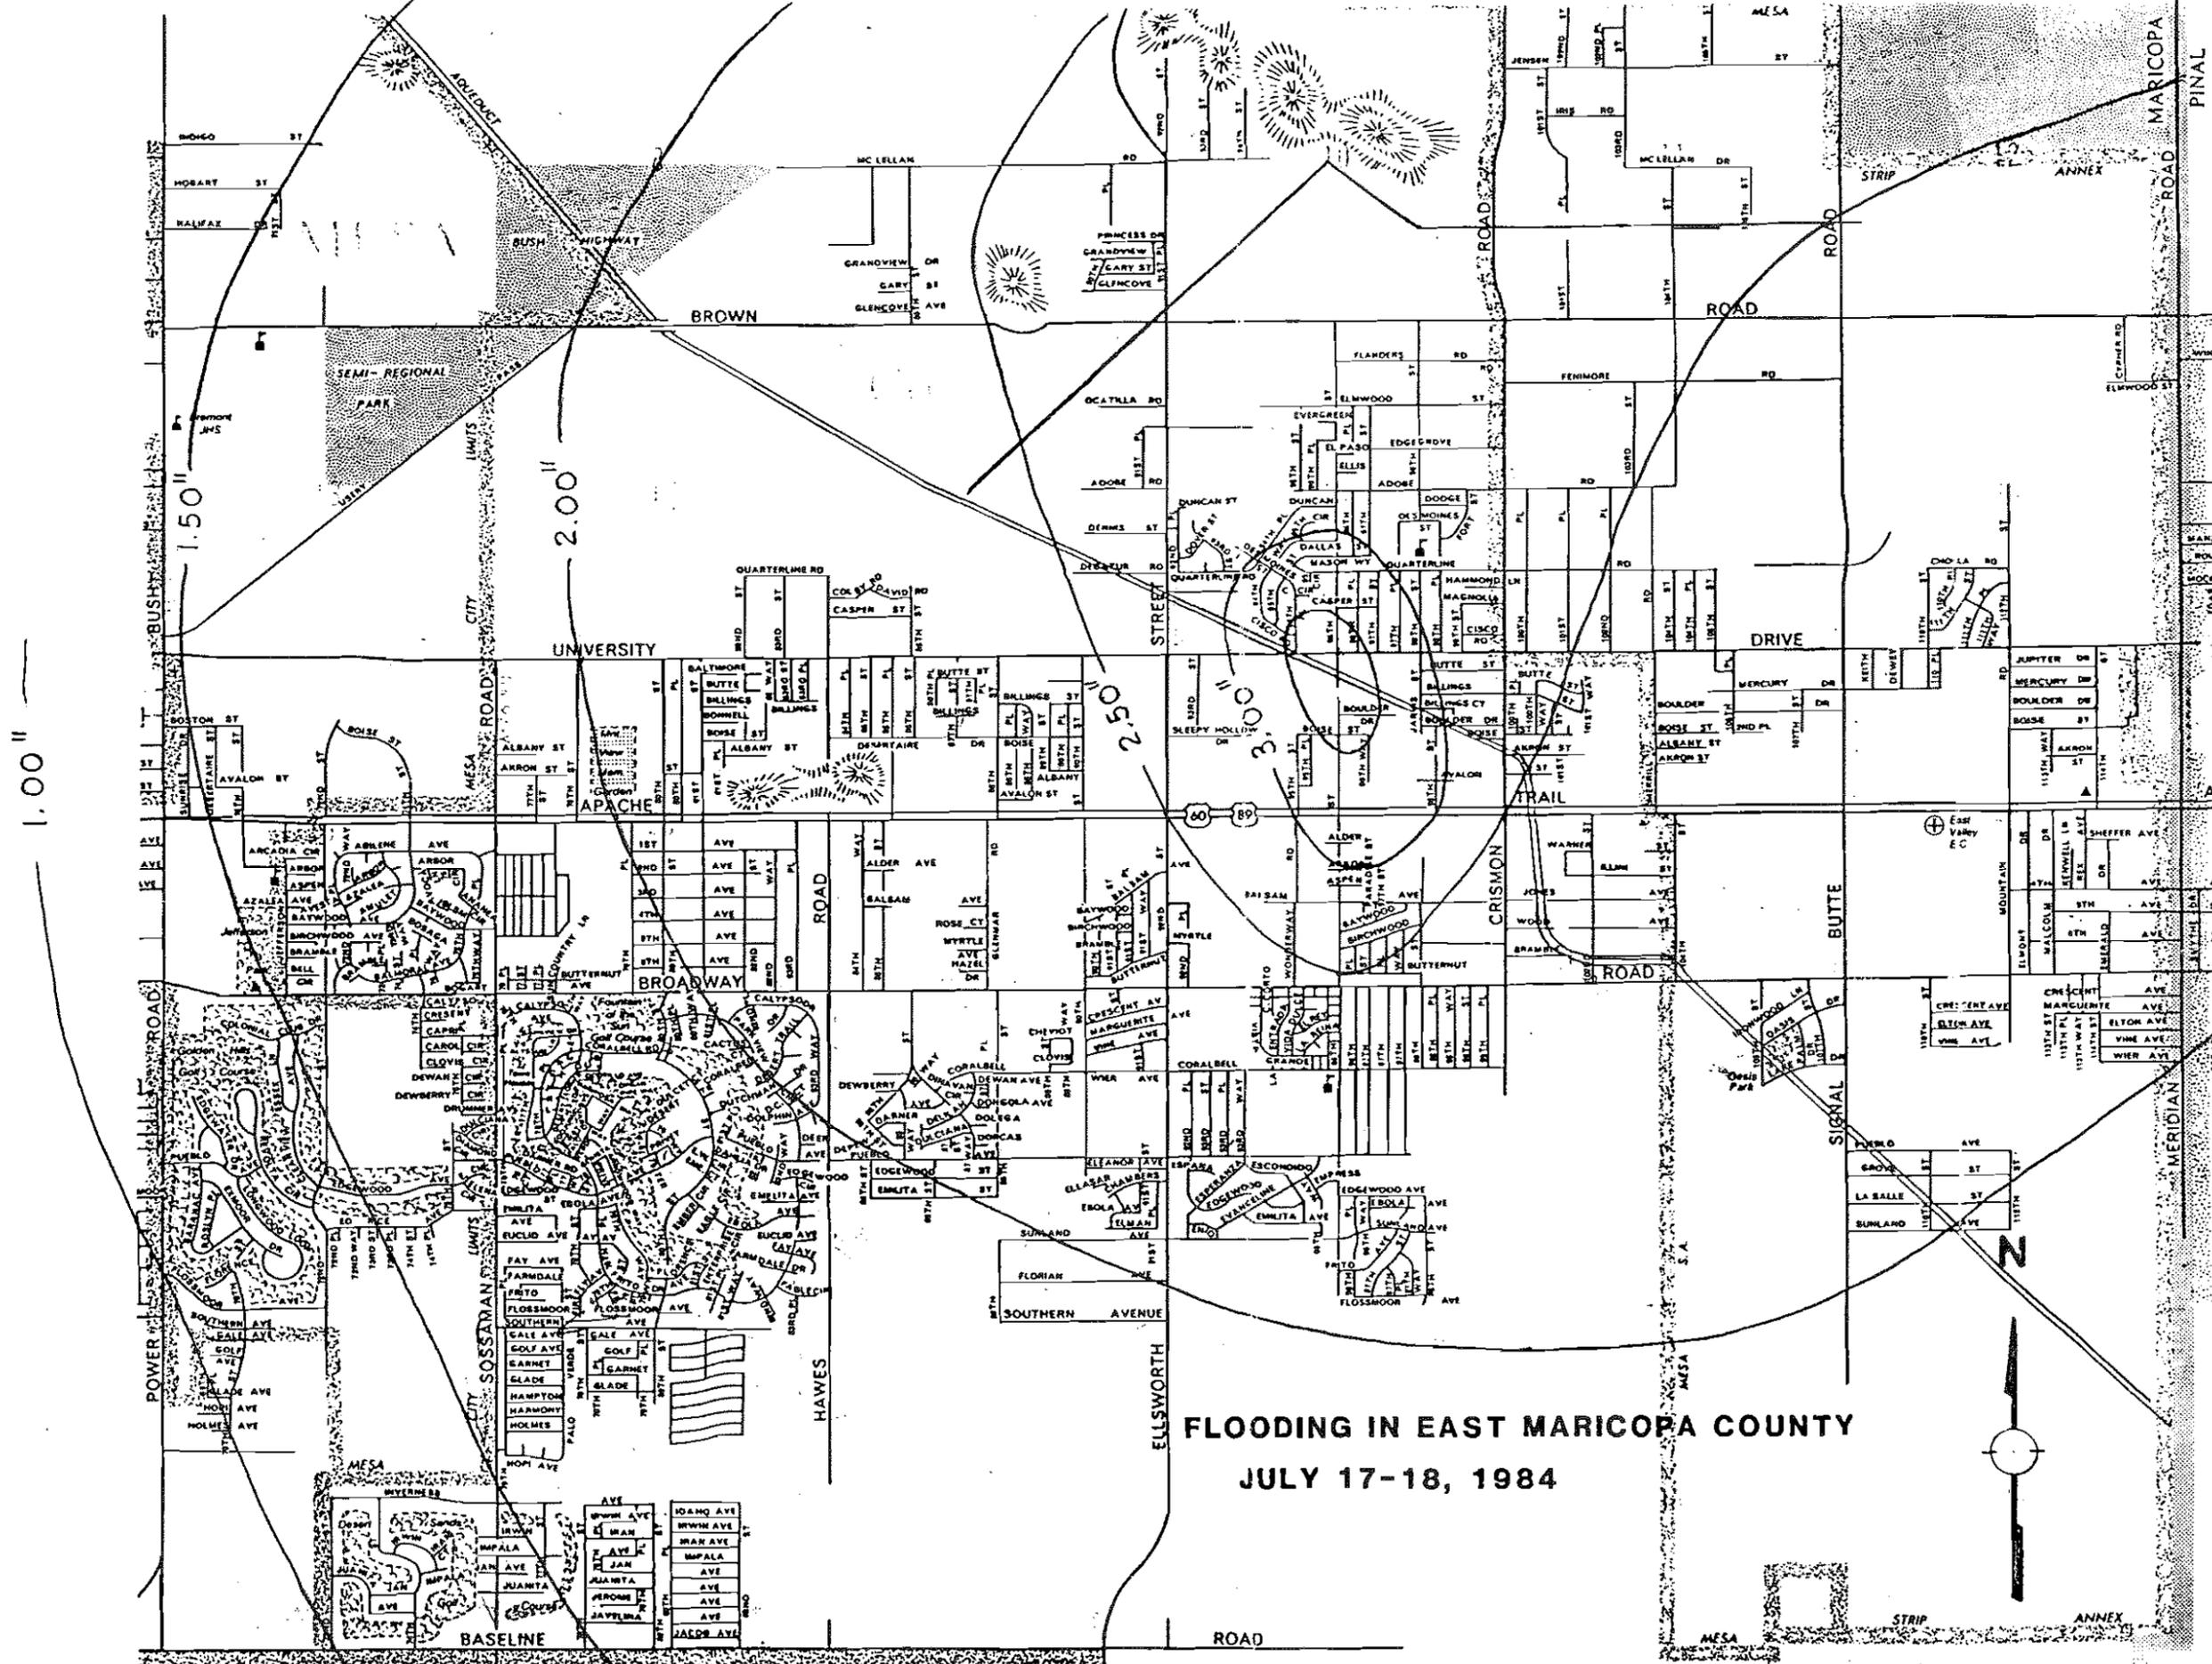
FIGURE 1: ISOHYETS FOR STORM OF JULY 17-18, 1984

Three of the rain gauges located in the study area recorded total rainfall depths in excess of 2.60 inches; two of these were greater than or equal to 3.75 inches. This indicates that in parts of the study area this storm had a return period greater than the 100-year point precipitation values used for subdivision and development drainage review.

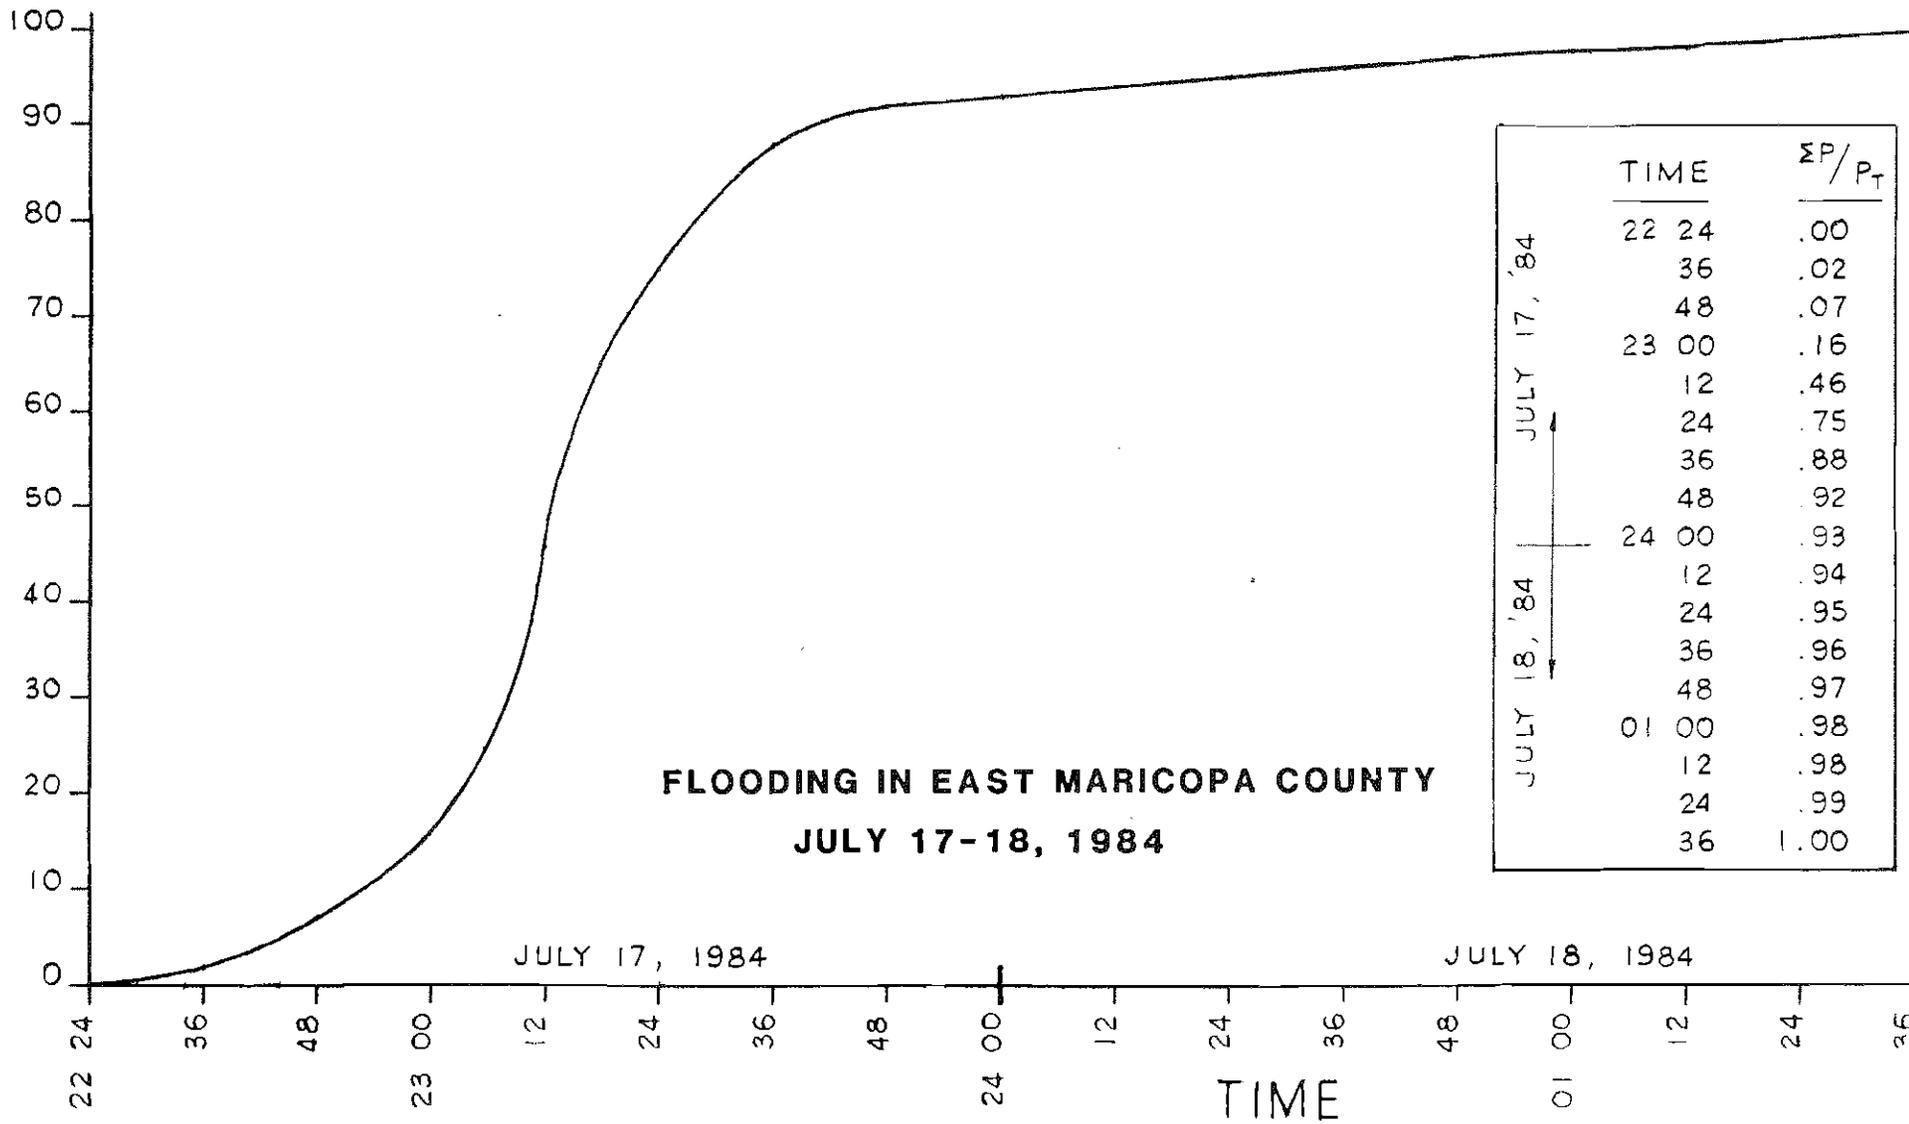
FIGURE 2: MASS CURVE FOR PRECIPITATION V.S. TIME (12 MIN. INTERVAL)

Data provided by the recording rain gauges indicated the storm began at approximately 10:30 p.m. with highly intense rainfall until 11:30 p.m. and rainfall ceasing at approximately 1:00 a.m. A mass curve (Figure 2) was drawn from the data to provide a temporal distribution of the rainfall for model input.

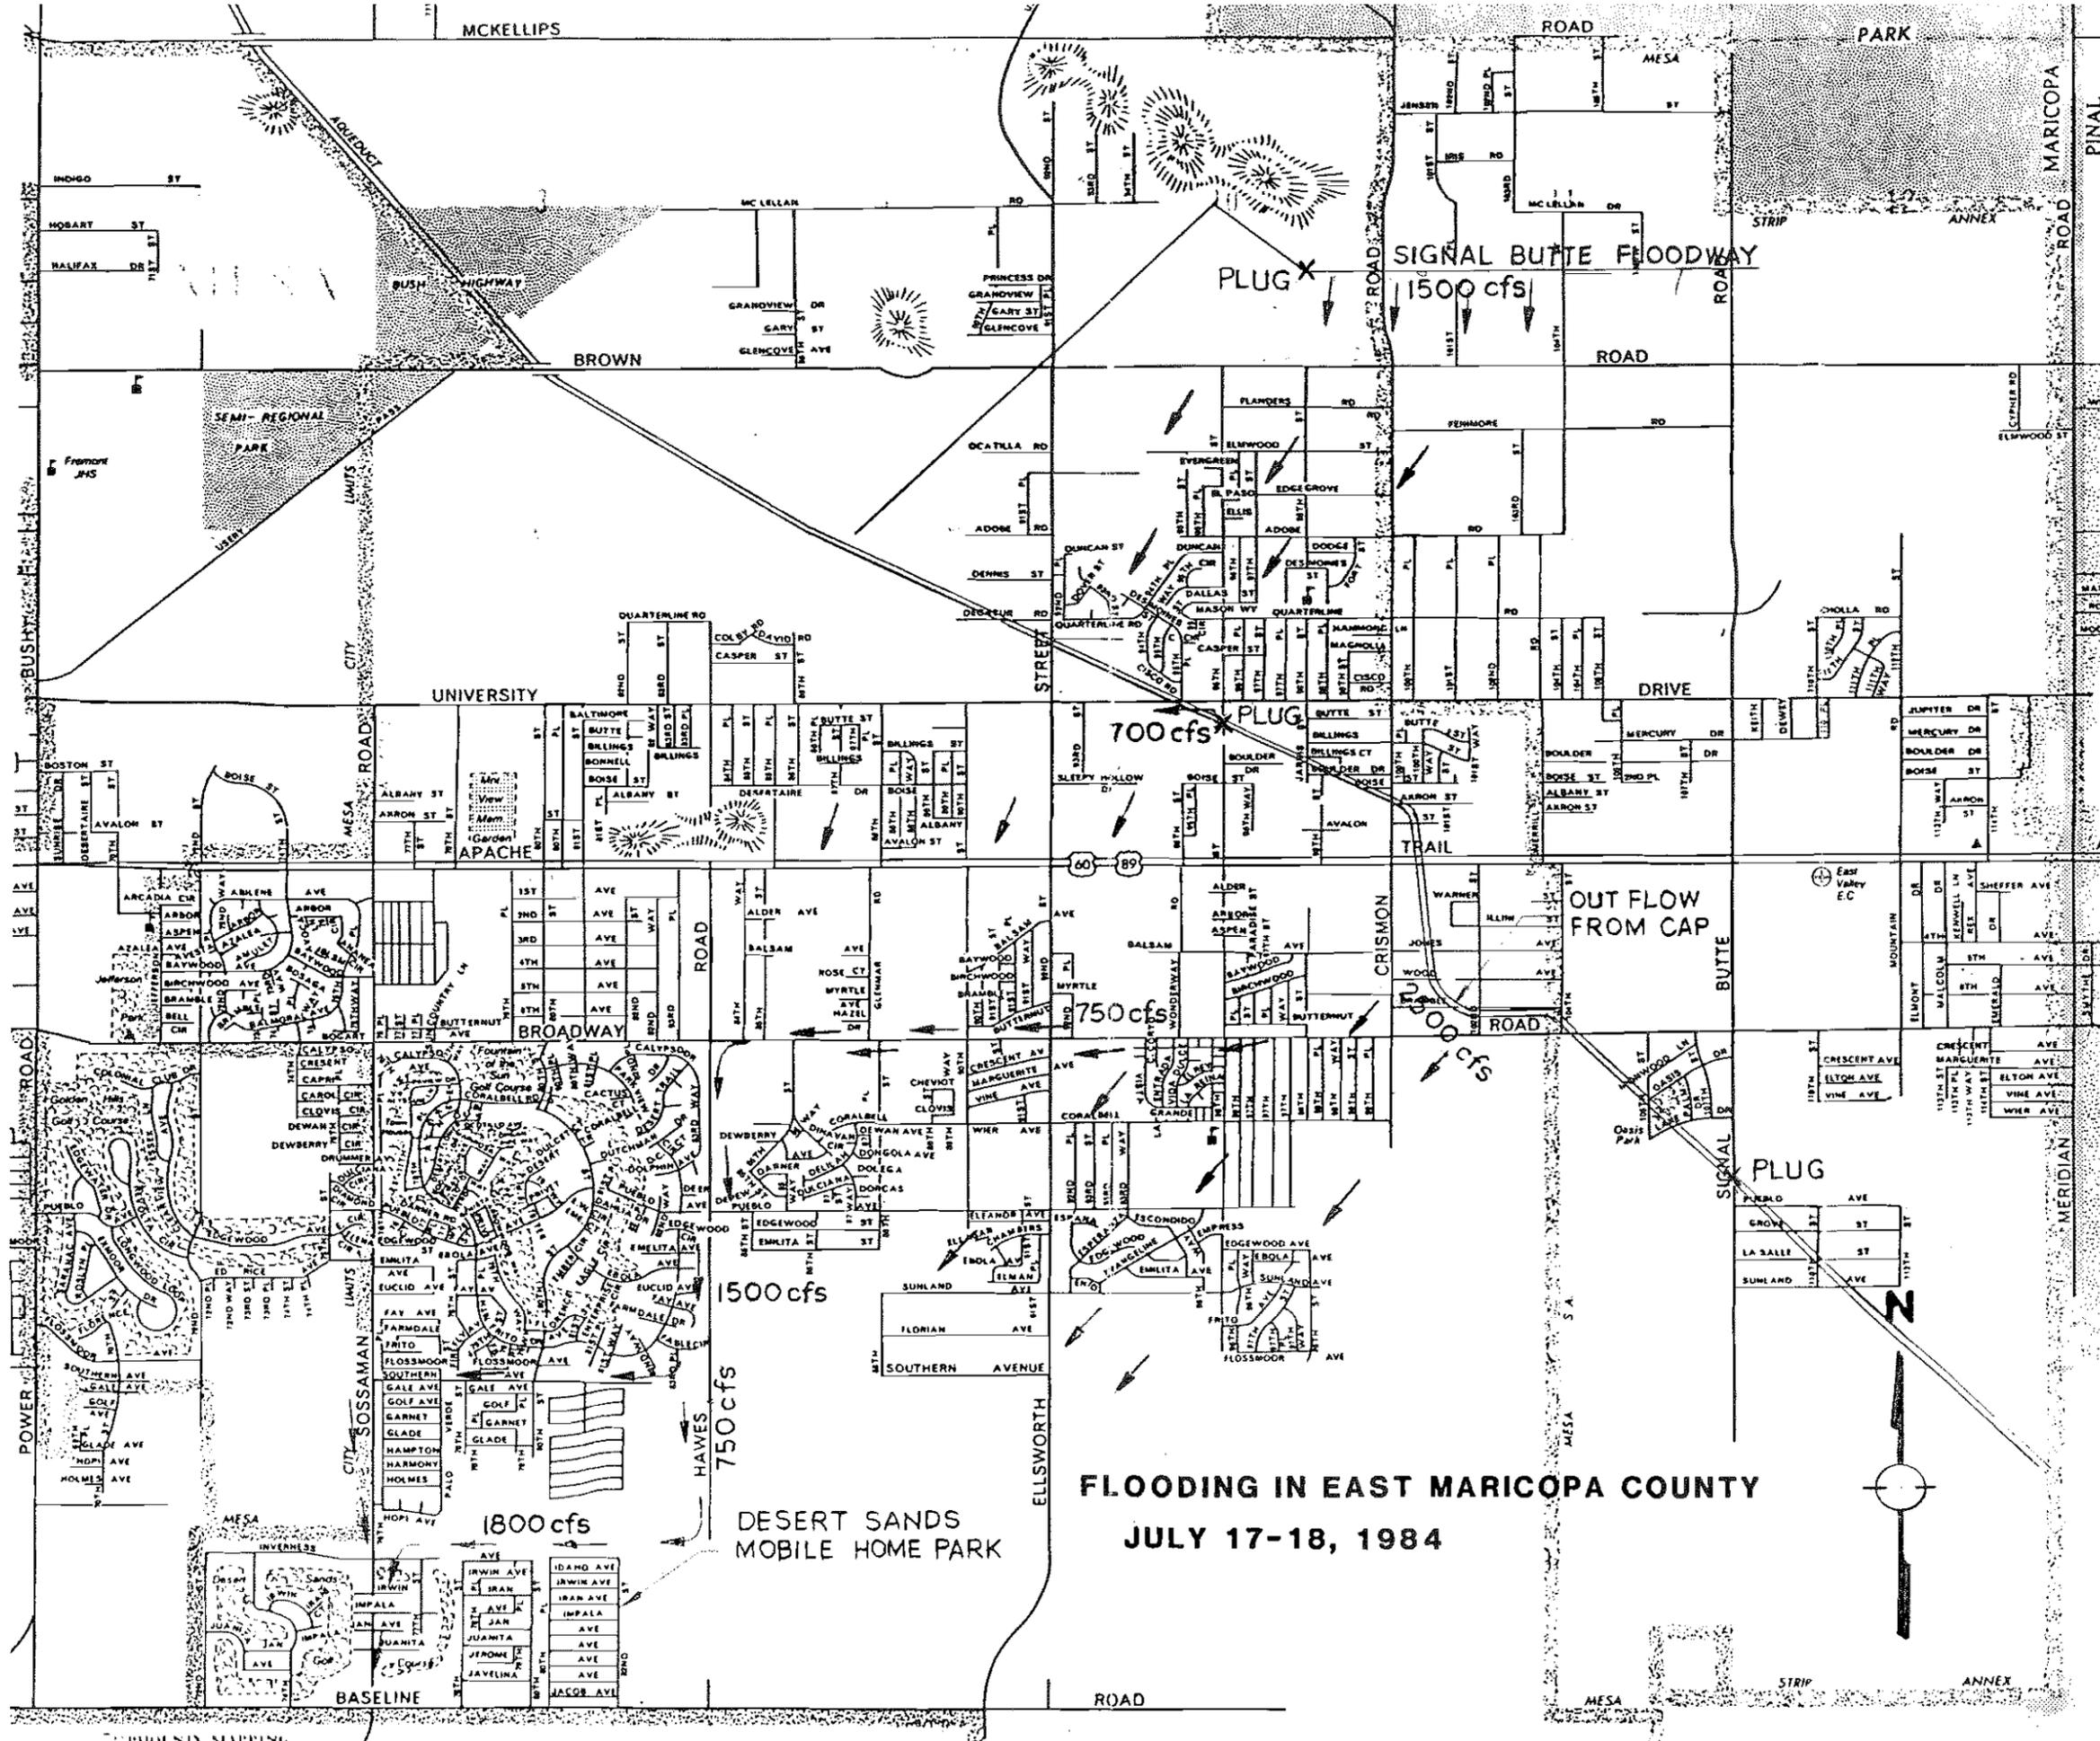
FIGURE 3: OVERVIEW OF RUNOFF RESULTING FROM STORM OF JULY 17-18, 1984

A pictorial summary of the runoff resulting from the storm of July 17-18 is provided in Figure 3.

The lined section of Signal Butte Floodway was separated from the unlined section by an earthen plug at their juncture. The apparent purpose of this plug was to aid in "tie-in" work at the juncture of the lined and unlined sections. As a result, runoff from the drainage above the unlined section first filled and then overtopped that section of the floodway. Approximately 75 acre-feet of runoff were stored in the unlined section of the Signal Butte Floodway.

At some time the inflow to this area greatly exceeded the outflow into the collection channel and severe ponding, as deep as 3-4 feet, occurred in the area of University Drive and 96th Street. Highwater marks on the University Drive bridge indicate that in excess of 700 cfs flowed over the bridge in a westerly direction. This flow then continued as sheetflow and as channel flow in the existing drainage patterns in a southwesterly direction.

In excess of 120 acre-feet of water was stored in the aqueduct until the water surface elevation exceeded the elevation of an overchute excavation on the downslope side of the aqueduct in the vicinity of Broadway Road.

Runoff exiting the aqueduct at this point caused erosion of the aqueduct embankment which in turn allowed the previously stored water to exit. Failure of the embankment at this section was gradual.

The peak discharge of these combined flows was approximately 1800 cfs. This exceeded the capacity of that drainage channel and caused some flooding in the Desert Sands Mobile Home Park. This flow was ultimately captured by the Sossaman Road drainage channel.

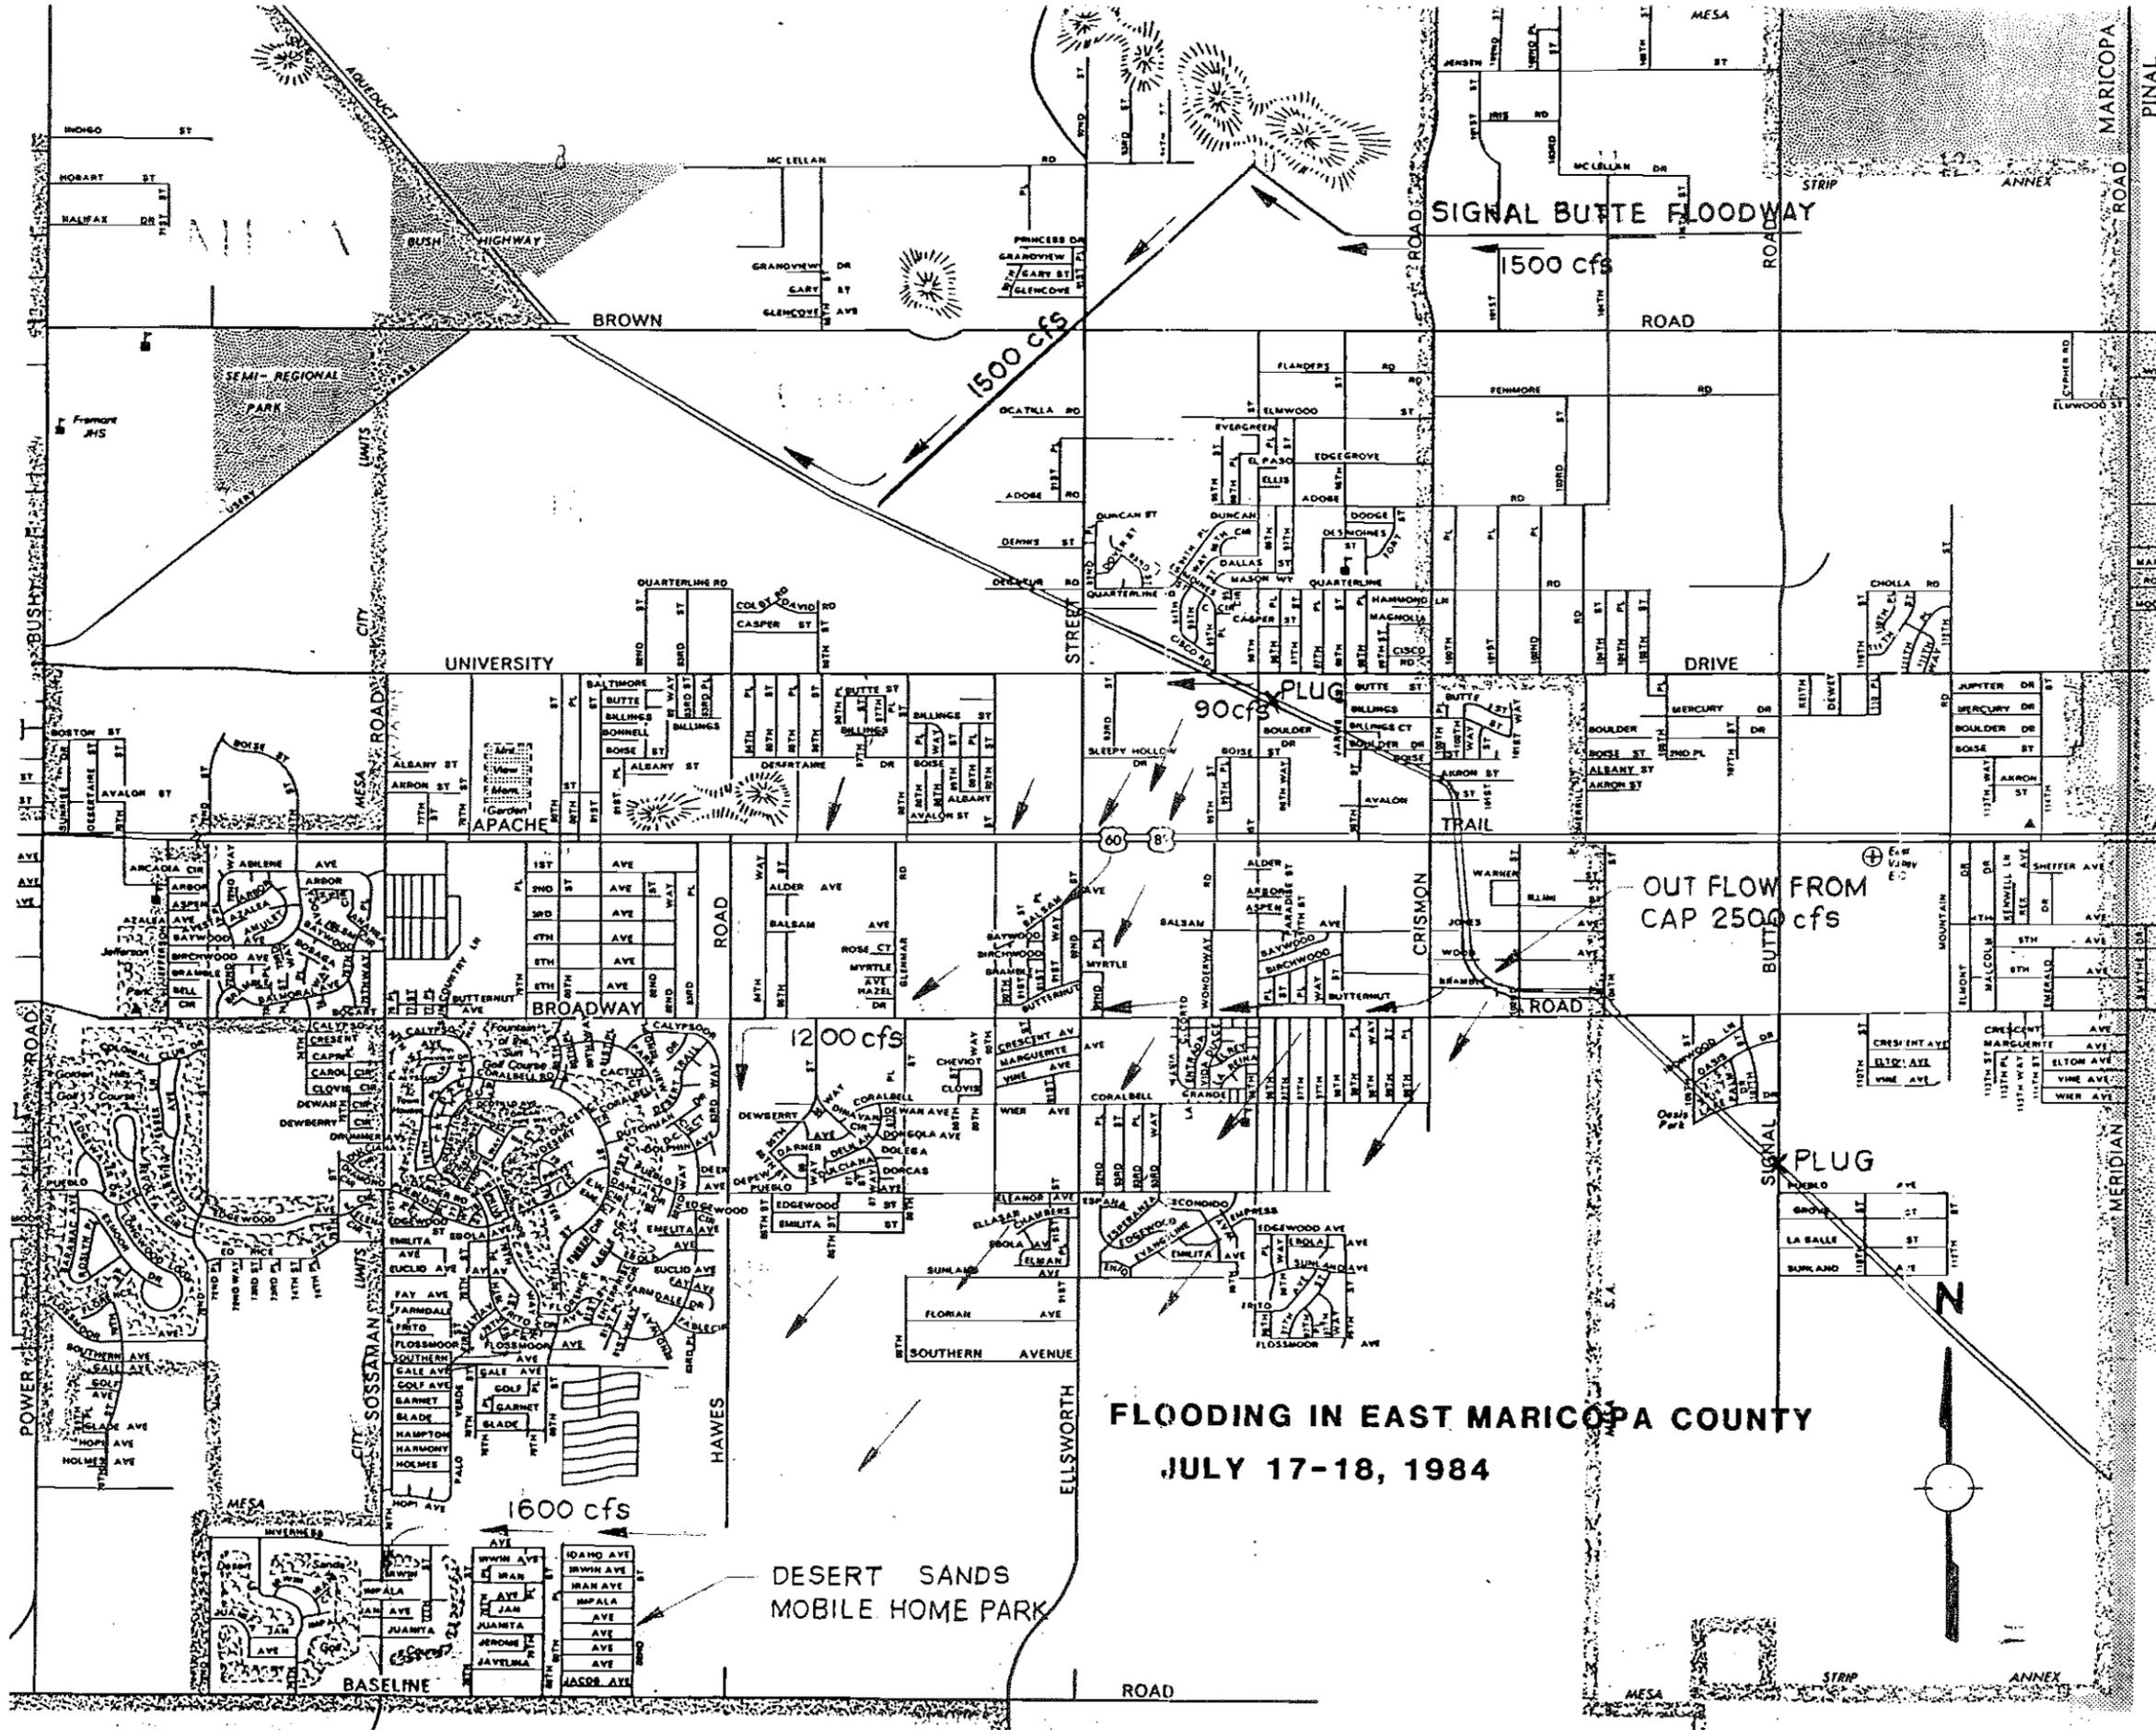
FIGURE 4: OVERVIEW OF RUNOFF RESULTING FROM SITUATION 2 (SIGNAL BUTTE FLOODWAY OPERATIONAL)

A pictorial summary of the runoff described in the following discussion is provided in Figure 4.

The area most directly impacted by the construction of the Signal Butte Floodway was that area immediately below it which received the overflow from that structure; specifically, the Desert Vista Estates subdivision located in the vicinity of 96th Street and University Drive. A comparison of peak flows through this area for actual conditions (see above section), and those which might have occurred had the structure not been in place, provide a measure of its effect. The peak flow under actual existing conditions was approximately 800 cfs; under this hypothetical condition the flow would have been 1200 cfs,

or an increase in peak discharge of 50%. Stated differently, the Signal Butte Floodway, even in its partially constructed form, significantly reduced the flows.

On the other hand, had this floodway been fully operational at the time of the storm, the peak flow into this area would have been less than 550 cfs or a reduction in peak flow of nearly 30%. Additionally, the flow over the University Drive bridge would have been reduced from 700 cfs to only 90 cfs, thereby alleviating, if not eliminating, the flooding on the west side of that bridge and further south.

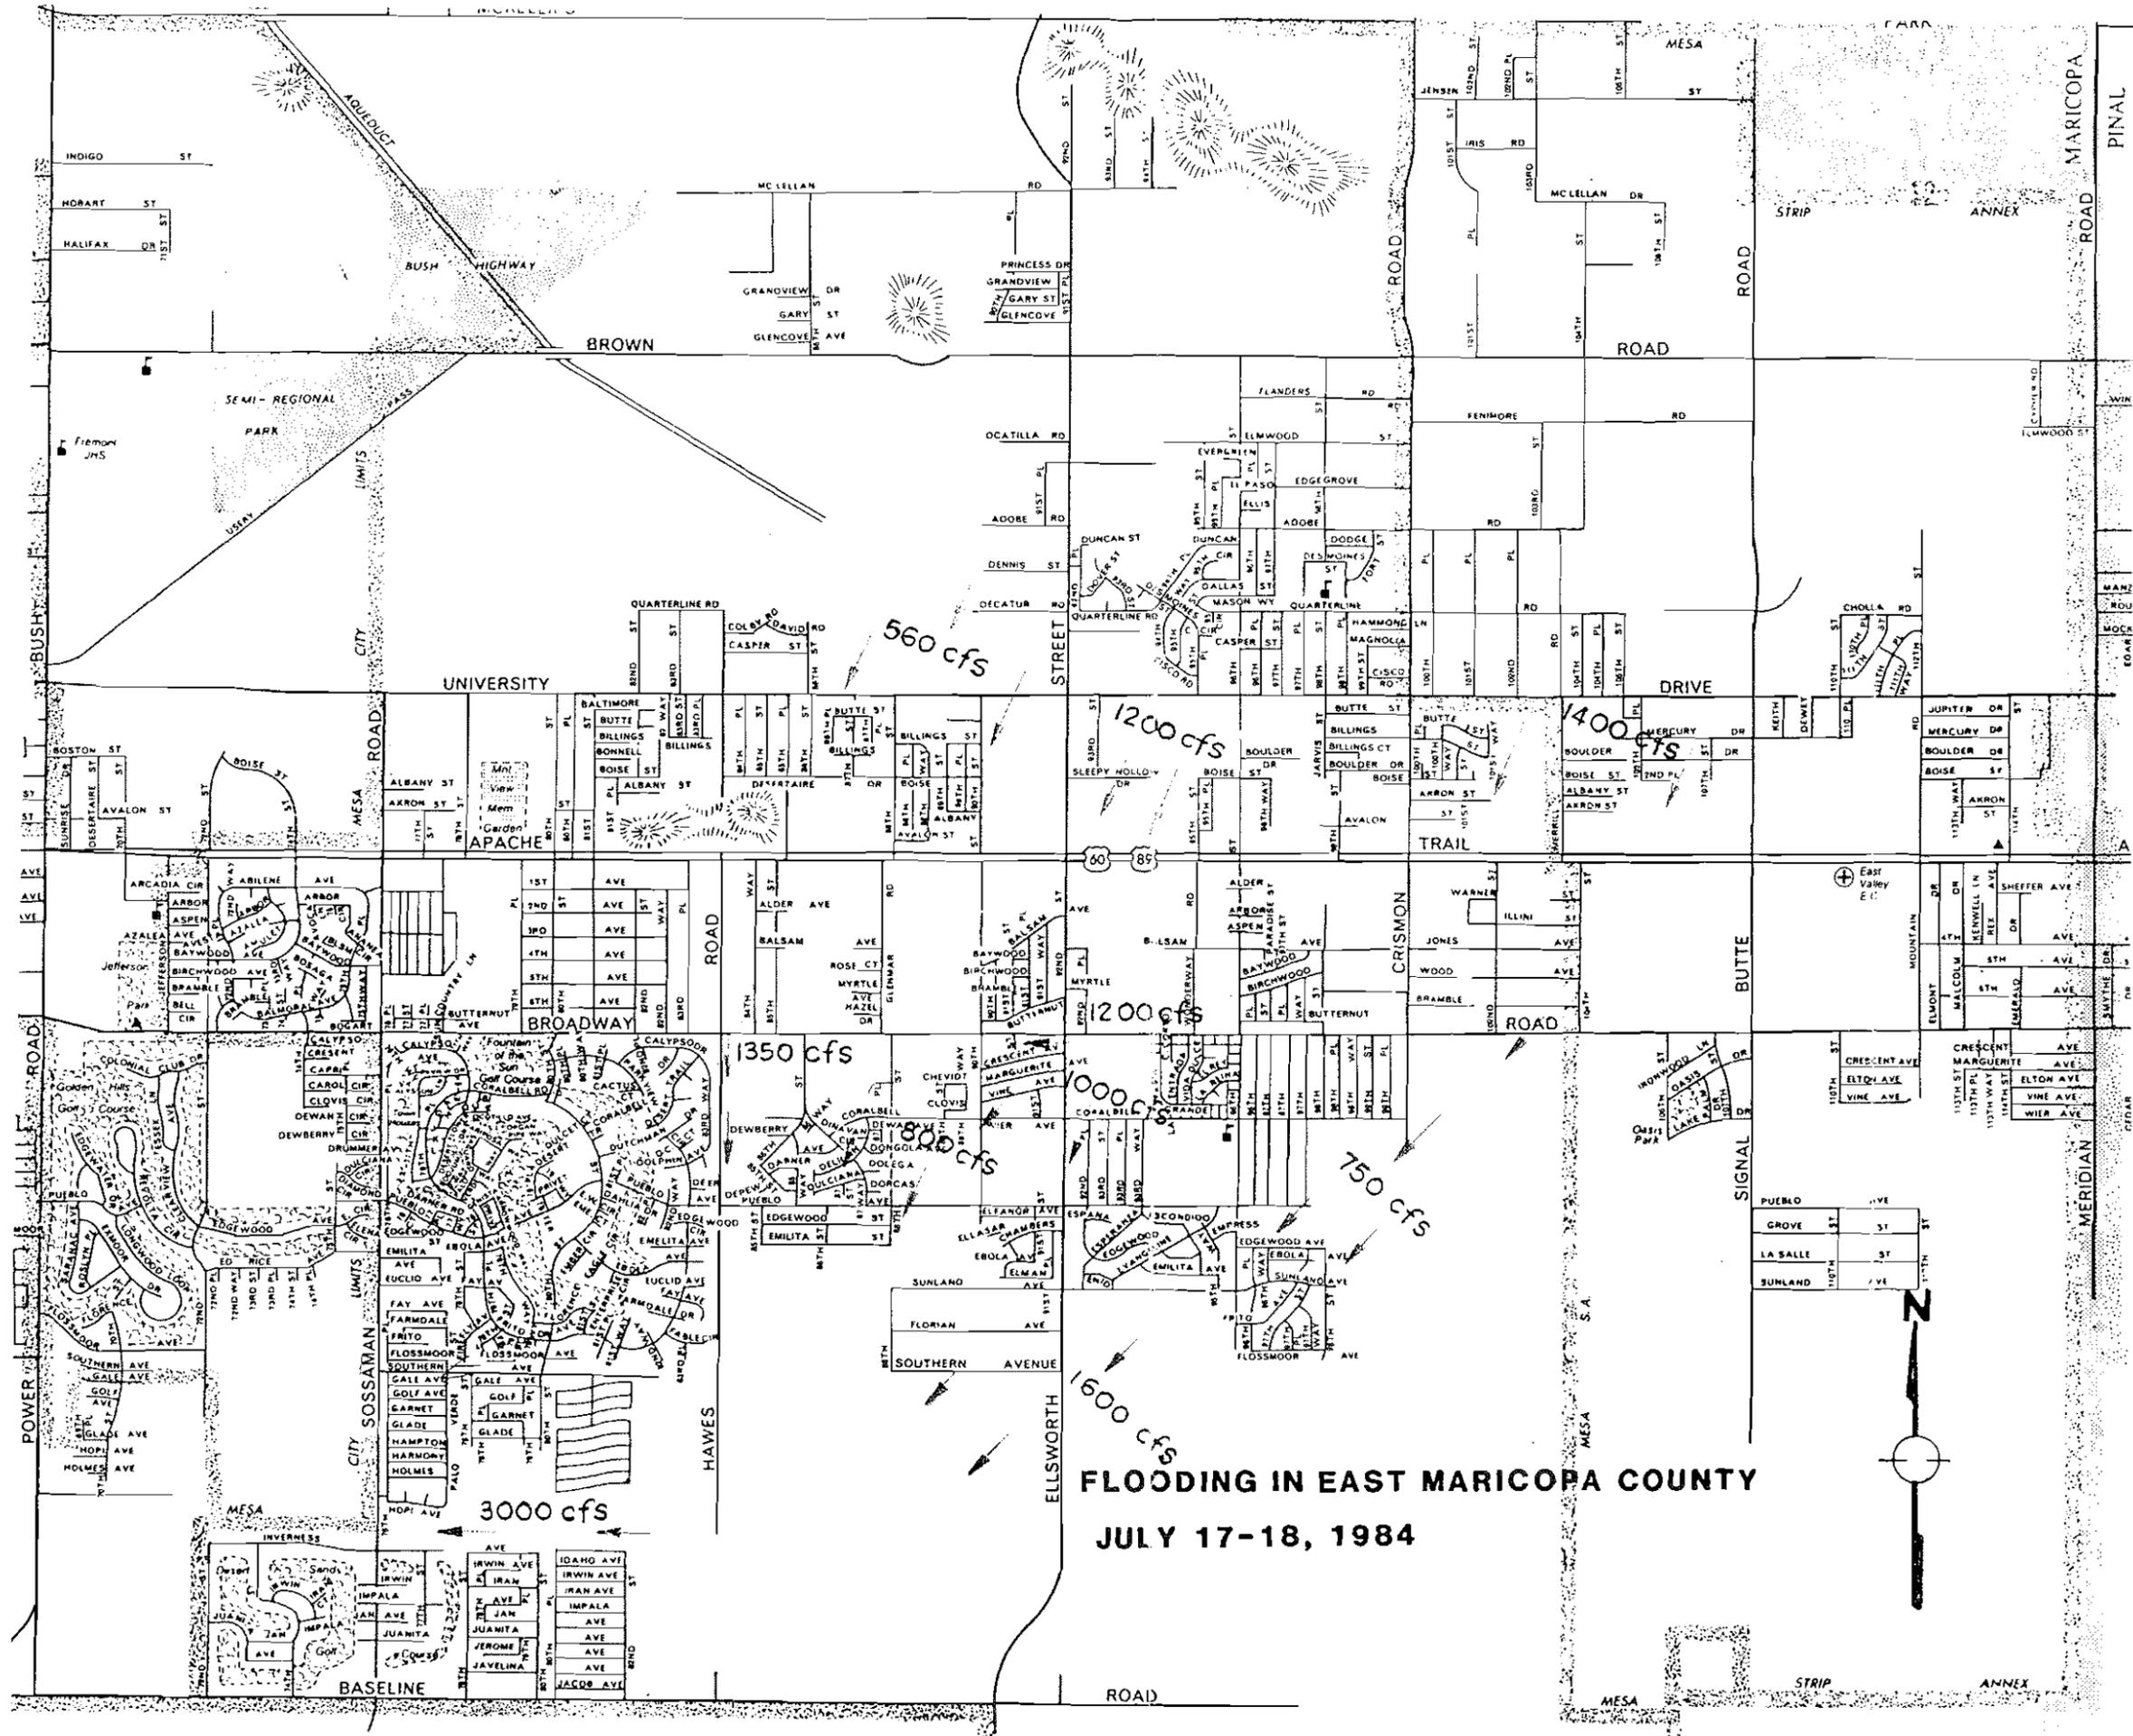
FIGURE 5: OVERVIEW OF RUNOFF RESULTING FROM SITUATION 3

A pictorial summary of the runoff described in the following discussion is provided in Figure 5.

After entering the aqueduct this water was stored until the water surface elevation exceeded the elevation of an overchute excavation site on the downslope side. This stored volume of water then exited the aqueduct at this point. The effect of the aqueduct, then, was to funnel a large volume of runoff to a single outlet. The peak flow through the area in the vicinity of 96th Street and Pueblo Avenue under these conditions was approximately 1800 cfs. Without this funneling effect, the peak flow at that point would have been approximately 750 cfs.

However, this is not to say that flooding would not have occurred under pre-construction conditions. Rather, different areas which were not inundated under actual conditions would have been subjected to flooding. For example, under actual conditions Broadway Road and the bordering blader ditches did not flow much in excess of their capacity, if at all, west of Ellsworth Road. Had the aqueduct not been in place, the capacity would have been exceeded by approximately 1100 cfs near Ellsworth Road and by 800 cfs near 88th Street. This would have resulted in flooding of the areas south of Broadway Road between Ellsworth Road and Hawes Road.

Under actual conditions, the drainage channel on the north side of Desert Sands Mobile Home Park experienced a peak flow of 1800 cfs, which exceeded its capacity. As a result, some mobile homes in this area experienced some flooding. Model output indicates that this channel would have received a peak flow of 3000 cfs under pre-construction conditions.
