# Individual Structures Assessment Report

Spook Hill FRS  
Signal Butte FRS  
Apache Junction FRS

## Structures Assessment Program - Phase 1

FCD No. 98-41/PCN PLAN.01.00

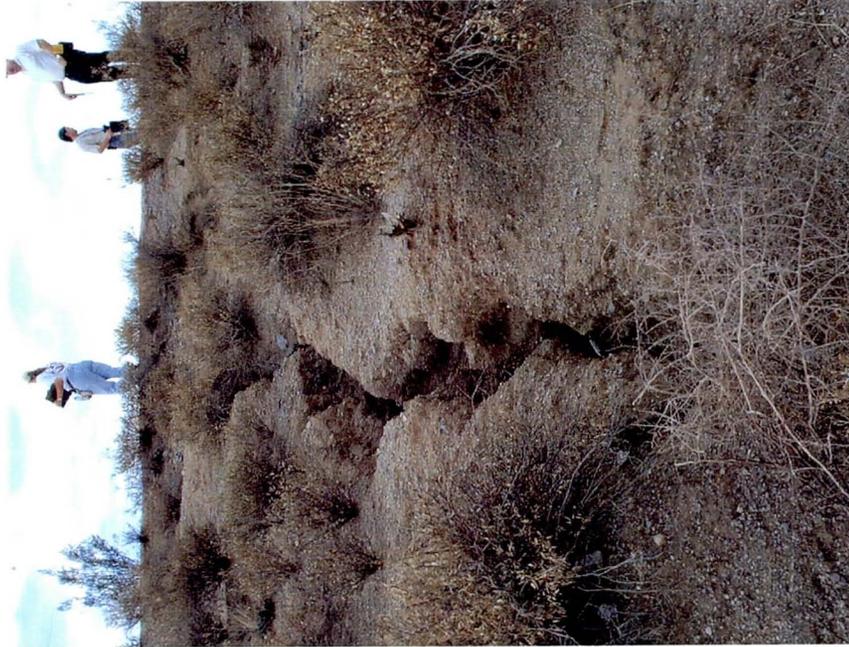
Spook Hill FRS. Downstream slope rill erosion Station 96+00.

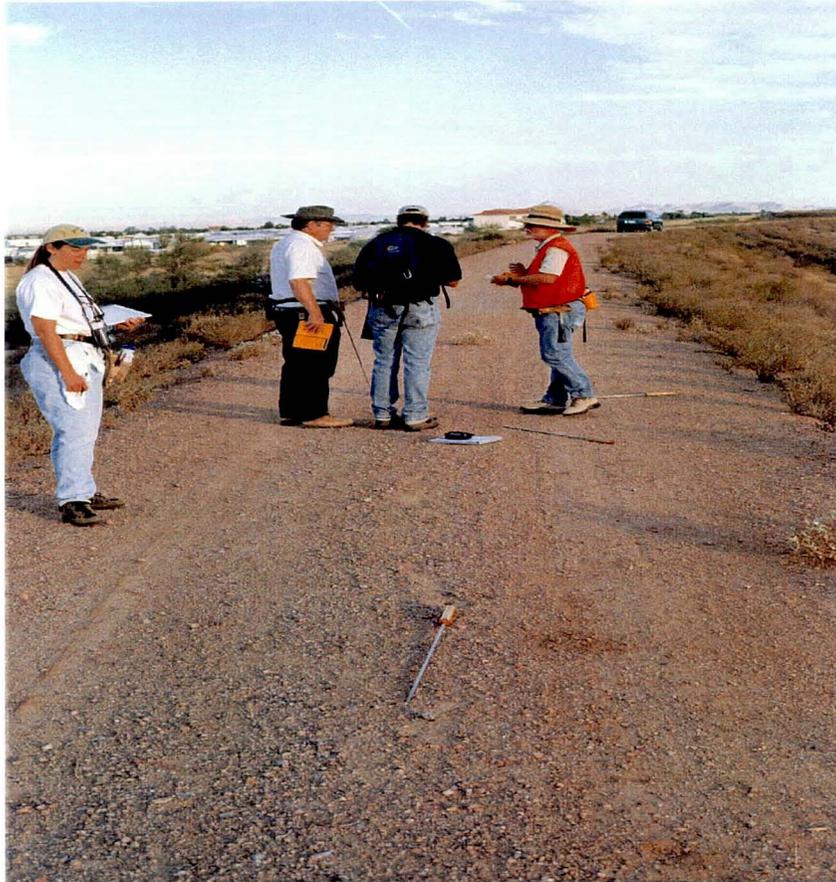
Spookhill FRS. Station 97+05. On crest 30-ft long longitudinal crack.

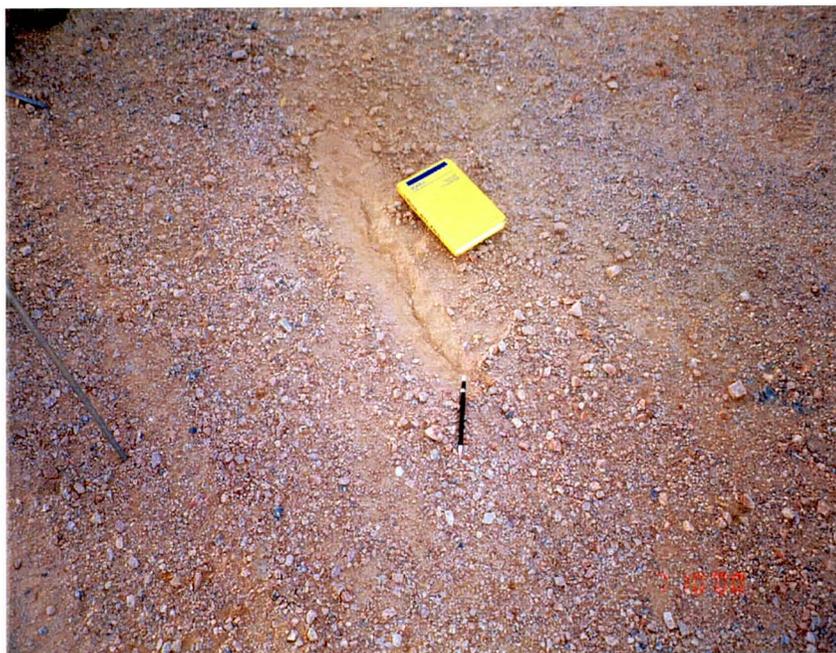
Spookhill FRS. Station 97+20. Longitudinal crack on crest offset to downstream side of crest.

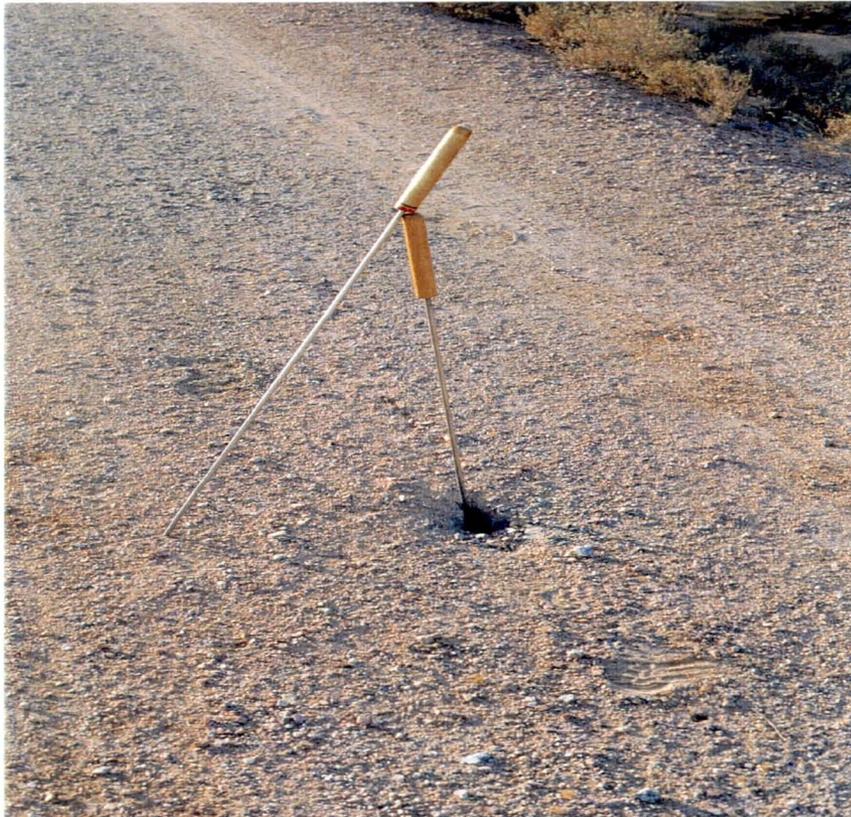
Spookhill FRS. Station 117+00. Hole on crest. Four inches long, 2 inches deep. Probed to 4 inches.

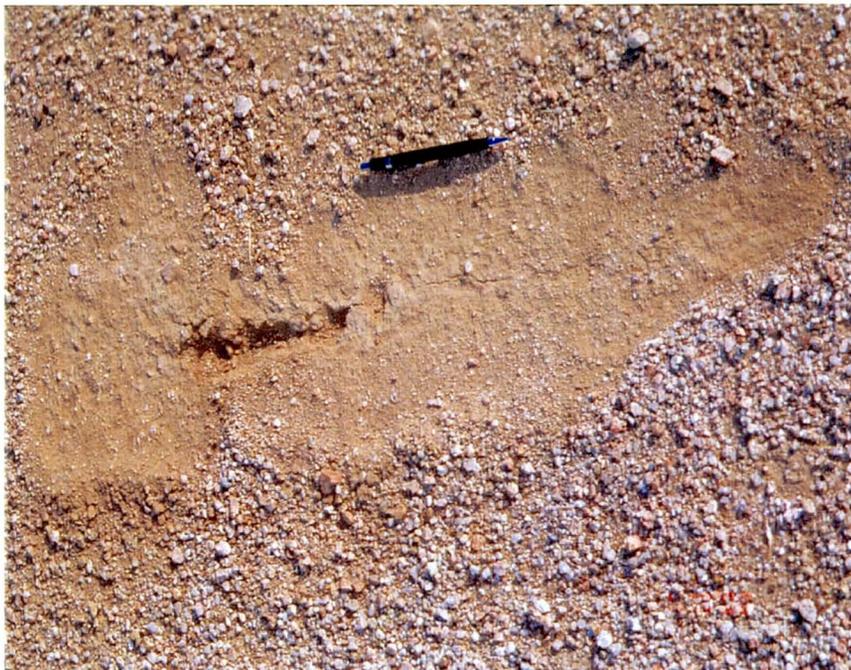
Spookhill FRS. Station 139+00. Longitudinal crack on crest. Small hole with 1/16-in crack, found from previous ADWR inspection report.

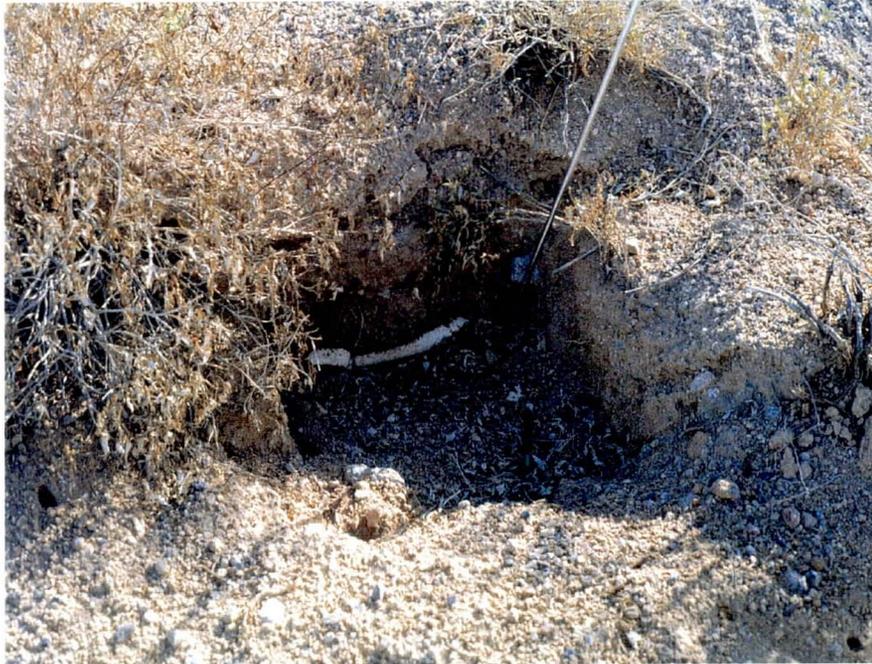
Spookhill FRS. Station 118+00. Blowout hole from irrigation line. On downstream side of crest.

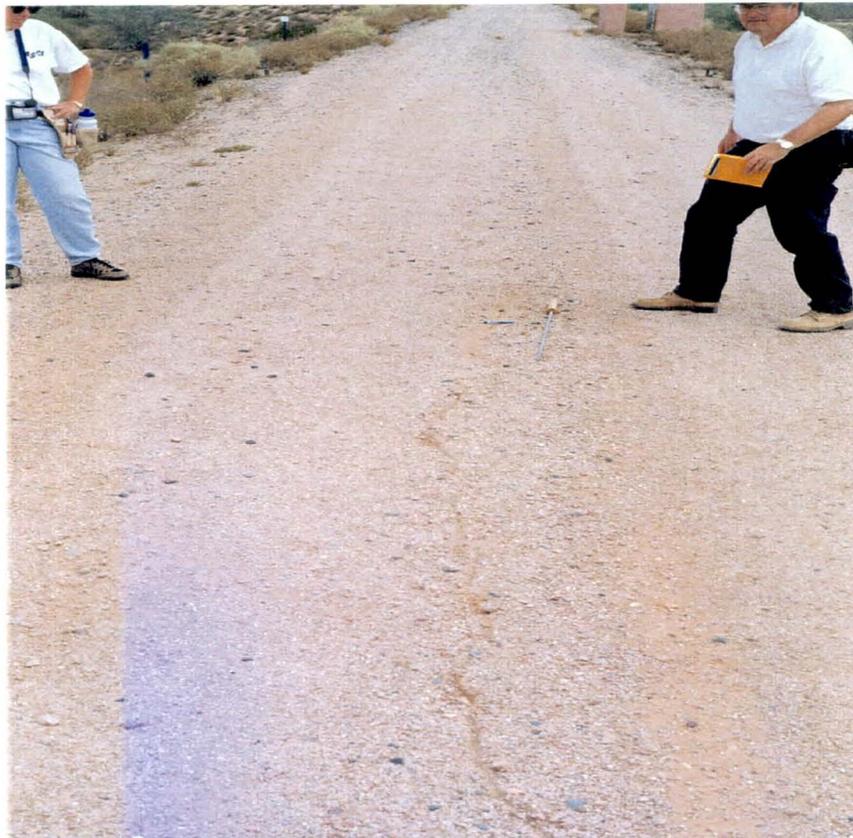
Spookhill FRS. Station 188=26 to 188+56. Crest - Longitudinal crack.

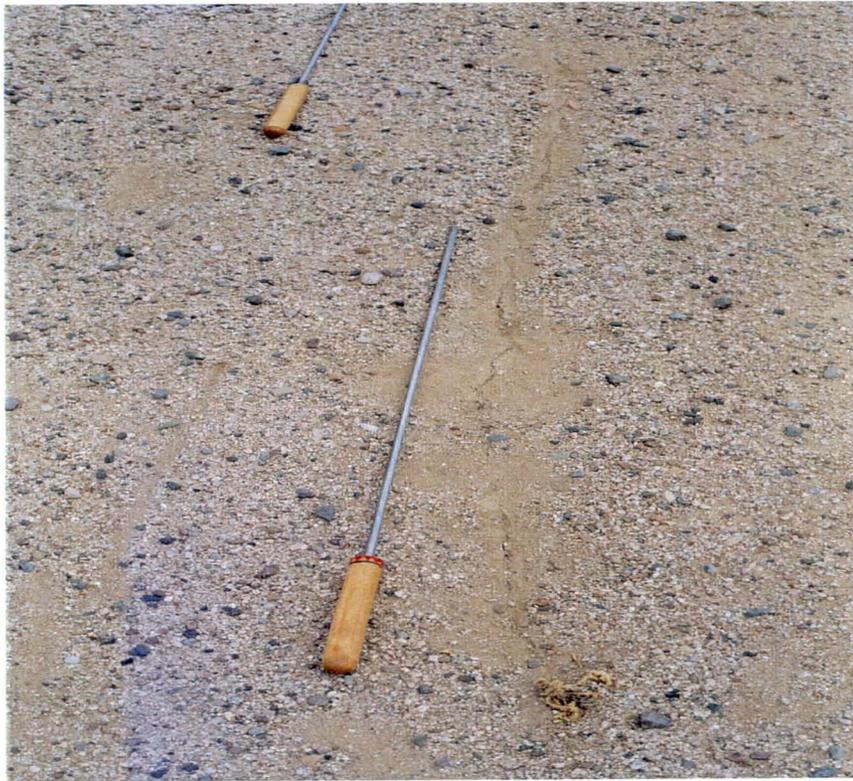
Spookhill FRS. Station 201+65. Longitudinal crack on crest centerline.

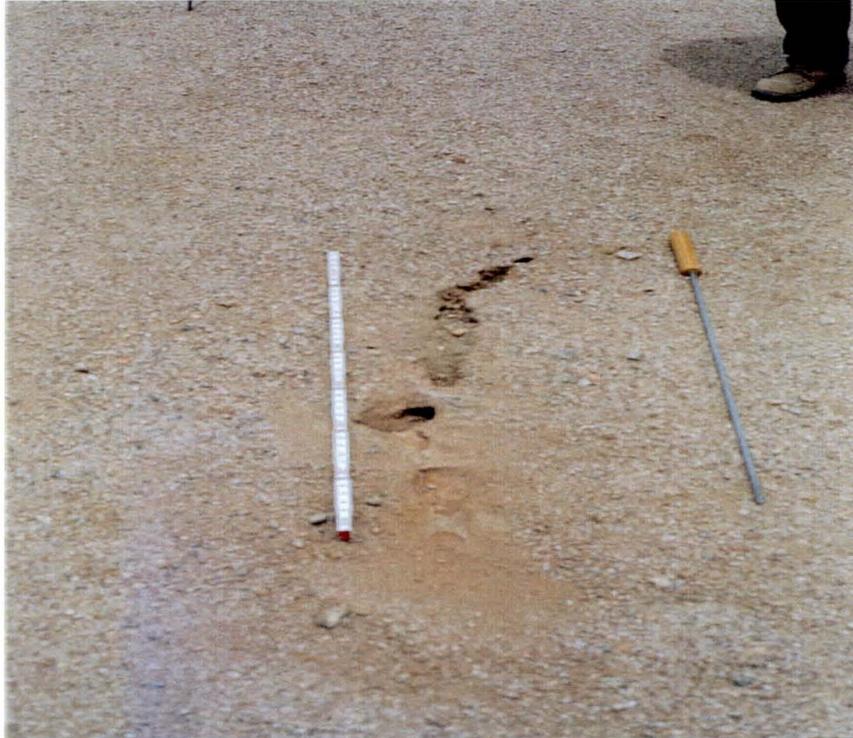
Spookhill FRS. Station 284+10. Longitudinal crack on crest. Ruler is 3-ft long. Crack may be associated with rodent activity.

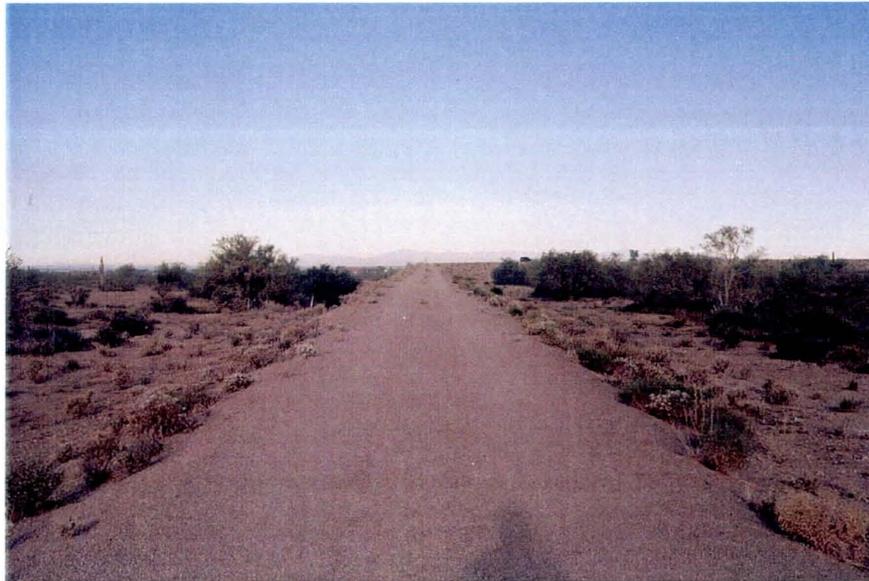
Apache Junction FRS. Crest Station 30+00. Gravel plating surface. Line of small shrubs along longitudinal centerline crack?.

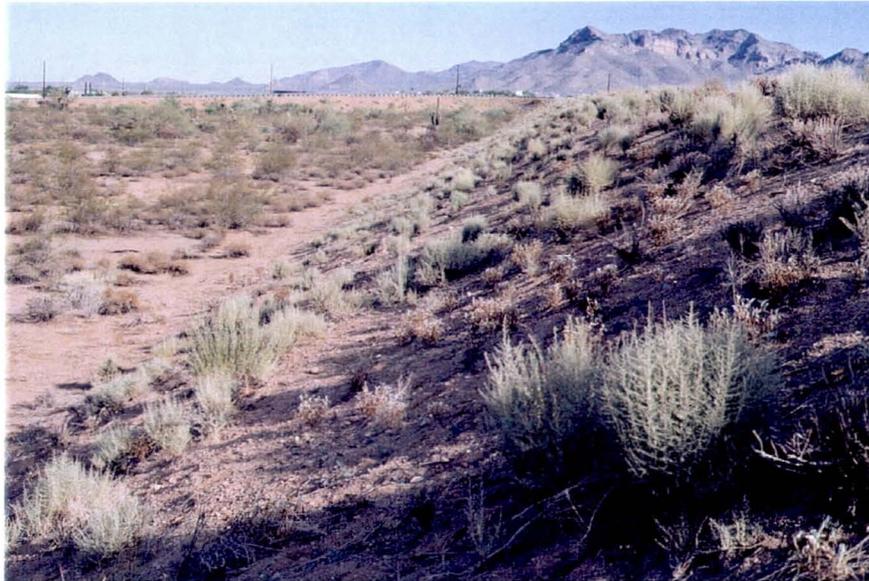
Apache Junction FRS Downstream Slope Station 60+20. Found bulge reported in previous ADWR report. Recommend monitoring during each inspection.

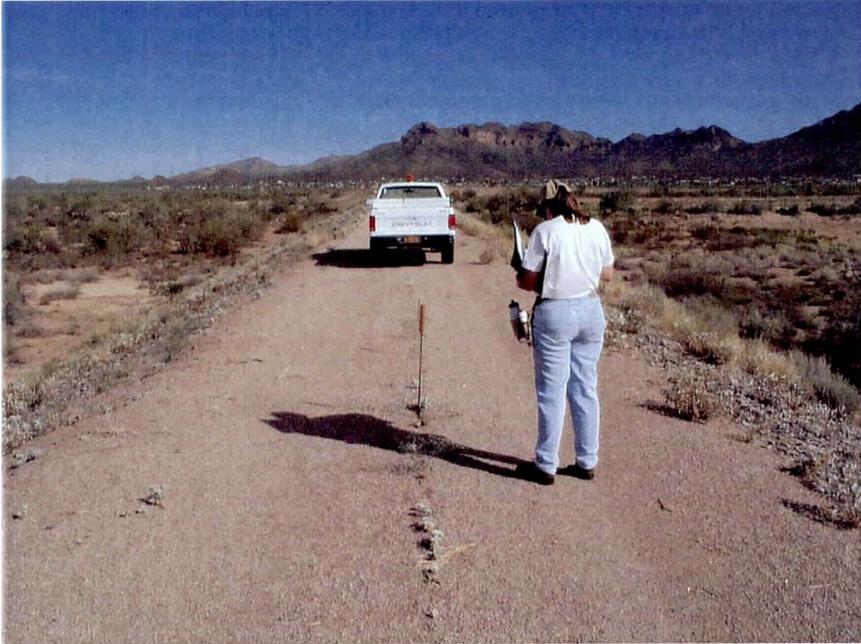
Apache Junction FRS. Crest. Longitudinal Crack Station 82+00.

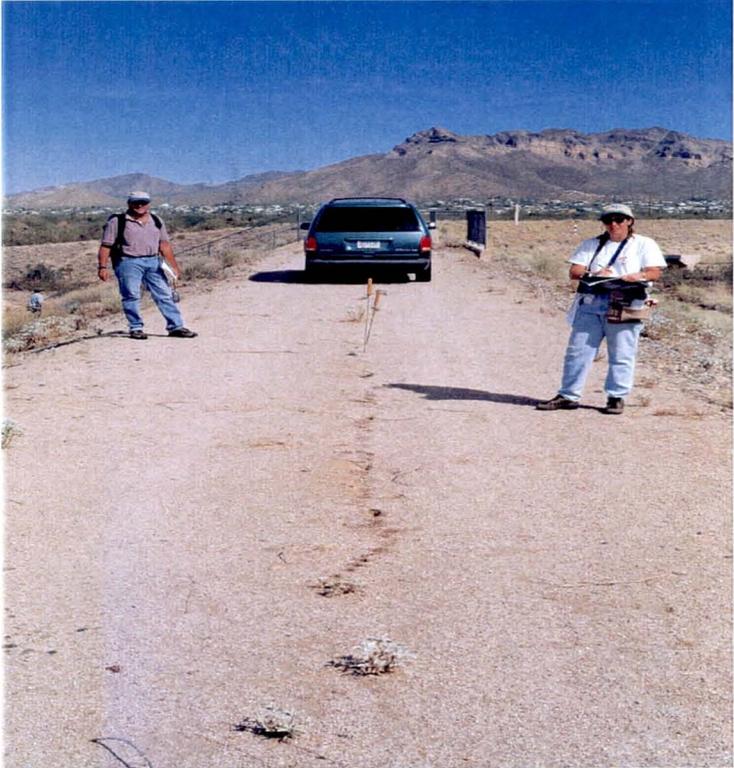
Apache Junction FRS. Station 95+50. Longitudinal crack on crest.

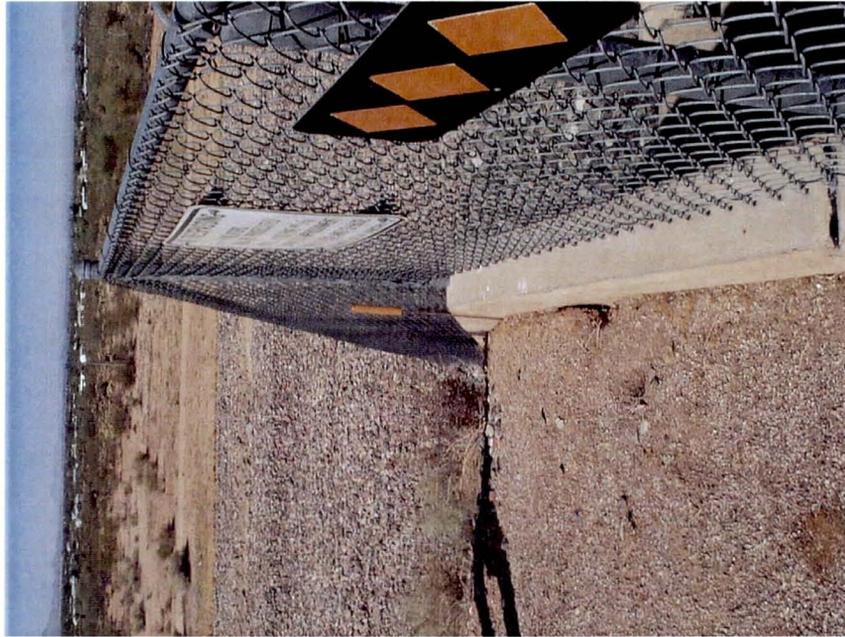
Apache Junction FRS. Left wingwalls of emergency spillway chute slight separation between embankment of concrete walls
