ENVIRONMENTAL SITE ASSESSMENT
FOR
FLOOD CONTROL DISTRICT
OF
MARICOPA COUNTY

CROSSCUT CANAL

EXCELTECH PROJECT NO. 5-50057-51

DECEMBER, 1990

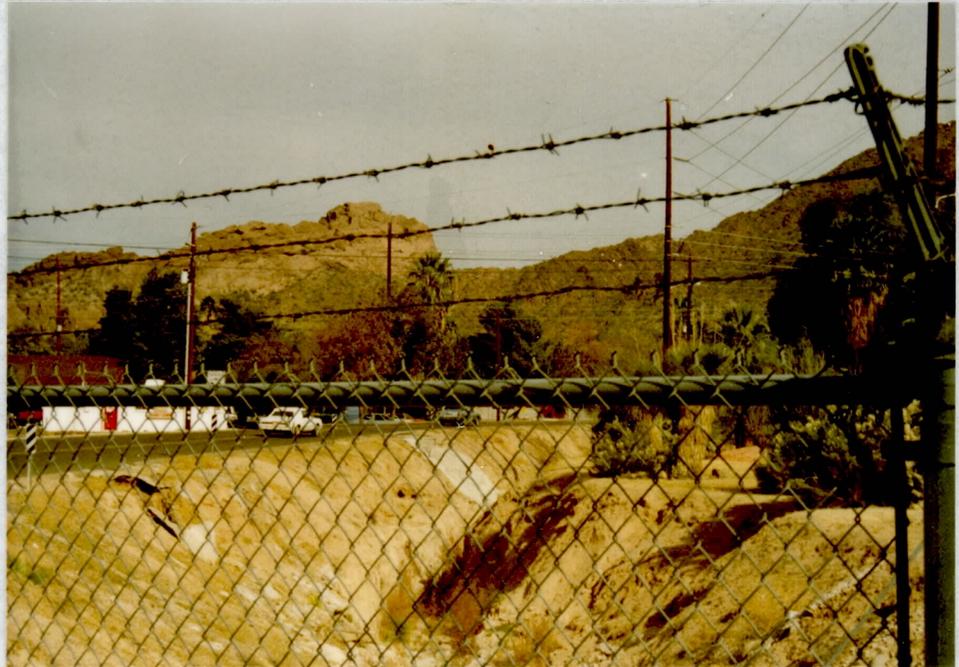
View of Property
looking north from
Indian School Road.

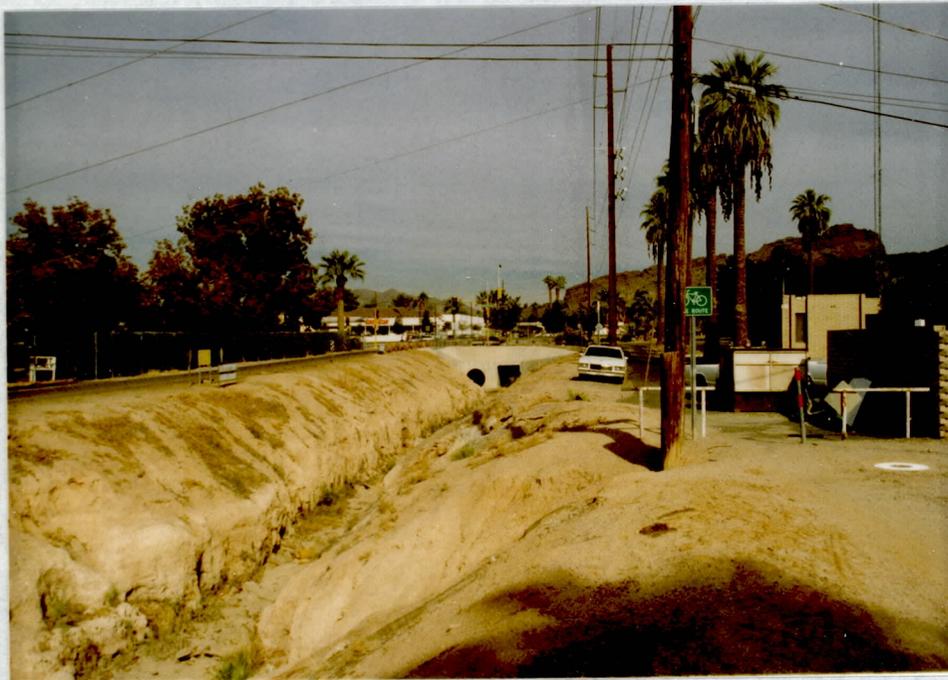
View of Property
looking north from south
of Indian School Road.

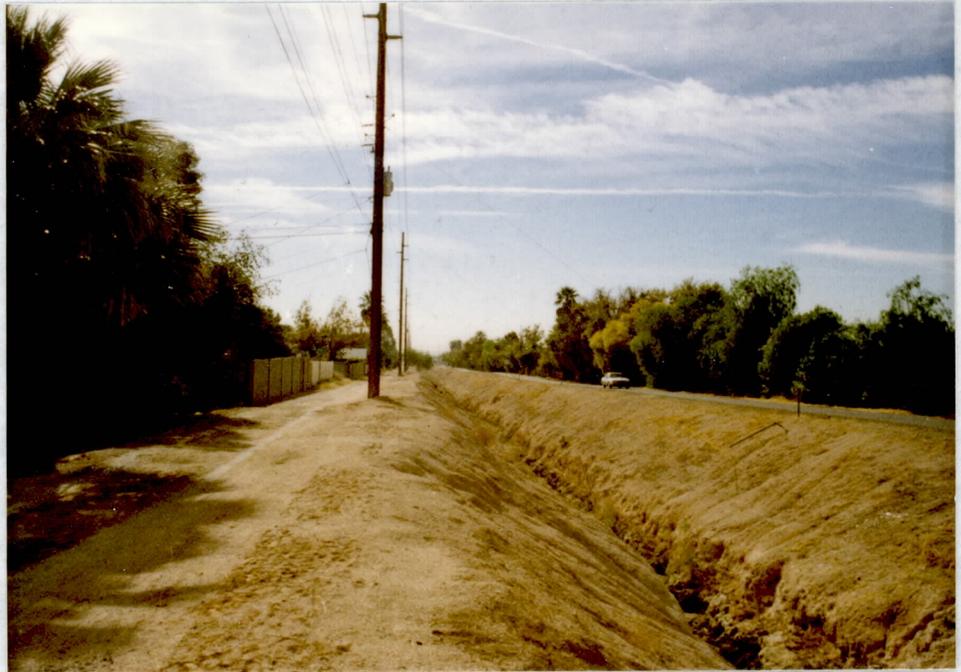
View of Property
looking south from
Indian School Road.

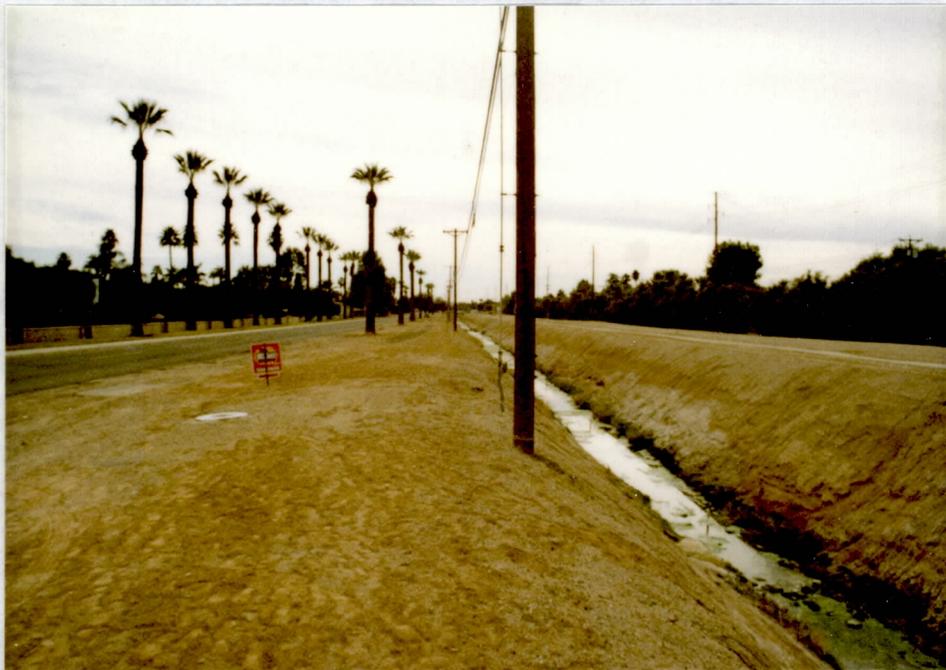
View of Property
looking south from
Thomas Road.

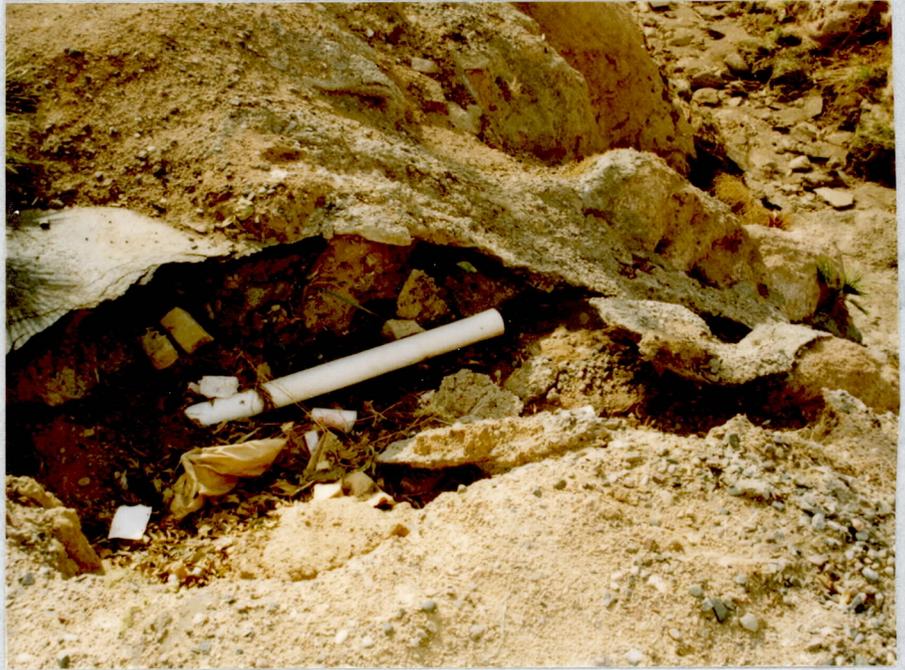
One area of discolored soil was identified. The soil discoloration emanates from the PVC drain that appears to be connected to the service bay area of the Safeguard Security Company. The stain is six inches to one foot wide, and begins at the drain, continues down the bank, and into the bottom of the canal.

3-inch PVC drain pipe
emanating from Safeguard
Security Company.

ET recommends that further investigation into the extent of possible soil contamination on the Property be conducted. Samples of the petroleum type substance emanating from the PVC drain should be collected. Soil samples from the bottom of the canal at this location and down stream should also be collected to determine if the contamination has migrated down the canal. The soil may contain hazardous materials regulated by 40 CFR 261.24 or 40 CFR 761.

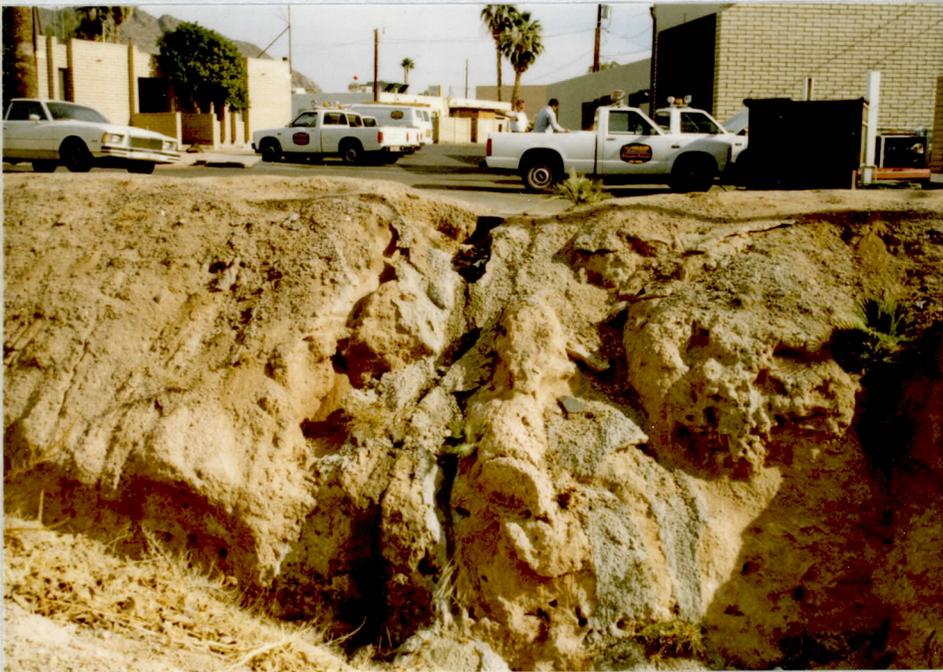
One area of surface staining and discolored soil was identified on the Property. The discoloration appears to be emanating from PVC drain from the adjoining Safeguard Security Company's vehicle service bay on the east bank of the canal on the southeast corner of Indian School Road and 48th Street. The vegetation occurring along the canal does not appear to be chemically stressed. The ponded water in the canal identified south of Thomas Road, was clear and there was no evidence of organic globules or oily sheen in or about the ponds.

Soil staining from PVC
drain emanating from
Safeguard Security
Company.

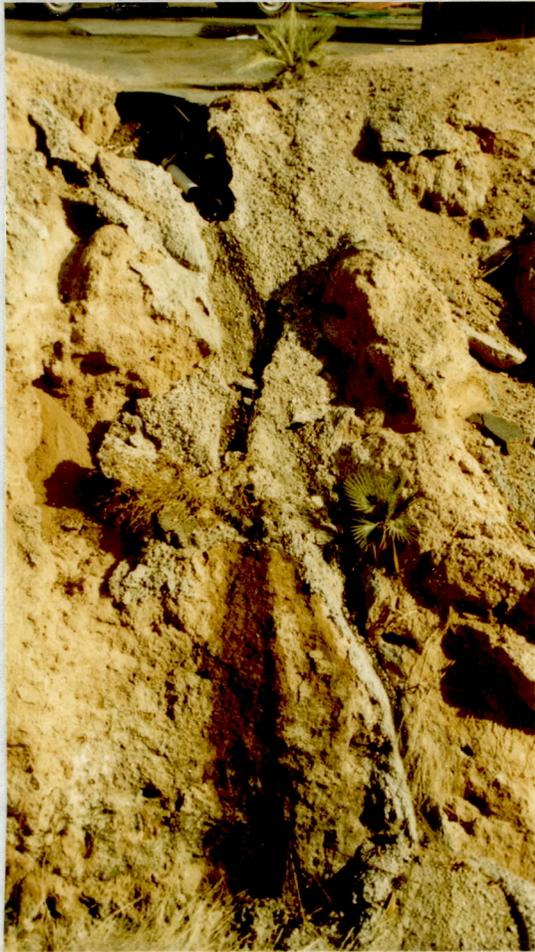
3-inch PVC drain emanating from Safeguard Security Vehicle Service Bay showing discoloration and staining of canal bank.

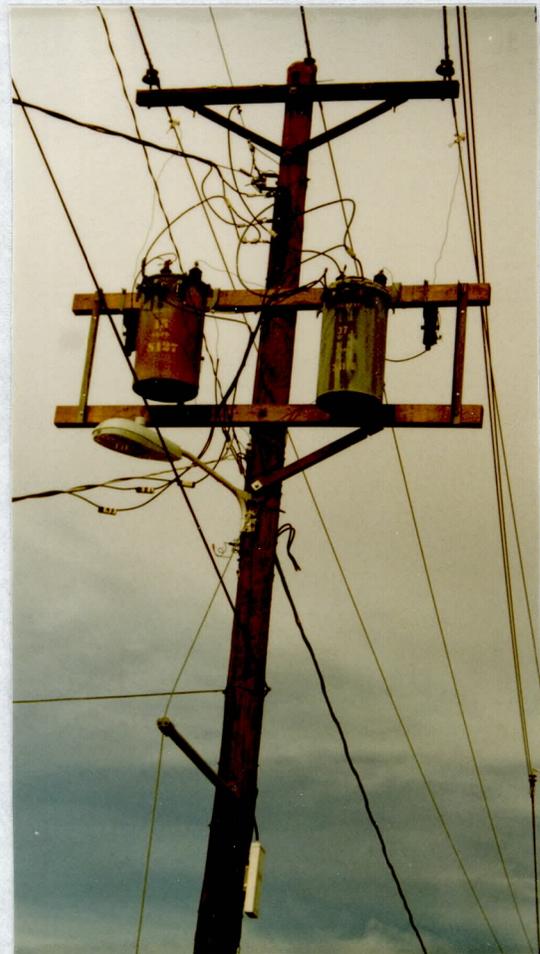
There are three overhead, pole-mounted transformers located off-site which are in close enough proximity to cause possible leakage onto the banks of the canal. Two of the transformers are located on the northwest corner of Thomas Road and 48th Street. One transformer was covered with rust, and the other had an oily stain. The third transformer is located along the east side of the canal, half-way between Thomas and McDowell Roads, near Oak Street. The transformer is rusted. No signs of leakage from the transformers onto the surface were noted at any of the locations. Photographs of the transformers are included in Appendix D. The transformers are the property of the Salt River Project Utility Company. If the transformers leak or fail, SRP will be responsible for cleanup.

Leaking and rusted transformers at 48th Street and Thomas Road (west bank of canal).
