TRILBY WASH DETENTION BASIN

LOWER AGUA FRIA RIVER

U. S. ARMY ENGINEER DISTRICT, LOS ANGELES

JANUARY 1973

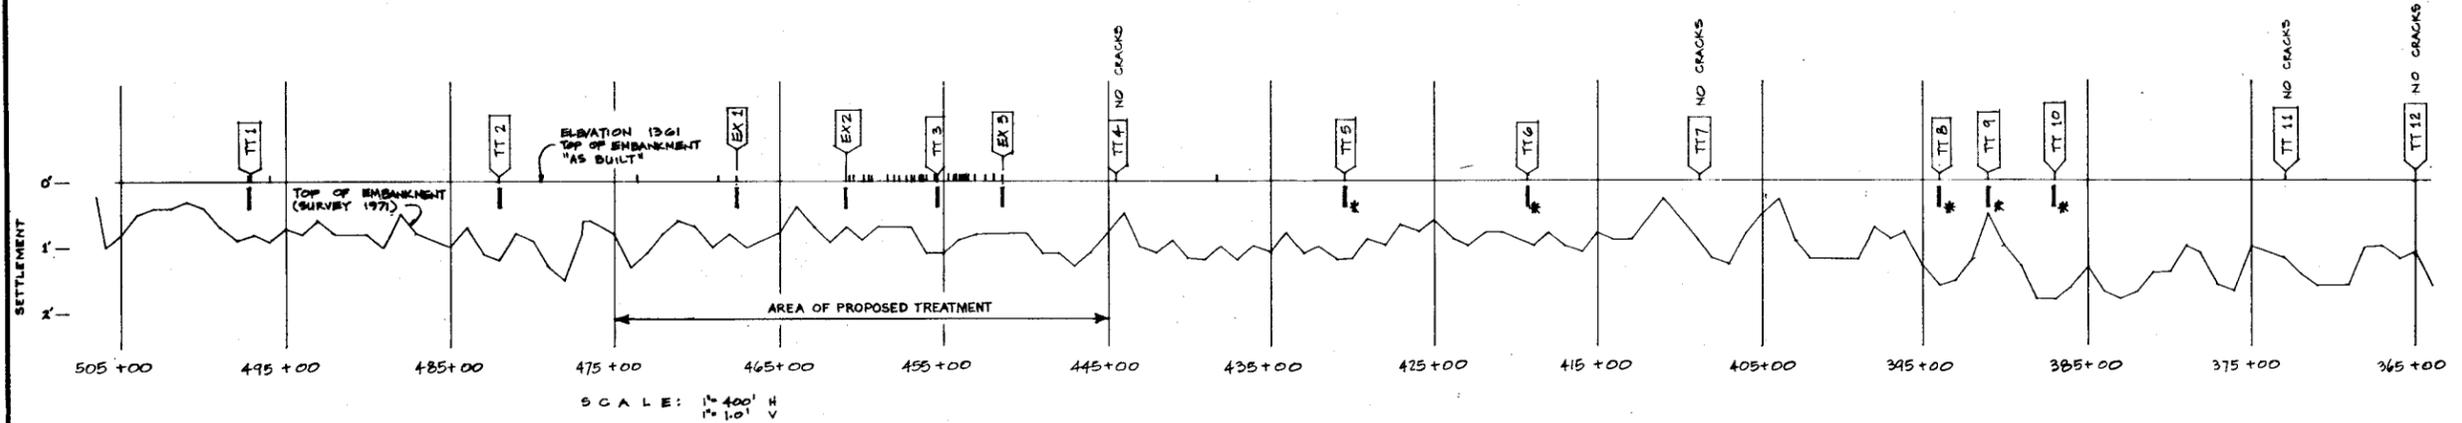
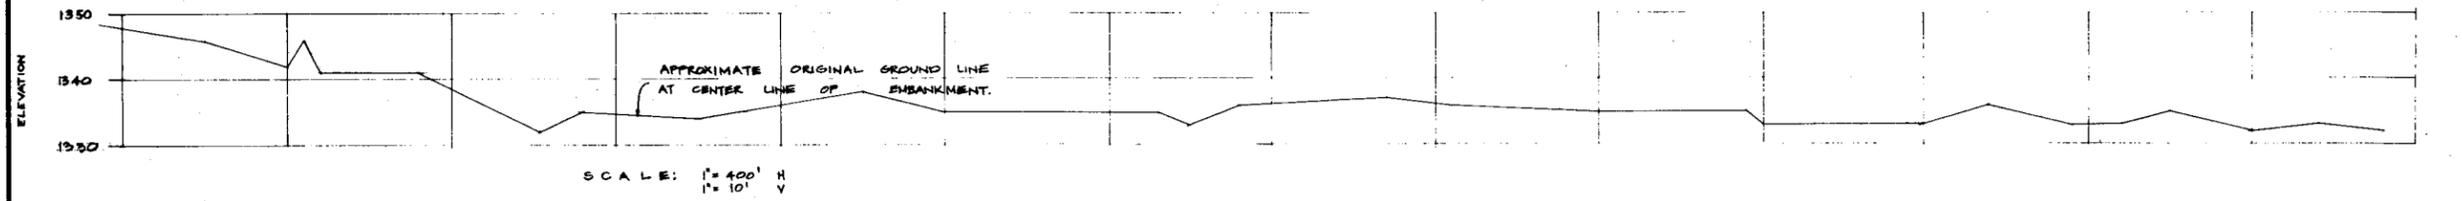
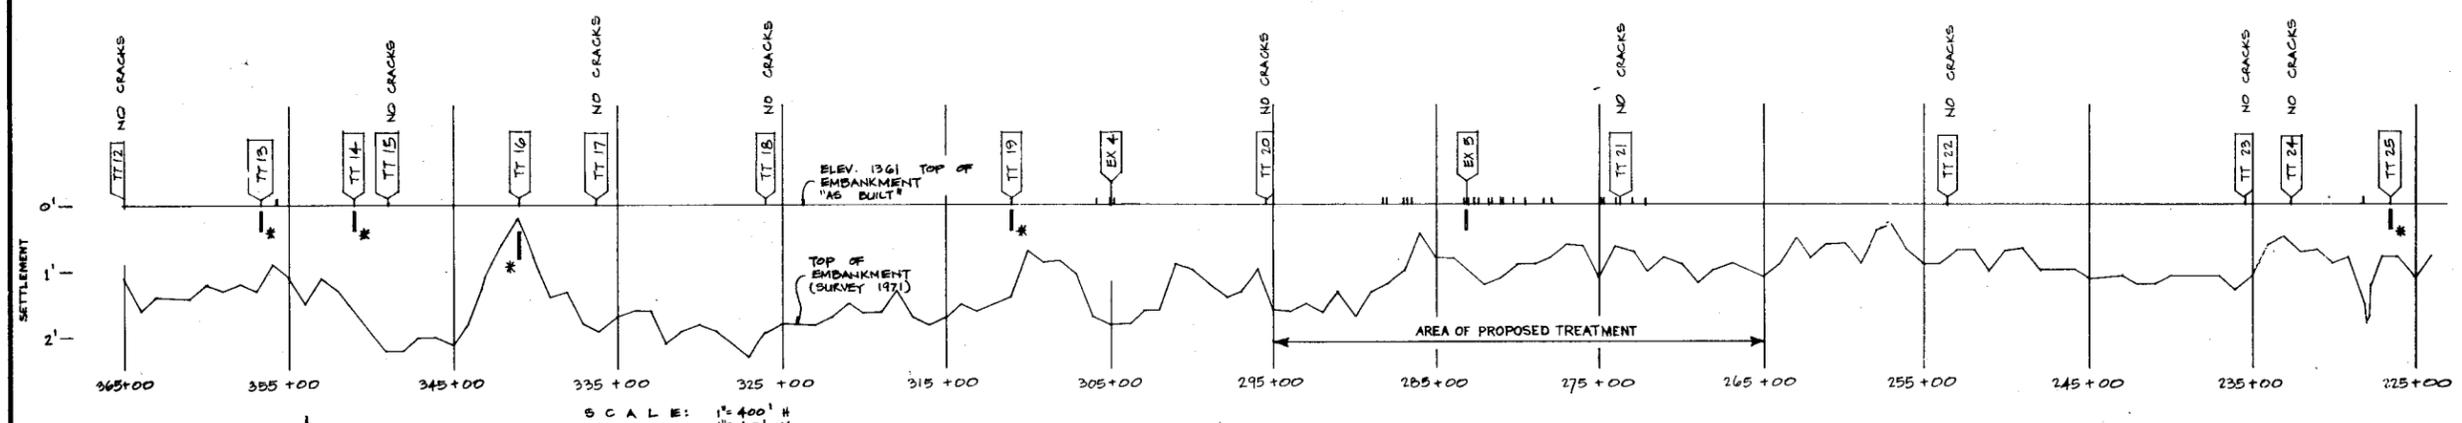
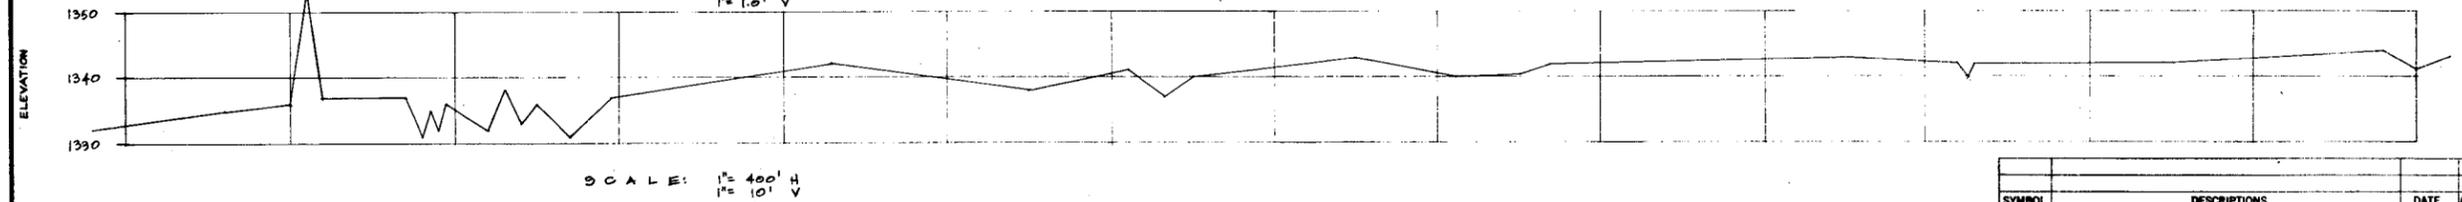
10. Embankment conditions. The investigations indicate a predominance of transverse cracking between Stations 475+00 to 445+00 and between Stations 295+00 to 265+00. Cracking occurs in other areas of the embankment but not with the same frequency or having the depths encountered in the above mentioned reaches.

21. Four methods of treatment were considered for the upstream slope of the embankment between Stations 445+00 to 475+00 and 265+00 to 295+00. The methods consisted of (1) removal and recompaction of the outer 6 feet of material, (2) an overlay with 6 feet of compacted fill, (3) installation of a buried membrane and (4) paving with asphaltic concrete. Comparative cost estimates are shown on table 2. The recommended treatment would be the asphaltic concrete paving. The treatment was selected as additional settlements of the embankment and foundation are expected. The soil treatment methods would experience cracking that would not lend itself to detection or easy maintenance. The selected treatment provides a desirable degree of flexibility, is visible for easy detection of cracking and can be readily maintained. In addition, the asphaltic concrete paving may be easily extended in the future.

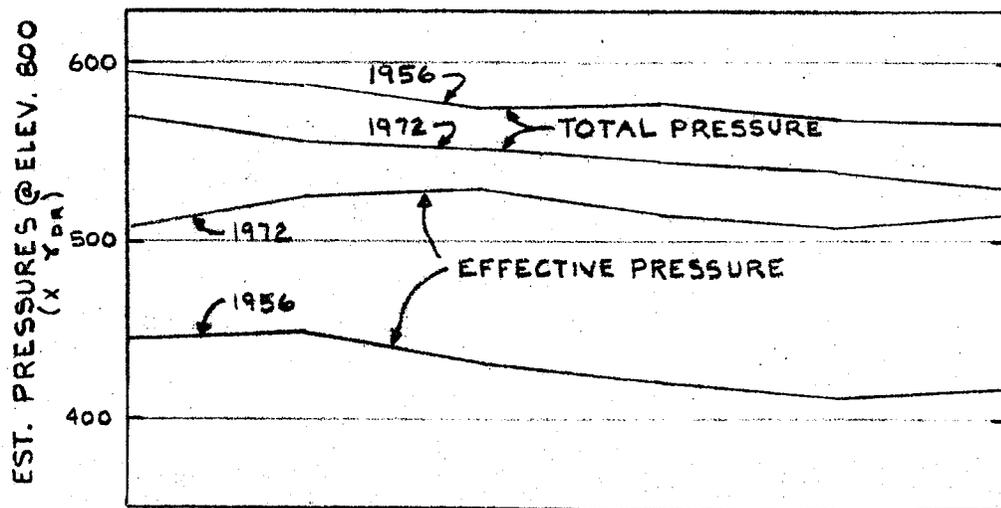
FIGURE 17

Figure 17 shows the estimated decline of the ground water surface and the estimated ground subsidence along the embankment alignment. Total and effective pressures were determined based on the estimated decline of the water table since construction. The effective pressure, the pressure that causes consolidation and shear deformations, increased about 100 times the drained unit weight of alluvium (about 6 tons per square foot) at an elevation of 800 feet (550 feet below the ground surface). The typical change in vertical pressure with depth is shown in figure 18. Since construction the change in effective pressure shows an increase from zero at a depth of 300 feet to approximately 6 tons per square foot at a depth of 500 feet. Below this elevation the effective pressure increase is 6 tons per square foot. As the depths involved are great, deformations can be significant with the large pressure changes. For example assuming the alluvium is about 1000 feet deep and the foundation materials have an elastic modulus of 50,000 psi, the computed shorting would be about 1 foot for a change in vertical stress as shown in figure 18. Unexplainable with the available data is the lesser magnitude of ground subsidence at the north end of the embankment. This may be due to geologic conditions or differences in properties of the deeper foundation materials, however, no data of this type is available.

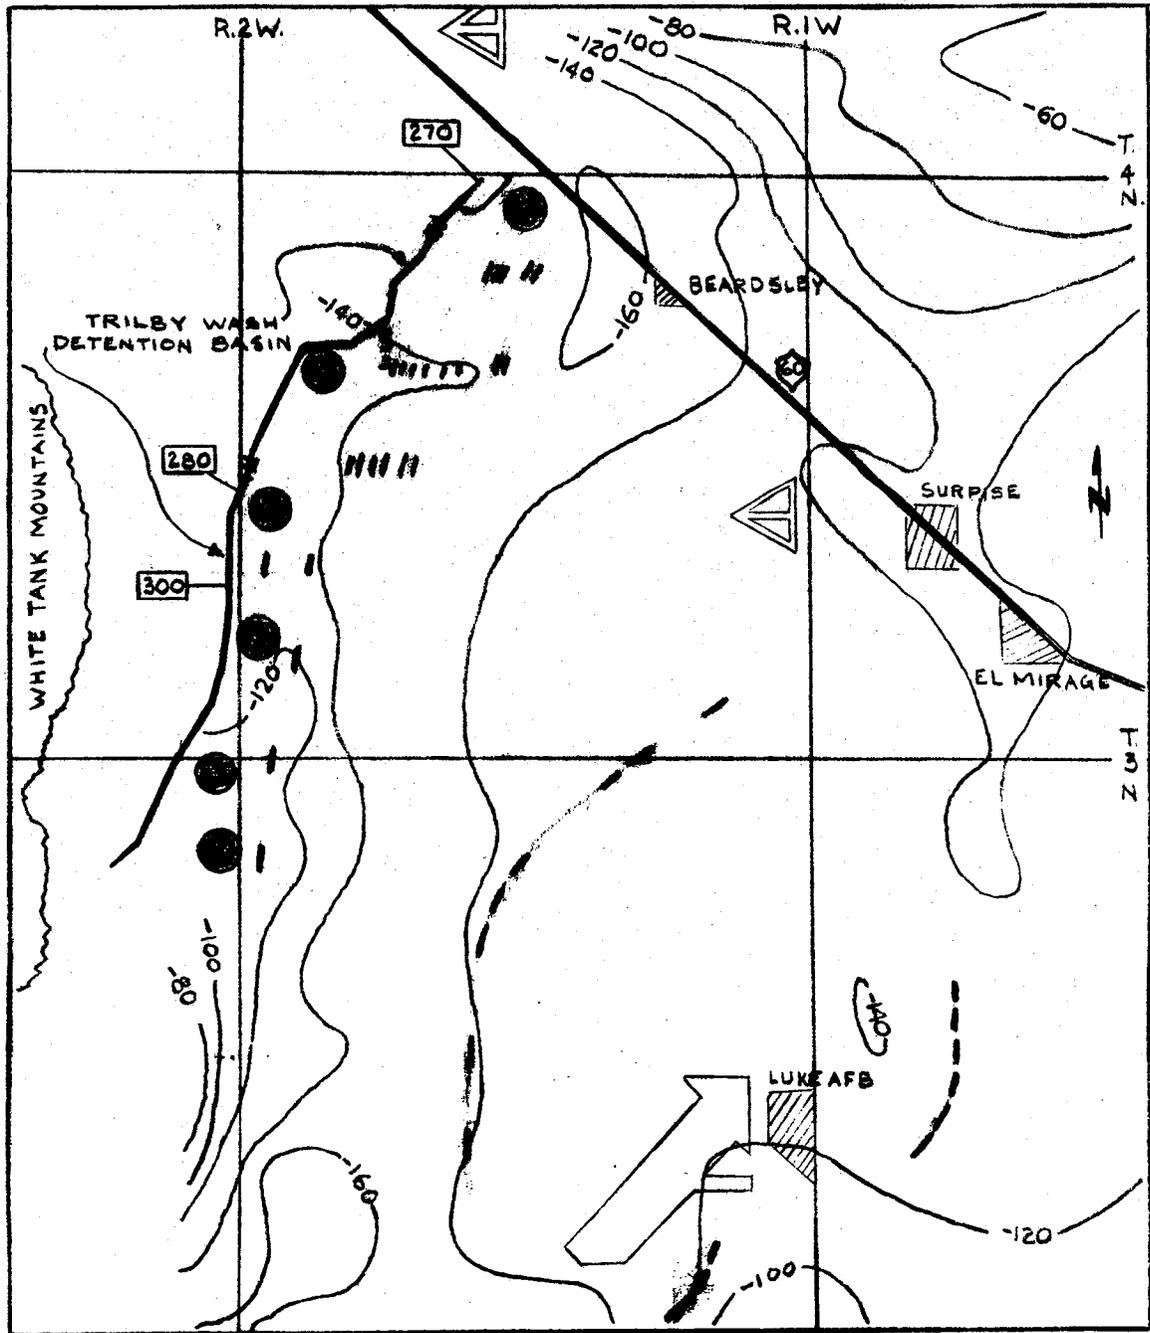
FIGURE 19

Associated with the ground water decline and subsidence is the development of surface fissures and evidence of ground cracking on a regional basis. A limited inspection of the area in the vicinity of the embankment resulted in observation of cracking evidence on cultural features such as paved road, ditches and canals. This data is shown in figure 19 along with earth fissures 4 to 9 miles distant from the embankment reported by others. The cracking evidenced in the vicinity of the embankment is in the form of displacements and patching of pavements, ditches and canal linings and is not as pronounced as the distant earth fissures which are over a foot in size. The embankment cracks diminished in width with depth below the embankment crest and are larger than the cracks observed adjacent to the embankment.

The apparent non extension of the embankment cracking into the foundation may be due to the embankment being constructed after a significant amount of regional subsidence had already occurred. It is felt the larger embankment cracks are due to the embankment soils being much more brittle than the foundation soils as they are denser. It appears the embankment cracking could be attributed to the regional subsidence.

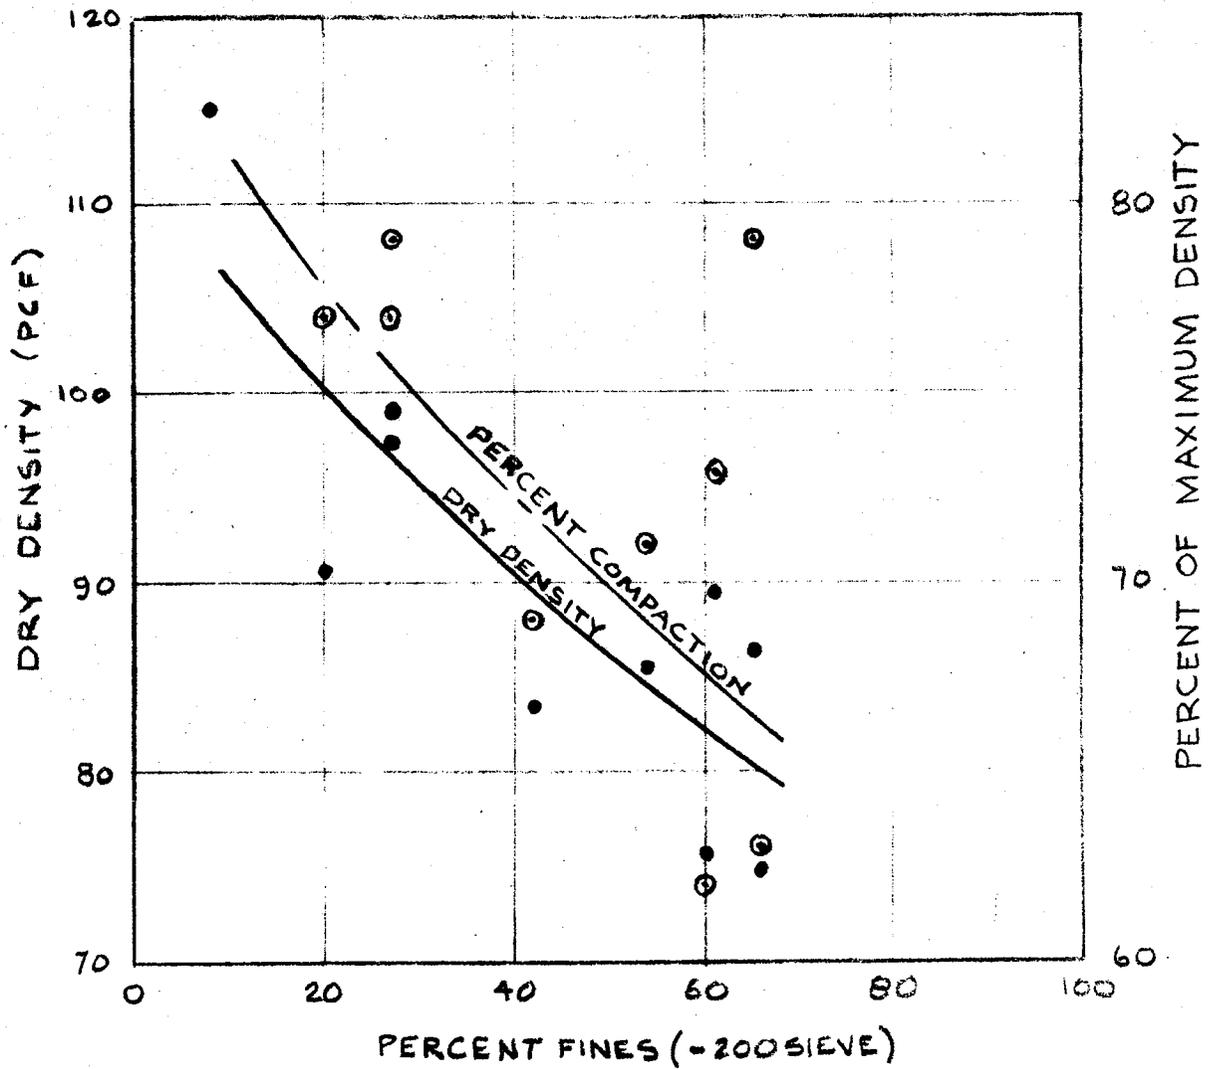
FIGURE 2

a. Density tests. The results of the in-place density tests on the foundation materials indicated a range of dry densities between 74 and 115 pounds per cubic foot with an average of 90 pounds per cubic foot. The percent compaction ranged from 63 to 90 with an average of 73. The dry density and relative compaction is lower for the fine grained materials (the sandy clays and sandy silts), see figure 2.

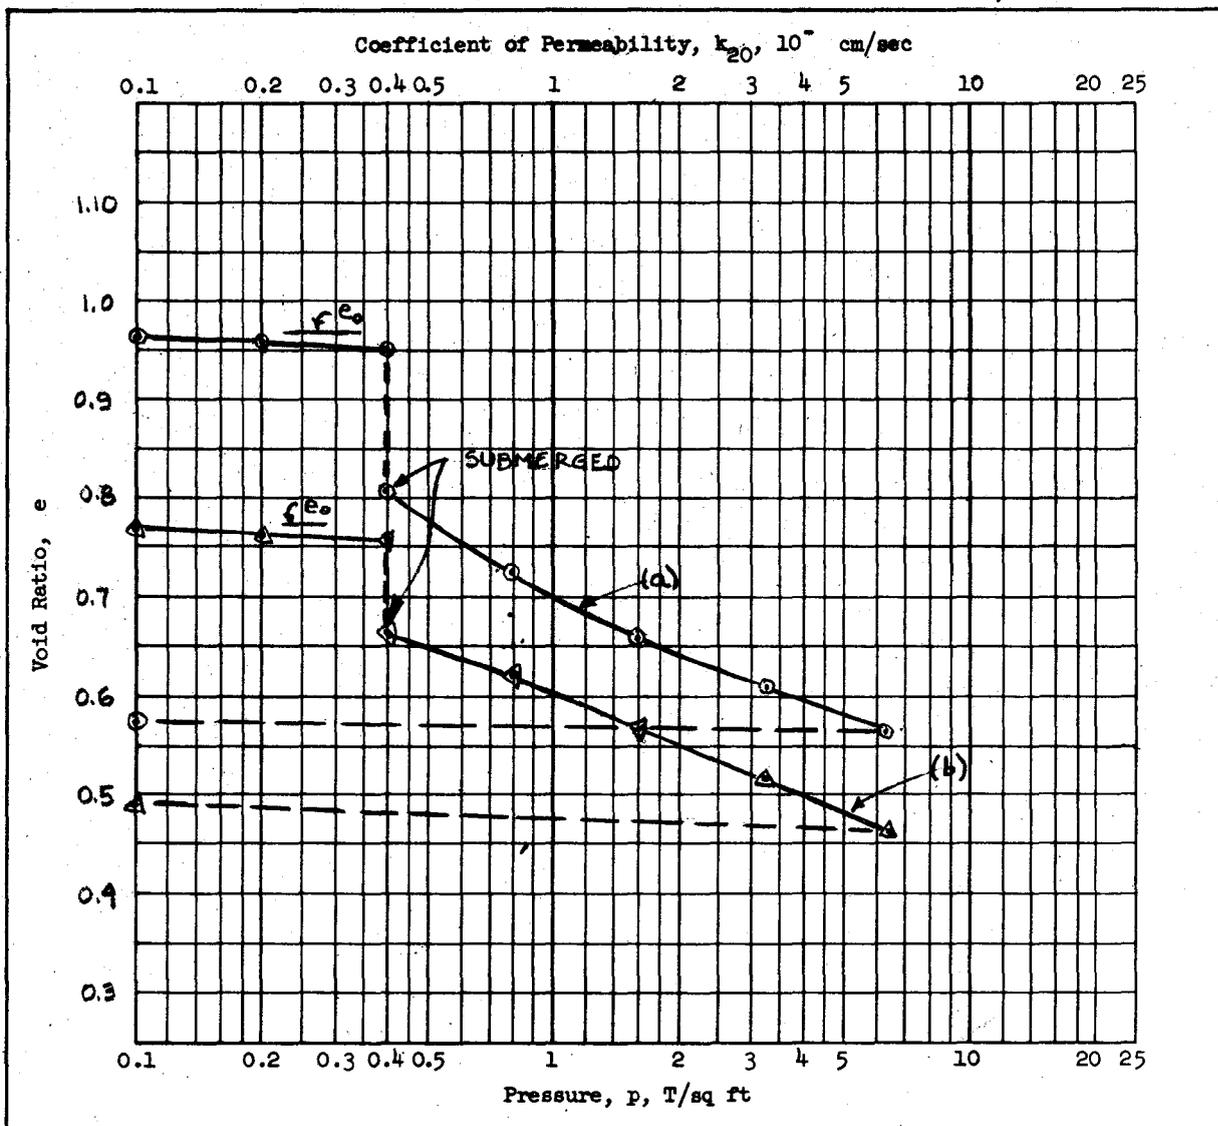
b. Consolidation testing. The two undisturbed samples obtained in 1953 during the design phase of the project, show the foundation and existing berm samples would collapse when saturated under pressure consistent with their in-situ pressure, see figure 3.

Extrapolation of the consolidation data for foundation sample (a), a sandy silt, indicates a 30% reduction in void ratio when subjected to embankment loading and saturation. This sample had an initial void ratio of 0.96, see figure 3.

Extrapolation of the consolidation data for existing berm sample (b), a sandy clay, under same conditions as above, indicates a 25% reduction in void ratio. This sample had an initial void ratio of 0.77, see figure 3.
