# DREAMY DRAW DAM

## DAM, OUTLET WORKS AND SPILLWAY

PERIODIC INSPECTION

REPORT NO. 4

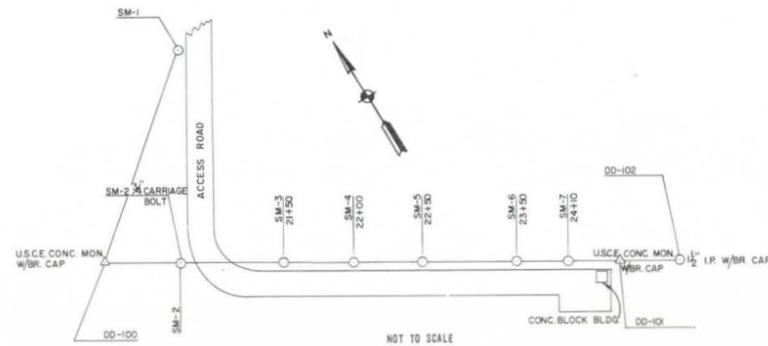
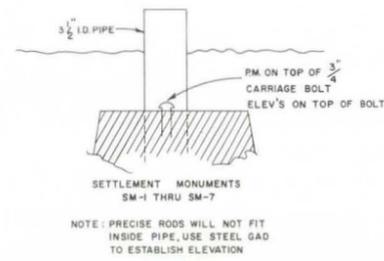
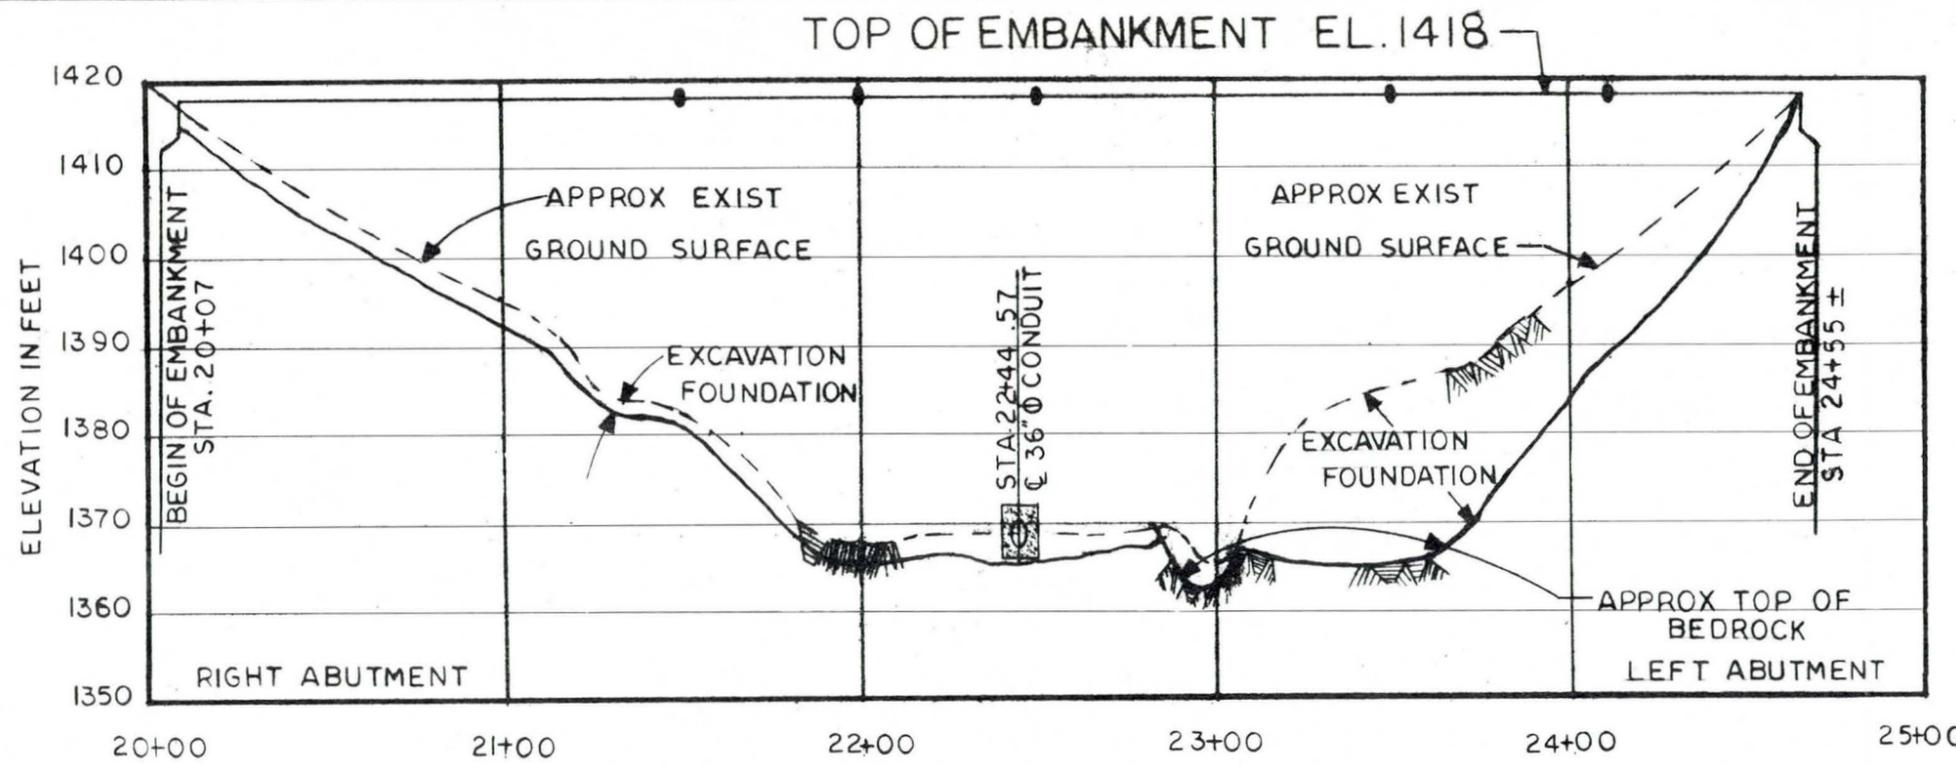
(1) Monuments - The embankment crest is instrumented with five settlement monuments, located between stations 21+50 and 24+10. A survey was conducted in September 1976. The location of the settlement monuments and the survey data is shown on plate 1. A settlement profile is shown on plate 2.

(2) Analysis of data - The survey of settlement monuments indicates insignificant horizontal and vertical movements to date.

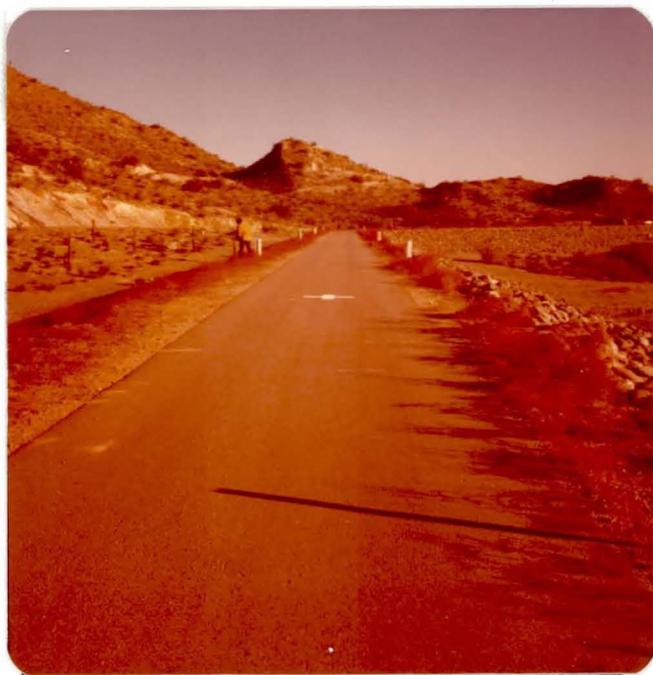
(1) Crest - free of erosion. Shoulders of road sparsely covered with growth of weeds. A.C. paving in good condition with no evidence of settlement or cracking. Some cracking of downstream shoulder is occurring between topsoil that was placed and original downstream slope of saddle dike.

Photo 1 – Crest of Saddle dike. Looking north.

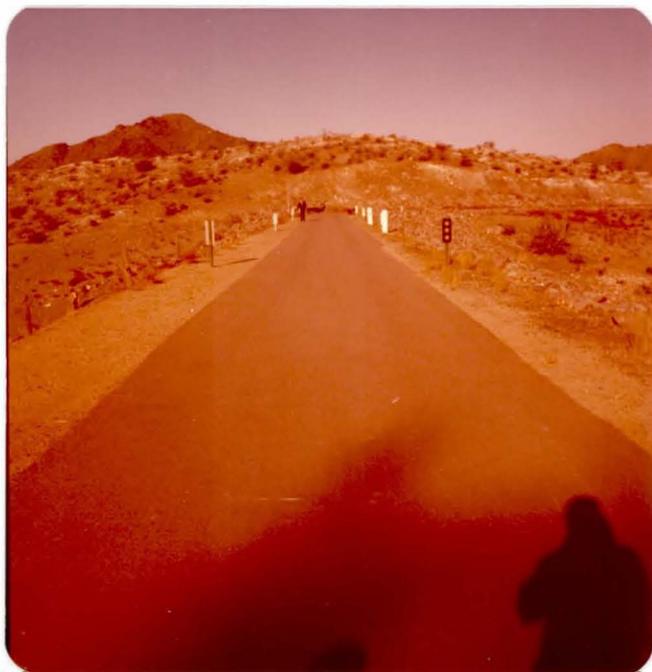
(1) Crest - Free of erosion. Shoulders of road sparsely covered with growth of weeds. A.C. paving in good condition with no evidence of settlement or cracking. Settlement monuments and guard posts in good condition.

Photo 2 – Crest of dam. Looking west.

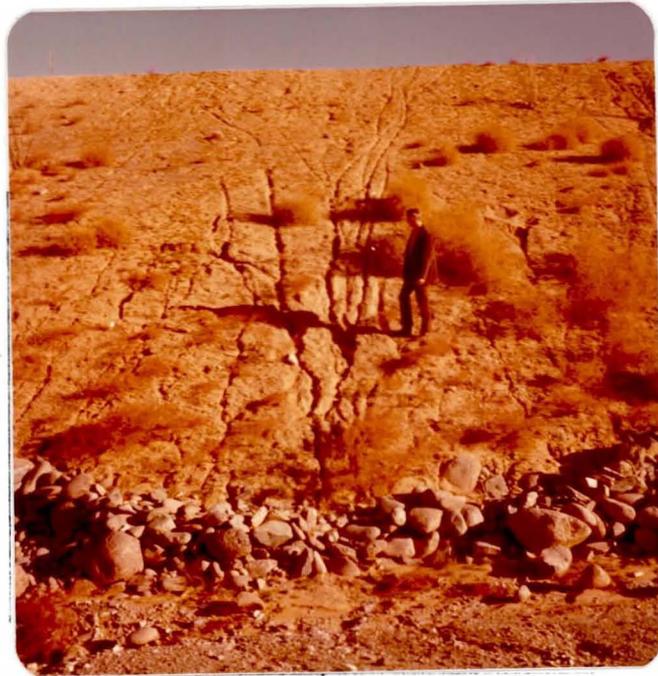
(3) Upstream and downstream slopes - upstream slope had no erosion or evidence of burrowing animals. Stone facing was sound and durable. Downstream slope where top soil was placed for landscaping was eroded into gullies a foot deep and 4" to 6" wide. There is a sparse growth of grass and weeds, but not enough to prevent erosion.

a. The erosion on the downstream slopes of the embankments is not structurally significant since a stable layer of slope protection was placed on the slope during construction. However, a large part of the erosion appears to be caused by water running off the crest of the embankment and this could be easily prevented by constructing an earth or asphaltic berm along the downstream edge of the crest.

Photo 3 – Downstream slope of dam showing erosion of top soil placed over stone facing.

a. Place earth or asphaltic berm along downstream edge of embankment crest to control erosion of landscape fill.

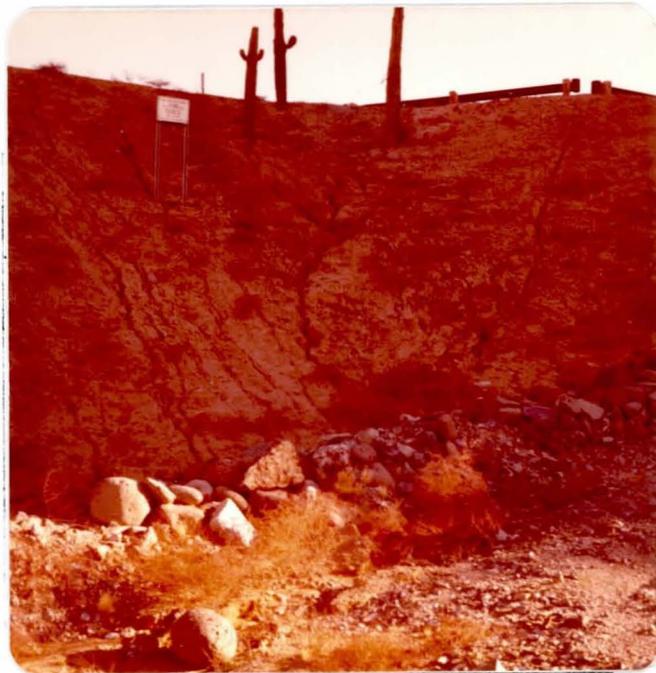
Photo 4 – Downstream slope of dam showing erosion of top soil placed for landscaping.

a. Landscaping of the downstream face is deteriorating due to erosion. Loss of the earth is not a safety hazard in itself but could clog the downstream channel. Therefore an earth or asphaltic berm should be added on the downstream edge of the crest to channel the water to the abutments.

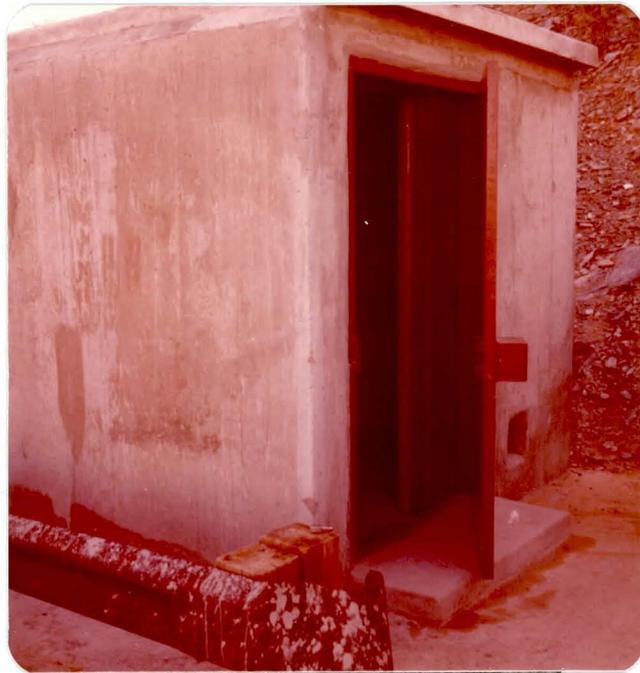
Photo 5 — Recorder House showing 6 inch thick concrete shell placed over existing concrete block.

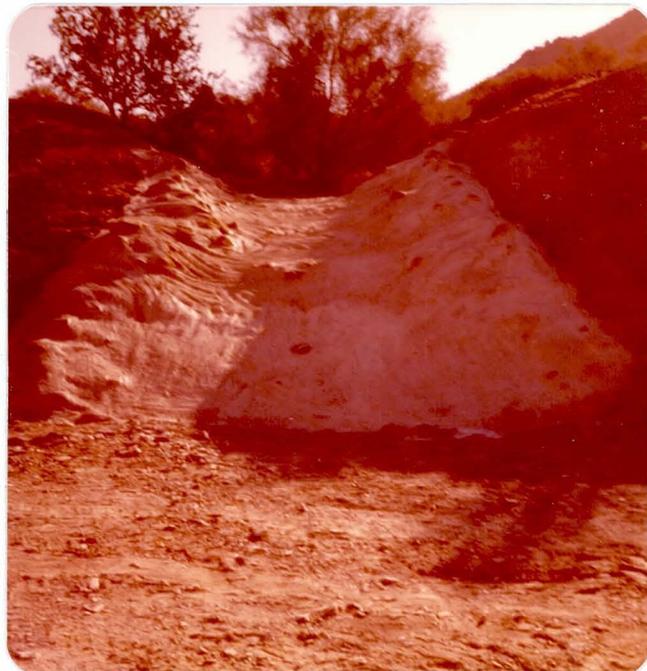
(3) Outlet channel - clean and unobstructed. The three gullies that had eroded the left excavated slope of the channel have been satisfactorily repaired using 6" to 12" cobbles and concrete grout. (See photo No. 6)

Photo 6 — Typical Grouted Stone repair of one of three gullies that were eroding the spillway outlet channel bank.
