**Golden Eagle
Park Dam
Construction
Photos**

DISK 10

JUNE 2000

Golden Eagle Park Dam Construction of Improvements in 2000

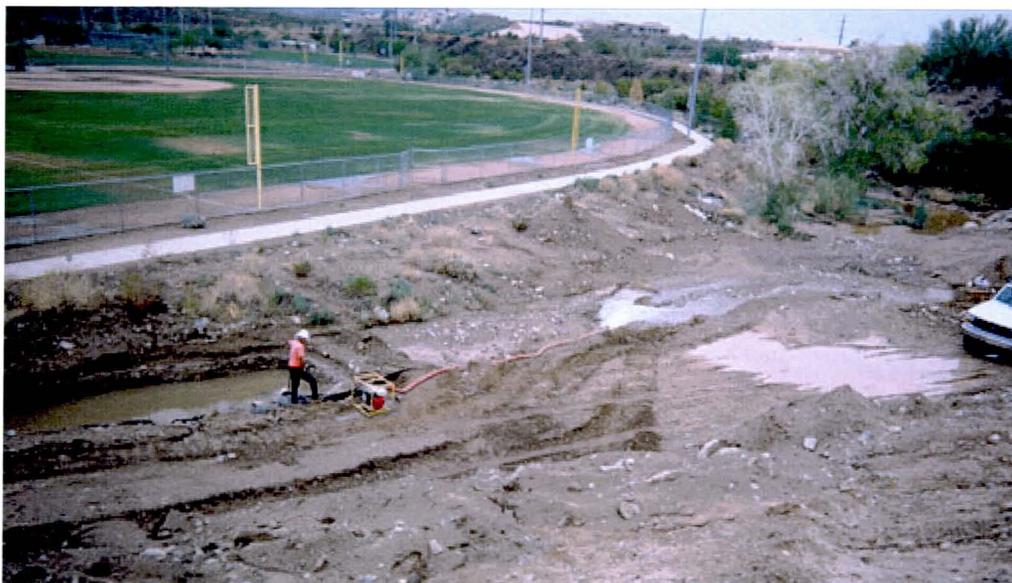
- Date: August 2000
- Location: upstream of auxiliary outlet works
- Description: pumping water due to rain and broken waterline

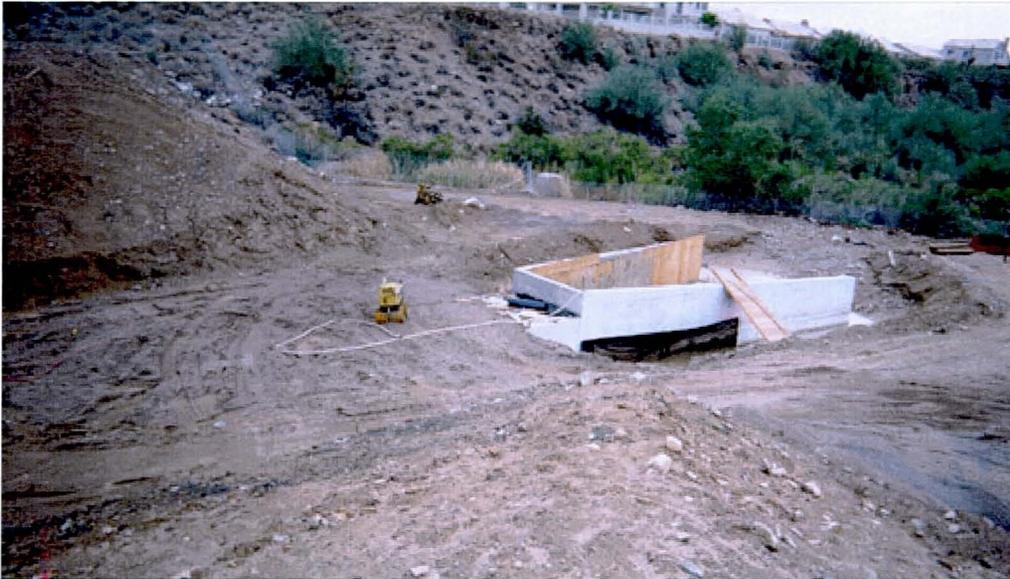
- Date: August 2000
- Location: auxiliary outlet works
- Description: backfilling box culvert, beginning structural backfill around wingwalls

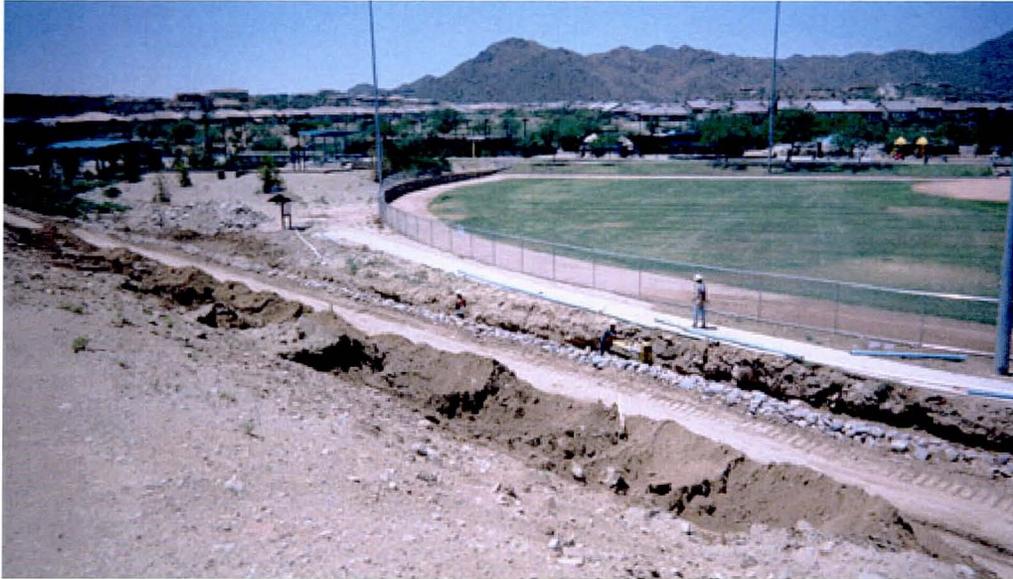
- Date: August 2000
- Location: upstream dam embankment
- Description: repairing broken irrigation line

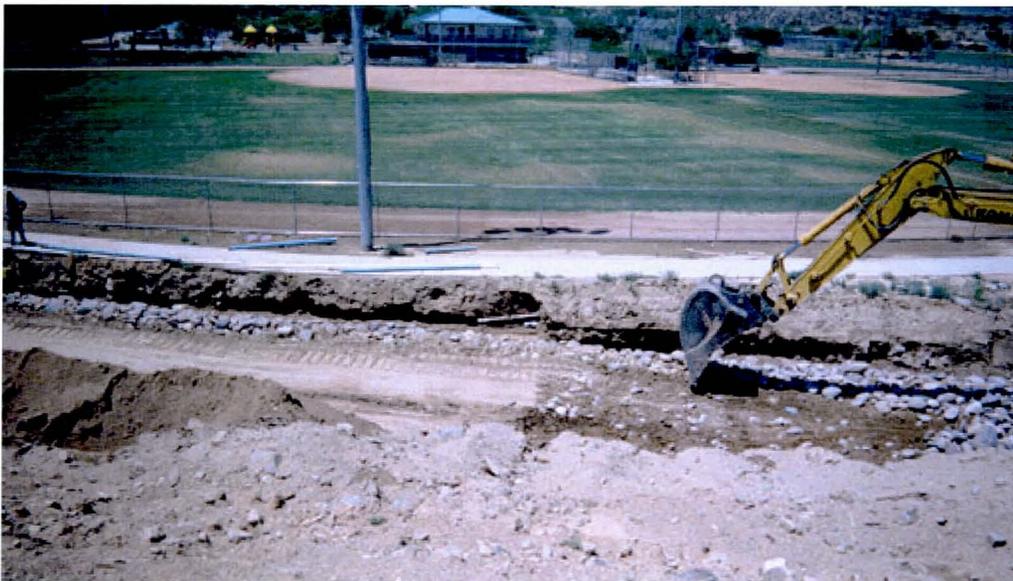
- Date: August 2000
- Location: upstream dam embankment
- Description: placing riprap

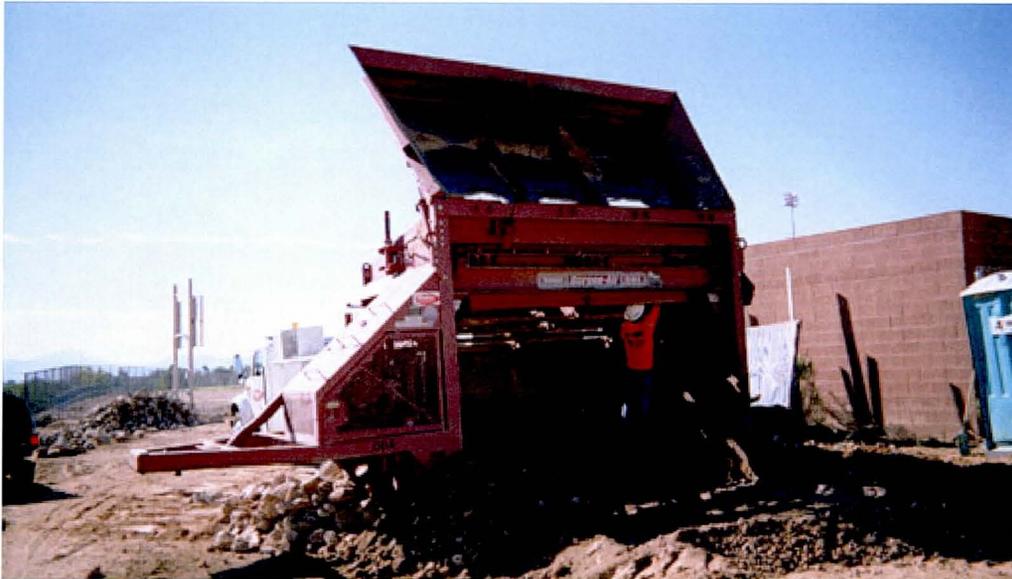
- Date: August 2000
- Location: auxiliary outlet works
- Description: grizzly used to screen onsite soil for replacement in the impervious zone

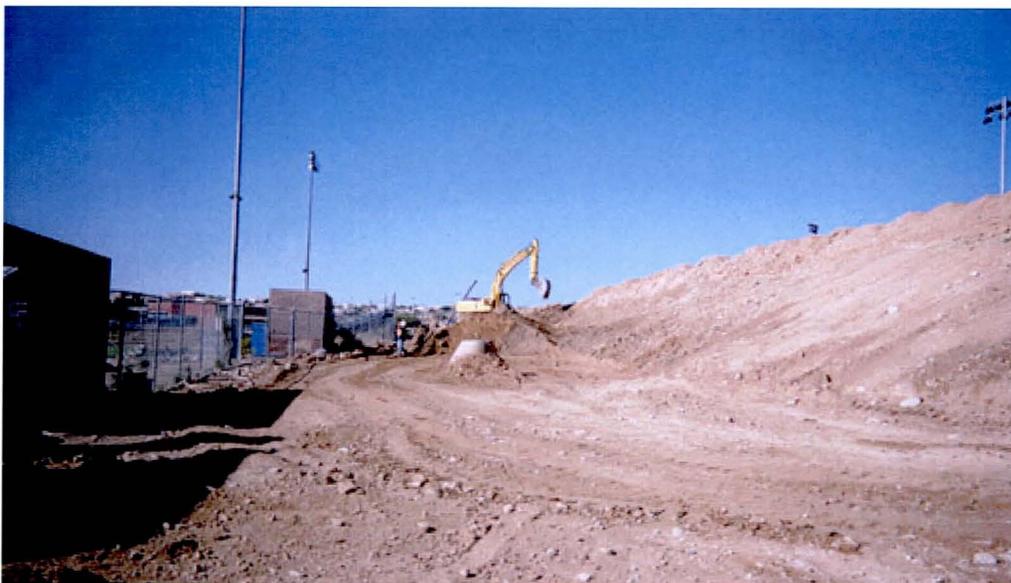
- Date: August 2000
- Location: downstream side of dam looking south
- Description: stockpiled material mostly gone and placed on upstream face and top of dam

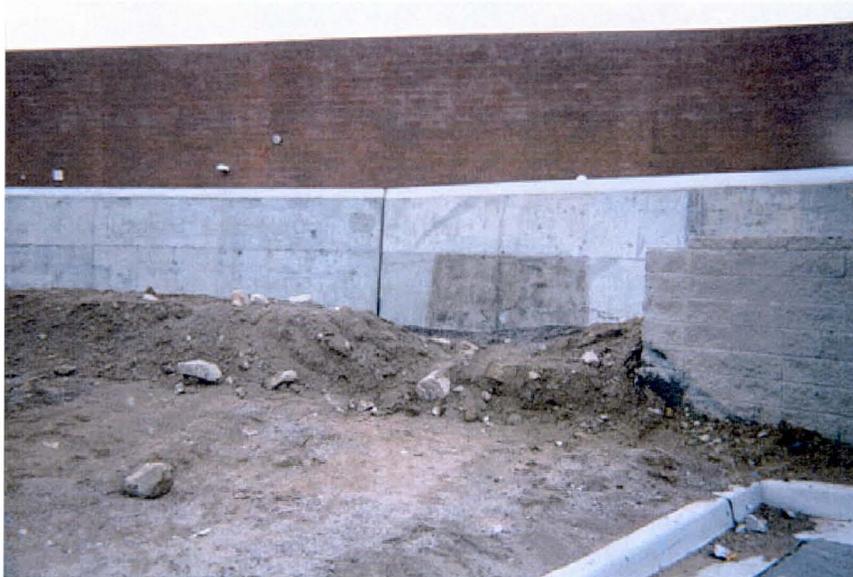
- Date: October 2000
- Location: emergency spillway
- Description: desert varnish stain sample applied to the floodwall
