ENGINEERING REPORT

SIGNAL BUTTE FLOODWAY

BUCKHORN-MESA WATERSHED

ENGINEERING INVESTIGATION REPORT

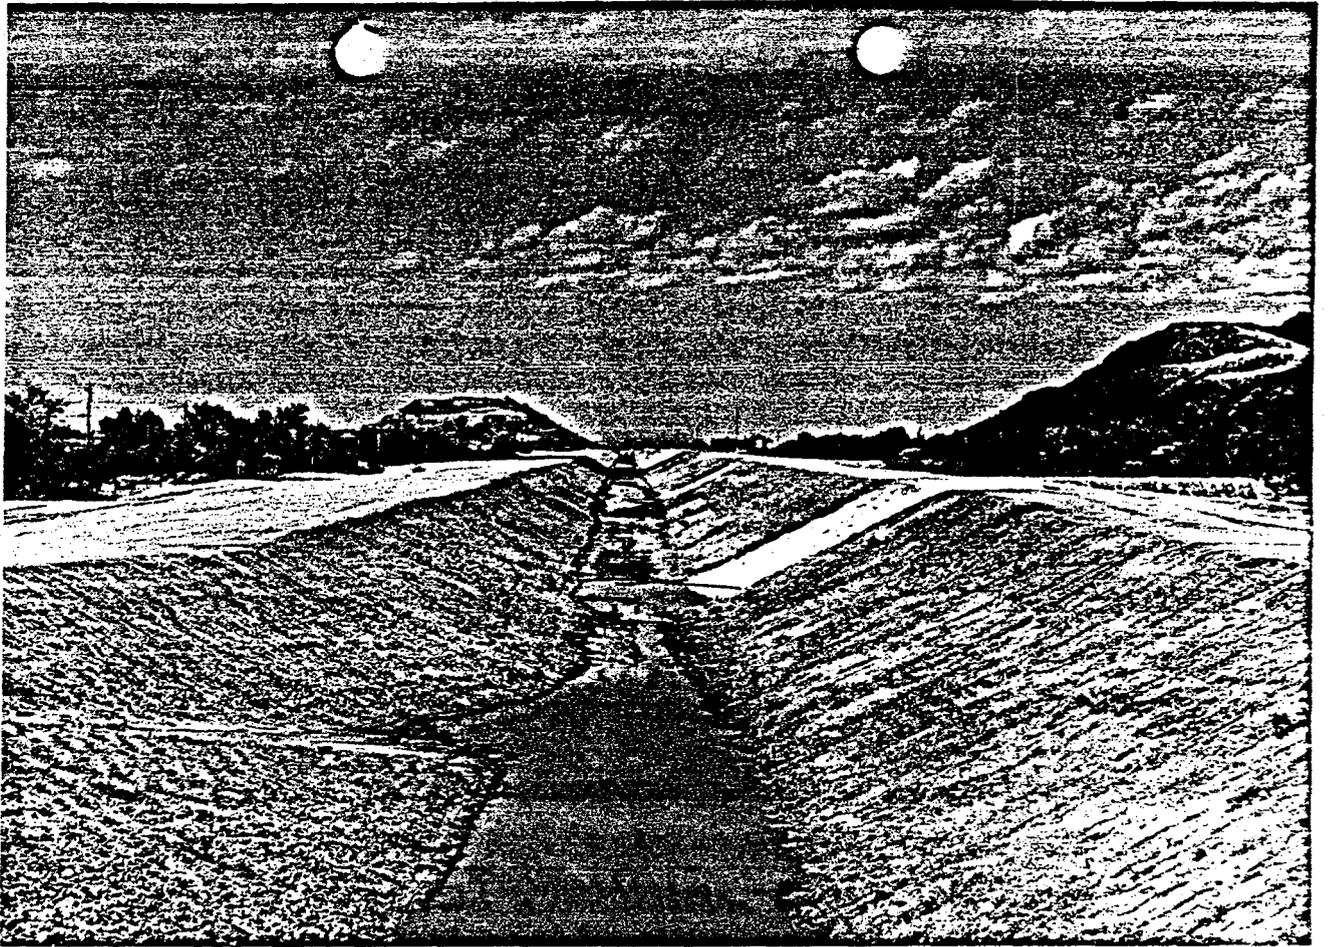
Photo Number No. 1 - View of Channel

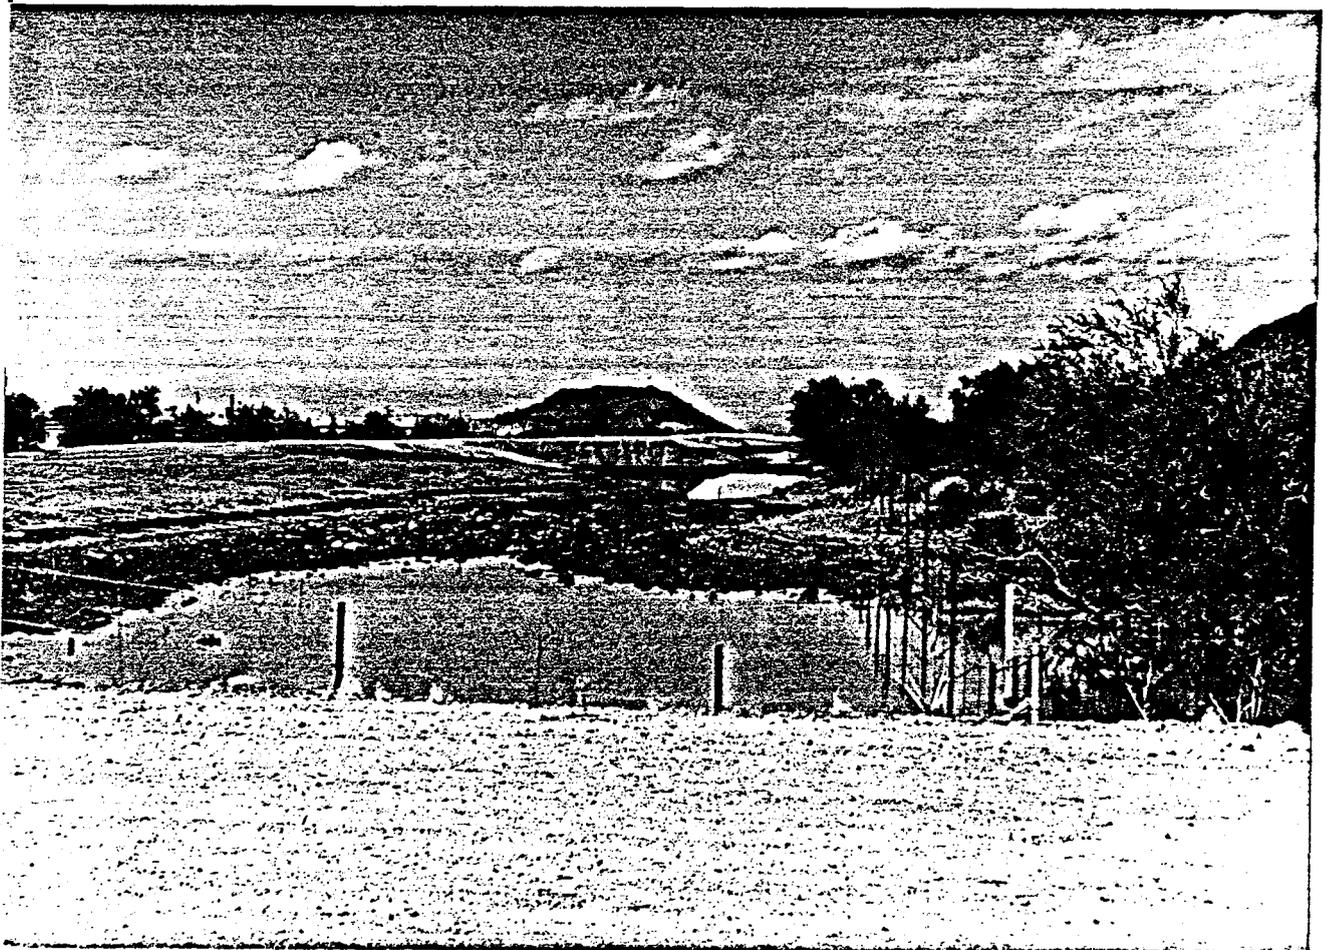
Photo Number No. 2 - Upstream of Inlet

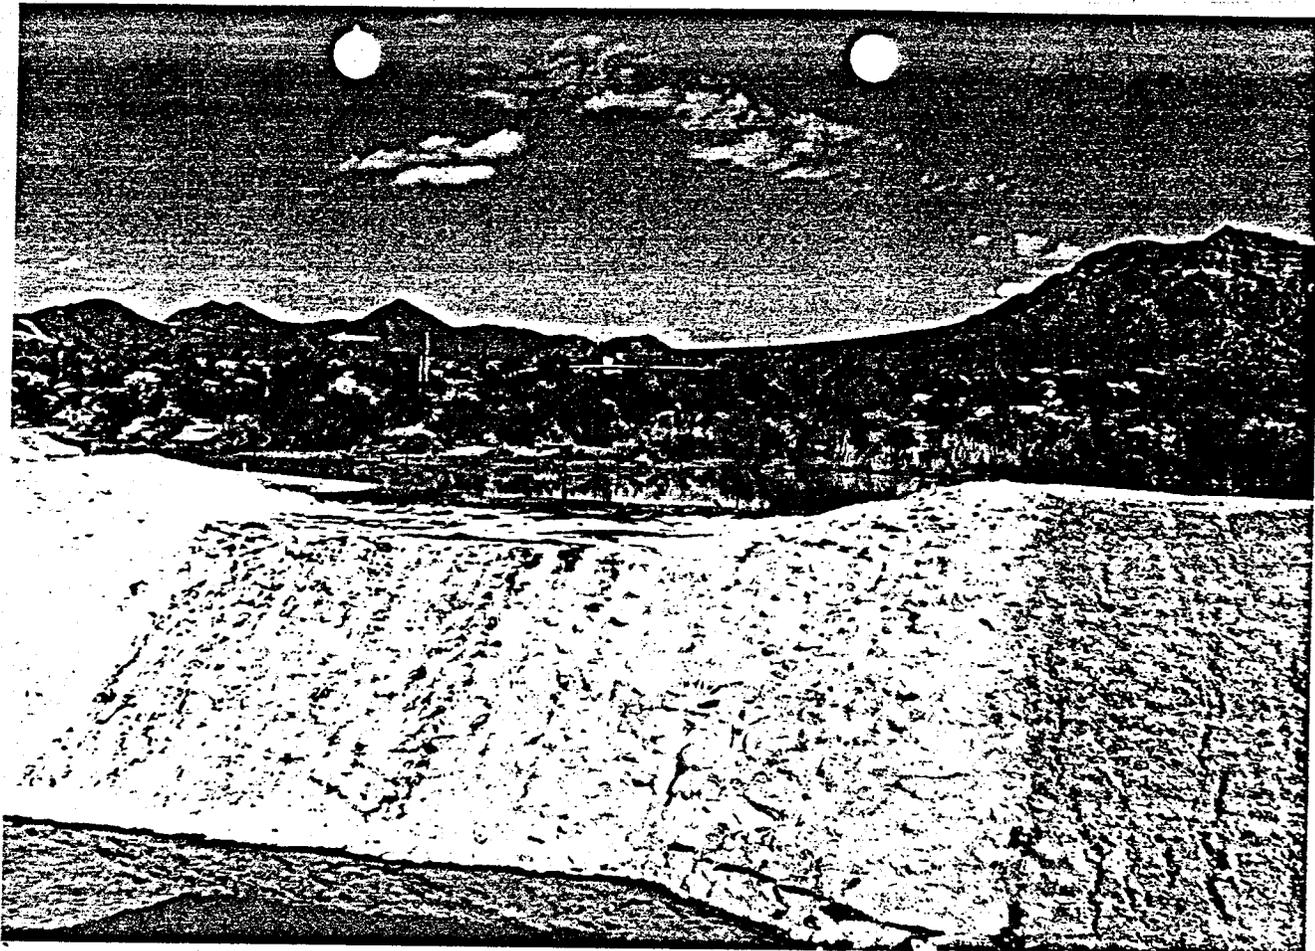
Photo Number 3 - Grouted Rock Side-inlet

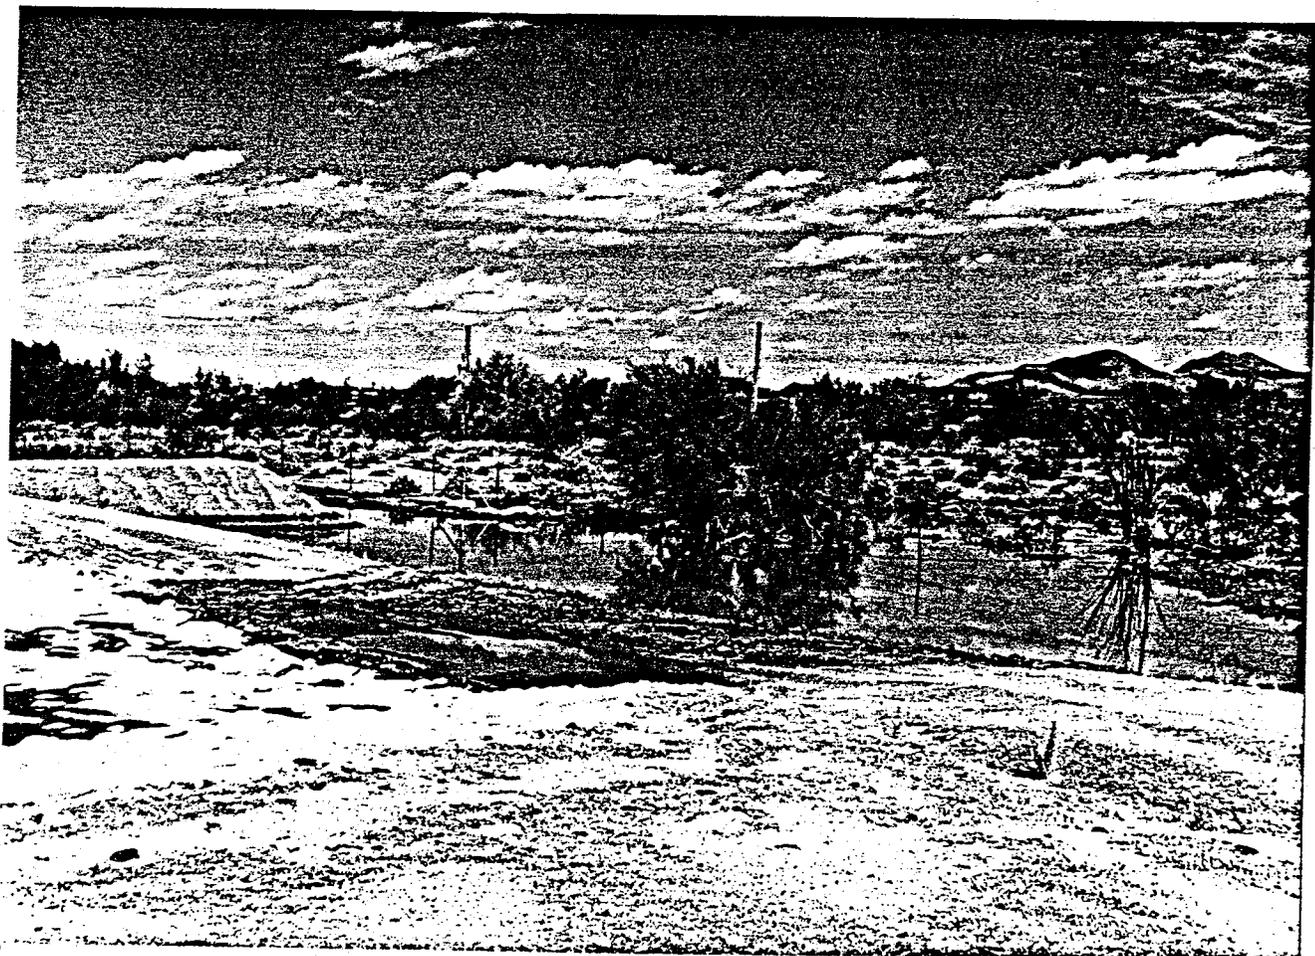
Photo Number 4 - Sediment trap

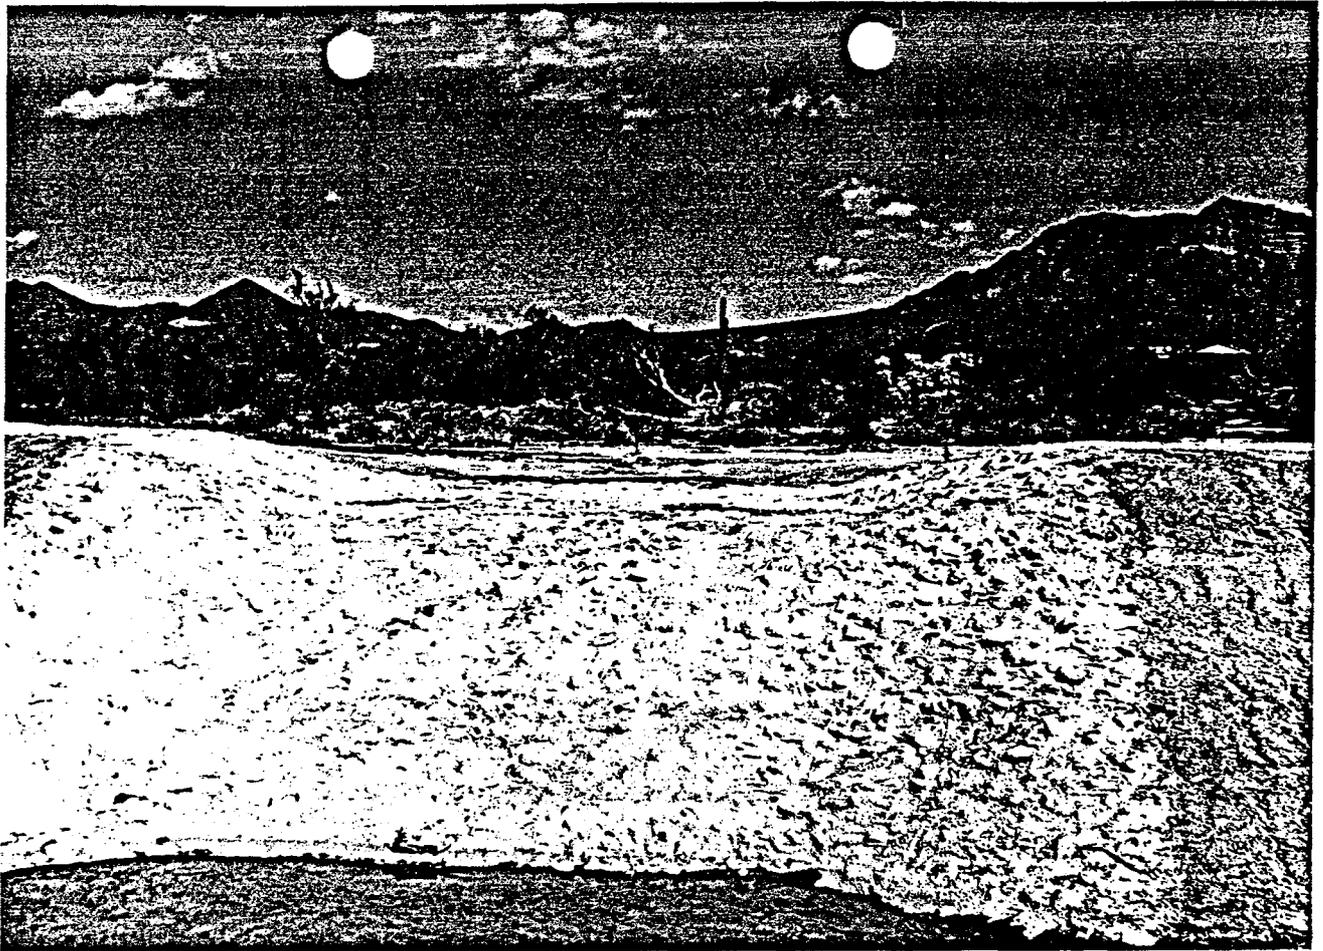
Photo Number 5 - Sideinlet - sediment full

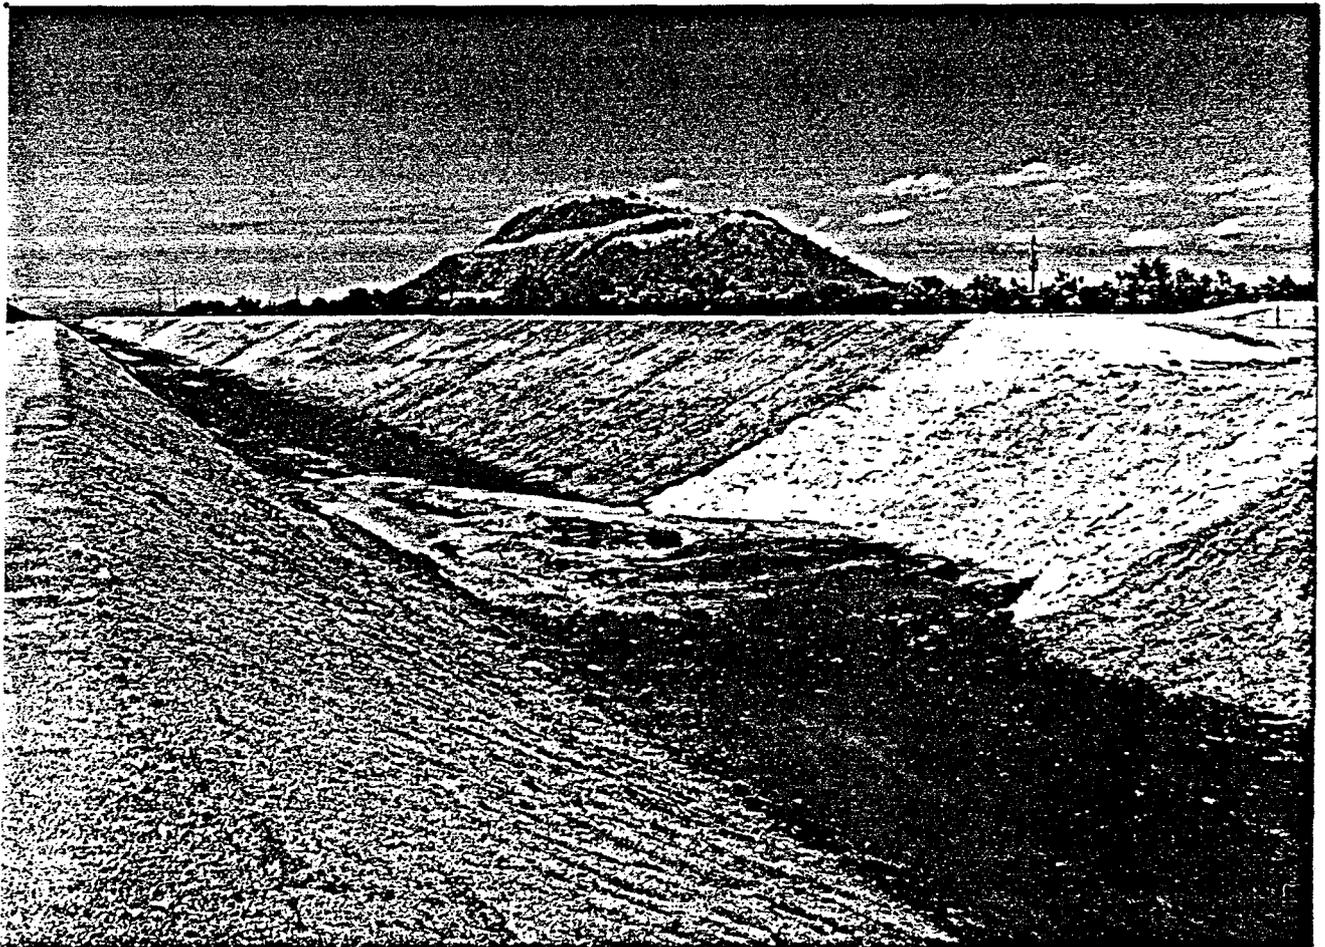
13. On September 18, 1985, there was a storm event that covered the area of the site. The storm created sufficient runoff that caused flows in the washes. Some of the runoff was ponded in low area outside of the R/W and some flows were great enough to flow through the side inlets and into the floodway. At some of these inlets there were sediment deposits in the floodway channel.

Photo Number 6 - Sediment in Channel
