SPECIAL REPORT
EMBANKMENT CRACKING
VINEYARD ROAD DAM
WILLIAMS-CHANDLER WATERSHED

Background

The Vineyard Road Dam was constructed during the fall of 1967 and the winter, spring and summer of 1968. This 20 ft. high embankment is approximately 29,000 ft. long and is located 4 miles south of Apache Junction on the alluvial fan which spreads southwestward from the Superstition Mountains. The foundation soils consist of varying gradations of clean sand (SP), silty sand (SM) and sandy silt (ML) overlying siltstone and interbedded gravel (GP) layers. Construction materials primarily consist of silty sands with some sandy silts used as they occurred within the borrow.

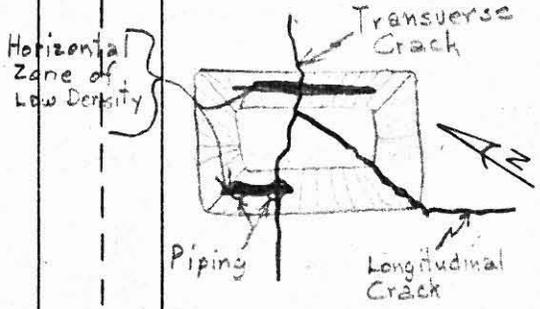
Horizontal Zone of Low Density

Transverse Crack

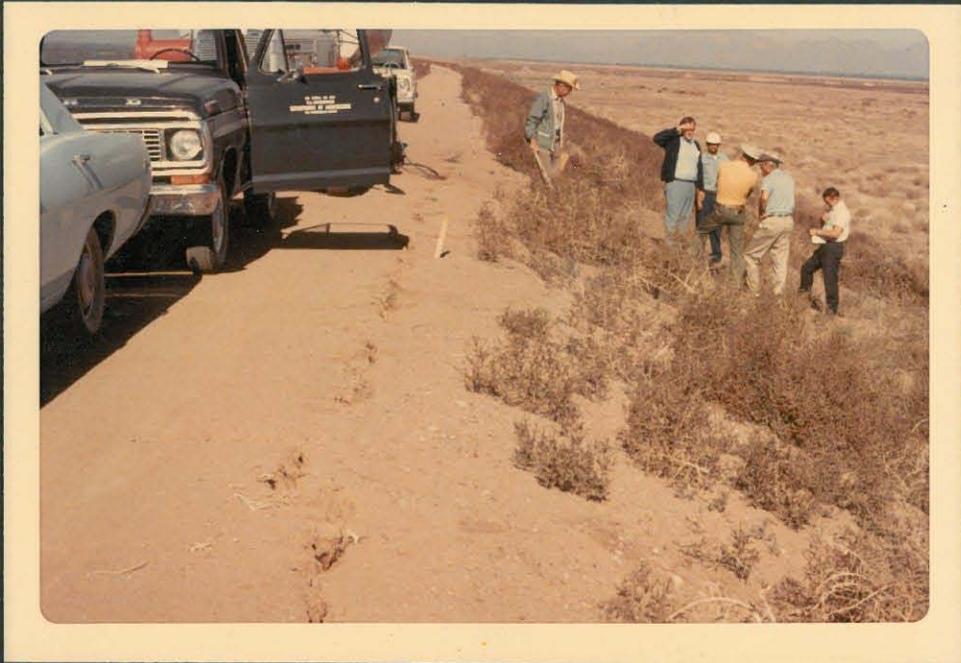
LONGITUDINAL CRACK
Sta 316+27

Approximately a 60 ft. long longitudinal surface crack exists along the front edge of the crest of the earth embankment. The alignment of the crack is parallel with the centerline of the dam without deviation. Numerous small transverse cracks of short length extend mainly in the downstream direction. The large crack is receiving surface rain waters, and consequent erosion and small sloughing results increasing the upper width of the crack.

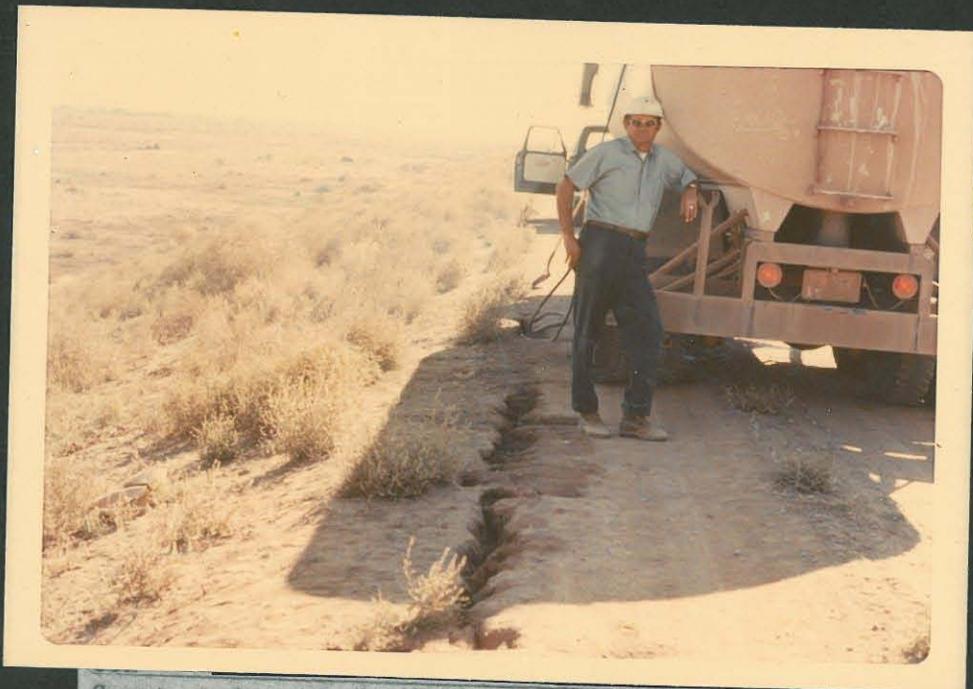
Water was pumped into the north section of the longitudinal crack at low pressure for approximately 15 min. without any water appearing within the slope cracks. The rate was increased to full pressure for another 45 min. Water appeared approximately 11 ft. down the slope emerging at a slow rate. A cone was built up around the outlet to allow building the hydraulic head, but it was building so slowly that the decision was made to move on to another section. It was assumed the bottom of the long crack and its system was encountered and that the reservoir of the total crack volume was slowly filling. We allowed the wall surfaces to soak ready for excavation by backhoe and later observation.

Looking north along longitudinal crack.
Note hose directing water into crack.

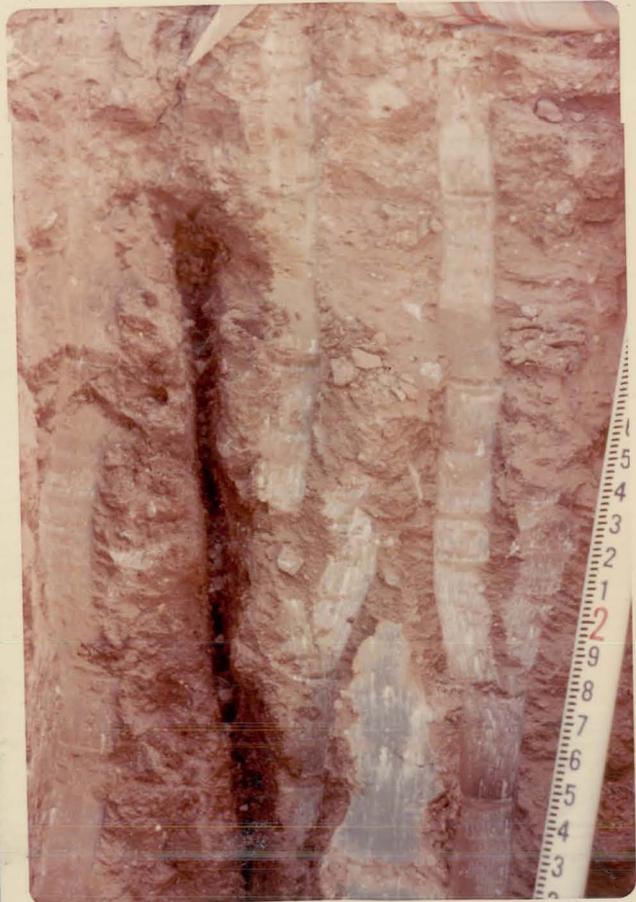
Test Pit # 1

Located 11 ft. upstream of \bar{E} at Sta 316+27
across a transverse crack - depth 3.5'

County back-hoe begins excavation.

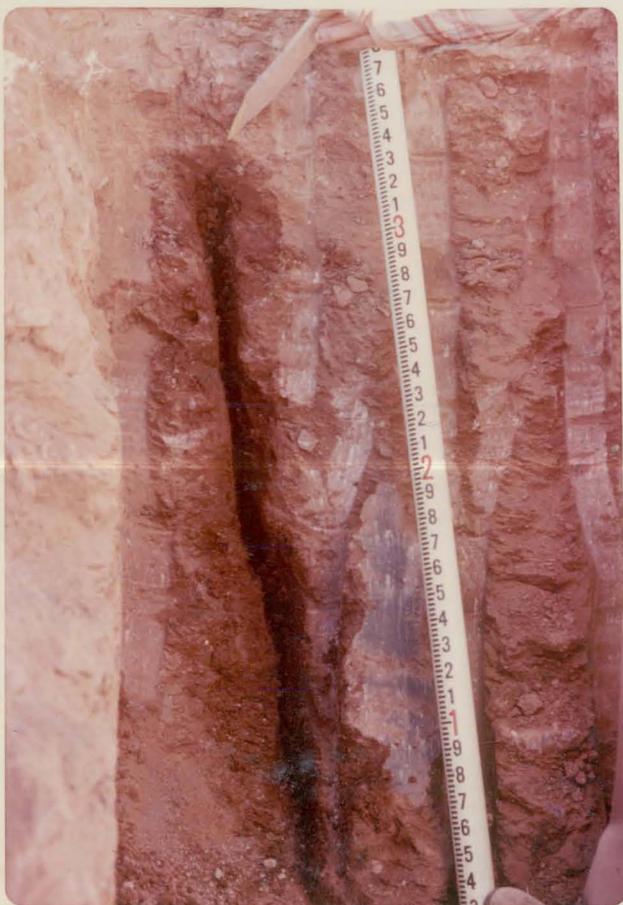
Test pit No. 1 was excavated across the point where water emerged 11 ft. down the upstream slope of the dam. The excavation showed the depth of crack at approximately 3.0'. The excavation below the 3.0' level was moist at the natural embankment water content. The cracking disappeared (as visible by eye) and no wetting occurred as in the visible cracks above. The upper portion of the crack (1'-0") was dry with a width of 1/8". The lower portion had wetted to a width of approximately 6 inches. The crack alignment and depth were easily followed from the saturated condition.

Upper portion of crack is dry and extends
to surface.

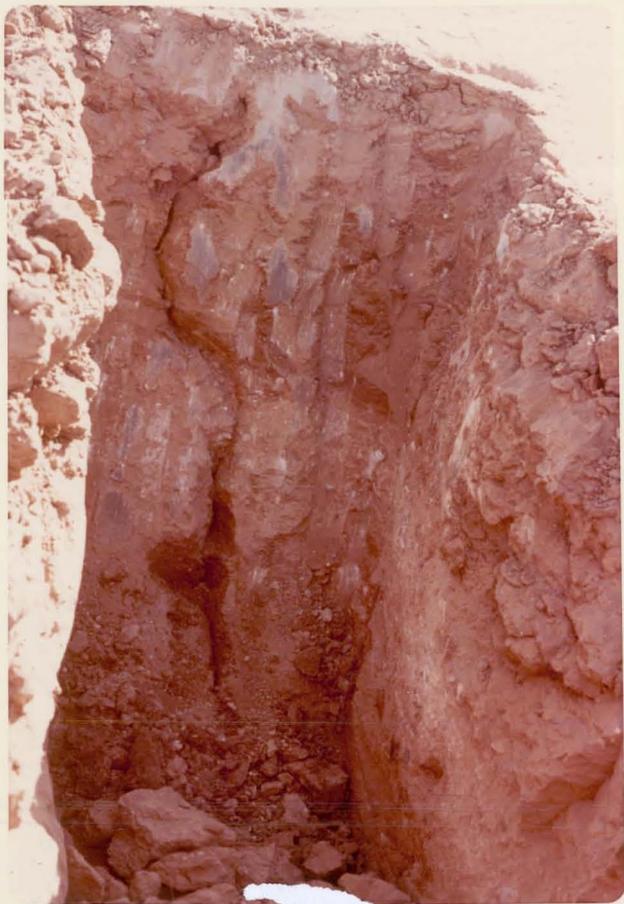
Moisture samples from pit No. 1 showed a water content of approximately 7.6% in the upper 3.5 ft. excavated.

Wetted portion extends to 3.0 ft.

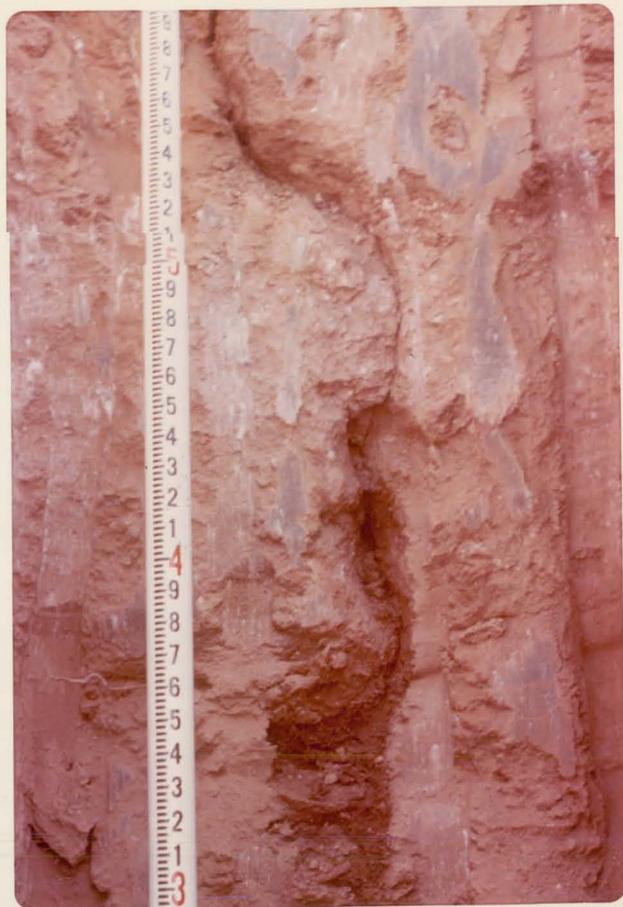
Test Pit # 2

Located on top of dam and excavated
across a longitudinal crack Sta 316+22
depth 8.0 ft.

Irregular alignment due to calcareous
zones.

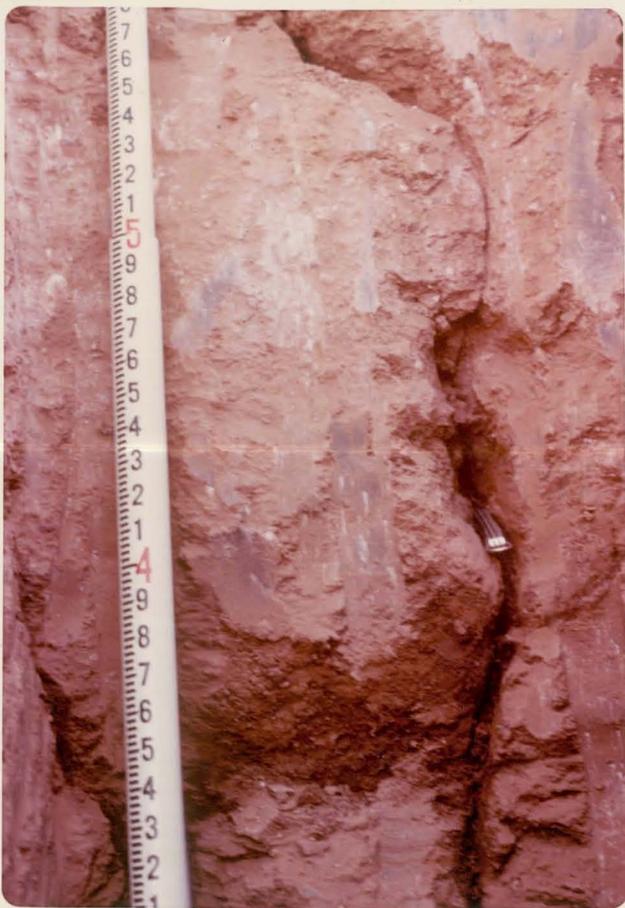
Moisture samples taken show 7% water content at the 2.0 ft. level, 11.0% from 3 ft. to 7 ft. and near 12% at 8.0'. Placement moisture in this vicinity is recorded at 12.6%.

Increasing moisture content with depth.

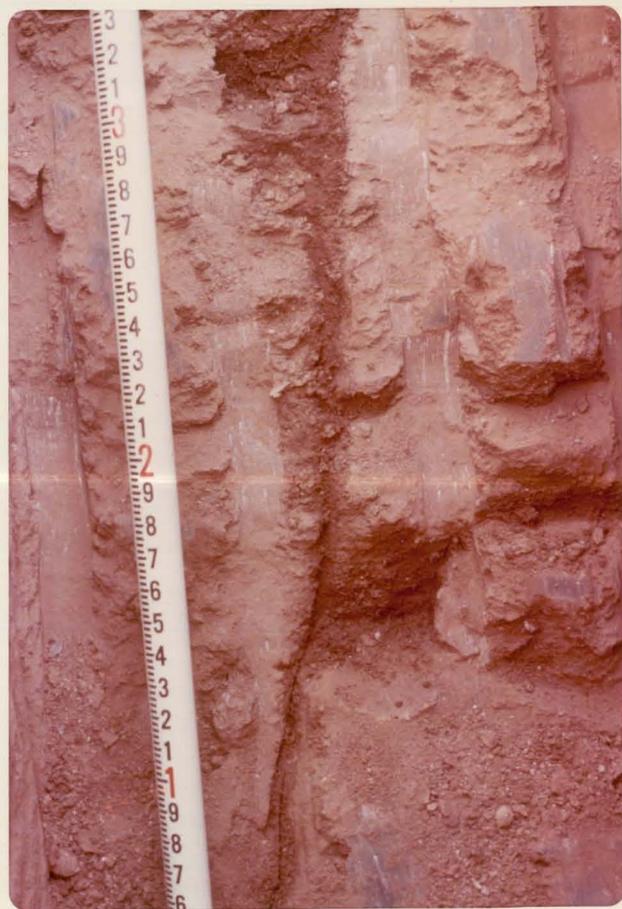
Crack $\frac{1}{8}$ " to $\frac{1}{4}$ " open to top.

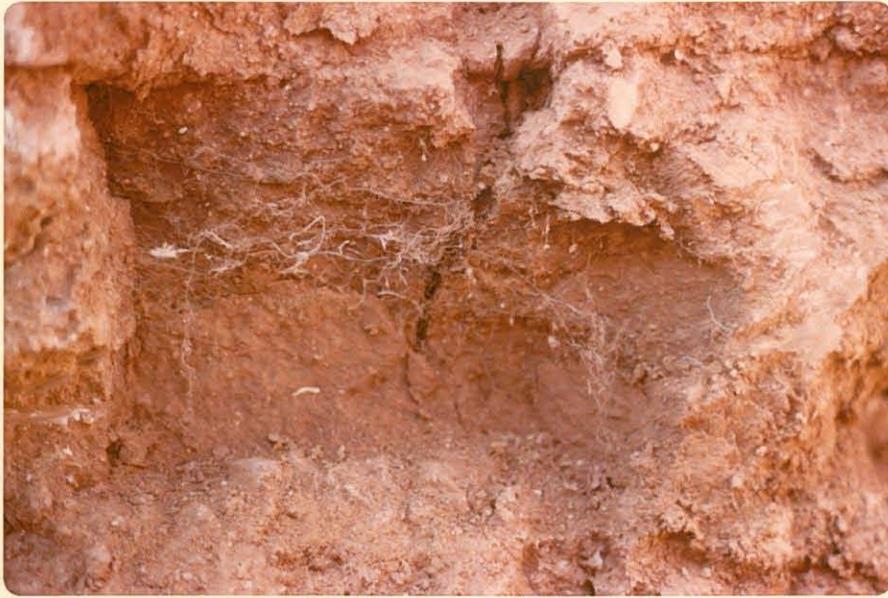
Test Pit No. 2 was excavated near mid length of the longitudinal crack, being also the point of water intake. Excavation extended to a depth of 8.0 ft. The visible cracks extended to the 6.8 ft. level and closed. The backhoe was unable to continue the excavation beyond 8.0 ft. The crack was $\frac{1}{2}$ " to $\frac{1}{16}$ " wide closing near the 6.8 ft. level. A horizontal deflection in the crack occurred near the 1.3-1.8 ft. level due to a calcareous horizon. No evidence of vertical displacement was observed along the crack. Clean sands deposited within the 3.5-4.0 ft. zone at the crack shows evidence of internal erosion occurring during runoff.

Crack closes at the 6.8' depth.

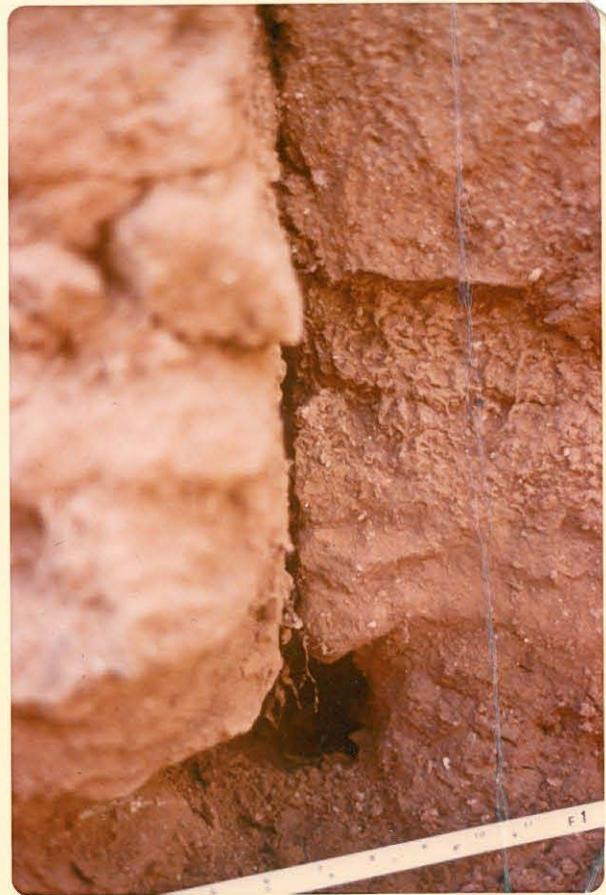
Test Pit No. 3 was excavated on the embankment crown near the mid point of the longitudinal crack in vicinity of Station 313+20. The pit was excavated to a final depth of 8.0 ft. The profile showed the transverse crack was $\frac{1}{4}$ " wide at 2.0 ft. then hairline to 4.5 ft. The wetting process had extended from 2.5 ft. to the 4.5 ft. level.

Test Pit # 3
Located on top of dam and excavated at
junction of transverse and longitudinal
cracks Sta 313+20.

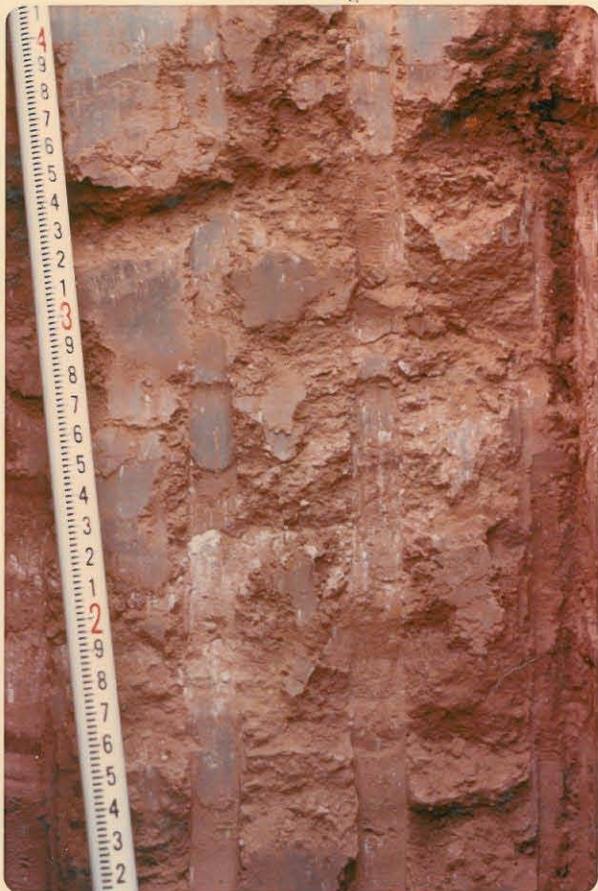
Fine roots were found within the longitudinal cracks to a depth of 2.0 ft. The type of plant to which they belong was not determinable. The adverse effect of the existence of these roots on the cracking problem is unknown but felt to be negligible.

Looking into transverse crack. Fine roots
at 2.0 ft. depth - crack is $\frac{1}{2}$ " to $\frac{3}{4}$ " open.

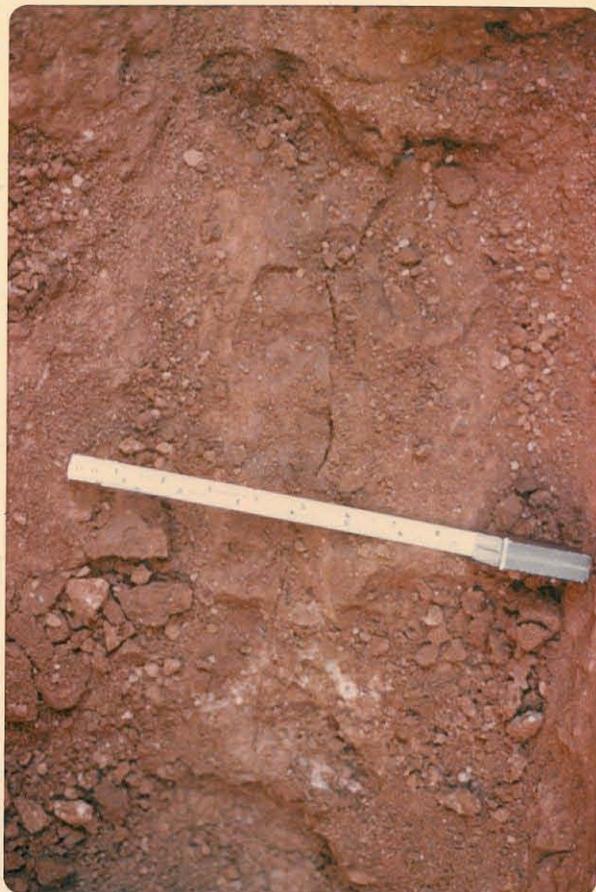
A horizontal zone at low density was encountered from 3.0 to 3.3 ft. It was lense shaped with a maximum thickness of 0.3 ft. The horizontal extent was approximately 5.0 ft. at the pit excavation. An open pipe (3" diameter) at the juncture of the soft horizontal zone and the transverse crack was found. Probing inward a length of 3 ft. was possible.

Looking into base of crack at soft horizontal
layer 3.3 ft. depth. Hole eroded by piping
to a down stream outlet.

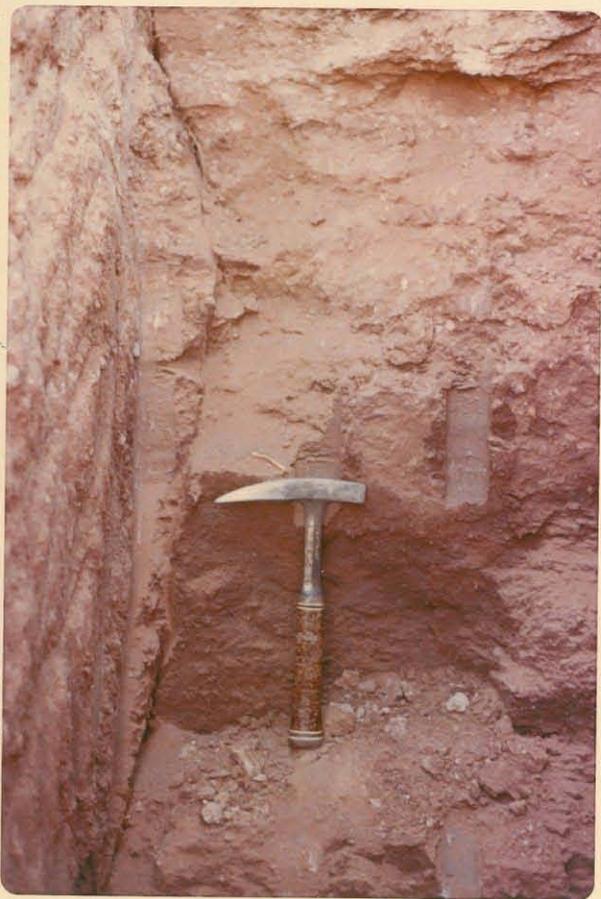
Looking into south face of pit
horizontal soft layer terminates.
Note deepening longitudinal crack
at right corner.

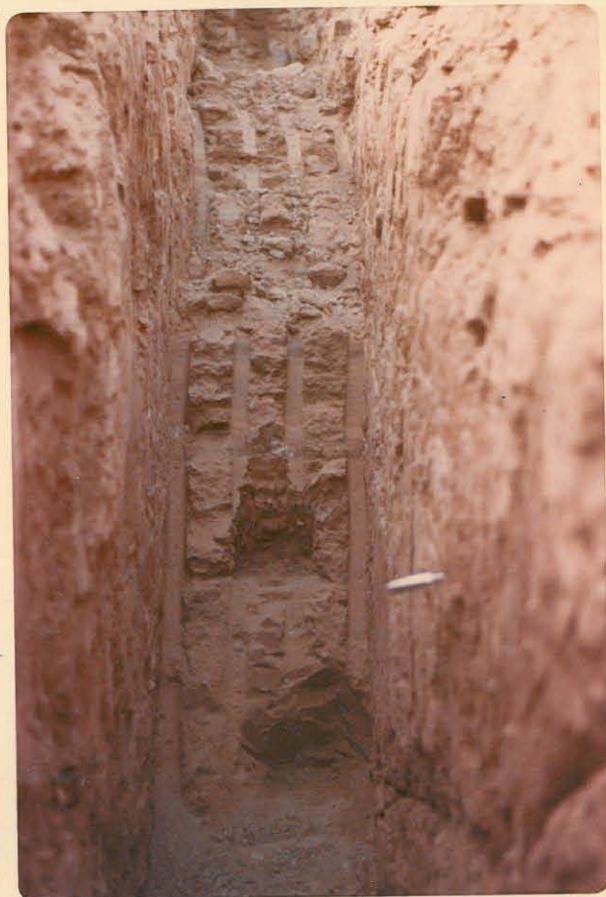
Test Pit # 4 was excavated as a trench down the front slope of the embankment beginning approximately 25 ft. downslope of the crest. An attempt was made to follow the alignment of a crack system. Depth at excavation varied from 4.0 ft. to approximately 10 ft. at the toe of the embankment.

Trench down the upstream slope of Sta 313+20 across transverse crack network. Also includes upstream toe of embankment and cut off trench. Depth 3.0 ft. to 10.0 ft.

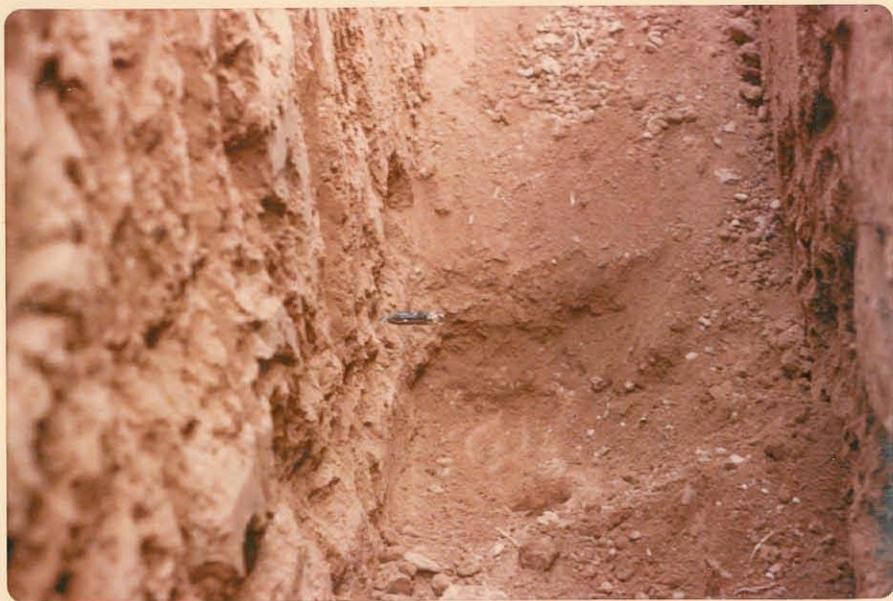
Due to the soil-colored blends, moisture contents, and closeness in density values the outline of the earth fill against the foundation soil could not be easily traced. Attempts to do so resulted in only partial correlation with as-built drawings.

Lower right approximate foundation contact. Knife indicates moisture penetration zone.

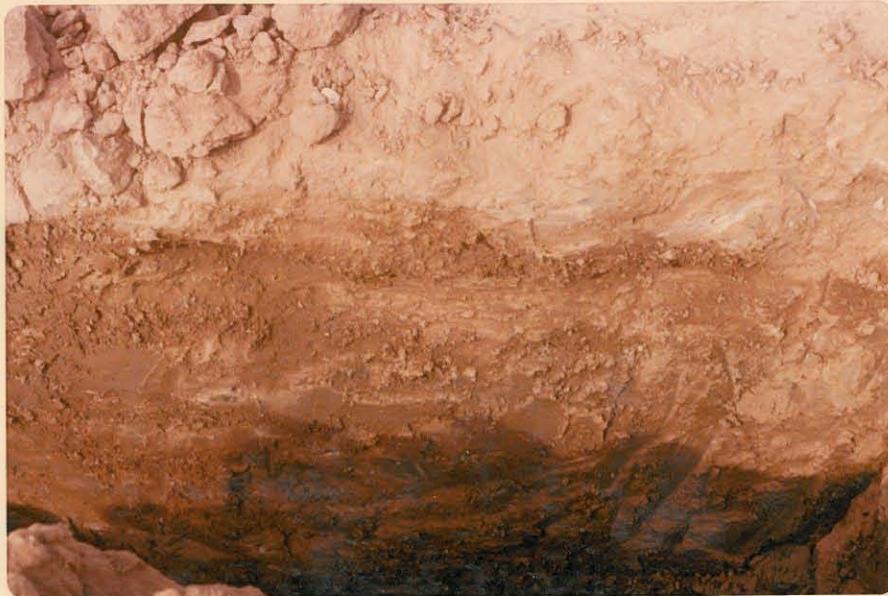
Density tests within the trench ranged from 85.5 pcf. at 13.8% moisture to 95.3 pcf. at 20.5% moisture. The density in comparison to 118.3 pcf. or 116.3 pcf. from laboratory soil curves results in 73% to 80% compaction. This would indicate a soil loosening had occurred since placement was at 95% or greater compaction.

Looking east. Density test of foundation toe.

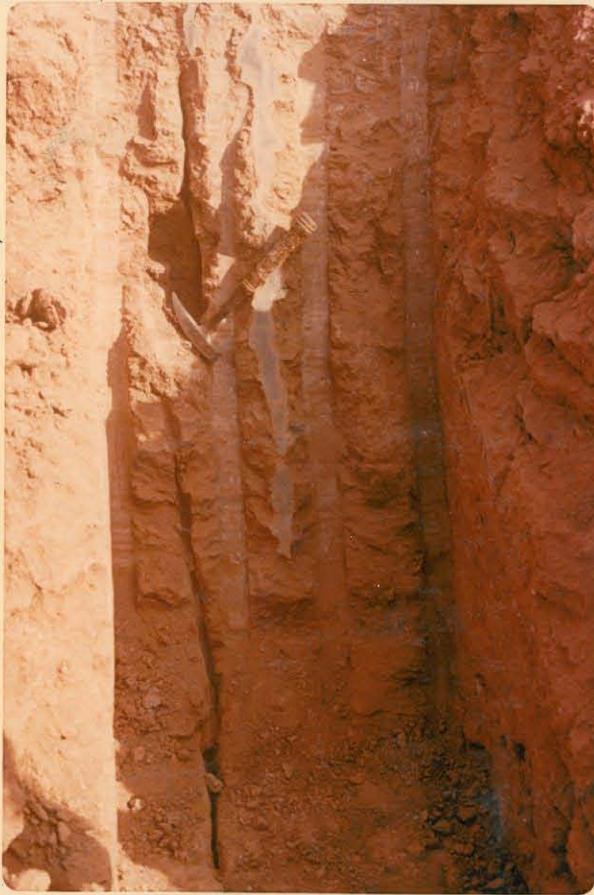
Test Pit # 5 was excavated approximately 3.5 ft. deep at the junction of a transverse and longitudinal cracks. The wetting pattern was to a maximum depth of 3.0 ft. The crack closed at that point and only hairline to no cracking existed. A horizontal lense 5 ft. long and 3 inches thick existed at the 1.0 ft. level.

Located at junction of transverse and longitudinal crack on crest of dam Sta. 266+00. Depth 3.0 ft.
