Wickenburg, FRS

Sunny cove

Sunset

WHITE TANK FRS

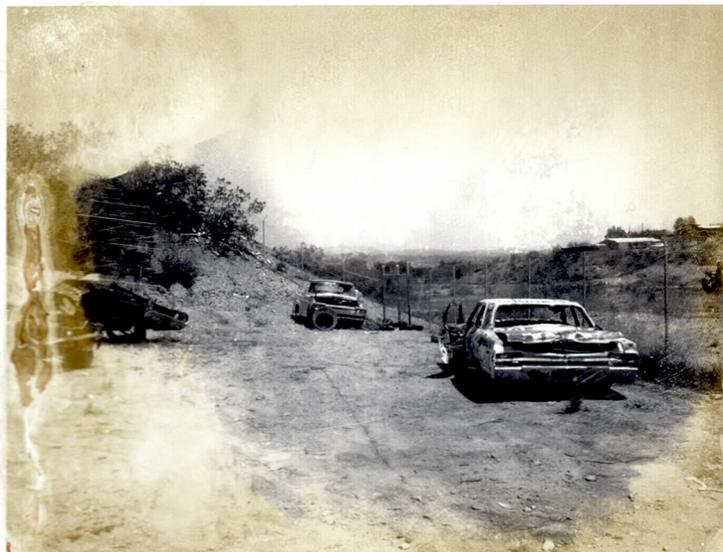
From north looking south at southwest corner. 4-26-76

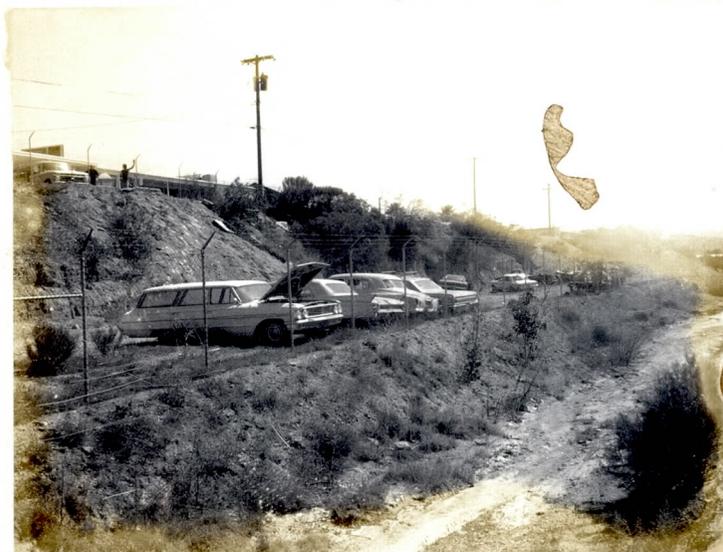
From the north looking south at north side of fence. 4-26-76 Wickenburg.

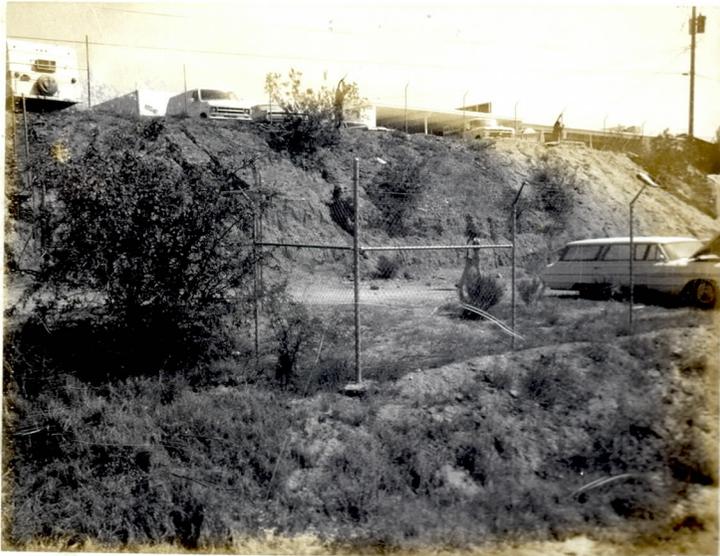
Wickenburg. From northwest looking southeast at northwest corner of fence. 4-26-76

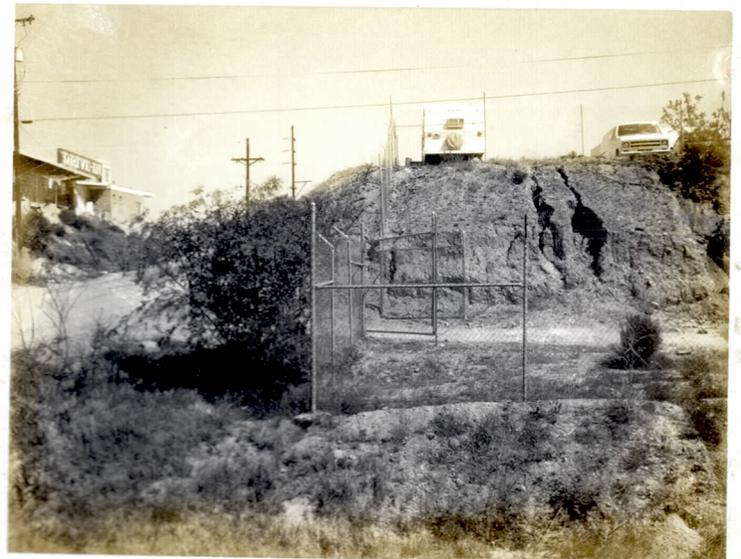
Wickenburg. West looking east at northwest corner of fence. 4-26-76

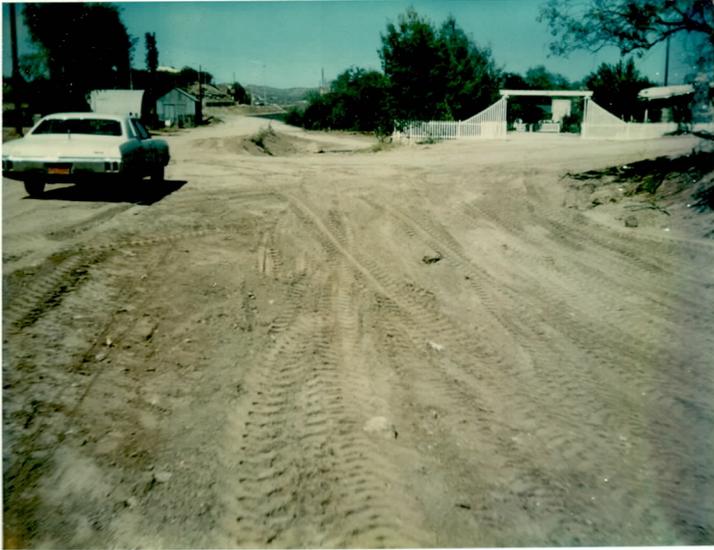
Wickenburg Dams. Pipeline work. Pipeline crossing at Jackson St. 5-14-76

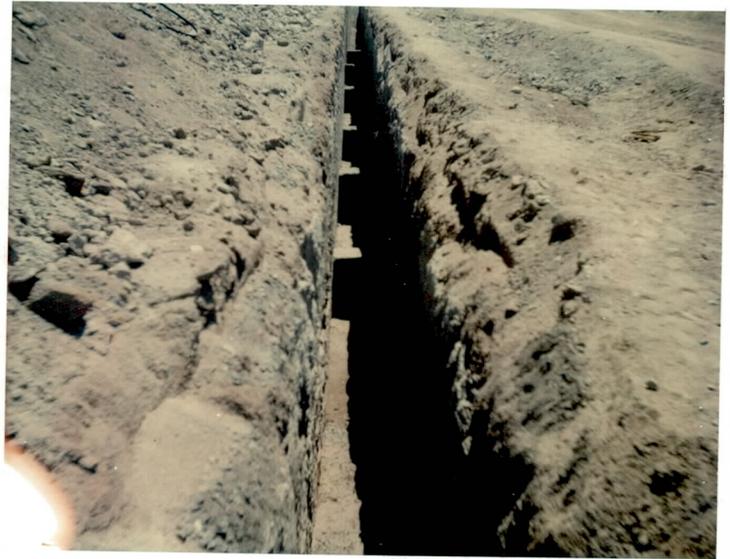
Spook Hill utility relocation.
View of encased waterline along
East Hermosa Vista as it was
when contractor was asked to
discontinue work by SCS to revise
specifications on backfill material.
View looking northeast. 6-9-77

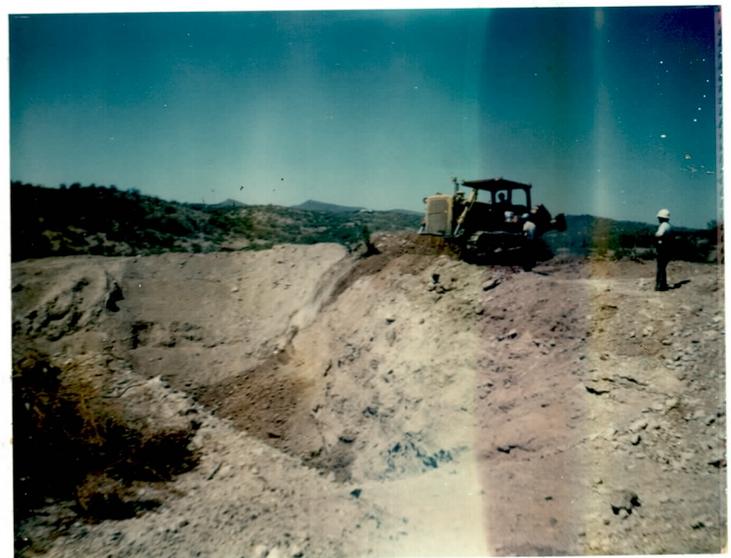
Sunnycove Dam. View of near vertical cut in dispute between Wakefield and Faar on this date. Contractor beginning to cut slope. 8-9-76

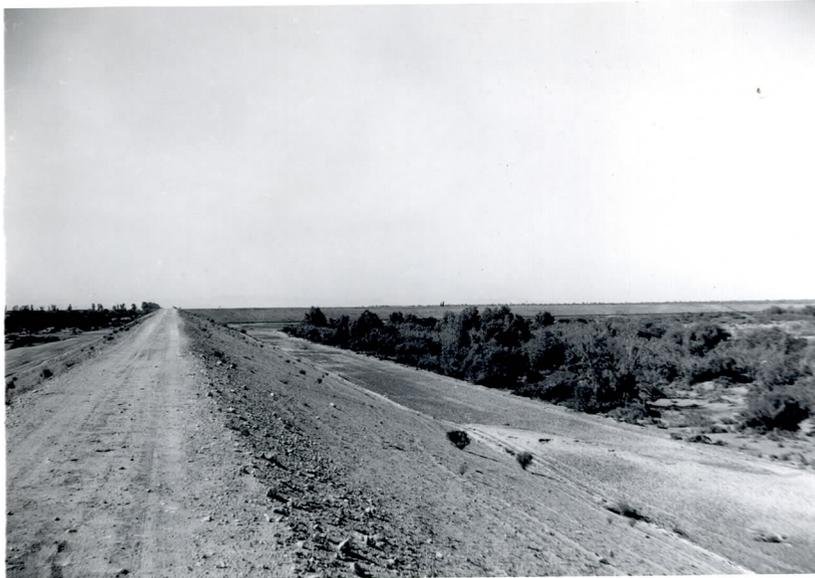
SCS Dam #3. Water was 15' from top
of dam. 9-16-77

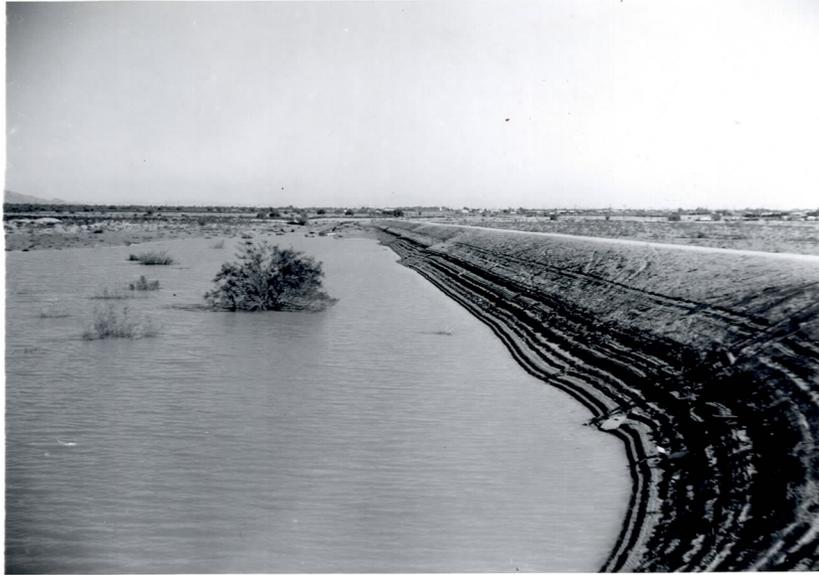
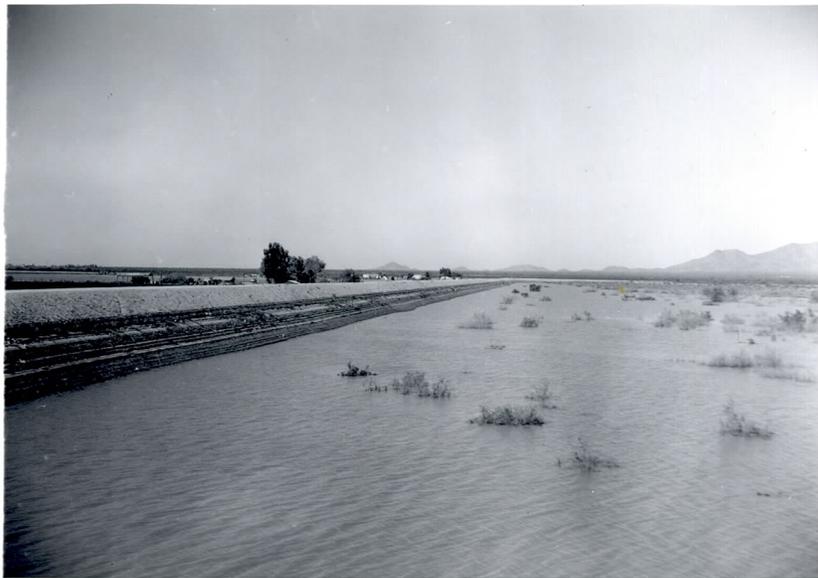
SCS Dam #4 spilled 9-6-70.
(Both pictures)

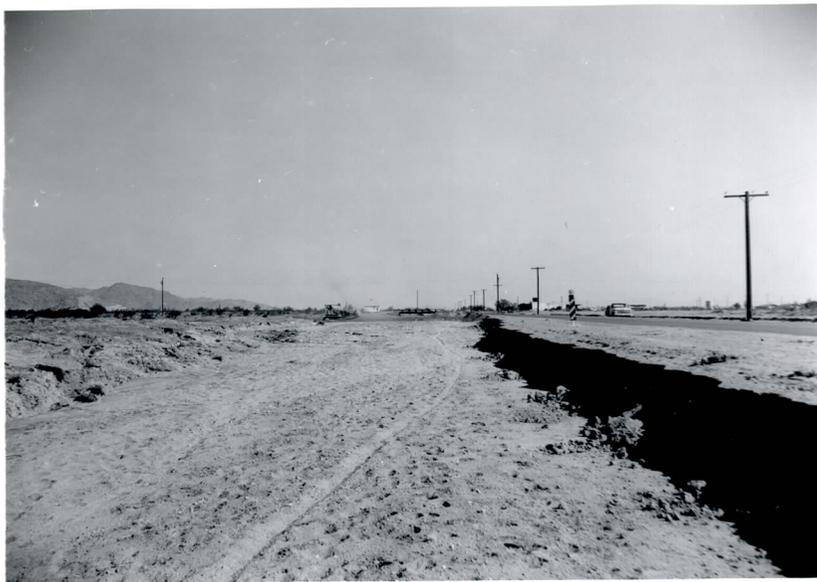
North along SCS Dam #4 channel on
Jackrabbit Trail. Flowed 3' deep,
40' wide. 9-6-70

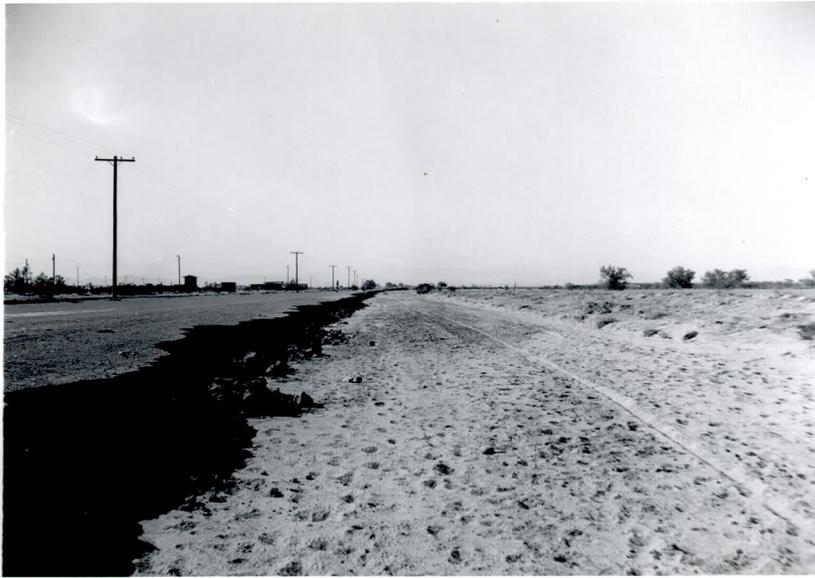
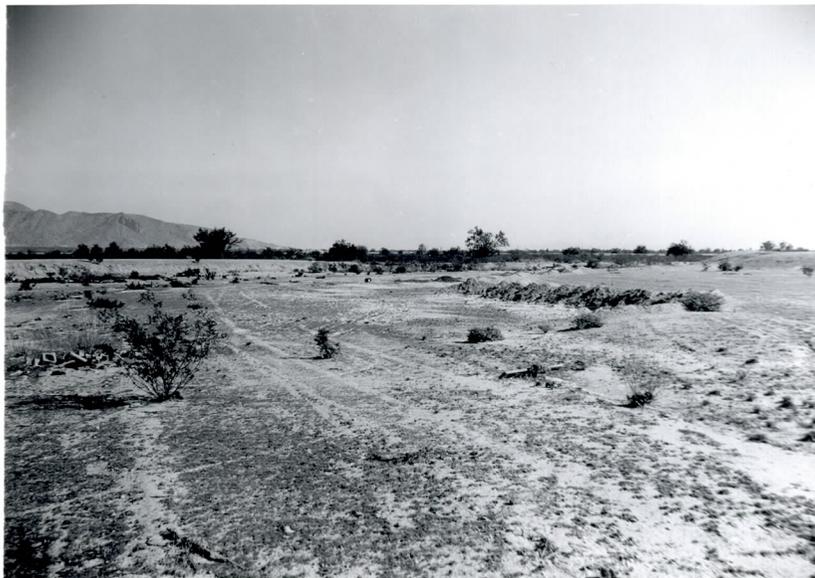
South along channel west side of
Jackrabbit Trail north of SCS Dam
#4. Flowed 9-6-70. 3' deep, 40'
wide. (See report in file dated
9-23-70)

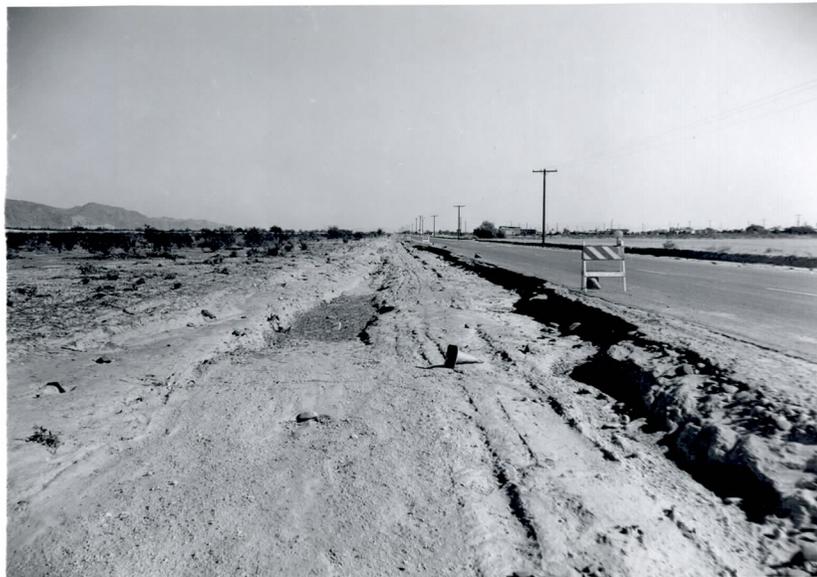
West spillway SCS Dam #4. Flowed 4-6"
deep, 50 - 100' wide. 9-6-70.
