US Army Corps
of Engineers
Los Angeles District

Gila River Basin
Arizona

ADOBE DAM FOUNDATION REPORT

October 1982

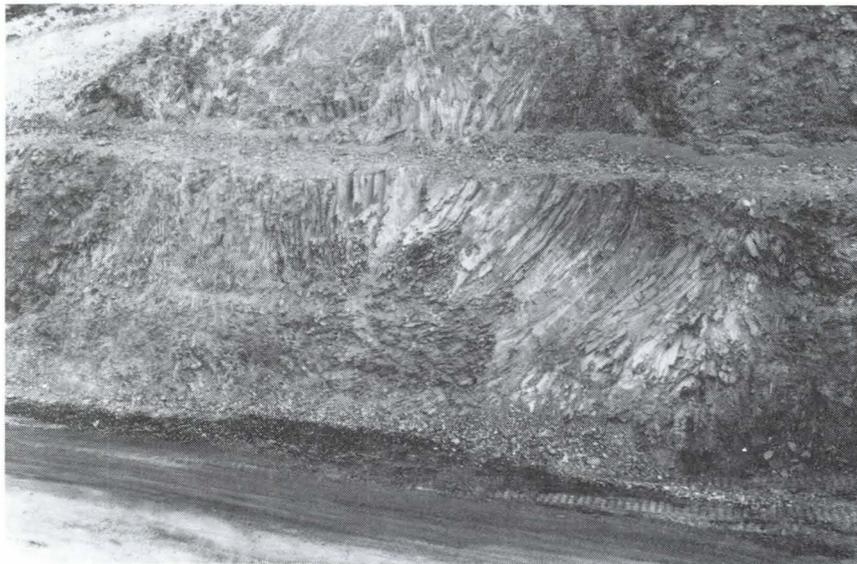
Photo 12
Swirling joint pattern with adverse dip towards spillway cut as developed in upper andesite unit; east side near station 22 + 50. Fifty percent of 12-foot-wide bench is already missing due to rock falls along joint planes. (6 Feb 1981)

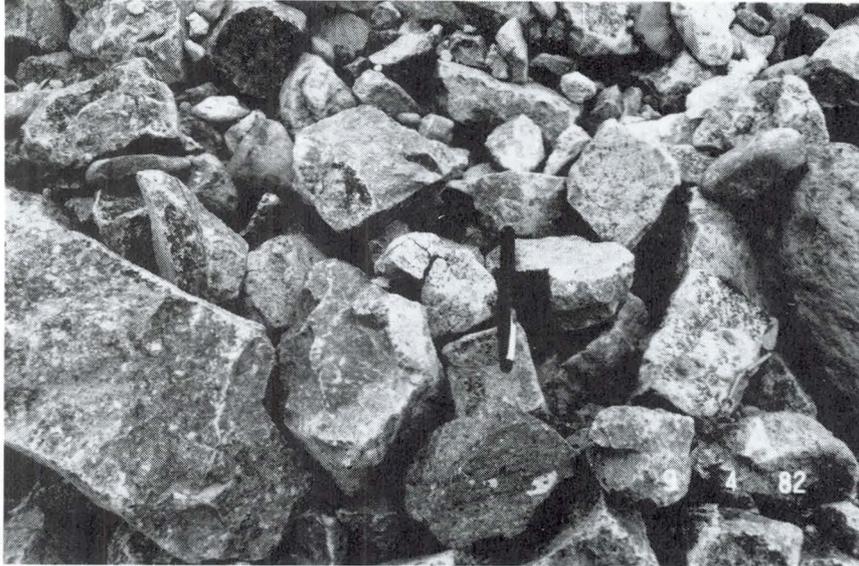
Photo 13
Typical example of Type III stone breakdown on downstream face of dam.
(19 Apr 1982)

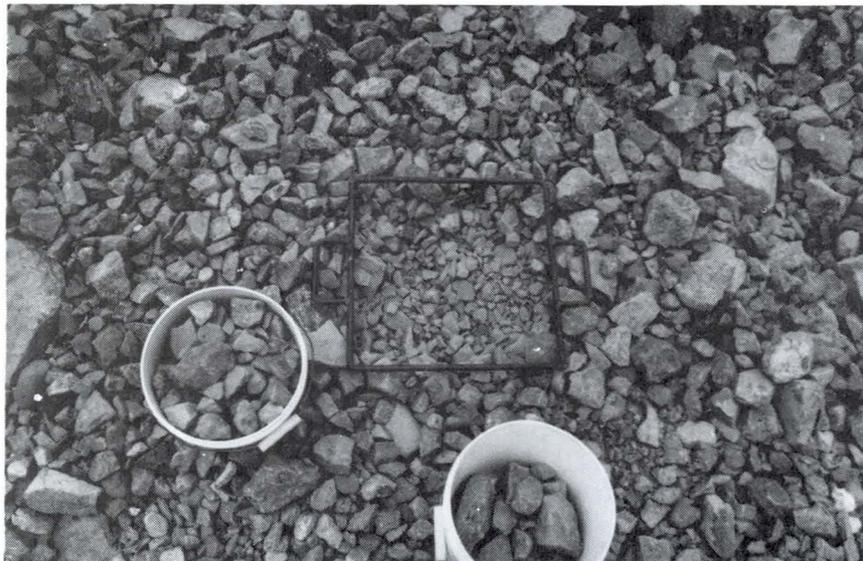
Photo 14
Area, 18 x 18 inch, mid-slope on downstream face of dam near station 60, after
sorting into cracked and non-cracked Type III stone. Cracked rock in bucket at
right. Note rock at lower left corner of metal template. (6 Apr 1982)

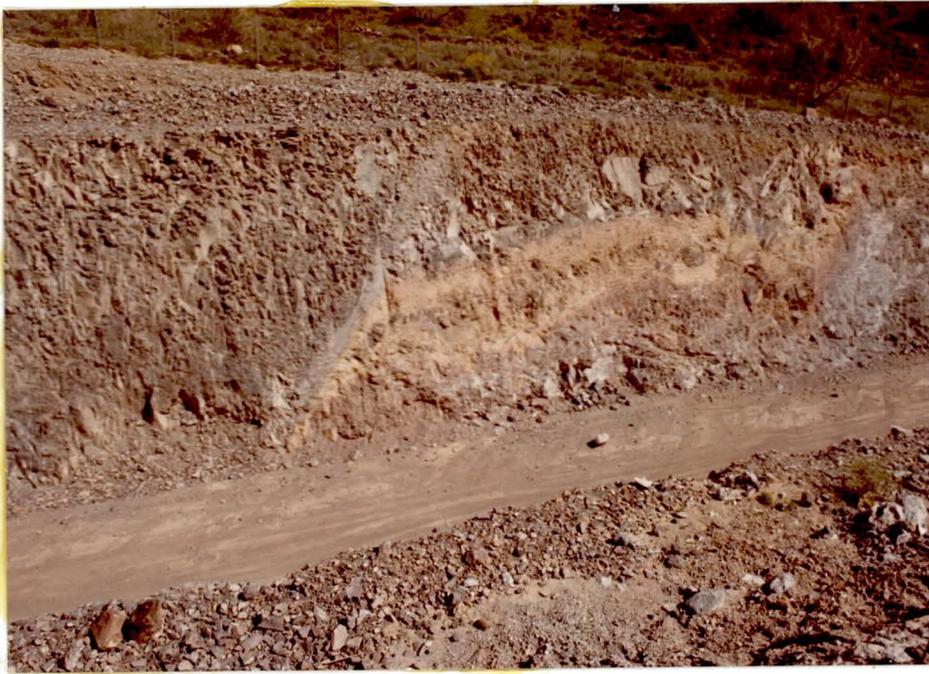
Photo 23
Normal fault at spillway station 16 + 50, east side, trends N50-60W, dips 60 degrees NE. Upper andesite at left; upper andesite/clastic tuff/amygdaloidal andesite at right. (6 Apr 1982)

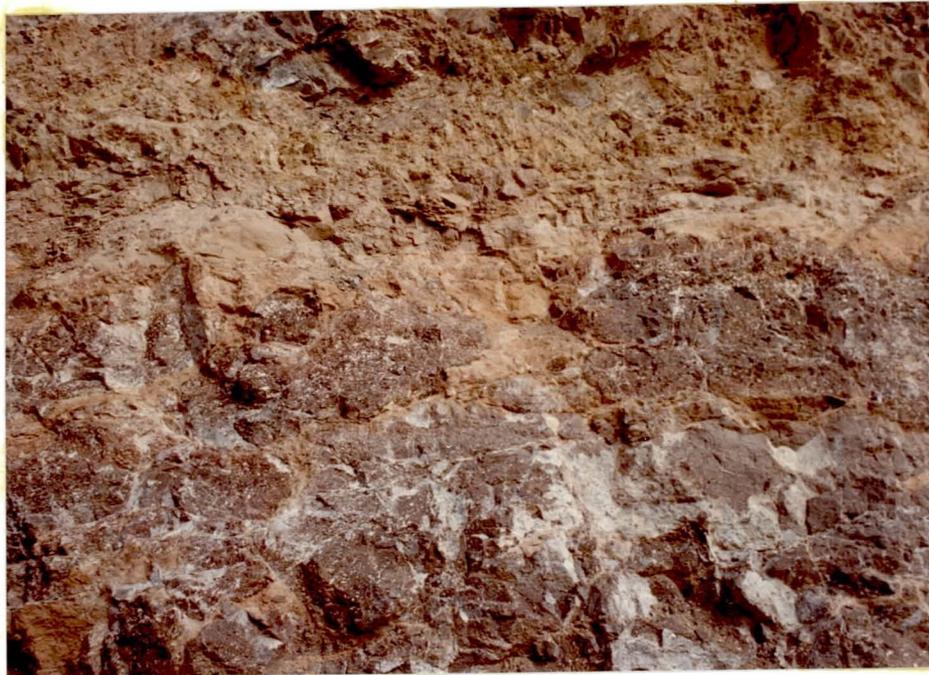
Photo 24
Typical example of amygdaloidal andesite rockmass. Note irregular fracturing and apparent complete infilling by tuffaceous sand from above. (6 Apr 1982)

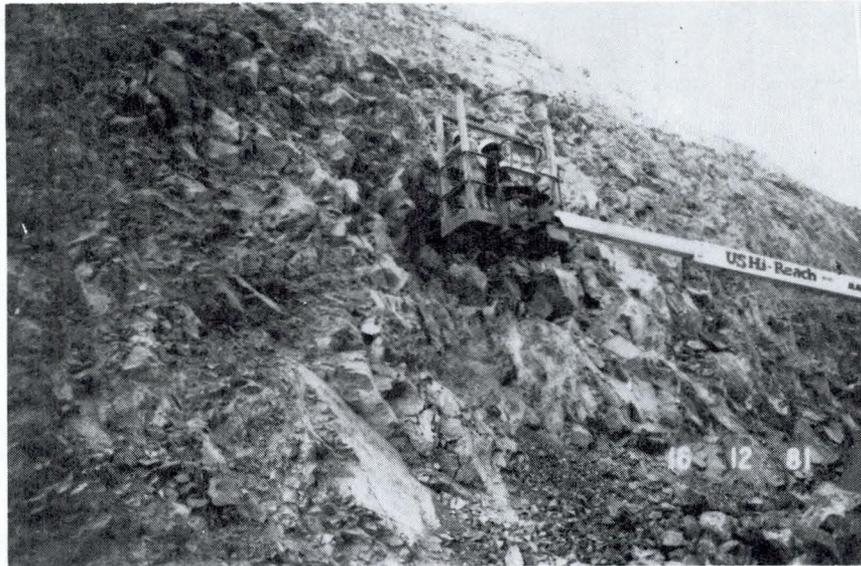
Photo 43
Laborers using shovels and pry bars to dislodge loose and unsafe rocks from above the initial excavation for the side-wall sill on the east spillway slope.
(16 Dec 1981)

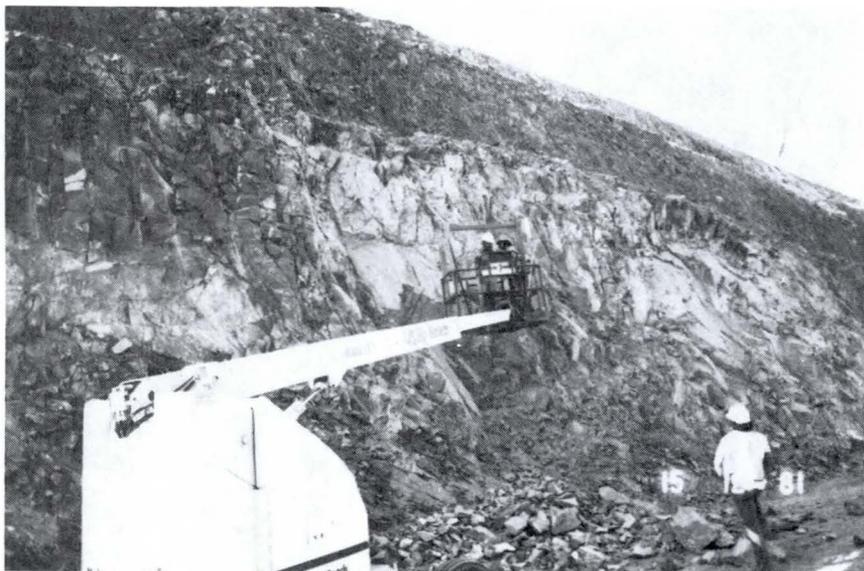
Photo 44
West slope at sill (station 20 + 00) after scaling of unstable rock from above initial cut into slope. Note distinct, smooth, joint planes dipping toward excavation.
(16 Dec 1981)

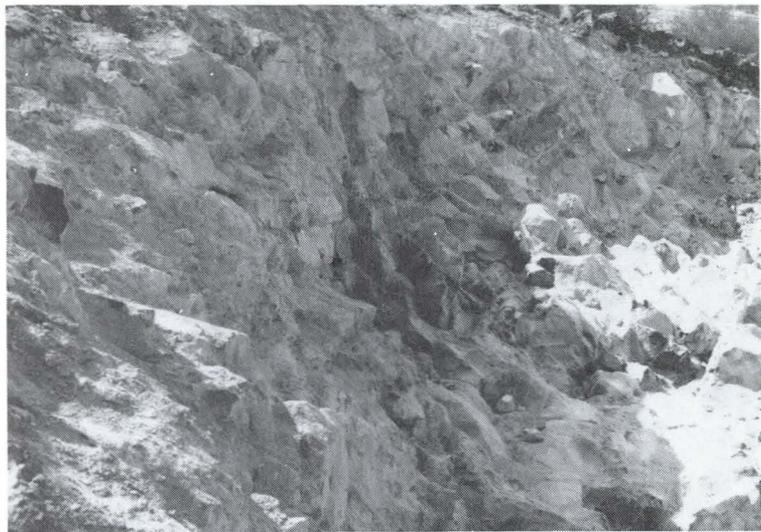
Photo 75
Steep headwall excavation at top of
abutment prior to sloping back at 1:1.
(12 Mar 1981)

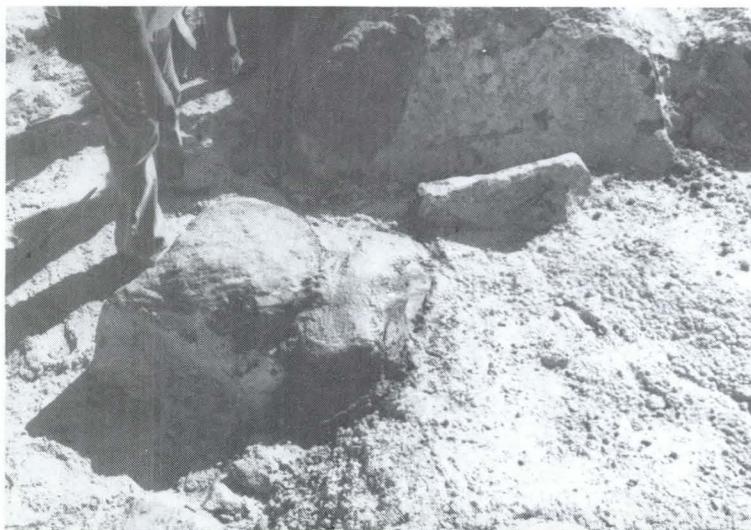
Photo 109
The finished product after slurry grout application. Note abundant dental concrete in surrounding area.
(6 Nov 1981)

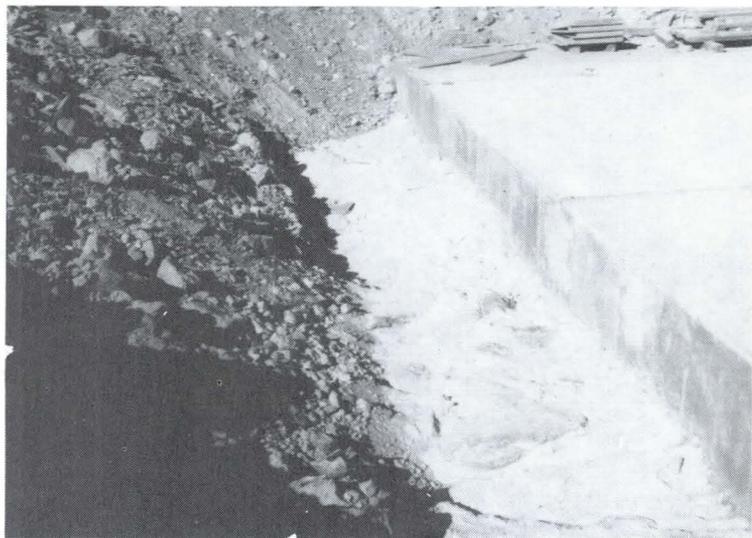
Photo 130
 West slope of outlet trench at stations 74 + 00 to 74 + 40. Note relatively planar, steeply dipping discontinuities in center and lower right of photo which trend N5E 70N and N10E 75N. (20 May 1981)

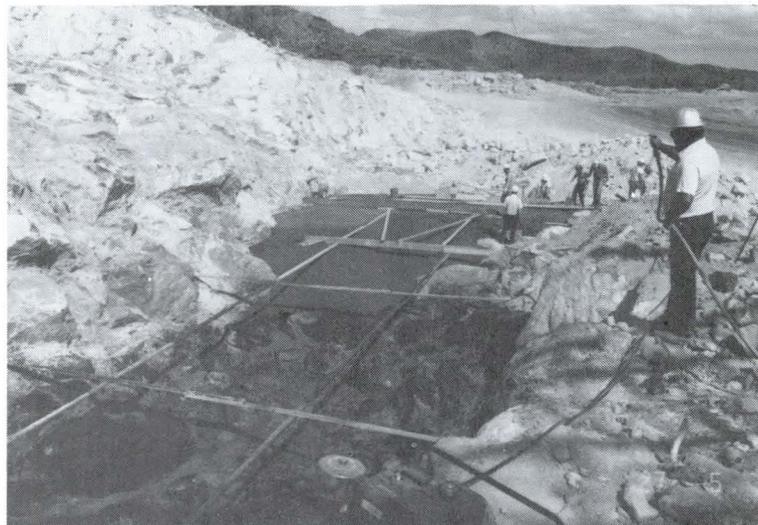
Photo 136
 Effects of production blast in bottom of outlet trench. Note how smaller blocks and infilling have been removed below the level of the bottom of the blast holes in the center and upper left of photo. Final surface preparation not yet completed.
 (20 May 1981)

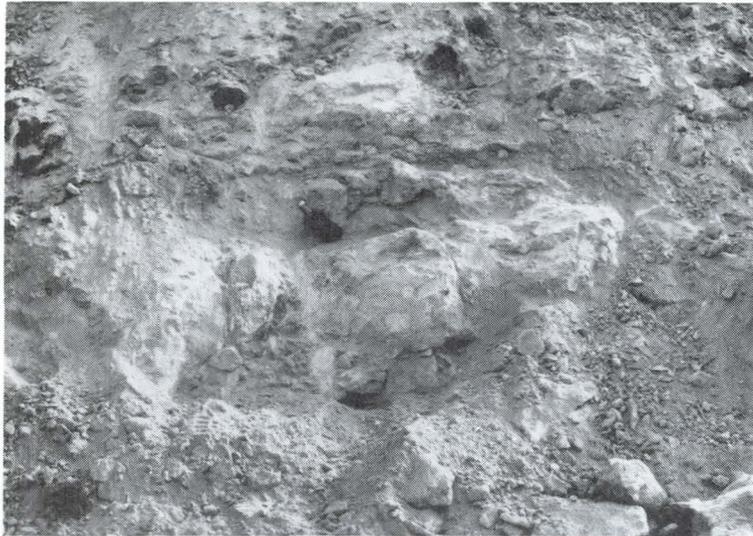
Photo 145
Close-up view of caliche-cemented basalt blocks (slope wash and talus) at left abutment excavation. This represents the final surface prior to placement of random material.
(26 Mar 1981)

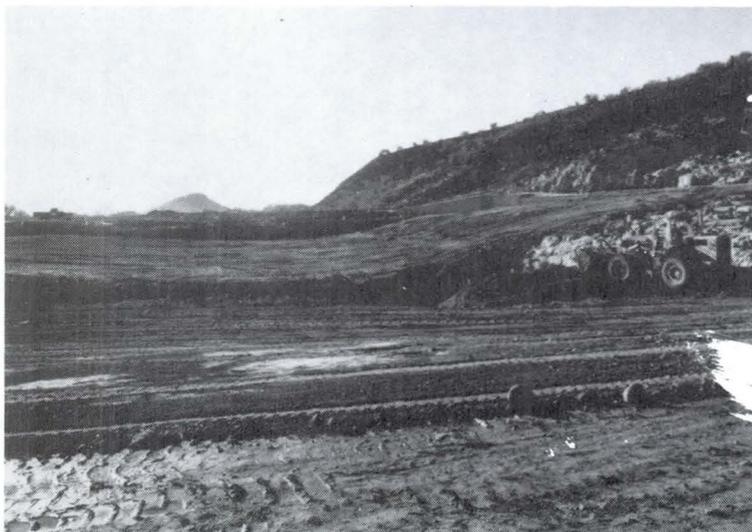
Photo 147
"Swale in foundation under horizontal gravel drain, station 13 + 50 to 15 + 00, after inspection and proofrolling. Sand filter-blanket on abutment rock at right.
(3 Nov 1981)
