**New River Dam
Embankment Criteria
And
Performance Report**

February 1987

GILA RIVER BASIN
PHOENIX, ARIZONA AND VICINITY (INCLUDING NEW RIVER)

NEW RIVER DAM
EMBANKMENT CRITERIA AND PERFORMANCE REPORT

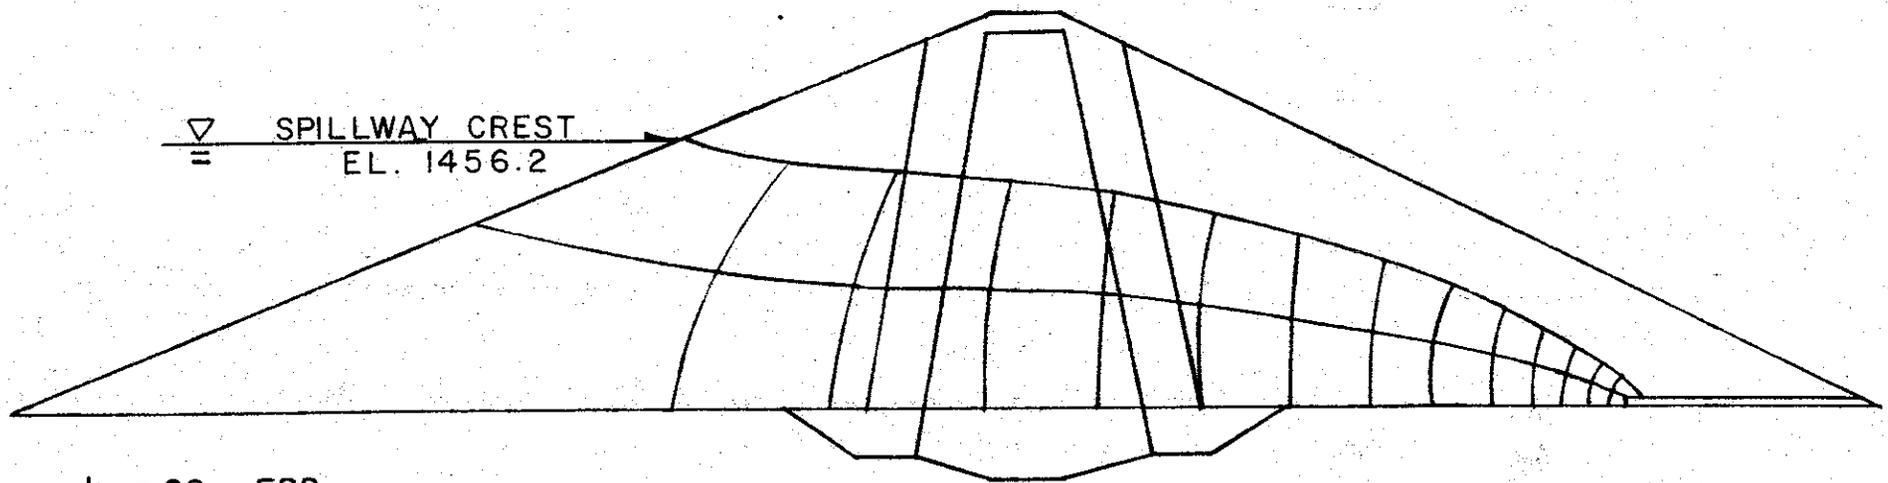
Figure 5 Dam embankment through seepage, Design

$$k_h = 20 \quad \text{FPD}$$

$$k_v = 20 \quad \text{FPD}$$

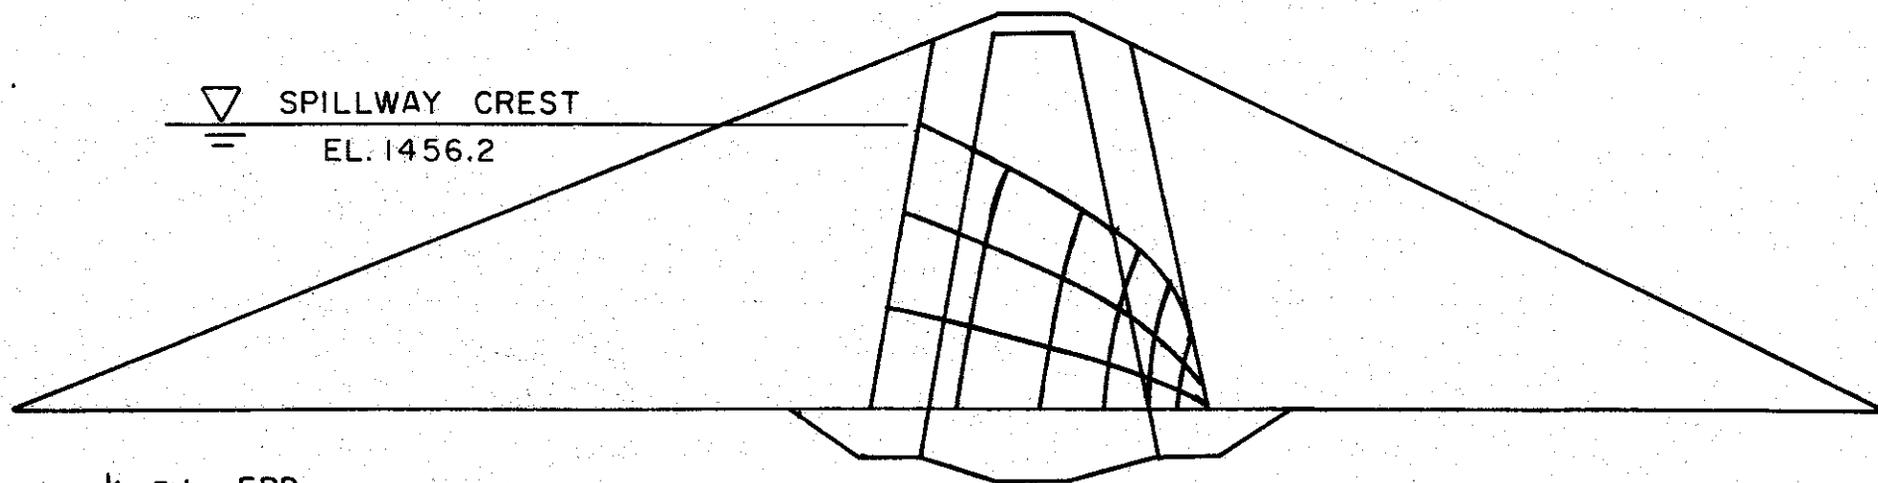
1. Page 31, paragraph 10.05 replace the last two sentences with "The reanalysis indicates that the as-constructed embankment requires a 1.6-foot thick gravel drain to control seepage. A 2-foot thick gravel drain was constructed; therefore the as-constructed gravel drain is capable of handling the as-constructed seepage quantities."

$$k_h = 1 \text{ FPD}$$

$$k_v = 1 \text{ FPD}$$

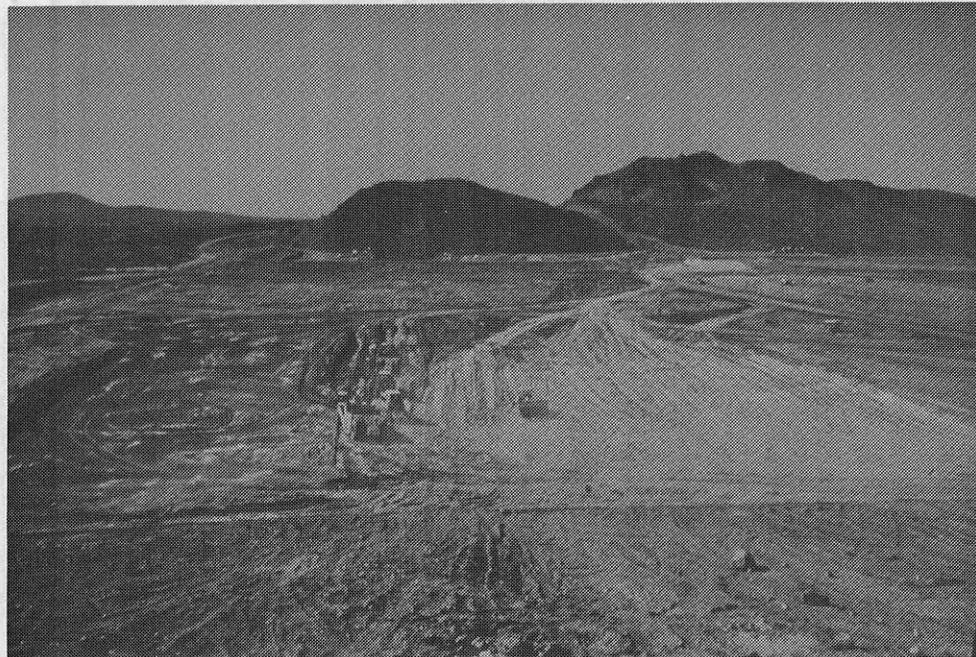
Photo 14. Foundation excavation using push cats, scrapers, and dozer. Note lighter colored areas of caliche, or bedrock in upstream portion of dam foundation. January 1984

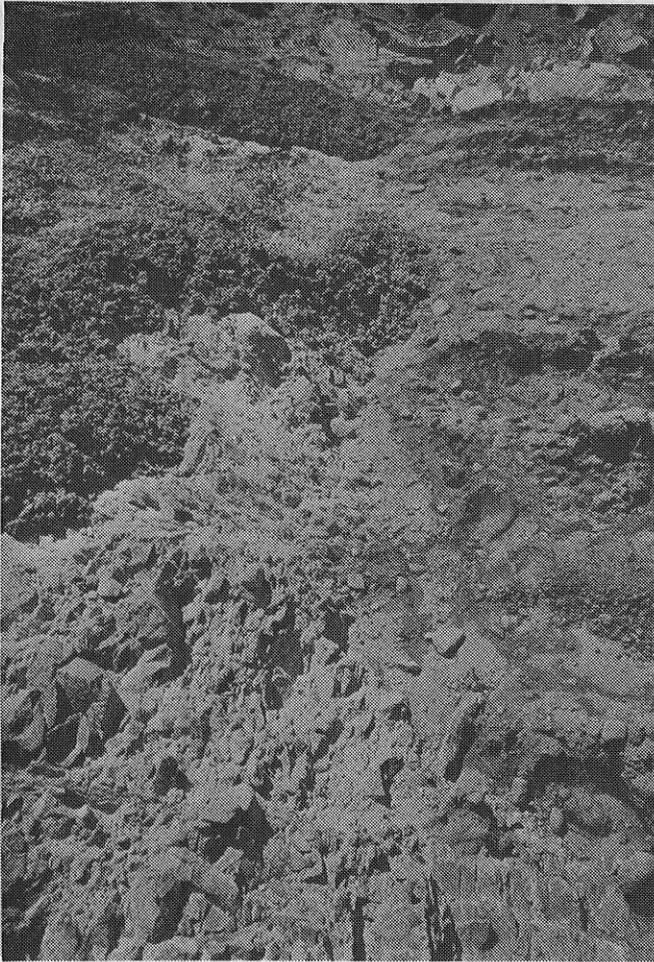
Photo 41. Typical example of rock-core contact on east abutment approximate elevation 1447). Pneumatic wheel rolling core material prevented damage to highly fractured granitic bedrock surface by tamping roller. July 1984

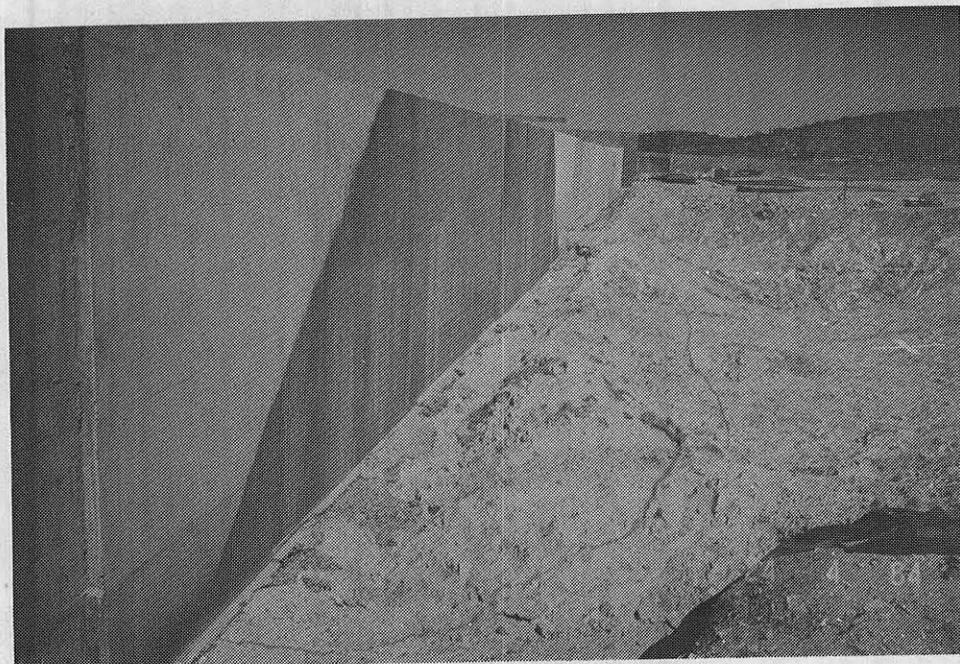
Photo 50. Outline of concrete plug (fillet) area marked on the east side of outlet. Note most of conduit projects above adjacent foundation surface due to greater depth of core trench excavation. April 1984

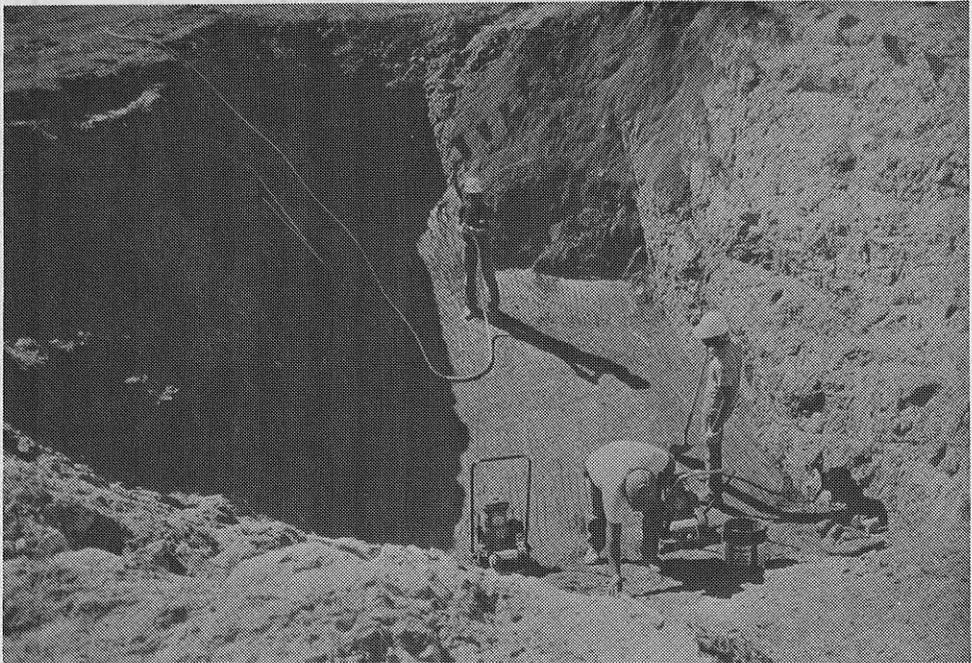
Photo 54. Backfilling foundation depression upstream of dam centerline between stations 14+85 and 15+25. February 1984
