NEW RIVER DAM

GILA RIVER BASIN
PHOENIX, ARIZONA AND VICINITY

DAM, OUTLET WORKS AND SPILLWAY

PERIODIC INSPECTION
REPORT NO. I
MARCH 1985

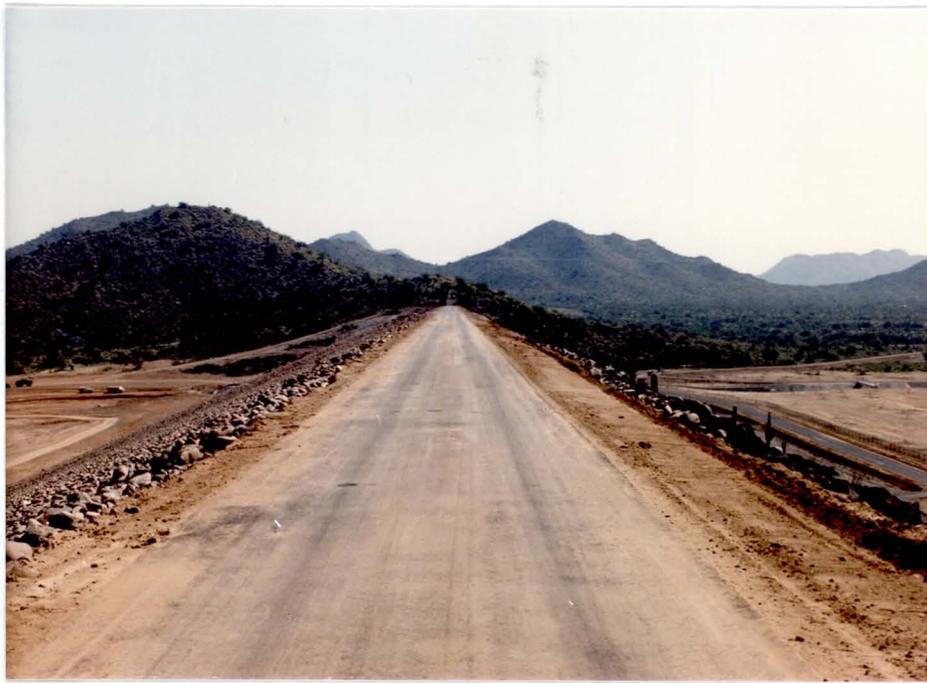
(1) Crest. The crest of the dam was clean and free of weeds and brush (photo 1). The asphalt pavement was in excellent condition. There was no evidence of cracking or erosion on the crest. On the embankment for a distance of 300 feet along the upstream edge of the crest near the left abutment the riprap is about 6 to 12 inches below the shoulder of the asphalt pavement, leaving the shoulder material unsupported. Riprap should be added to the same elevation as the shoulder of the asphalt pavement.

Photo 1. Crest of dam taken toward left abutment from area near right abutment.

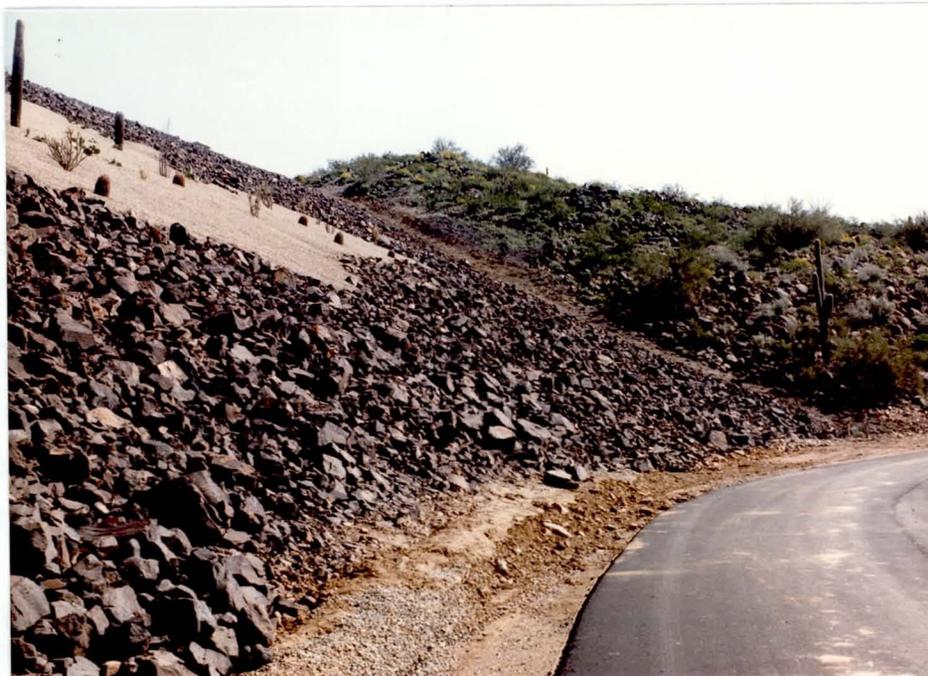
(2) Abutment contacts. The abutment contacts were in excellent condition. (Photo 2)

Photo 2. Downstream toe area showing access road, left abutment and landscaping on face of dam.

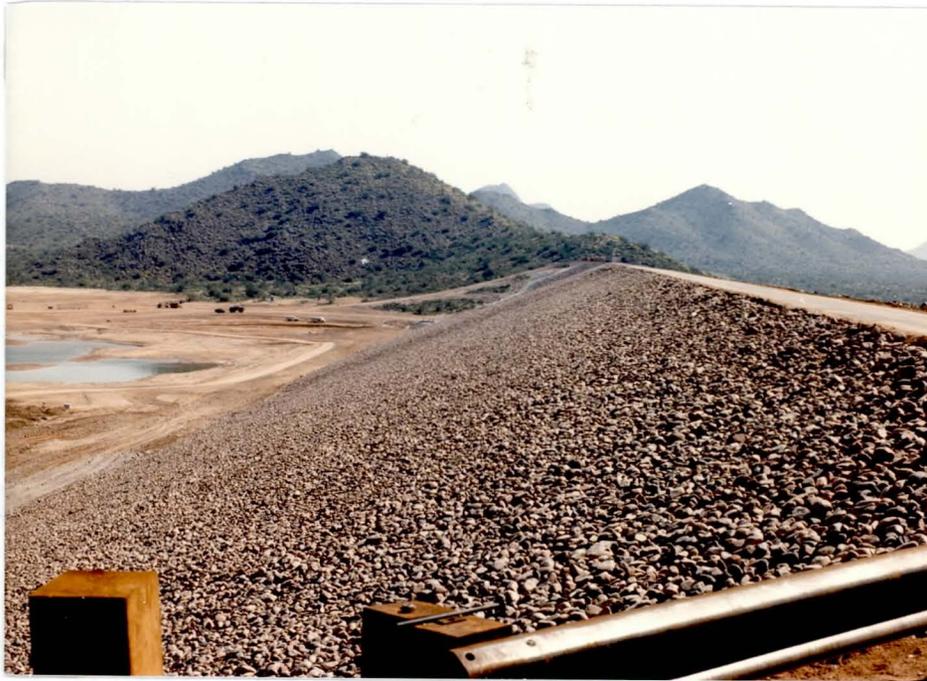
(3) Upstream and downstream slopes. The embankment slopes were in excellent overall condition (photos 3 and 4). There was no evidence of differential settlement, cracks or erosion. The stone on the upstream slope was in good condition.

Photo 3. Upstream face of dam taken toward the left abutment.

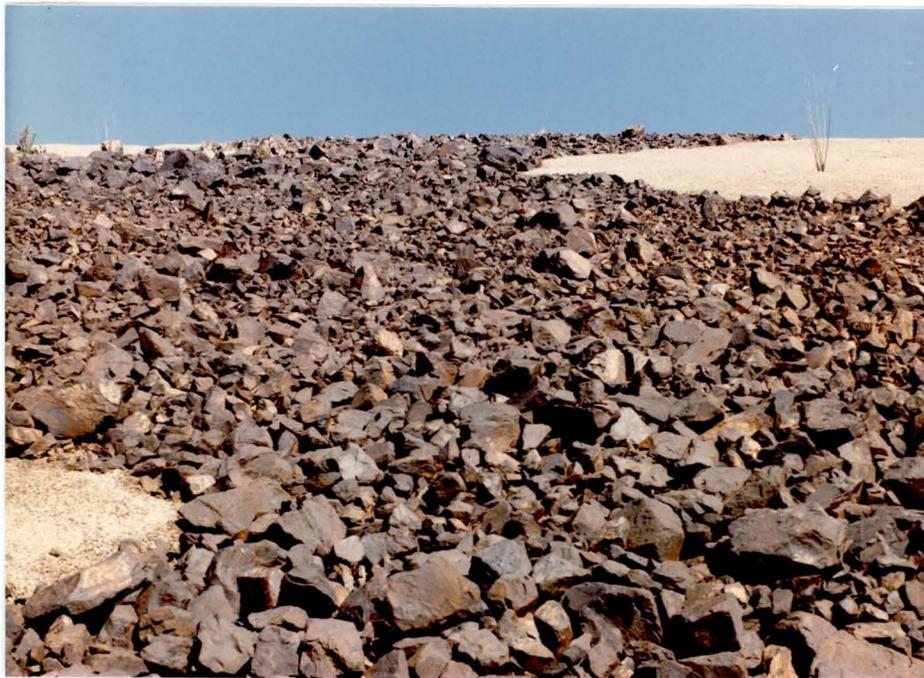
Photo 4. Downstream face of dam showing landscape sand and stone with desert varnish.

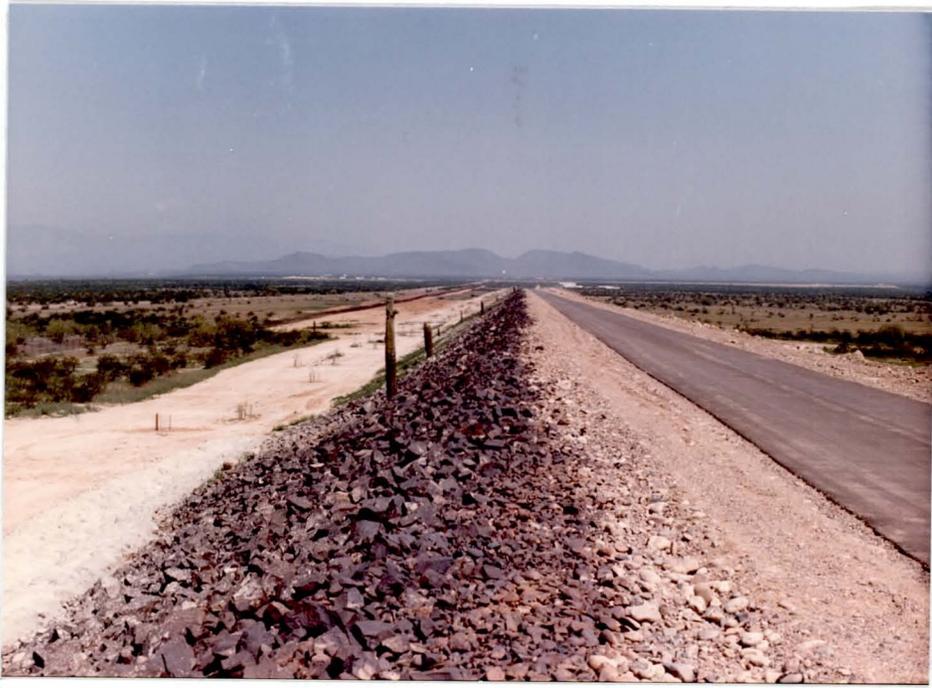
(1) Dike No. 1 (photo 5). The crest, upstream and downstream slopes, embankment toes and abutment contacts were all in excellent condition. It is noted that the portions of landscaping which includes 8 inches of top soil may erode easily and therefore be a maintenance problem. Future repairs in the top soil areas should be backfilled with compatible riprap material.

Photo 5. Dike #1 looking north downstream face with landscaping on left.

3. For beautification purposes on Dike No. 1, many areas on the downstream slope were covered with 8 inches of top soil for seeding and planting. The top soil is subject to erosion and will be a problem for future maintenance. For future repair due to erosion in the planting areas on the downstream slope use compatible riprap instead of backfilling the similar erodible top soils.

e. This inspection report will serve as a recommendation to the flood control district to use compatible riprap material to replace landscape top soil on Dike #1 (indicated in paragraph 4b.(1)) as required.

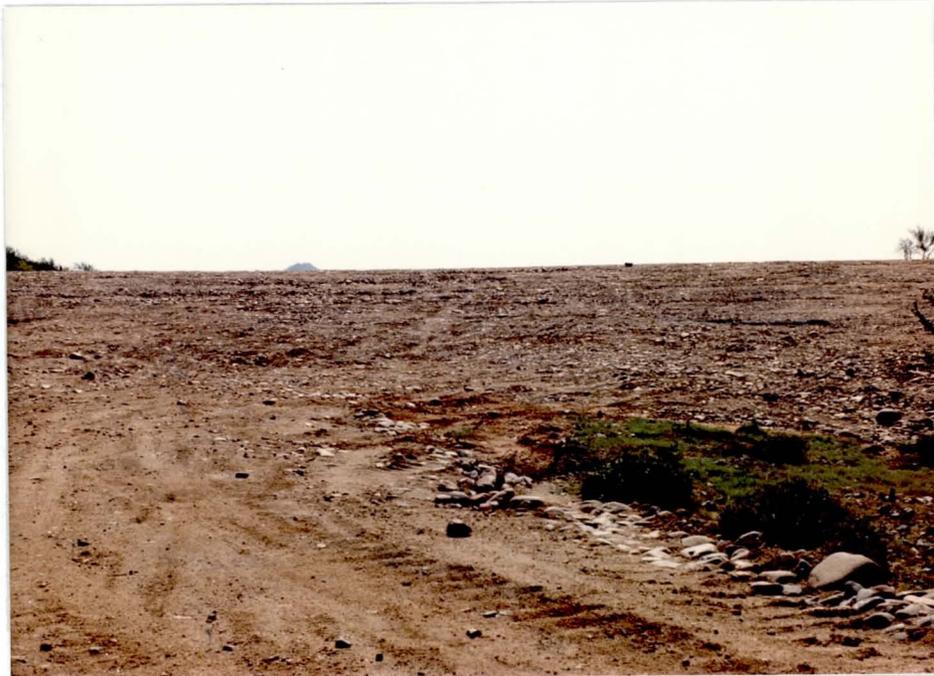
(2) Dike No. 2 (photos 6 and 7). The crest, upstream and downstream slopes, embankment toes and abutment contacts were all in excellent condition.

Photo 6. Upstream face of Dike #2. This is a freeboard dike therefore no rip rap, short duration of water contact.

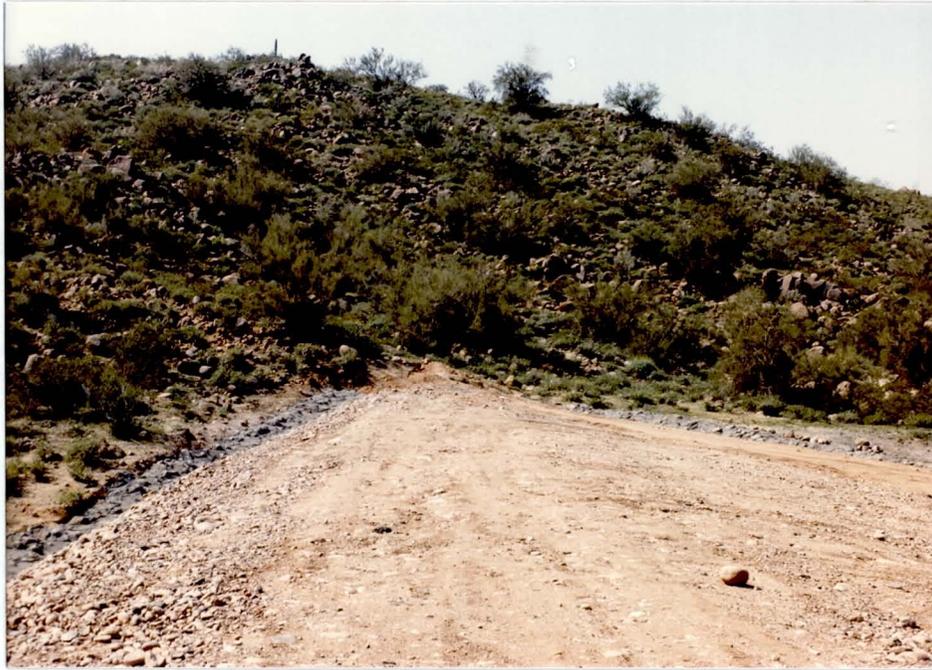
Photo 7. Crest of Dike #2 looking toward right abutment.

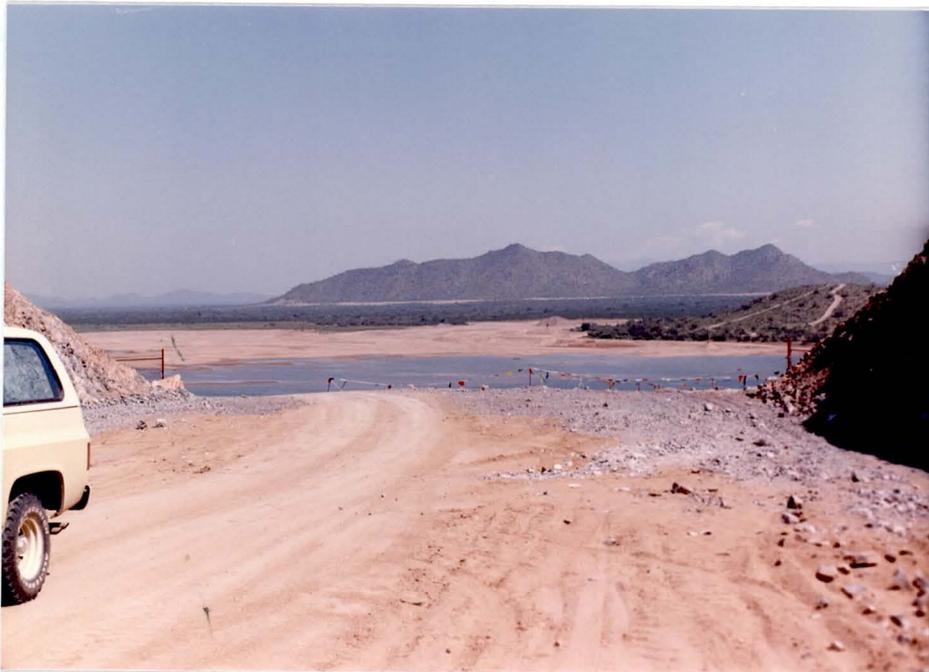
(1) Approach channel. The approach channel was in good condition (photo 8). The channel was clean and unobstructed.

Photo 8. Approach channel to spillway taken from crest.

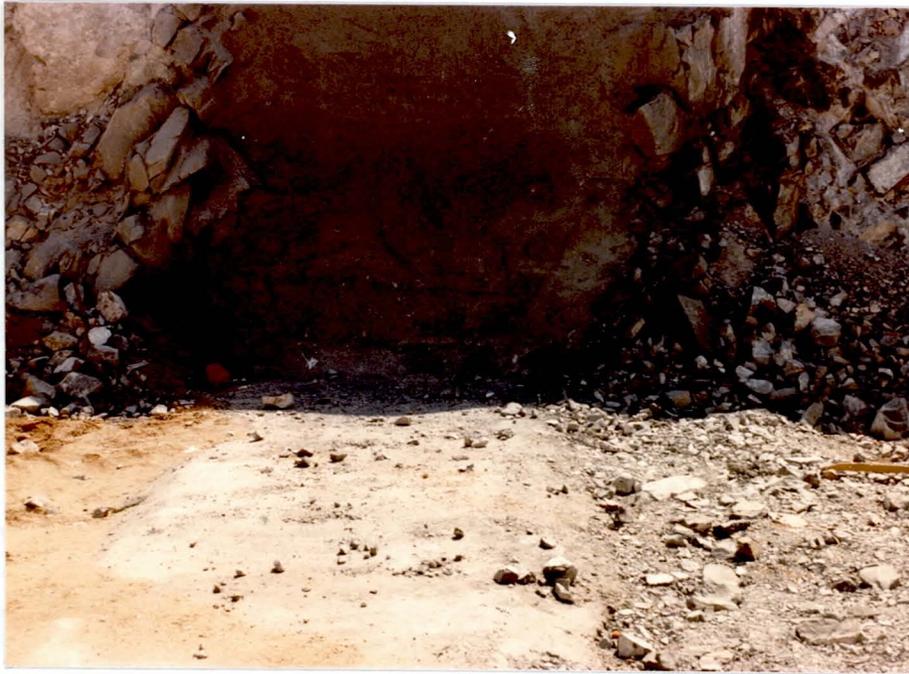
(2) Control section (photo 9). Concrete in the sill was in good condition. There was only minor raveling of the excavated slopes.

Photo 9. Control section of grout. Note minor raveling of cut slope, this is within expected amount and will be observed.

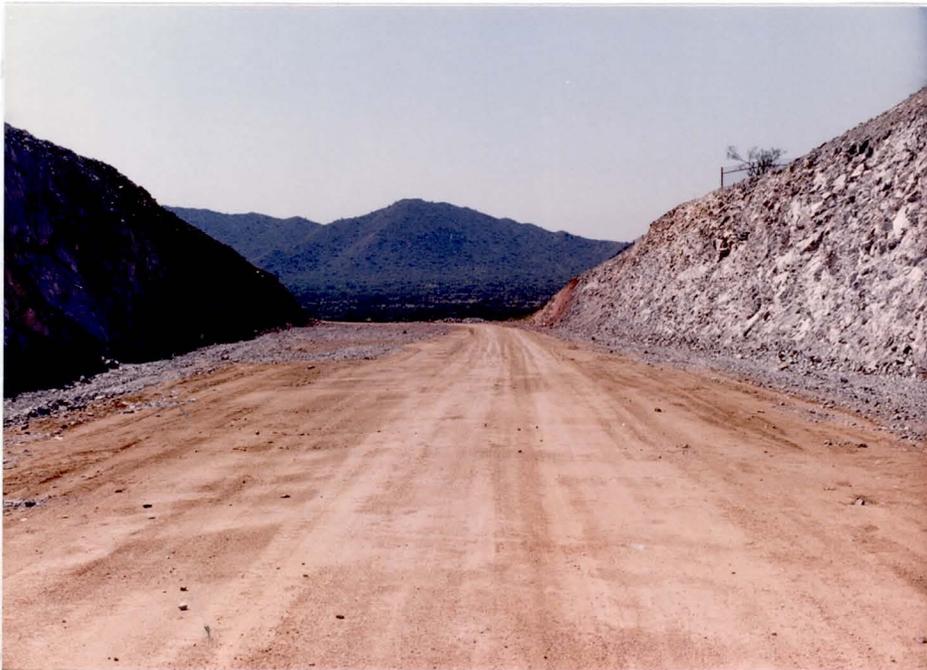
(3) Outlet channel. The outlet channel was in good condition (photo 10). There was only minor raveling of the excavated slopes. The channel was clean and unobstructed.

Photo 10. Discharge channel for spillway taken from crest.

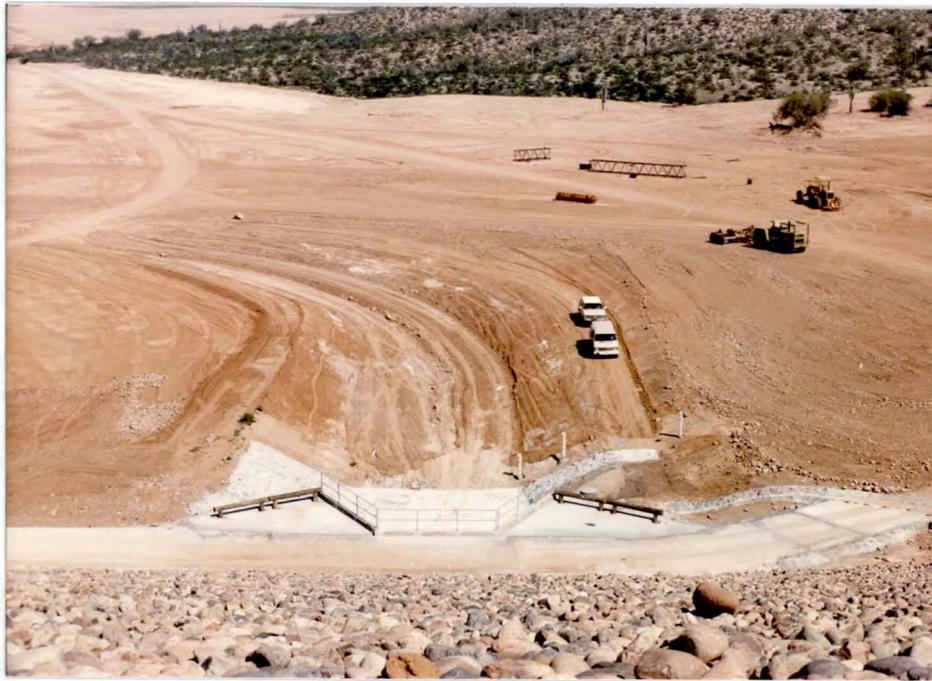
Photo 11. Approach channel to intake structure.

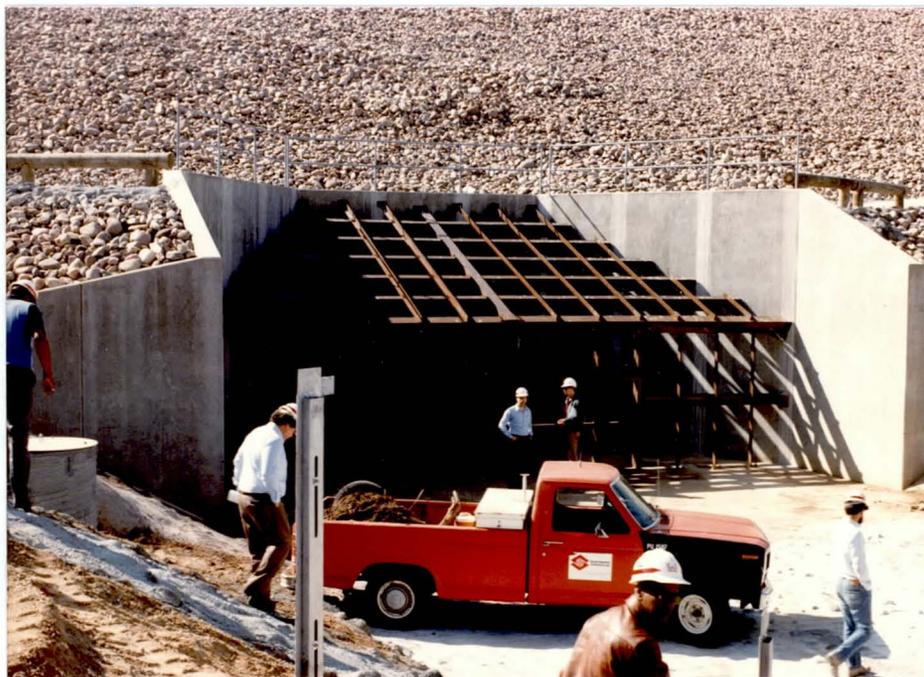
(2) Trash rack structure (photo 12). The concrete side walls and the steel in the structure were in good condition.

Photo 12. Intake structure and trash rack.

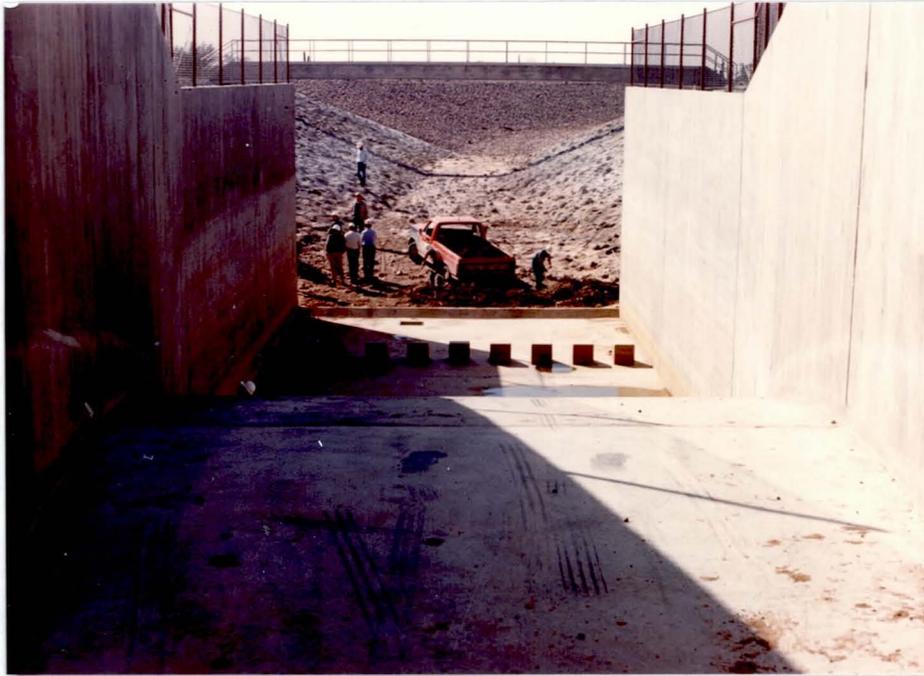
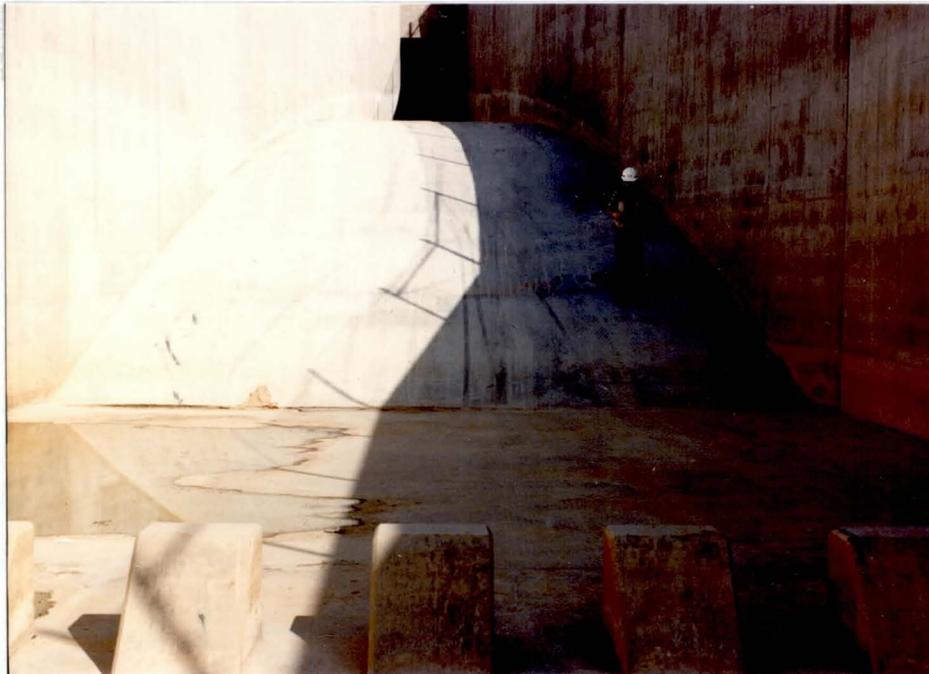
(4) Energy dissipator (photos 13 and 14). Concrete in the stilling basin walls, invert and dentates was in good condition.

Photo 13. Outlet energy dissipater and dentates.

Photo 14. Upstream view of parabolic energy dissipater and dentates.

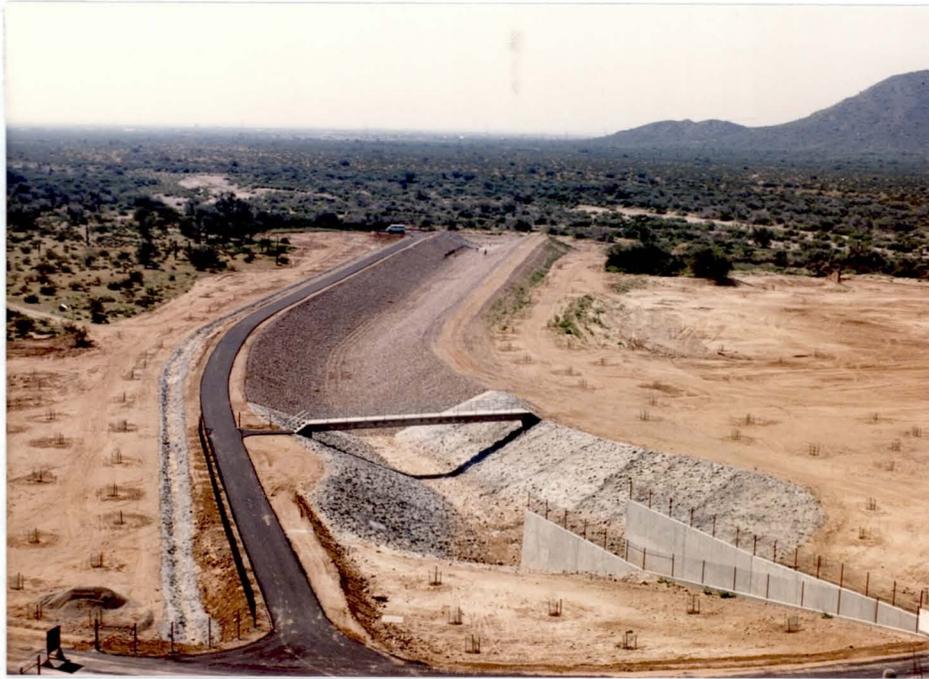
(5) Outlet channel (photo 15). The stone facing on the side slopes and invert of the trapezoidal channel was in good condition. At some localized areas of the outlet channel, the type III stone placed within the channel had been eroded by a flow of about 2 feet in depth.

Photo 15. Downstream view of outlet channel. Note erosion area of type III stone near end of channel. The area has since been repaired by the contractor.

f. The area under the type III stone which was eroded in the outlet channel was considered a localized construction problem and has subsequently been repaired by the contractor. Future flows will be observed to determine the overall performance of the type III stone remaining in the channel.

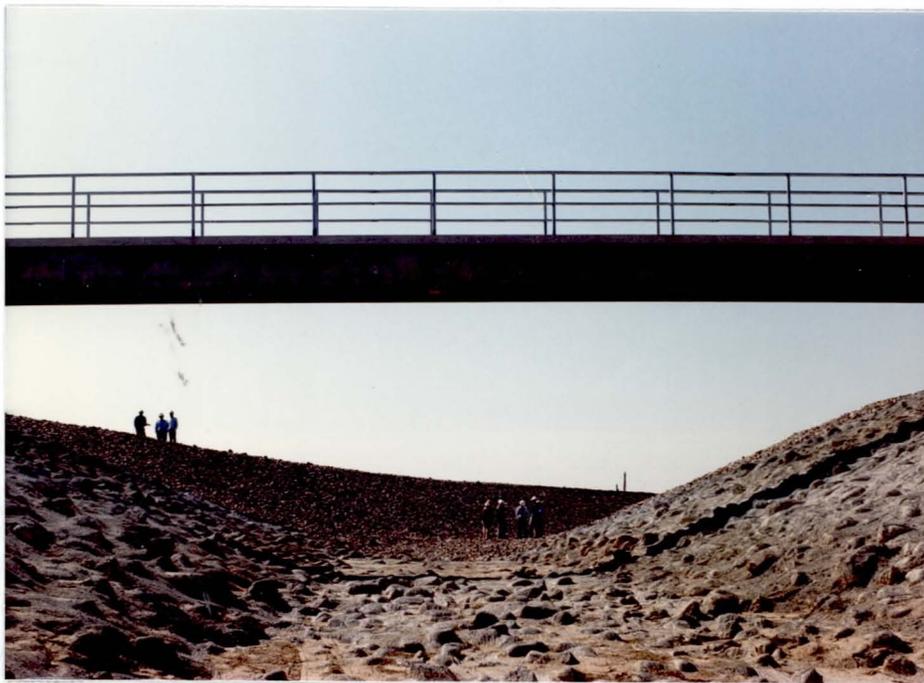
(6) Gaging station bridge (photo 16). The bridge was in good condition with no signs of structural distress.

Photo 16. Downstream view of outlet channel and gaging station bridge. Taken from end of energy dissipator.
