**PHASE I
ENVIRONMENTAL SITE ASSESSMENT
AT THE NEW RIVER CHANNEL
IN MARICOPA COUNTY ARIZONA**

**MARICOPA COUNTY FLOOD CONTROL DISTRICT
2801 W. Durango Street
Phoenix, AZ 85009**

**CEC/WRA
4041 N. Central Avenue, Suite 1050
Phoenix, AZ 85012-3393**

September 21, 1993
WRA File AR-390-2059.AT1

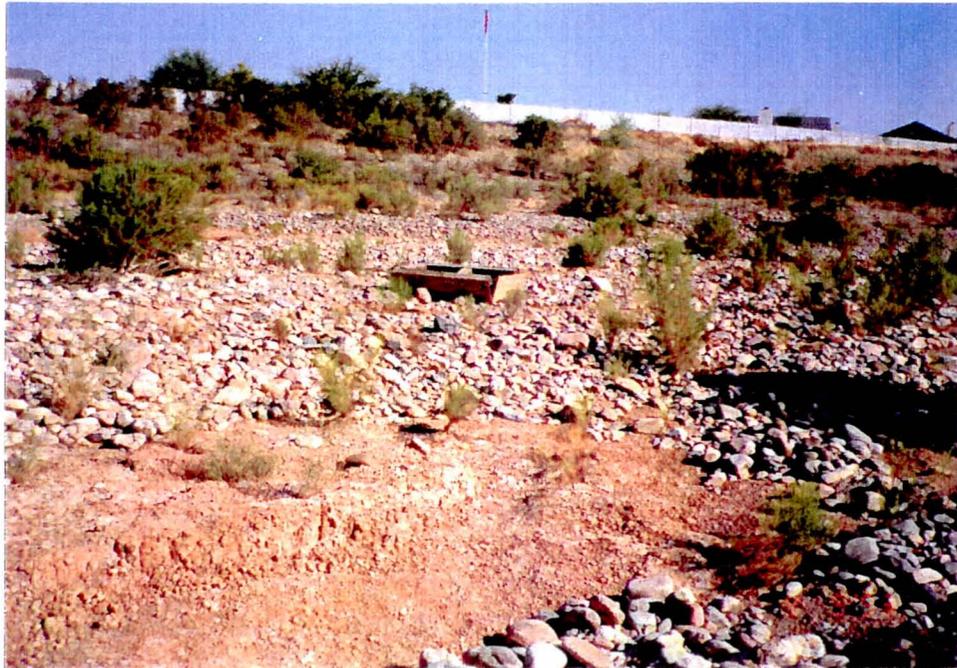
Photograph No. 4

Wood box in center of Parcel 7.

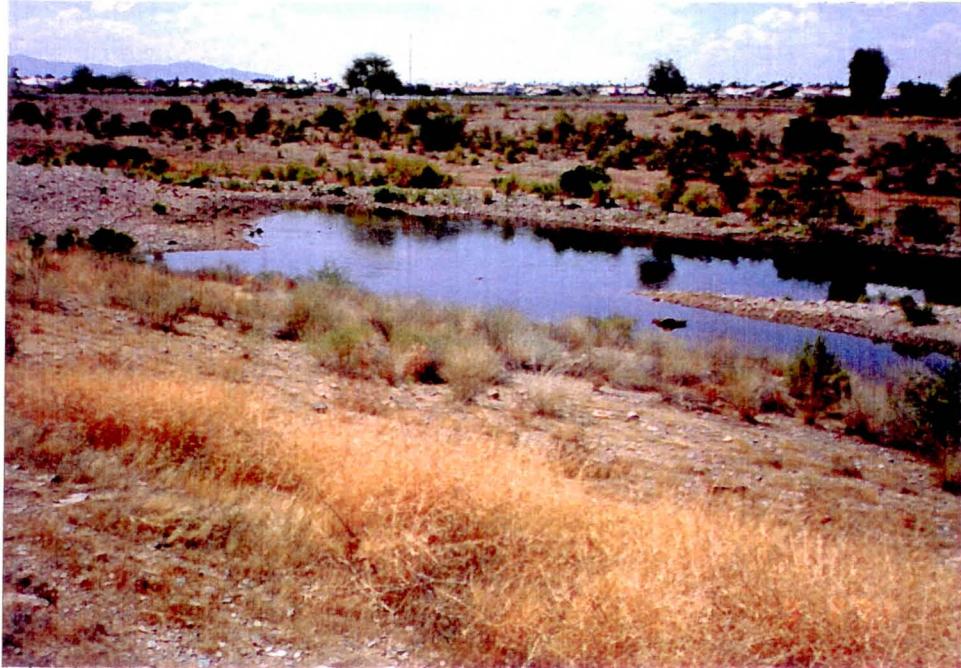
Photograph No. 5

Standing water on Parcels 2 and 7.

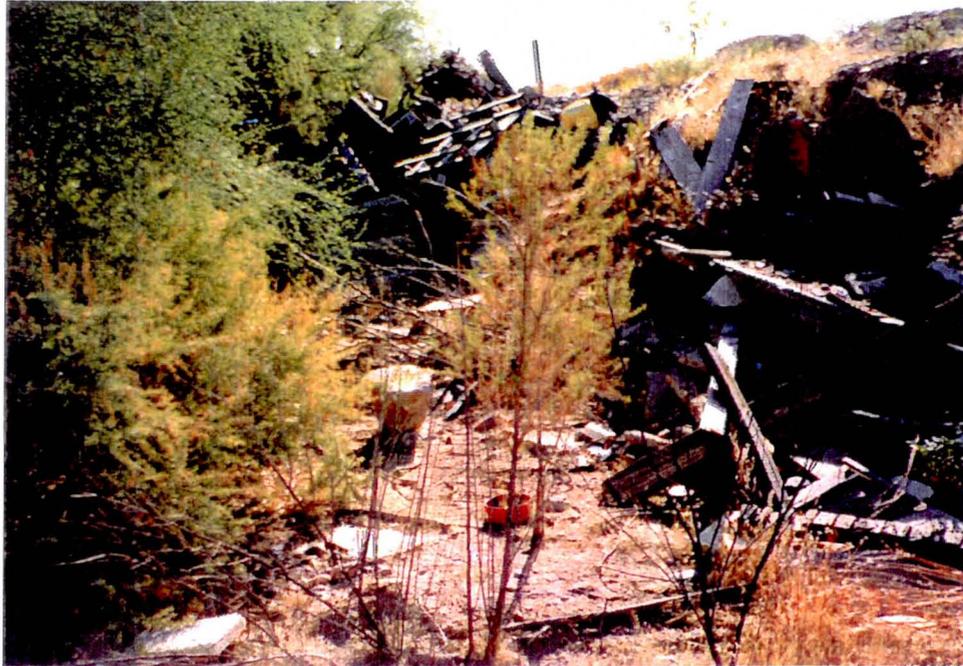
Photograph No. 7

Dumped refuse was observed on the east side of Parcel 6. This refuse consisted of household trash, lumber, landscaping debris, small containers and at least one empty 55 gallon drum (See Photograph Nos. 7-12) No staining or evidence of liquids were observed.

Dumped refuse on east side of Parcel 6.

CEC/WRA did not observe evidence of chemical or petroleum dumping on the subject property, however the amount of vegetation and dumped debris made it difficult to observe the entire surface area of the ground. CEC/WRA recommends that knowledgeable personnel be utilized to monitor the clean-up of the dumped materials to attempt to evaluate whether hazardous materials or petroleum products have been disposed of on the subject property. Sampling and testing may be recommended based on this evaluation.

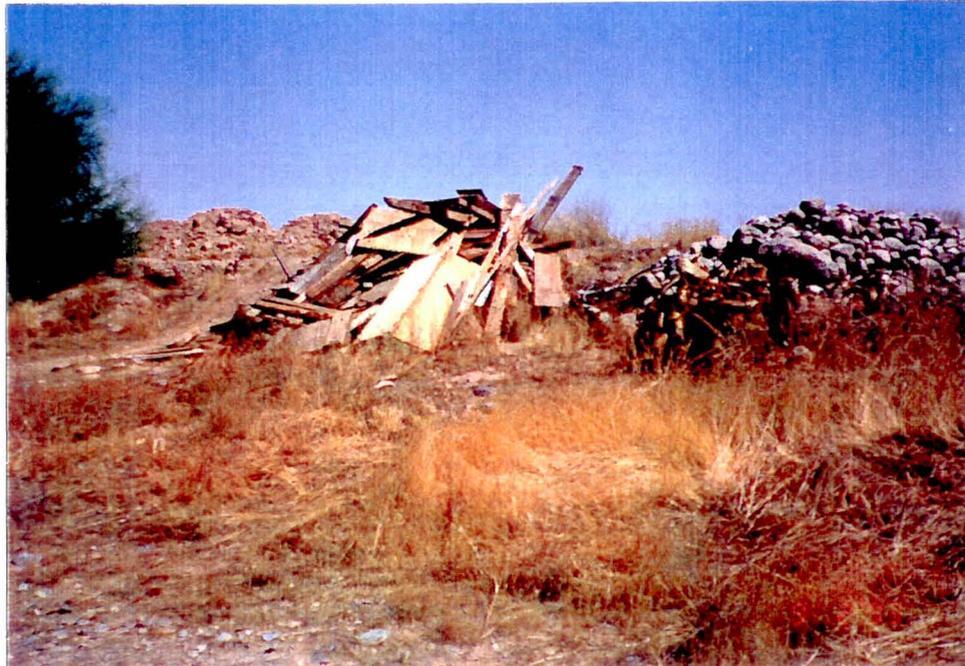
Photograph No. 8

Dumped refuse on east side of Parcel 6.

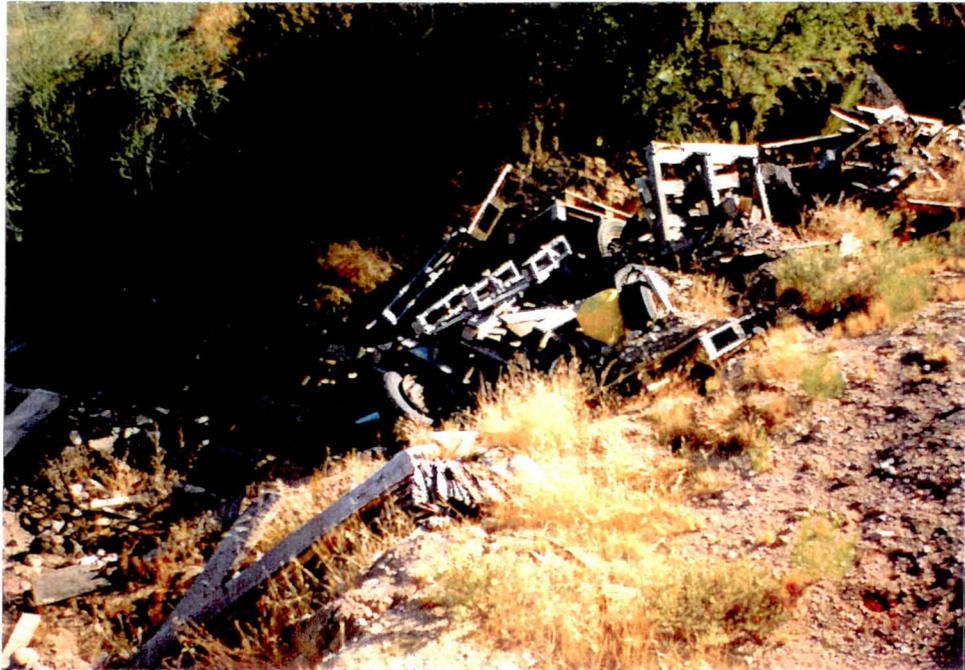
Photograph No. 9

Dumped refuse on east side of Parcel 6.

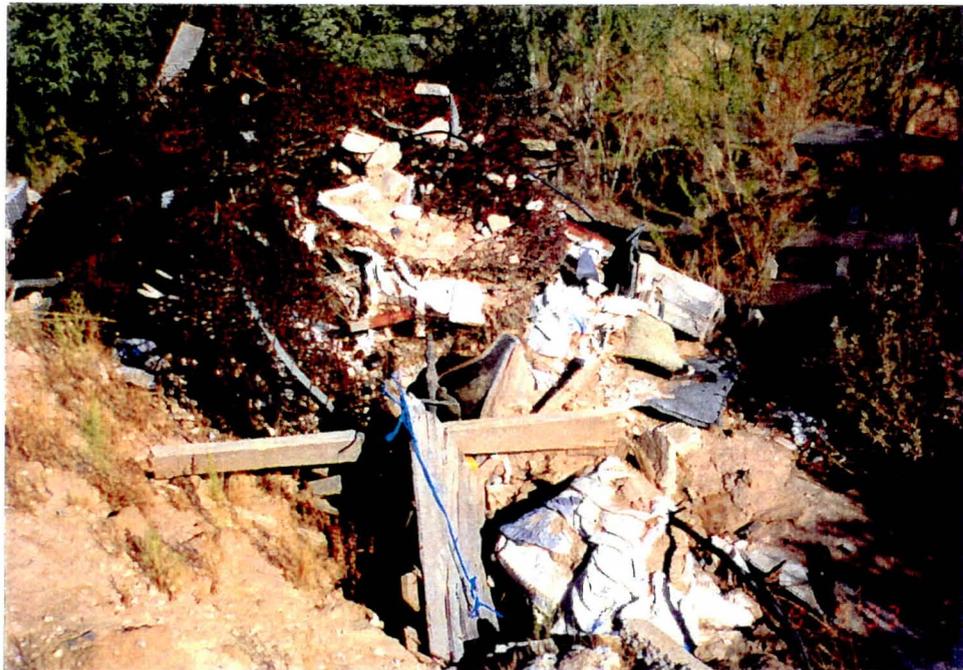
Photograph No. 10

Dumped refuse on east side of Parcel 6.

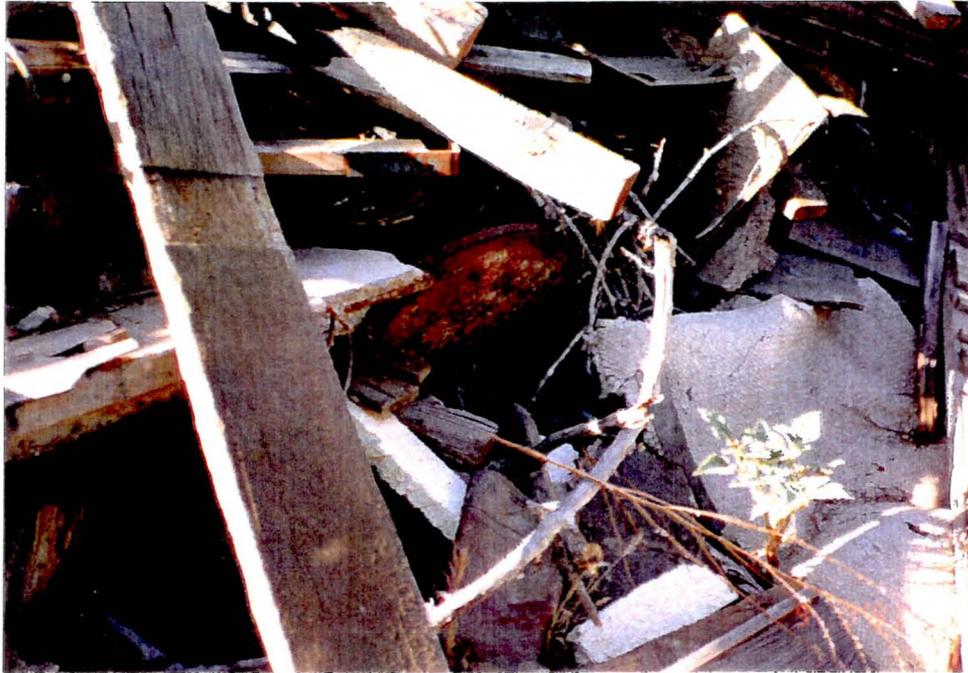
Photograph No. 11

Dumped refuse on east side of Parcel 6.

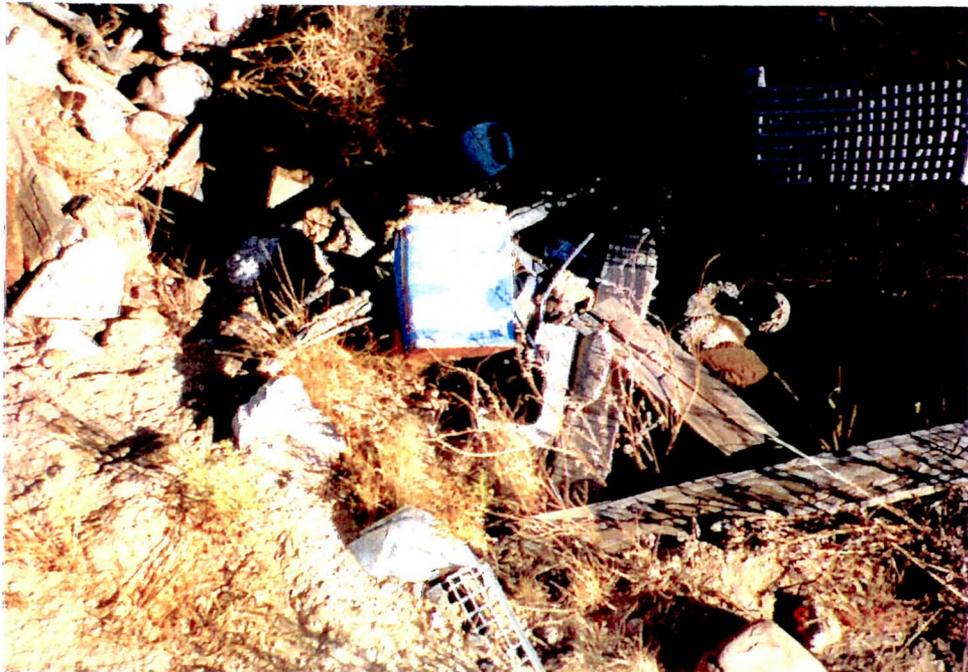
Photograph No. 12

Dumped refuse on east side of Parcel 6.

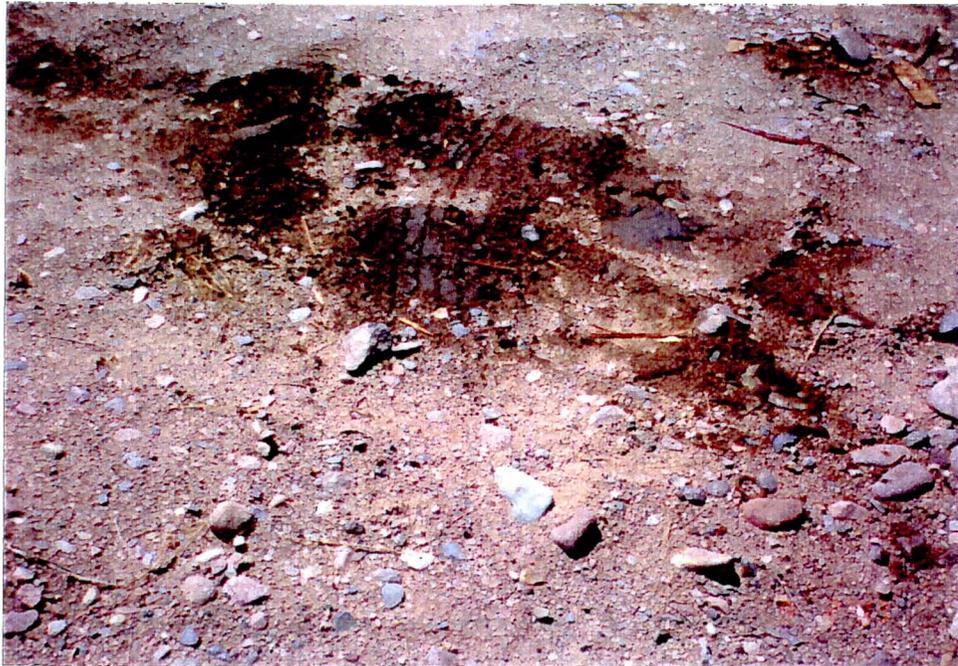
Photograph No. 14

A small oil stain was observed on the southwest corner of Parcel 5. (See Photograph No. 14) This stain appears to be from leakage of hydraulic fluid from a vehicle.

Soil stain in southwest corner of Parcel 5.

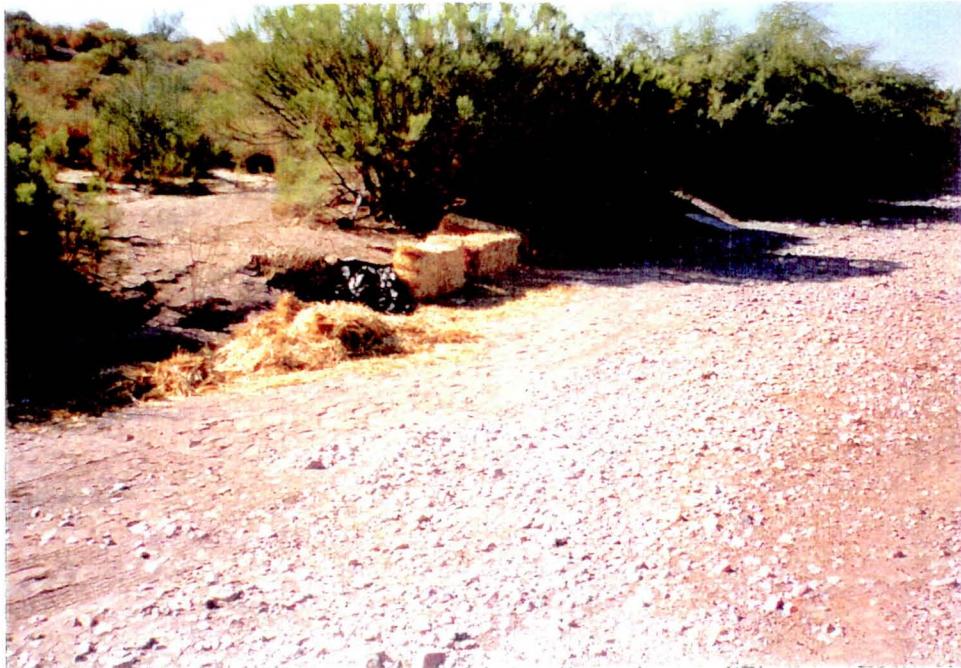
Photograph No. 18

Bales of hay in center of Parcel 4.
