**Annual Monitoring Inspection Report
Earth Fissure Site Investigation
Siphon Draw Wash Drainage Improvements Project
Contract FCD 2006C020, Work Assignment No. 9
Maricopa and Pinal Counties, Arizona**

**August 23, 2011
AMEC Job No. 17-2011-4025**

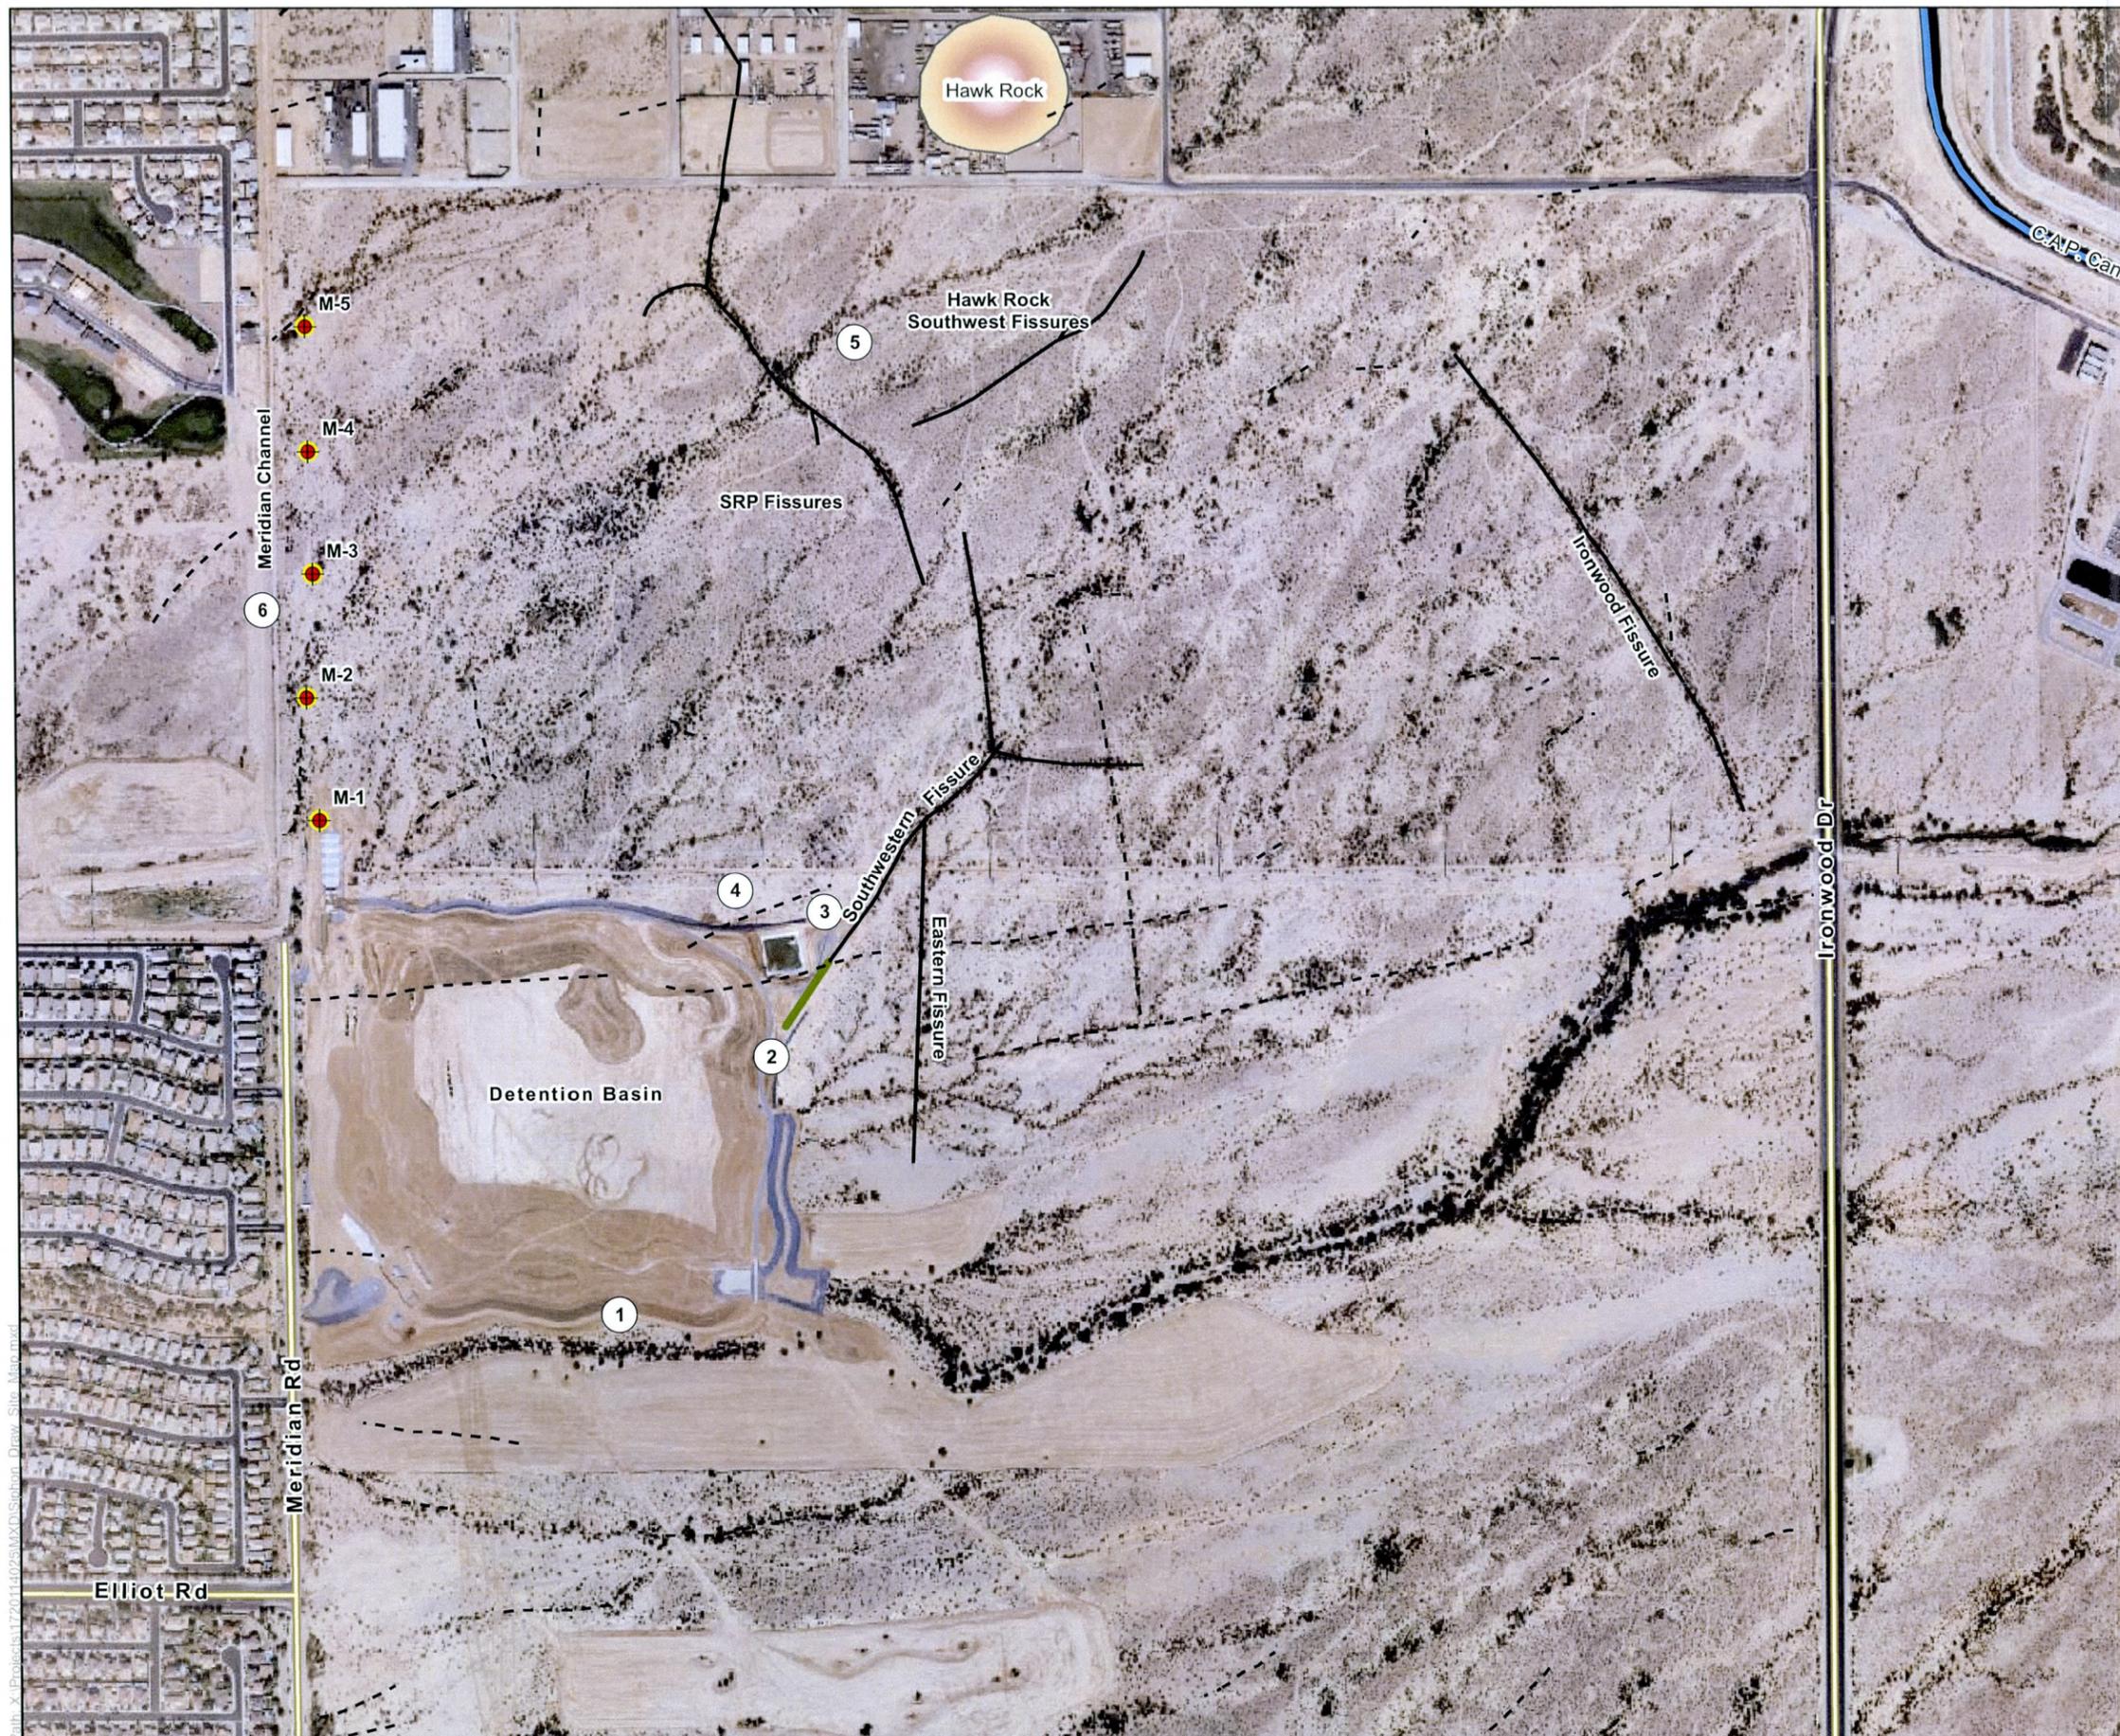
Figure 1

A driving inspection of the Siphon Draw detention basin was conducted along the perimeter of the crest of the basin. Visual observation revealed some minor erosional rills along the slope of the basin, but no significant signs of erosion or distress were observed. This area is represented as field notation area 1, in Figure 1.

A walking inspection of the Southwestern Fissure revealed areas of soil infilling within the earth fissure, but there have been no significant changes since construction completion. This area is represented as field notation area 3, in Figure 1.

A driving and walking inspection was conducted at the SRP and Hawk Rock Southwest Fissures and nearby drainages. In general, the investigation revealed no recent ground disturbances or immediate earth fissure hazards to the basin and channel. This area is represented as field notation area 4, in Figure 1.

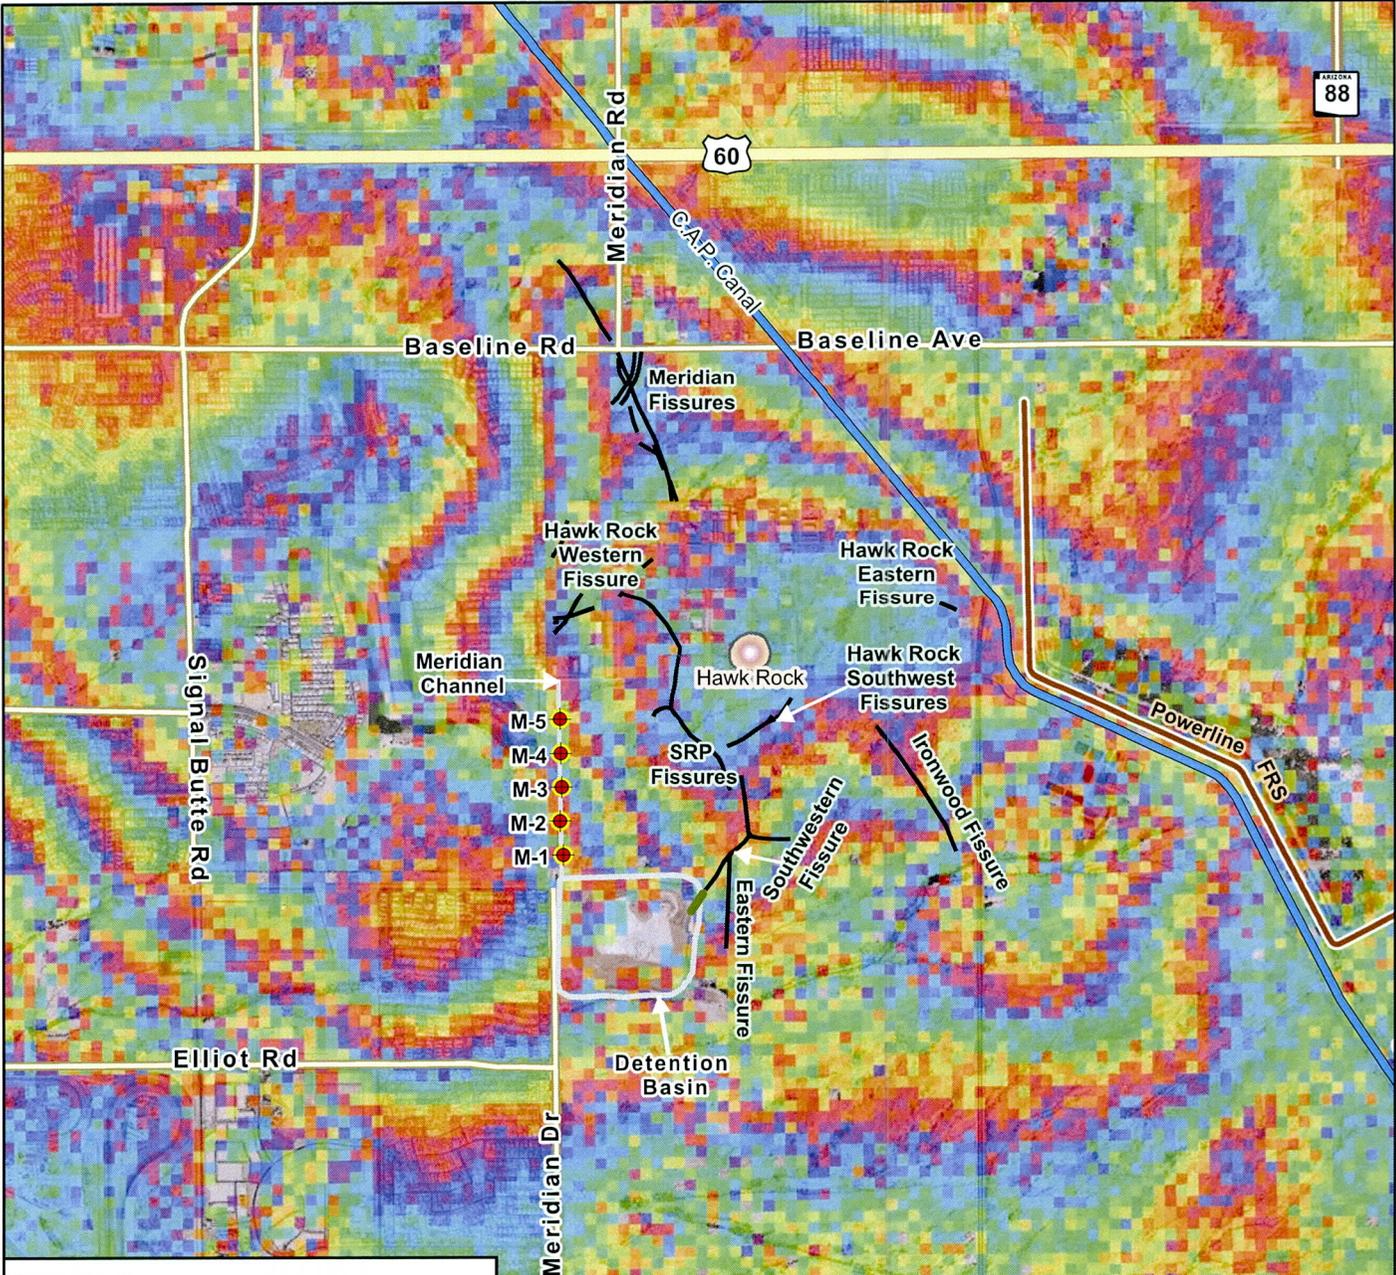
FIGURE
2

October 2004 to March 2010 InSAR imagery, previously published in a report by AMEC (2011), was analyzed for this investigation, as shown in Figure 2. This InSAR image indicates that relative subsidence of about 0.1 feet to 0.2 feet has occurred within this timeframe with the area around the detention basin subsiding the most and the north end of the existing Meridian channel subsiding the least. It is anticipated that this pattern of subsidence will continue into the future.

- Continue to monitor and remove any deep rooted vegetation in the locations where buried fissure mitigation has been constructed along the western and southwestern extents of the basin.
- InSAR imagery and photo lineament analyses for Siphon Draw should be performed in conjunction with the on-going annual monitoring of Powerline and Vineyard Road Flood Retarding Structures, each under separate work assignments. We recommend InSAR imagery be analyzed annually and photo lineament analyses be conducted at Siphon Draw every 5 years.

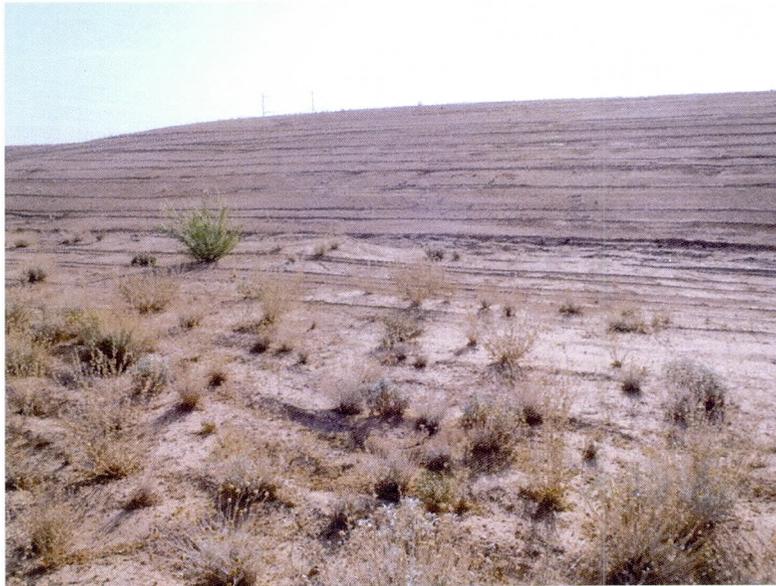
Brush and vegetation, approximately 3 to 4 feet in height, were observed within the detention basin along the fissure alignment; however, this vegetation consists primarily of tall pot plants that were planted as part of the landscaping. The observed smaller sized vegetation and brush were from hydro seed, as seen in Photograph 1 within Appendix A.

Viewing northeast within the Siphon Draw detention basin in the alignment of the Southwestern Fissure, with a tall pot plant and the basin embankment in background of photograph. See field notation area 2 on Figure 1 for approximate location.

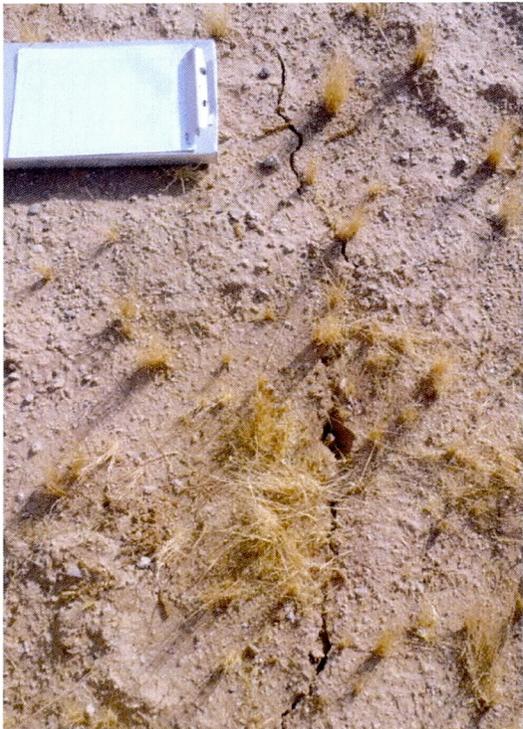
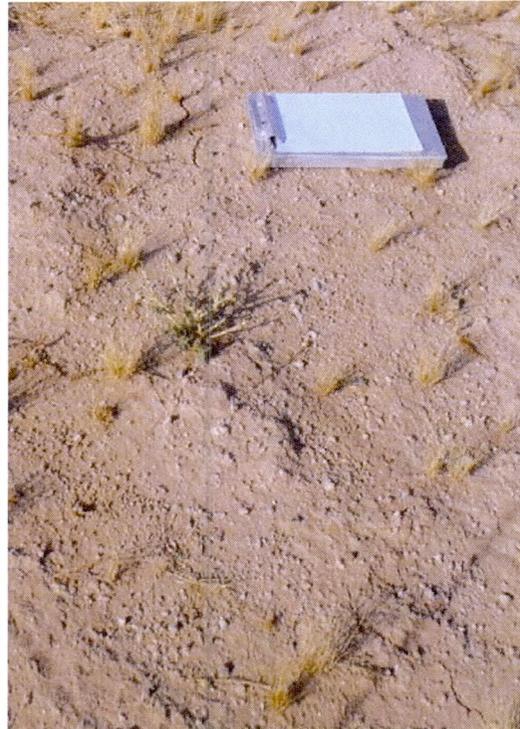
A walking inspection was also conducted along the crest of the detention basin in the projected alignment of the Southwestern Fissure. The fissure extension, as seen in Figure 1, occurred during a single storm event in October of 2007 when the Southwestern Fissure grew by a length of about 250 feet overnight. Visual observation did reveal a crack on the ground surface roughly parallel to the alignment of the earth fissure, as seen in photograph 2a through 2c in Appendix A. This crack ranged from $\frac{1}{4}$ inch to $\frac{1}{2}$ inch in aperture and 3 to 4 feet in length at the surface. Depth is unknown due to the narrowness of the crack, though the depth appears to be less than a foot or two. However, this crack appears to be a desiccation crack rather than cracking related to an earth fissure. Minor erosional rilling and some burrowing activity were observed east of the crest, along the backside slopes near the drainages, as seen in photograph 4 within Appendix A. There were no discernable cracks connecting the animal burrows at the ground surface. Overall, the subtle ground cracks observed appeared to be typical of desiccation style cracking and no significant signs of erosion or distress were observed. This area is represented as field notation area 2, in Figure 1.

Photograph 2a and 2b are of desiccation style cracking observed on the ground surface along the crest of the detention basin orientated roughly parallel to the Southwestern Fissure. See field notation area 2 on Figure 1 for approximate location.

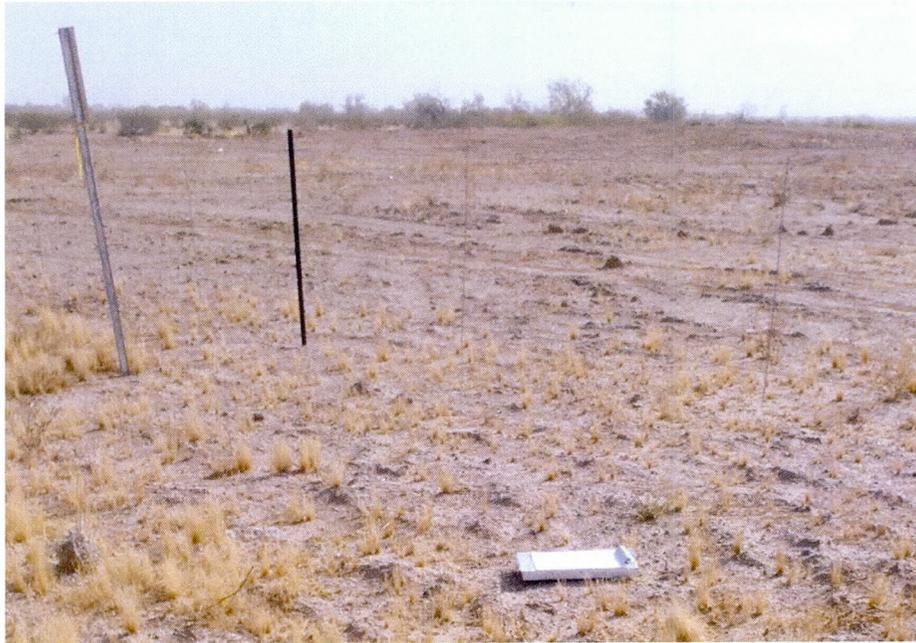
Photograph 2c depicts the same desiccation style crack observed on the ground surface in Photographs 2a and 2b. The sign in the background will be used as a reference point to relocate the crack during future inspections.

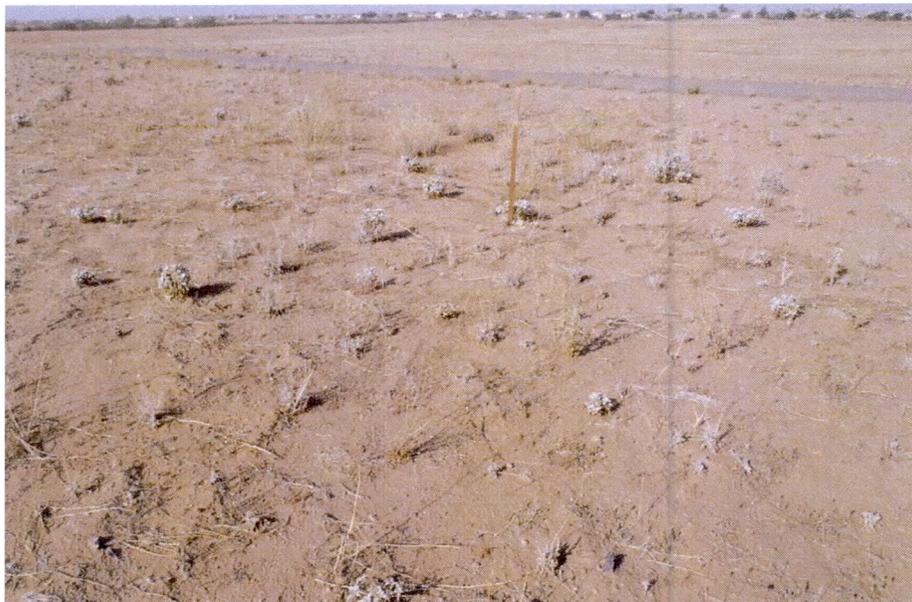
Photograph 3

Viewing southwest from the crest of the Siphon Draw detention basin in the alignment of the Southwestern Fissure. See field notation area 2 on Figure 1 for approximate location.

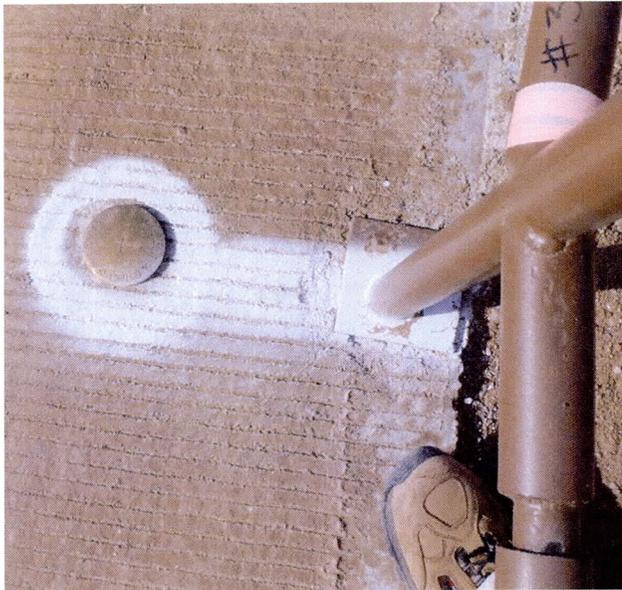
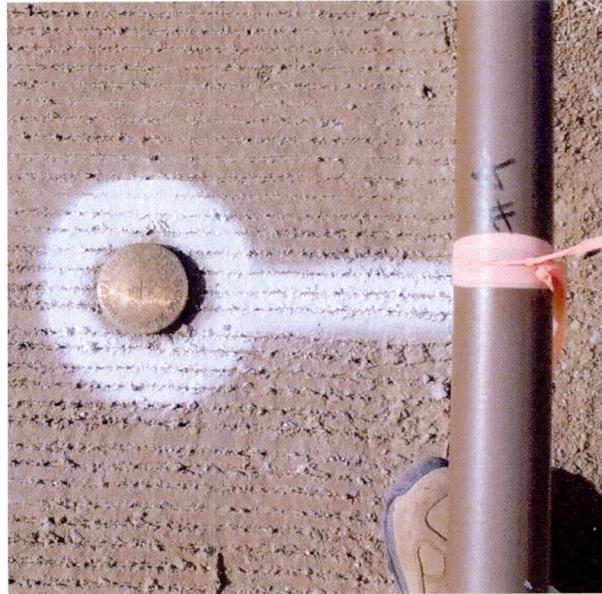
Photograph 6a is of the newly installed survey monument (M-3). Photograph 6b is of the newly installed survey monument (M-4). See field notation area 5 on Figure 1 for approximate location.

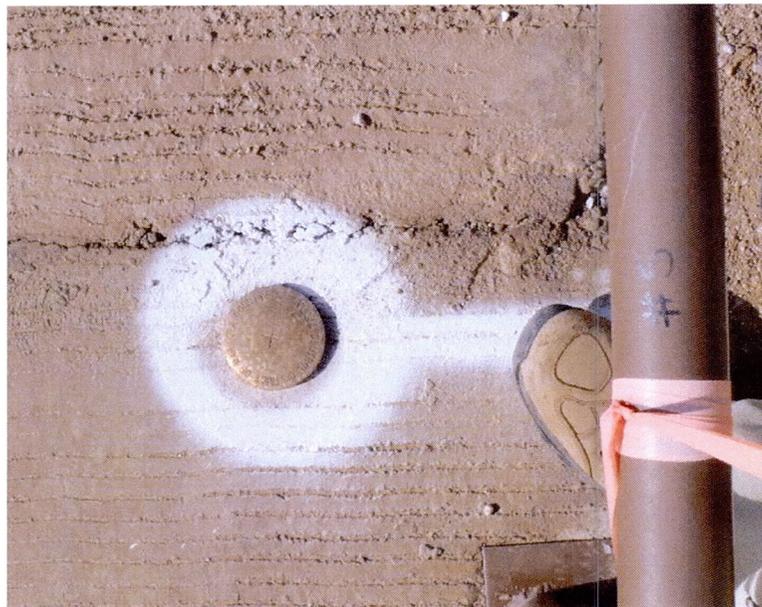
Photograph 7

Newly installed survey monument (M-5). See field notation area 5 on Figure 1 for approximate location.

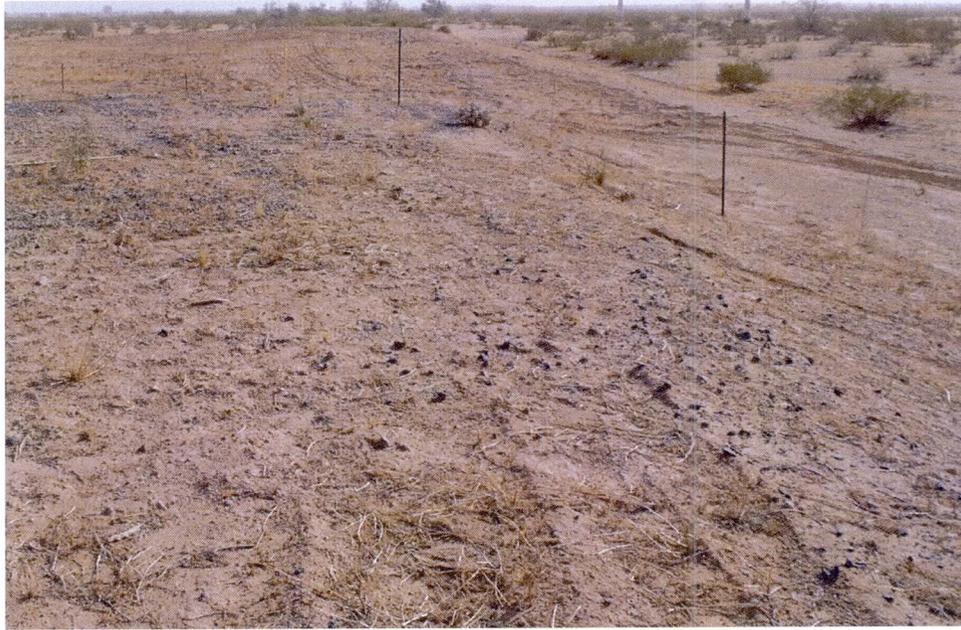
Photograph 4

Viewing north-northeast from the crest of the Siphon Draw detention basin in the approximate alignment of the Southwestern Fissure. Minor erosion rilling can be seen east of the crest, along the backside slope of the basin. See field notation area 2 on Figure 1 for approximate location.

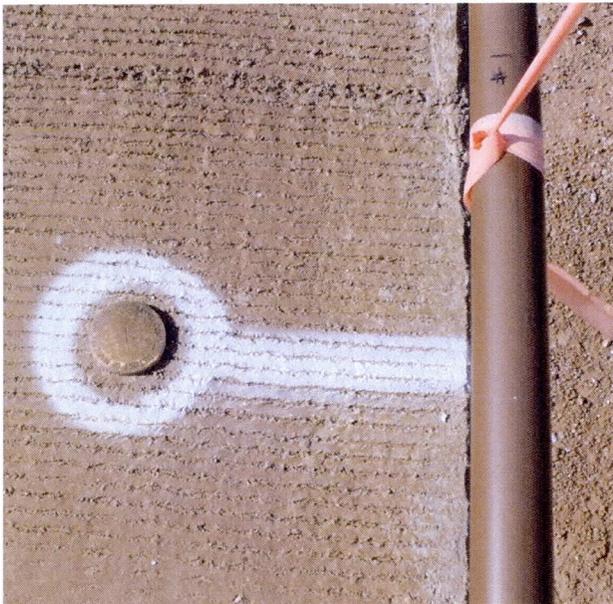
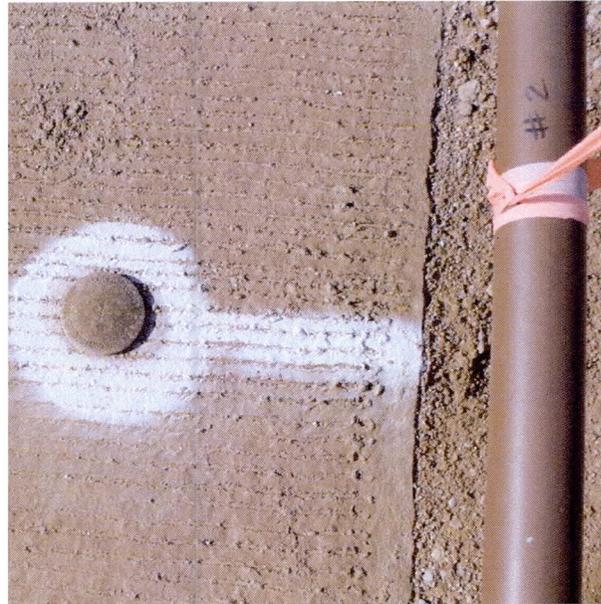
Photograph 5a is of the newly installed survey monument (M-1). Photograph 5b is of the newly installed survey monument (M-2). See field notation area 5 on Figure 1 for approximate location.
