**PHASE I  
ENVIRONMENTAL SITE ASSESSMENT  
and  
LIMITED SOIL SAMPLING AND ANALYSIS**

**DYSART DRAINAGE CHANNEL  
ASSIGNMENT NO. FCD-037  
MARICOPA COUNTY, ARIZONA**

November 30, 1993  
WRA File AR390-2073

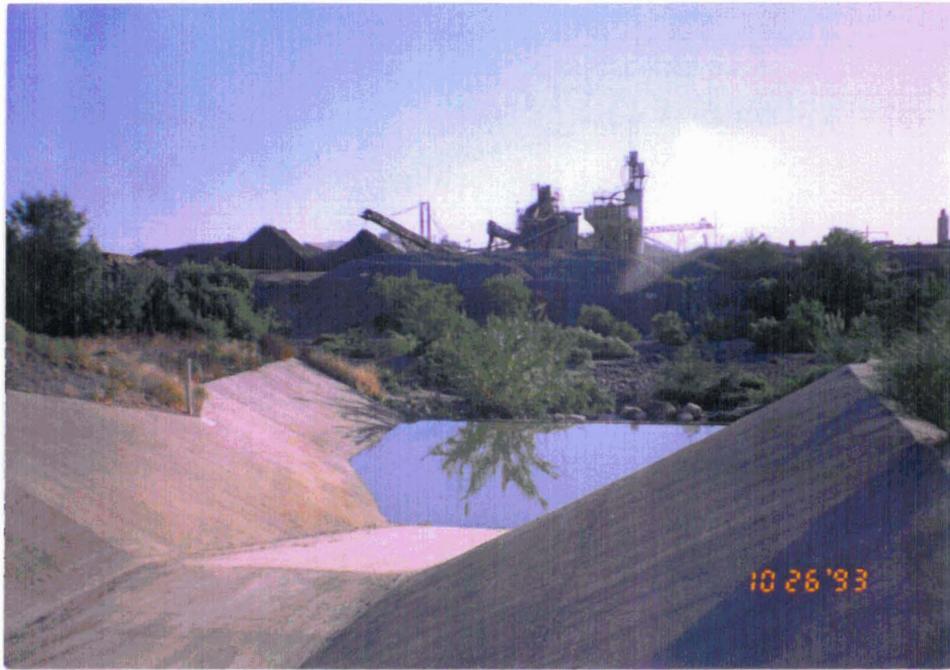
Photograph No. 1

The spillway (photo # 1) was concrete-lined and had a shallow retention area at its base. The retention area was filled with water at the time of the site inspection. Below the mouth of the spillway was a collection of concrete rubble and rusted steel reinforcing bars (photo # 2). The river bank sloped downward approximately 15 feet below the surrounding grade to become an irregular surface of sand, gravel and cobbles in the river bed (photo # 3). A small lagoon was present in the river bed near the spillway (photo # 4). Non-hazardous trash such as cans, bottles, papers, and landscaping debris was scattered about the area. Some trash had been carried onto the property by floodwaters and was stuck in the trees and bushes.

Dysart Drain spillway into Agua Fria River. Tanner sand and gravel plant in background.

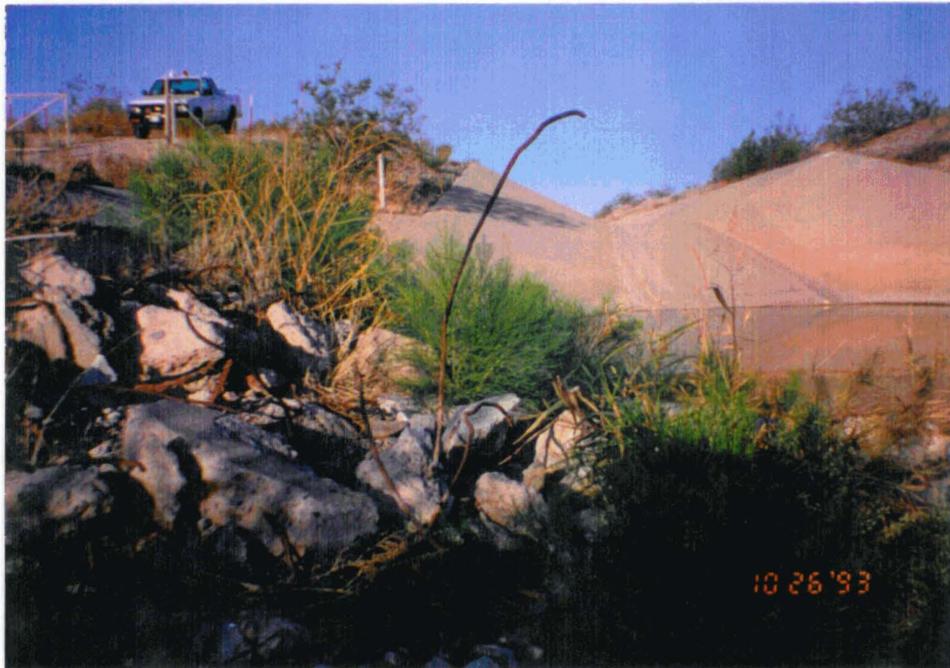
Photograph No. 2

Concrete rubble at spillway.

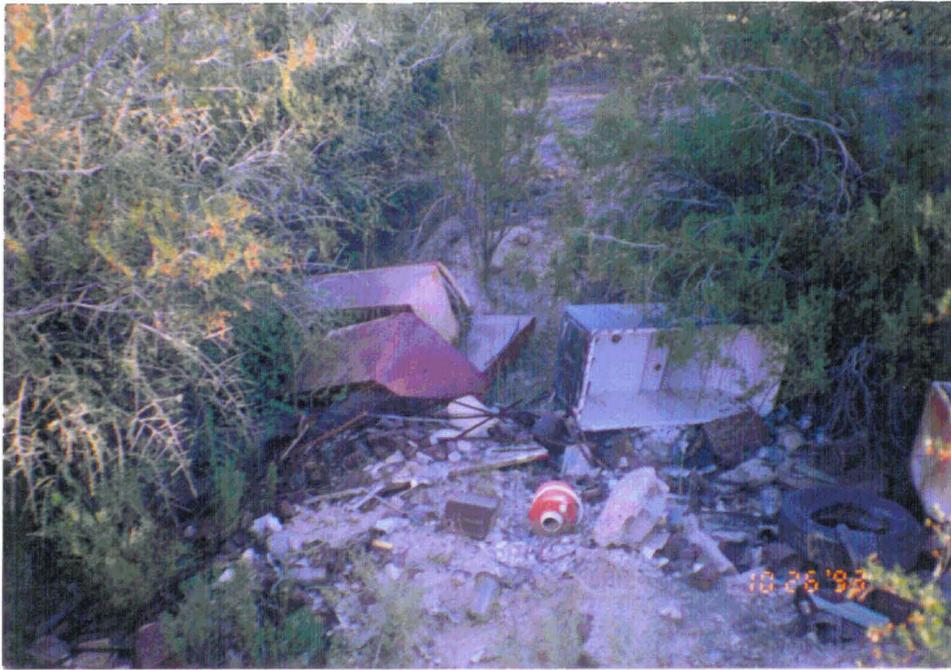
Photograph No. 5

Wildcat dumping north of spillway.

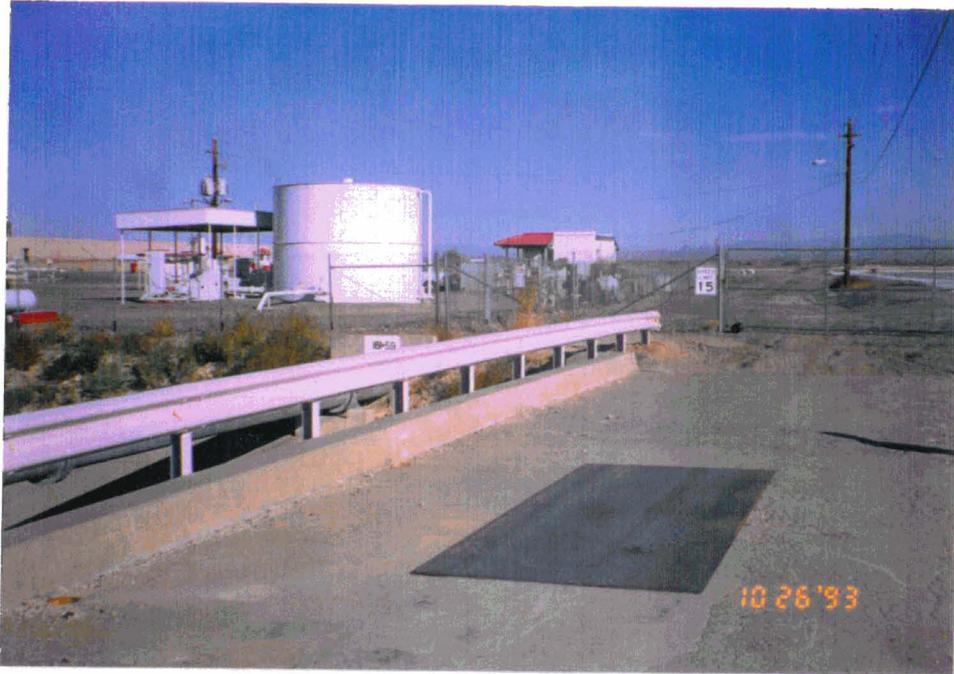
Photograph No. 13

Corroded reinforced-concrete bridge over Dysart Drain at Morton Salt plant.

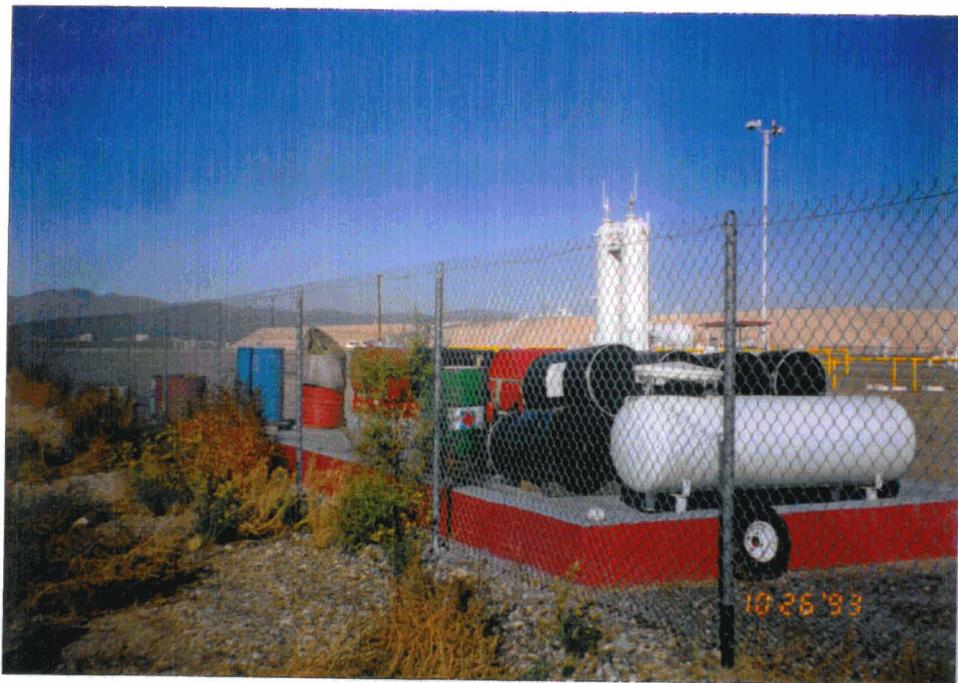
Photograph No. 14

Drum storage area at Amerigas facility, adjacent to the north.

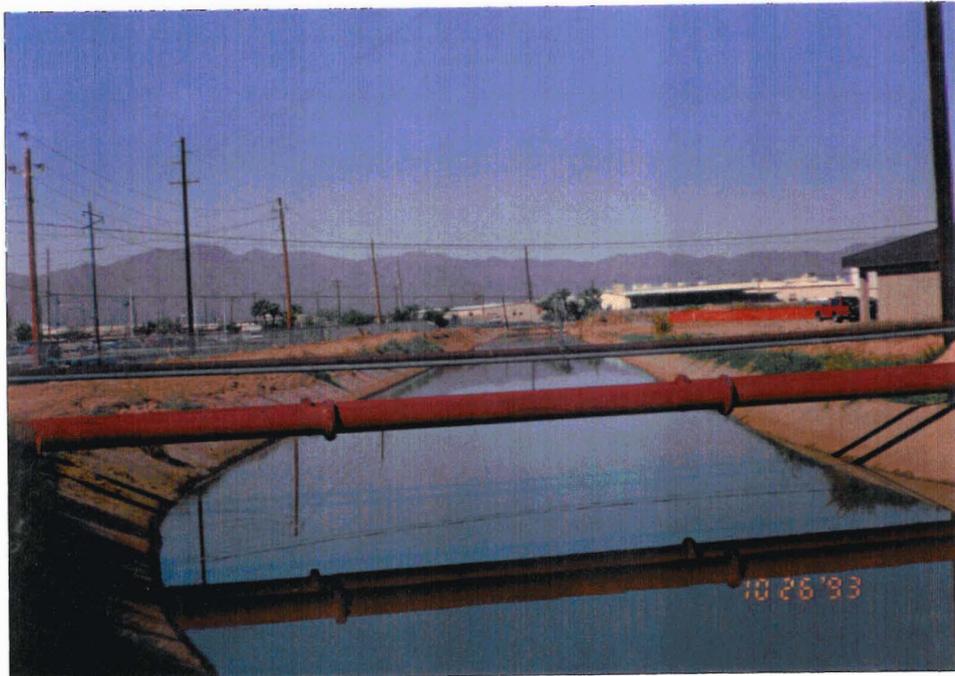
Photograph No. 20

Pipelines crossing channel near Litchfield Road.

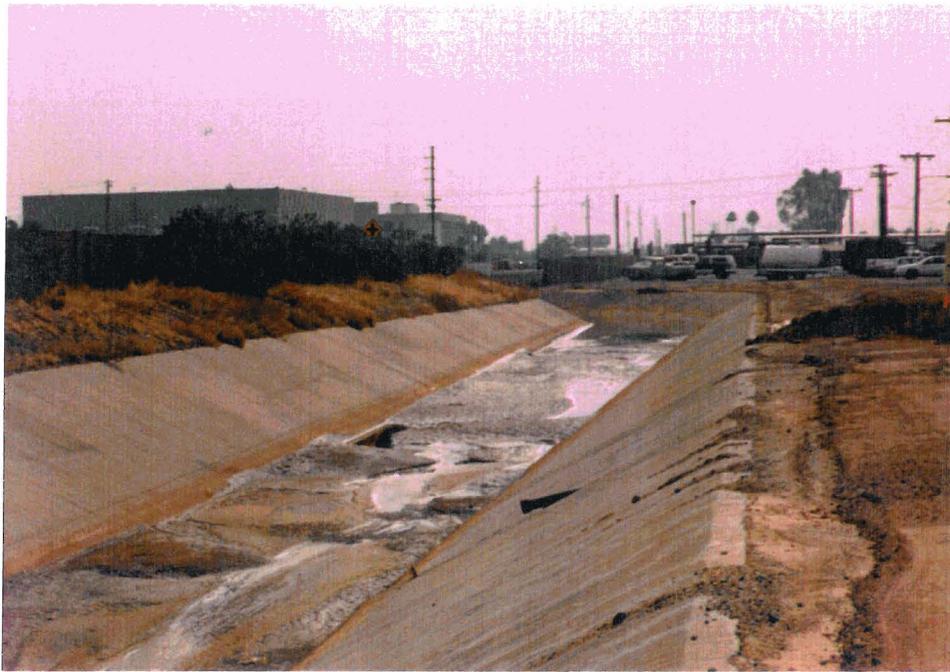
Photograph No. 23

Lined channel entering Luke AFB (looking south). Note four-inch pipe discharging from south side.

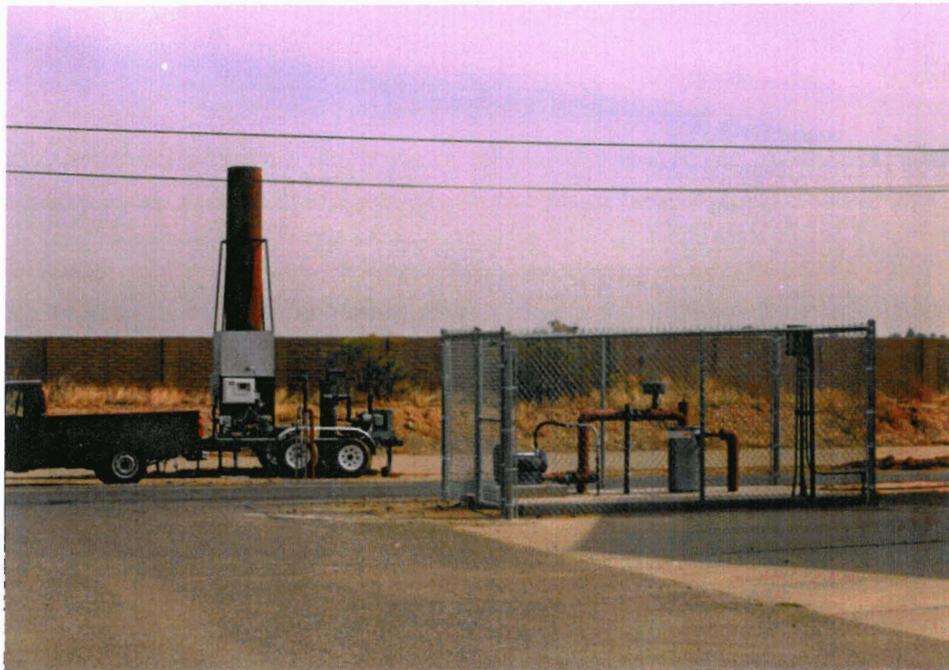
Photograph No. 25

Soil vapor extraction system associated with Building 353 LUST site. Dysart drain channel in background. Looking east.

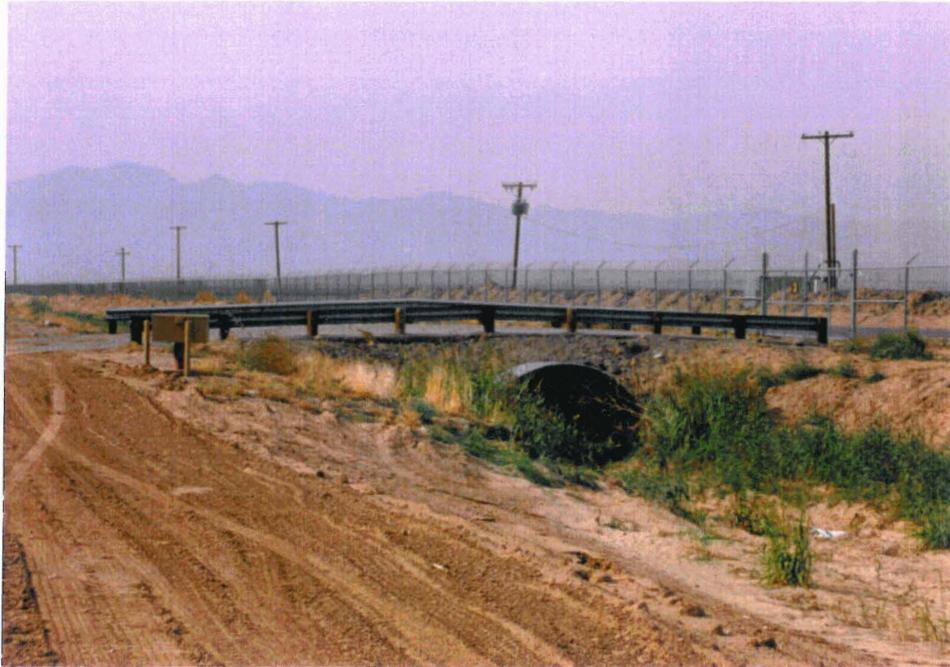
Photograph No. 31

Near building 1365 on Luke AFB, a monitor well is present within approximately ten feet of the south bank of the Dysart Drain channel. Care should be taken during any excavation of this area to ensure that the integrity of the wellhead is not compromised, or that any annular space surrounding the well casing does not collapse, thus creating an opportunity for infiltration of surface water to the sub-surface.

Typical stretch of unlined channel. Monitoring well visible adjacent to channel.

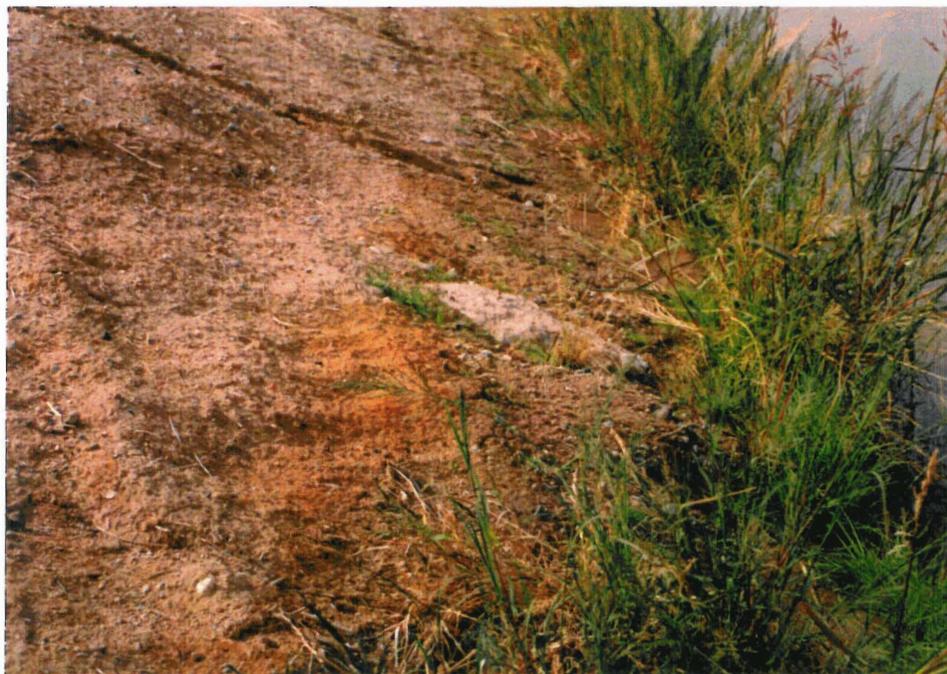
Photograph No. 34

Typical staining along unlined portions of the channel.

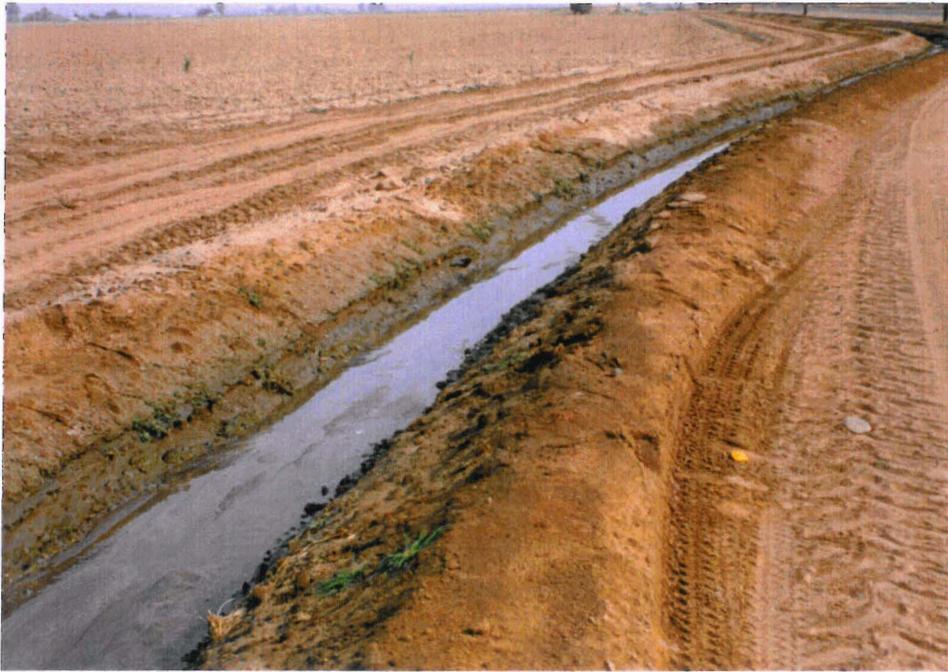
Photograph No. 37

Typical staining in unlined irrigation ditches on 160-acre parcel.

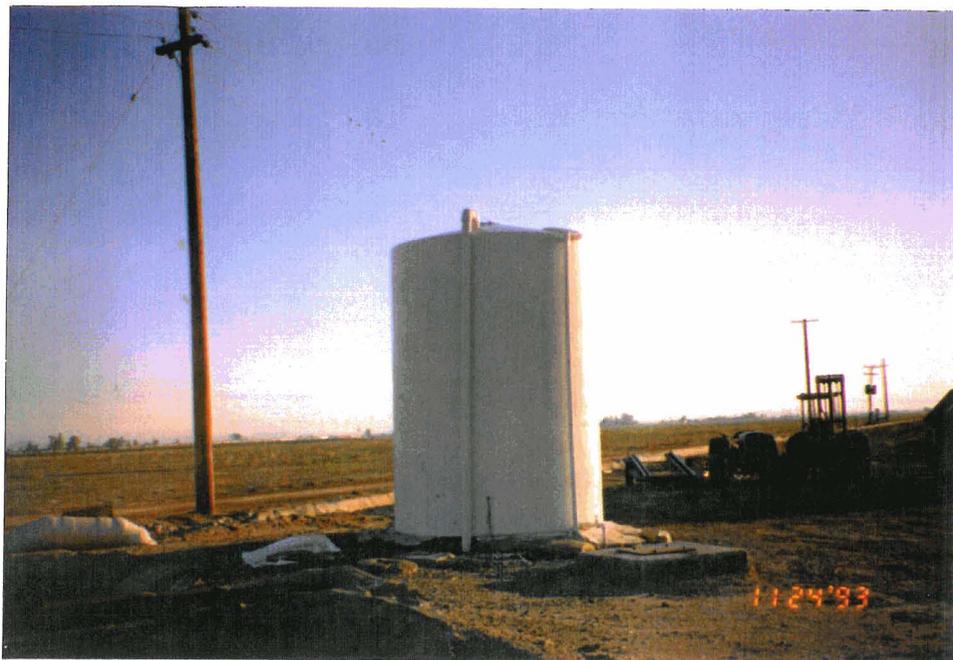
Photograph No. 39

One unused water well was observed on the subject property. This well was capped at the surface with a steel plate. CEC/WRA was not able to determine whether the plate was water-tight.

It is important for a property owner to realize that capping a well may not prevent or eliminate all the associated liability, although the requirements of ADWR have been met. Even in the cased portion of a well, there may be a large void area in the annulus outside the casing. If the well provides a means of contaminant migration, the property owner may incur some degree of responsibility, even though the contamination may have been caused by another. The proper abandonment of a well seals the annular space, eliminating the well as a potential means of contaminant migration.

Water tank and old well near homestead at northwest corner of 160-acre parcel.

Because the area is to be used as a retention basin, the integrity of the well is very important. CEC/WRA recommends that the well be inspected to determine whether it has been properly abandoned according to ADWR guidelines.
