Maryvale Storm Drain Settlement Study Report

February 7, 2003
File No.: 21517 (001)

**SUBJECT: Maryvale Storm Drain Settlement Study Report
Maryvale, Arizona**

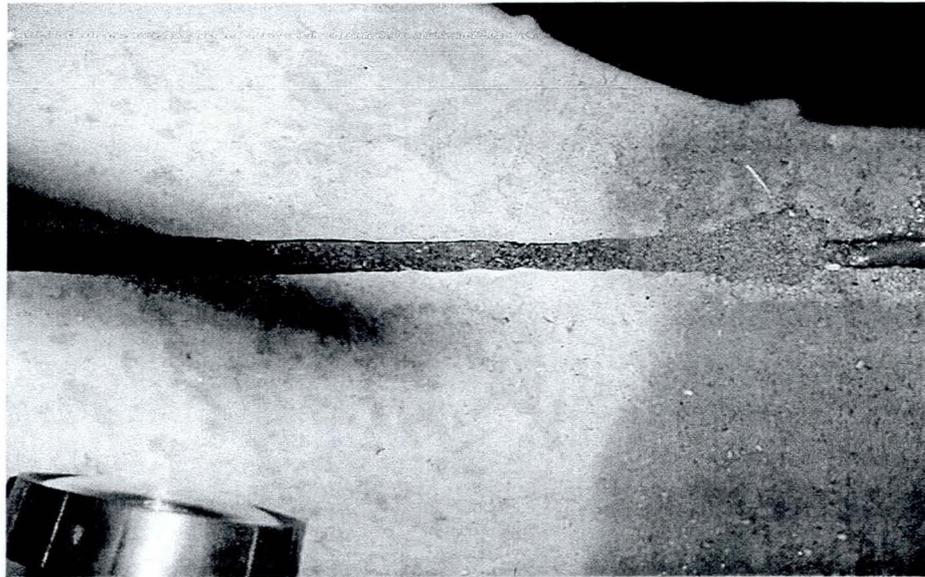
On December 23, 2002, a Kleinfelder representative was accompanied by Carlos Rivera of FCDMC on an internal traverse of the 60-inch diameter pipe between the above noted stations to assess the condition of gasket seals at each pipe joint and to attempt to determine if leaks may be present where fine grained soils may be washed into the pipe from the overlying backfill during irrigation events. It was found that most joints were grouted and of sound quality without apparent deterioration. Selected open joints were checked with a feeler gauge to determine if the pipe gasket at each joint was properly seated. All gaskets that could be checked appeared properly seated. Some build up of sediment was noted in the pipe invert, comprised mostly of fine to medium grained silty sand (SP) with some clay. Most of the invert accumulations were limited to two sag areas in the pipe invert where the invert elevation dipped approximately five to six inches along station, allowing for the accumulation of sediments during periods of low flow.

Photo 1. Typical sediment at ungrouted pipe joint.

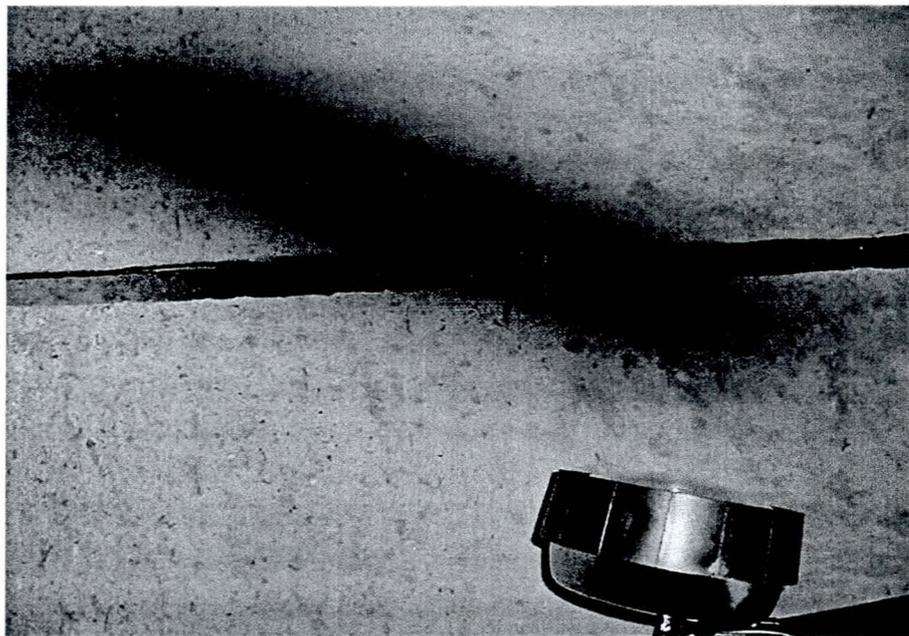
Photo 2. Minor sediment in ungrouted pipe joint.

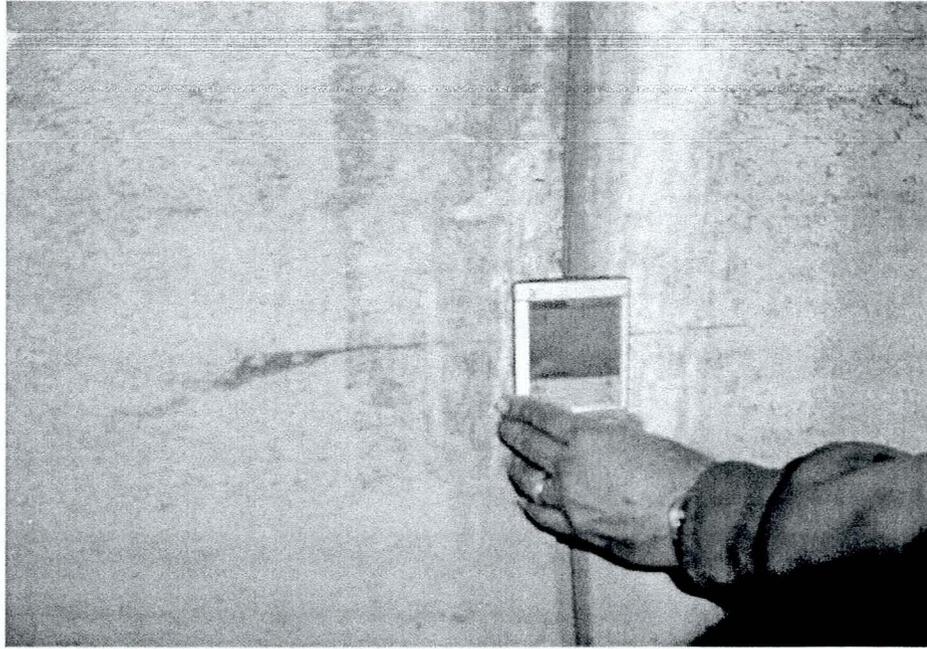
Photo 3. UngROUTED pipe point open to maximum width.

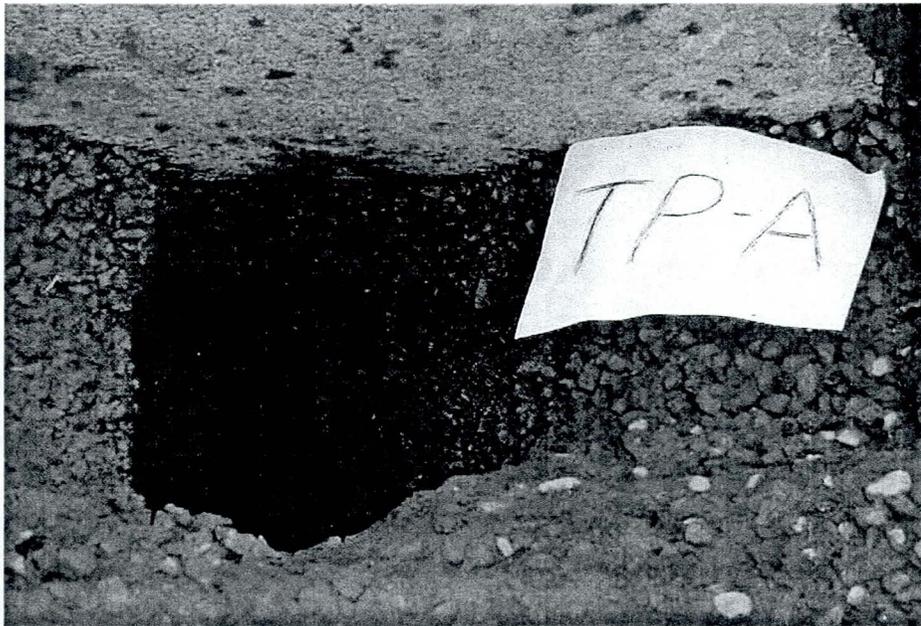
The second contributing factor to settlement may be the use of the gravel used for backfill up to springline of the pipe. The gravel, as placed, contains a significant amount of void space, allowing for fines to wash in from the overlying fine-grained soils. This loss of fines into the gravel may result in settlement of the overlying fine-grained soils. This is best evidenced in the

test pit at Station 27+00, where the gravel is significantly contaminated by fine-grained soils. The sand blanket present at Station 24+50 may have helped filter some of the fines.

Photo 4. Gravel bedding beneath pipe at approximate Sta. 27+00

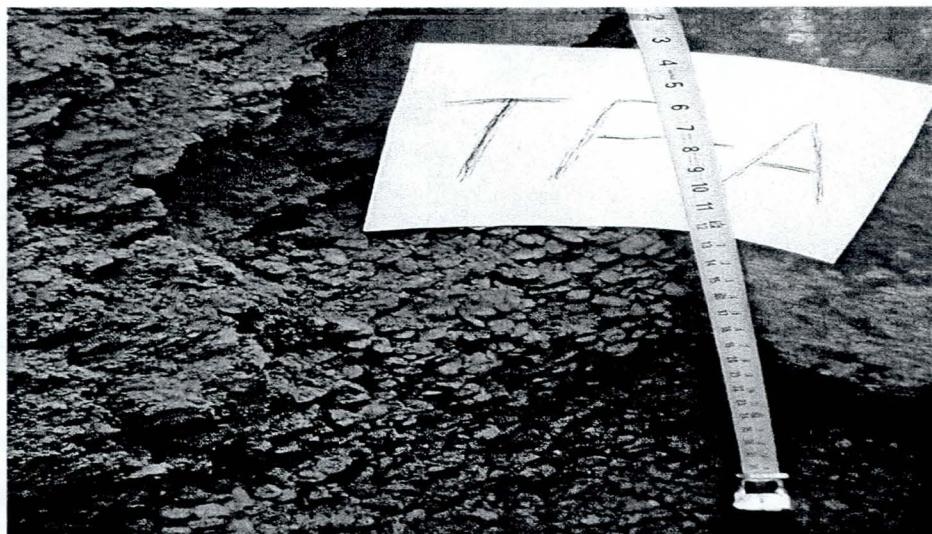
Photo 5. Gravel at springline contaminated by fine-grained soil.

It is our opinion that the vast majority of settlement has taken place along the pipeline located on the Borman School property. Repeated wettings and repairs completed to date have most likely allowed the backfill to attain an equilibrium condition. Therefore, alternative #5 is the most desirable, and we recommend that any future settlement, as it arises, be treated as a maintenance item whereby soil is placed and compacted in areas where minor settlement occurs. We do not recommend any further deep excavation and replacement and compaction of the trench backfill. Additionally, we do not believe it is cost effective to address the potential washing of fines into the gravel bedding and backfill.

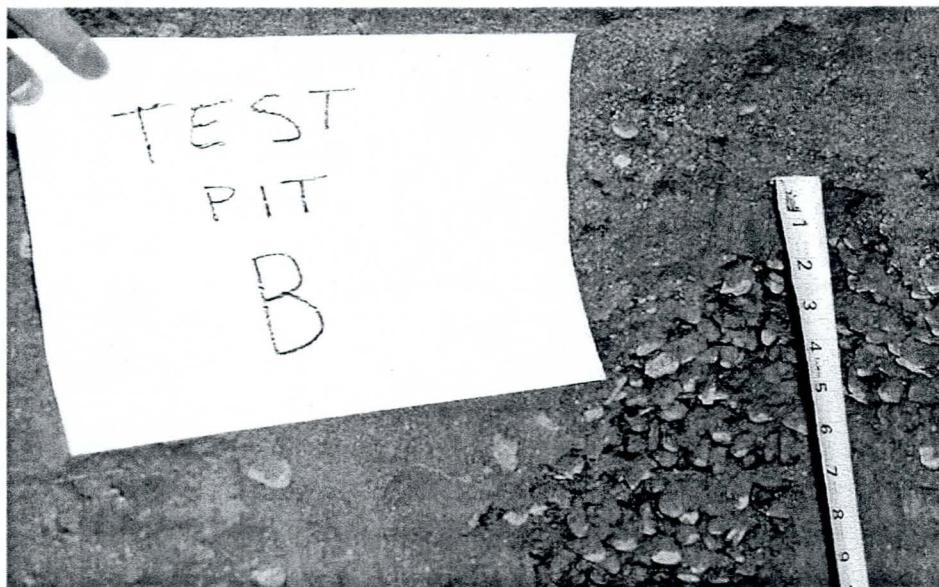
- Station 24+50 - Fine-grained, dry to slightly moist, native soils (sandy silt to clayey silt) present from the surface to a point approximately one foot above the top of pipe where clean, fine sand was encountered. The fine sand was present from the point encountered to springline of the pipe. Density of the fine-grained soils approximately 93 pcf. Clean gravel present from springline and below. No apparent contamination of the gravel.
- Station 27+00 - Fine-grained, moist to very moist, native soils (sandy silt to clayey silt) present from the surface to the springline of the pipe. Density of the fine-grained soils approximately 93 to 103 pcf. Gravel contaminated by fine-grained soils was present from springline and below. The gravel was excavated by hand to a point approximately one foot below the invert of the pipe.

Photo 6. Gravel at springline with overlying sand at Sta. 24+50.

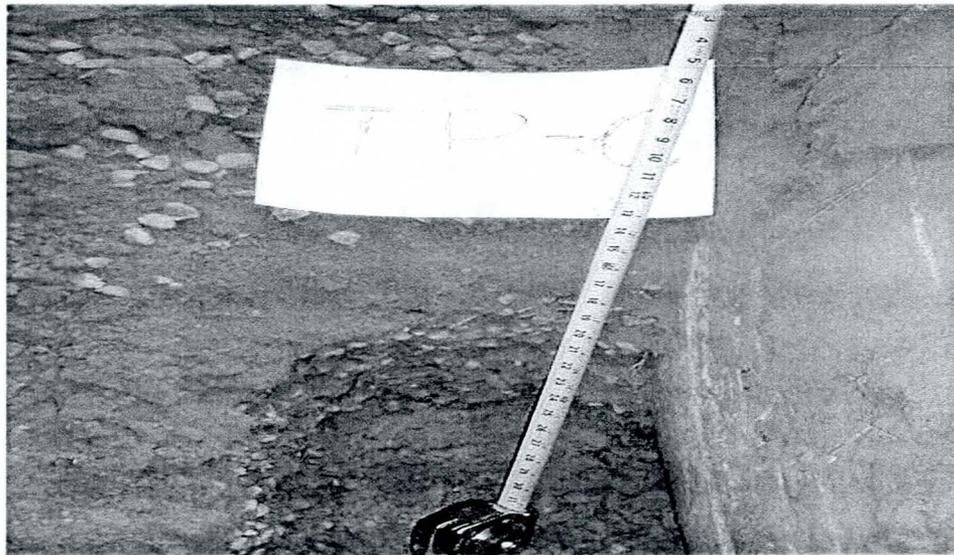
Photo 7. Gravel at springline near Sta. 22+00.

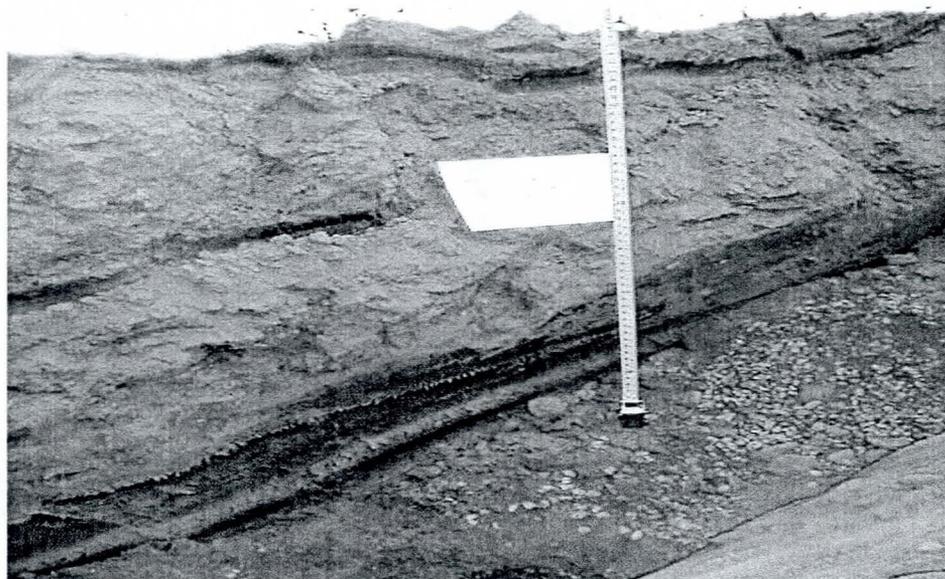
It is difficult to know what the condition at the time of construction or quality of the native soils place above the top of pipe. It is believed that the MAG specifications for placement may have required 85% of the maximum dry density. This alone would result is a certain amount of settlement upon wetting by irrigation activities. This is suspected because settlement of the pipe trench has only been noted on the Borman School property where the backfill is subjected to repeated wettings.

Photo 8. Typical condition of backfill above gravel.

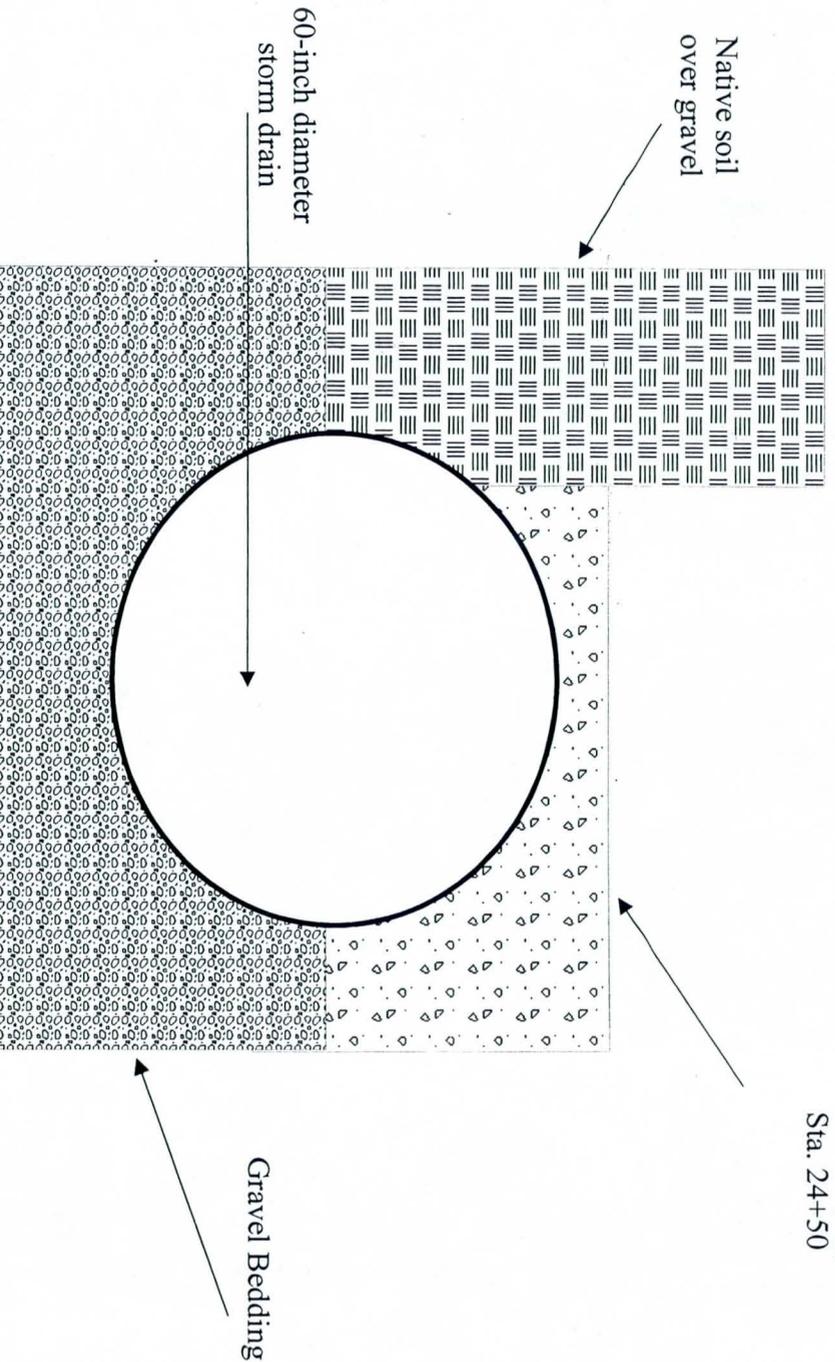
Typical As-Built Backfill
Configuration
Sta. 19+25 to 28+00
Maryvale Storm Drain

Sand over gravel at
Sta. 24+50
