REPORT
ON
THE CONDITION OF THE SUPERSTRUCTURE
OF
OLD CAVE CREEK DAM

FOR
MARICOPA COUNTY FLOOD CONTROL DISTRICT

April 1969

John Carollo Engineers

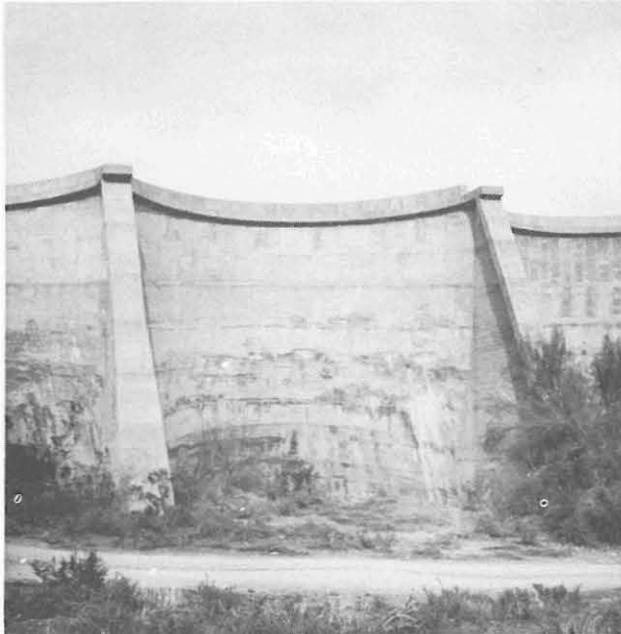
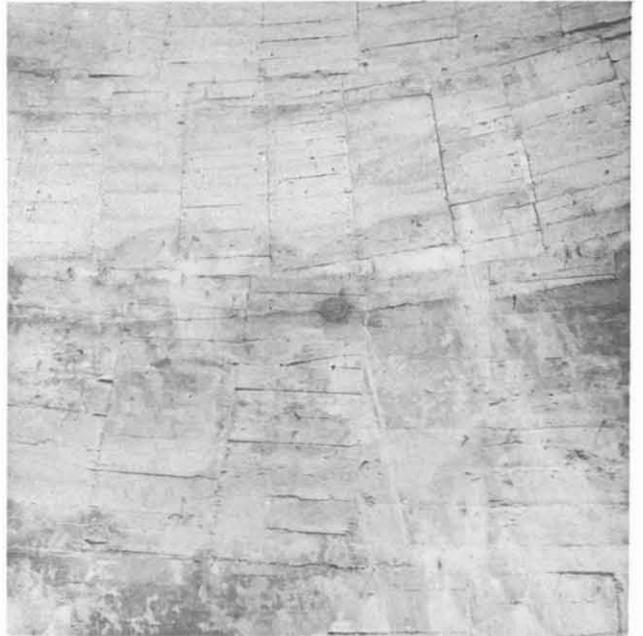
4" CORE No. 1
ARCH No. 6

CORE No. 1 - ARCH No. 6: 4" DIAMETER, $12\frac{1}{2}$ " LONG. CORED IN CRACK, 20' DOWN FROM DAM TOP AND 5'6" FROM EAST ABUTMENT. THE CRACK WAS SMALL, EXTENDING TO A DEPTH OF $3\frac{1}{2}$ ". CORE WENT COMPLETELY THROUGH DAM AND INDICATED GOOD DENSE CONCRETE THROUGHOUT.

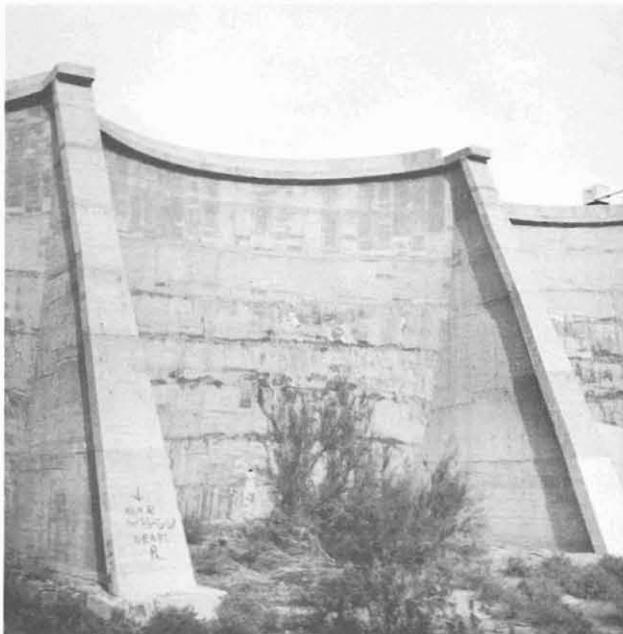
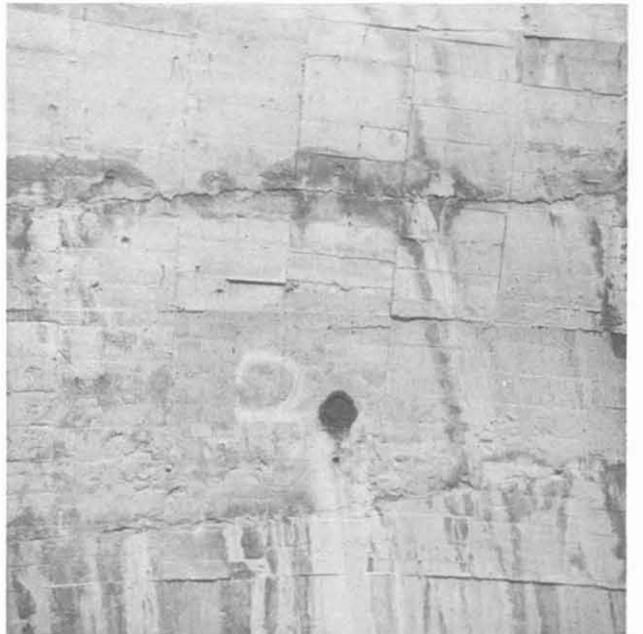
4" CORE No. 2
ARCH No. 8

CORE No. 2 - ARCH No. 8: 6" DIAMETER, 12" LONG. CORED BETWEEN JOINTS ONE AND TWO, DOWN 33' FROM DAM TOP AND 15'4" FROM EAST ABUTMENT. THIS CORE WAS TAKEN FOR TEST PURPOSES AND RESULTED IN A COMPRESSIVE STRENGTH OF 3842 PSI.

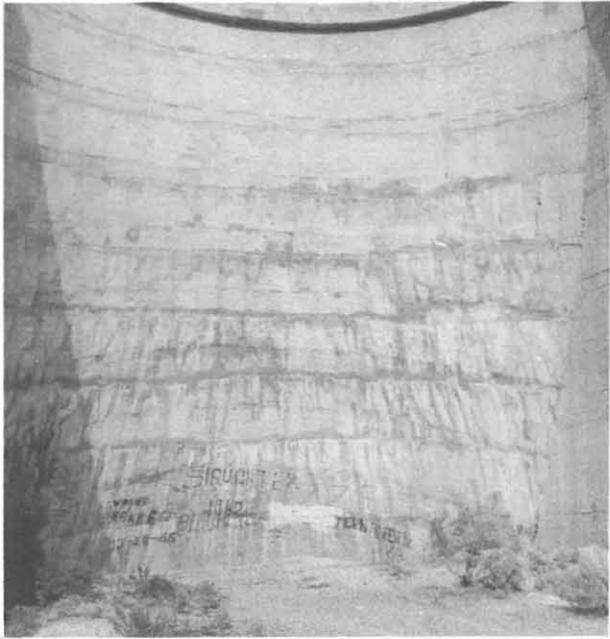
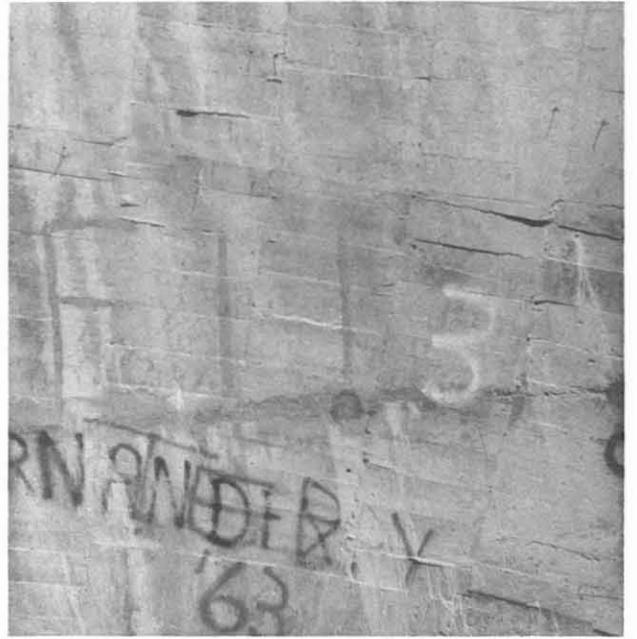
4" CORE No. 3
ARCH No. 10

CORE No. 3 - ARCH No. 10: 4" DIAMETER, $18\frac{1}{2}$ " LONG. CORED IN PATCHED CRACK, DOWN 39'7" FROM DAM TOP AND 7' FROM EAST ABUTMENT. CORE WENT COMPLETELY THROUGH DAM, AND BROKE AT A DEPTH OF APPROXIMATELY 8" DUE TO POOR BOND WITH SOME FLAT AGGREGATE, OTHERWISE THE CONCRETE APPEARED TO BE OF GOOD QUALITY.

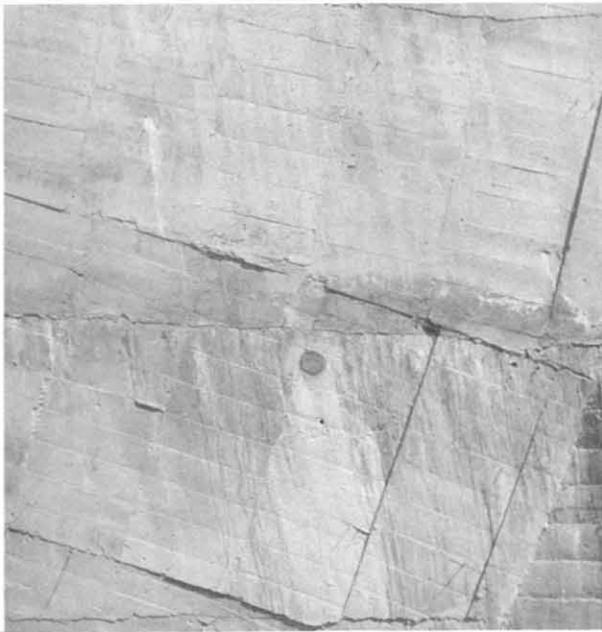
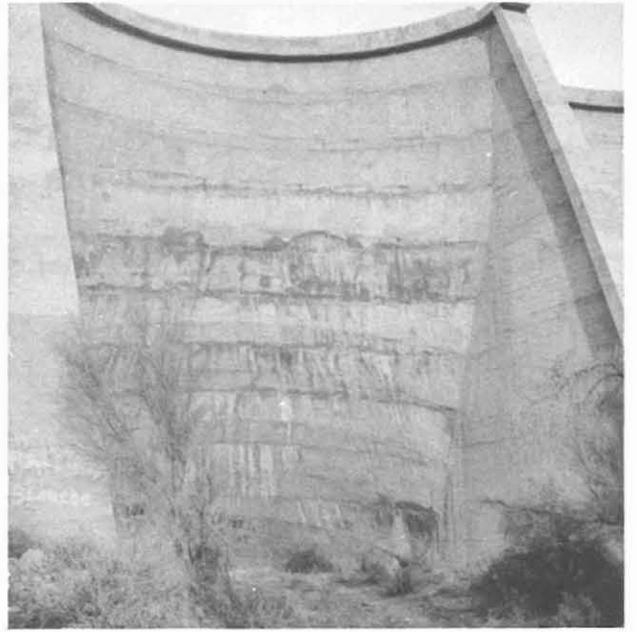
4" CORE No. 4
ARCH No. 11

CORE No. 4 - ARCH No. 11: 4" DIAMETER, $19\frac{1}{2}$ " LONG. CORED BELOW CRACK IN AREA COVERED WITH BROWN MUD STAINS, DOWN 45'3" FROM DAM TOP AND 2'6" FROM EAST ABUTMENT. CORE WENT COMPLETELY THROUGH DAM, WAS STARTED BELOW A CRACK IN AN EFFORT TO INTERSECT SAME. HOWEVER, THE CRACK WAS NEVER INTERSECTED. GOOD DENSE CONCRETE EXCEPT FOR A DEPTH OF FROM 10" TO 16" WHERE SMALL VOIDS WERE NOTICED AROUND AGGREGATE ON ONE SIDE.

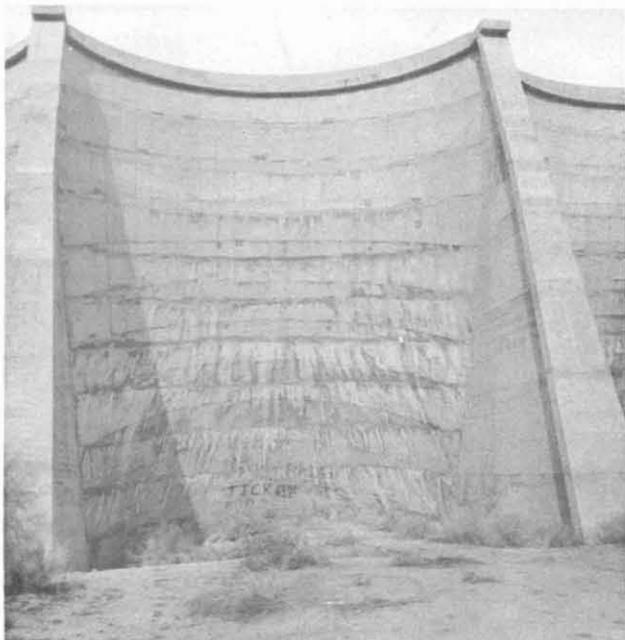
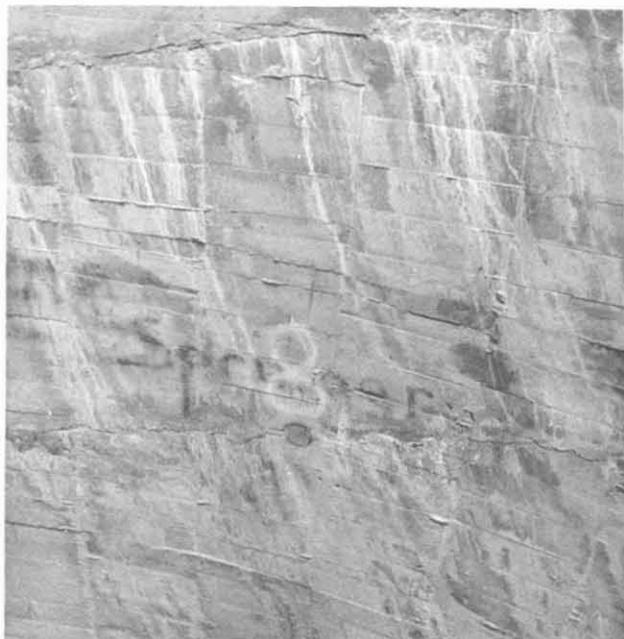
4" CORE No. 8
ARCH No. 18

CORE No. 8 - ARCH No. 18: 4" DIAMETER, 12 $\frac{1}{2}$ " LONG. CORED IN CRACK, HEAVY BROWN STAIN ALONG WITH HEAVY EFFERVESCENCE, 48'5" DOWN FROM DAM TOP AND 6'4" FROM EAST ABUTMENT. CRACK EXTENDED TO A DEPTH OF 5 $\frac{1}{2}$ ". CUT THROUGH $\frac{3}{4}$ " REINFORCING BAR 3 $\frac{1}{2}$ " IN. NO RUST ON BAR AND CONCRETE APPEARED TO BE GOOD AND DENSE THROUGHOUT.

THE LARGEST ROCK ENCOUNTERED IS SEEN IN CORE No. 8. EVIDENTLY NATIVE ROCK FROM THE AREA WAS USED AS AGGREGATE AND IN GENERAL IT CONSISTS OF GOOD DENSE ROCK.

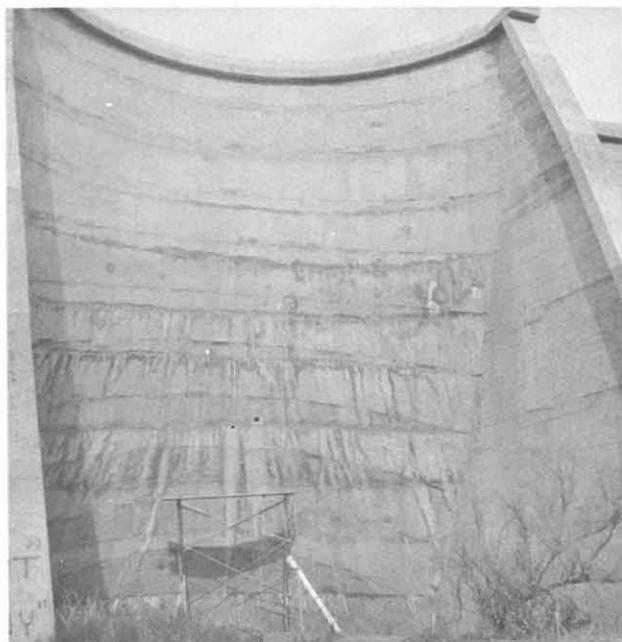
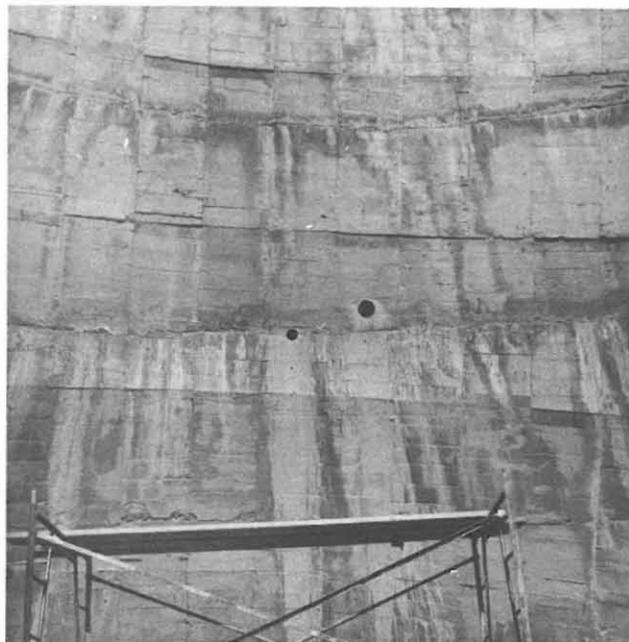
4" CORE No. 9
6" CORE No. 10
ARCH No. 22

CORE No. 9 - ARCH No. 22: 4" DIAMETER, 12" LONG. CORED IN CRACK, HEAVY EFFERVESCENCE, 34' DOWN FROM DAM TOP AND 17' FROM EAST ABUTMENT. CRACK EXTENDED TO A DEPTH OF 3 $\frac{1}{2}$ ". CORE BROKE OFF AT END DUE TO CONCENTRATION OF AGGREGATE. OTHERWISE, CONCRETE APPEARED TO BE GOOD AND DENSE THROUGHOUT.

CORE No. 10 - ARCH No. 22: 6" DIAMETER, 12" LONG. CORED 34'9" DOWN FROM DAM TOP AND 18'6" FROM EAST ABUTMENT. THIS CORE WAS TAKEN FOR TEST PURPOSES AND RESULTED IN A COMPRESSIVE STRENGTH OF 2933 PSI.

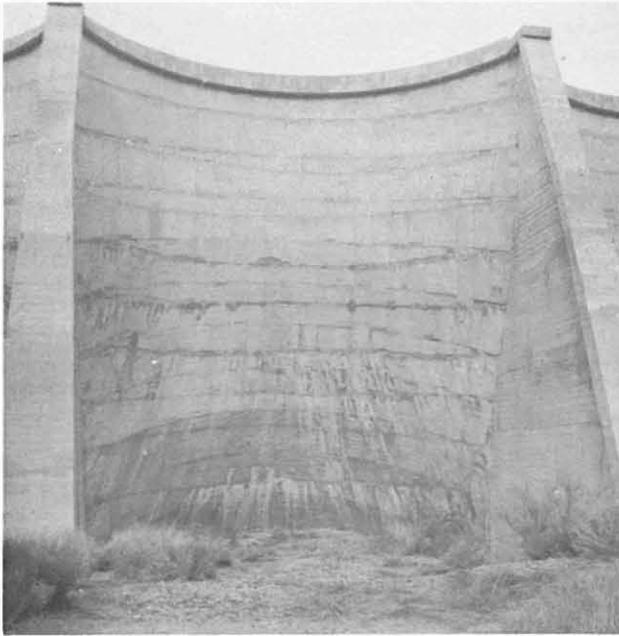
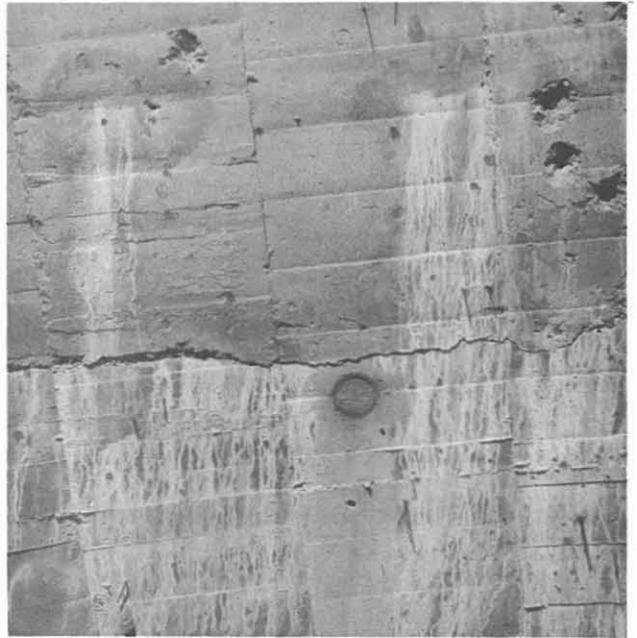
4" CORE No. 12
ARCH No. 27
NOTE: HOLES FROM
RIFLE BULLETS

CORE No. 12 - ARCH No. 27: 4" DIAMETER, 16" LONG. CORED IN CRACK, HEAVY EFFERVESCENCE IN THIS AREA, 43' DOWN FROM DAM TOP AND 22'10" FROM EAST ABUTMENT. CUT THROUGH $\frac{3}{4}$ " REINFORCING BAR $2\frac{3}{4}$ " IN. BAR SHOWED NO RUST, BUT CONCRETE AREA SHOWED A SMALL CRACK FROM FACE OF BAR TO THE FACE OF THE DAM. CORE BROKE AT DEPTHS INCLUDING LOCATIONS AT REBAR ON END (16") AND AT 8" IN WHERE A LARGE ROCK WAS BUT, $6\frac{1}{2}$ " OF WHICH WAS IN THE CORE. ROCK WAS BONDED WELL TO THE OTHER SECTION OF THE CORE. WITH THE EXCEPTION OF THE CRACK AND ROCK, THE CONCRETE APPEARED TO BE GOOD AND DENSE.

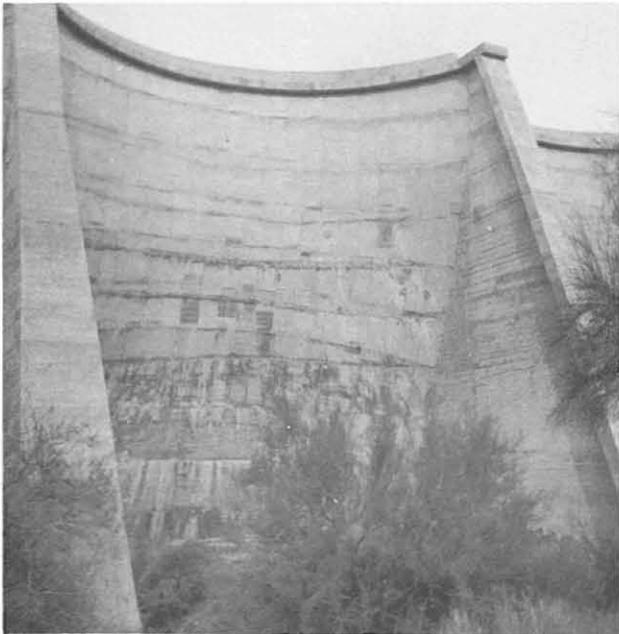
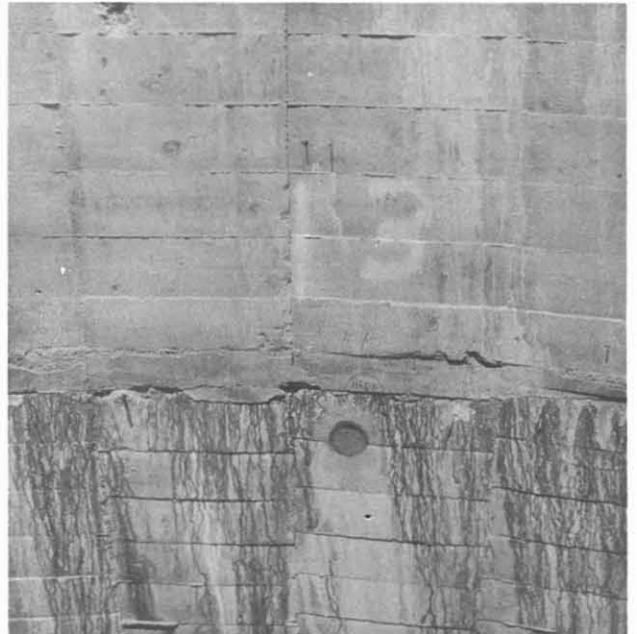
4" CORE No. 13
ARCH No. 29

CORE No. 13 - ARCH No. 29: 4" DIAMETER, $12\frac{1}{2}$ " LONG. CORED IN CRACK, HEAVY BROWN STAIN AREA, 44' DOWN FROM DAM TOP AND 17'6" FROM EAST ABUTMENT. STARTED CORING BELOW CRACK, ENCOUNTERED CRACK AT A DEPTH OF $8\frac{1}{2}$ " AND CORE BROKE AS CRACK ANGLED ACROSS IT. CONCRETE APPEARED TO BE GOOD AND DENSE WITH THE EXCEPTION OF SMALL CHECK CRACKS IN AREA 3" TO 6" IN ON THE CORE.

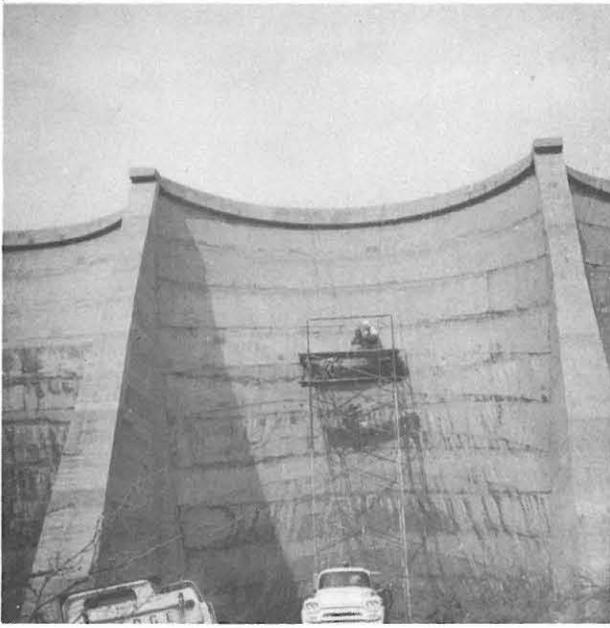
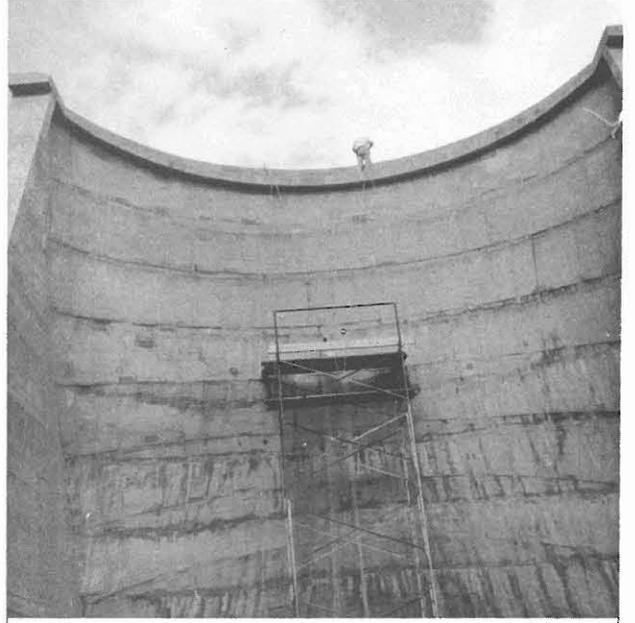
4" CORE No. 5
6" CORE No. 6
ARCH No. 13

In January 1969, Engineering Testing Laboratories, Inc., of Phoenix took twelve 4-inch cores and four 6-inch cores in the downstream face of the dam. Plate 4 indicates the approximate location of the cores. The 4-inch cores were taken at horizontal crack locations while the 6-inch cores were obtained in sound concrete for a determination of the present strength of the concrete. Since the horizontal cracks along the construction joints are in a more or less horizontal plane through the dam and the face of the dam is not a vertical plane and the cores had to be drilled perpendicular to the face, the core drilling had to be started at a lower elevation than the face of the crack in order to intersect the crack somewhere within the concrete. Therefore, no cores were able to follow a crack for its full width through the dam. One core (Core No. 5) indicated that the crack extended completely through the dam.

This core went completely through the dam at a point 16'-3" down from the top. All later cores were limited to a 12-inch depth and can not be used as an indication of the total depth of a crack. Several cores indicated that the cracks stopped at depths ranging from 3-1/2 inches to 5-1/2 inches while other cracks were noted at the interior end of the 12-inch depth of the core and evidently continue deeper into the wall. No cores were taken in the buttresses.

CORE No. 5 - ARCH No. 13: 4" DIAMETER, $12\frac{3}{4}$ " LONG. CORED IN MUD STAINED AREA, 16'3" DOWN FROM DAM TOP AND 21'6" FROM EAST ABUTMENT. CORE WENT COMPLETELY THROUGH DAM. STARTED CORING BELOW A CRACK AND ENCOUNTERED SAME AT A DEPTH OF 2" IN. THE CRACK EXTENDED COMPLETELY THROUGH DAM, WITH THE BROWN STAIN NOTICEABLE THROUGHOUT. CUT THROUGH $\frac{3}{4}$ " REINFORCING BAR AT $9\frac{1}{2}$ " DEPTH, ONE FACE OF WHICH WAS EXPOSED IN THE CRACK. THIS FACE WAS SLIGHTLY RUSTY WITH NO PITTING EVIDENT. CONCRETE APPEARED TO BE GOOD, DENSE CONCRETE.

CORE No. 6 - ARCH No. 13: 6" DIAMETER, 12" LONG. CORED IN SAME AREA AS No. 5, 15'6" DOWN FROM DAM TOP AND 20'3" FROM EAST ABUTMENT. THIS CORE WAS TAKEN FOR TEST PURPOSES AND RESULTED IN A COMPRESSIVE STRENGTH OF 3103 PSI.

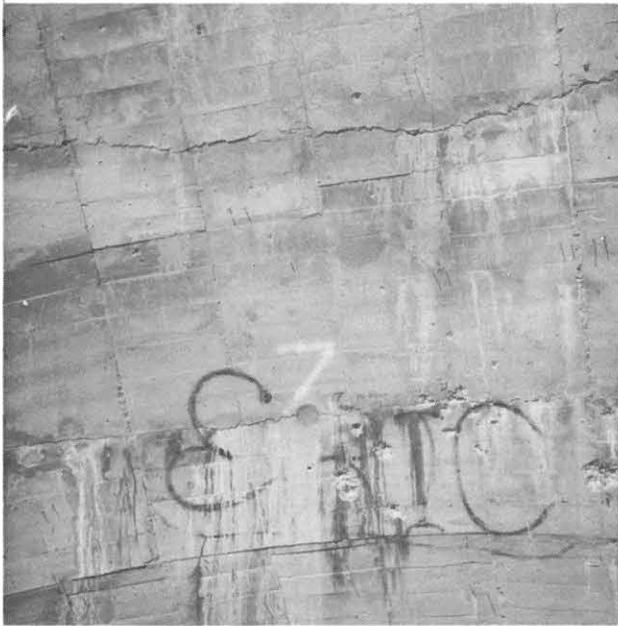
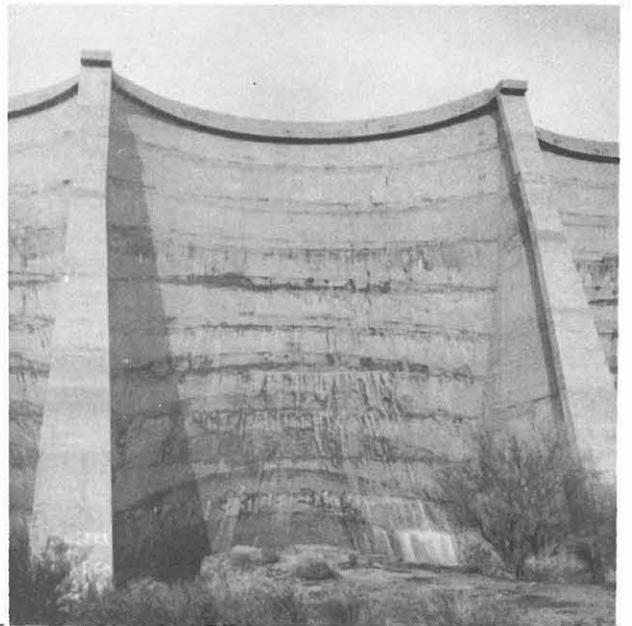
4" CORE No. 7
ARCH No. 16

CORE No. 7 - ARCH No. 16: 4" DIAMETER, 12" LONG. CORED IN CRACK 43'7" DOWN FROM DAM TOP AND 25' FROM EAST ABUTMENT. CRACK EXTENDED TO A DEPTH OF 4 $\frac{1}{2}$ ". CUT THROUGH $\frac{3}{4}$ " REINFORCING BAR 3 $\frac{1}{4}$ " IN. NO RUST ON BAR AND CONCRETE APPEARED TO BE GOOD AND DENSE THROUGHOUT.

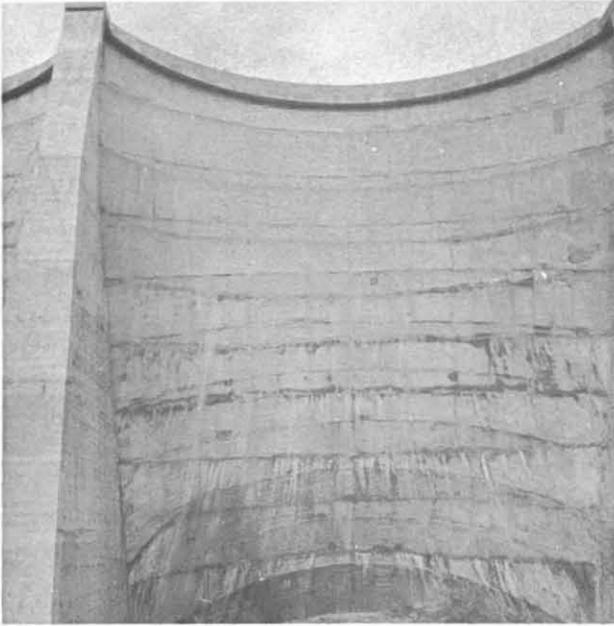
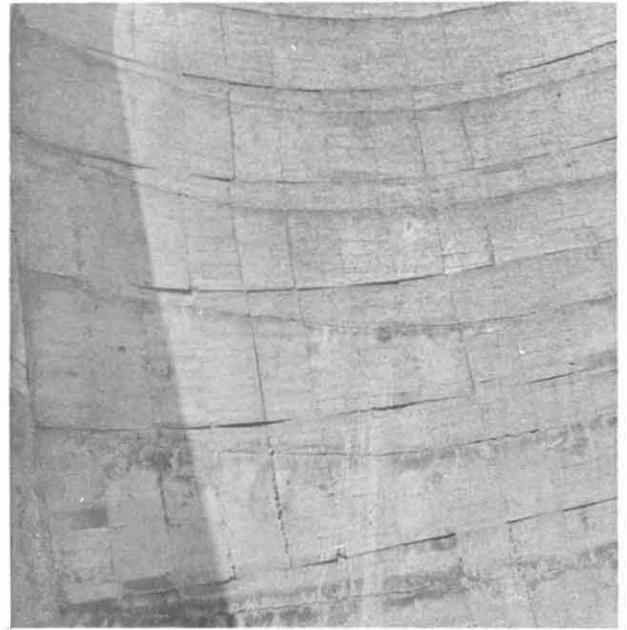
4" CORE No. 11
ARCH No. 25

CORE No. 11 - ARCH No. 25: 4" DIAMETER, 12" LONG. CORED IN CRACK 21' DOWN FROM DAM TOP AND 34'8" FROM EAST ABUTMENT. STARTED BELOW CRACK AND ENCOUNTERED CRACK AT A DEPTH OF 5". CRACK WAS IN THE APPROXIMATE CENTER AT THE END OF THE CORE. CONCRETE APPEARED TO BE GOOD AND DENSE THROUGHOUT.

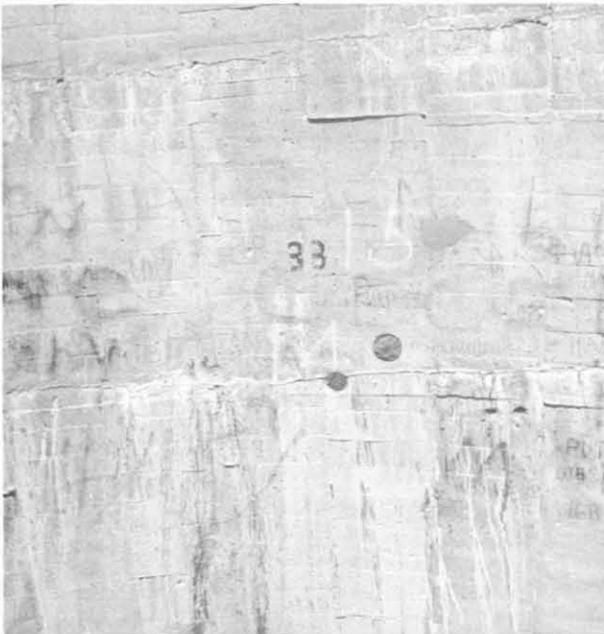
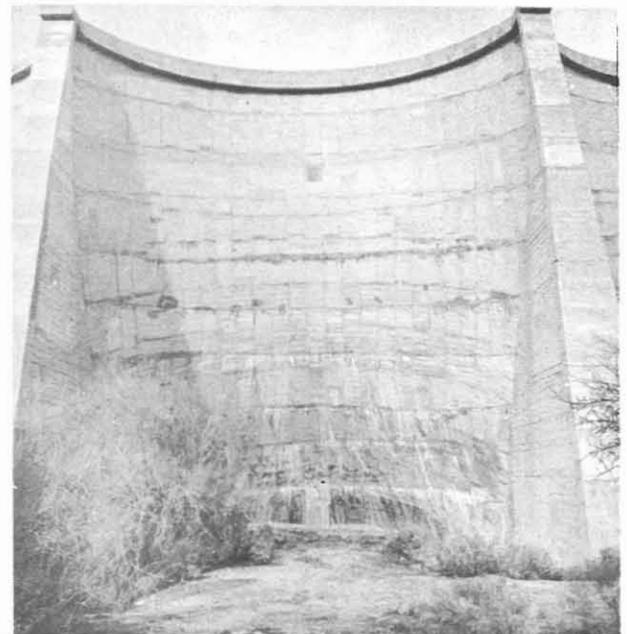
6" CORE No. 15
ARCH No. 33
4" CORE No. 14

CORE No. 14 - ARCH No. 33: 4" CORE, $10\frac{1}{2}$ " LONG. CORED IN CRACK WHERE CONCRETE SURFACE WAS COVERED WITH A BROWN STAIN AND HEAVY EFFERVESCENCE, 42'3" DOWN FROM DAM TOP AND 28'6" IN FROM EAST ABUTMENT. CRACK EXTENDED TO A DEPTH OF $5\frac{1}{2}$ ". CORED 12" BUT CORE BROKE AT $10\frac{1}{2}$ " DUE TO LARGE FLAT ROCK. CONCRETE APPEARED TO BE GOOD AND DENSE.

CORE No. 15 - ARCH No. 33: 6" DIAMETER, 12" LONG. CORED IN SAME AREA AS No. 14, 42'10" DOWN FROM DAM TOP AND 19'6" IN FROM EAST ABUTMENT. THIS CORE WAS TAKEN FOR TEST PURPOSES AND RESULTED IN A COMPRESSIVE STRENGTH OF 4061 PSI.

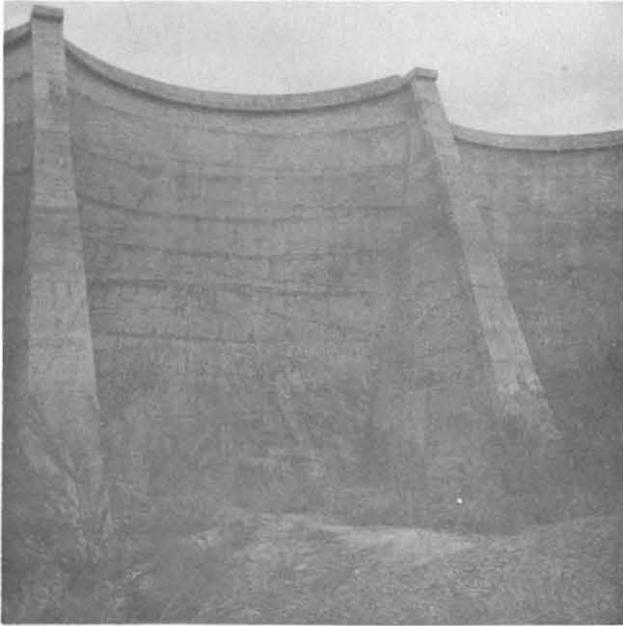
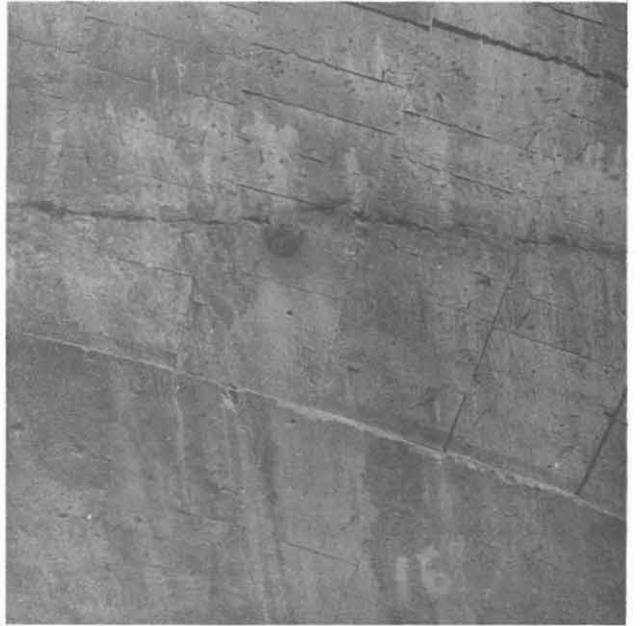
4" CORE No. 16
ARCH No. 36

CORE No. 16 - ARCH No. 36: 4" DIAMETER, 12" LONG. CORED IN CRACK AND SPALLED AREA, 44'4" DOWN FROM DAM TOP AND 7'3" FROM EAST ABUTMENT. STARTED CORING BELOW CRACK AND ENCOUNTERED CRACK 3" TO 11"

CONTINUOUSLY FROM DEPTH WHERE IT EMANATED AWAY FROM CORE AREA. CRACK WAS COVERED THROUGHOUT WITH A HEAVY BROWN STAIN. CONCRETE APPEARED GOOD AND DENSE THROUGHOUT.

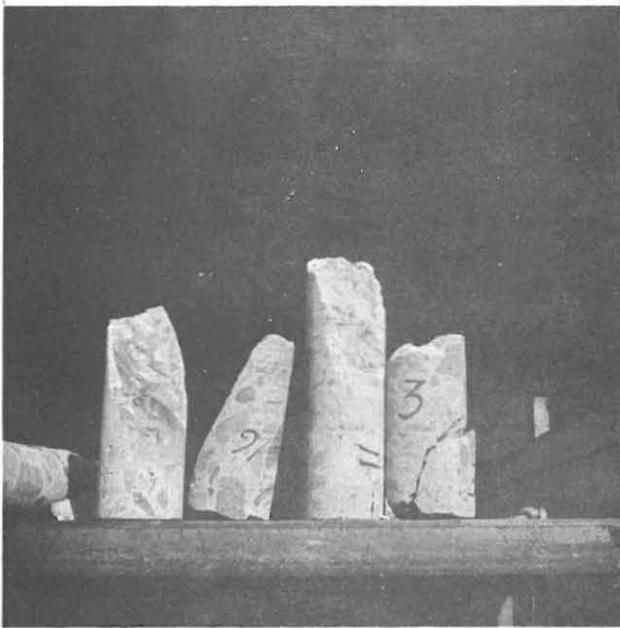
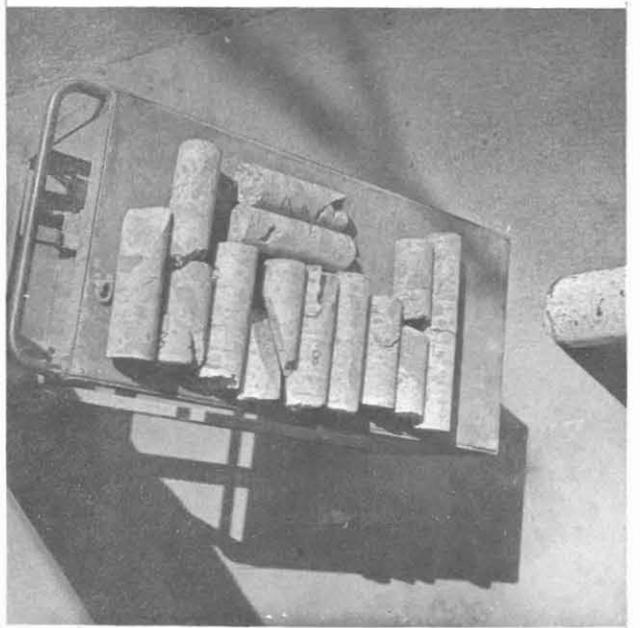
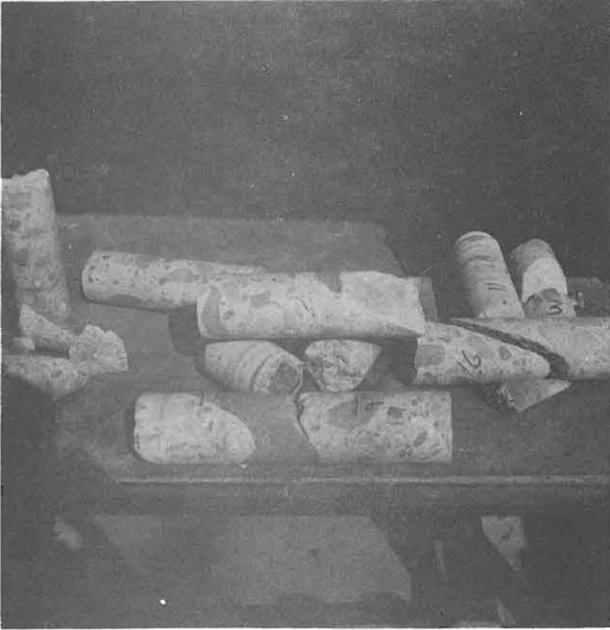
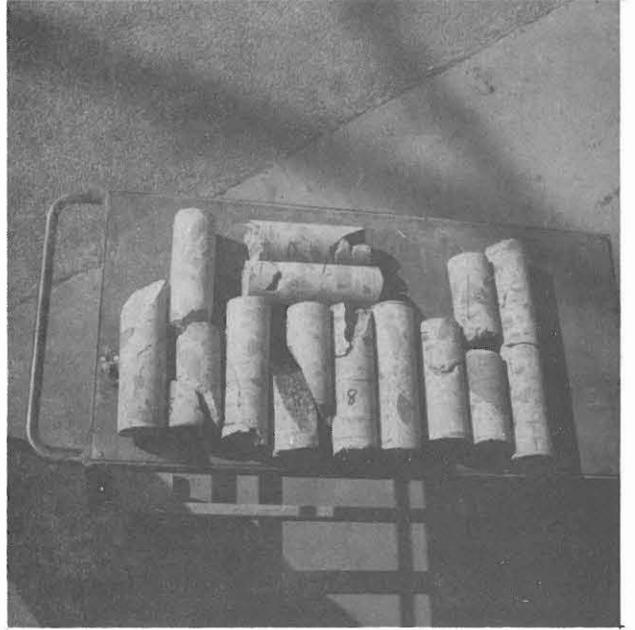
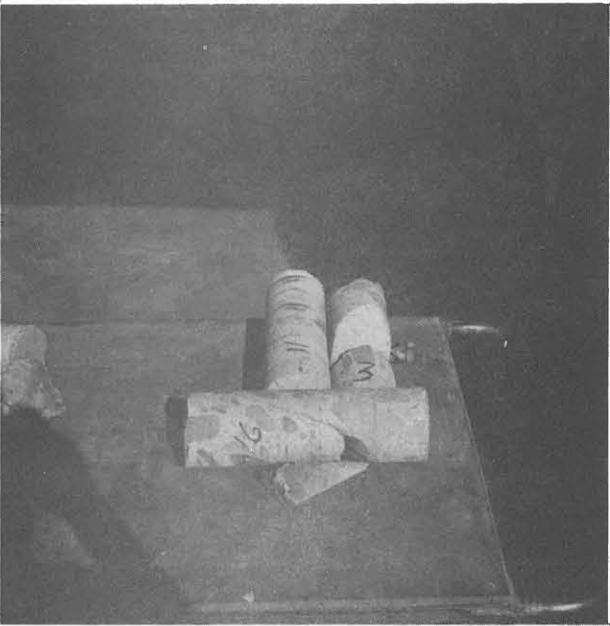
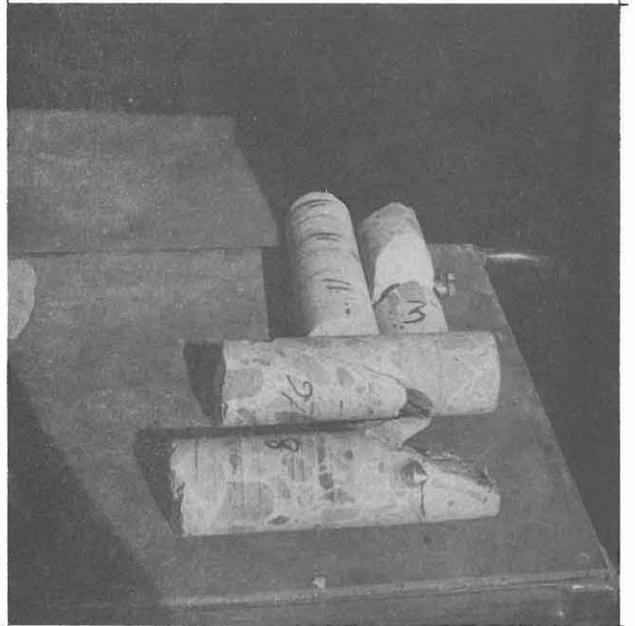
CONCRETE CORES

PICTURES OF THE CORES ARE ENCLOSED. ALL DIAGONAL CRACKS ARE DUE TO DRILLING THROUGH THE COLD OR POUR JOINTS. IT WAS DIFFICULT TO FOLLOW THE CRACKS THROUGH THE DAM, SINCE THE DAM FACE IS CURVED, BOTH VERTICALLY AND HORIZONTALLY. THE DRILL WAS FASTENED TO THE DAM FACE, SO THE CORE WAS DRILLED NORMAL TO THE SURFACE, WHILE THE COLD OR POUR JOINT WAS FORMED IN A HORIZONTAL PLANE. BY STARTING THE CORE DRILL BELOW THE CRACK, THE CRACK WAS ENCOUNTERED AT DIFFERENT DISTANCES IN FROM THE DAM FACE AND AS HAS BEEN STATED, SOME OF THE CORES SHOWED THE JOINT COMPLETELY THROUGH THE DAM.
