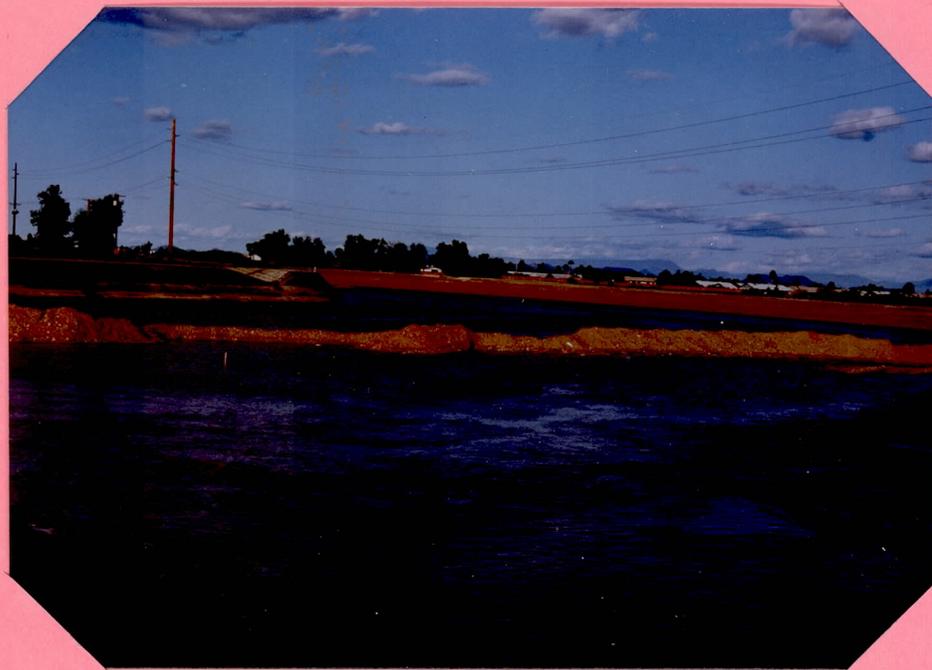
LOOKING EAST,
SOUTH OF OLIVE SHOWING INVERT PROTECTION (WEST HALF)

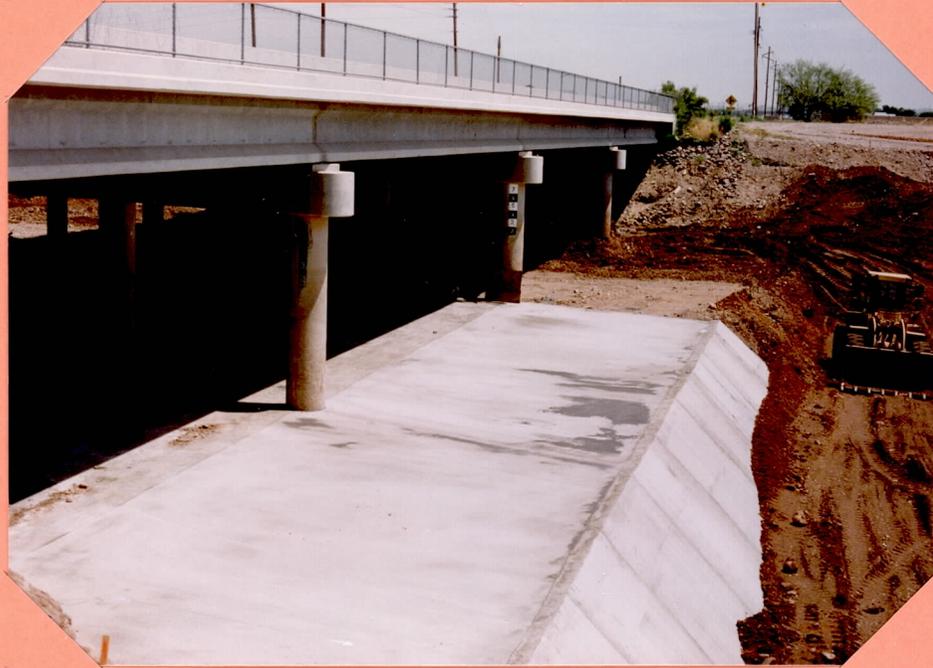
LOOKING NORTH
SOUTH OF OLIVE SHOWING INVERT PROTECTION (WEST HALF)

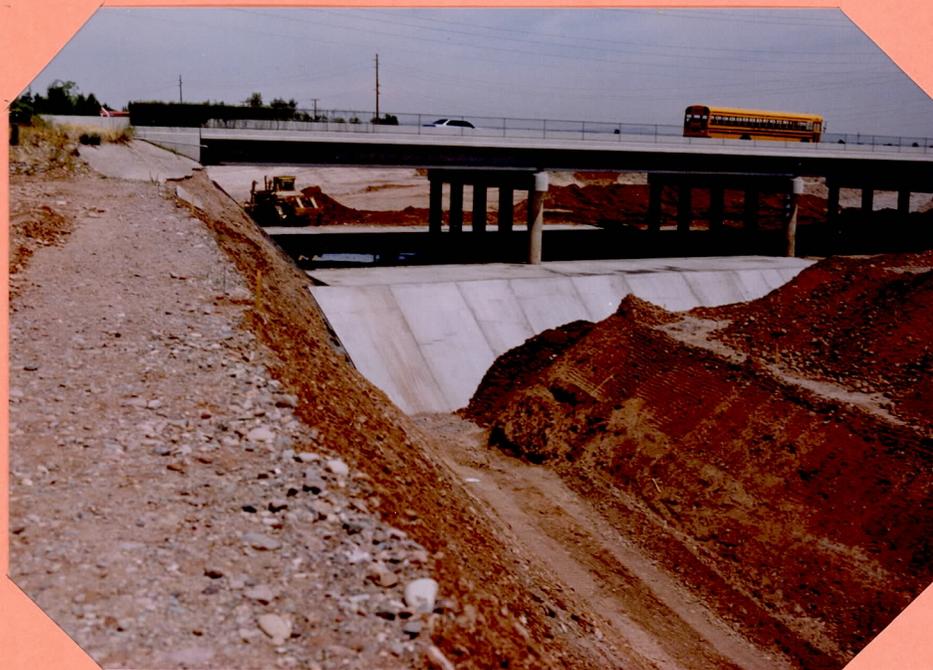
DIKE FOR DIVERTING FLOWS NORTH OF OLIVE

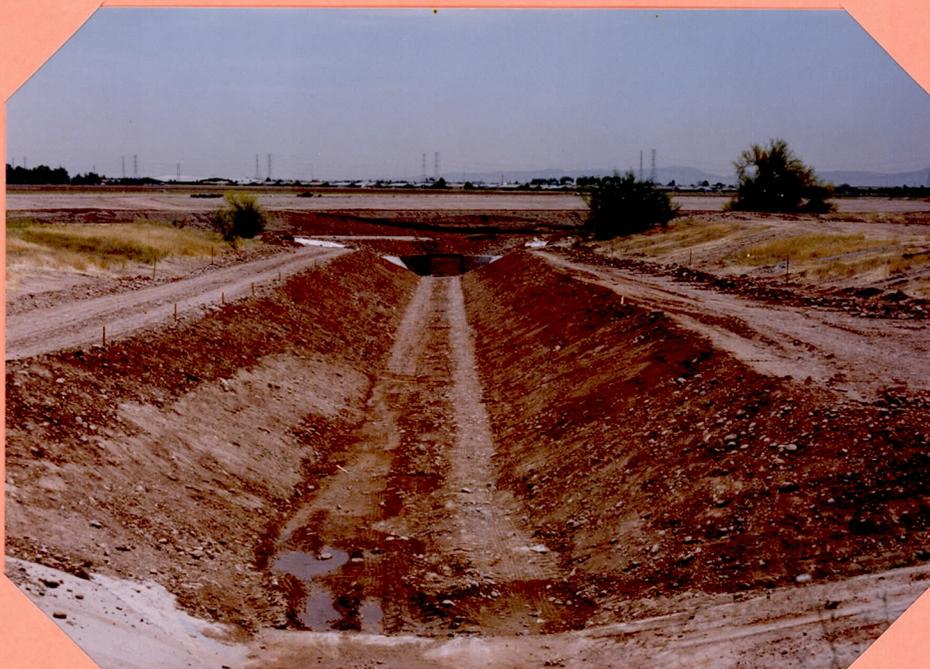
LOOKING EAST SHOWING THE SUN CITY CHANNEL BOX OUTLET
AND NEPDES WHICH WAS NOT EXPECTED

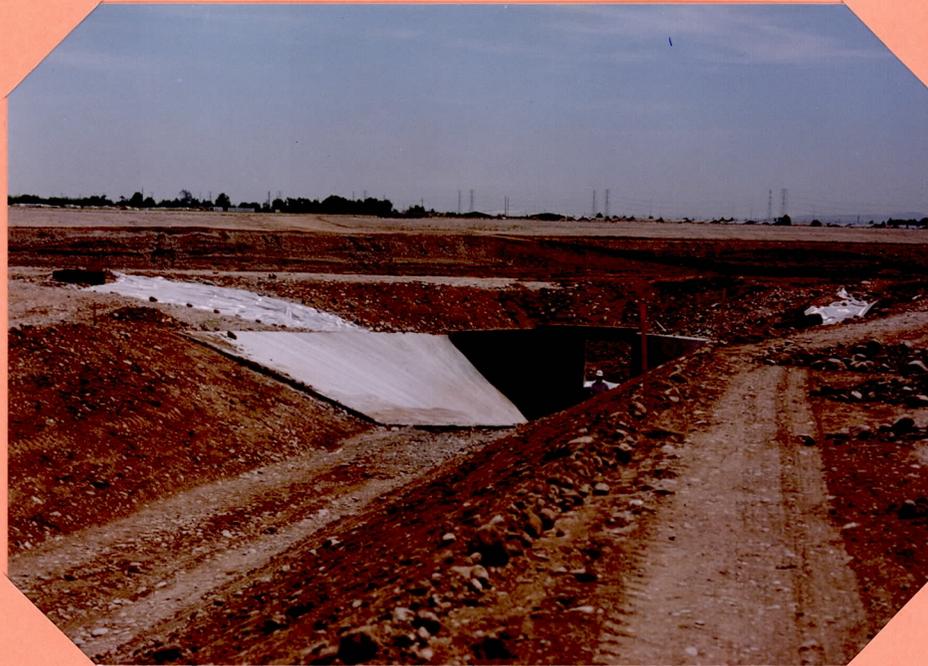
LOOKING NORTH SHOWING NEPDES WHICH WAS NOT EXPECTED

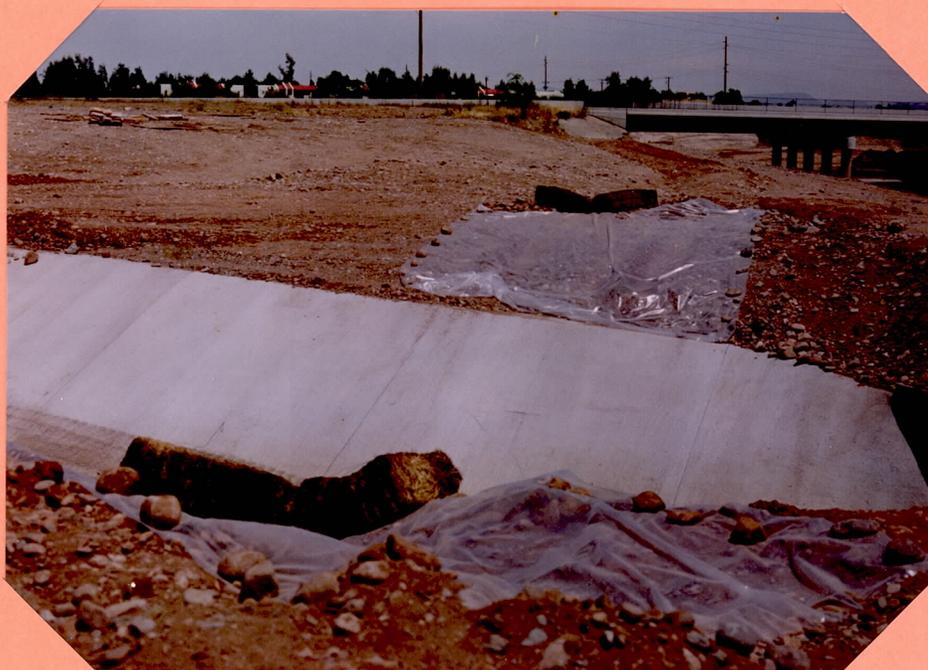
LOOKING SOUTH SHOWING NEPDES WHICH WAS NOT EXPECTED

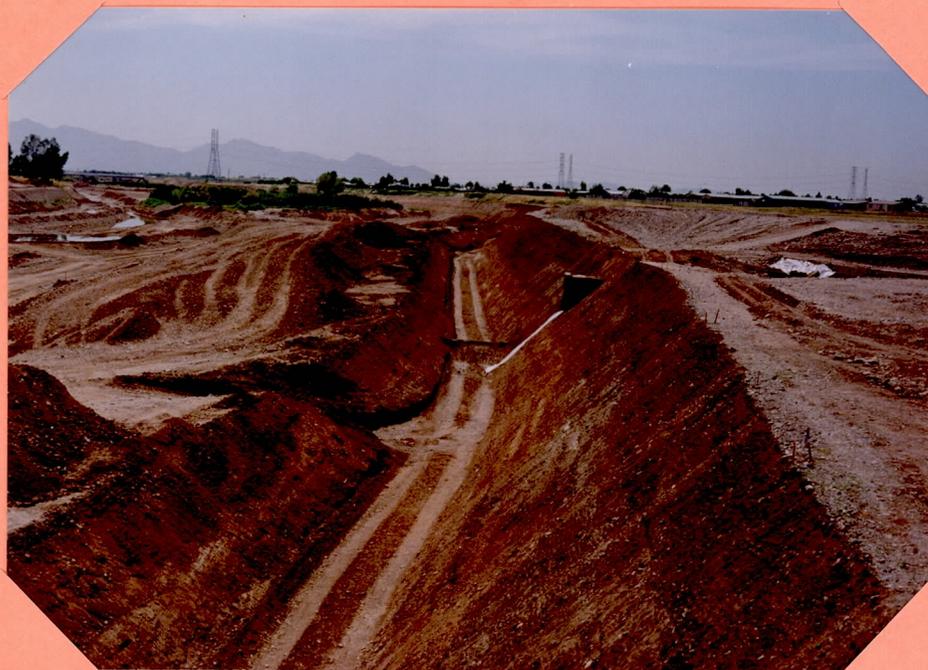
LOOKING EAST SHOWING THE SUN CITY CHANNEL BOX OUTLET
AND NEPDES WHICH WAS NOT EXPECTED

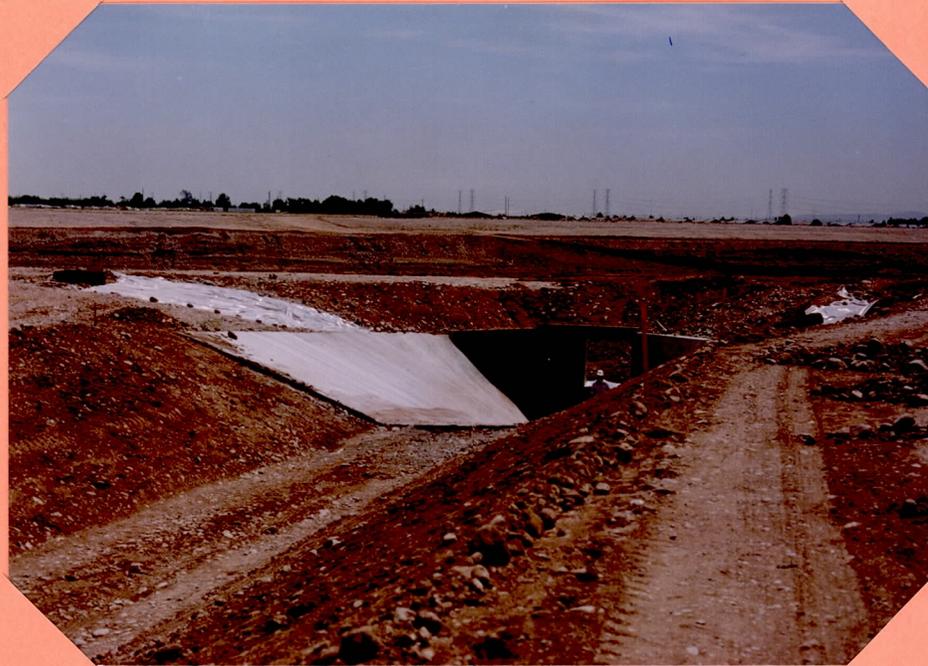
LOOKING NORTH SHOWING NEPDES WHICH WAS NOT EXPECTED
