1986

The Tucson, Arizona, Flood of October 1983

Committee on Natural Disasters
Commission on Engineering and Technical Systems
National Research Council

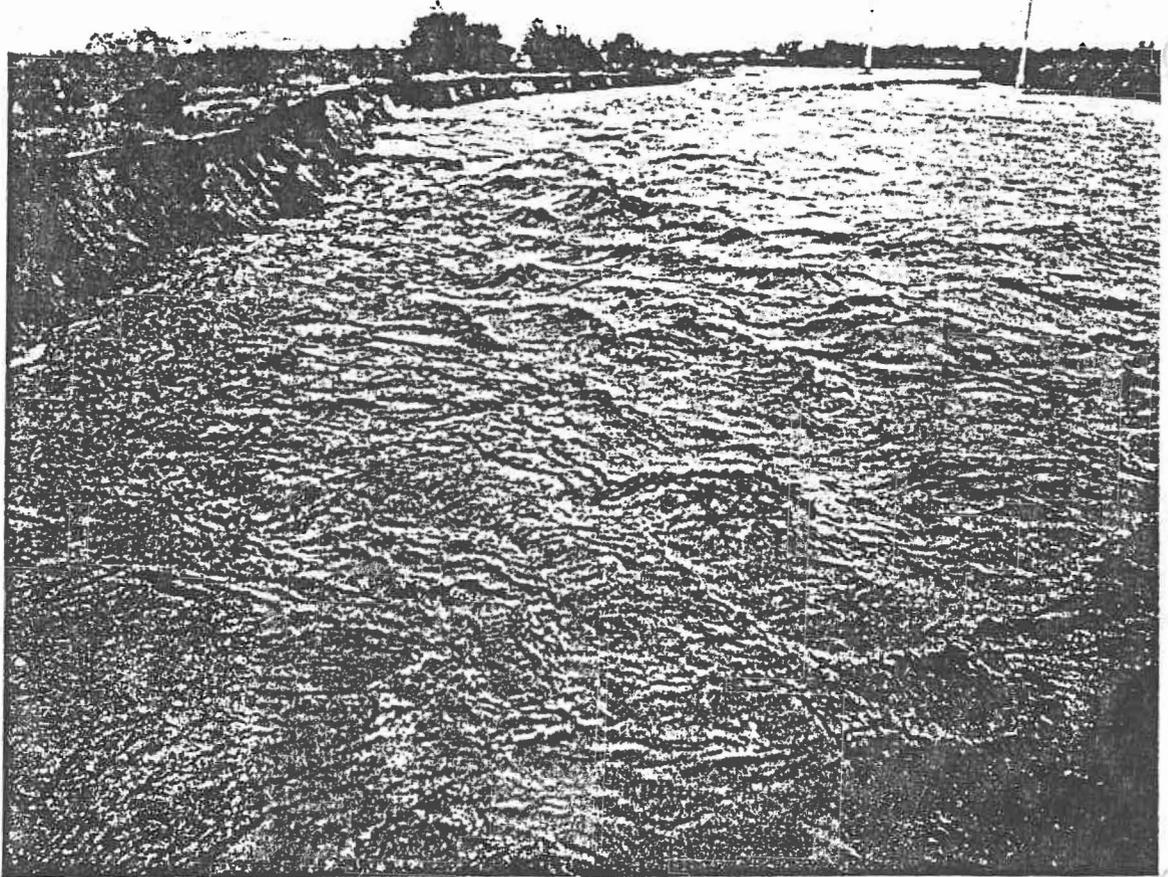
FIGURE 13 View upstream (east) from the Campbell Avenue bridge on October 1, 1983, showing erosion of the north (left) bank by meander flow. Note the dark thread of high-velocity water following the meander thalweg from the next bend upstream. Also note the utility lines in the stream channel. Photograph by Peter Kresan.

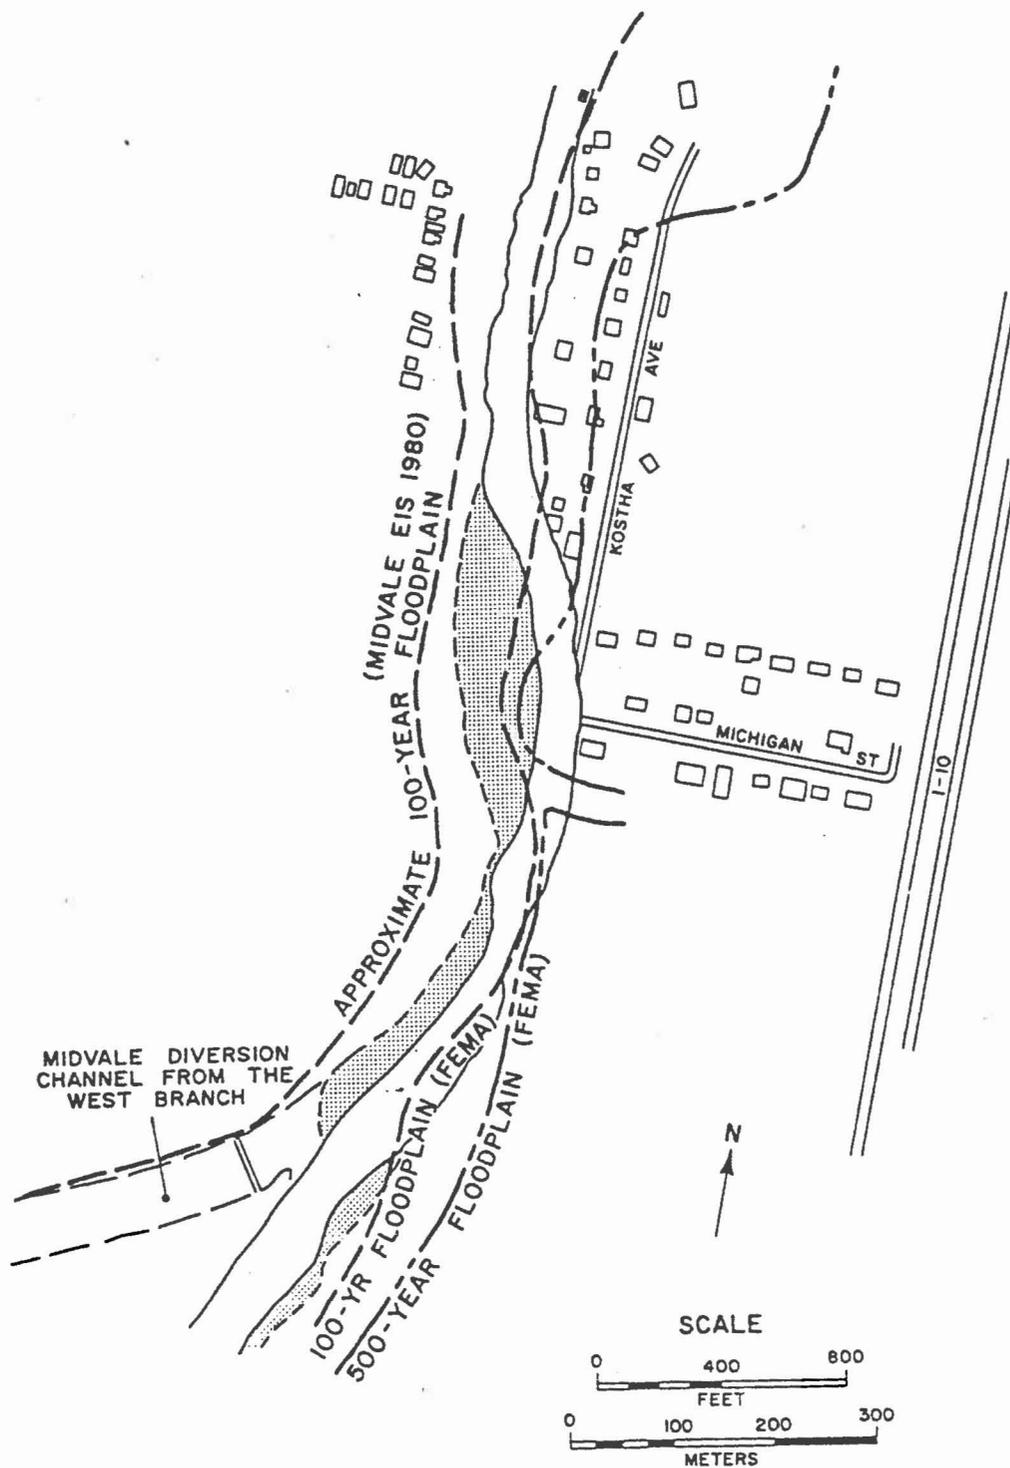
FIGURE 18 Map showing channel migration of the Santa Cruz River from within the 100-year floodplain designated by FEMA in 1982 eastward into areas not designated as hazardous from flooding. Several houses were destroyed near the junction of Kostha Avenue and Michigan Street. The stippled areas are point bars that developed in the October 1983 flood.

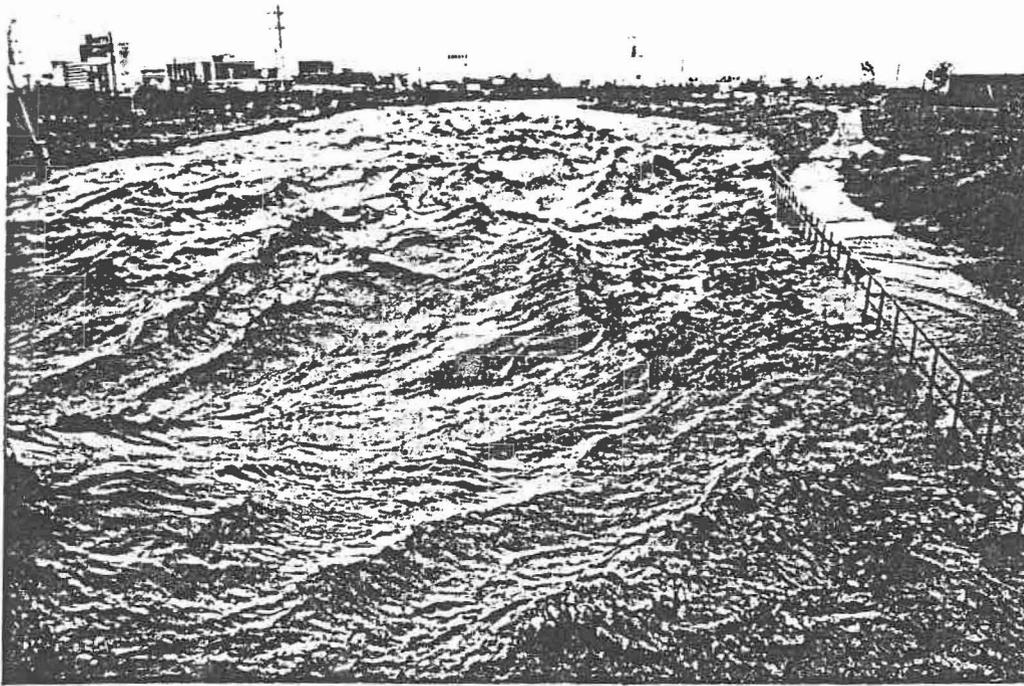
FIGURE 19A View of Santa Cruz River upstream (south) from St. Mary's Road bridge on October 2, 1983. Note confinement of flow within artificial banks composed of soil cement. Photograph by Peter Kresan.

FIGURE 19B View from approximately the same position in late October 1983. Note incision at base of soil-cement slope and meandering thalweg of low-flow channel that developed during waning flow. Photograph by Peter Kresan.

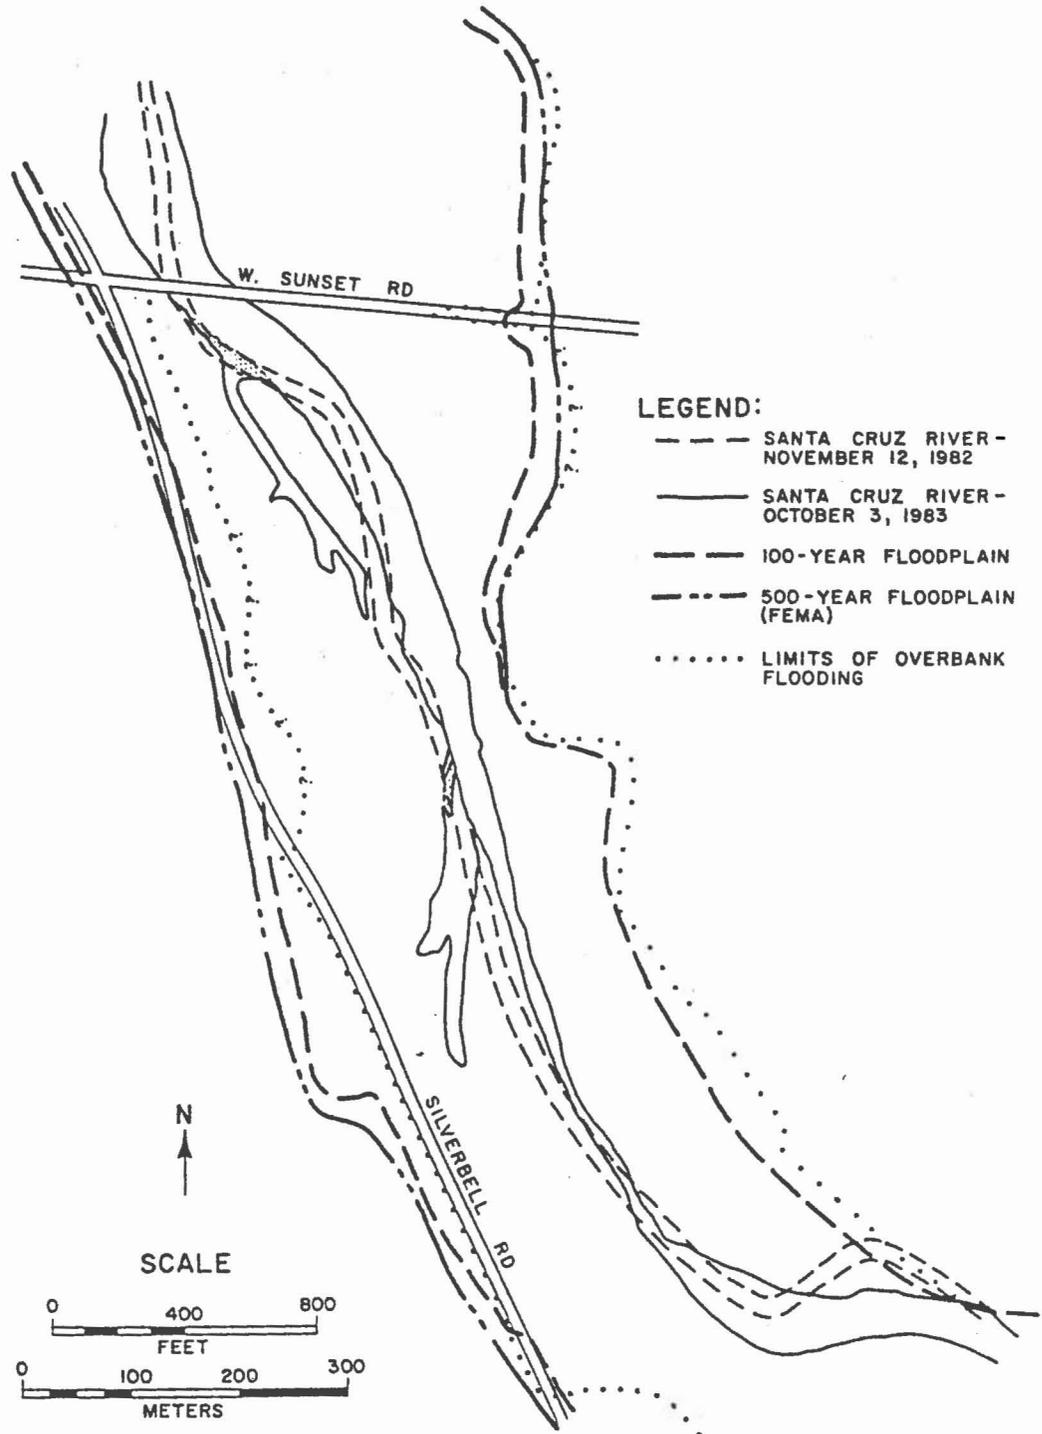
FIGURE 20 Map showing channel changes and FEMA floodplain designations along the Santa Cruz River near West Sunset Road.

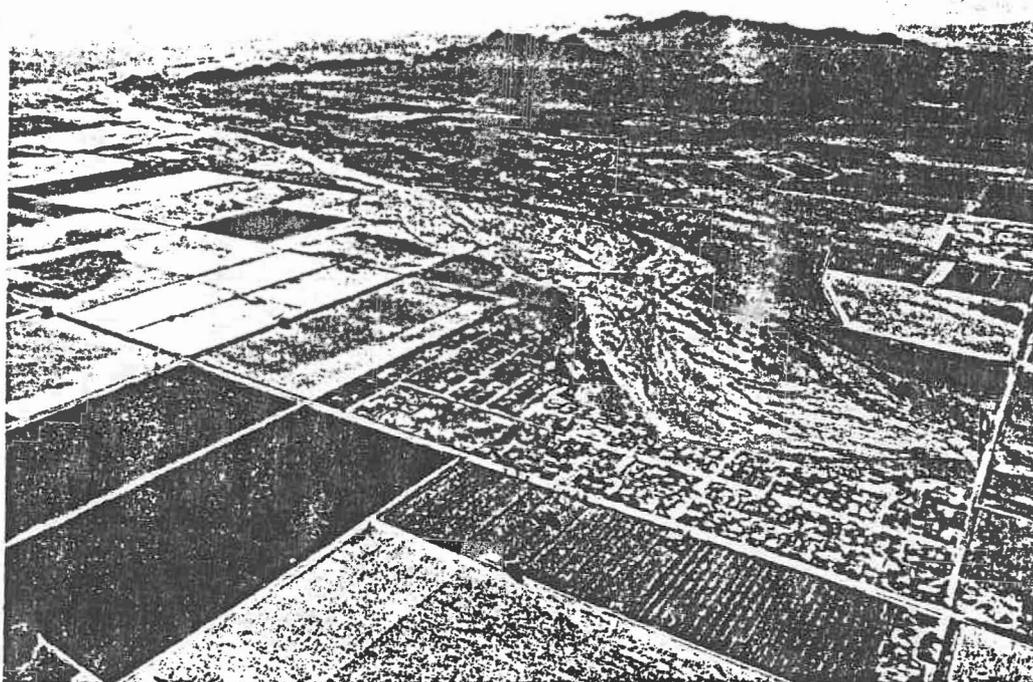
FIGURE 23 View of Marana (center) looking south toward the Tucson Mountains on October 9, 1983. Floodflows in this area spread over extensive agricultural land and caused considerable damage. The prominent meander bend at Marana experienced severe erosion during the prolonged winter flood of 1978. In contrast, the much larger 1983 flood peak resulted in relatively little erosion on this bend. Photograph by Peter Kresan.
