FLOODING - APACHE WASH AUGUST 28, 1988

FLOOD CONTROL DISTRICT OF MARICOPA COUNTY
Interoffice Memorandum

Subject: Flooding Problem of Aug. 28, 1988

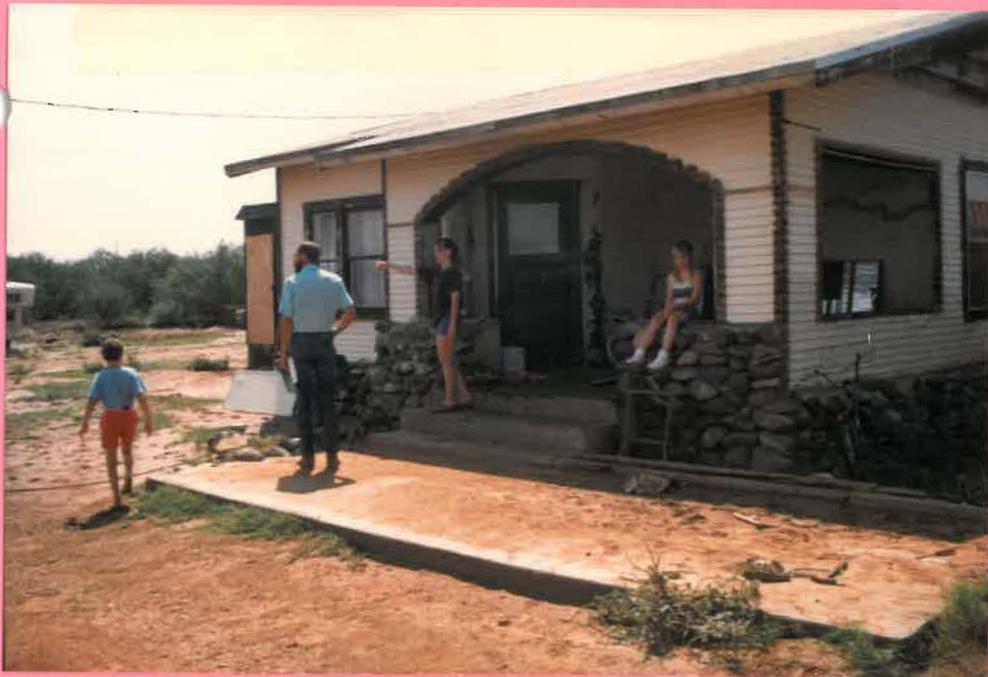
The house they live in is about 8-12 inches above grade and that may have saved their house from being flooded. The yard, garage, automobile and fence however received some damage. Water did reach the second step of the porch. She blames an abandoned stock tank that is located just down stream of her property to have caused the water to back up into their property. She didn't recall when the rain had started. The debris along the fence on the west property line were 4-6.inches high (see figures 1a-1d).

1a. Looking south east at the residence from Galvin Ave.

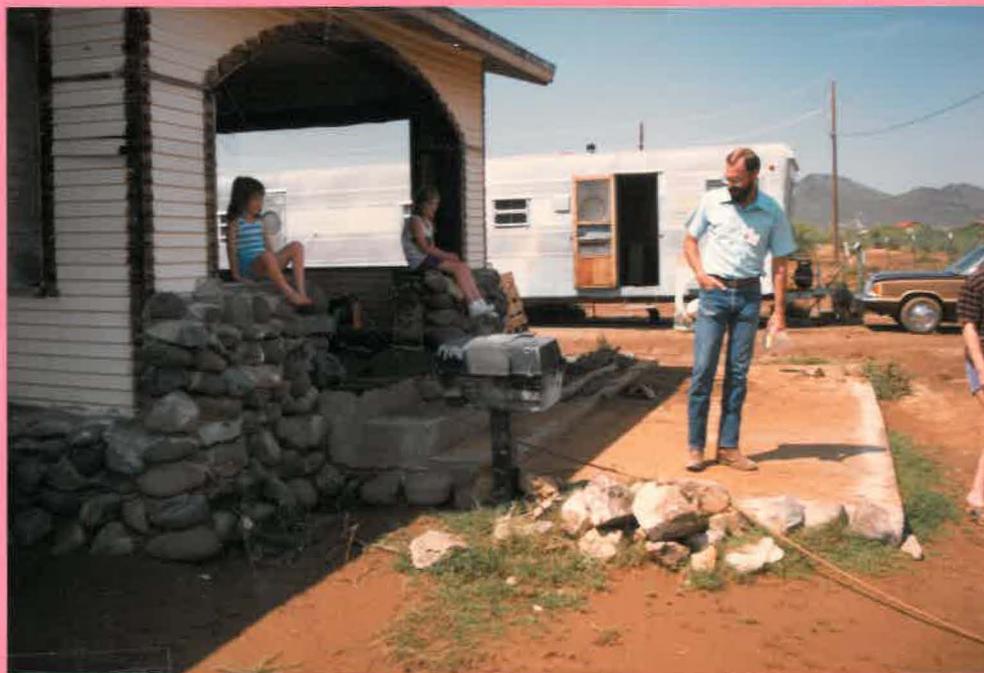
1b. Another view, water topped the second step of the house.

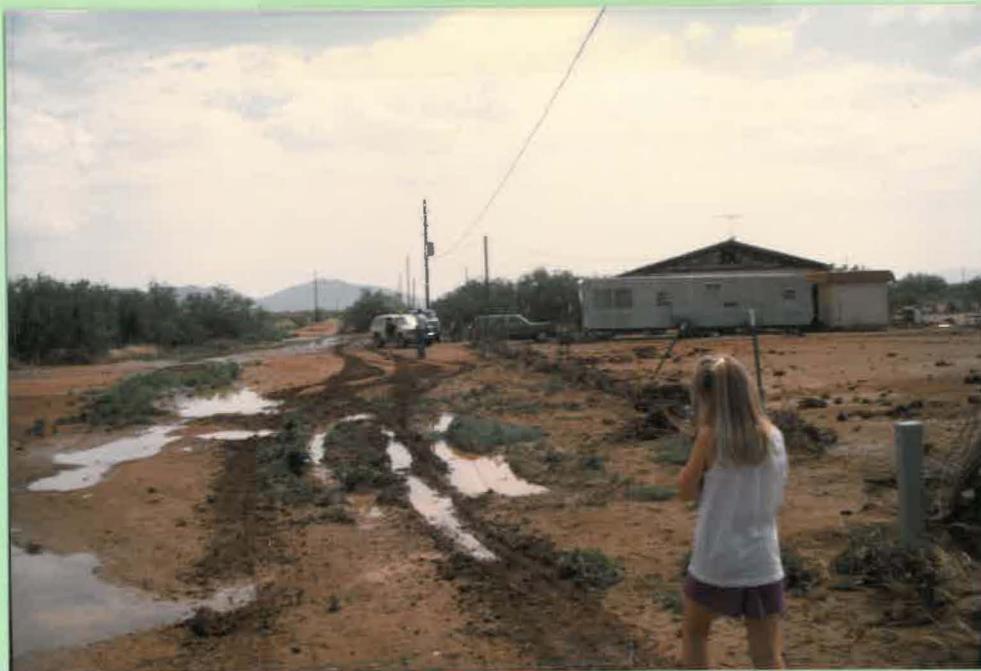
1c. Looking EAST along Galvin, from the properties north west corner.

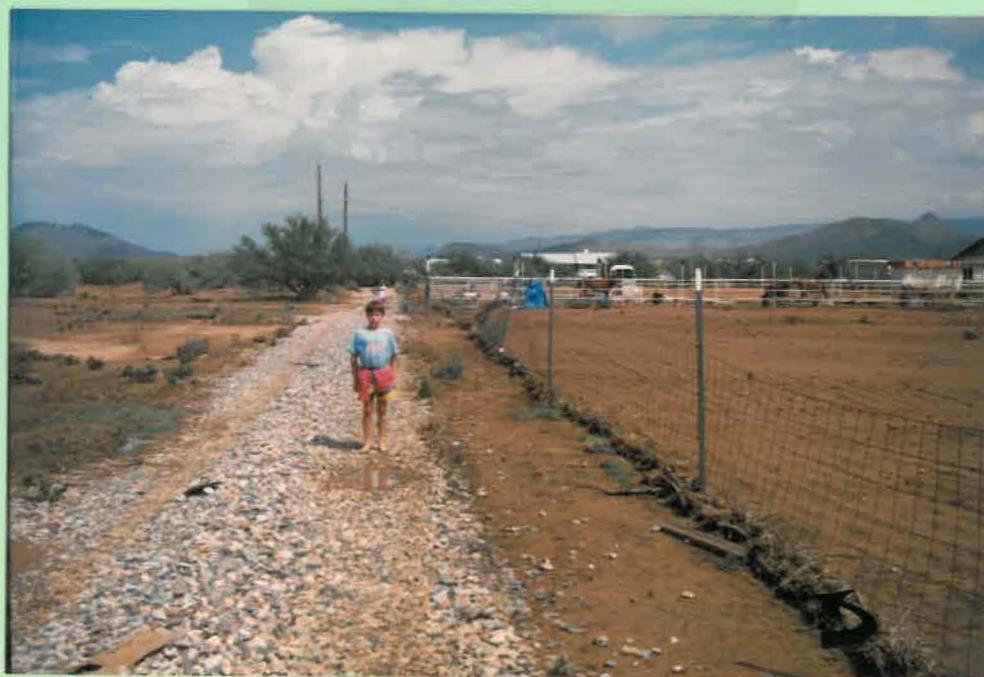
1d. Looking north along properties west boundary. Note the debris on fence.

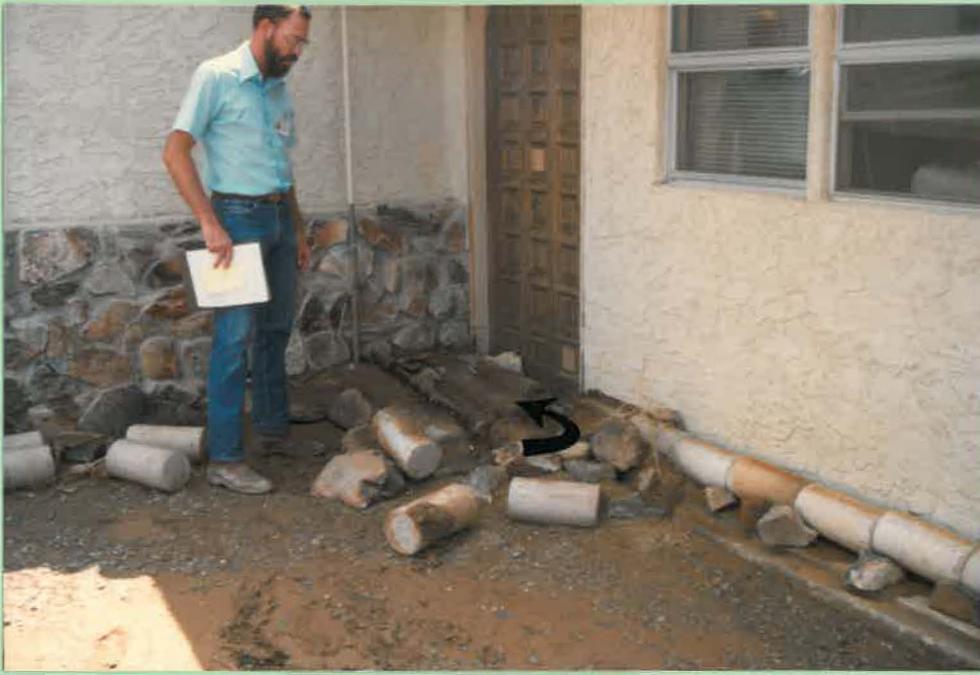
She and her husband arrived home last night to find the 3rd street crossing of the wash impassable. They had to wait till about 1 a.m. to get in their house and found their bedroom to be flooded. There were high water marks and debris on the north entrance of the building. She blamed County Highway for the flooding. She indicated that the culverts installed by the Highway department are inadequate to handle the water in the wash and that they have filled the Wash in after they installed the culverts (see figures 2b-2i).

2a. Looking on the north entrance to the residence, note the mud.

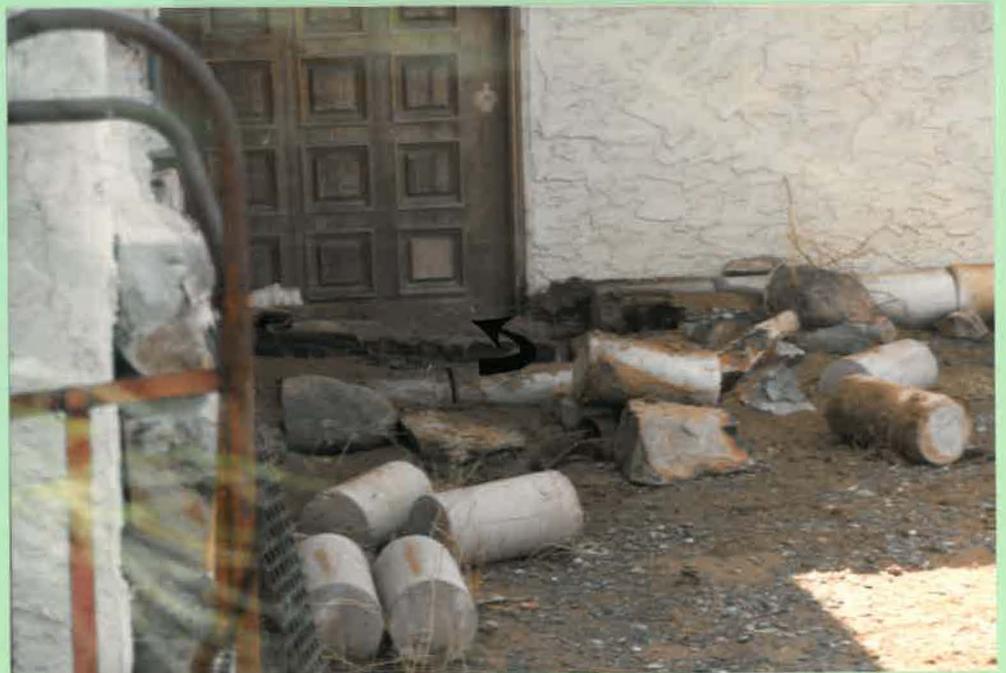
2b. Looking at the north entrance.

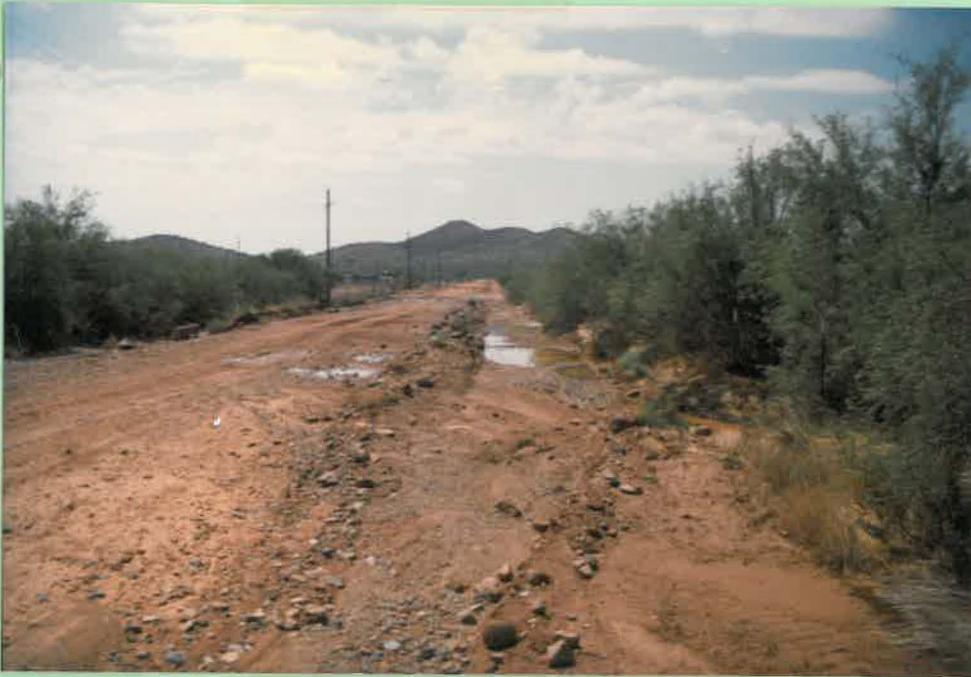
2c. Looking south along 3rd Street at the wash crossing.

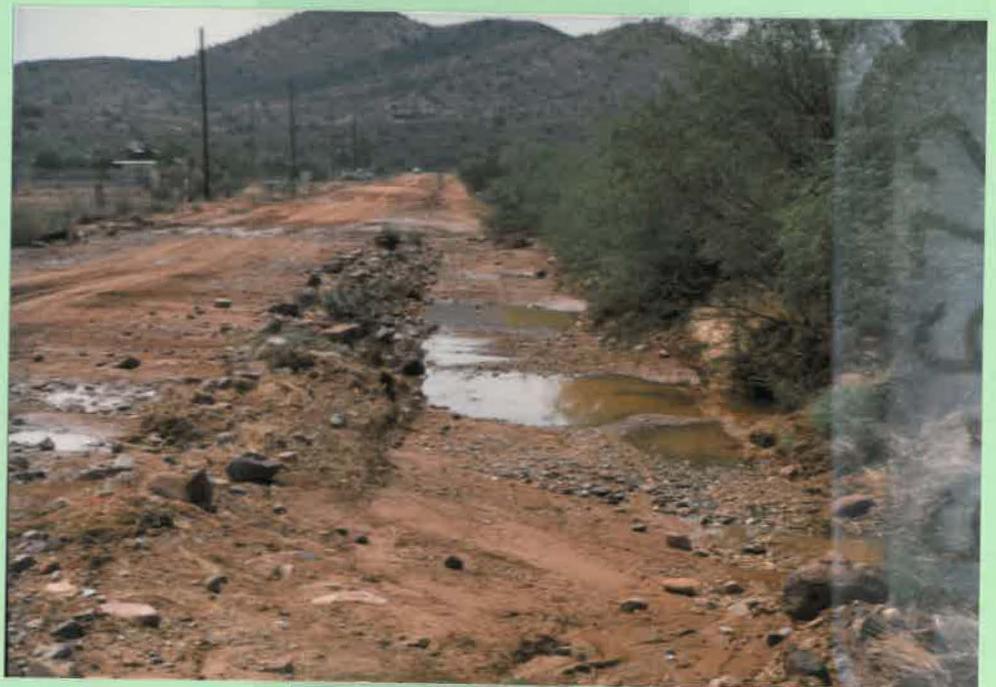
2d. same as 2c.

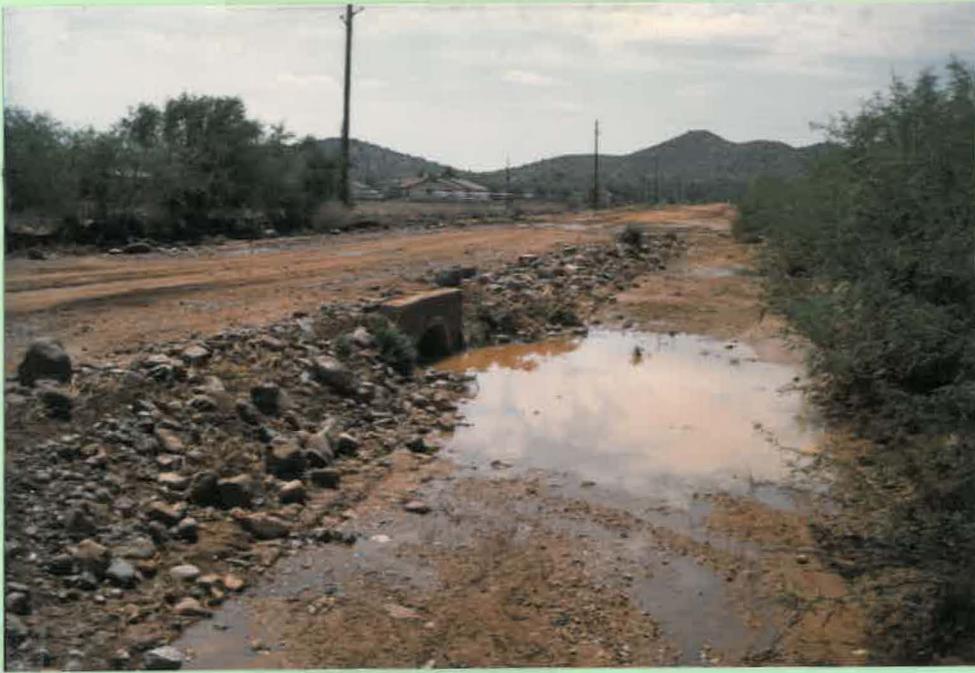
2e. Culvert installed by County Hwy where the wash crosses 3rd Street south of Galvin.

The stock tank (pond) does not appear to be the cause of the flooding in either of the properties as originally suggested by Mrs. Kritchfield. The culverts installed by County Highway under 3rd Street appear to be under designed and could have caused some back water and ponding. With all the new development that is being placed on the upstream end of the washes and the subsequent increase in the runoff, it is hard to blame the culverts as the only source of the flooding in the area.

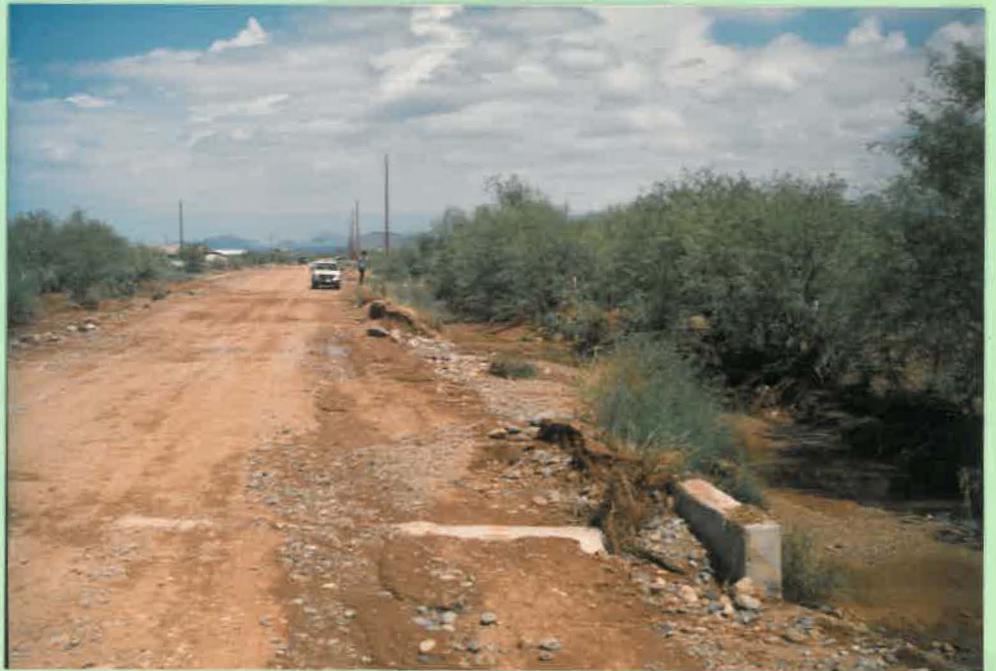
2f. Looking north along 3rd street where the wash crosses south of Galvin.

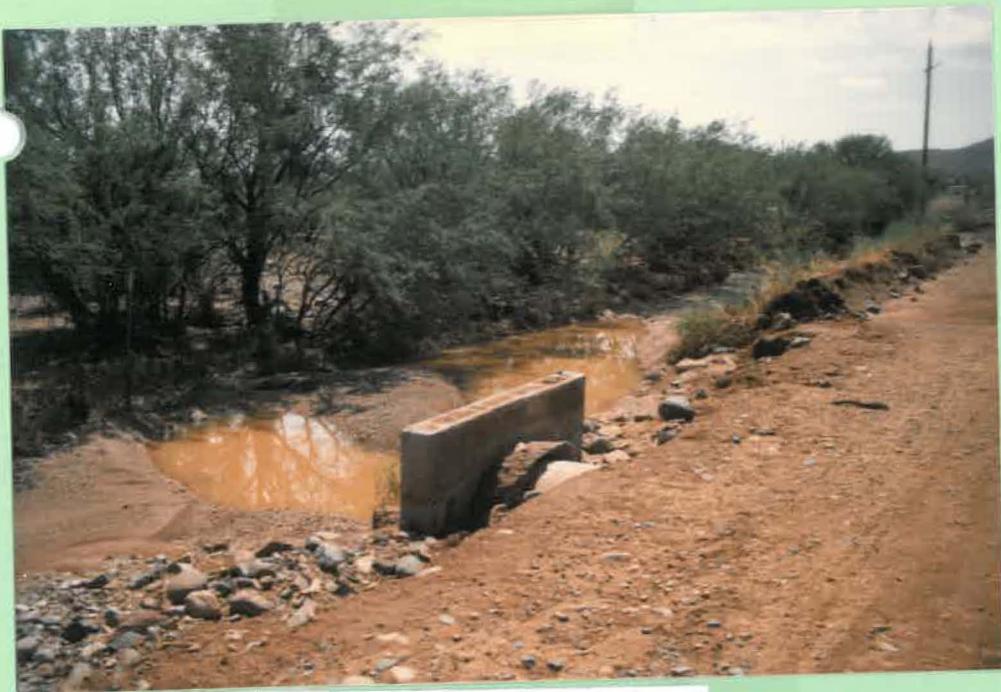
2g. South east along 3rd Street.

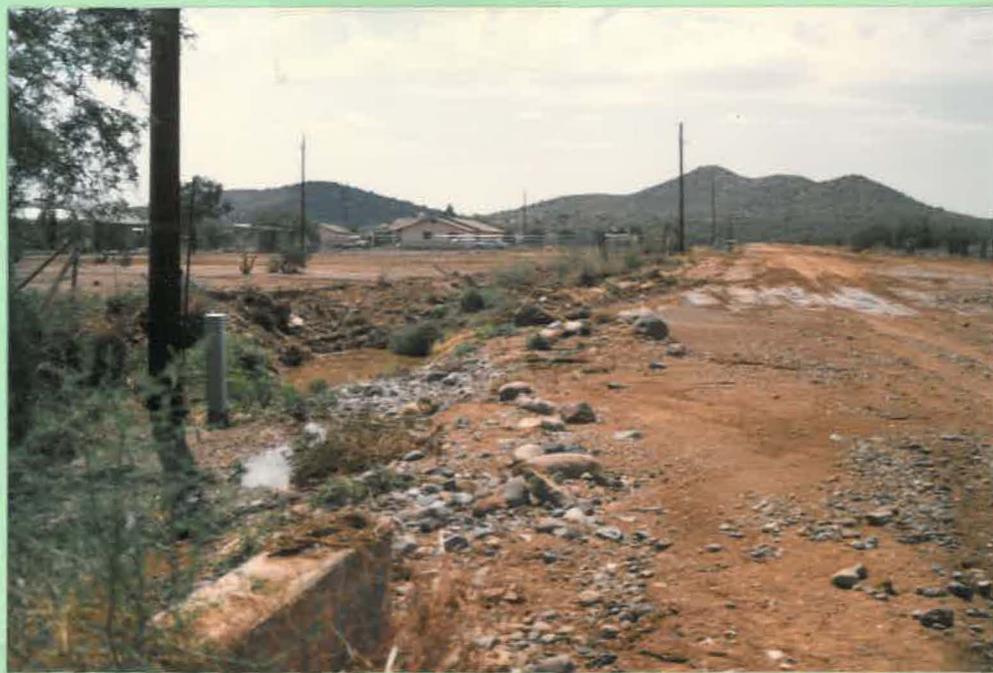
2h. South east along 3rd Street. Note debris on fence.

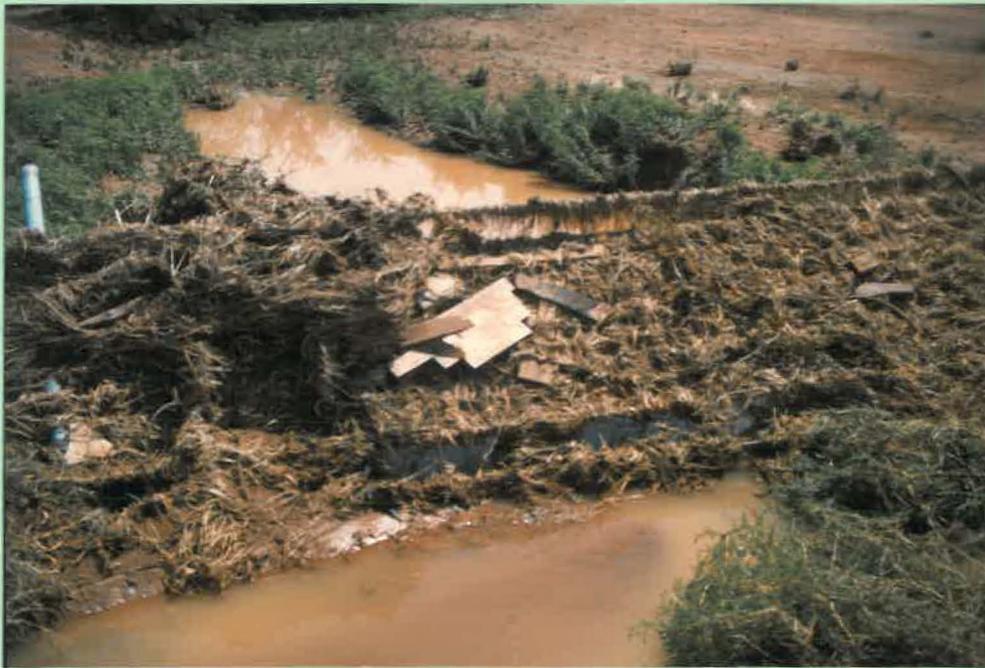
2i. Debris cut on fence traversing the wash, just to the east of 3rd Street.

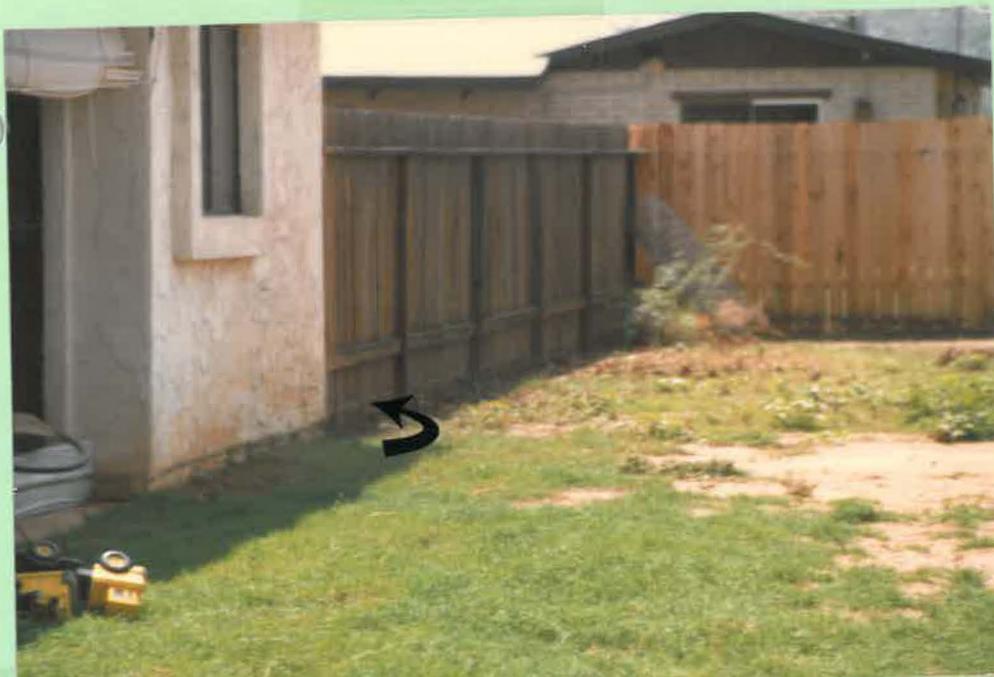
Water damage inside and outside of the house. Her husband indicated that it started raining after 8 p.m. and he decided to take drastic actions by 10 or 10:30 p.m. Water had entered the porch on the west side of the house and had backed up high enough to enter the house through the back door (see figures 3a-3i).

3a. Back yard (west side) of the residence where the water ponded.

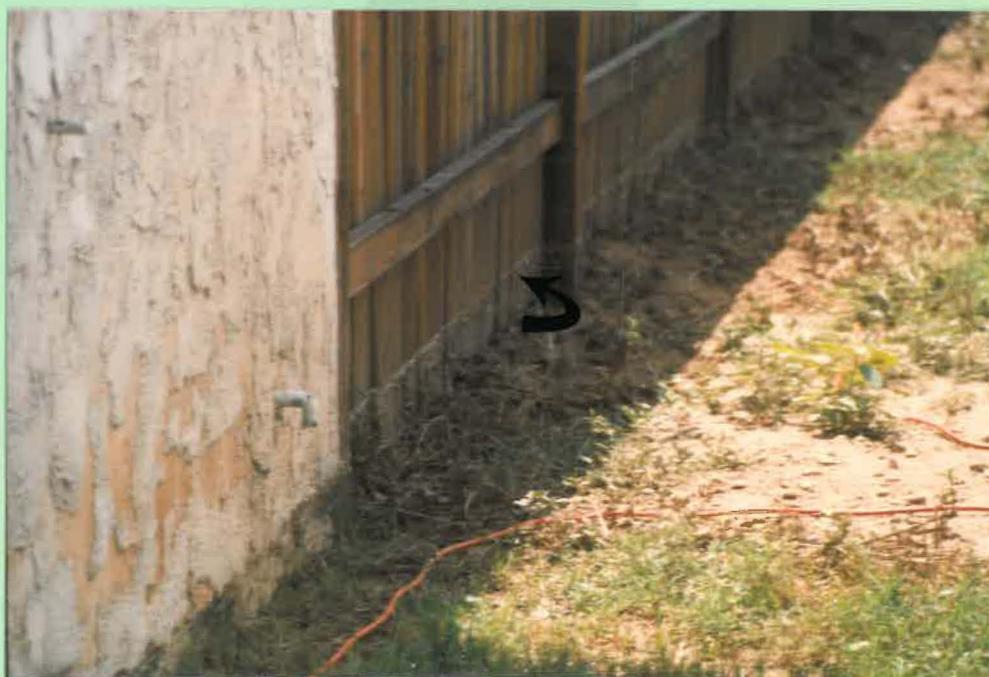
3b. High water mark on the fence.

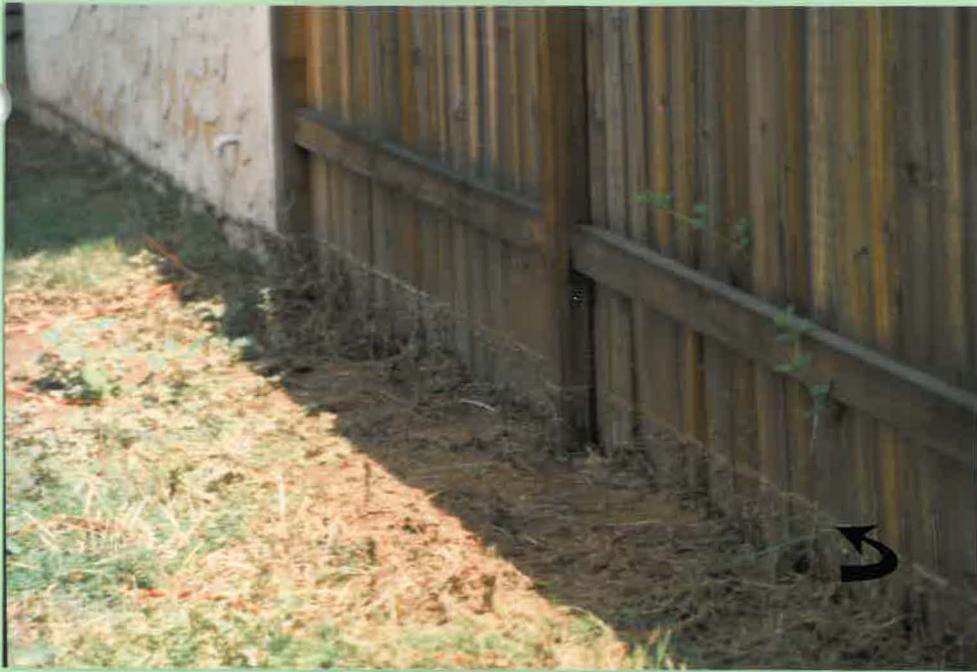
3c. same as 3b.

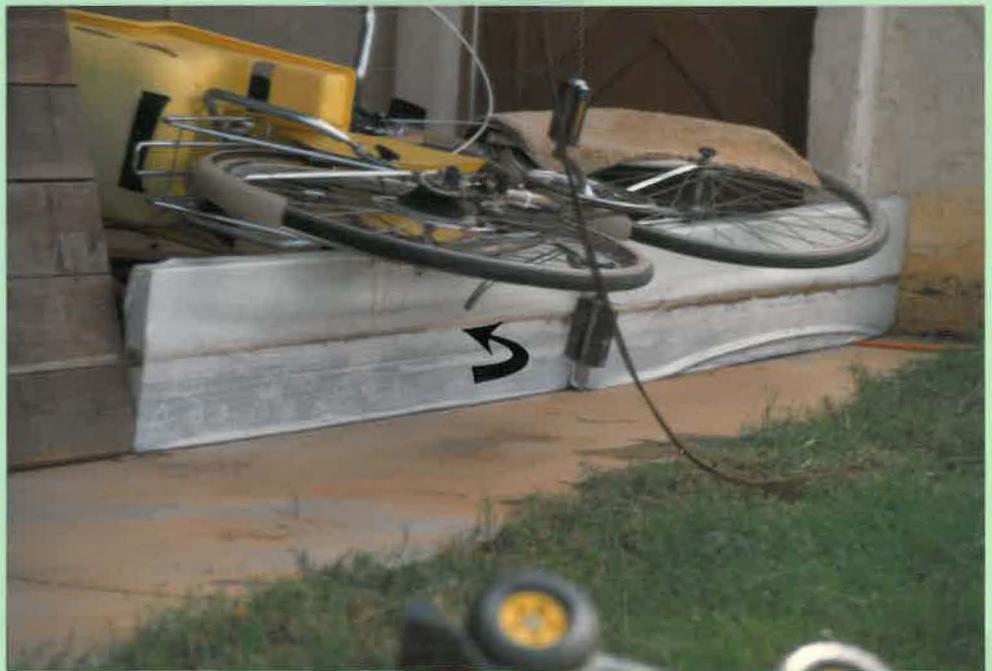
3d. efforts to hold the water out of the porch, also shows high water mark.

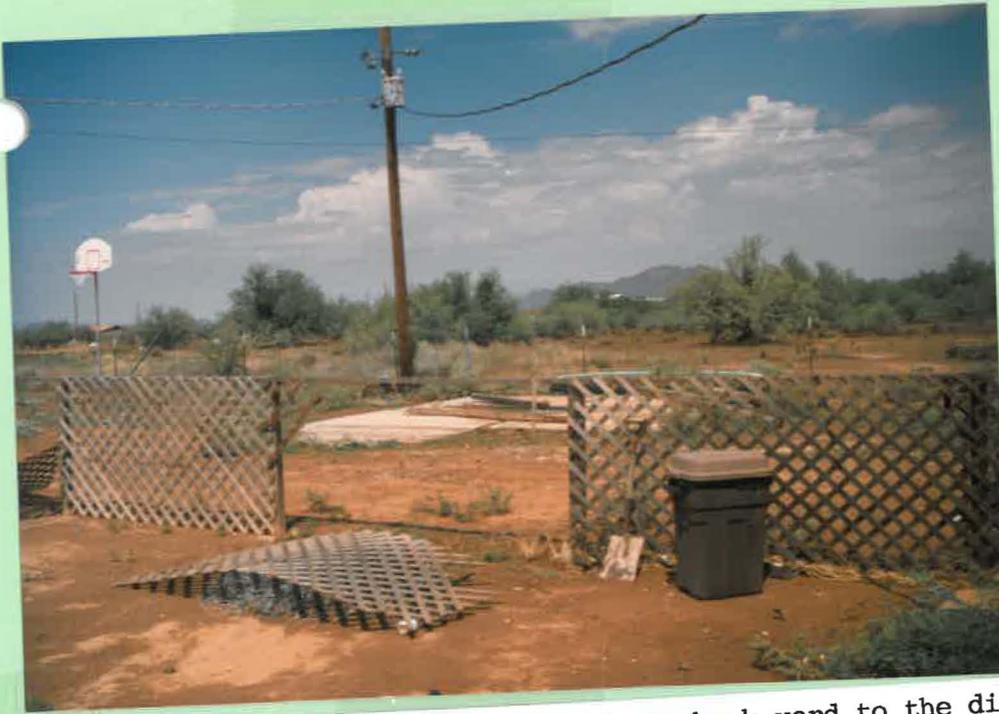
3e. Looking north west from the residents back yard to the direction of the wash (trees)

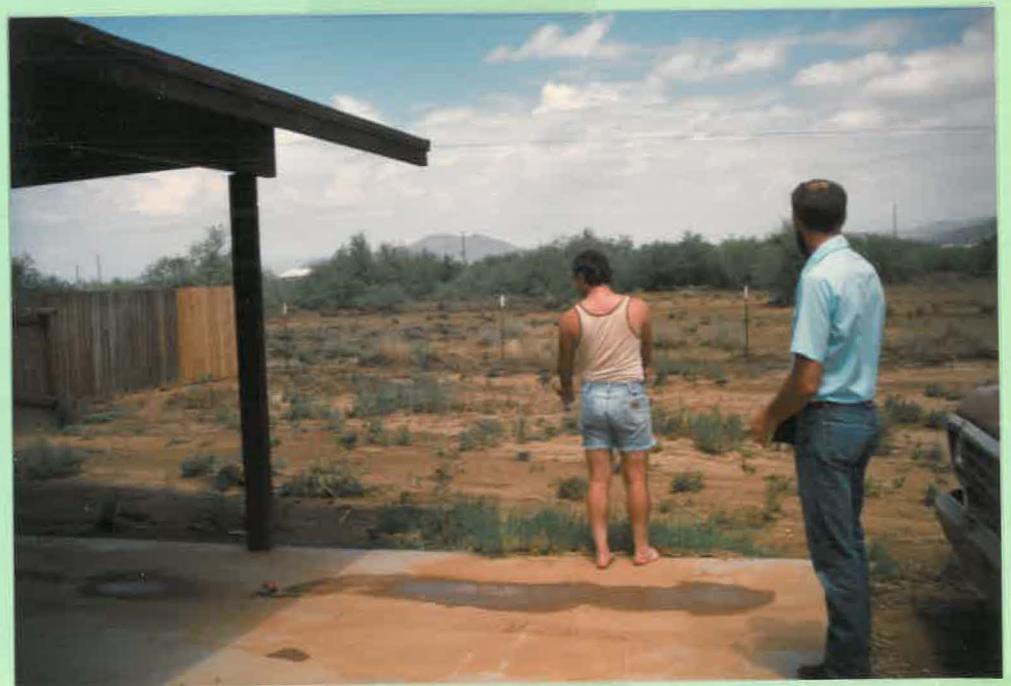
3f. Residents car port on the east side of the residence. Most of the water flowed through the gate connecting the carport and the back porch.

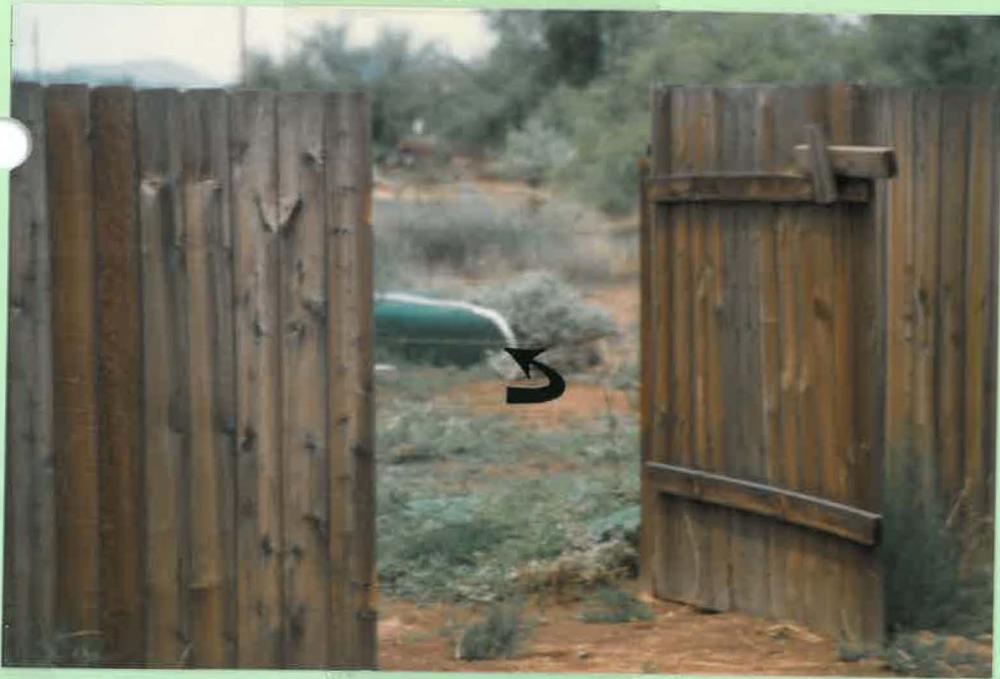
3g. gate along the east fence where a lot of the flow went through

Note the high water mark on the boat.

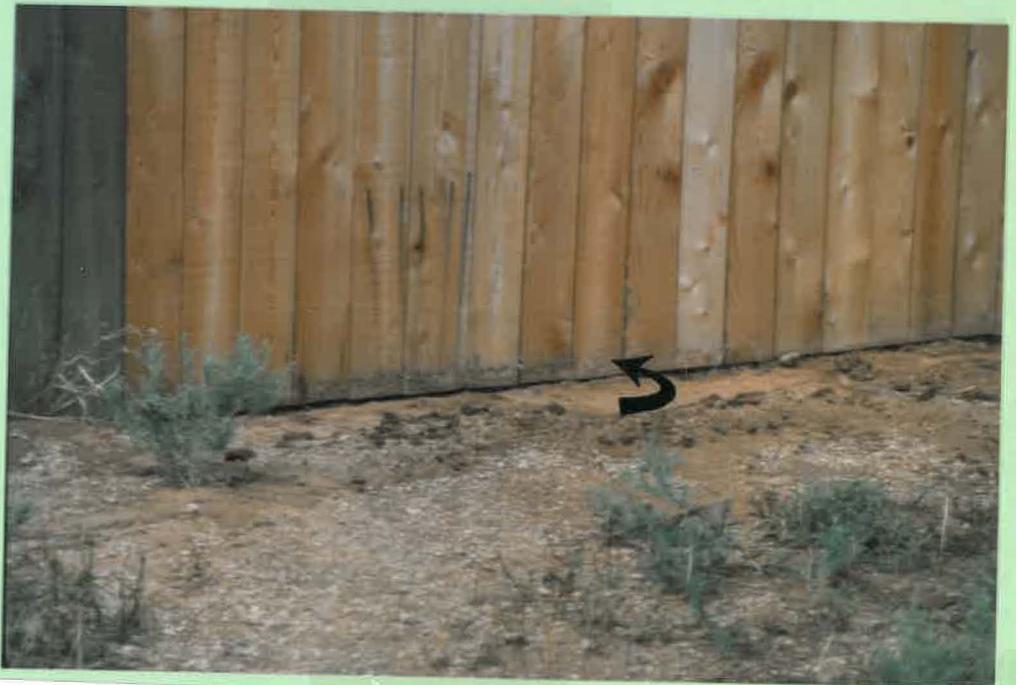
3h. Water seeping from under the fence along the east side fence.

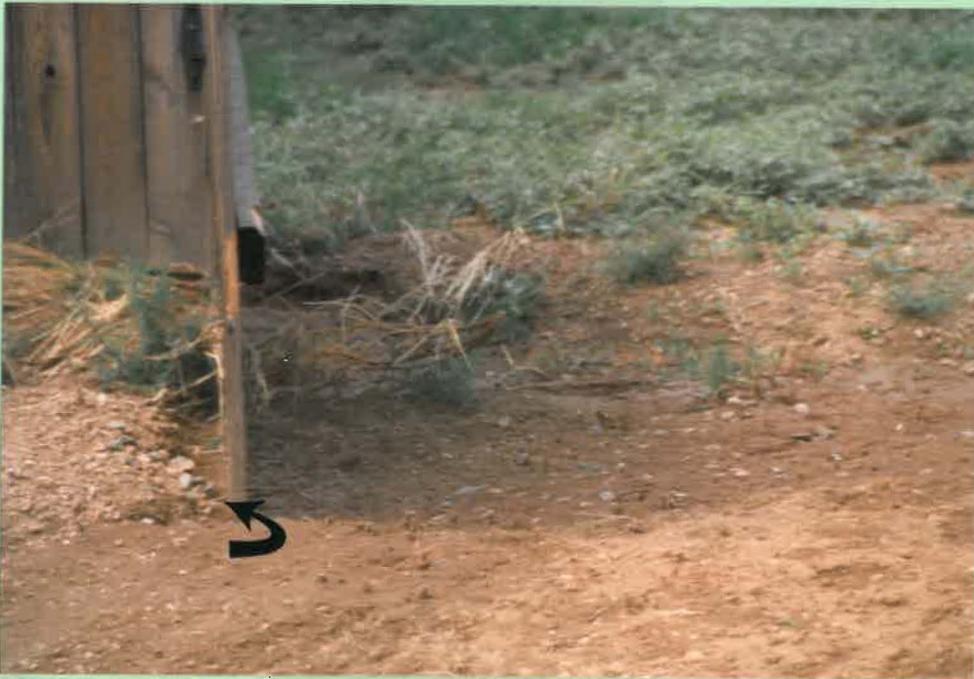
3i. water forcing itself through the fence and under the gate.

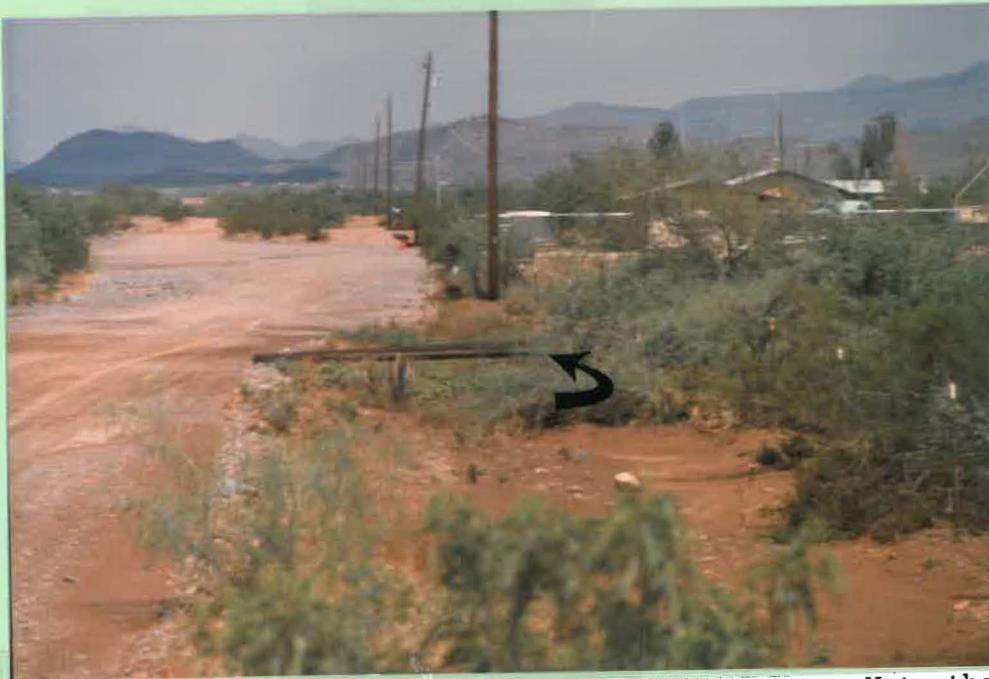
Some high water marks we noticed in that area. Water did not appear to have over topped the Highway.

4a. Looking north along 10th Street from Carefree Hwy. Note the high water mark.

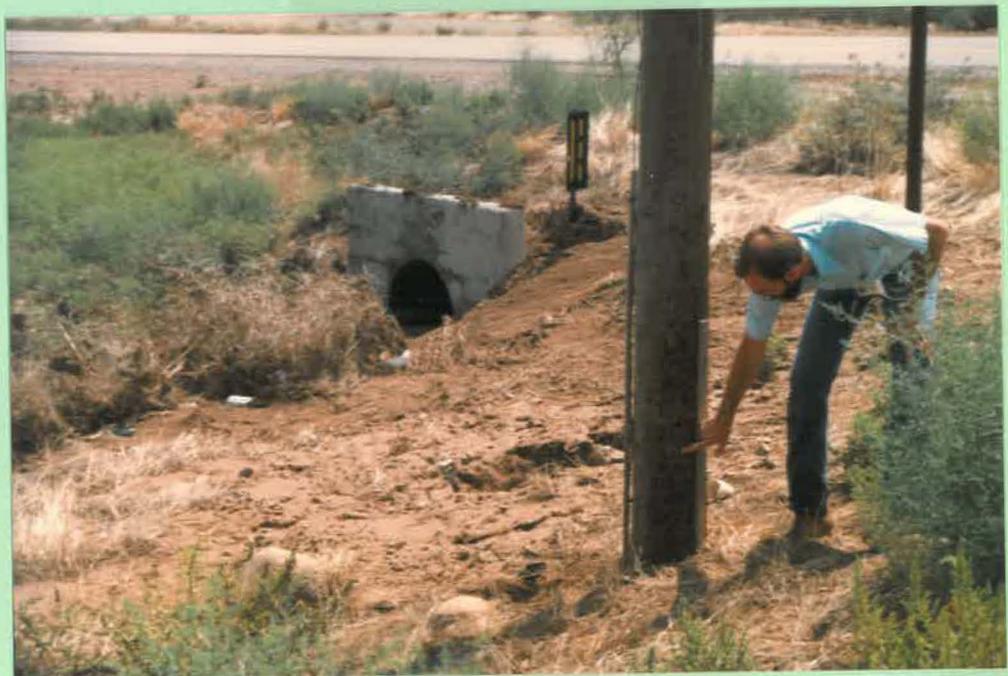
4b. Water ponding behind the culvert on north east corner of Carefree and 10th Street.

The low grade of 12th Street allows the flood waters from the wash to the west of the street to cross it to the east, however the culvert on the north east corner of the intersection is not capable of handling this additional flow and therefore it will pond behind it (see exhibit 1).

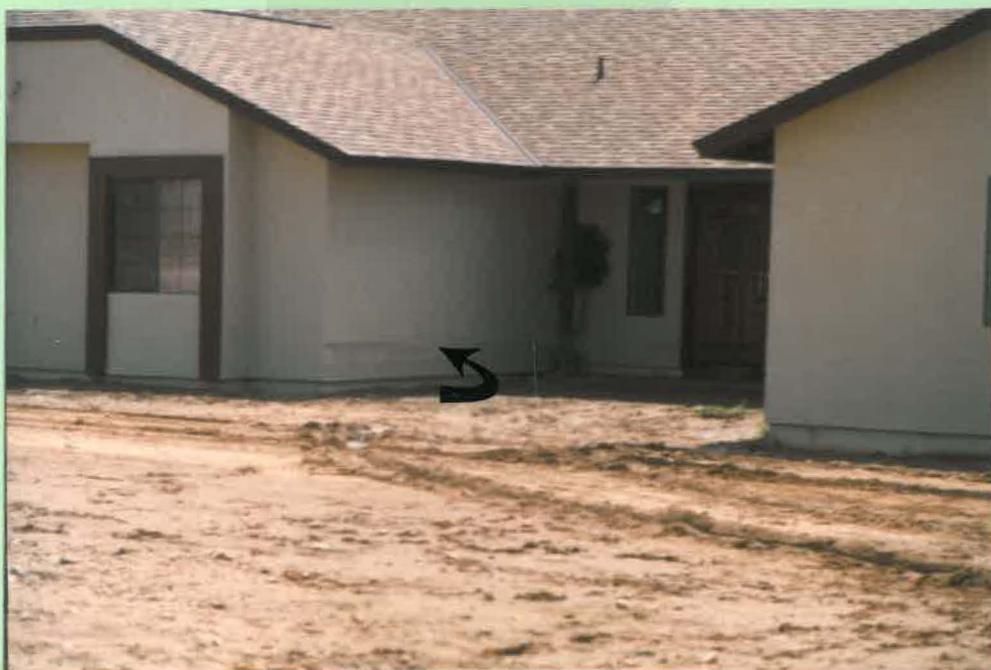
Extensive water damage inside and outside the house. Water up to 2 feet high on the perimeter of the house. The house is located in a swale adjacent to the wash and a fence chain link fence crosses the wash to the west of the residence. The flood had picked up the hot tub belonging to the neighbors to the north and had brought it over to their yard (see figures 5a-5j).

5a. High water mark on the north entrance to the resident.

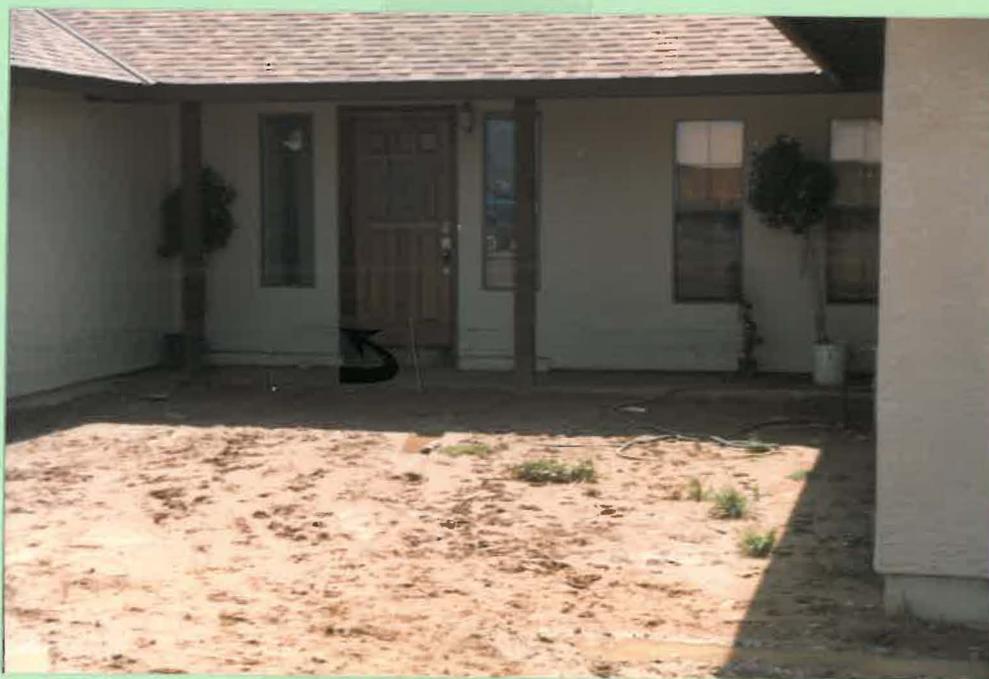
5b. same as above.

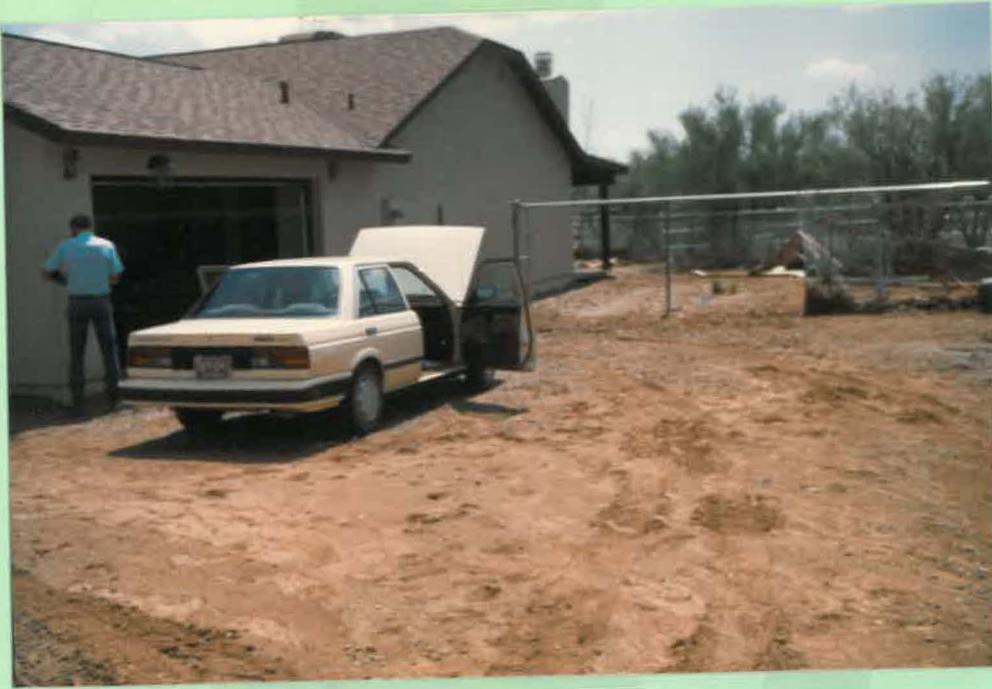
5c. east side of the resident.

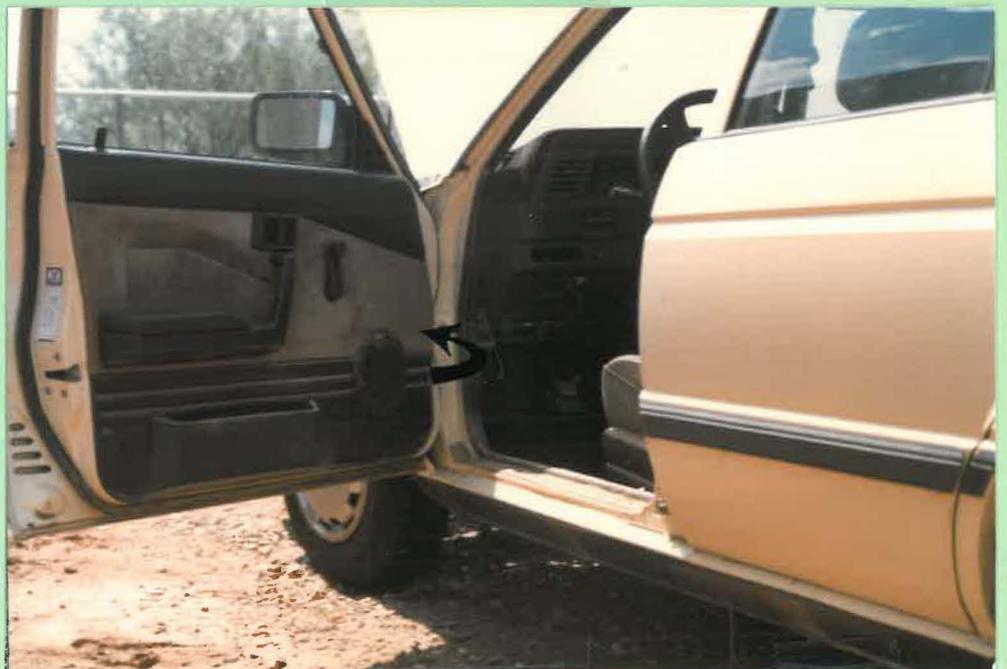
5d. High water mark inside the automobile.

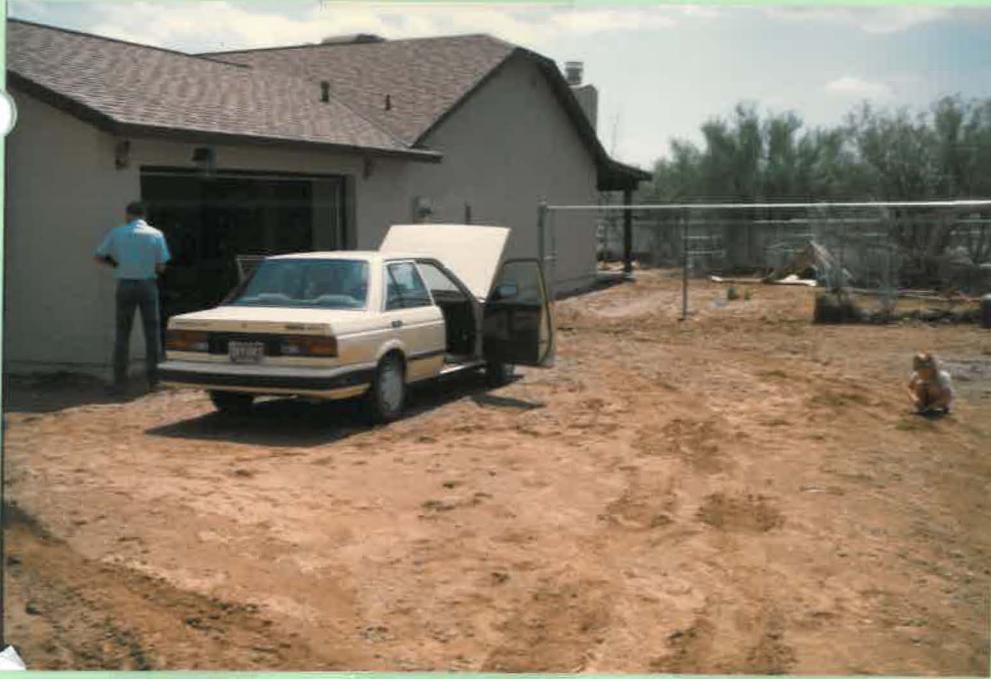
5e. East yard of the residence.

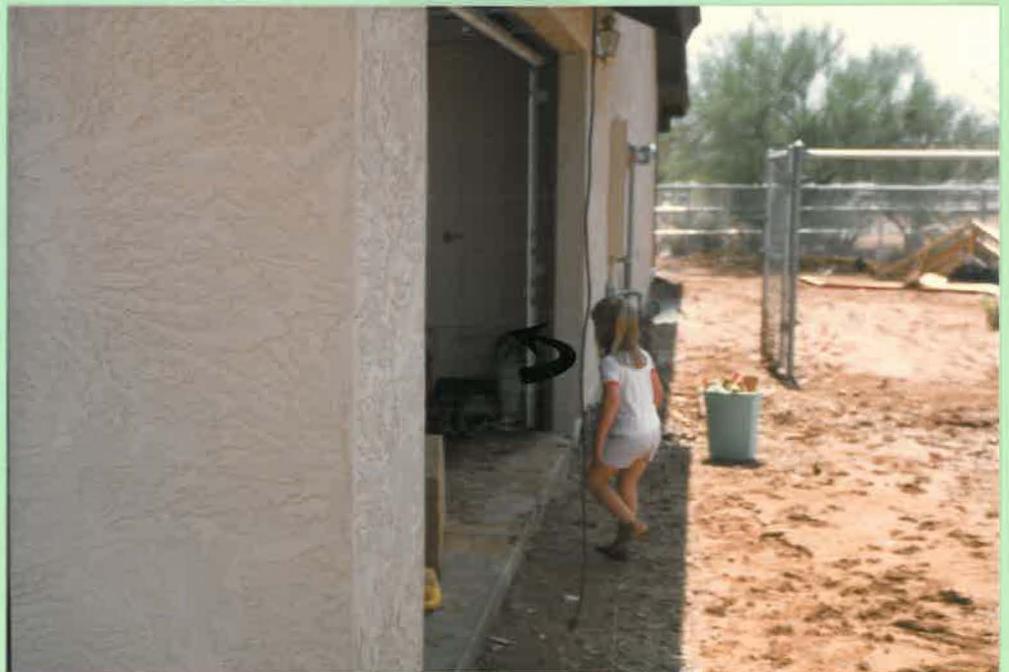
5f. High water mark inside the garage.

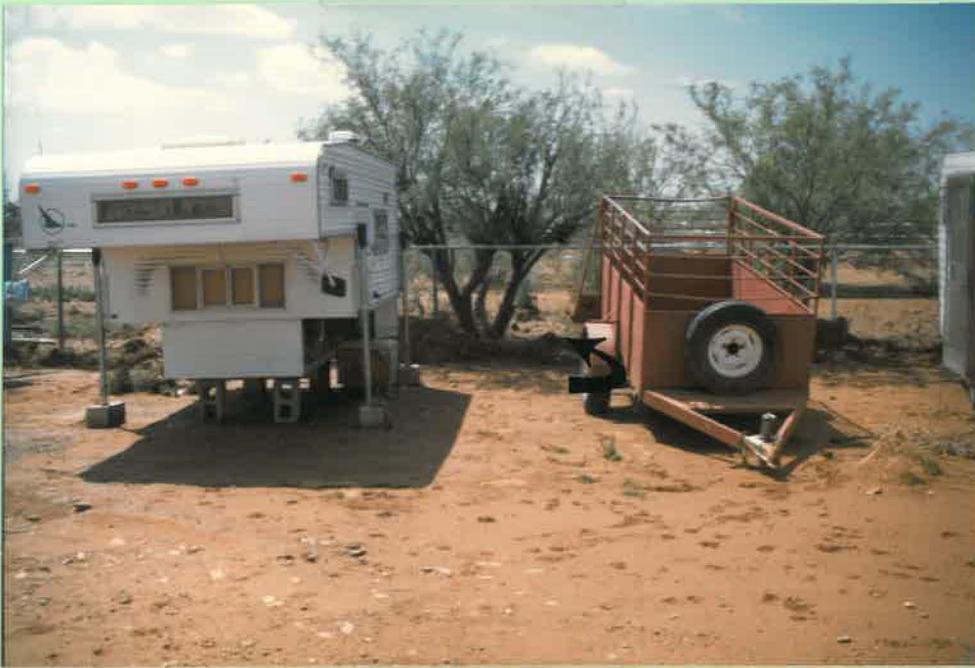
5g. high water mark along the fence that borders the east yard.

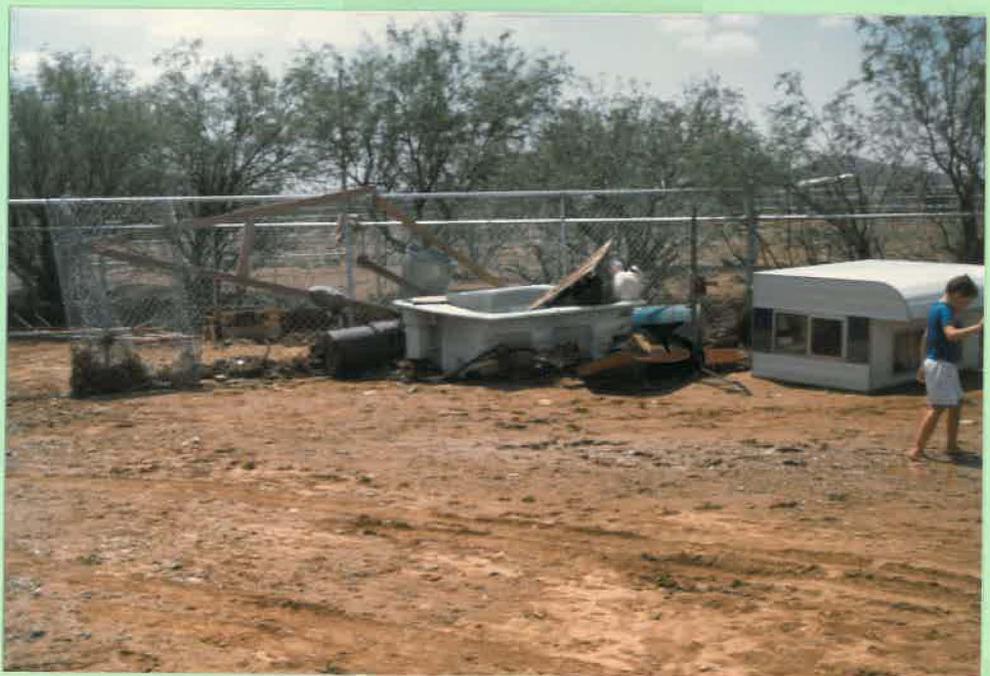
5h. Hot tub brought over by the flood belongs to the neighbors to the north.
