FLOODING - APACHE WASH AUGUST 28, 1988

FLOOD CONTROL DISTRICT OF MARICOPA COUNTY
Interoffice Memorandum

Subject: Flooding Problem of Aug. 28, 1988

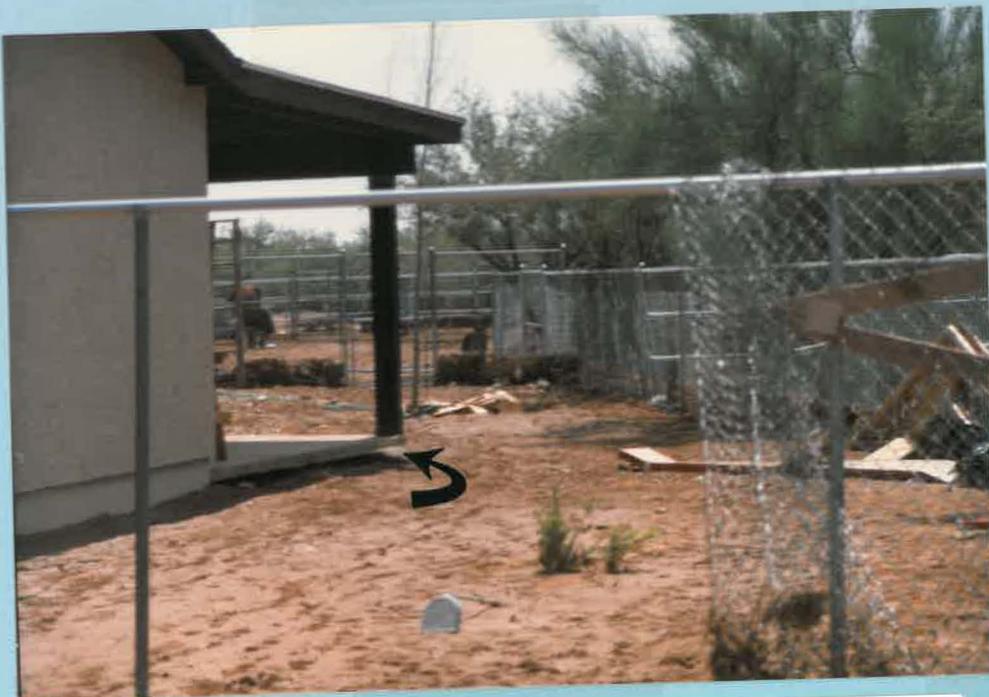
5i. Water has washed the ground from under the patio.

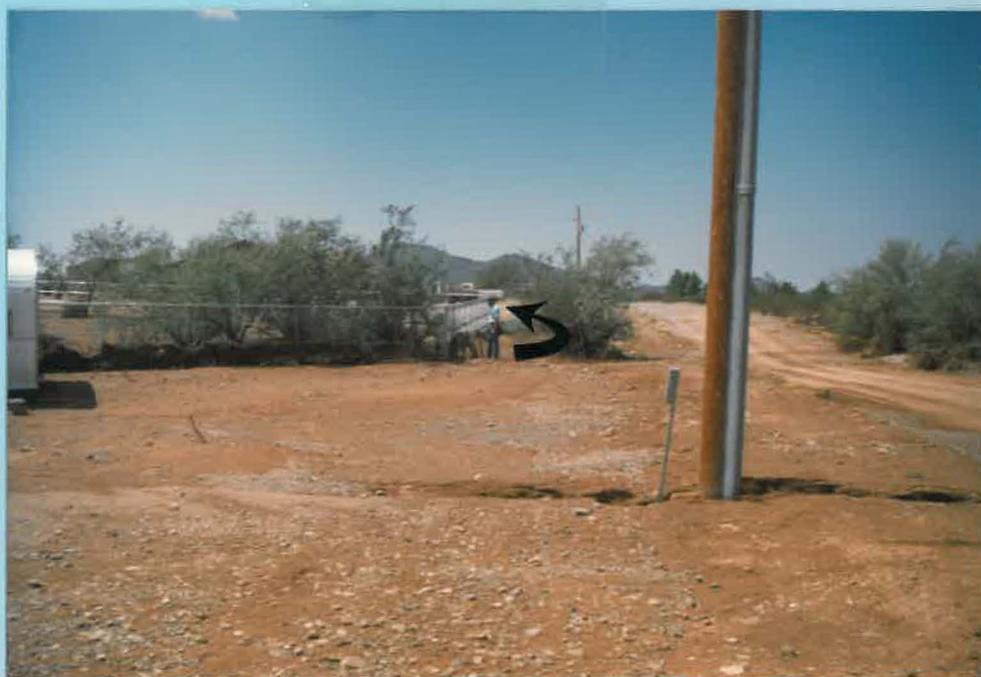
5j. The fence that traverses the wash along the south side of Cloud Rd to the east of the residence.

I believe two factors contributed to the flooding problems in Mr. Coopers Property. The important factor being that the house was just built too low in the wash area. Second contributing factor is the chain link fence that is built across the wash and the debris caught behind it during the flood will block the wash and retard the flows.

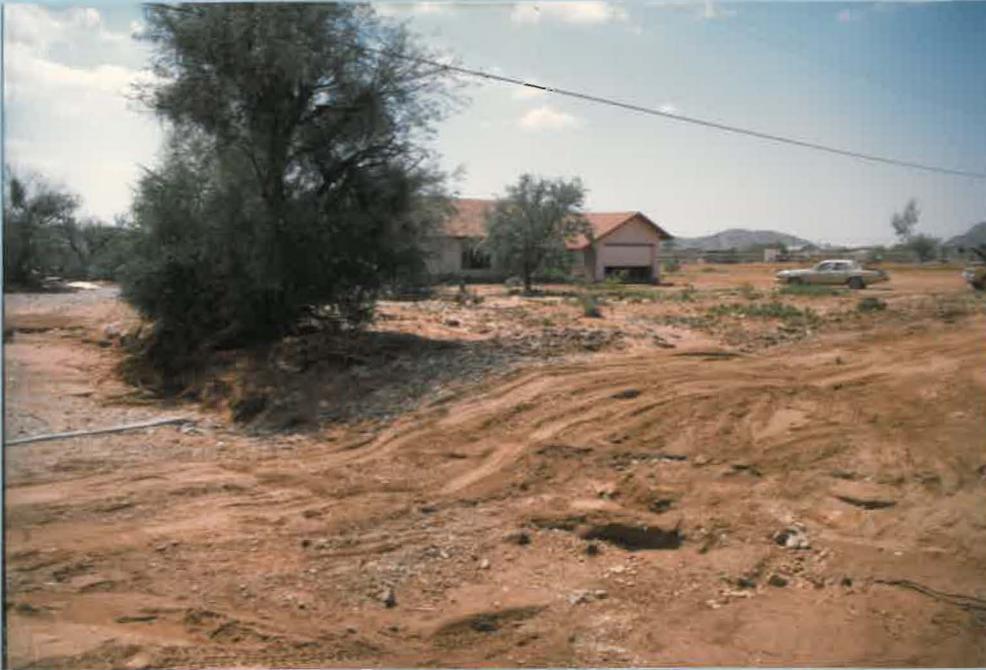
Damage inside and outside the house. He indicated that it started raining about 7:30 or 8:00 p.m. the night before and by 10:30 p.m. the water was so high that they decided to evacuate the house. However by 11:00 pm the water had receded enough for them to return to the house. Mr. Murrell blamed the grade control structure installed by county Highway just to the south of Cloud Road in the wash to have caused enough deposition of sediment upstream that the water this time had to jump the banks to go through (see figures 6a-6k).

6a. Looking south west across the Cloud road and the Wash. This seemed to be the direction the water moved where it over topped the bank.

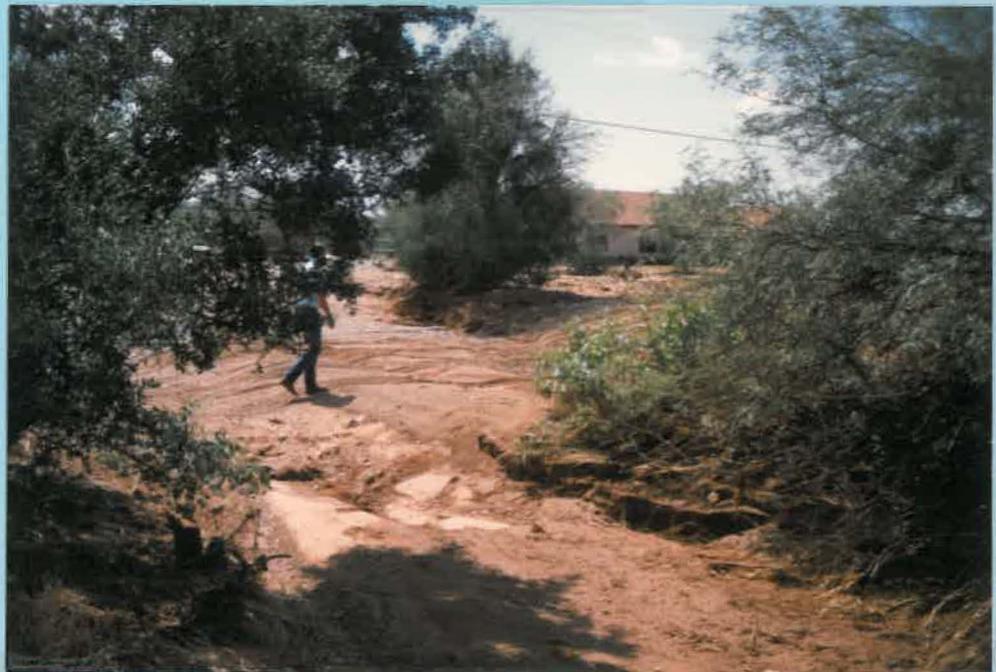
6b. Looking south south west at the wash crossing Cloud Rd.

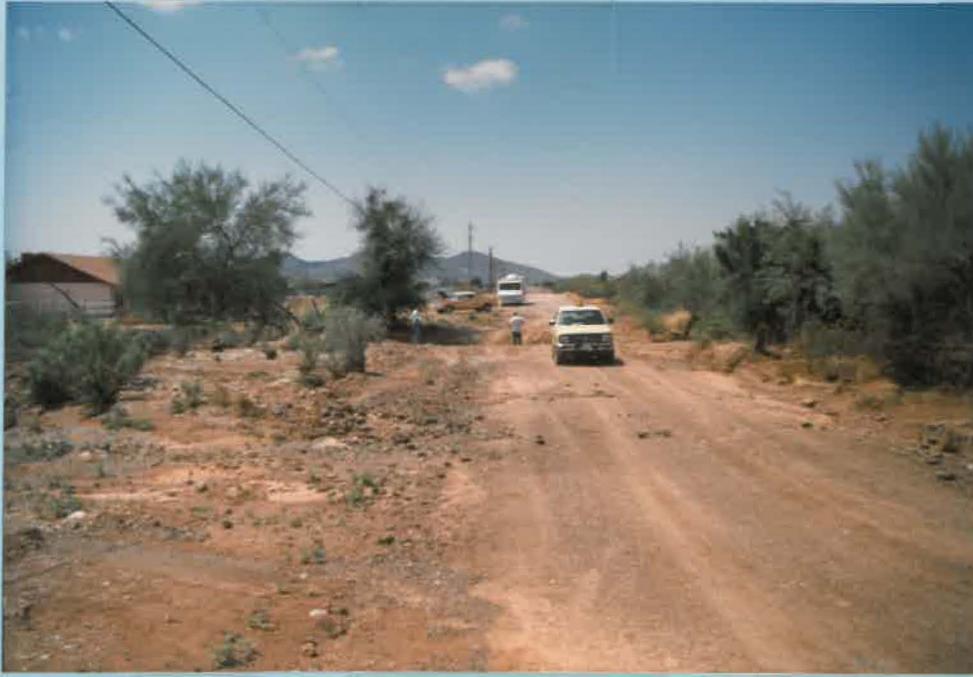
6c. Looking west along Cloud Road.

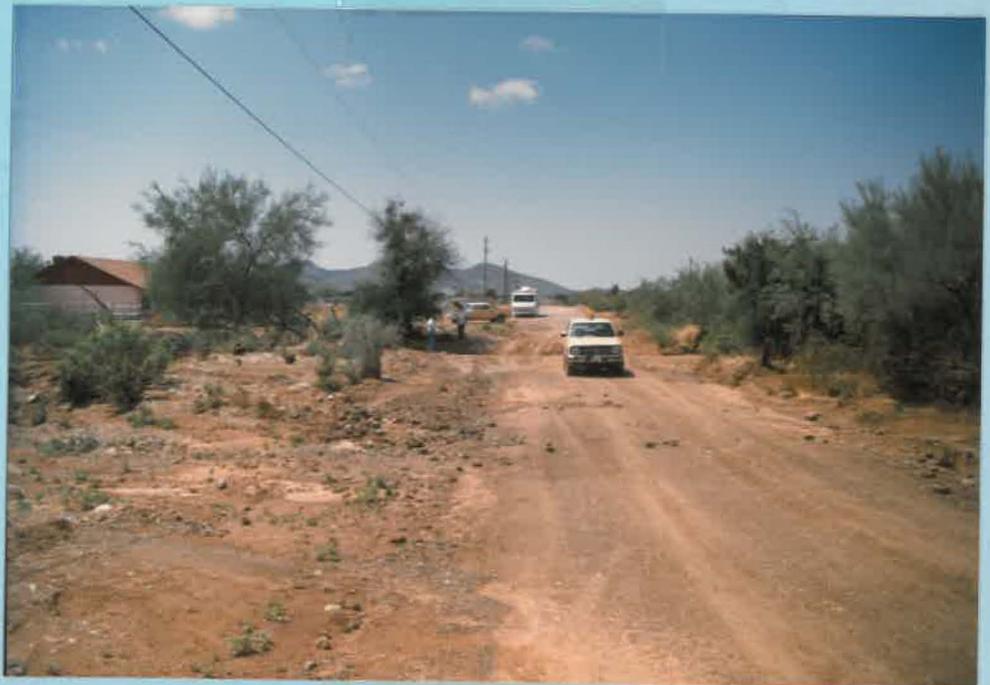
6d. Same as 6c.

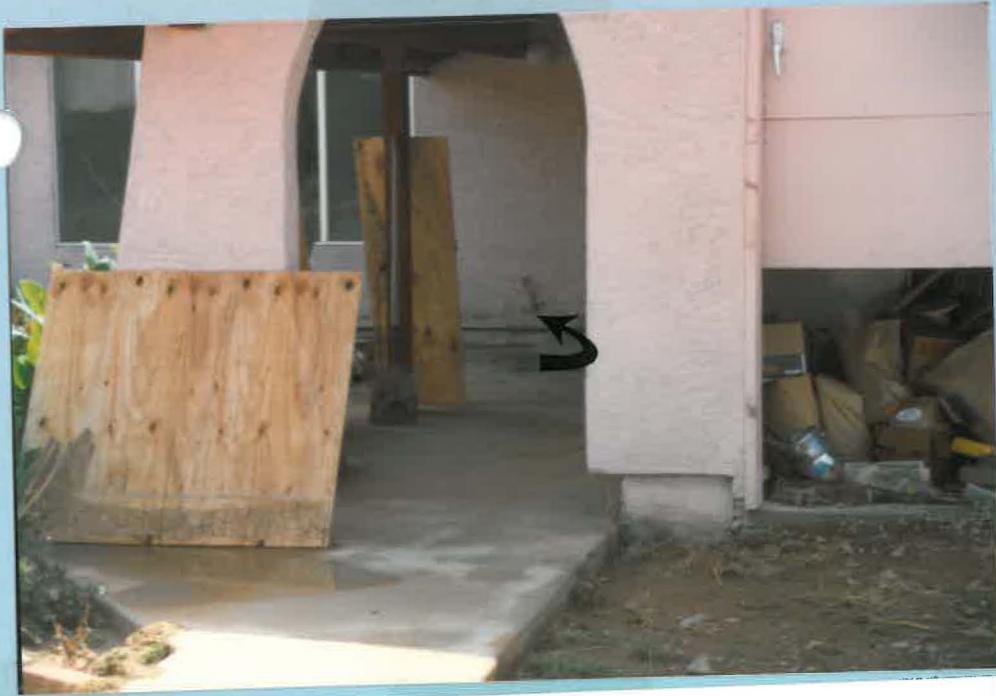
6e. North entrance to the residence. Note high water mark.

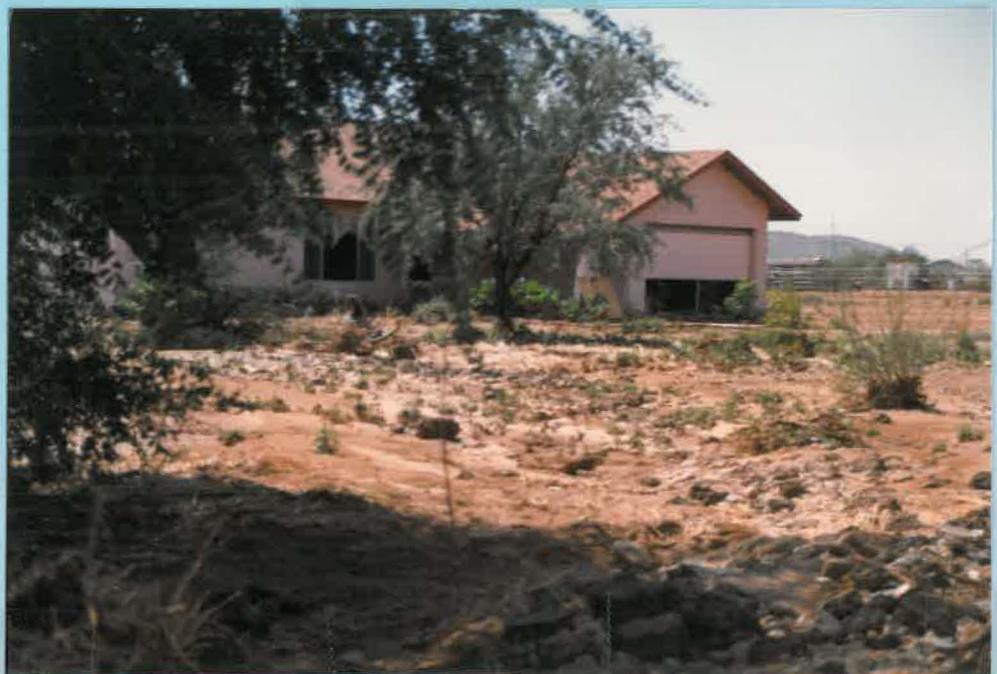
6f. Direction the water flowed where it over topped the bank.

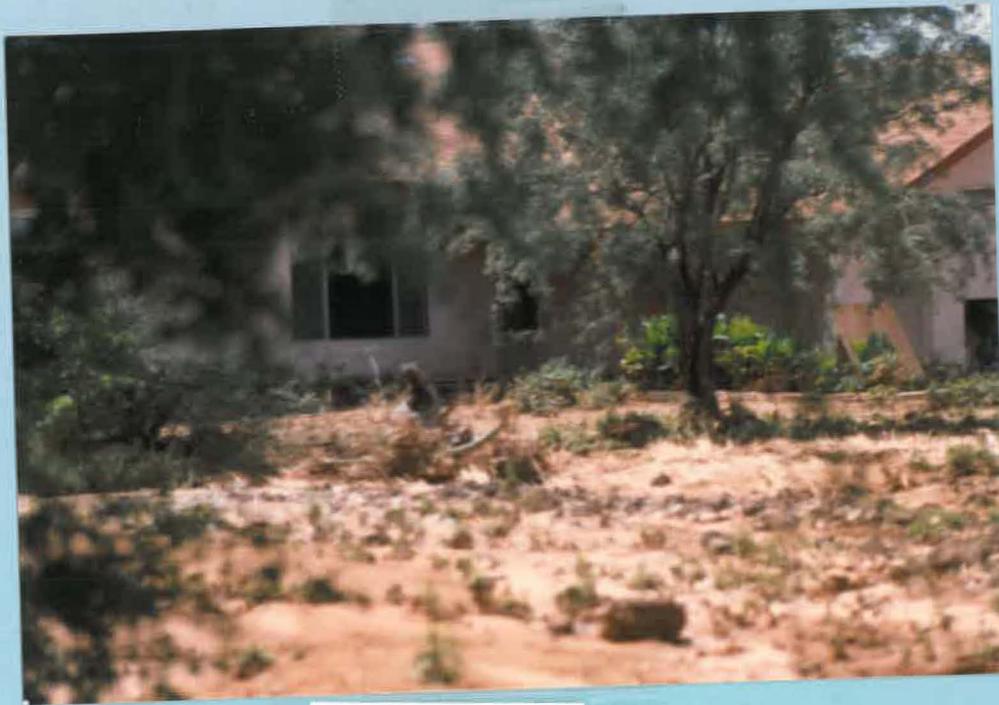
6g. Same as 6f.

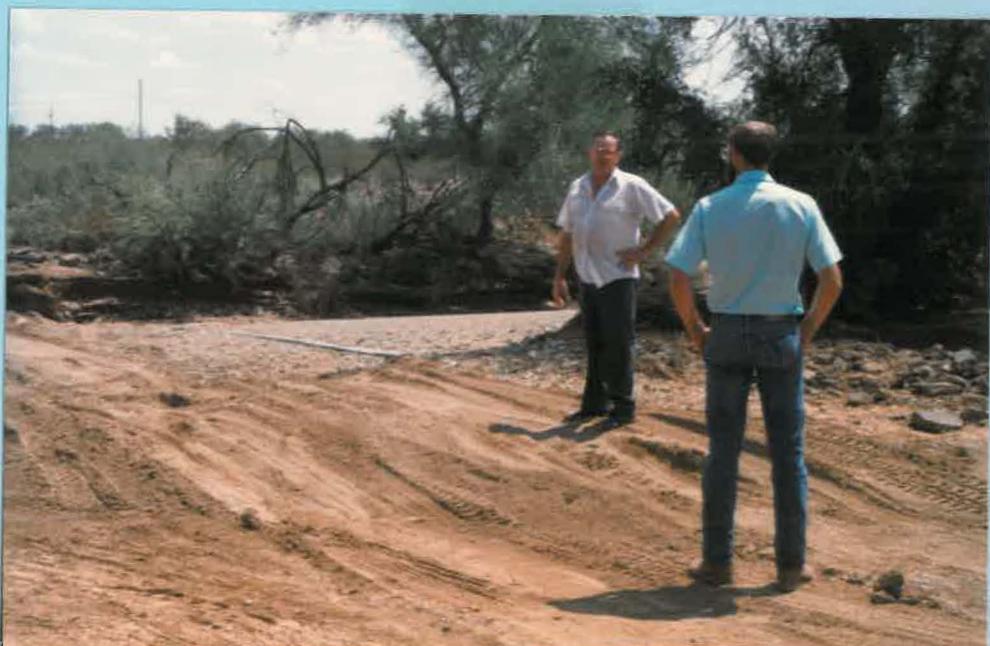
6h. Looking south east at Cloud Road crossing the Wash. Note grade control structure installed by County Hwy.

I do not believe that the grade control structure put in by the County Hwy Department has contributed to the flood. The structure has only provided to maintain the grade and not necessarily has caused deposition upstream of the road. If the grade structure was significantly above the grade (bottom of the wash downstream), then there may have been enough evidence to say that the structure has caused deposition upstream and therefore reduced the capacity of the wash.

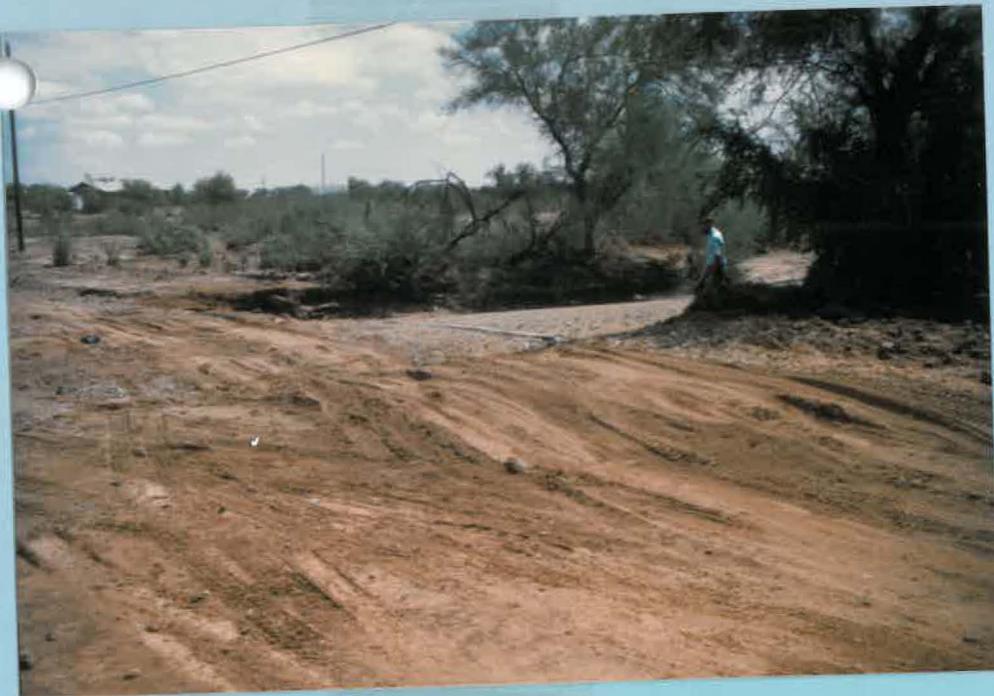
6i. Same as 6h.

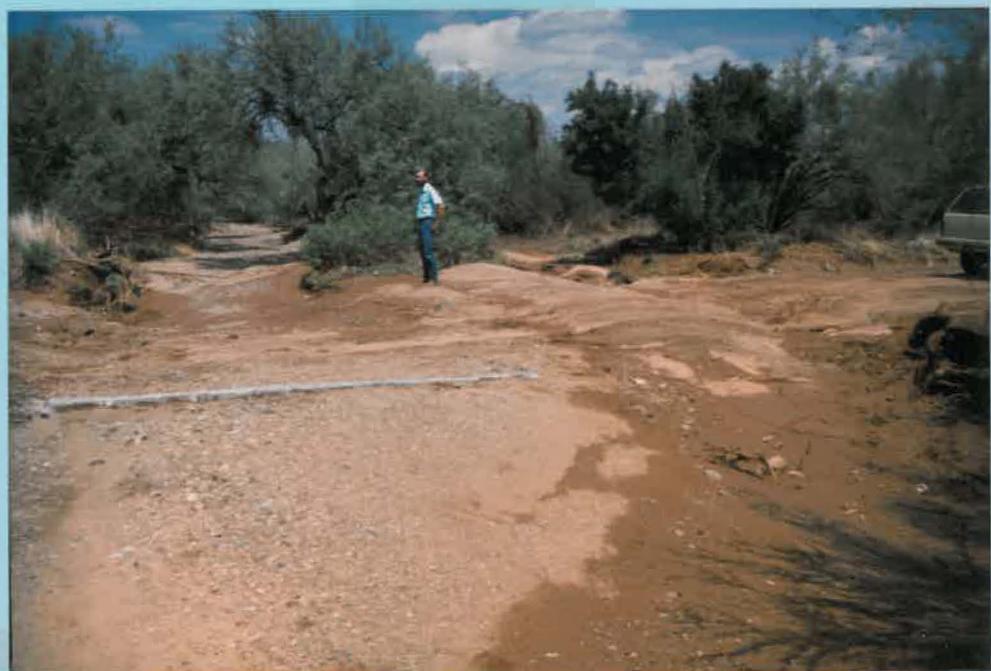
6j. Looking North along the wash south of cloud Road. Note Grade control Structure.

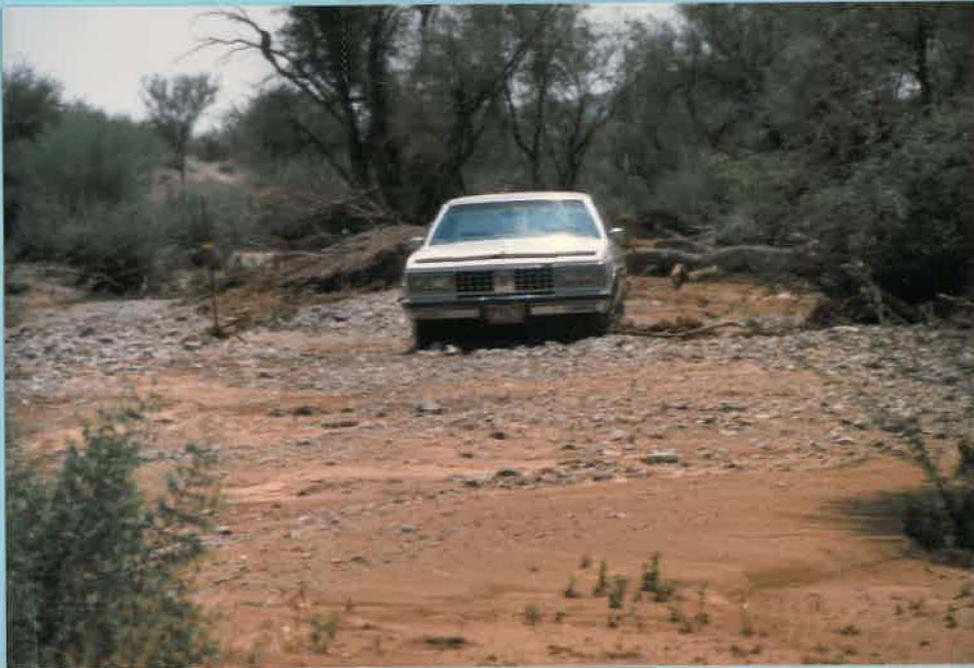
6k. Car stalled facing north along the wash south of Cloud Road, .
