WATERCOURSE MASTER PLAN

El Mirage Landfill Site Summary of Status Review

As Part of The
**Agua Fria River Watercourse
Master Plan Study**

**Kimley-Horn
and Associates, Inc.**

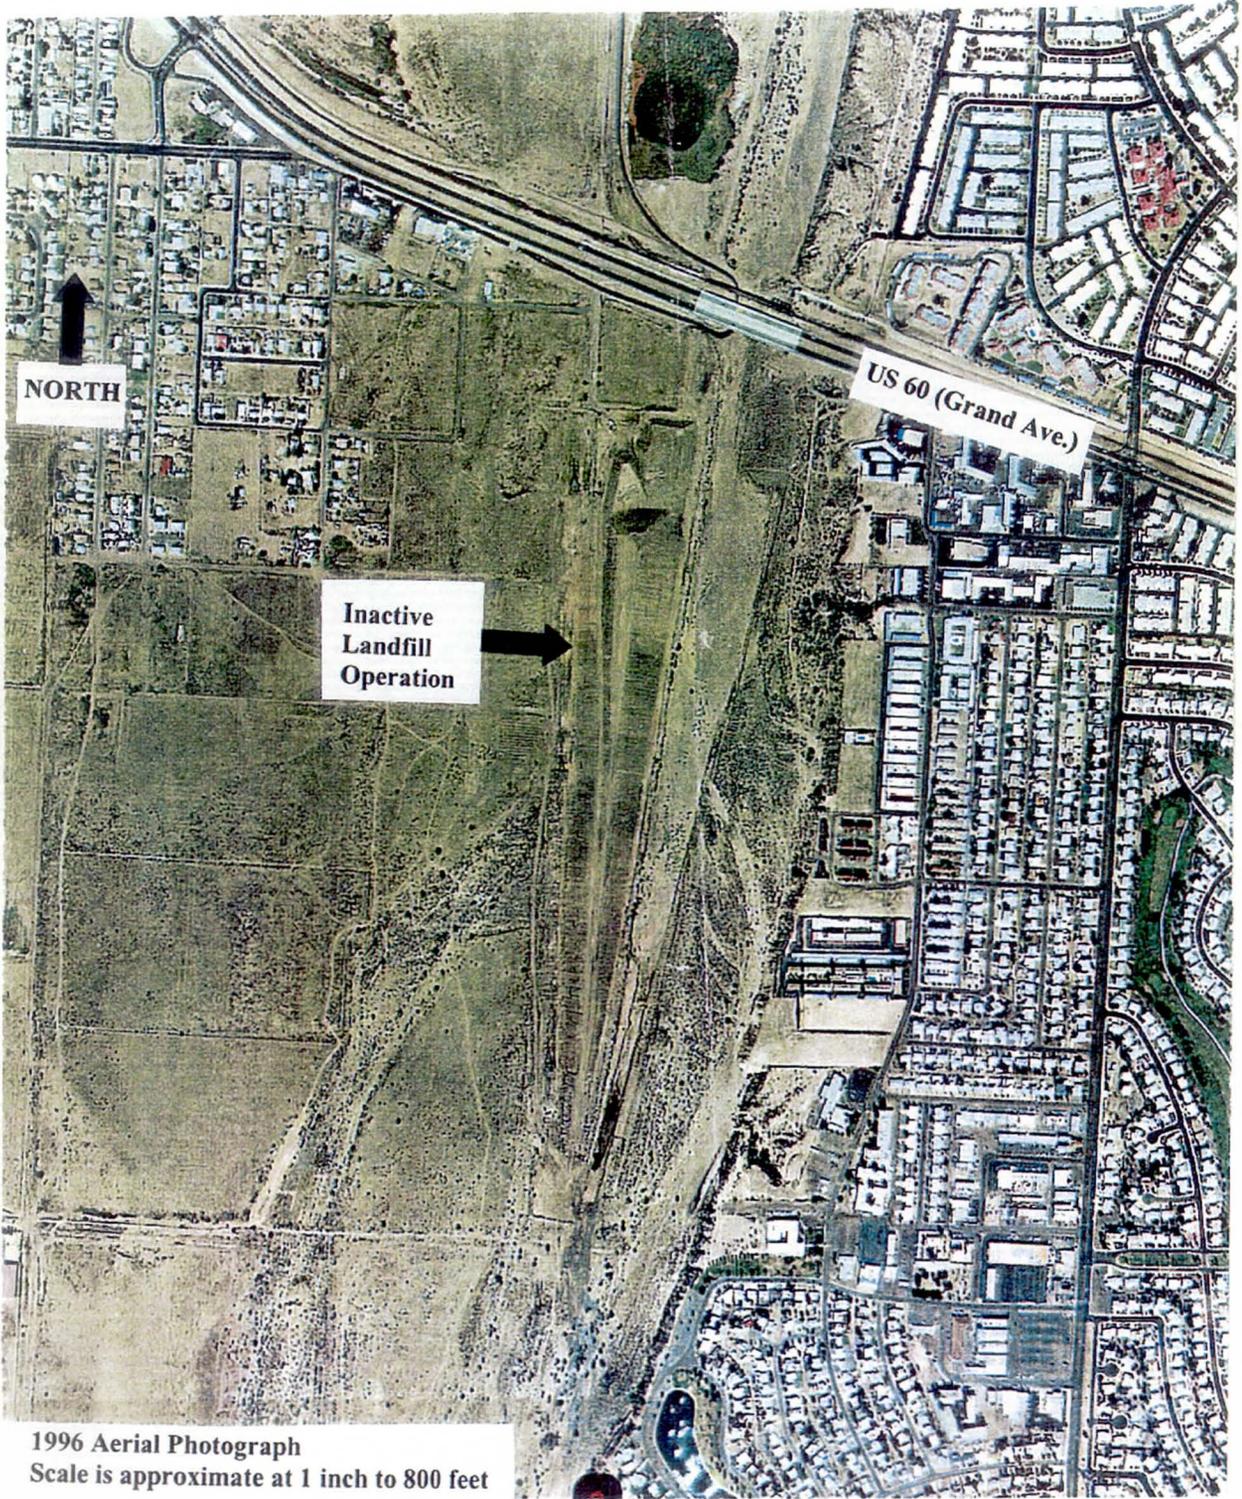
Figure 3
Aerial Photography

The actual landfill footprint is located in the western portion of Parcel 1 and forms the western bank of the river channel. This aboveground cell is approximately fifty feet high, 600 feet wide and 2500 feet long. The cell progressively narrows from its widest point near Grand Avenue (Highway 60) to its terminus in the south. The facility included a maintenance and operations yard in the northwestern corner of the property (See Figure 3).

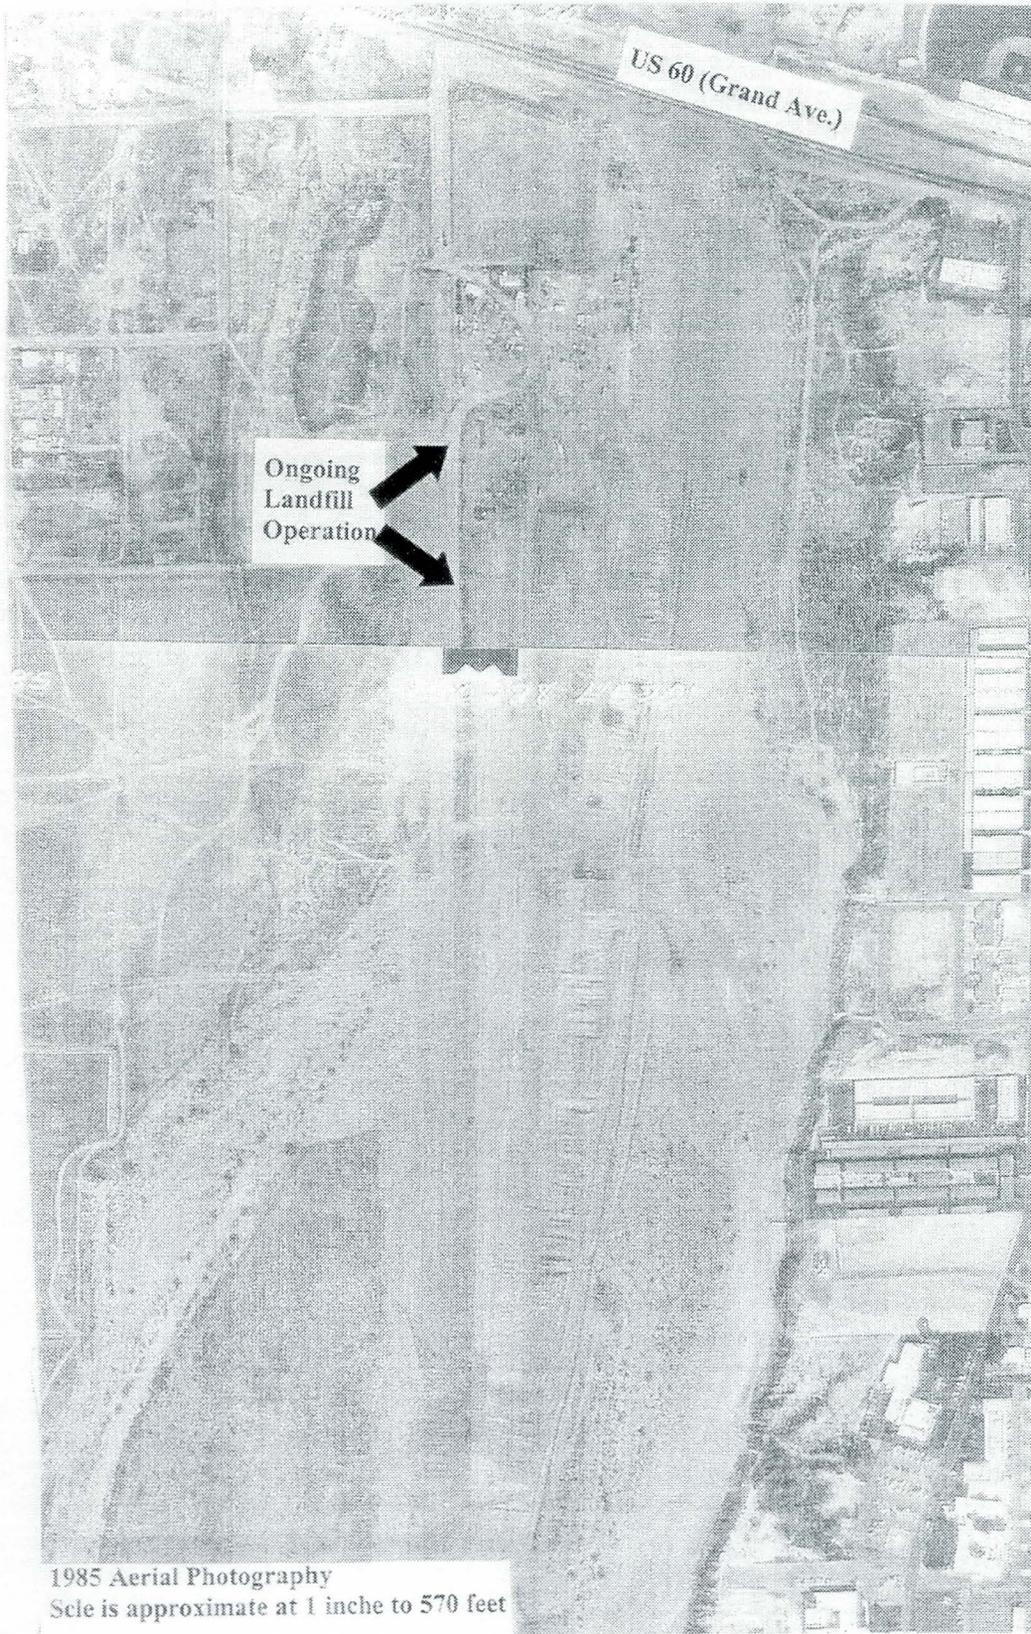
Figure 4
Historical Aerial
Photography

The review of historical aerials at the Arizona State University Noble Science Library noted activity indicative of a “landfill operation” along the western channel bank of the Agua Fria River, from approximately the late 1970s until the early 1990s. This activity includes aboveground stockpiling of soil and related earthmoving, several small buildings along the northern boundary, and truck traffic on and off the site. The sequence of activity is similar to ongoing site processing of solid waste material and the later photography clearly shows an ever-increasing aboveground stockpile. An aerial photograph of the landfill operation in 1985 illustrates the approximate extent of the aboveground cell and the amount of material being removed from the river channel (See Figure 4).

The current above ground footprint of the landfill appears to mimic the estimated northern and western extent of the operation (based on estimates from the historical aerial photography). The eastern boundary of the landfill, now forming the west bank of the Agua Fria River channel, is reportedly 50 to 75 feet east of its original approved location. The 1980 Operational Report suggests that an error in field staking or site surveying resulted in the toe of the slope encroaching into the original river channel.

While post license activity appears to have been confined to the currently visible footprint, early unregulated activity may have occurred to the east and south of the existing footprint. Historical aerial photography suggests some excavation activity to the east of the existing above ground footprint, that may indicate pre-1960 disposal of material. Furthermore, the same photography indicates activity on the parcel immediately south of the existing footprint that may be related to early landfill operations.

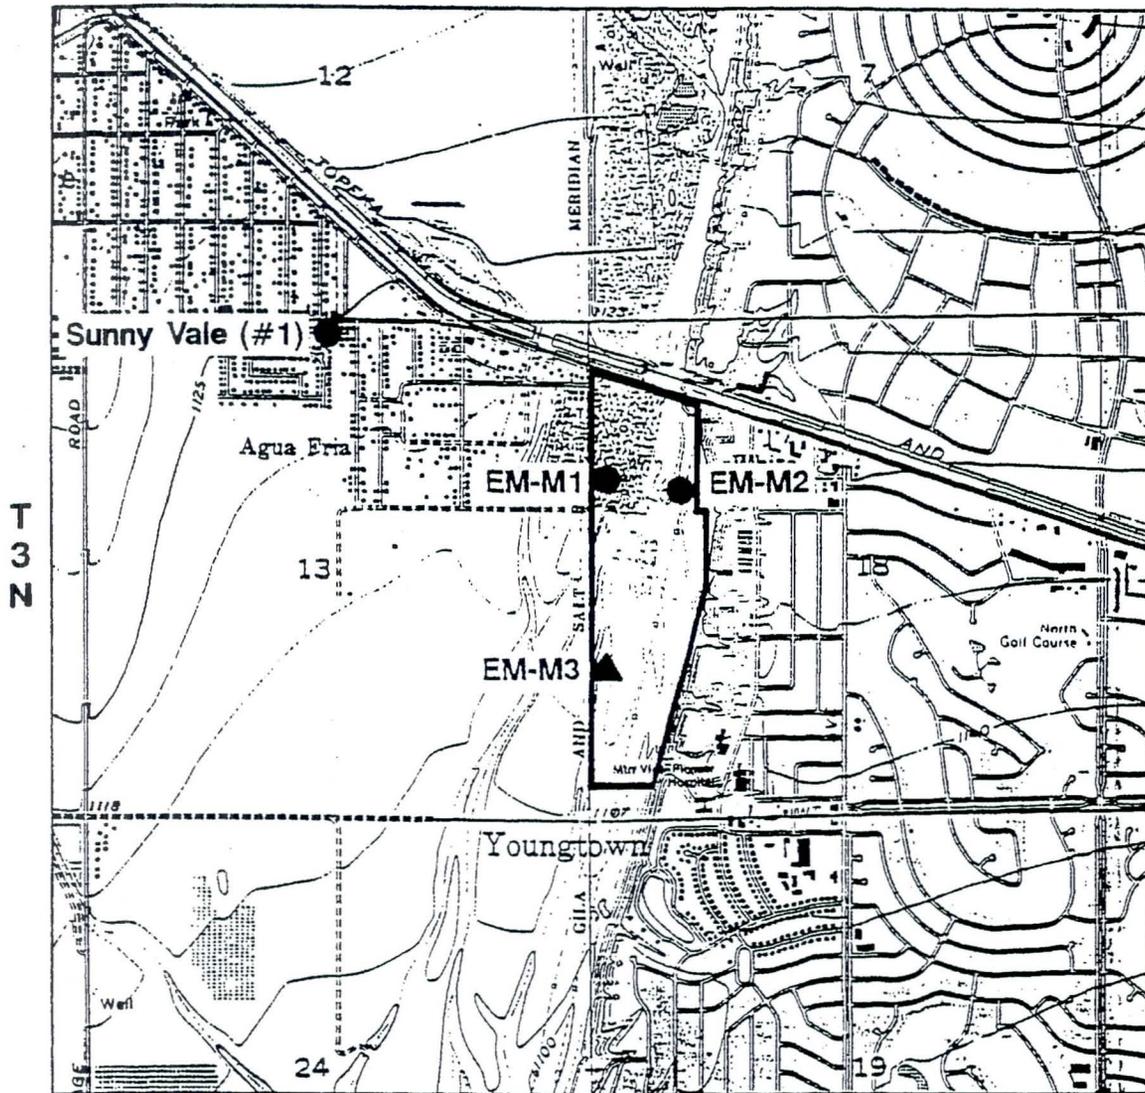
Figure 5
Ground Water
Monitoring Wells

The site closure plan required groundwater monitoring. The ADEQ record indicates numerous monitoring wells in the general area of the landfill (See Figure 5). Some of the wells are no longer active and the location of some is uncertain. Information regarding subsurface flow direction and depth of the groundwater is incomplete. Larger production withdrawal wells in the general vicinity may be influencing groundwater patterns.

Currently, ADEQ maintains and samples at least two monitoring wells along the northern end of the landfill. These two wells were identified during the field reconnaissance. Water samples have been collected from these two wells and others in the landfill area and analyzed periodically since the 1980s. Analysis has resulted in the identification of 12 volatile organic compounds (VOC) in the groundwater. Two of the compounds, tetrachloroethene and dichlorodifluoromethane, have exceeded state drinking water standards on at least one occasion.

- Prepare a groundwater-monitoring program that will attempt to verify the general groundwater flow patterns in the area and predict the direction and extent of the VOC plume. This program may include the installation of additional monitoring wells (to triangulate the site and adjacent contributing areas). The monitoring program should also include the development of recommendations for action necessary to minimize the potential of additional migration of the contamination plume.
