TRILBY WASH FIS

MANNING'S "n" VALUE ESTIMATION  
FROM FIELD INSPECTION  
11/20/90

(Completion of Task 4.4.1)

NOVEMBER 27, 1990

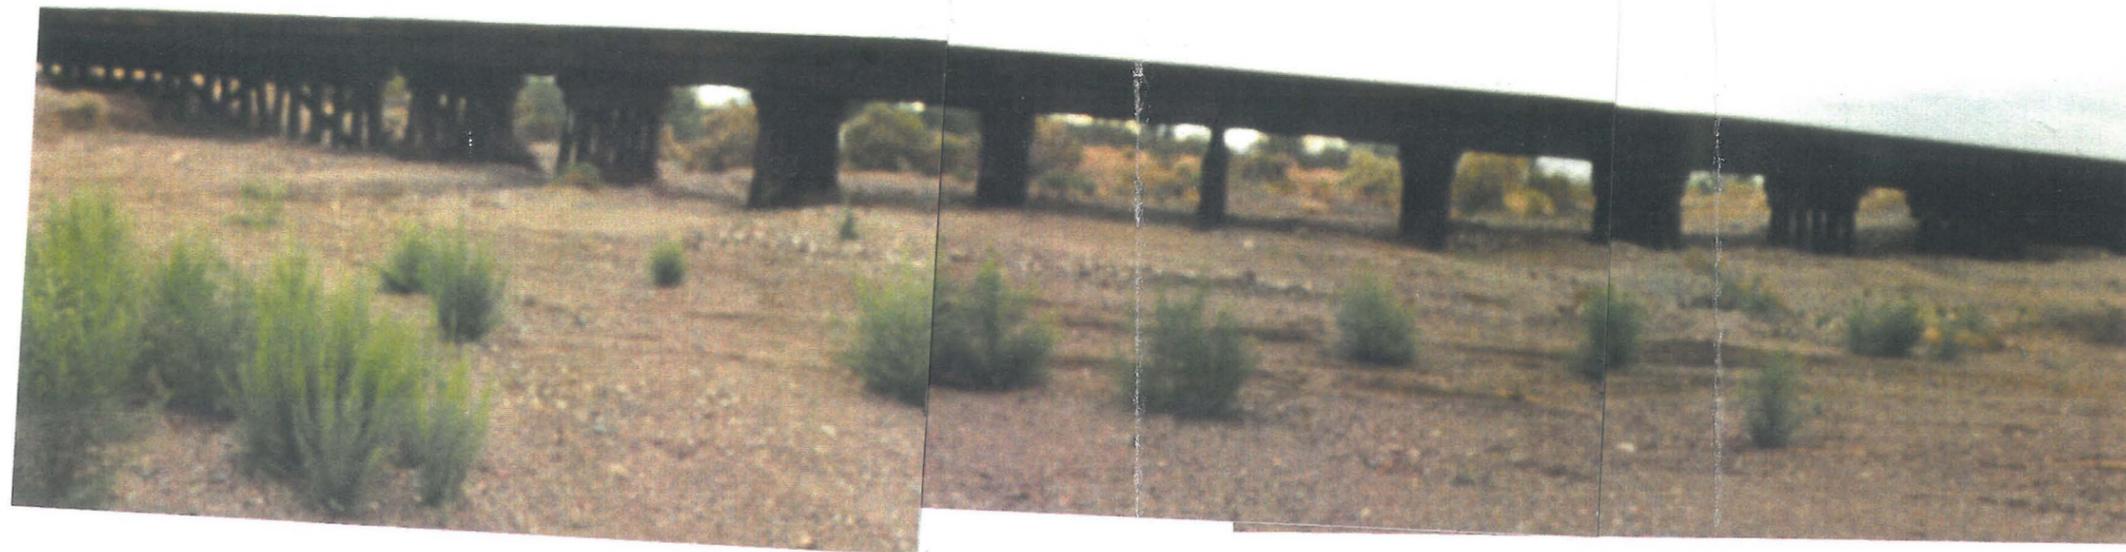
**PHOTO SET 1:** AT&SF Railroad crossing at Trilby Wash north of Grand Avenue, looking north upstream. (Match to previous study by the WLB Group of 0.080 for both east and west overbank and 0.050 for the main channel).

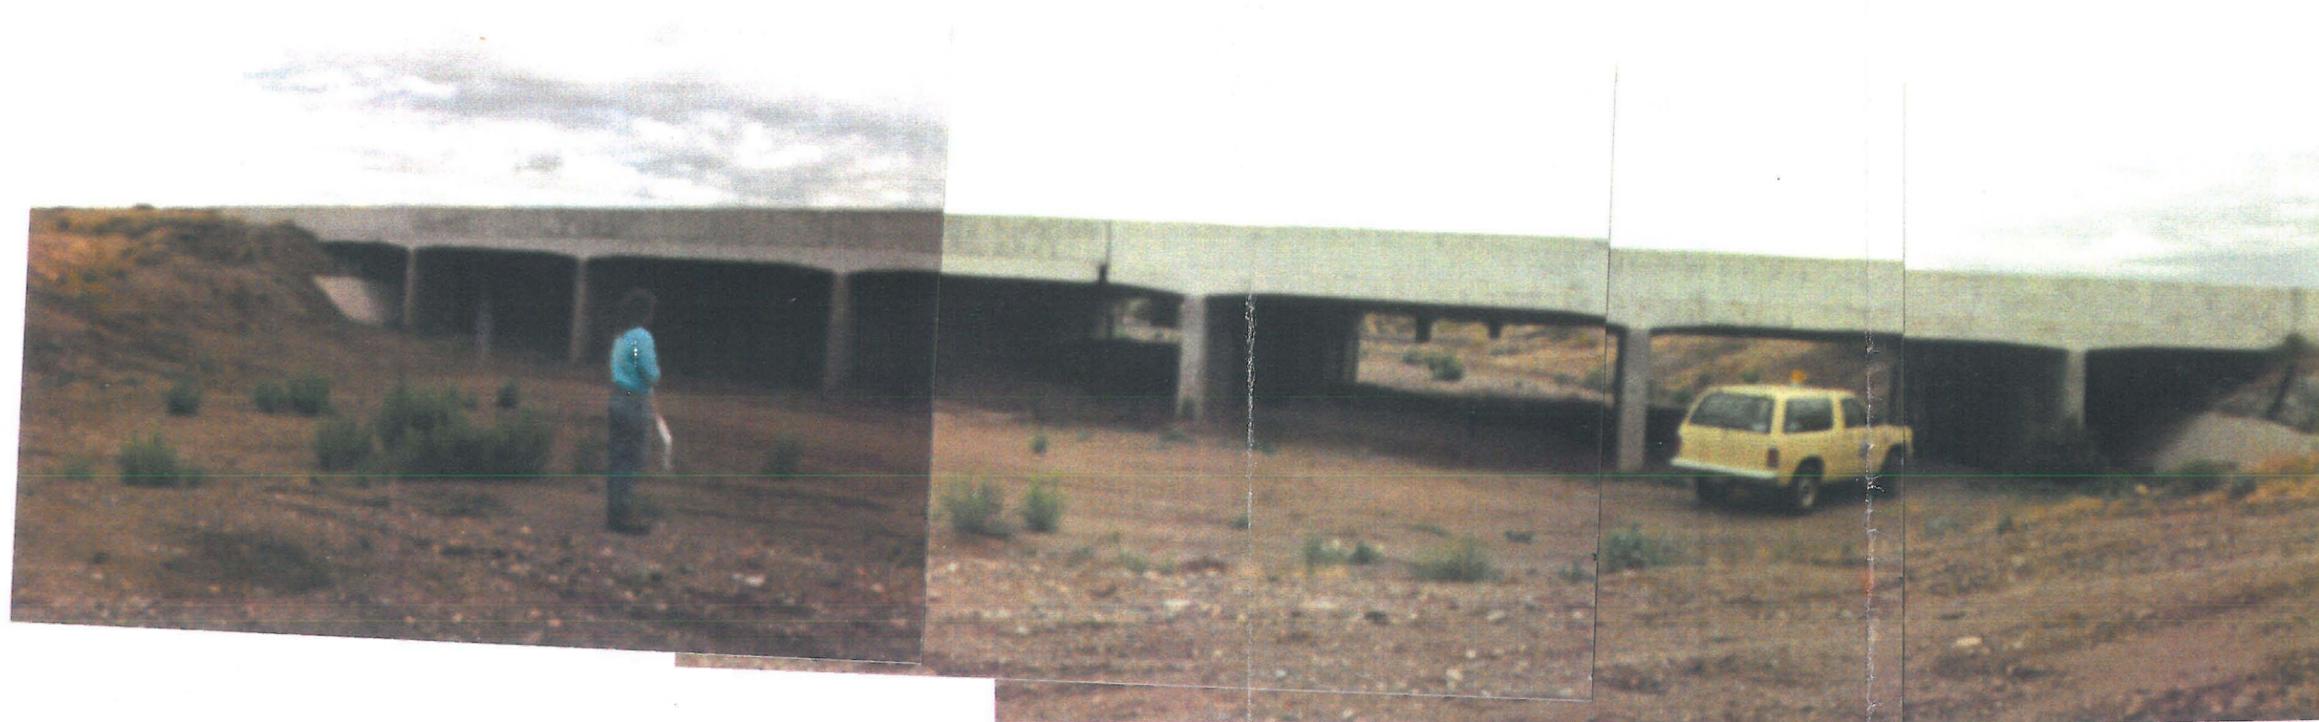
PHOTO SET 2: Grand Avenue crossing at Trilby Wash looking north upstream. (Match to previous study by The WLB Group, Inc. of 0.080 for the east and west overbank and 0.050 for the main channel).

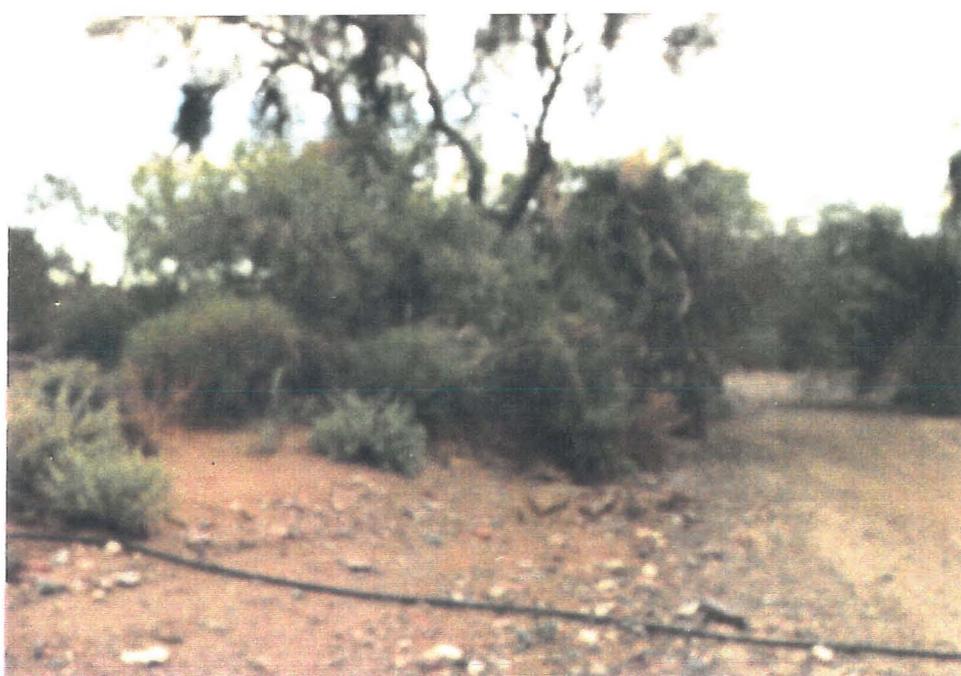
**PHOTO SET 3:** Dove Valley Road crossing at Trilby Wash looking north upstream. (Match to previous study by The WLB Group, Inc. of 0.080 for the east and west overbank and 0.050 for the main channel).

West Overbank  $n = 0.080$

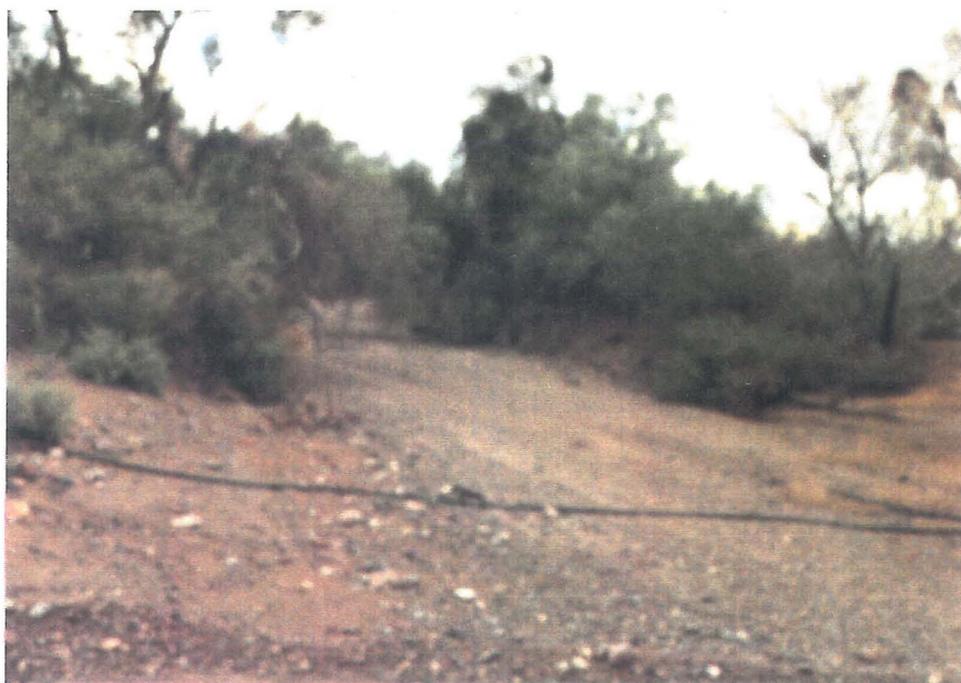
Main Channel  $n = 0.050$

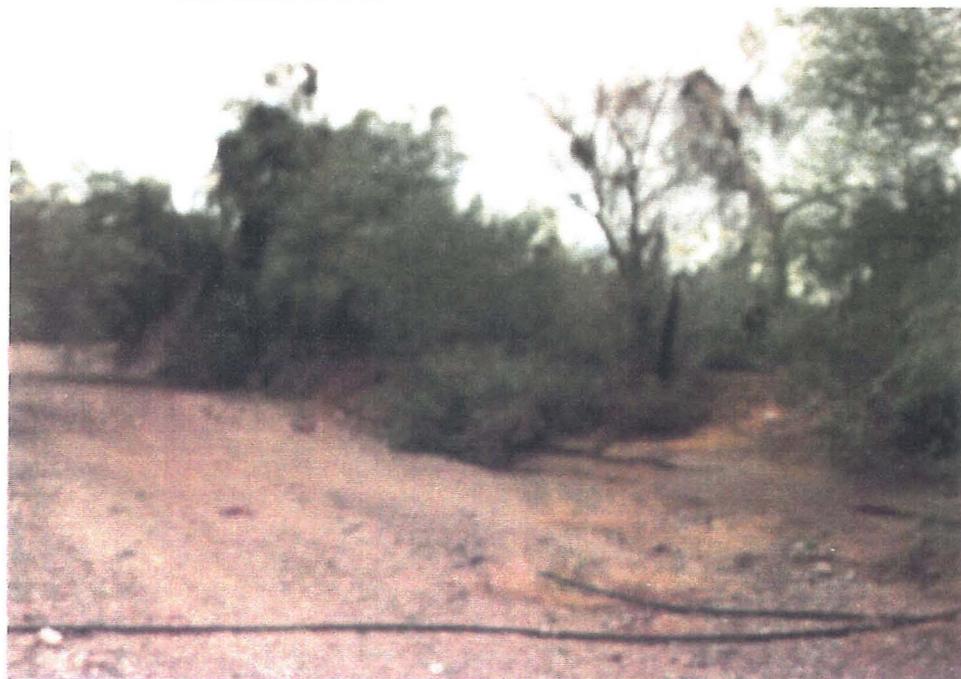
East Overbank  $n = 0.080$

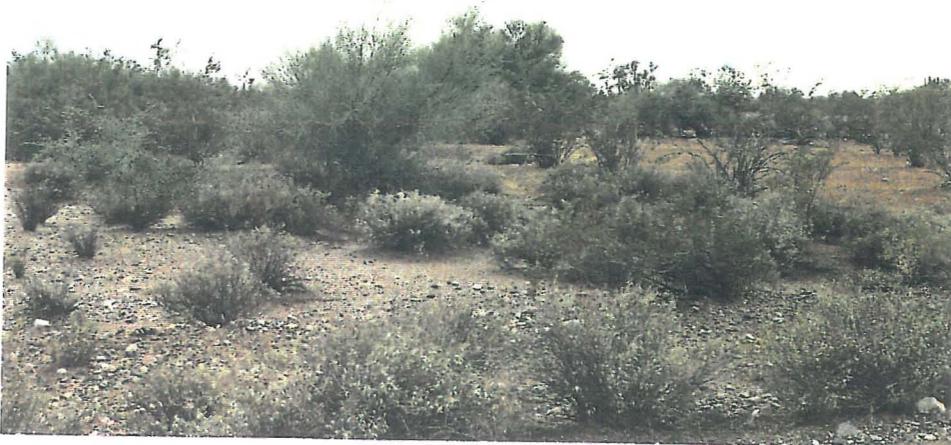
**PHOTO SET 4:** Dove Valley Road at Trilby Wash looking south downstream.

East Bank n = 0.080

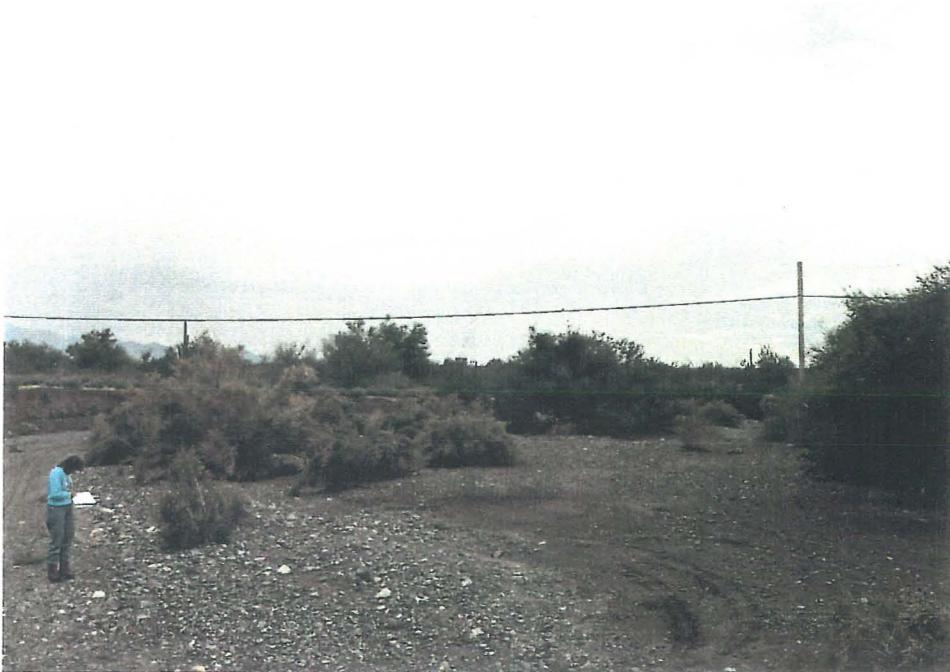
Main Channel n=0.065

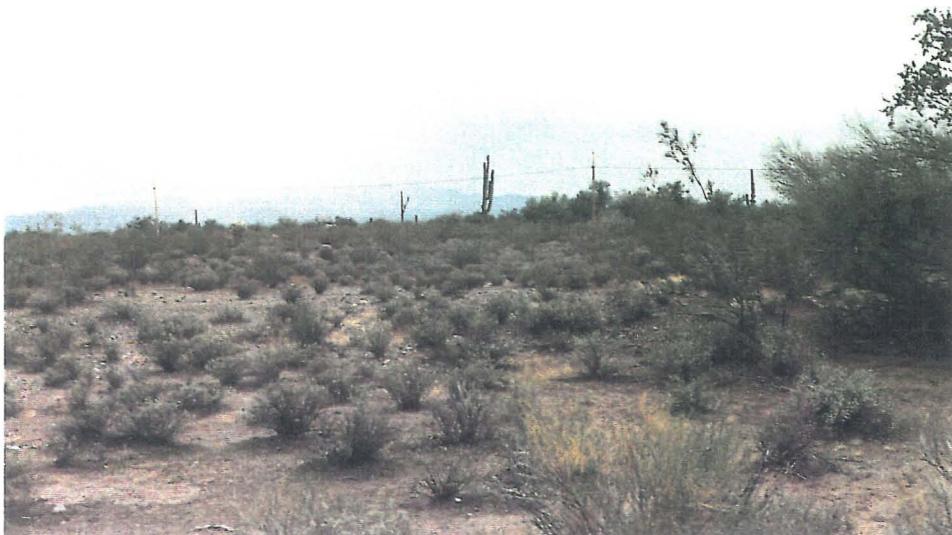
West Bank n=0.080

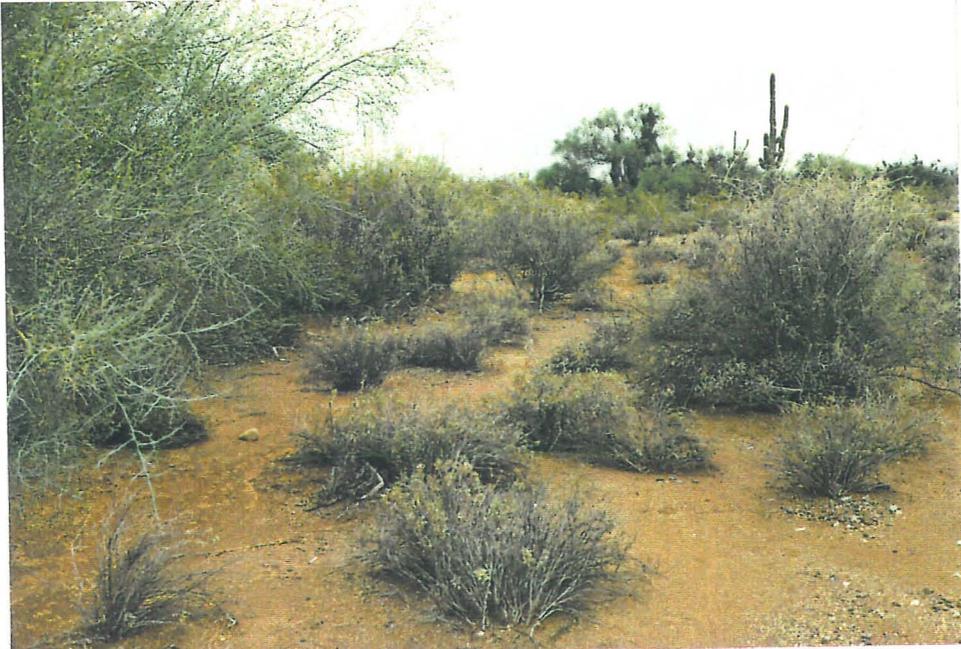
PHOTO SET 5: In Trilby Wash looking south downstream.

(Mileage = 0.1)  
East Bank "n" = 0.085

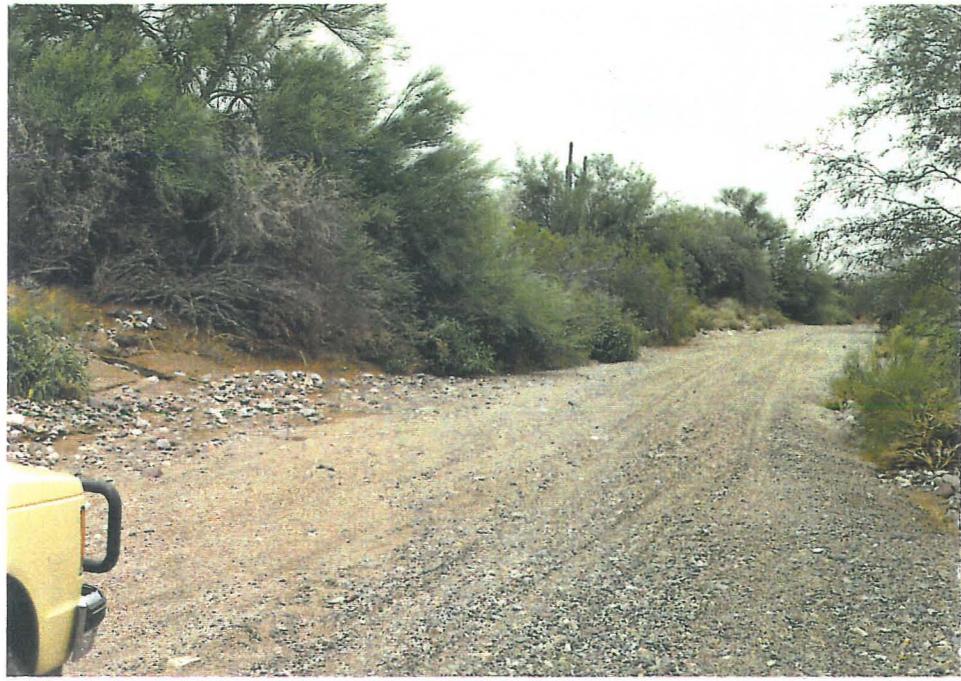
Main Channel "n" = 0.050

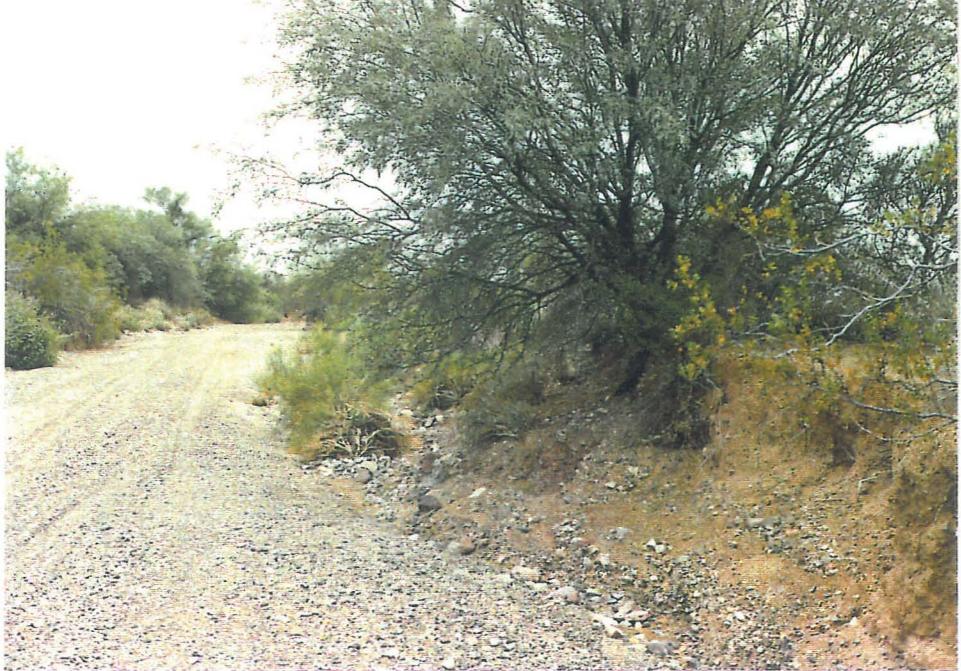
West Bank "n" = 0.085

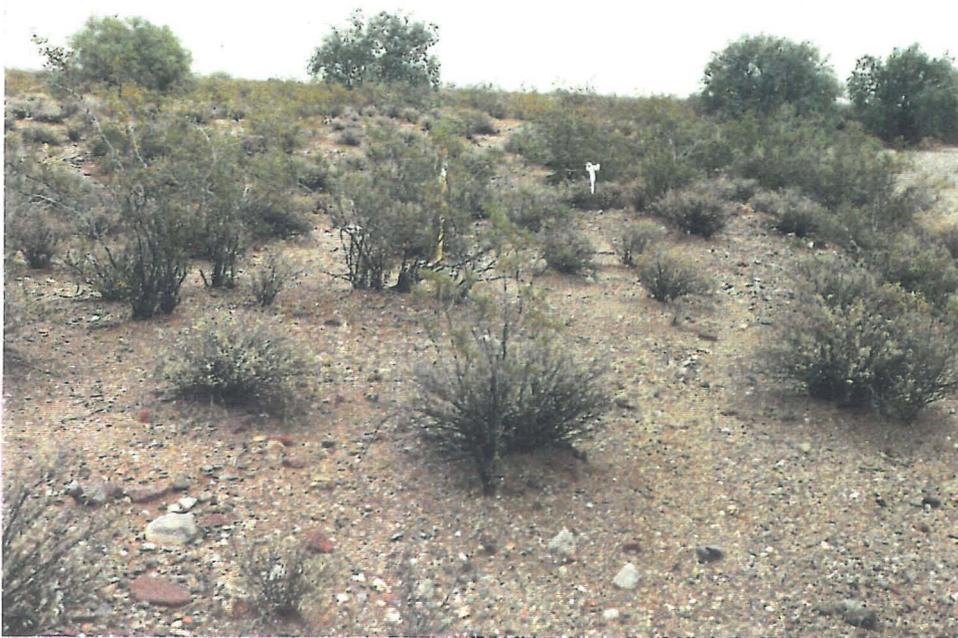
**PHOTO SET 6:** In Trilby Wash looking south downstream.

East Bank "n" = 0.080

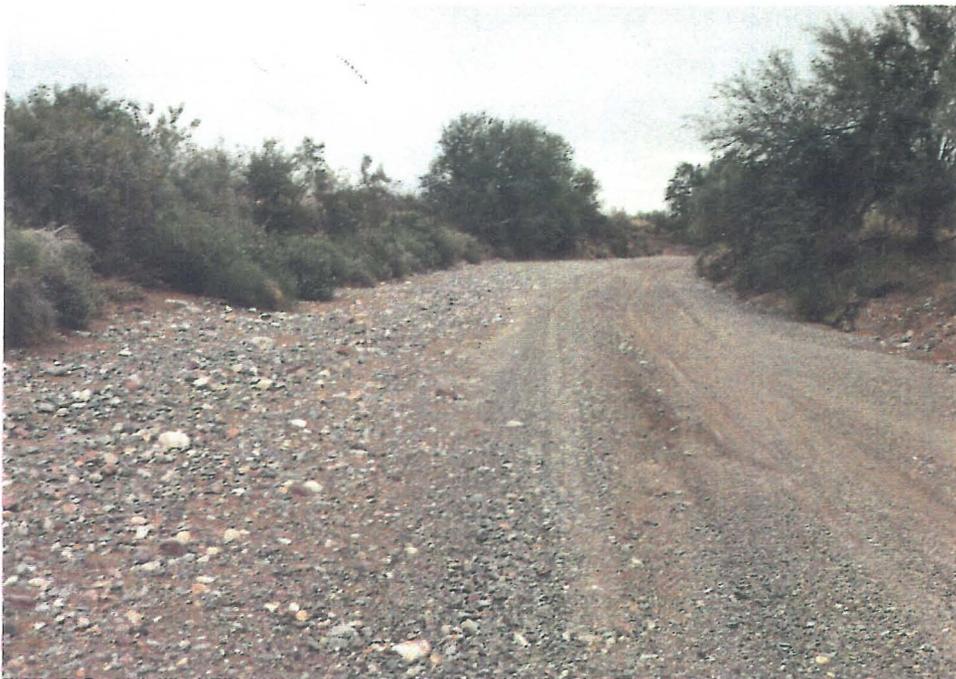
Main Channel "n" = 0.045

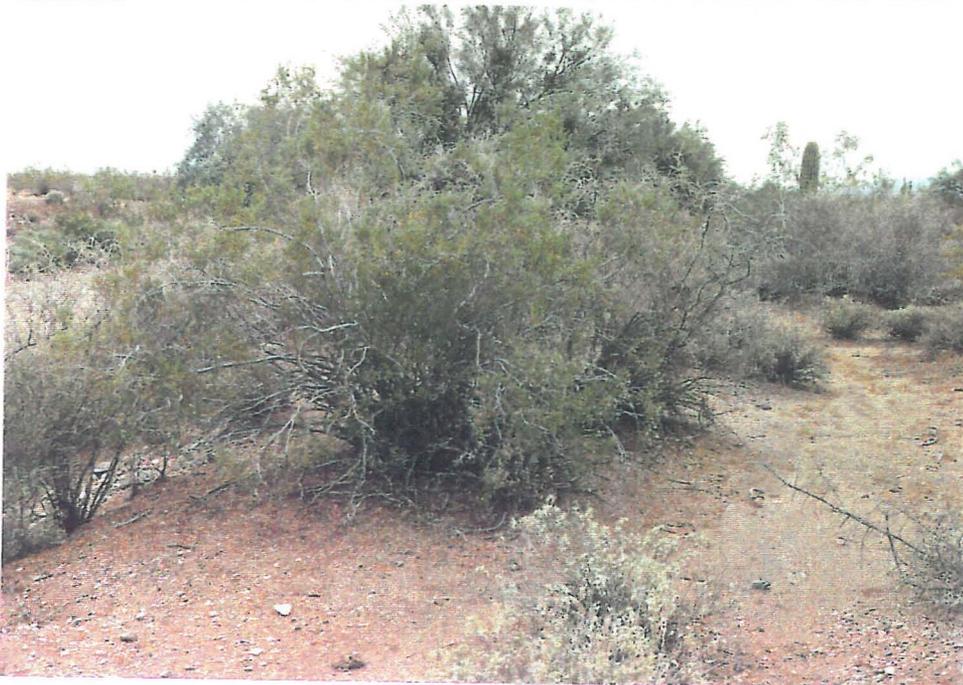
West Bank "n" = 0.080

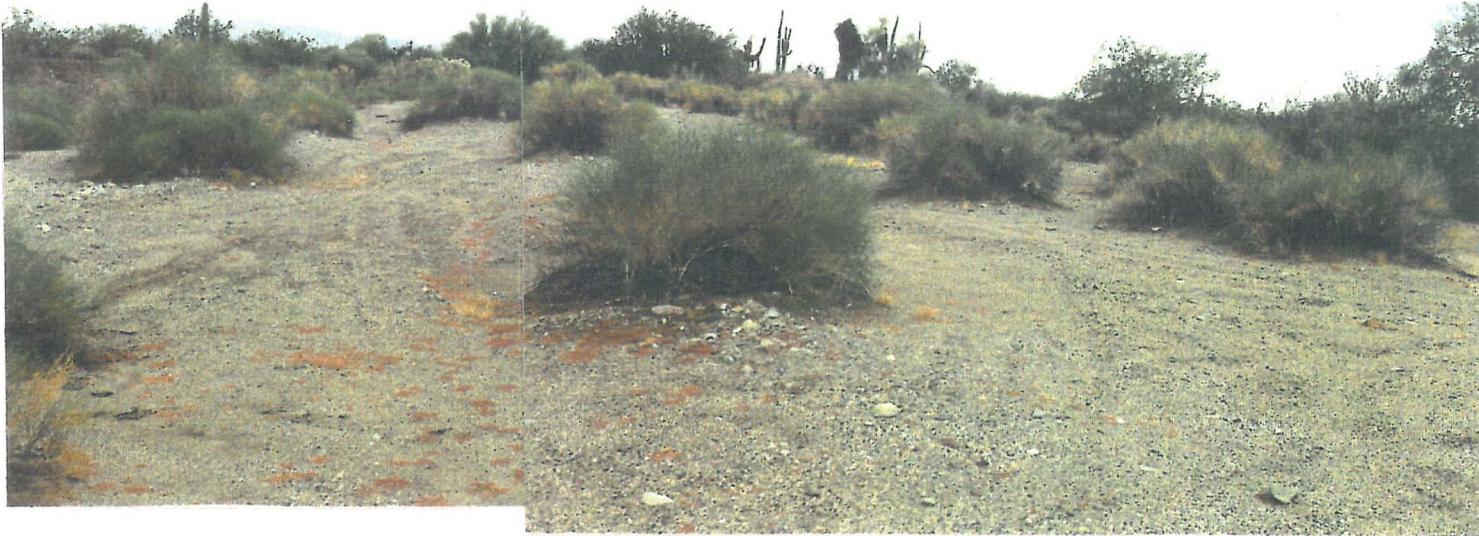
East Bank "n" - 0.085 Main Channel "n" = 0.045 West Bank "n" = 0.070

PHOTO SET 7: In Trilby Wash looking south downstream (Mileage = 0.050).

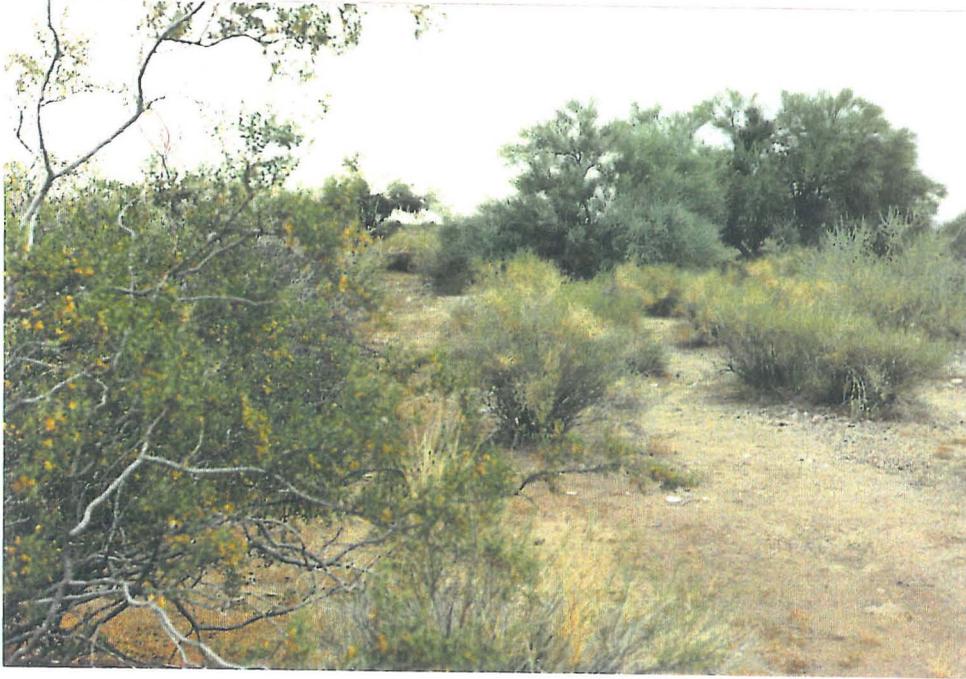
East Bank "n" 0.080

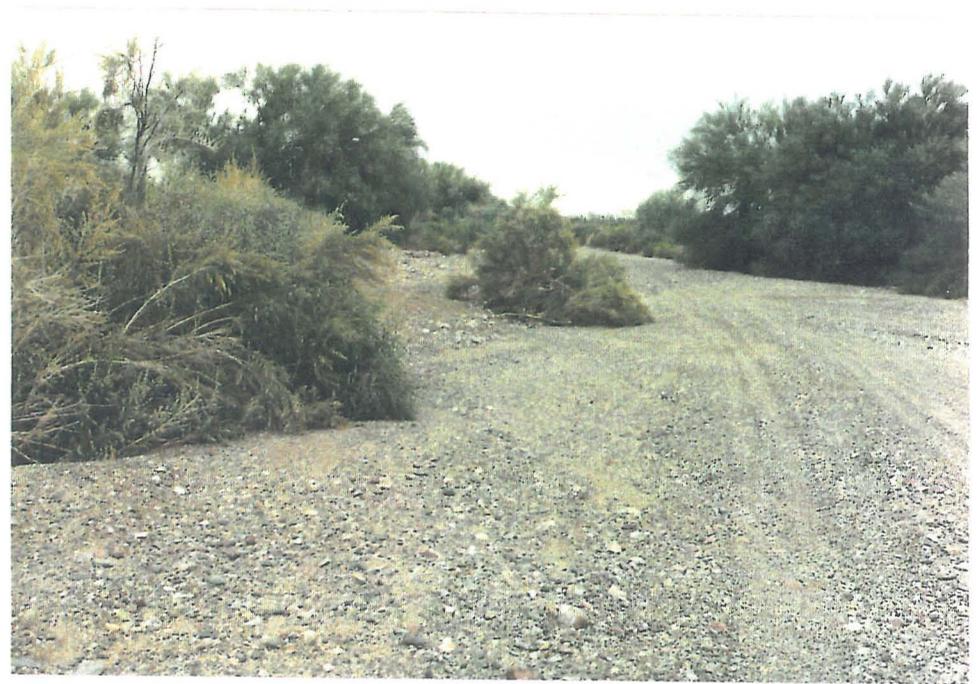
Main Channel "n" = 0.055

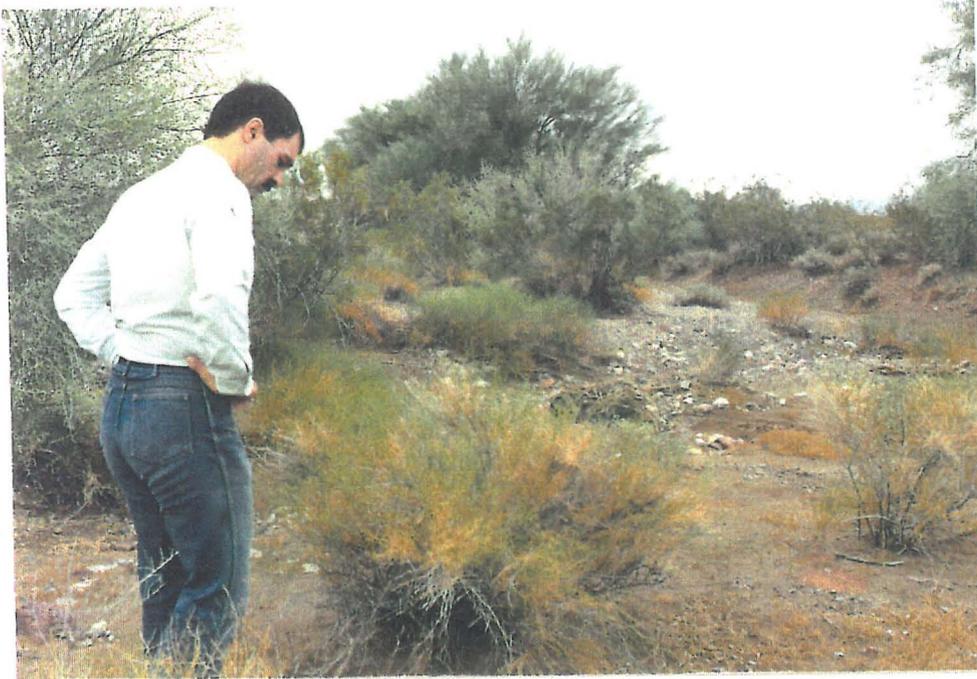
West Bank "n" = 0.080 looking west  
and downstream across secondary wash.

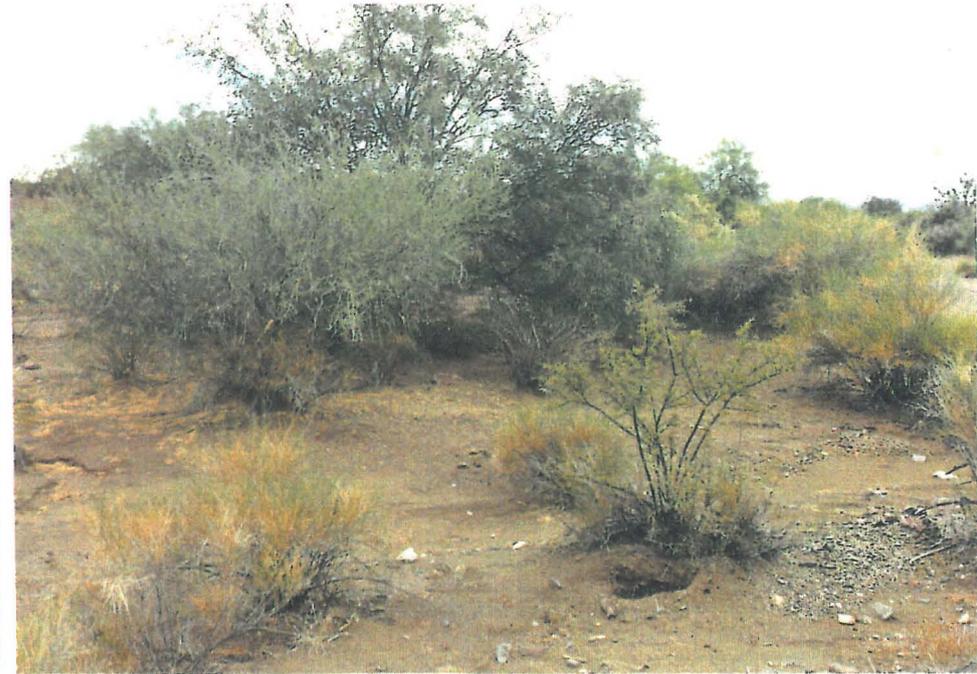
West Bank "n" = 0.080 looking  
north upstream.

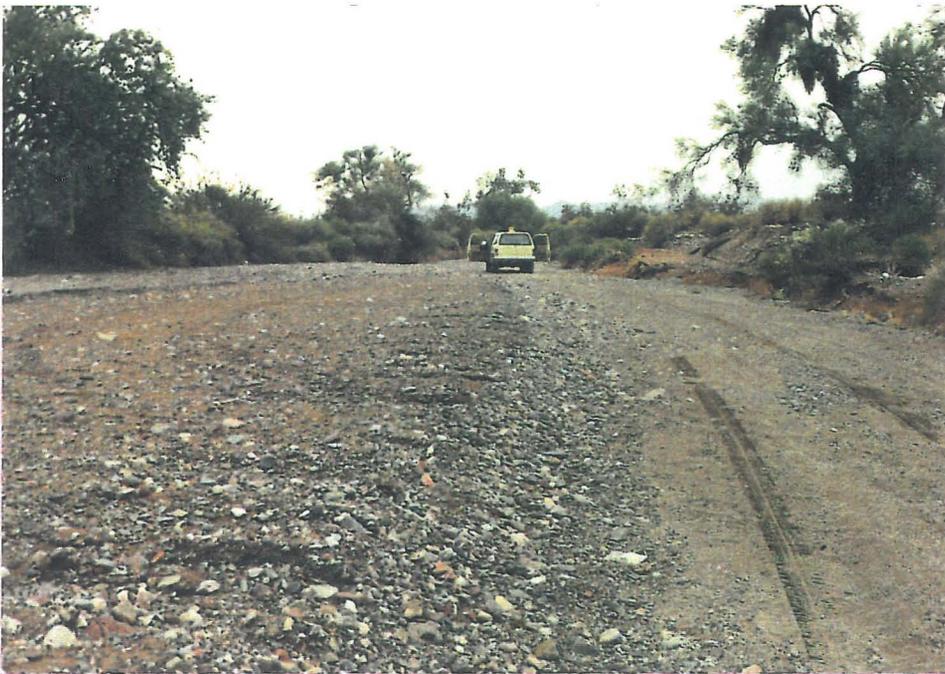
PHOTO SET 9: At major split flow in Trilby Wash Section 9, T.5 N., R.3 W, looking south downstream.

Main Channel "n" = 0.050

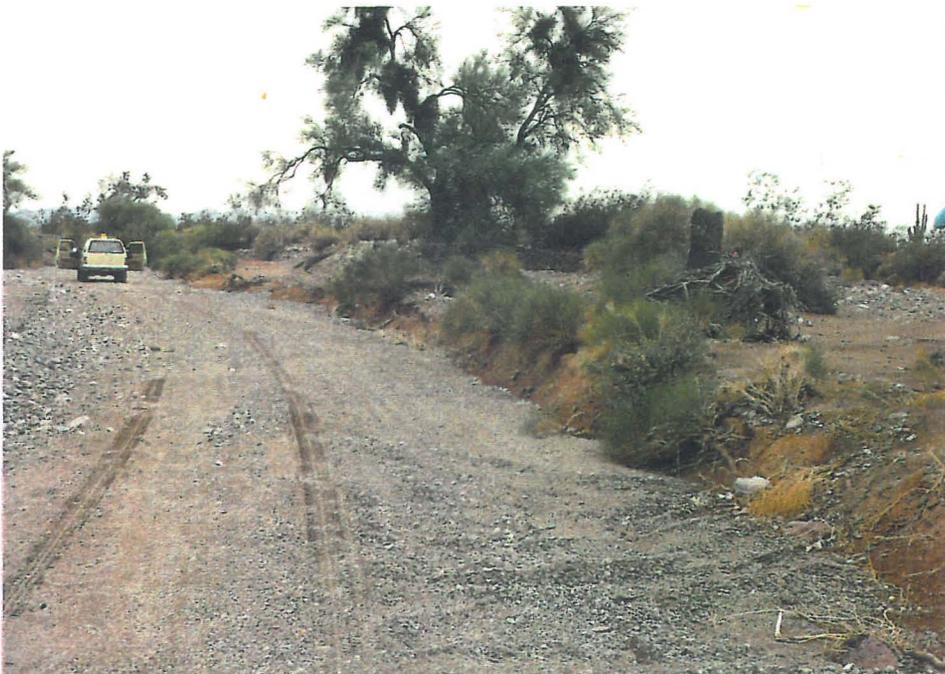
West Bank "n" = 0.080

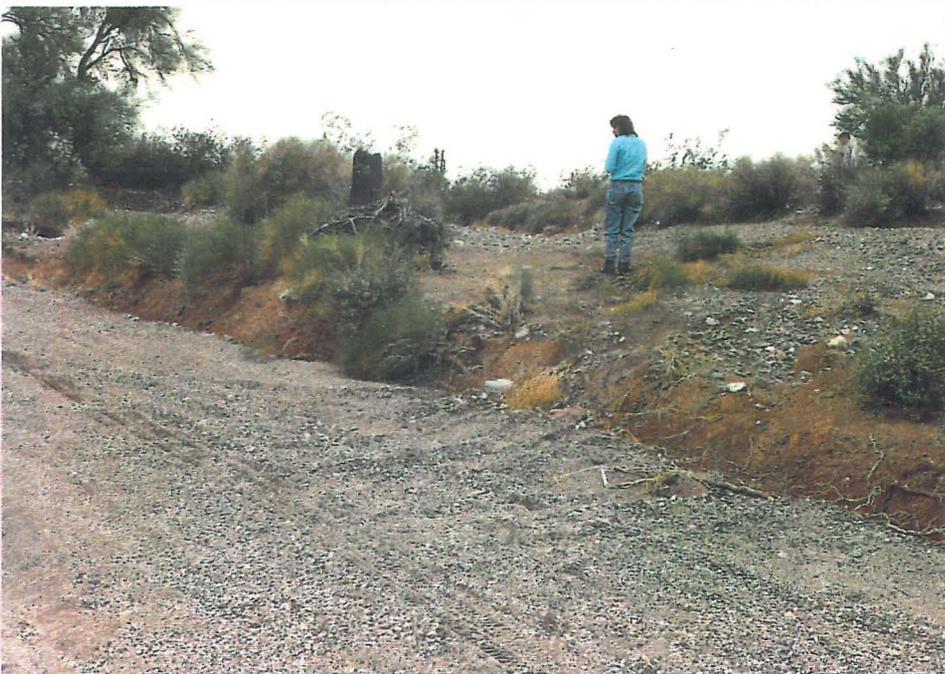
Split flow secondary channel cut in West Bank "n" = 0.050

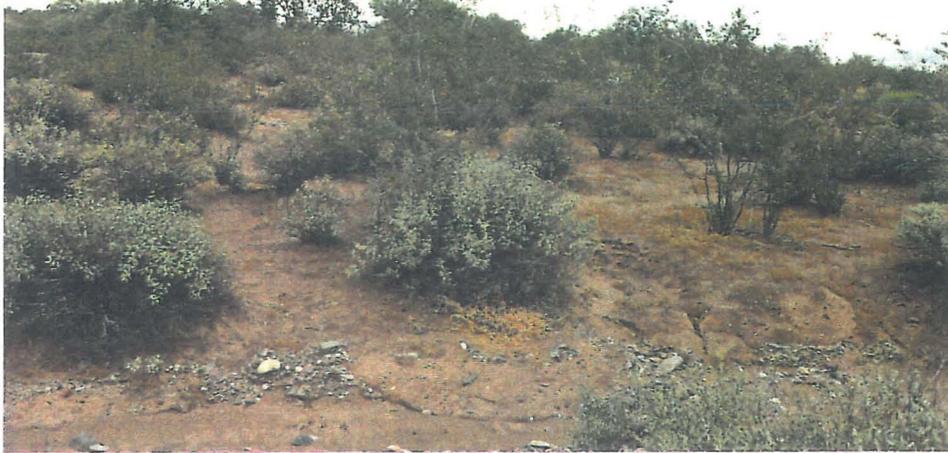
Taken on the top of split flow "island".  
Average "n" value of 0.060.

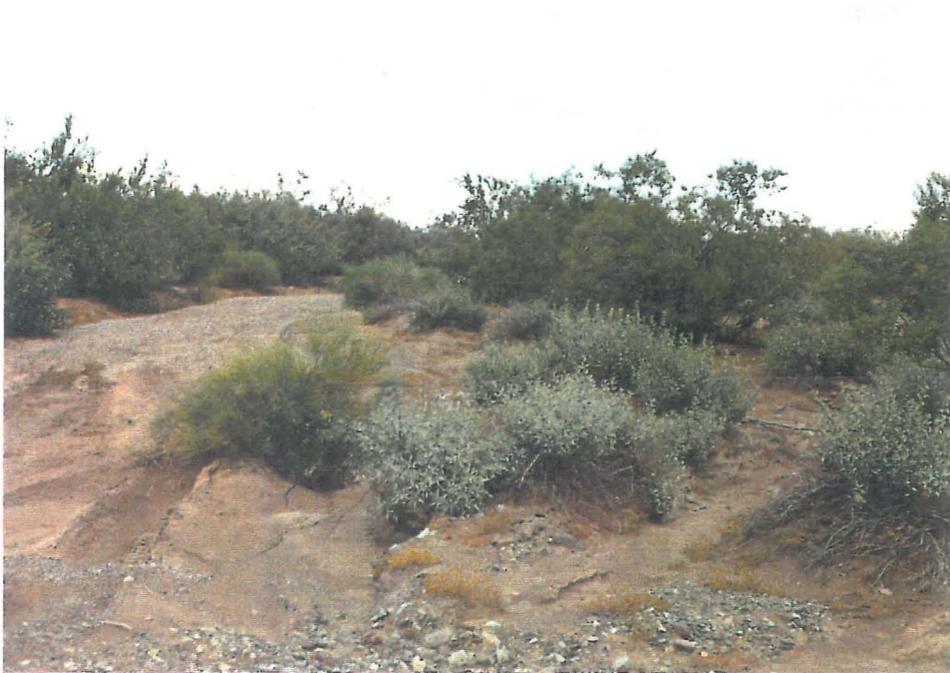
Taken in secondary channel looking north  
upstream, average "n" value of 0.060.

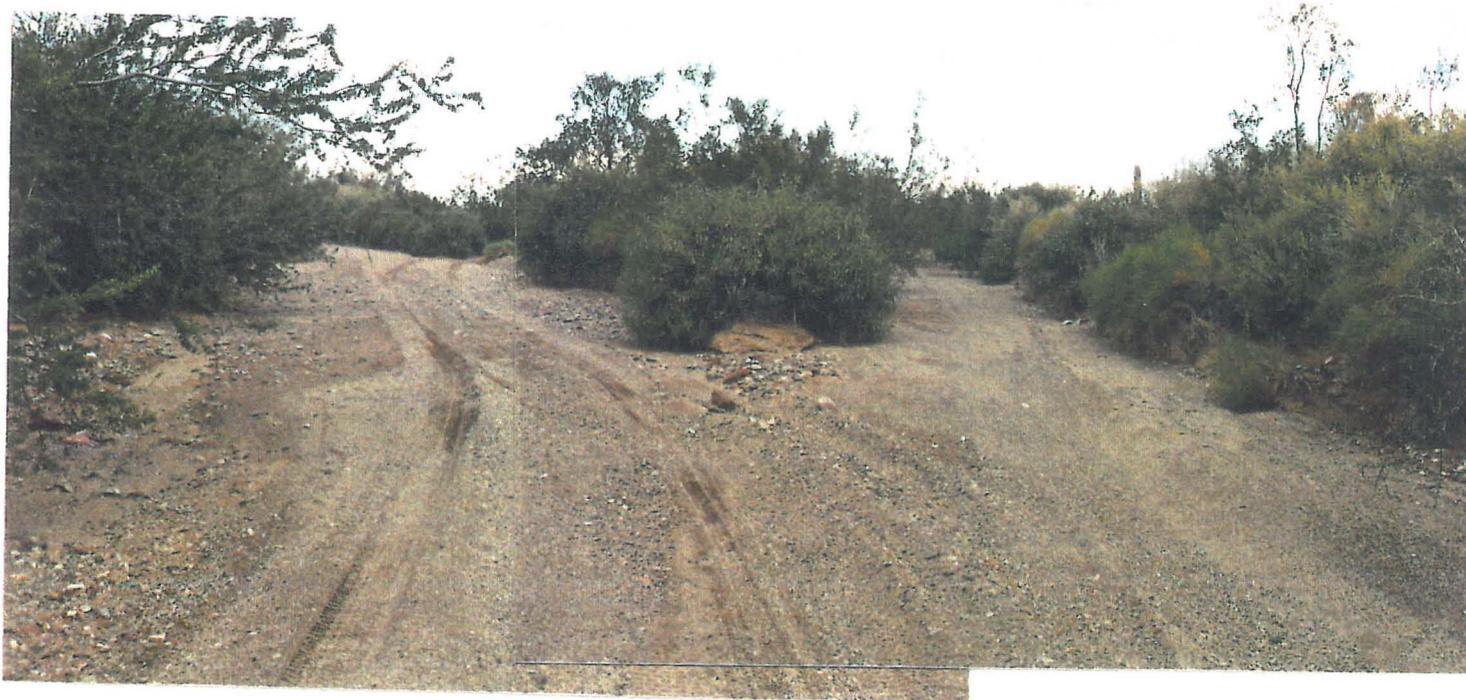
West Bank "n" = 0.10

"Island n" = 0.10

East Bank "n" = 0.10

"n" both channels 0.050

PHOTO SET 11: At split flow confluence in Trilby Wash, looking north upstream (Mileage = 2.00).

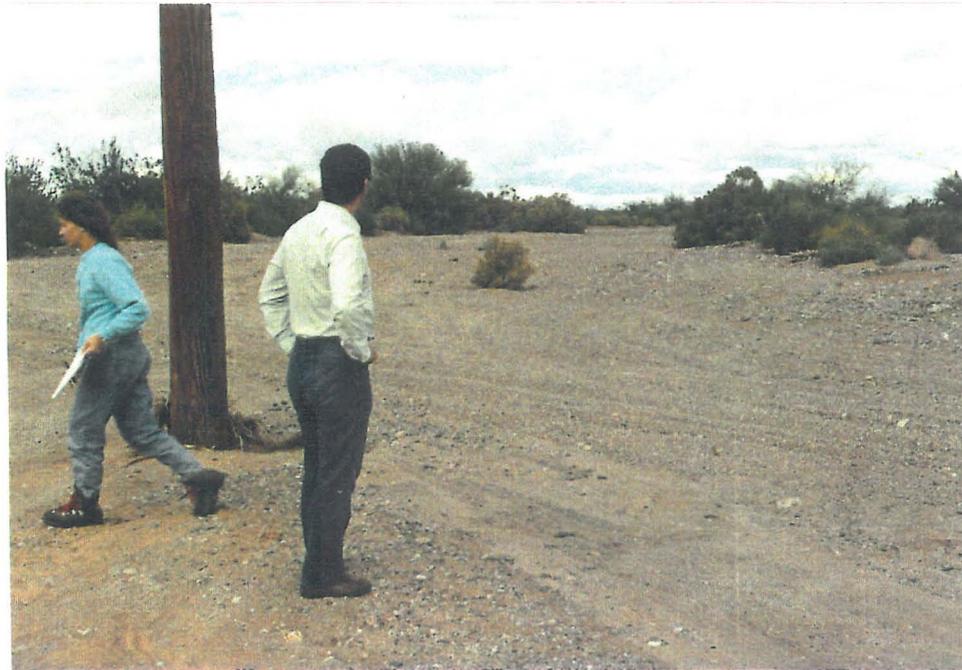
**PHOTO SET 12:** At Lone Mountain Road and Trilby Wash looking north upstream (Reset mileage at 0.0) Average "n" = 0.070.

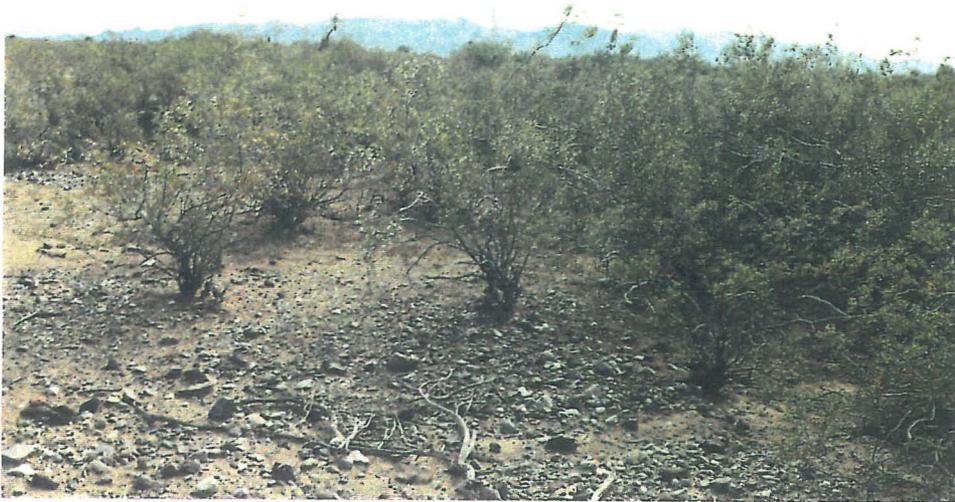
**PHOTO SET 13:** In Trilby Wash looking south downstream.

East Bank "n" = 0.080

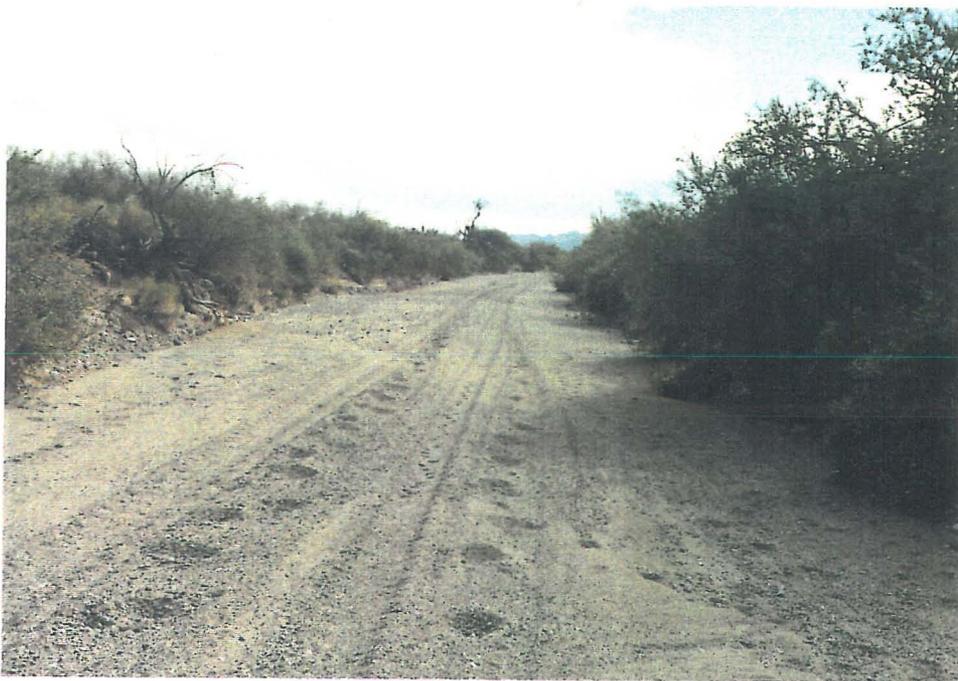
Main Channel "n" = 0.040

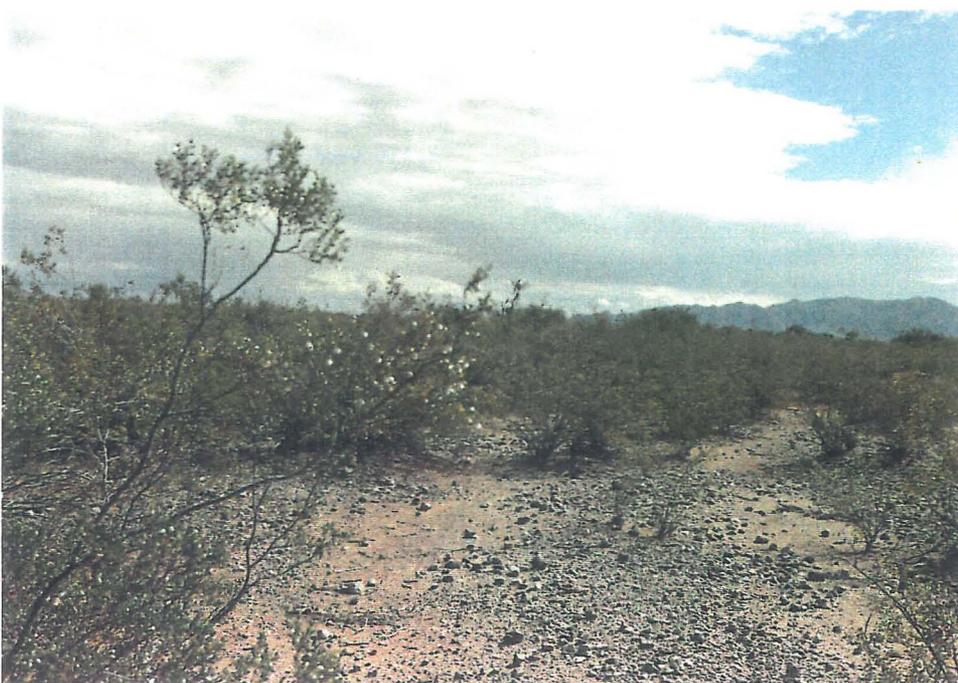
West Bank "n" = 0.080

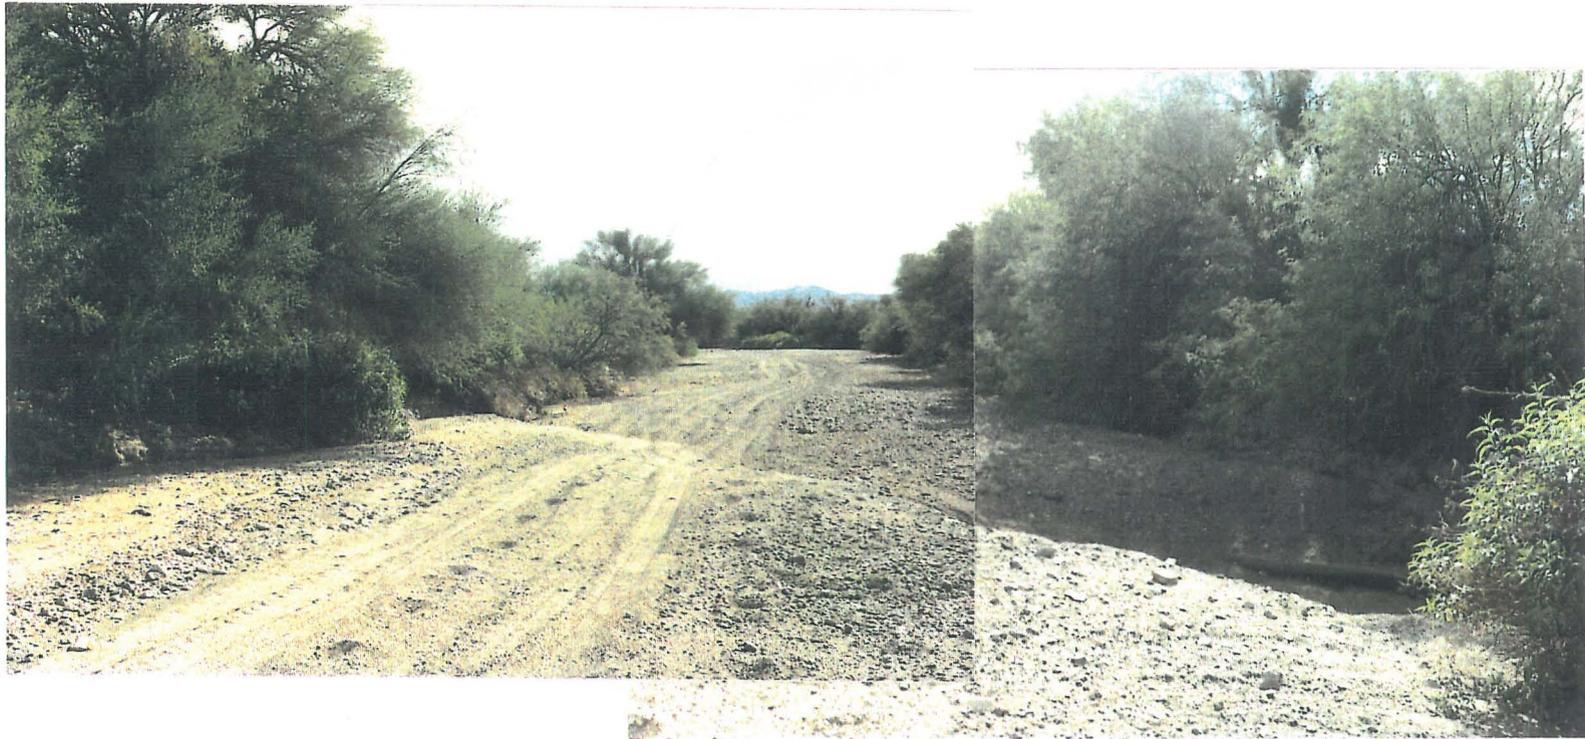
East Bank "n" =0.080

Main Channel "n" = 0.055

West Bank "n" =0.095

**PHOTO SET 14:** In Trilby Wash looking south downstream (Mileage = 1.50).

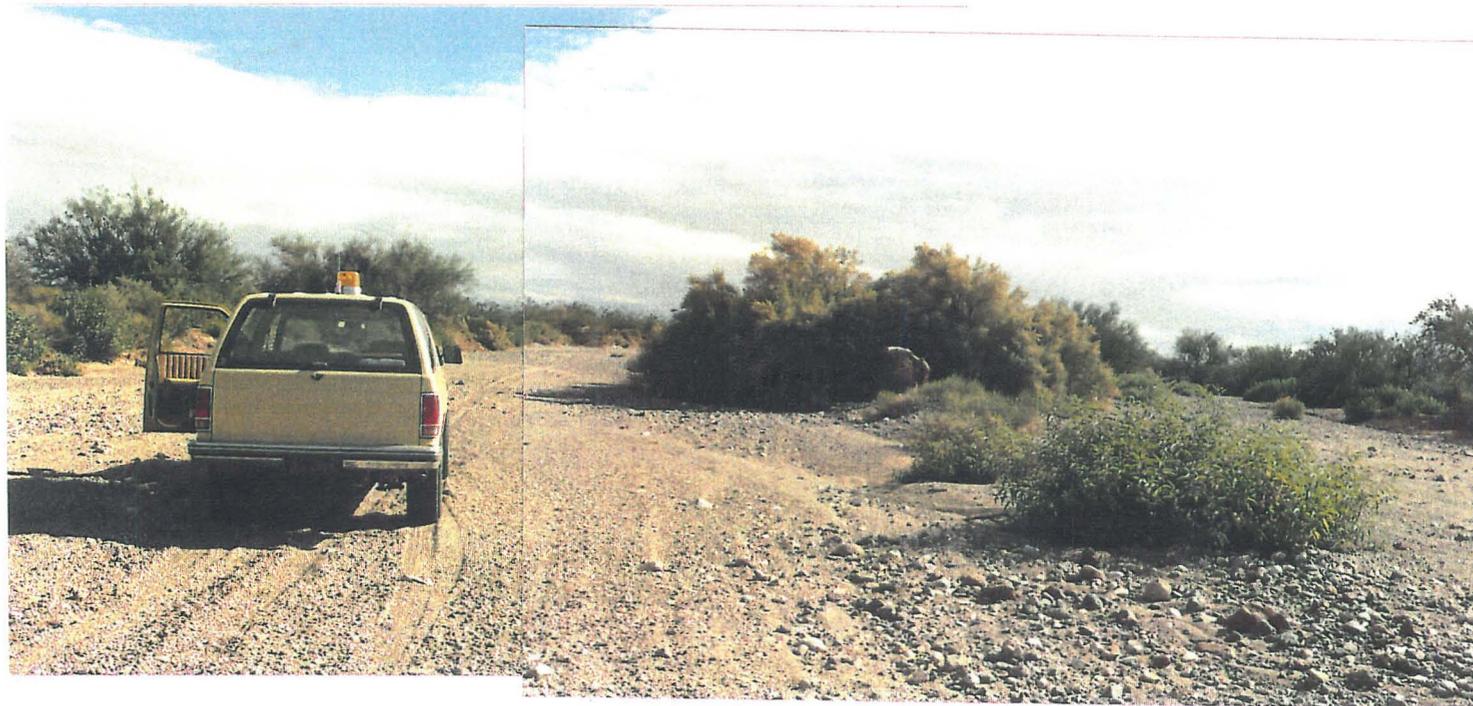
East Bank "n" =0.085    Both Channels "n" = 0.055    "Island n" =0.090    West Bank "n" =0.085

**PHOTO SET 15:** In Trilby Wash looking south downstream at minor split flow condition  
(Mileage = 1.70).
