TRILBY WASH FIS

MANNING'S "n" VALUE ESTIMATION  
FROM FIELD INSPECTION  
11/20/90

(Completion of Task 4.4.1)

NOVEMBER 27, 1990

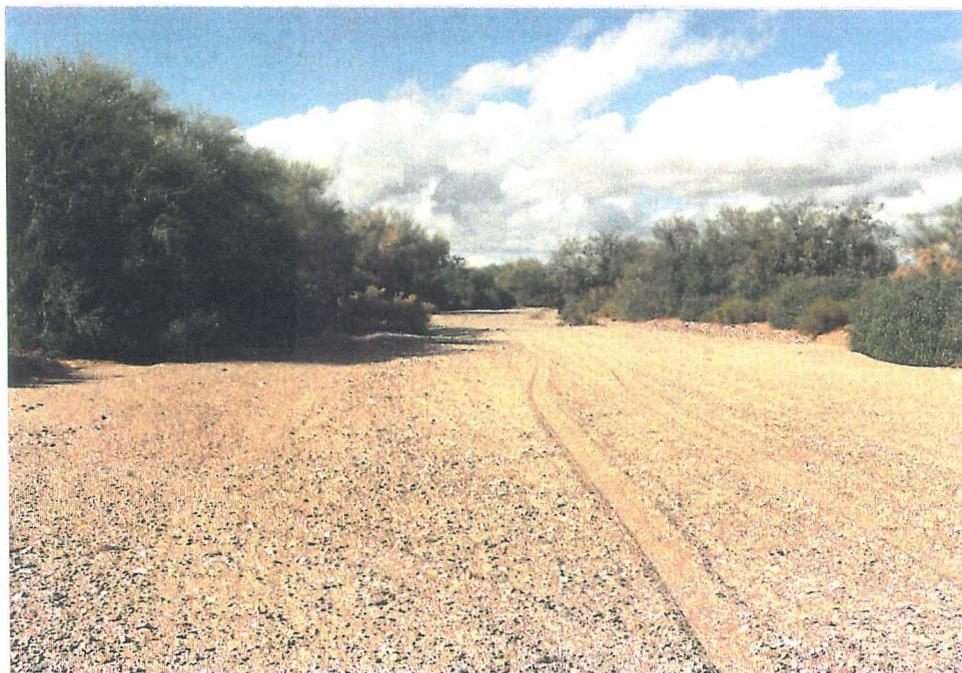
Channel "n" = 0.055

PHOTO SET 15 (Cont.): In Trilby Wash looking north upstream in main channel (Mileage = 1.70).

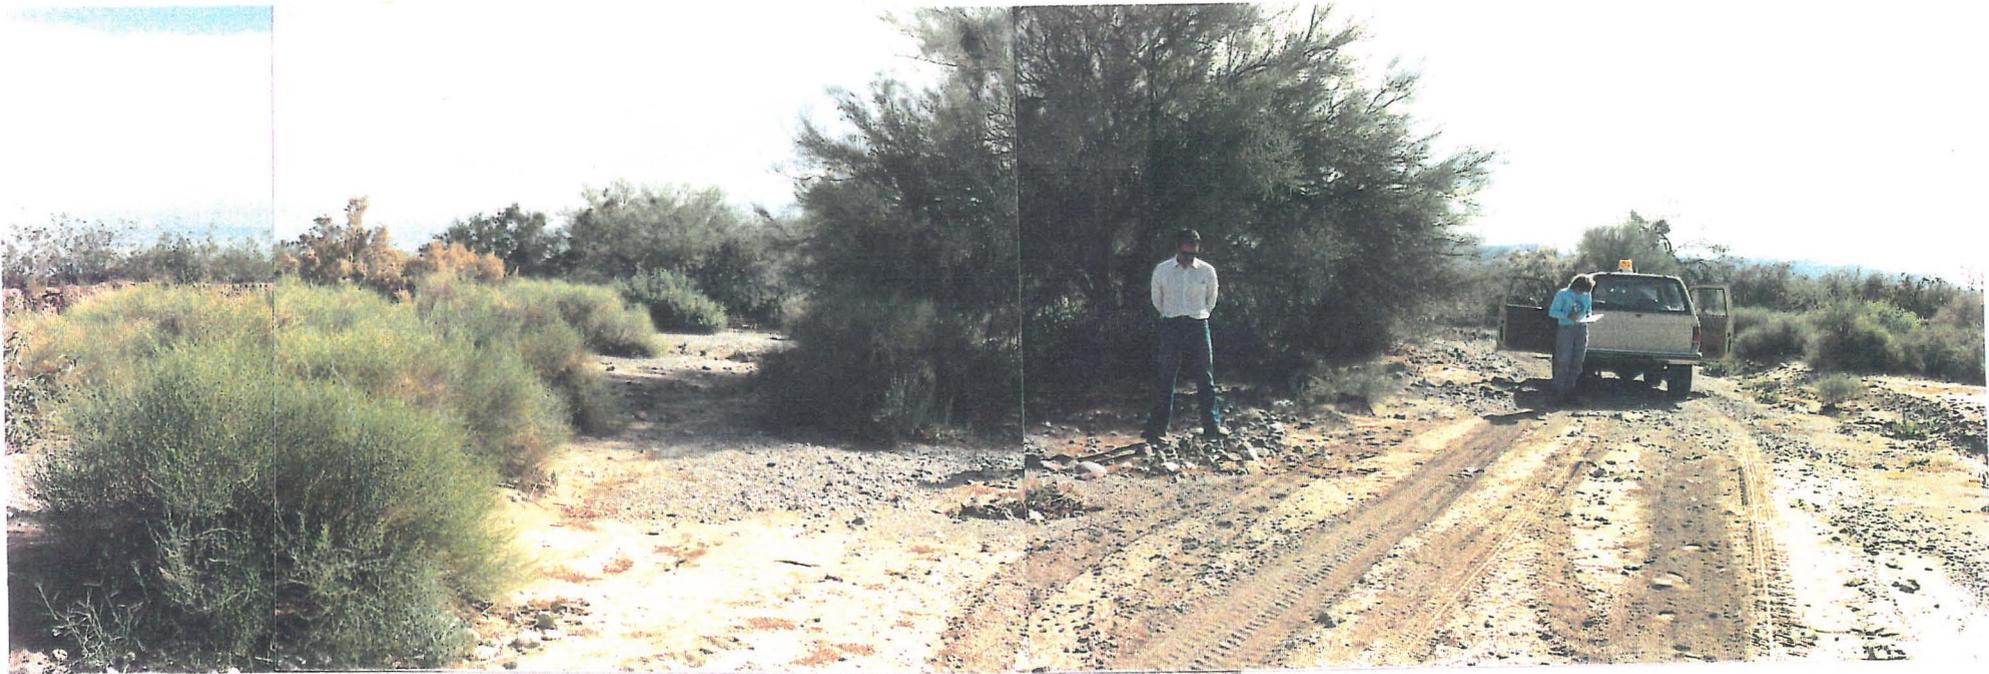
**PHOTO SET 16:** In Trilby Wash looking south downstream. Wash is braided forming several vegetated islands. The banks are steep to vertical (note: top of east bank, far left side, middle of photograph). (Mileage = 1.78)

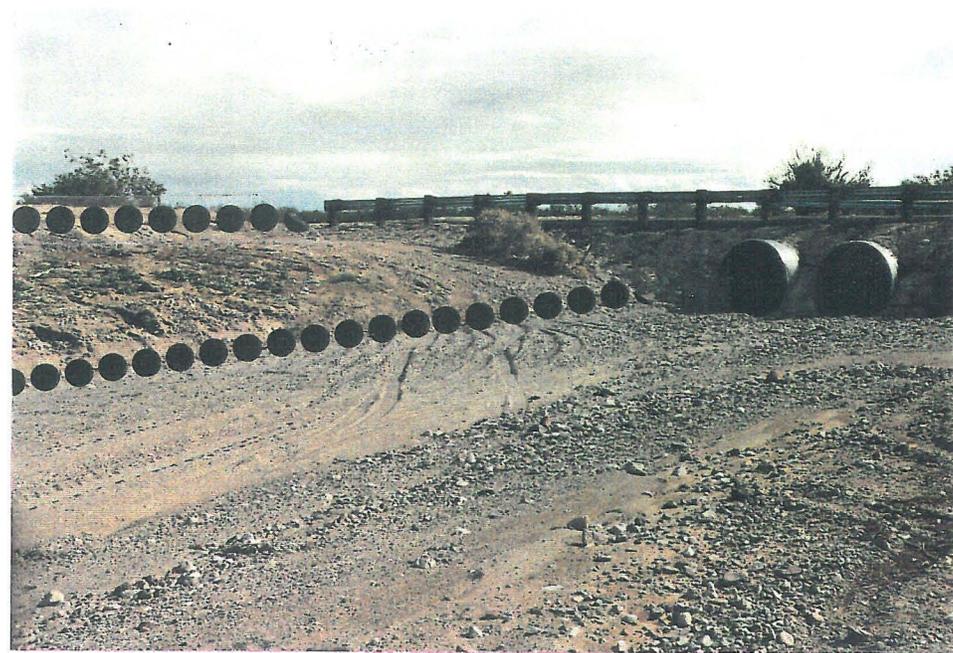
PHOTO SET 17: Patton Road crossing at Trilby Wash looking south downstream.

East slope "n" = 0.075  
East bank "n" = 0.080

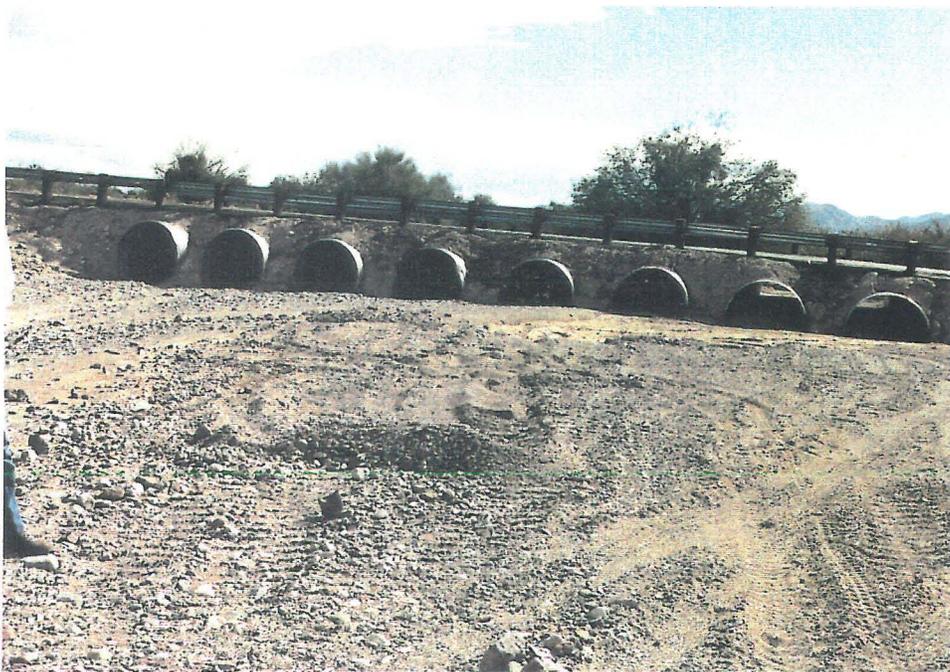
Main Channel "n" = 0.050

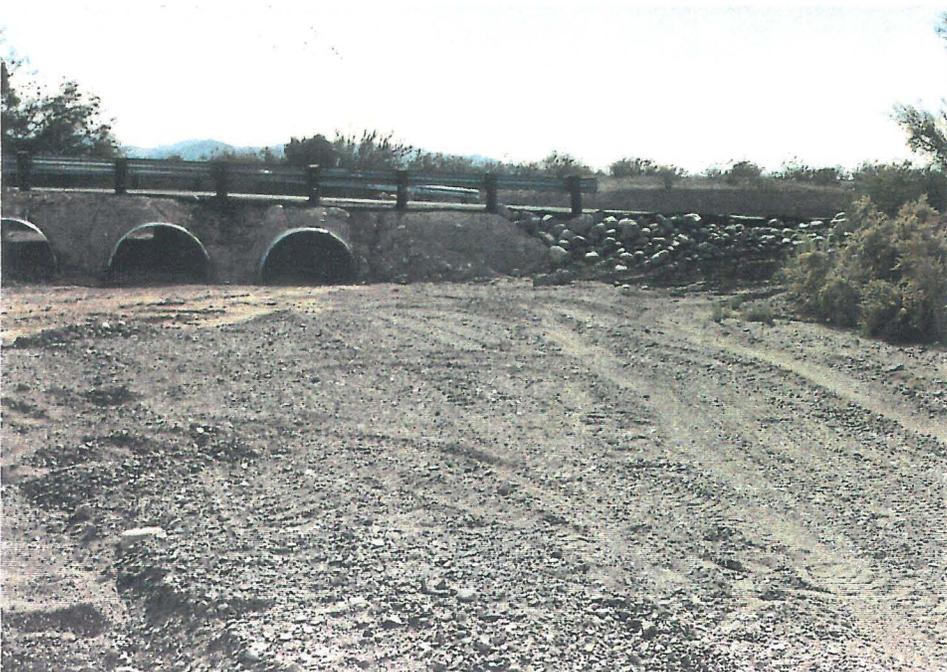
West Bank "n" = 0.080

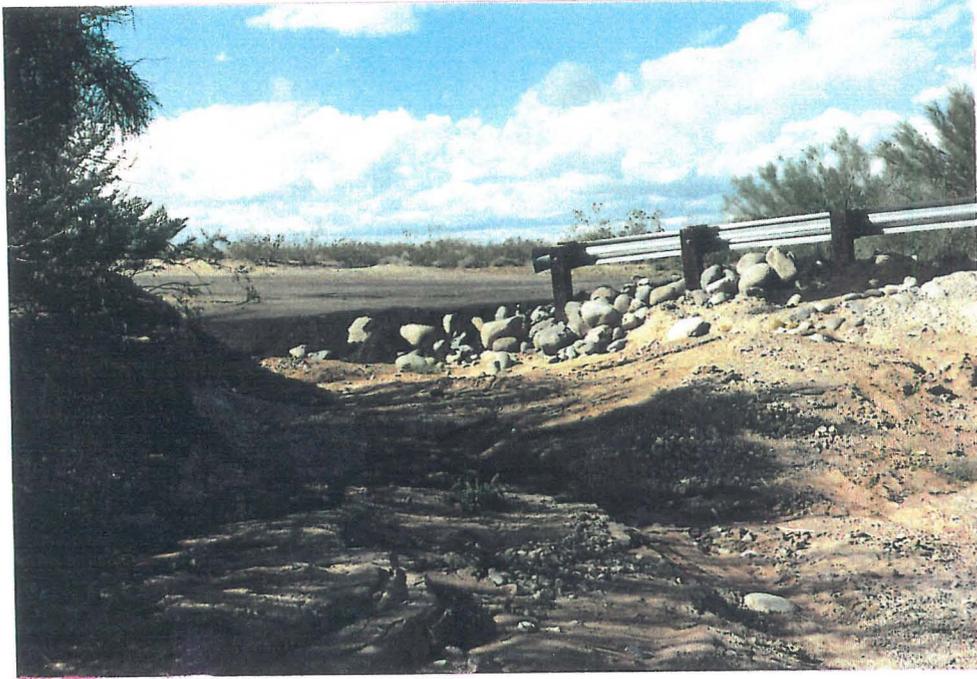
It was noted during the field inspection that the west side of Patton Road crossing the Wash has a small dip in it. Also noted, was the fact that the west side of the Patton Road crossing of Trilby Wash had been damaged from overbank flooding and erosion. This was evidenced by a very recent patch job on the West side of the wash/roadway crossing as well as undercutting of previously placed concrete bank protection. As a result, it appears that for purposes of modelling the Patton Road crossing and dip section appear to form a weir structure during periods of high flow. This is further illustrated in Photo Set 18, in Appendix I.

Water appears to flow over Patton Road on the west side of culvert crossing as evidenced by road and bank undercutting.

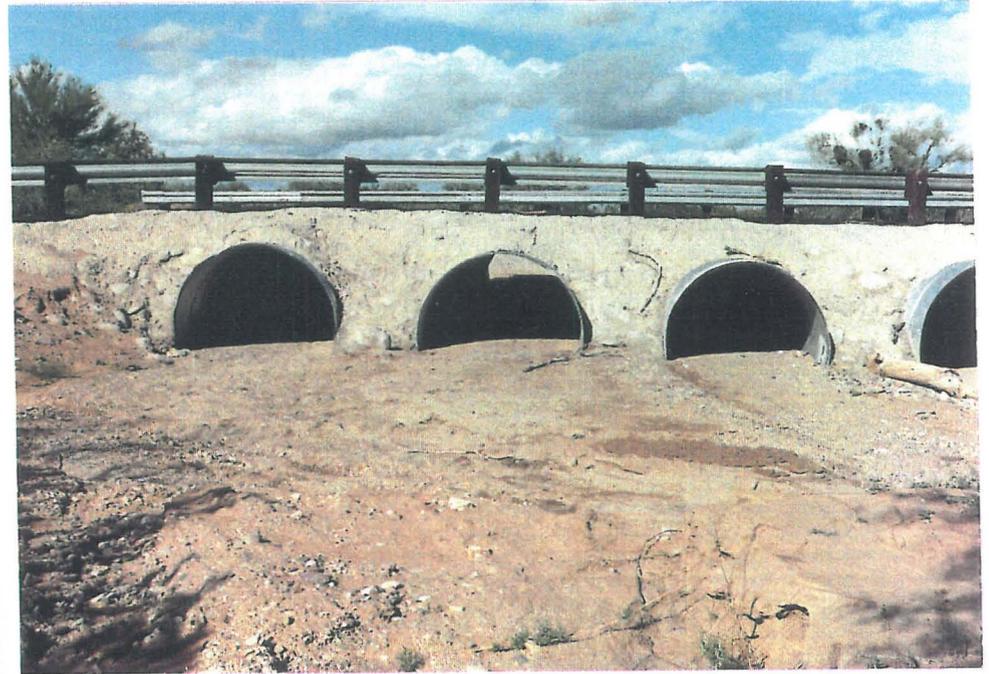
Main Channel "n" = 0.050  
Note: sediment deposition in culverts

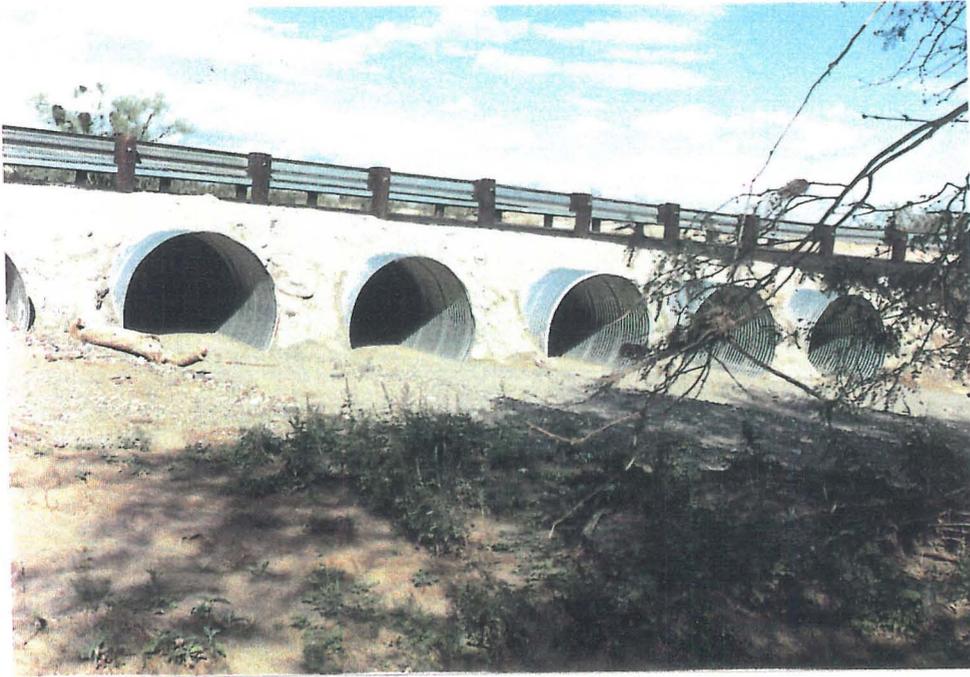
PHOTO SET 18: Patton Road crossing at Trilby Wash looking north upstream (Reset mileage = 0.0).

Main Channel "n" = 0.050

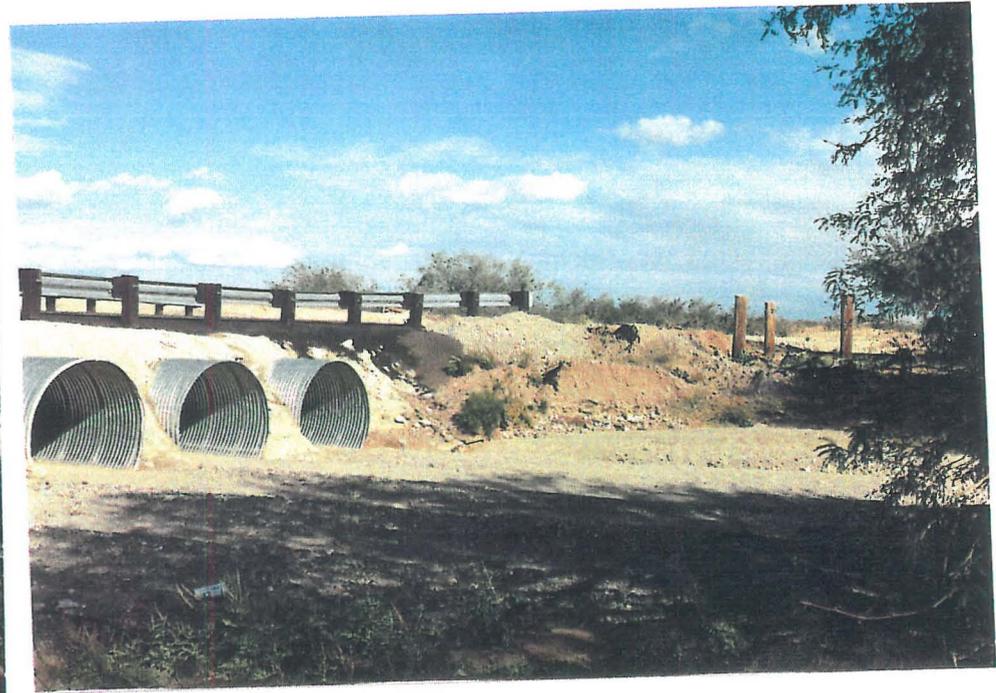
East Bank "n" = 0.085

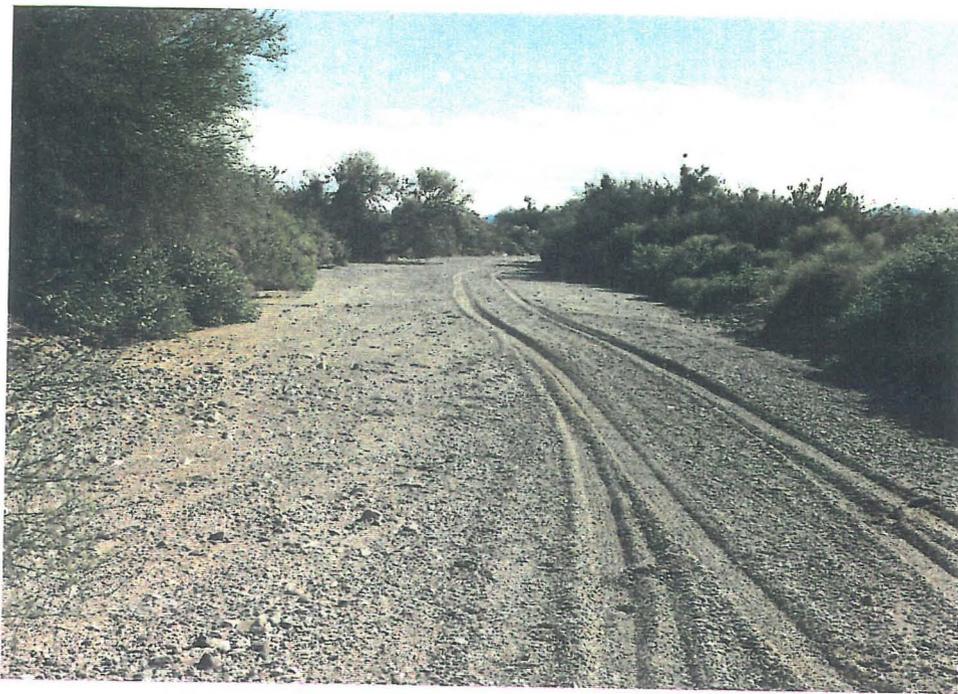
PHOTO SET 19: Photo taken at centerline of Patton Road crossing Trilby Wash looking south downstream.

East Bank "n" = 0.085

Channel "n" = 0.050

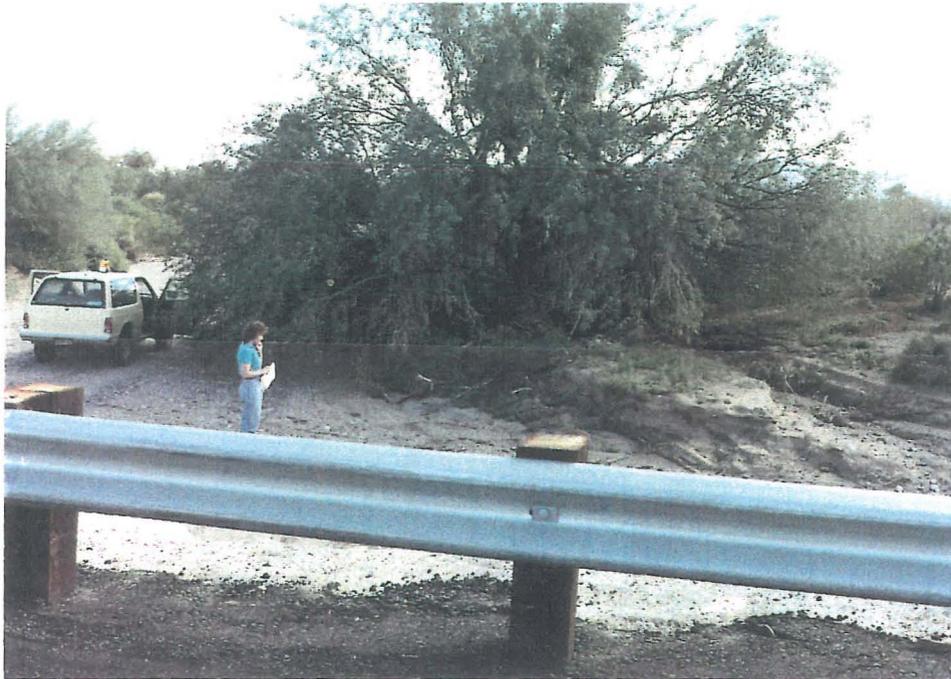
Channel "n" = 0.050  
West Bank "n" = 0.085

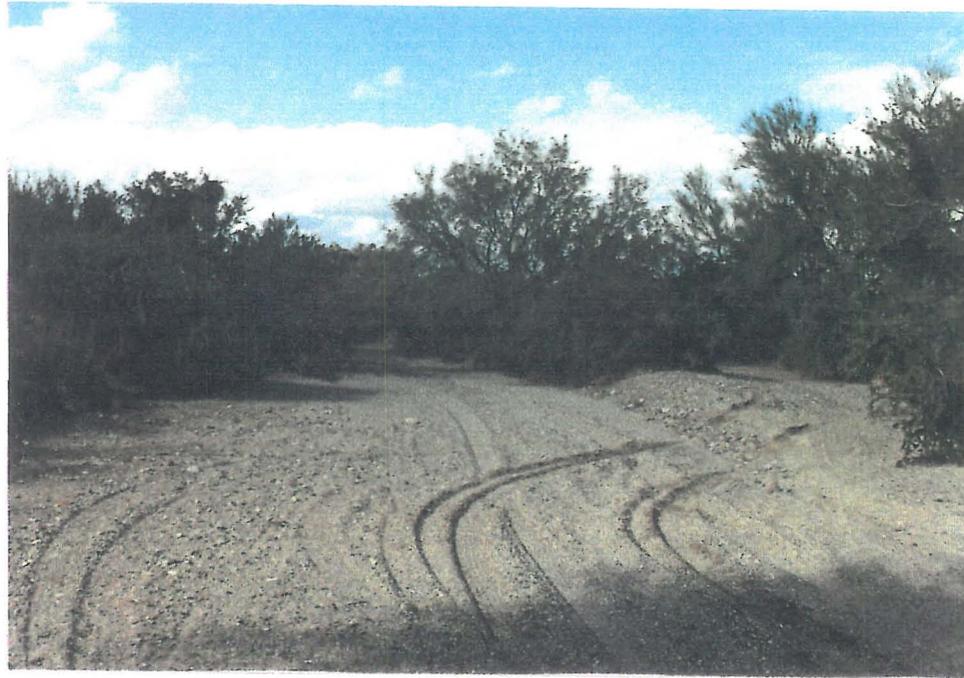
West Bank "n" = 0.085      Channel "n" = 0.055      East Bank "n" = 0.090

**PHOTO SET 20:** In Trilby Wash looking north upstream at typical island (Mileage = 1.09).

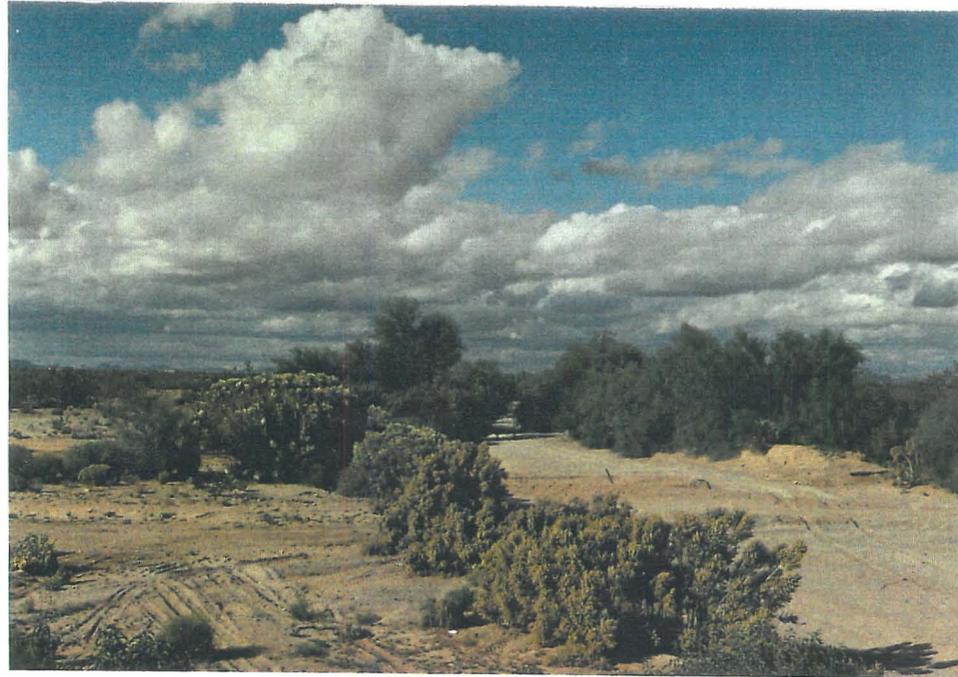
West Bank "n" = 0.085

Channel "n" = 0.060

East Bank "n" = 0.090

**PHOTO SET 21:** CAP crossing at Trilby Wash looking north upstream. Photo taken from on top of west wall of CAP Flume Structure. (Mileage = 1.25)

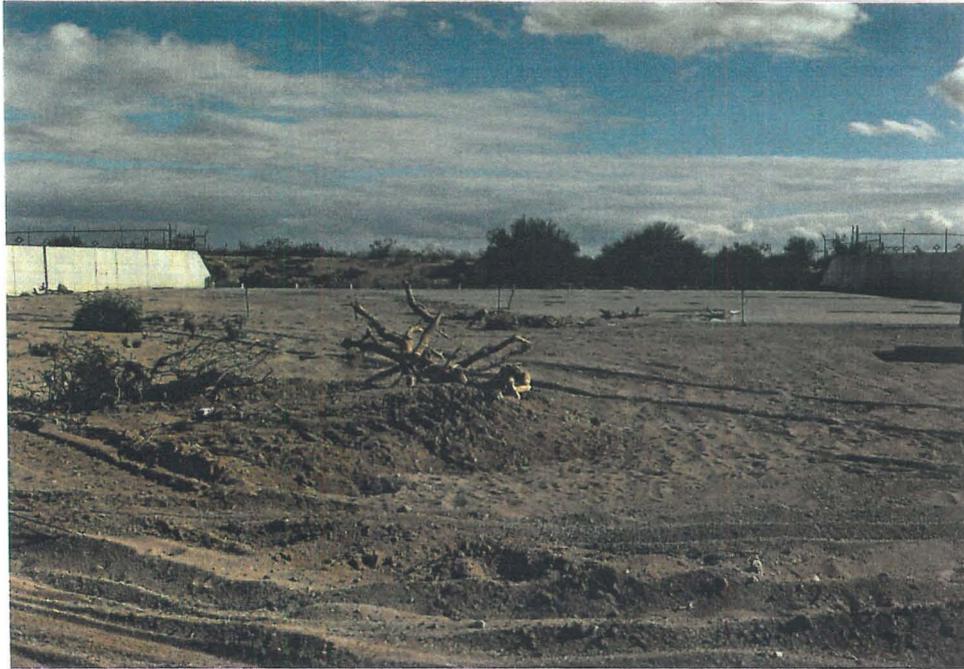
Prior to concrete CAP crossing, channel "n" = 0.065  
At CAP crossing Flume is a concrete lined rectangle channel "n" = 0.013 (Match "n" values with previous study by The WLB Group, Inc.)

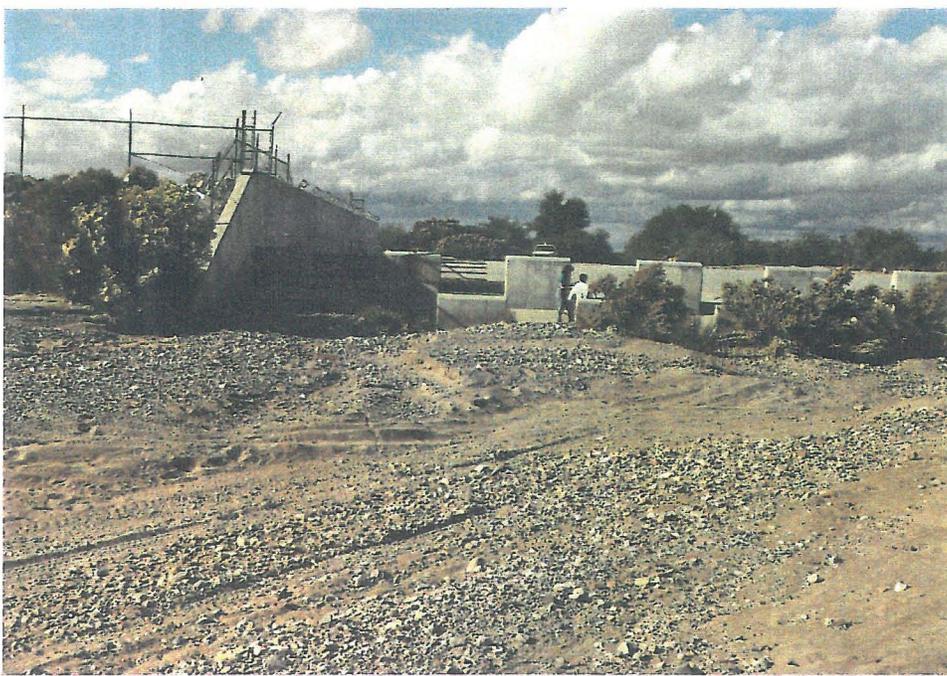
PHOTO SET 22: CAP Crossing at Trilby Wash looking south downstream (Mileage = 1.25)

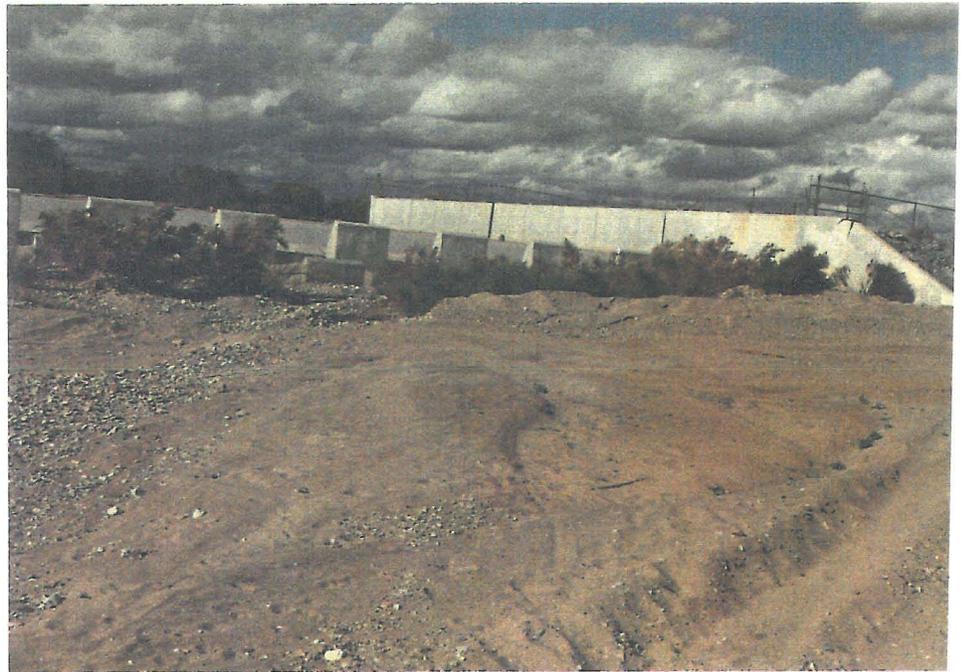
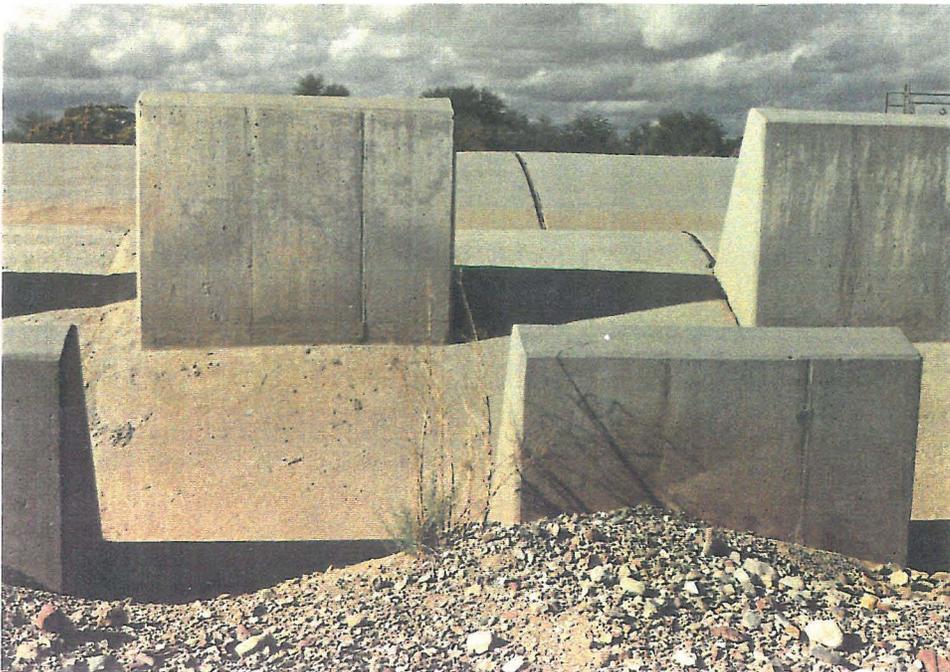
PHOTO SET 23: Downstream from concrete CAP crossing at Trilby Wash looking north upstream. (Match "n" values with previous study by The WLB Group).
