**Trilby Wash Detention Basin**  
**ENVIRONMENTAL SITE ASSESSMENT**  
**FOR**  
**FLOOD CONTROL DISTRICT**  
**OF**  
**MARICOPA COUNTY**

### EXECUTIVE SUMMARY

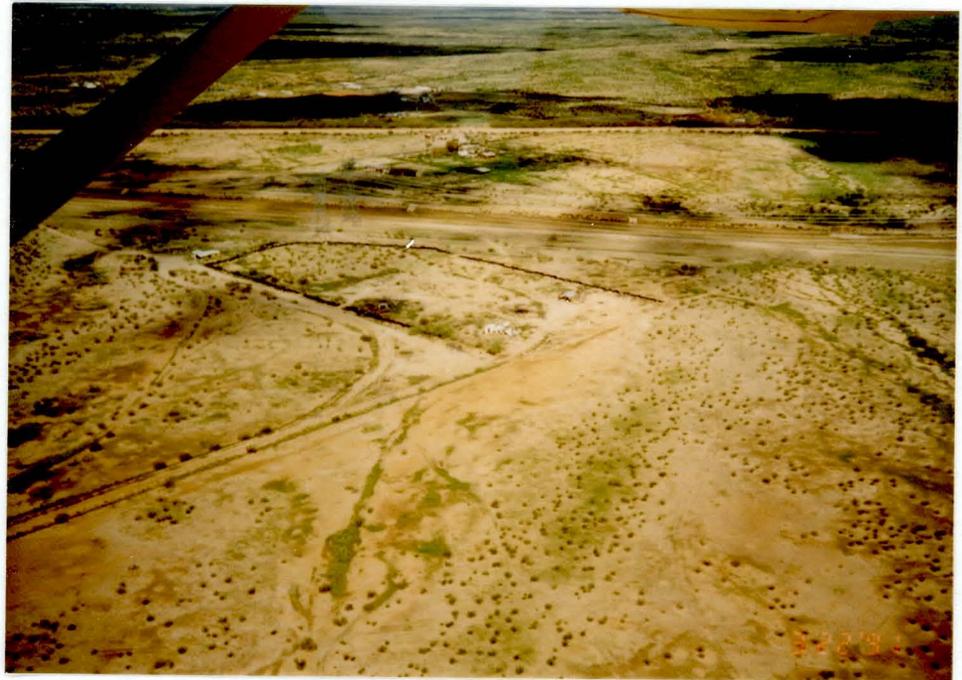
Aerial view of the area south of the Property in Section 9 of T4N, R1W, where buildings, dumping, and old tires are located.

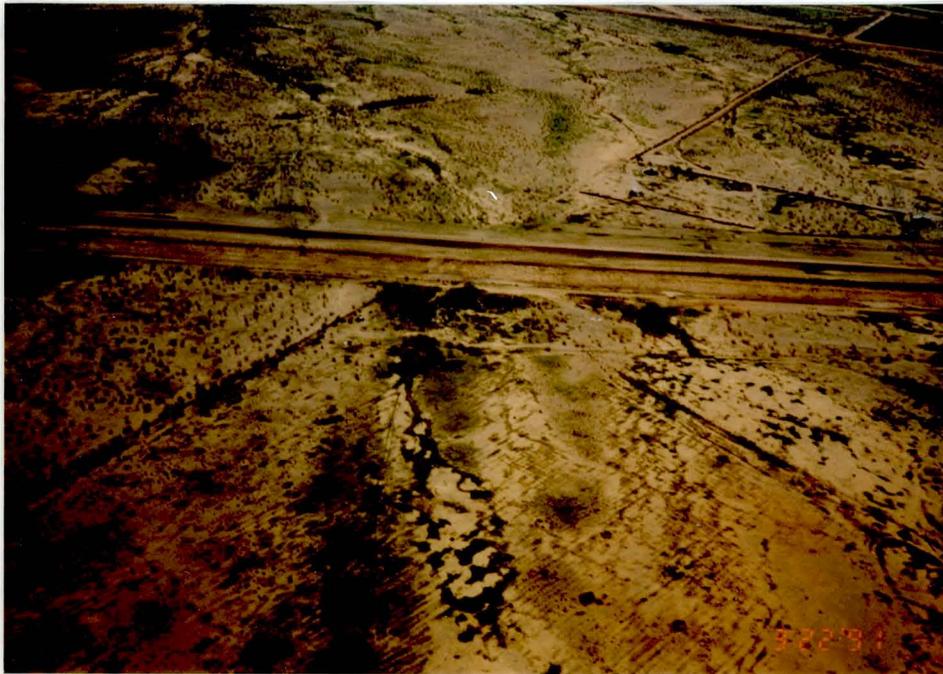
Dump Area No. 1 is located at the west end of the Property. The area has been used for dumping domestic garbage. There are several 55-gallon drums in this area. All of the drums are open ended drums that are rusted and empty with no labels. Also identified in the area are old car bodies and parts, lumber, and three to four 5-gallon cans that are empty and rusted with no identification. A photograph of Dump Area No. 1 is contained in Appendix D.

Aerial view of Dump Area No. 1 in Section 18 or T4N, R1W.

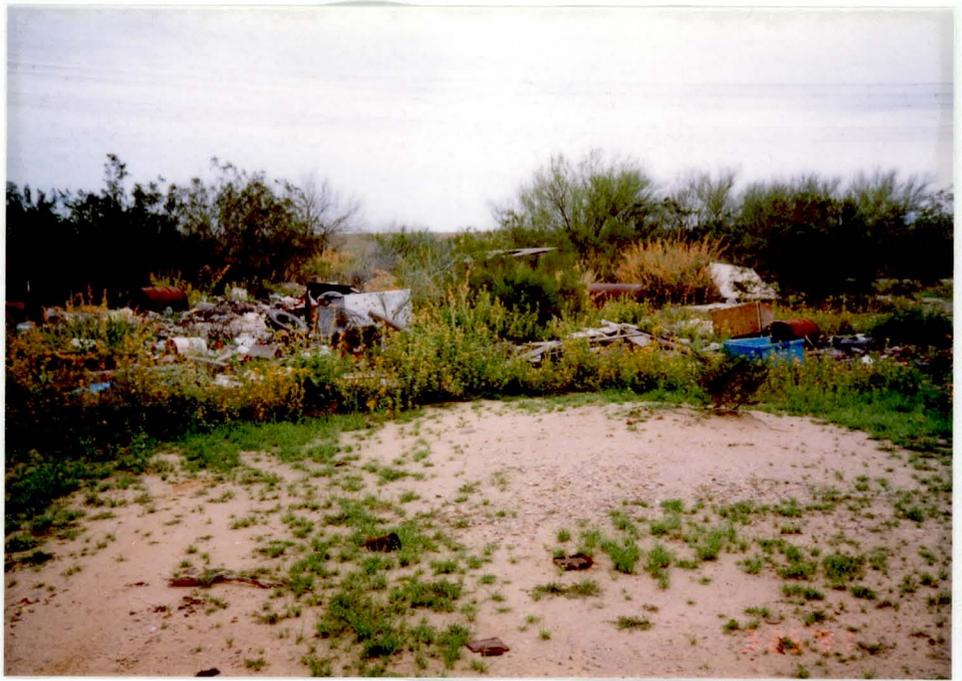
Photograph illustrating  
Dump Area No. 1 in Section  
18 of T4N, R1W.

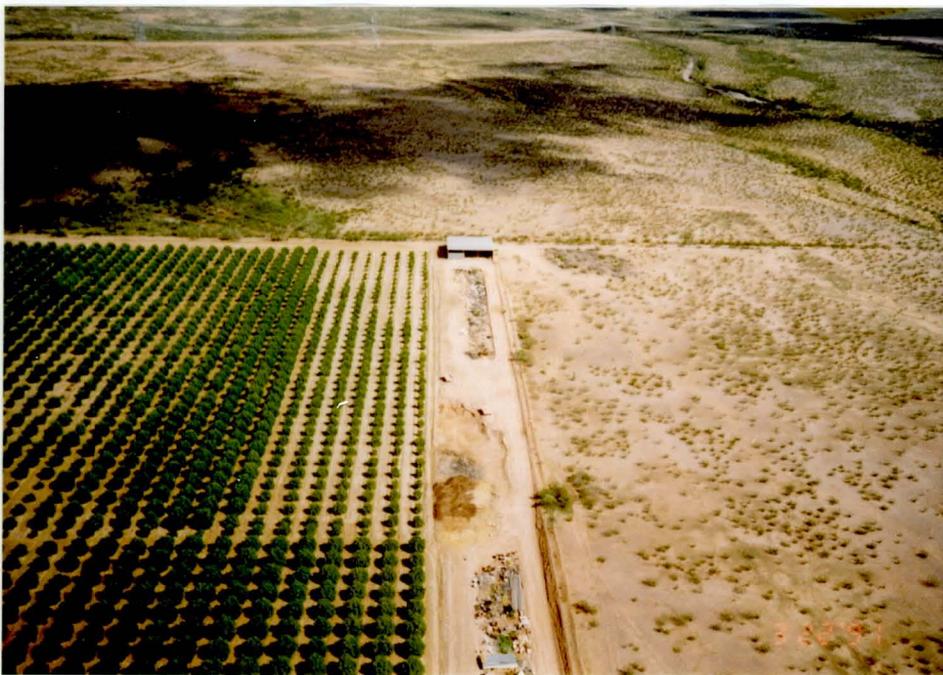
The west half of Section 14 is composed of the Bodine Citrus Grove. At the northeast corner of the grove is a trench, designated as Dump Area No. 3, where 55-gallon drums are being dumped. Refer to Appendix D, Site Photographs, for illustrations of the

Aerial view of Dump  
Area No. 3 near the  
Bodine citrus grove in  
Section 14 of T4N, R1W.

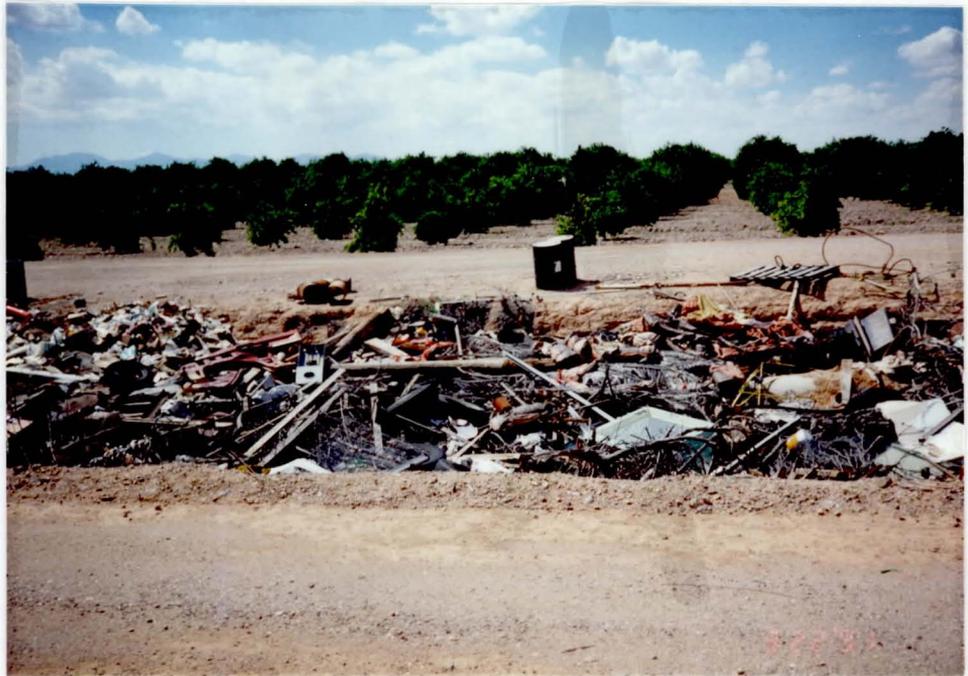
dumping. The trench was not accessible for investigation at the time of the assessment. There are several 55-gallon drums of unknown contents in the trench. Most of the drums are rusty, open-ended and appear to be empty. At the north end of the trench are three large pole-mounted type of transformers sitting on the ground. The transformers did not appear to be leaking, as shown in the Site Photographs in Appendix D. South of the trench is an area where the following is stored: smudge pots, pesticide and fertilizer sprayers, and some more 55-gallon drums of unknown contents. Refer to Appendix B, Topographic Maps, for the location of Dump Area No. 3.

Photograph of two 55-gallon drums of unknown content at Dump Area No. 3 in Section 14 of T4N, R1W.

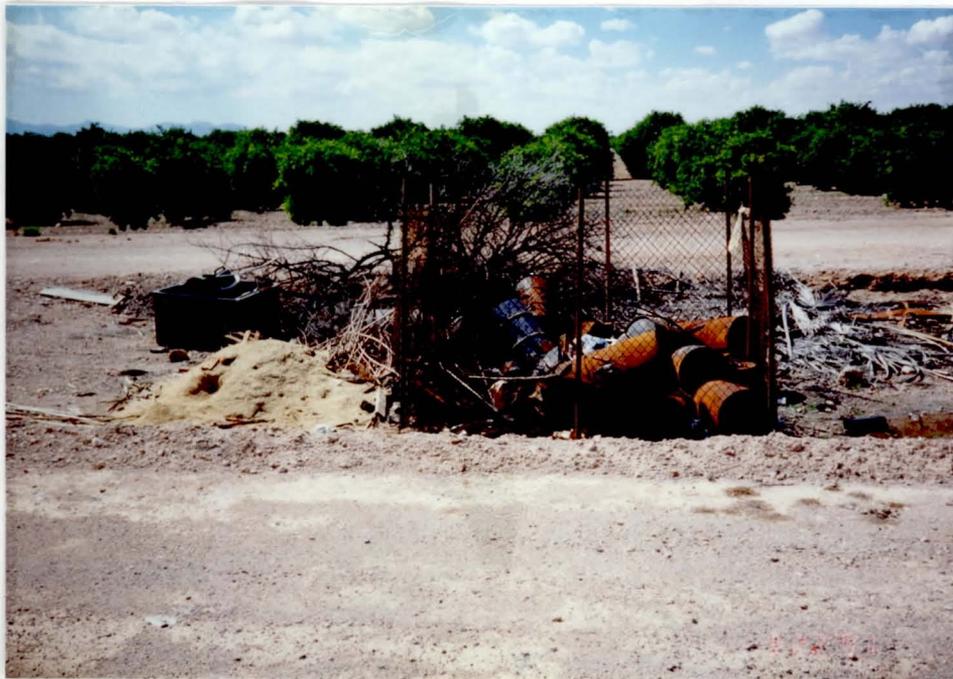
Old rusty, empty 55-gallon drums located at Dump Area No. 3.

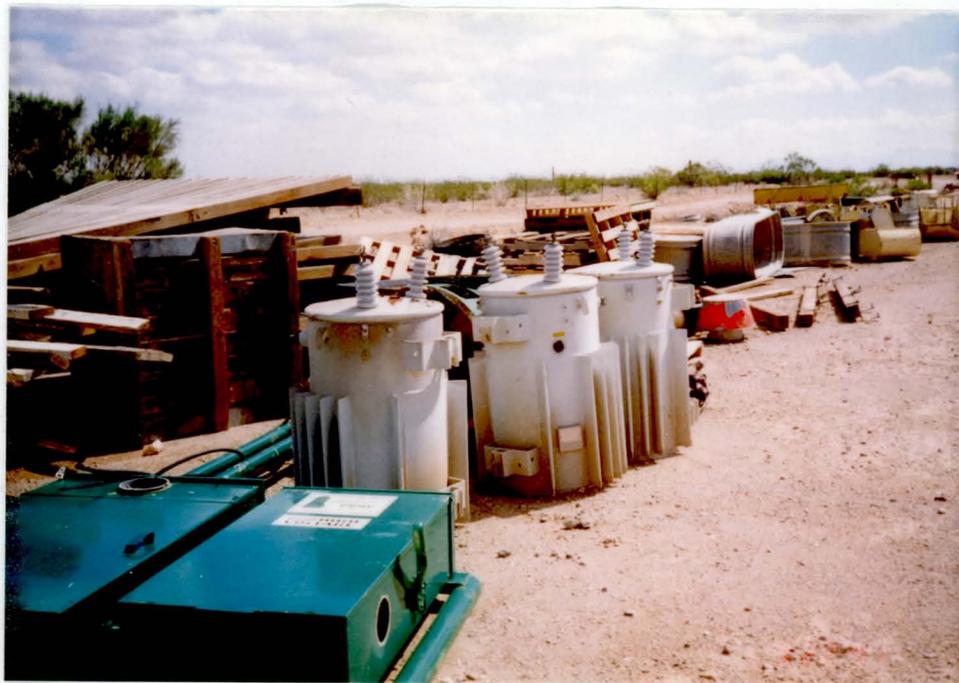
Three transformers located at Dump Area No. 3 located near the citrus grove in Section 14, T4N, R1W.

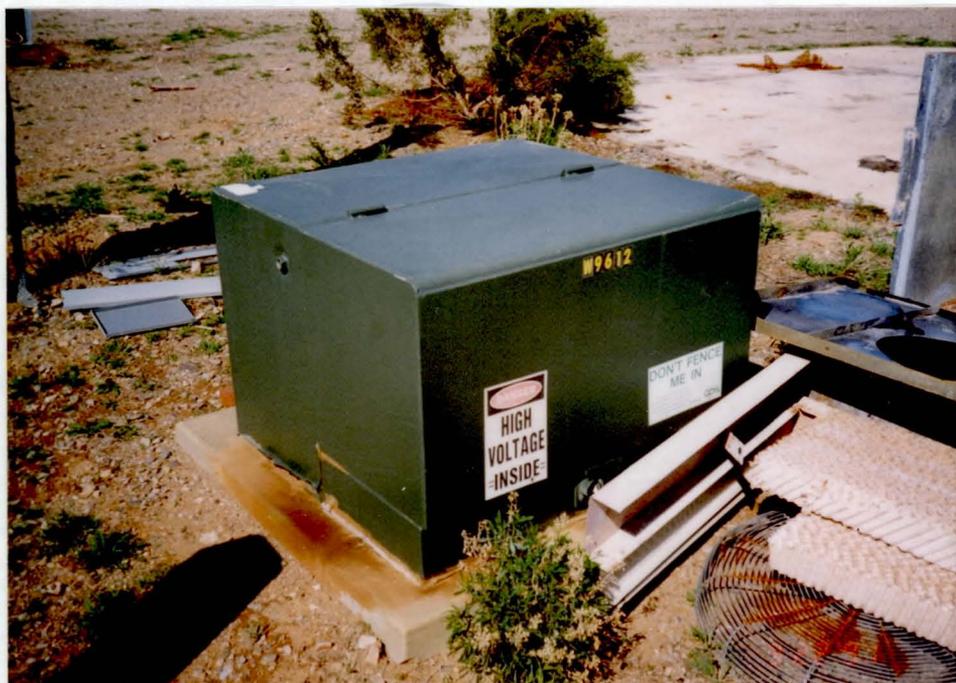
Located south of the Property is a second landing strip. Dumping of domestic garbage was identified near this landing strip, but no drums that could potentially contain hazardous materials were visually observed. At the west end of the landing strip is a house that has been abandoned. The inside of the house has been stripped and vandalized. The house is a wood frame with stucco on the exterior, gypsum dry-wall interior walls, and has a concrete floor, as shown in the Site Photographs included as Appendix D. A shed-type structure is located west of the house and is constructed of wood and a concrete floor. There is an above ground storage tank for water near a well located east of the house. There is a transformer on a concrete pad near the well, that has a dark oily-type of stain on the concrete pad indicating that the transformer may have leaked in the past, as shown in the Site Photographs included as Appendix D. A second pad-mounted transformer is located west of the house. This transformer did not show signs of having leaked dielectric fluid.

Transformer near the well by the landing strip south of the Property in Section 9 of T4N, R1W. Note the oily stain on the concrete pad.

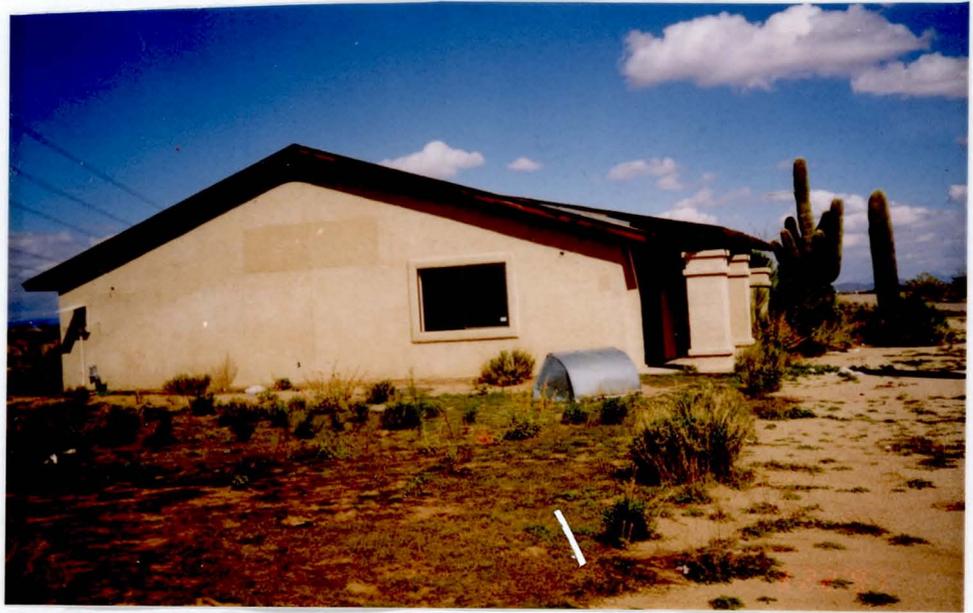
The house located near the landing strip south of Section 9 of T4N, R1W.

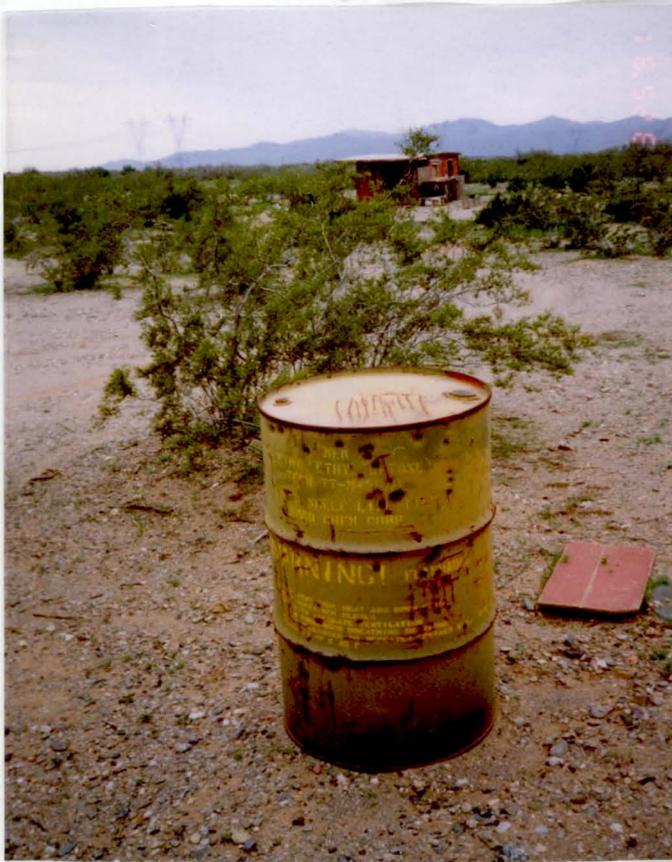
Located at the northwest end of the Property is a small, circular race track. The track is paved with asphalt and there are tires surrounding the entire track. East of this track is a small landing strip for airplanes with a red painted building at the west end. The building is in a state of disrepair. There is a well for water and a small outhouse. There were two 5-gallon paint cans and two of 55-gallon drums that are rusted and empty identified near the building. One of the empty 55-gallon drums was labeled as methyl ethyl ketone.

The empty 55-gallon drum located near the red building by the landing strip on the Property in Section 9 of T4N, R1W. The drum is labeled as having contained methyl ethyl ketone.

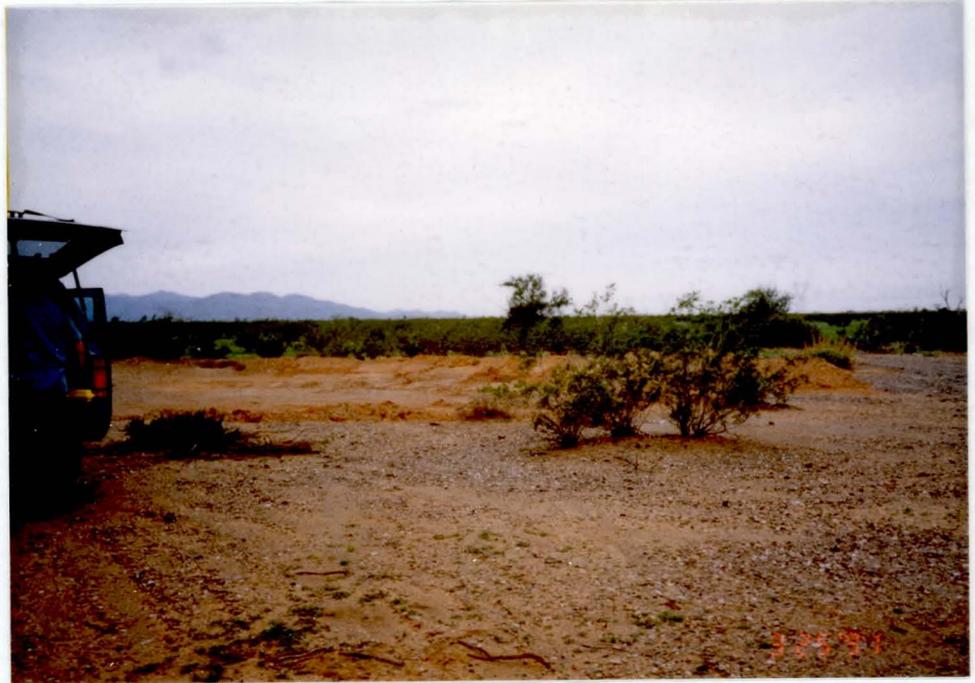
Dump Area No. 2 is located south of the Property. The dump contains garbage from domestic dumping and it follows along Padelford Wash. Farther south along Padelford Wash is an area of disturbance designated as Disturbance Area No. 1, and is illustrated in the Site Photographs in Appendix D. A magnetometer scan of this area was conducted and no buried metallic debris was identified. The surface disturbance was similar to an area where a front-end loader had scraped the surface down approximately 6 to 12 inches.

Disturbed Area No. 1 located south of the Property in Section 10 of T4N, R1W.

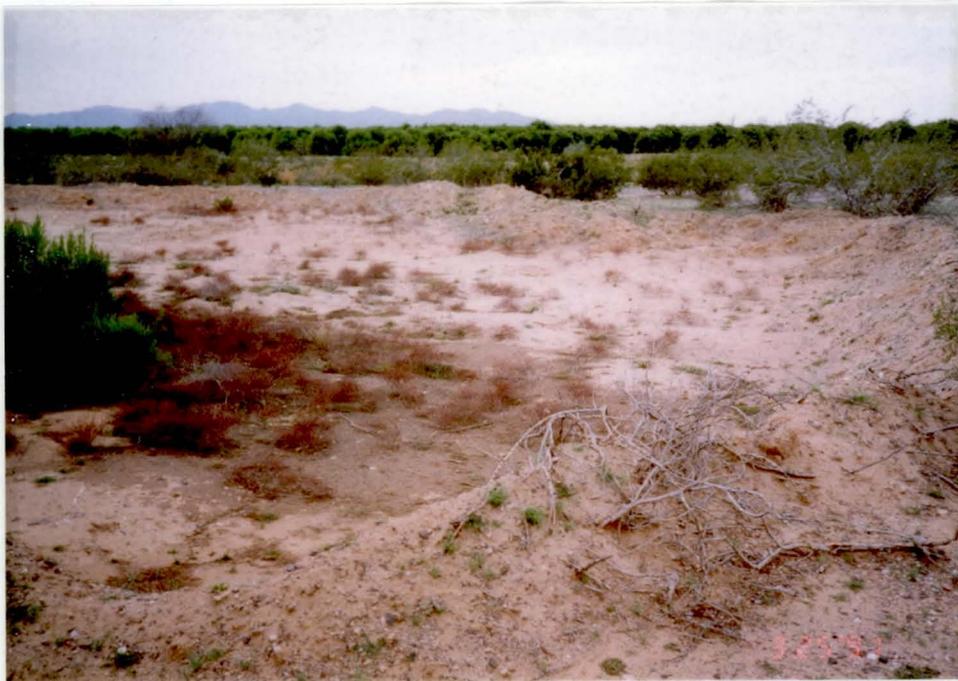
Approximately 500 yards south and west of Dump Area No. 3 is an area designated as Disturbed Area No. 2. This area has been scraped by a front end loader of some type down 6 to 12 inches. A magnetometer scan of this area did not identify any buried metallic debris. A photograph of Disturbed Area No. 2 is illustrated in Appendix D, Site Photographs.

Disturbed Area No. 2 located east of the Bodine citrus grove in Section 14 of T4N, R1W.
