**Evaluation of Soil-Cement Cracking
McMicken Dam
Flood Control District of Maricopa County
Contract FCD 2004C068
Work Assignment No. 1**

**Flood Control District of Maricopa County
Phoenix, Arizona**

**AMEC Earth and Environmental, Inc.
Tempe, Arizona**

**April 13, 2006
AMEC Job No. 6-117-001007**

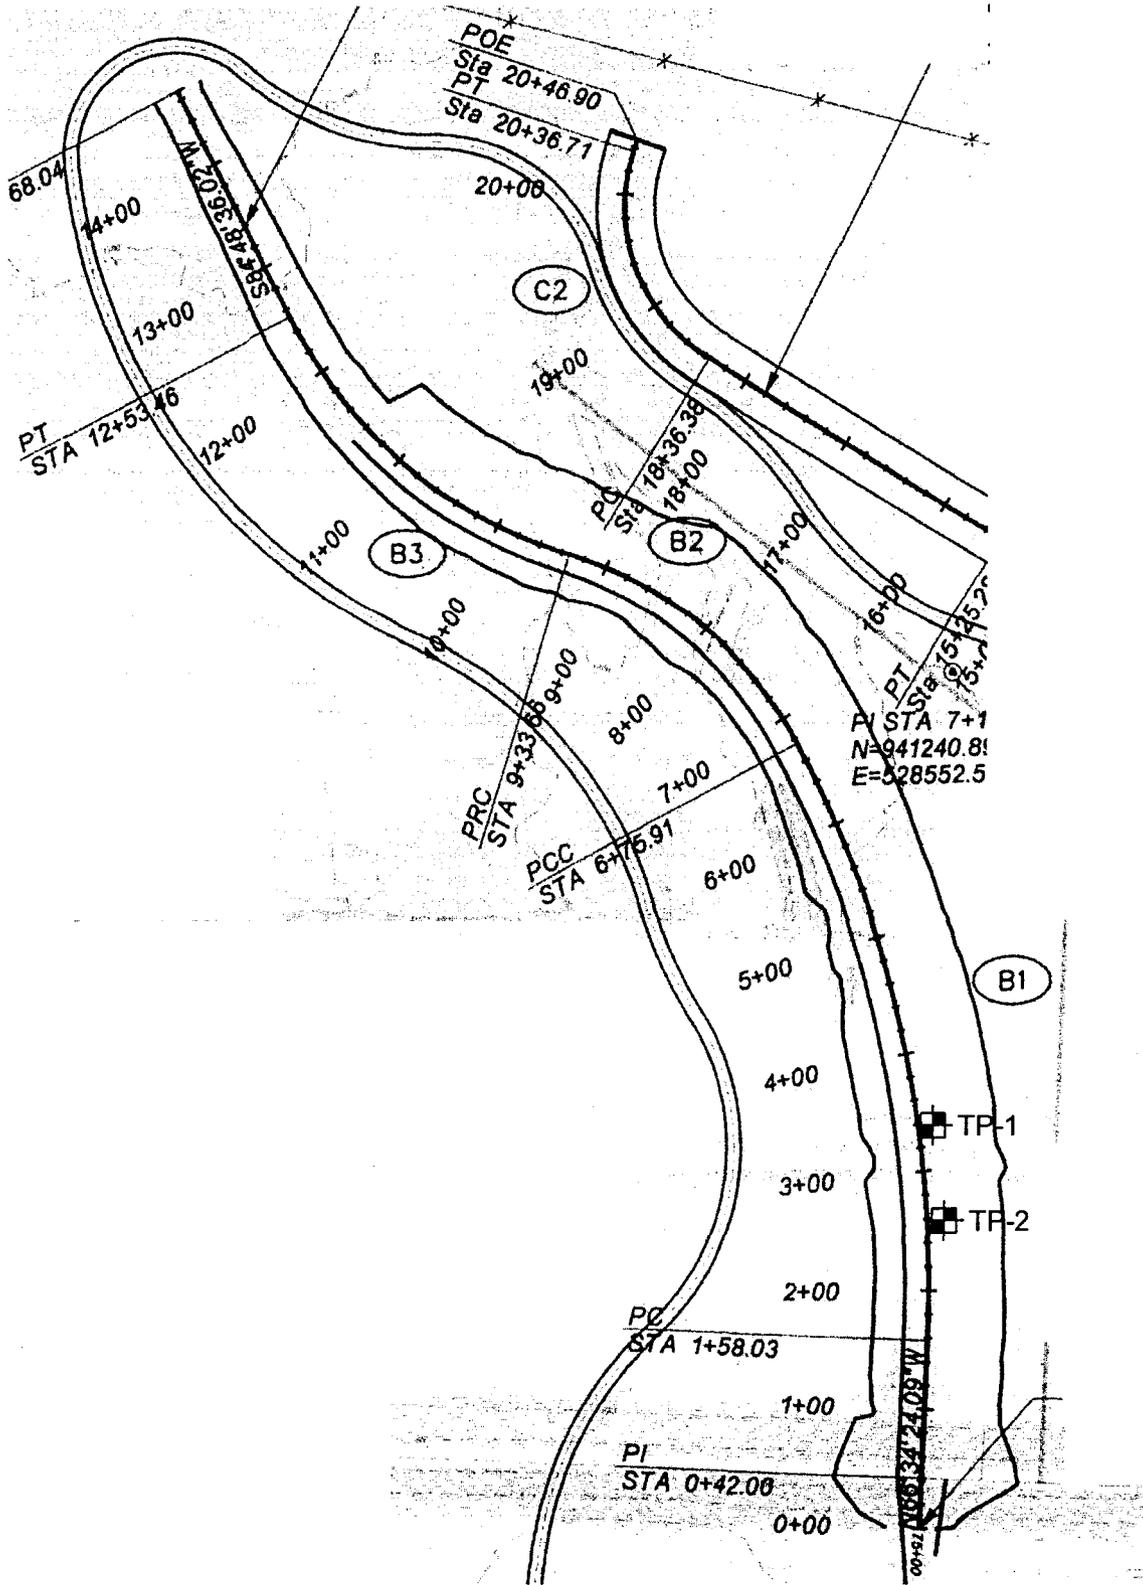
SITE MAP SHOWING TEST PIT LOCATIONS	
McMICKEN DAM - SOIL CEMENT CRACK EVALUATION	FIGURE 1

Two upstream test pits (TP-1 and TP-2) were excavated by means of a CAT 446B with a 24-inch bucket, provided by the District, at two crack locations that indicated the greatest open aperture at the dam crest. TP-1 was excavated at approximately dam Station 3+26 to a depth of approximately 8 feet below dam crest with a width of approximately 8 feet. TP-2 was excavated at approximately Station 2+49 to a depth of approximately 7 feet below dam crest to a width of approximately 8 feet. Both tests pits were excavated within the upstream landscape fill soils directly adjacent to the central soil cement section. Approximately 6 inches of the outer soil cement shell was removed at each crack location. Upon completion of the field investigation, the test pits were backfilled by District personnel with the previously excavated landscape fill spoils. The test pit locations are shown on Figure 1, and photographs of the test pits are presented in Appendix A.

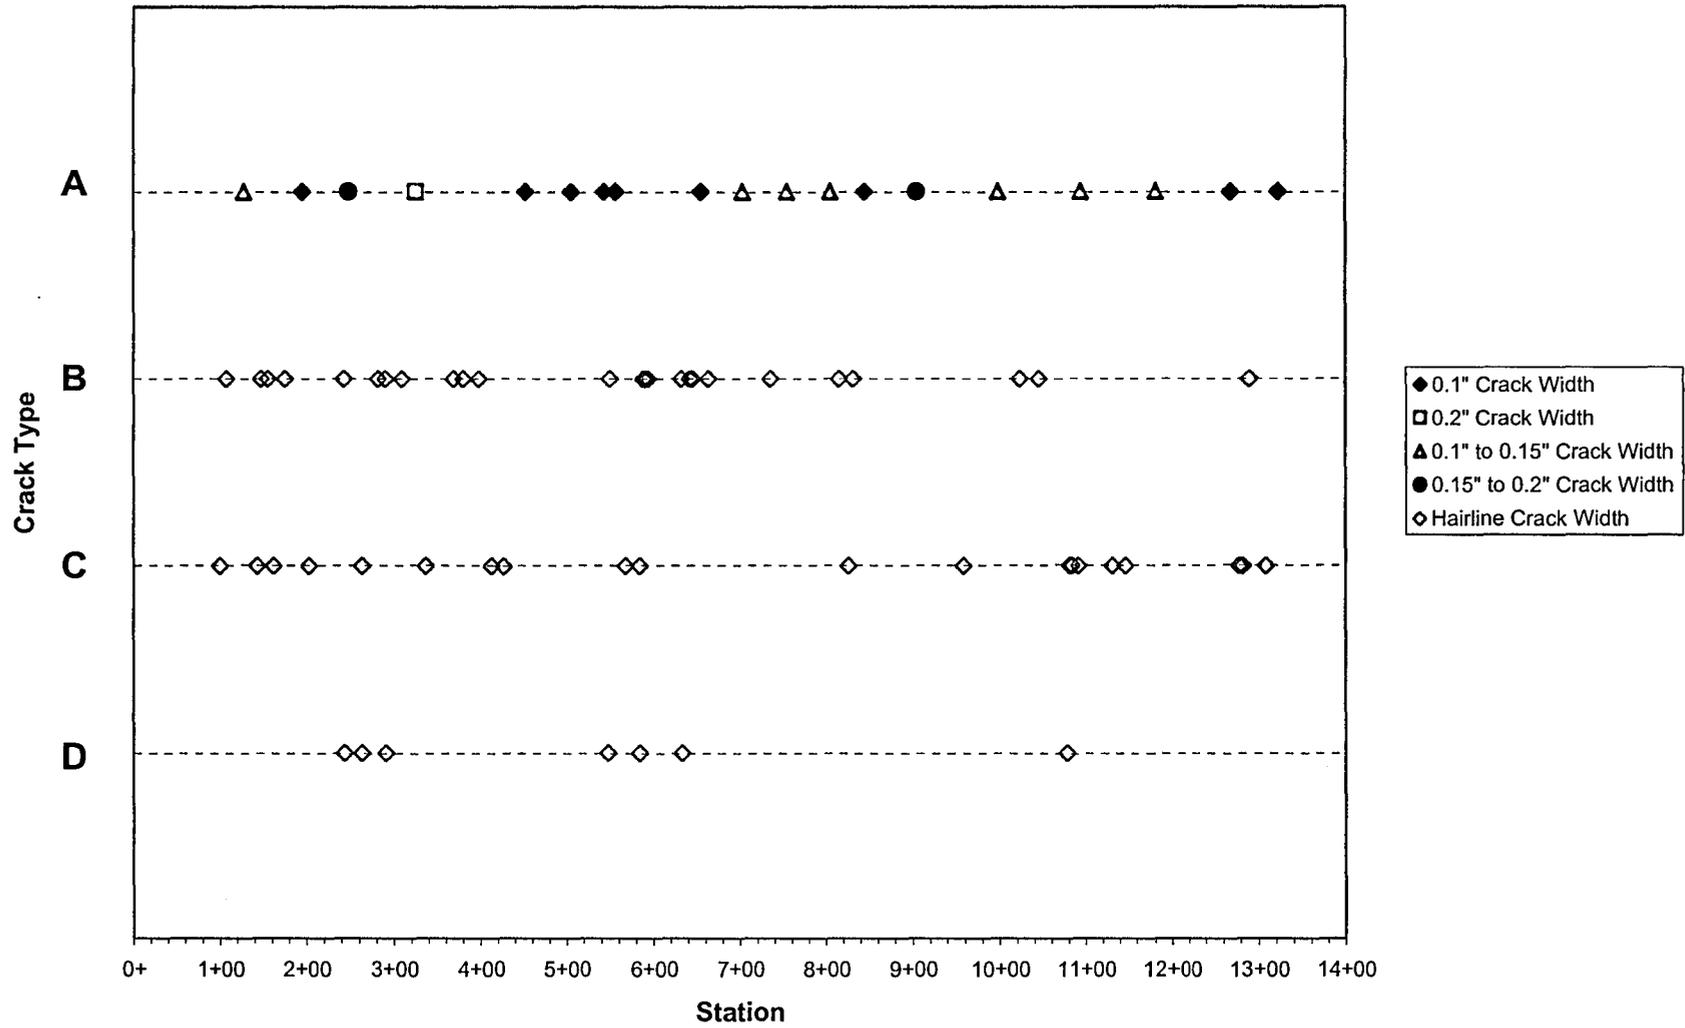
FIGURE 2.
Soil Cement Crack Type vs. Location
McMicken Dam Soil Cement Realigned Dam

The average crack spacing for all transverse cracks (Categories A, B, and C) was approximately one (1) transverse crack for every 59 feet of dam crest length. The frequency of cracking for Category A cracks was one (1) for every 66 feet of dam crest length. Furthermore, the frequency of Category A cracking was fairly uniform for the entire length of the soil cement dam section, independent of soil cement section height or width. A plot of crack type vs. crack location is presented in Figure 2.

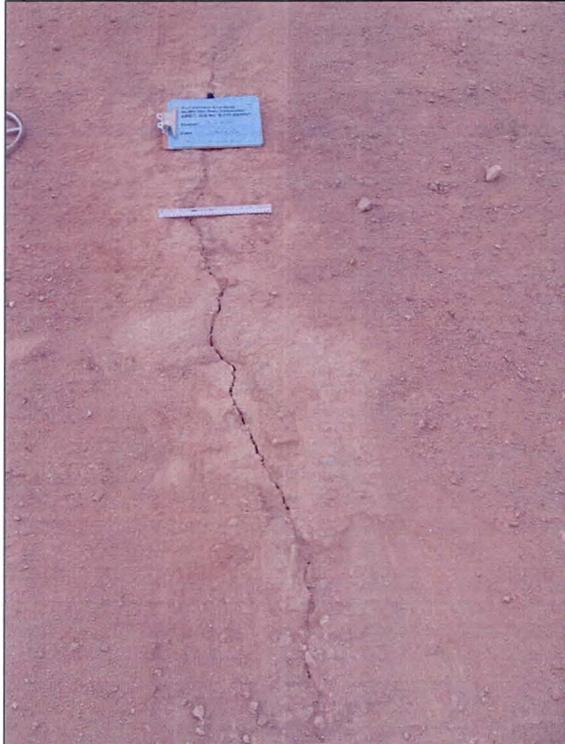
Station 1+28 – photo looking downstream

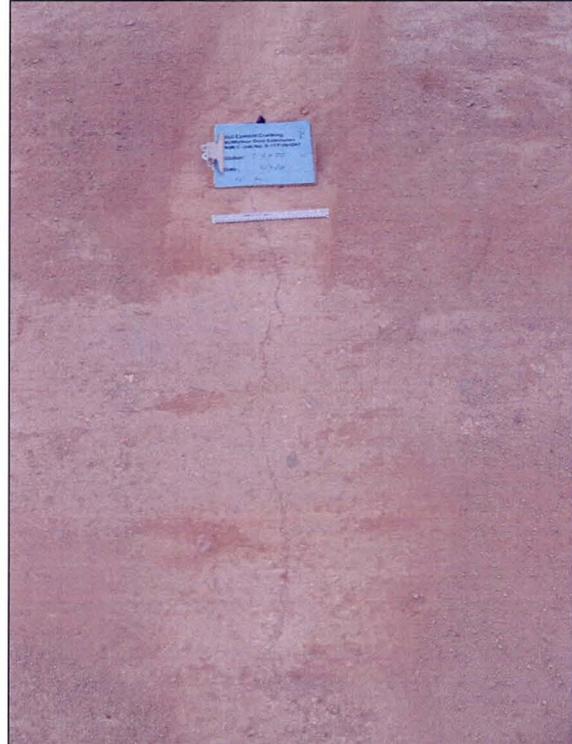
Station 4+13 – photo looking downstream

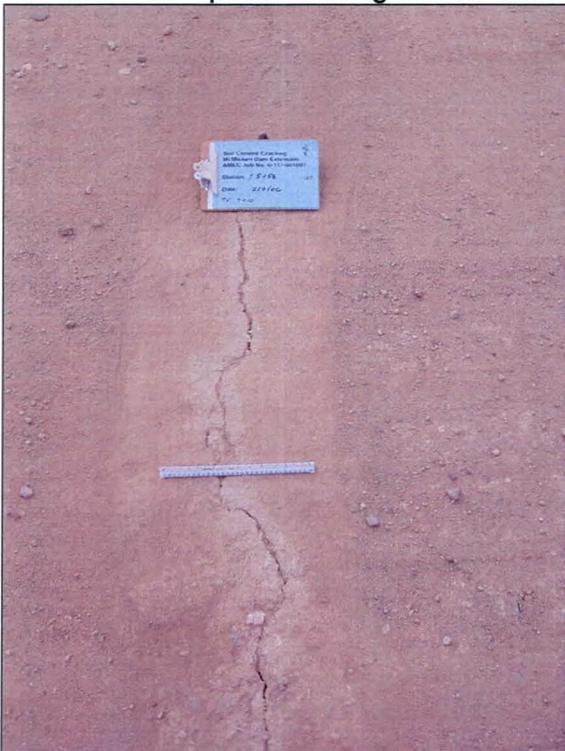
Station 5+57 – photo looking downstream

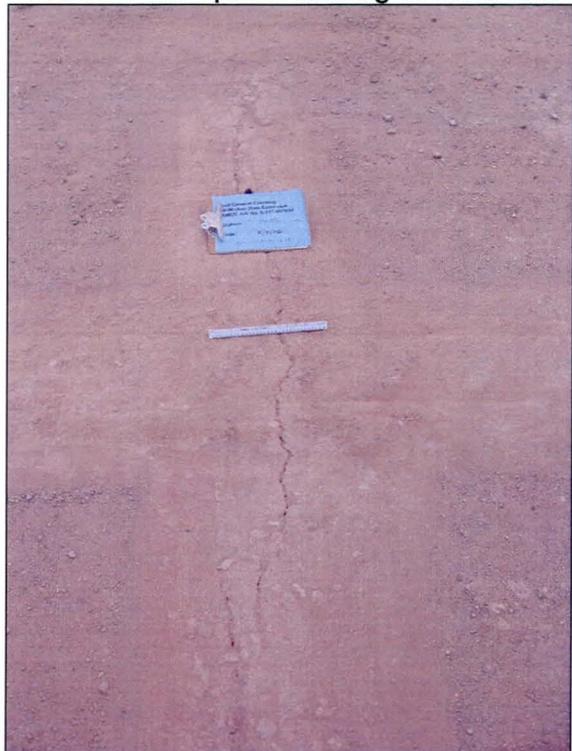
Station 7+55 – photo looking downstream

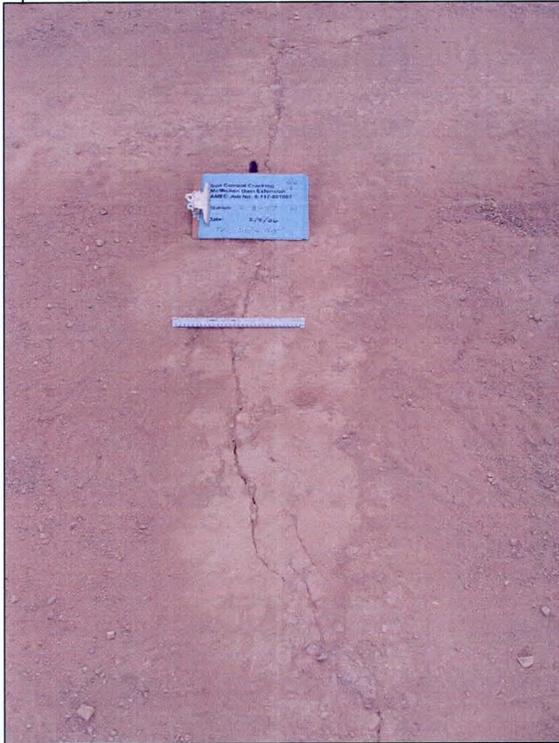
Station 8+05 – photo looking downstream

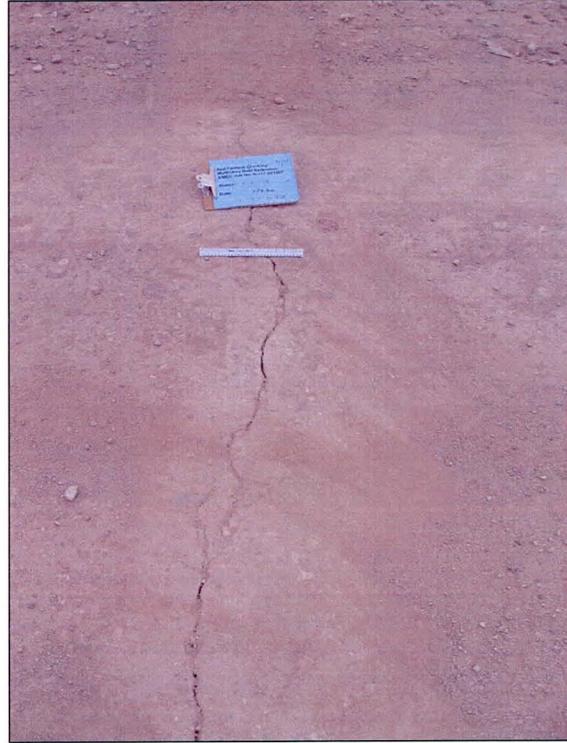
Station 9+05 – photo looking downstream

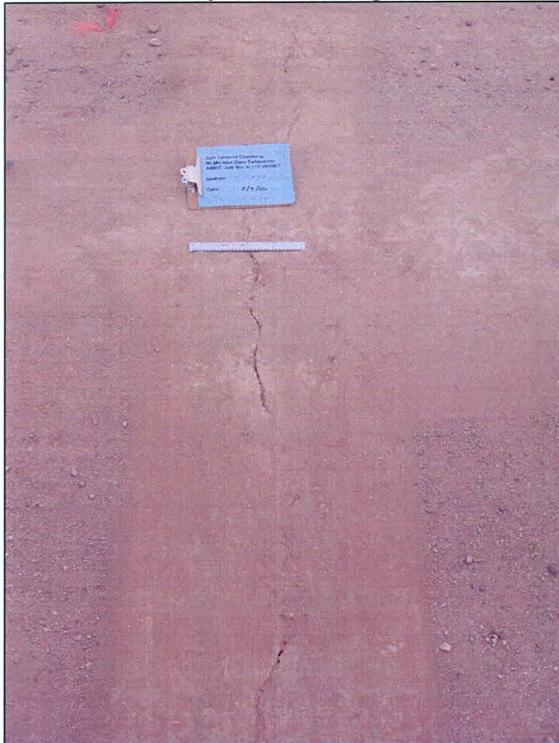
Station 10+94 – photo looking downstream

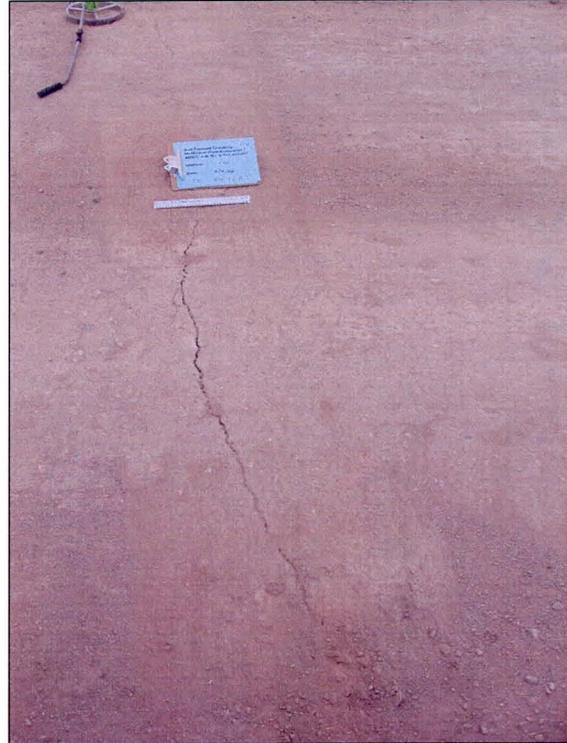
Station 11+81 – photo looking downstream

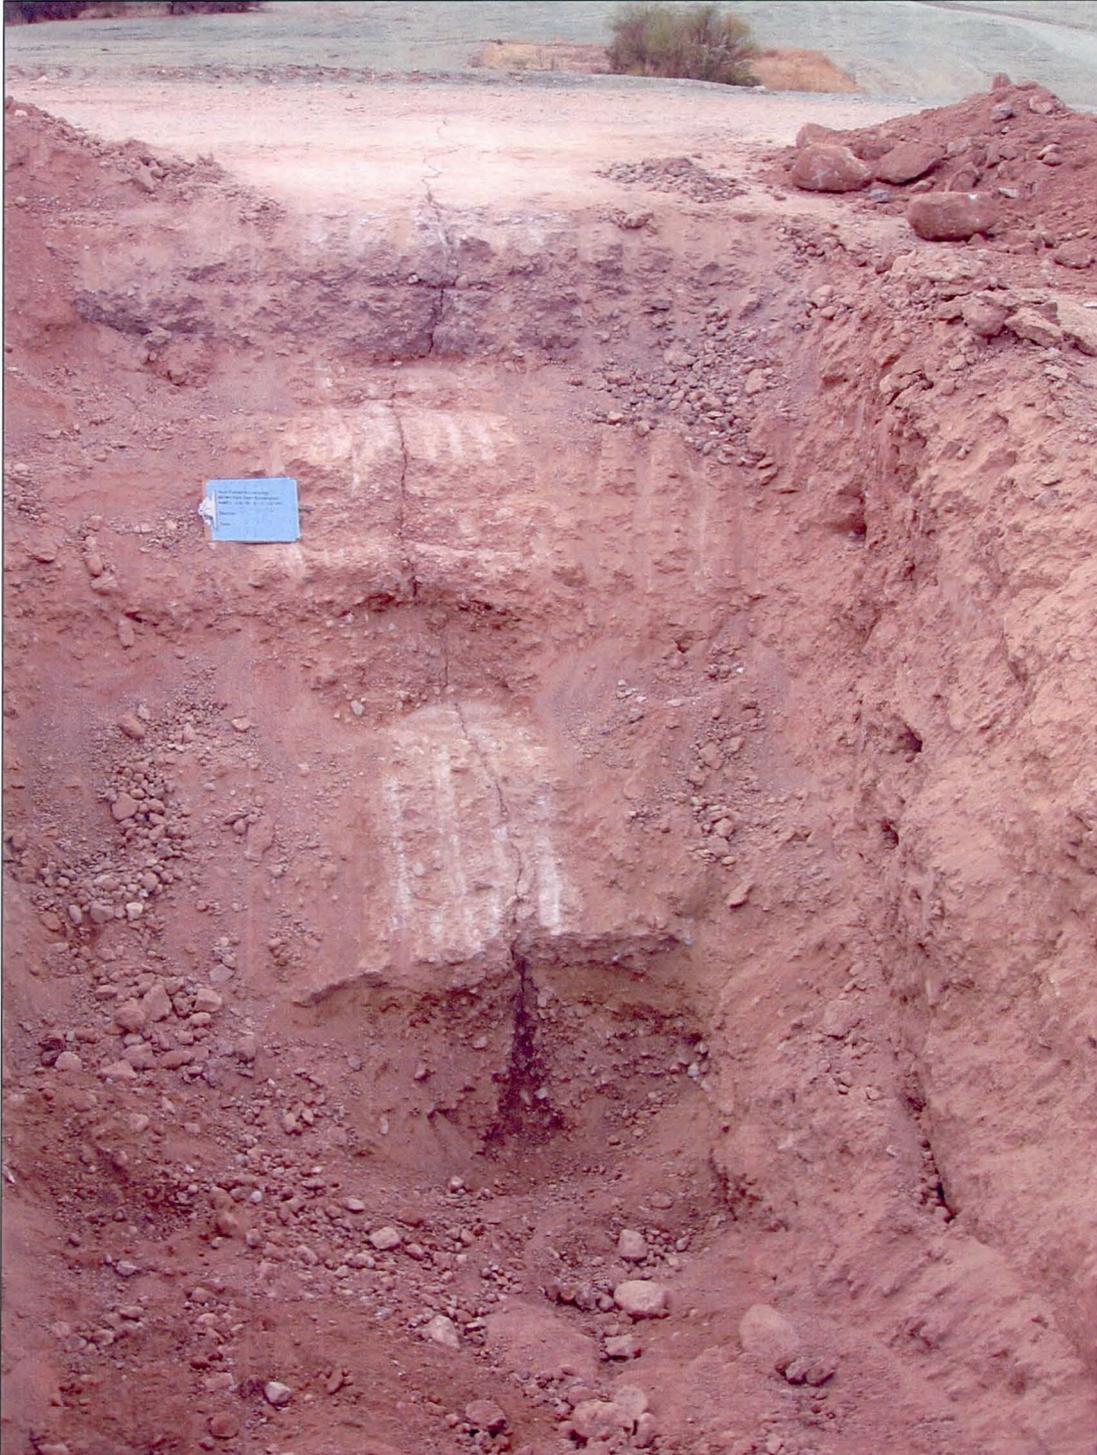
Two cracks located at Stations 2+49 and 3+26 were identified as having the greatest crack width of those observed and were therefore selected to be investigated further by means of two test pits at the upstream side of the dam. The two cracks observed in TP-1 and TP-2 showed similar characteristics, both of which exhibited a slightly more open aperture near the dam crest and then a fairly uniform width to depth. Additionally, crack propagation was through the concrete matrix and not through the soil cement aggregate. The transverse crack in TP-1 is approximately 0.2 inches in maximum width and is near vertical spatially. The crack did appear to occasionally shift sideways vertically at a soil cement lift, but not more than 0.5 feet horizontally. Similarly, the crack observed in TP-2 is 0.15 to 0.2 inches in maximum width and was near vertical with occasional horizontal shifting in vertical alignment at a lift line, but not more than 0.5 feet horizontally. Although the two select Category Type A cracks investigated were not investigated to full depth, it may be conservatively concluded that the transverse cracks investigate at these two locations likely extend to the soil cement foundation.

TP-1 Station 3+26 – photo looking downstream

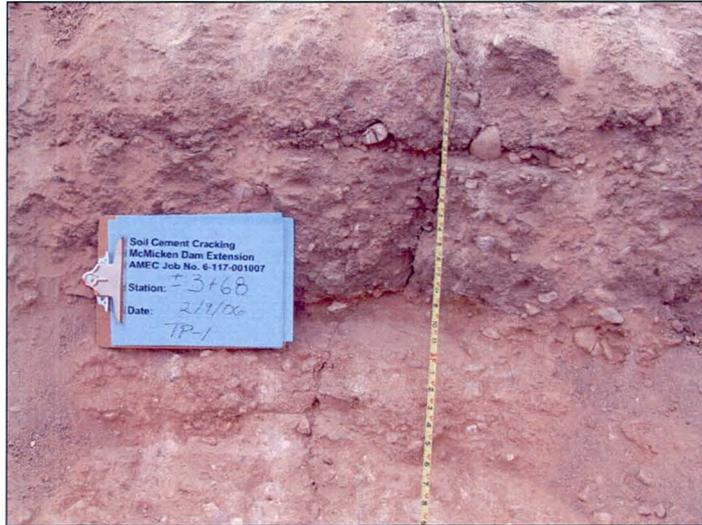
TP-1 Station 3+26 (0 to 2 feet below dam crest)

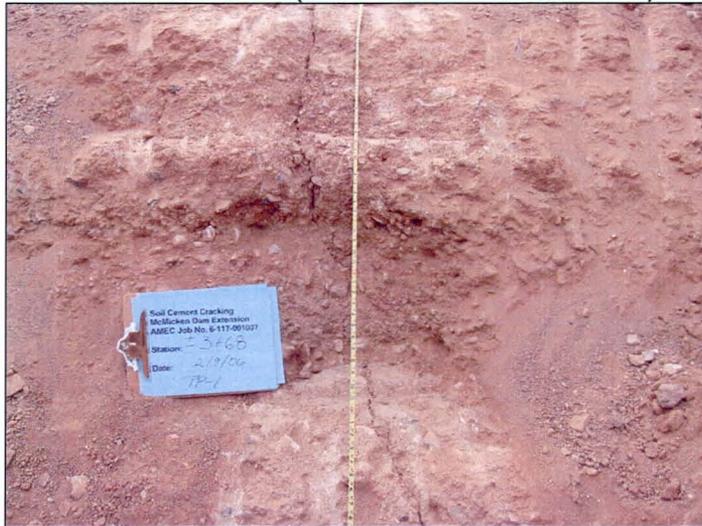
TP-1 Station 3+26 (3 to 6 feet below dam crest)

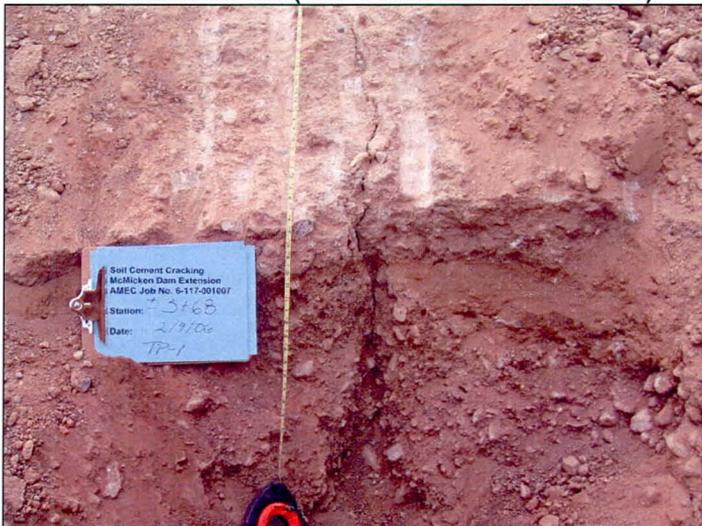
TP-1 Station 3+26 (6 to 8 feet below dam crest)

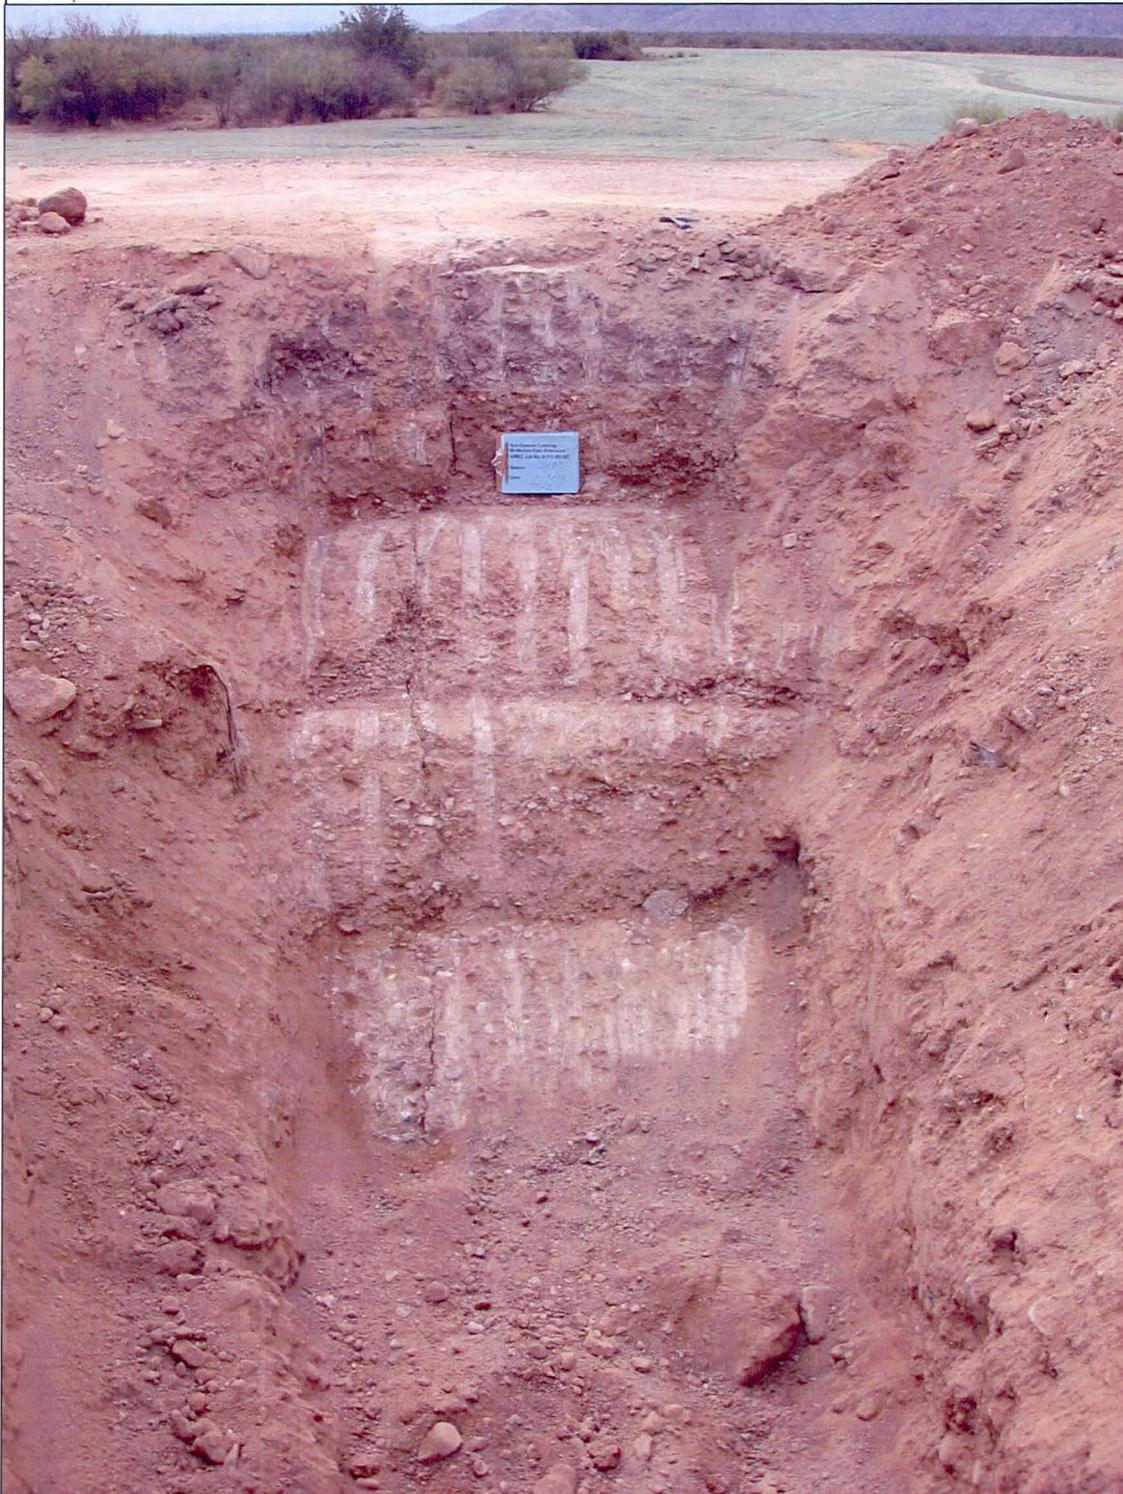
TP-2 Station 2+49 – photo looking downstream

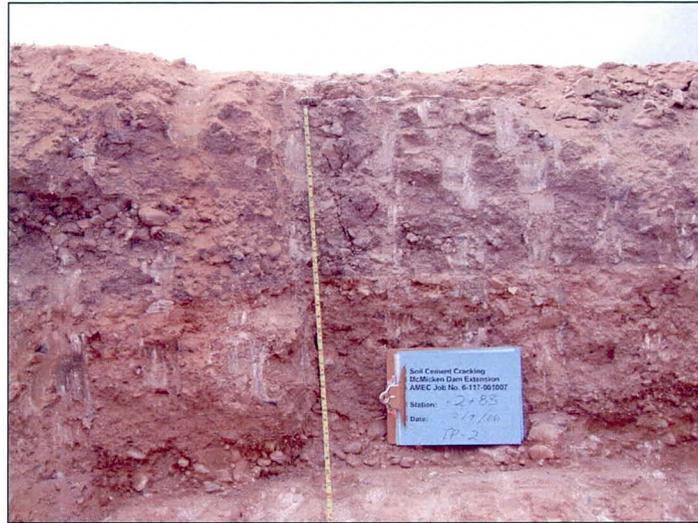
TP-2 Station 2+49 (0 to 3 feet below dam crest)

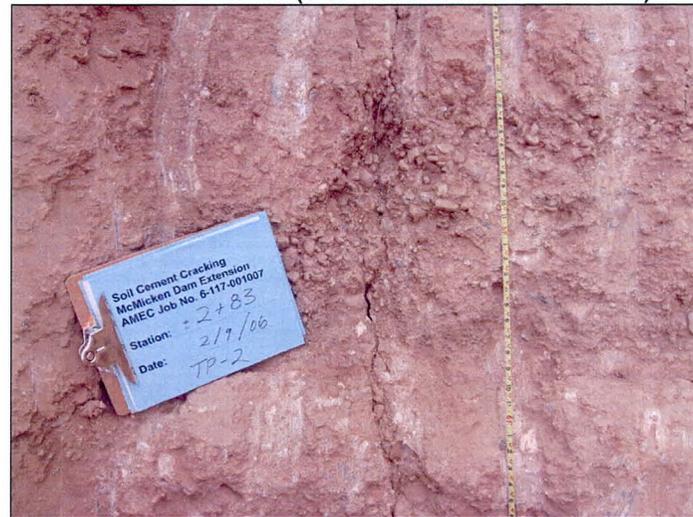
TP-2 Station 2+49 (3 to 6 feet below dam crest)

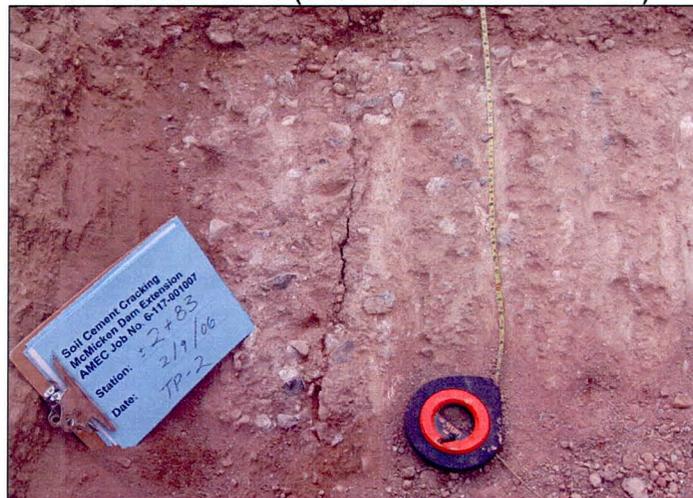
TP-2 Station 2+49 (6 to 8 feet below dam crest)

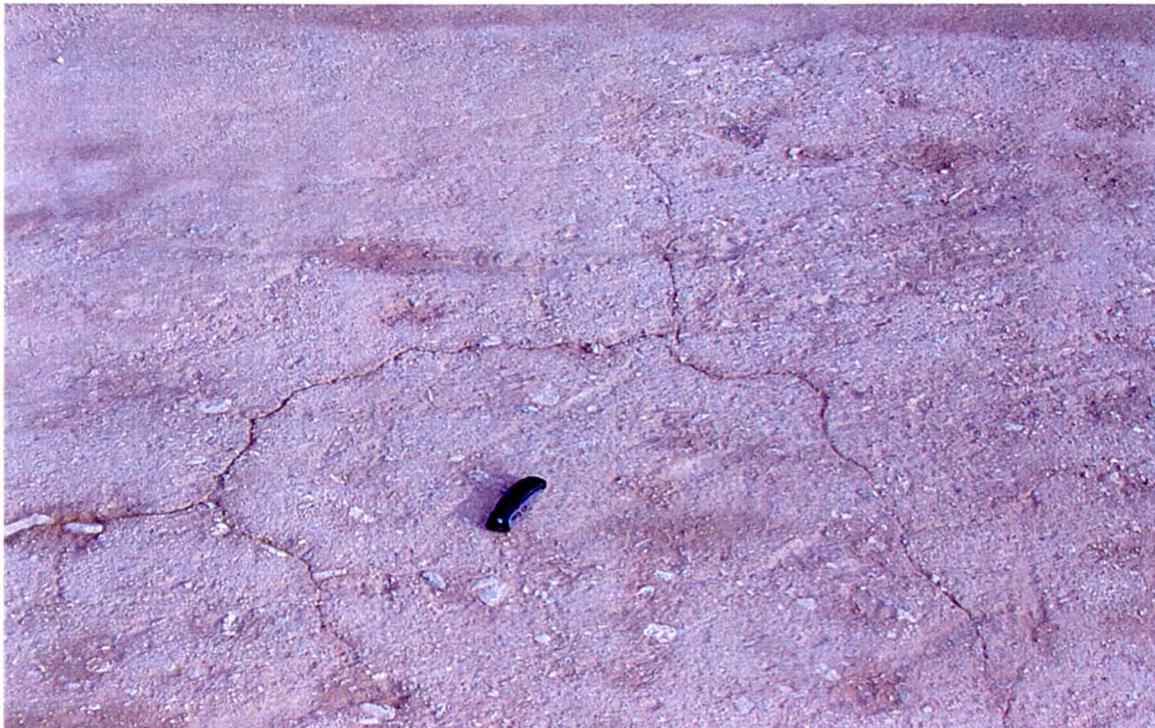
1. There were several types of cracks visible on the surface. There is a semi-polygonal pattern of thin cracks with approximate crack widths on the order of 1mm. The appearance of these cracks is similar to that of large dimension "alligator" cracks. This crack pattern lies primarily on the Western segment of the embankment. My impression of these cracks is that they are shallow in depth and non-continuous. These cracks are similar to the classical 120 degree angle cracks seen in many materials, plate 1.

Plate 1 Polygonal crack pattern

There are two classical crack types shown in Plate 1 that are related to their respective times of cracking. The 120 degree cracking is associated with cracks developing at the same time. Cracks that terminate at a crack are formed after the terminating crack existed. The release of tensile stresses at the existing crack is believed to be the reason the later crack does not pass beyond the existing crack. In the work of Bohn, Pauchard, and Couder, (2005) the development of both crack patterns is depicted by sketch and photos. In the sketch noted by Bohn, Pauchard, and Couder as FIG. 1 the progression of crack formation, as time changes, is provided. In their FIG. 3 the 120 degree cracks in (a) form at the same time associated with a defect. The (b) image depicts the terminated cracking that develops over time.

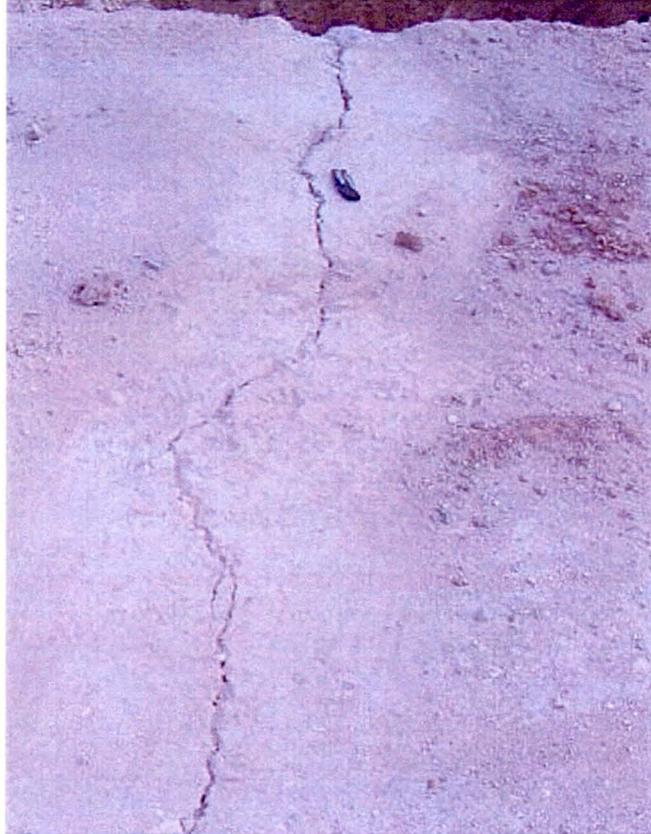
2. Cracks that have widths larger than 1 mm and appear to run transverse across most of the soil cement embankment crest, Plate 2. These cracks appear to persist for some depth and to have an almost constant dam axes period of less than 100 feet. These cracks appear to run across the crest as a single line with some surface widening that appears to be surface damage due to vehicle traffic.

Plate 2 transverse crack that persists across the soil cement embankment crest

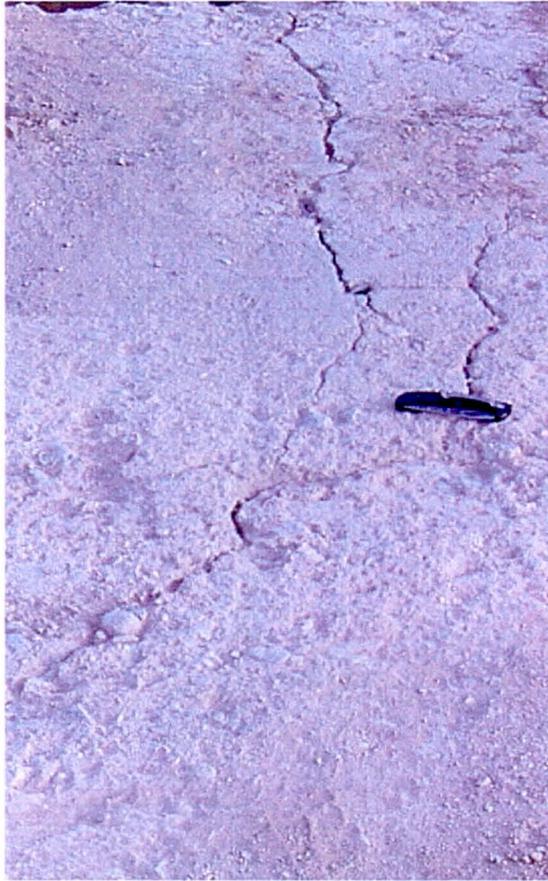
3. Transverse cracks that have bifurcated and do not progress across the soil cement embankment crest as a single crack line were also detected, Plate 3. These cracks sometimes

form rectangular blocks with length to width ratios of approximately 2 or 3. These cracks appear to extend to some depth.

Plate 3 transverse cracks with a bifurcated crack pattern

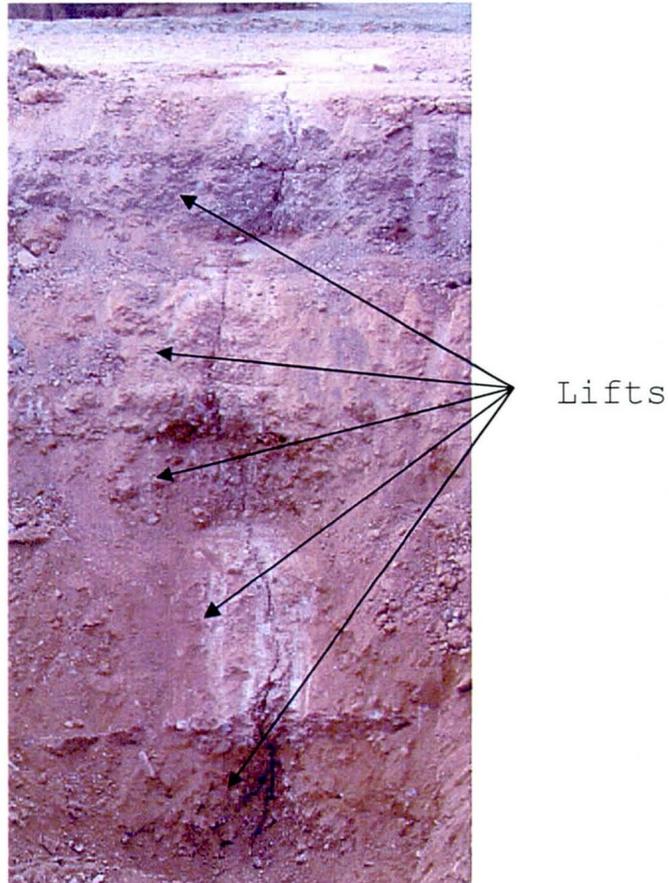
Greenslade had trenches excavated exposing the 2nd and 3rd types of crack, Plate 4. Both types of cracks were traced to the full depth of excavation. Neither crack ran in a continuous plane from the crest to full depth, Plate 4.

Plate 4 Lift influence on Crack offset and plainer geometry

All exposed cracks expressed offset as they traversed what appear to be lifts of the soil cement. The 3rd type of crack also split into two separate cracks in small segments of the exposure. Crack widths appeared to be essentially constant with depth. All lifts of the soil cement were visibly moist and in some areas the adjacent soil was also moist. The soil cement sections I examined were primarily granular in appearance.

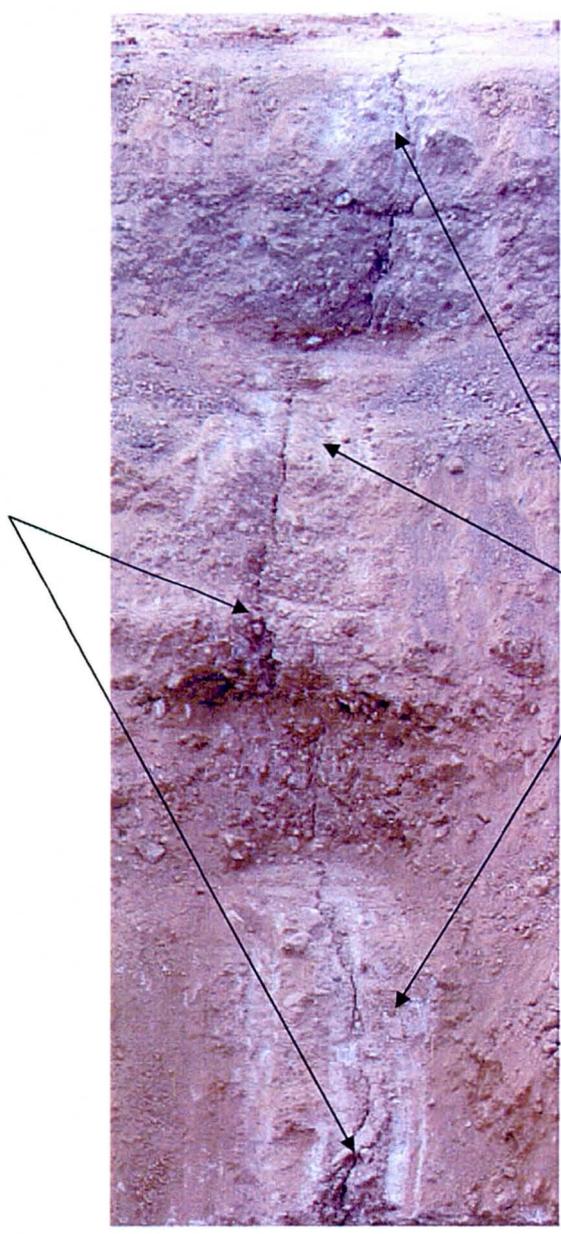
Cracks developing
around gravel
particles

Gouge & streak marks

Plate 5a with gouge and streak marks from excavator teeth
visible, trench 1

The importance of the gouge marks shown in Plates 5a and 5b, is significant. The soil cement embankment is intended, in part, to prevent embankment erosion subsequent to earth fissure formation

and reservoir filling at McMicken FRS. The streak marks are clear evidence of resistance of soil cement particles to movement. Since the soil cement is insoluble to reservoir water the flow of water through such cracks will produce little if any crack erosion. In neither excavation, Plate 5a nor Plate 5b, is there evidence of layer disbanding in spite of the excavation difficulty.

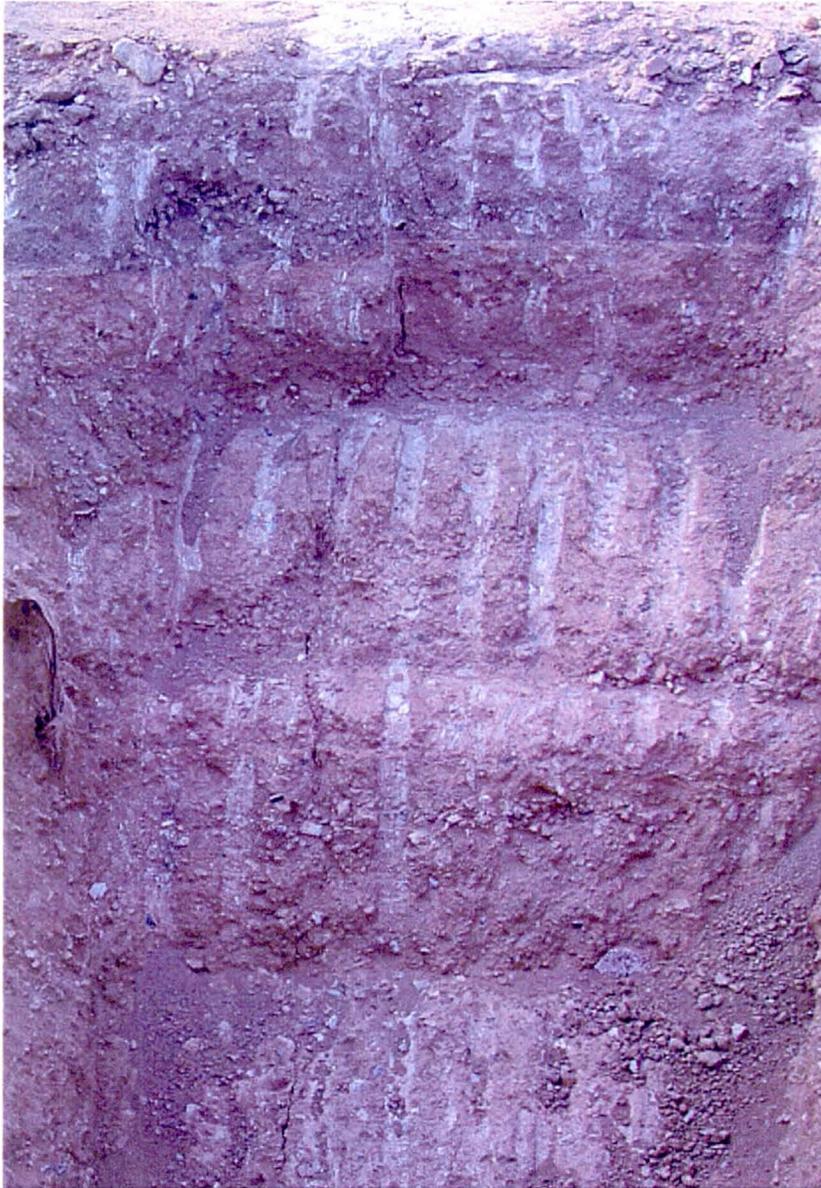
Plate 5b with gouge and streak marks from excavator teeth visible, trench 2

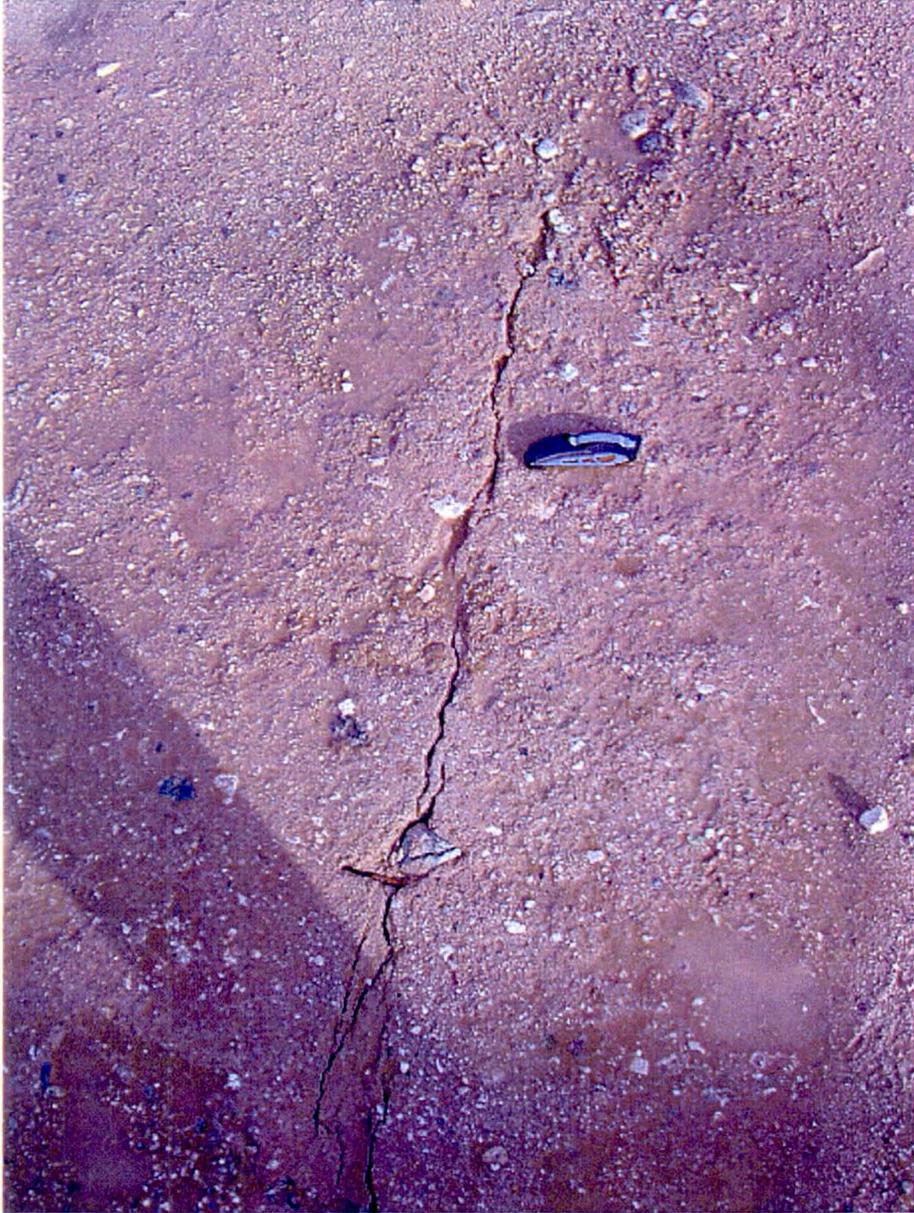
Plate 6 Soil cement crack before high pressure jet is applied

Plates 6 and 7 reinforce the belief that the soil cement embankment is not only resistant to mechanical excavation it is resistant to fluid erosion. There is no appreciable erosion of the crack seen in Plate 7. There is slight crack widening in some segments of the crack that are believed due to the removal of soil cement damaged by heavy vehicle traffic. The presence of gravel size particles in the soil overlying the soil cement are believed to be "driven" by tires into the cracks and as a result damage the sides of the cracks. It is the damaged fragments that were jettted away while the non traffic damaged segments remained at constant width under the jetting action.

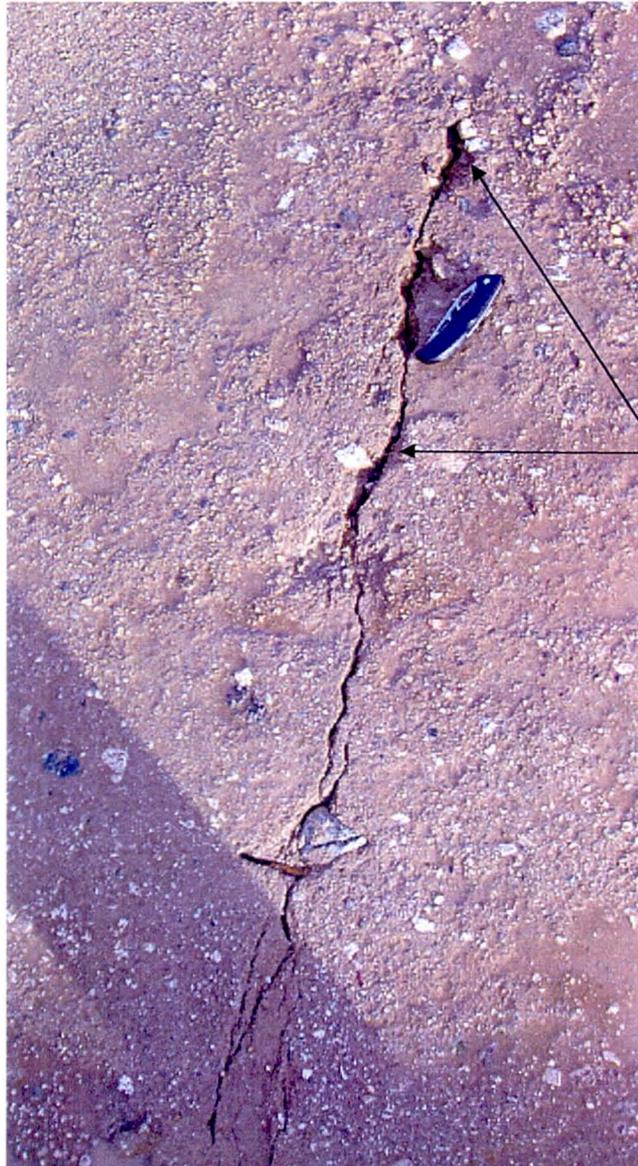
Damaged
sections of
crack removed
by jet

Plate 7 Soil cement crack after high pressure jet applied for 30 seconds. Pump running at full throttle with focused jet less than 8 feet away from crack
