# PHASE I INSPECTION REPORT NATIONAL DAM SAFETY PROGRAM

For: Los Angeles District Corps of Engineers  
Date: January 1979

Name of Dam: Guadalupe Dam (7-43)

Date of Inspection: June 6, 1978

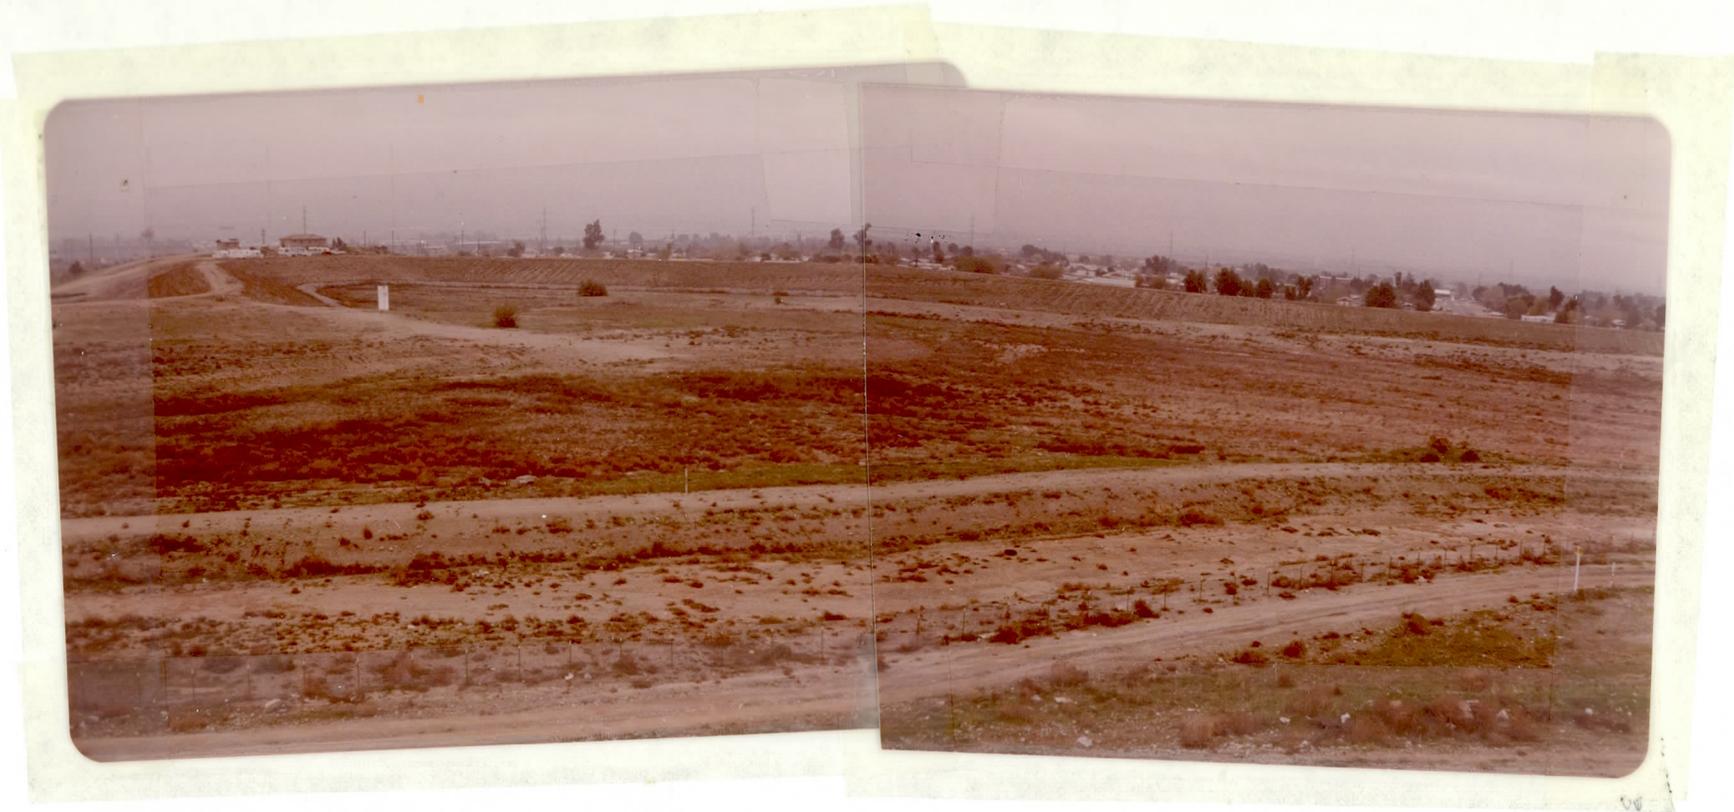
Photo 1 (January 9, 1979) - East Dam and North Dam #2. Outlet intake structure.

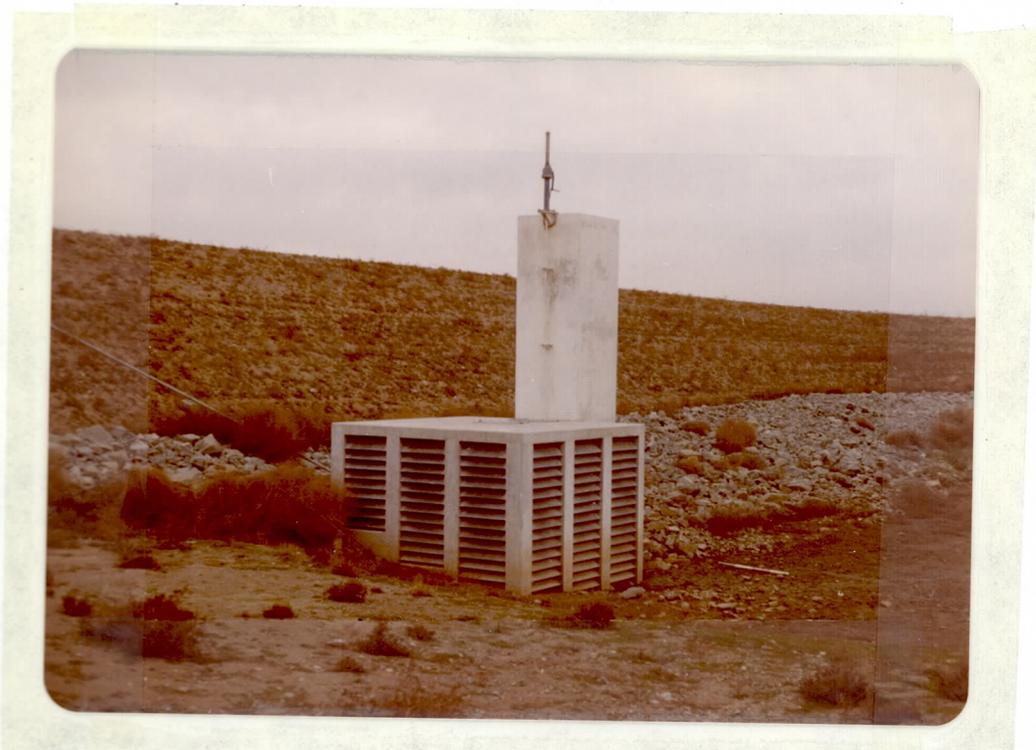
Photo 2 (January 9, 1979) - Upstream face of North Dam #2 and outlet intake structure.

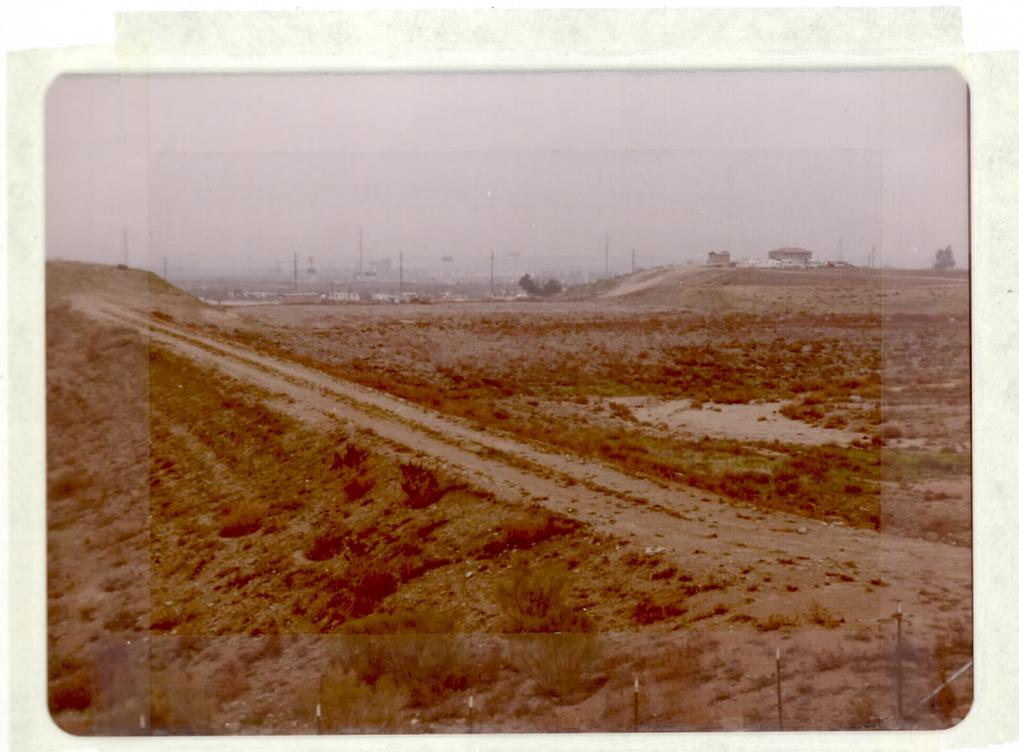
The spillway design is adequate. However, in future years as the area downstream of the spillway develops, changing from primarily agricultural to urban, any discharge will cause severe damage.

Photo 3 (January 9, 1979) - Looking across North Dam #1 and down emergency spillway channel.

B. Recommendations: Construction quality control records and the design report presently not in Commission files should be acquired for completion of the record. Because the dam is unattended and because discharge from the emergency spillway could cause damage downstream, it might be well for the Flood Control District to consider installation of a warning system to alert local emergency services people in time of extreme floods.
