PHASE I INSPECTION REPORT NATIONAL DAM SAFETY PROGRAM

Name of Dam: Buckeye Flood Retarding Structure No. 3, AZ DAM
No. (7-45)

Date of Inspection: June 6, 1978

Buckeye Flood Retarding Structure No. 3, AZ Dam No. (7-45)

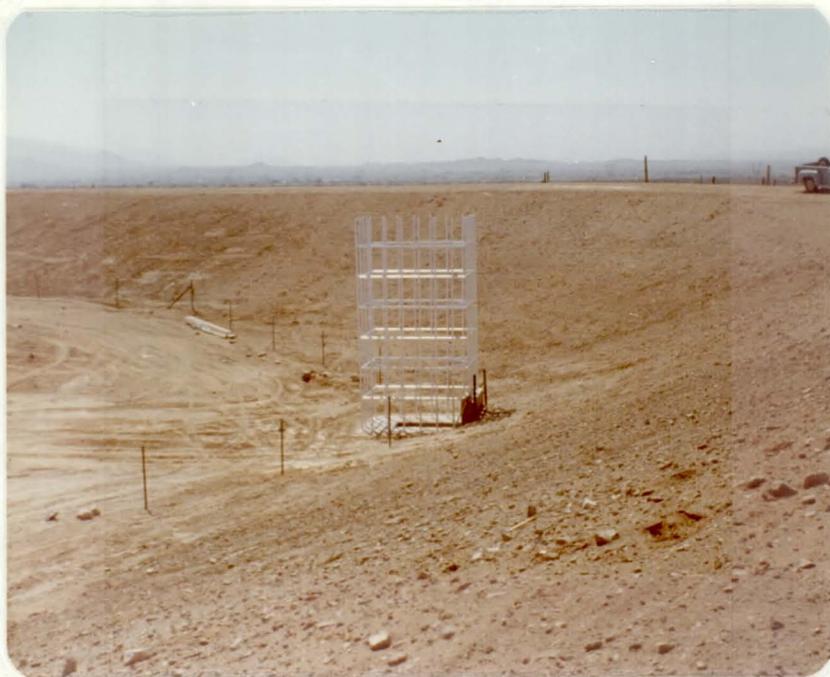
Photo 1 (April 25, 1975) - Trash rack over principal spillway intake structure.

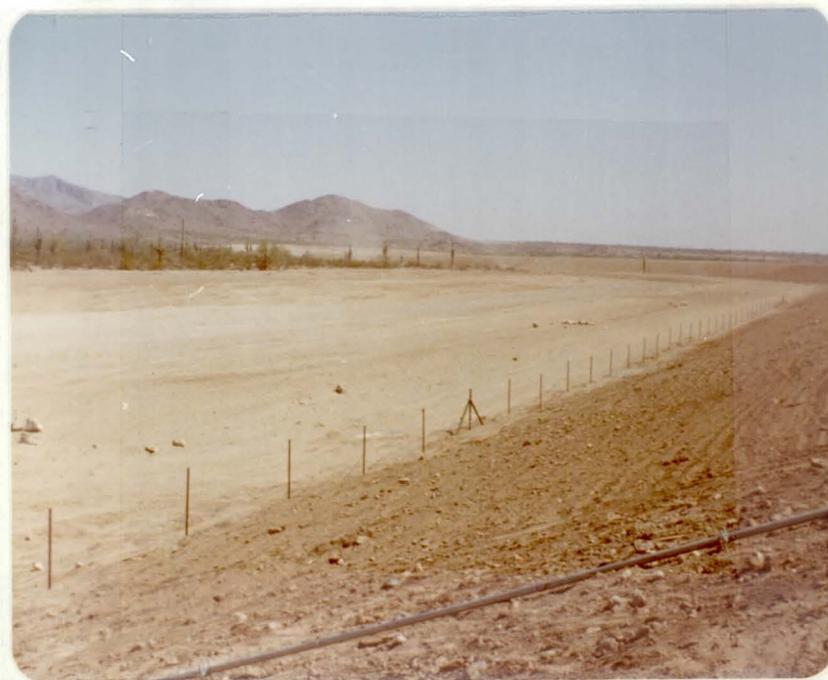
Photo 2 (April 25, 1975) - Looking east along upstream face of dam. Stem for 12" gate in foreground.

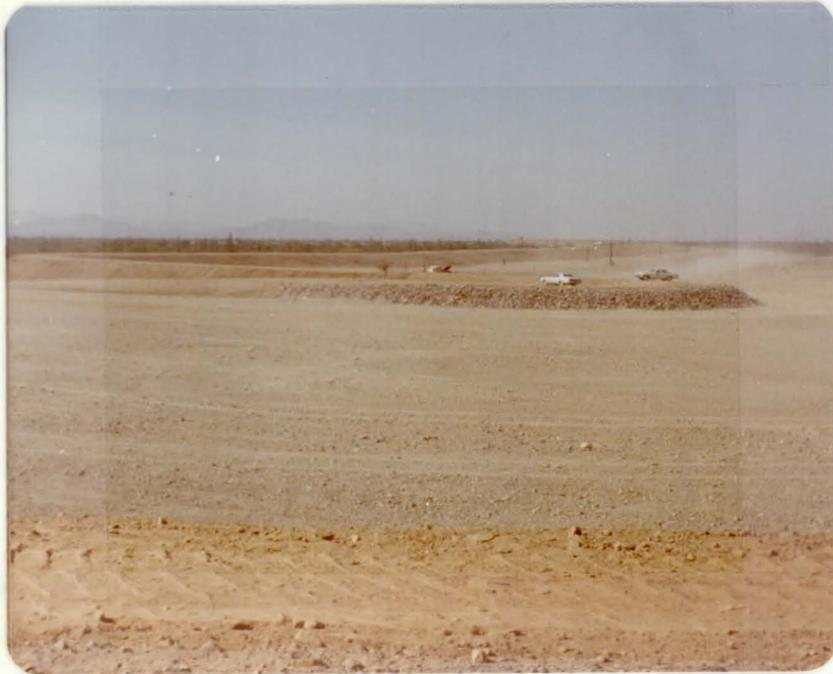
Photo 3 (April 25, 1975) - East end of emergency spillway near control section. Embankment in background.
