SADDLEBACK DIVERSION REPAIR DESIGN FILE

UNITED STATES DEPARTMENT OF AGRICULTURE
SOIL CONSERVATION SERVICE
ARIZONA STATE OFFICE
ENGINEERING STAFF
PHOENIX, ARIZONA
February 8, 1989

DESIGN REPORT

Job: Harquahala
Project: Saddleback Diversion Repair
Location: Maricopa County, Arizona
Authority: PL-566
Phase: Final Design

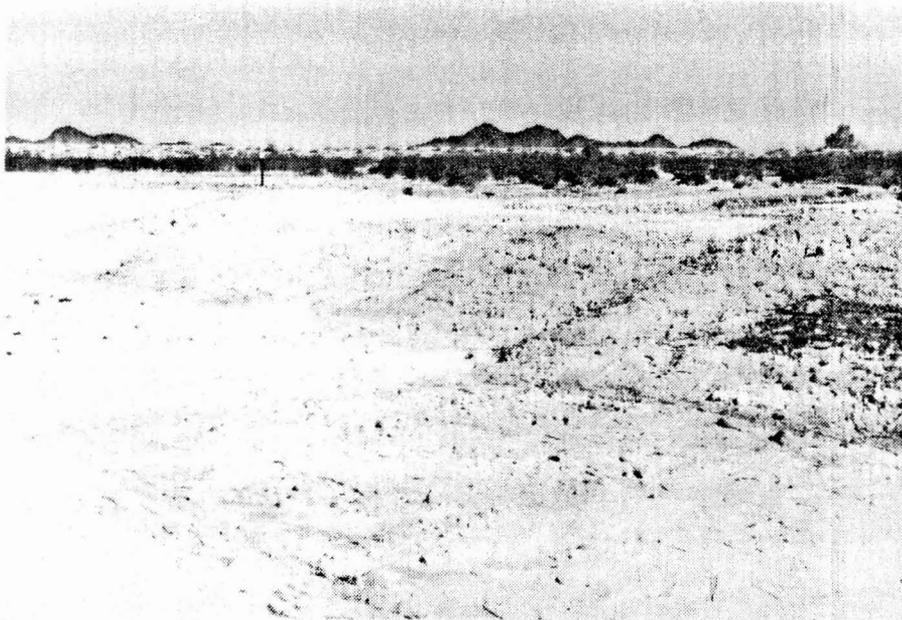
Photo No. 1

STATION 7+00 SIDE INLET #1
NO DAMAGE.

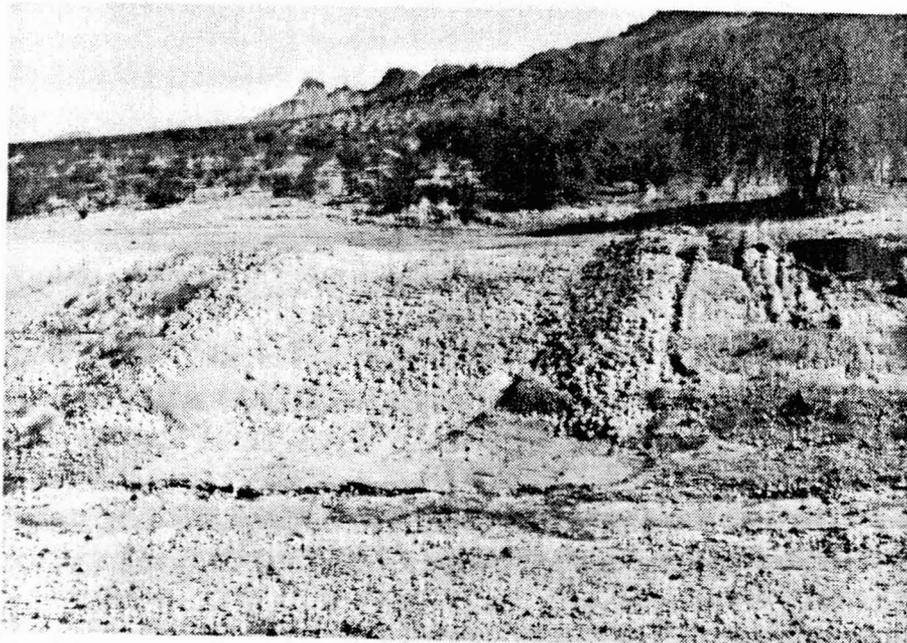
Photo No. 2

The runoff water from overland sheet flow and side washes caused sediment bar development in the collector channels which were overtopped by floodwaters.

Sediment bars across the collector channels caused overtopping and breaching of the collector dikes. Extensive attention was given in design to the subject of sedimentation for the main diversion channel but not for the collector channels. No allowances were made in the design for sediment. Hydraulic sizing assumed that the collector channels would carry the run-off without the need to increase capacity for sediment or added freeboard.

STATION 14+00 SIDE INLET #2
SEDIMENT BARS IN COLLECTOR CHANNELS
CAUSED OVERTOPPING OF DIKE

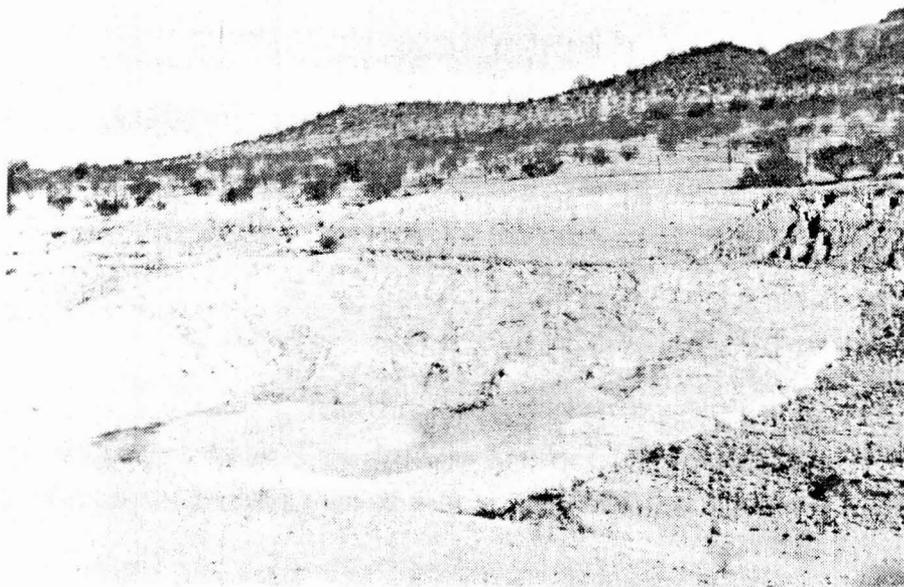
Photo No. 3

STATION 19+69 DROP #1
SOME OVERBANK EROSION

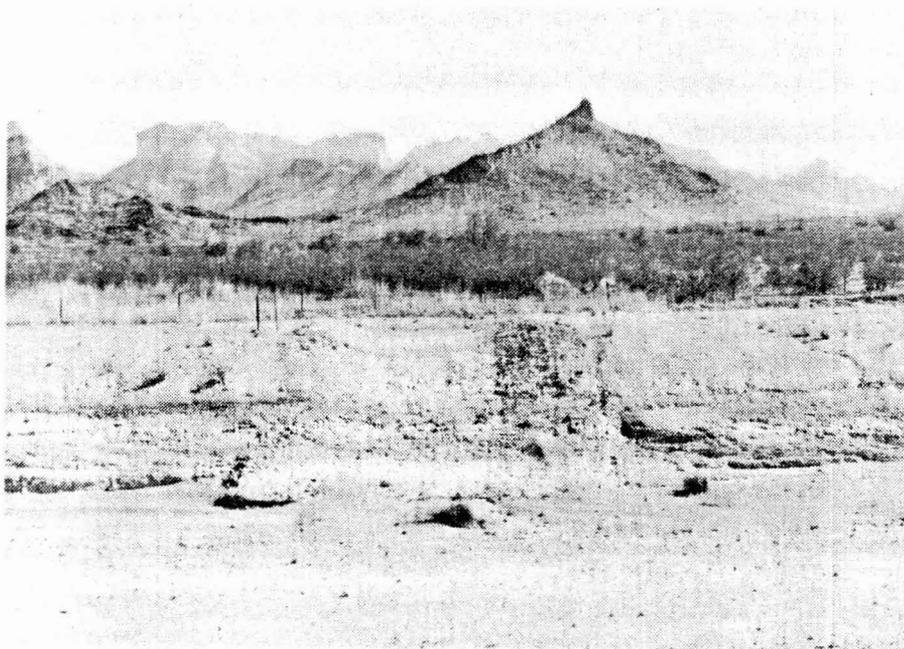
Photo No. 4

STATION 29+00 SIDE INLET #3
SOME RILL EROSION DUE TO OVERTOPPING

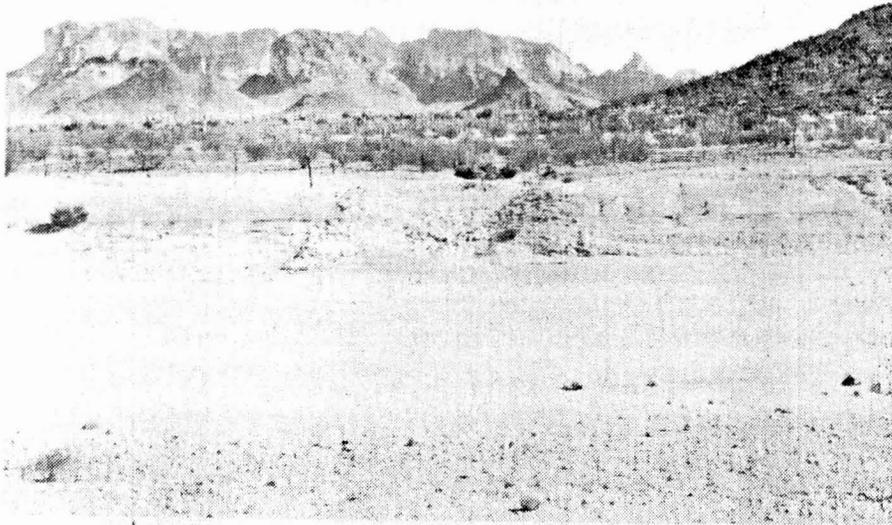
Photo No. 7

STATION 61+25 SIDE INLET #6
NO DAMAGE

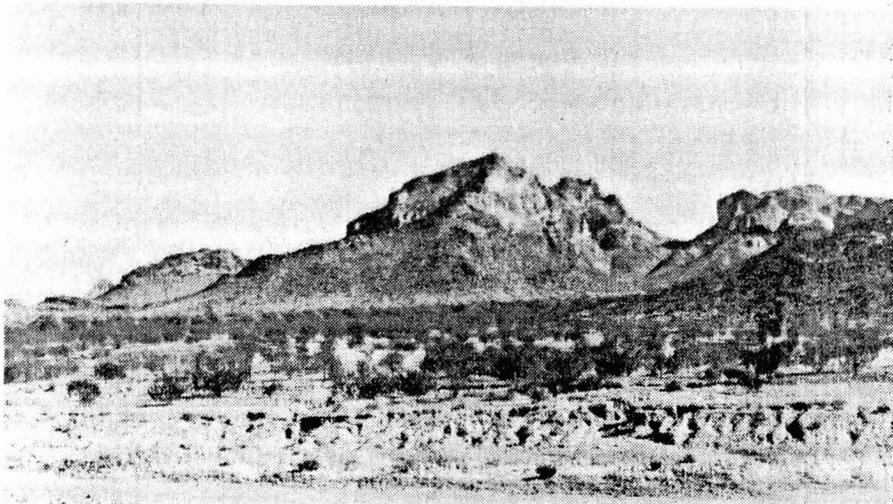
Photo No. 8

APPROXIMATE STATION 63+75
COLLECTOR CHANNEL AND DIKE OVERTOPPED
SEVERE EROSION

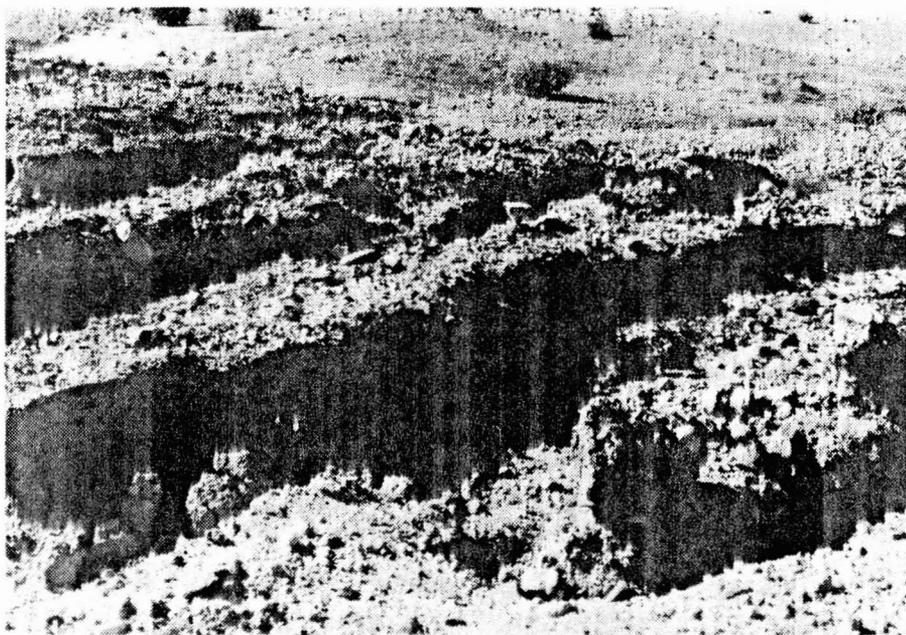
Photo No. 10

STATION 80+12 SIDE INLET #7 LOOKING
WEST. SEVERE EROSION ON SOUTH SIDE
FROM OVERTOPPING

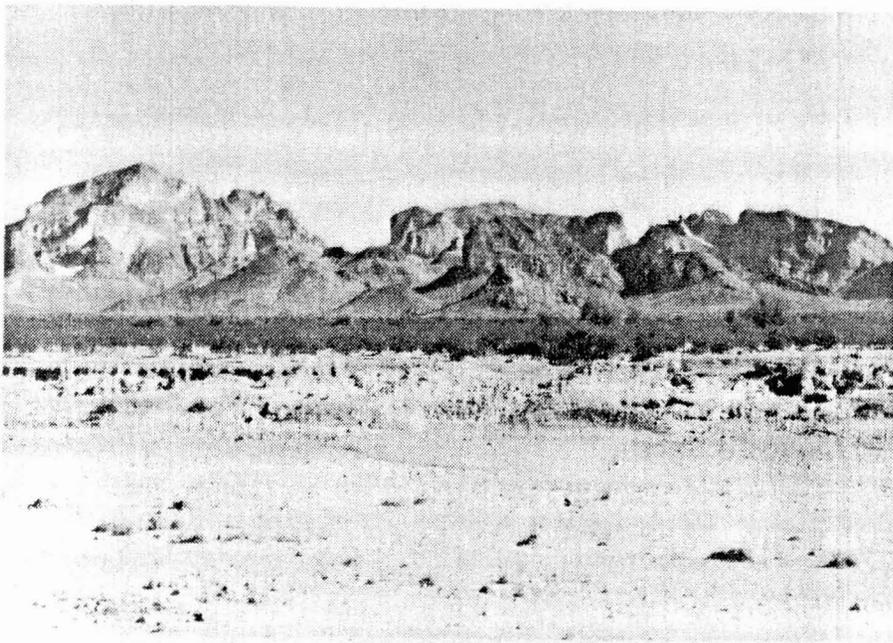
Photo No. 12

STATION 90+08.5 SIDE INLET #8
EROSION FROM OVERTOPPING
ON BOTH SIDES

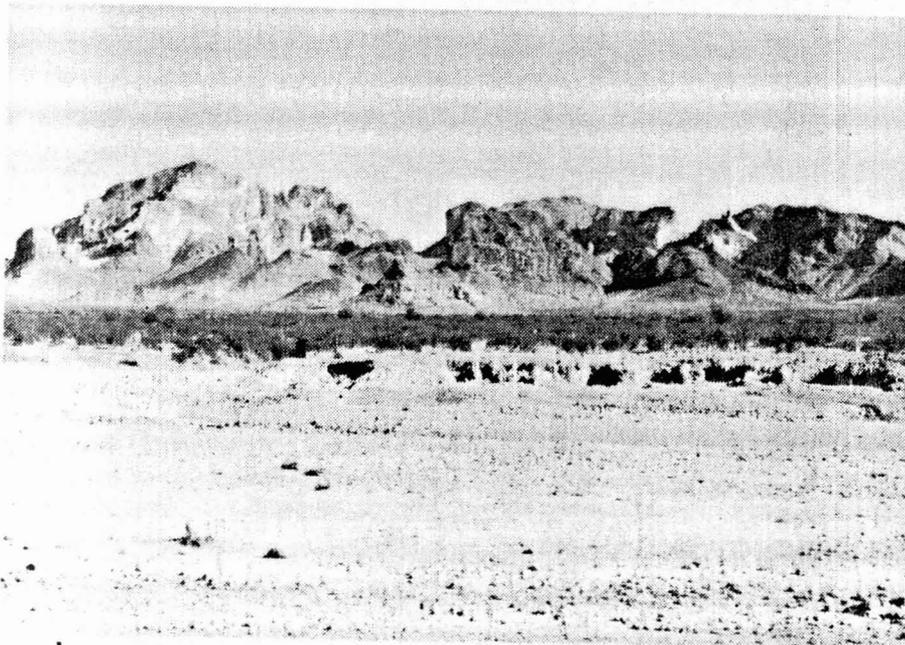
Photo No. 14

STATION 108+14.5 SIDE INLET #9
OVERTOPPING OF COLLECTOR DIKES

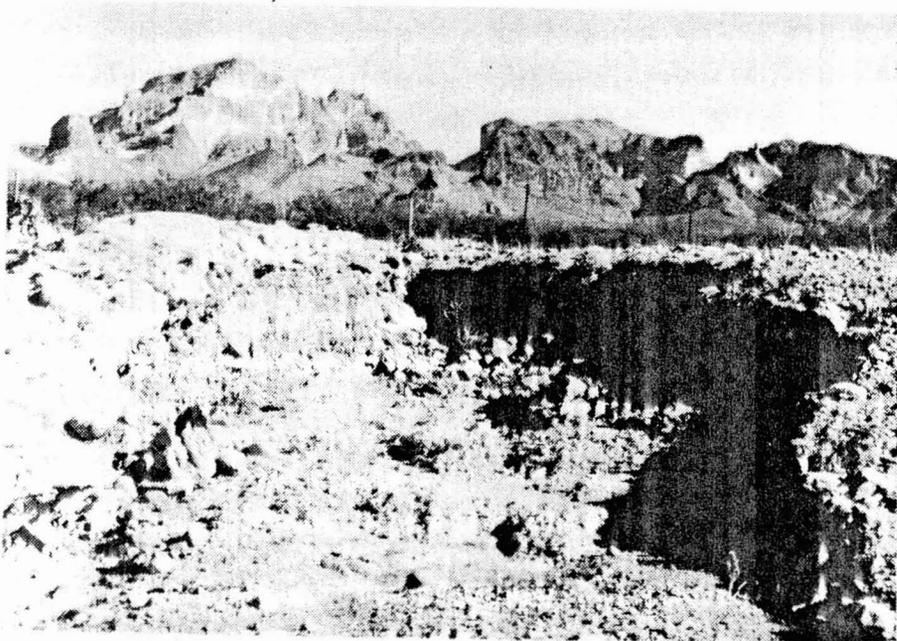
Photo No. 16

STATION 108+14.5 INLET #9
EROSION ON SOUTH SIDE

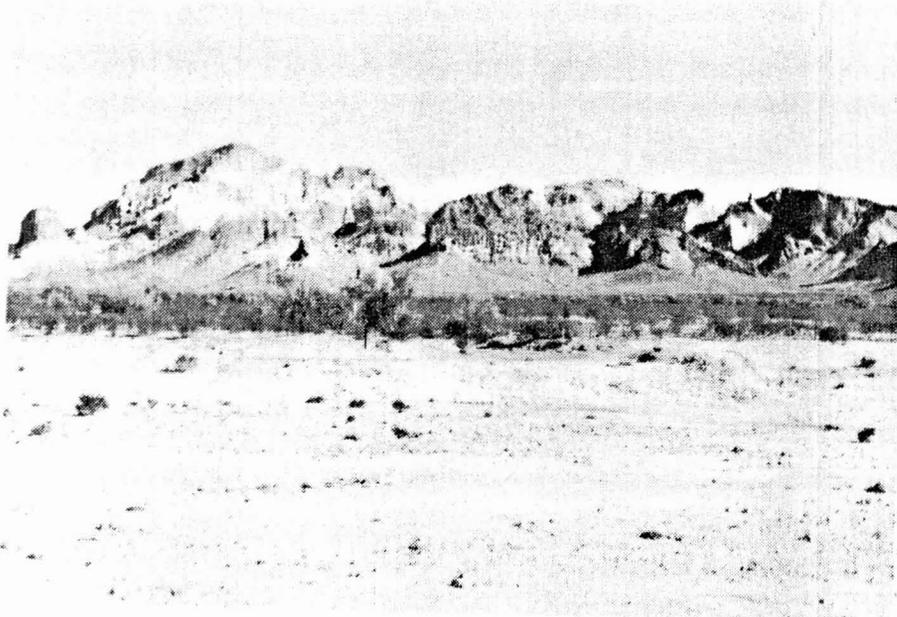
Photo No. 17

STATION 121+26 SIDE INLET #10
NO DAMAGE

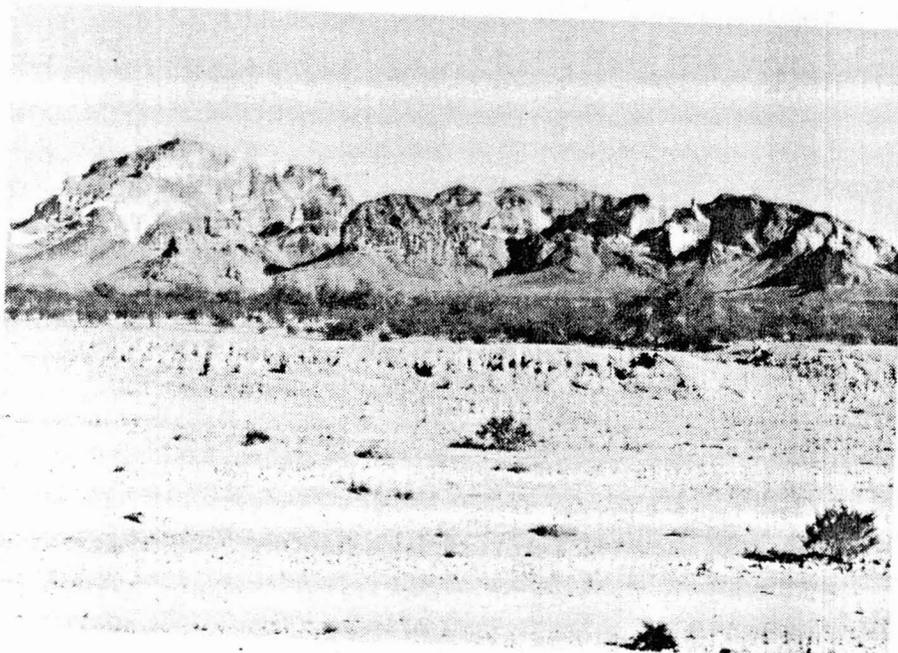
Photo No. 18

STATION 128+32 SIDE INLET #11
EROSION FROM OVERTOPPING

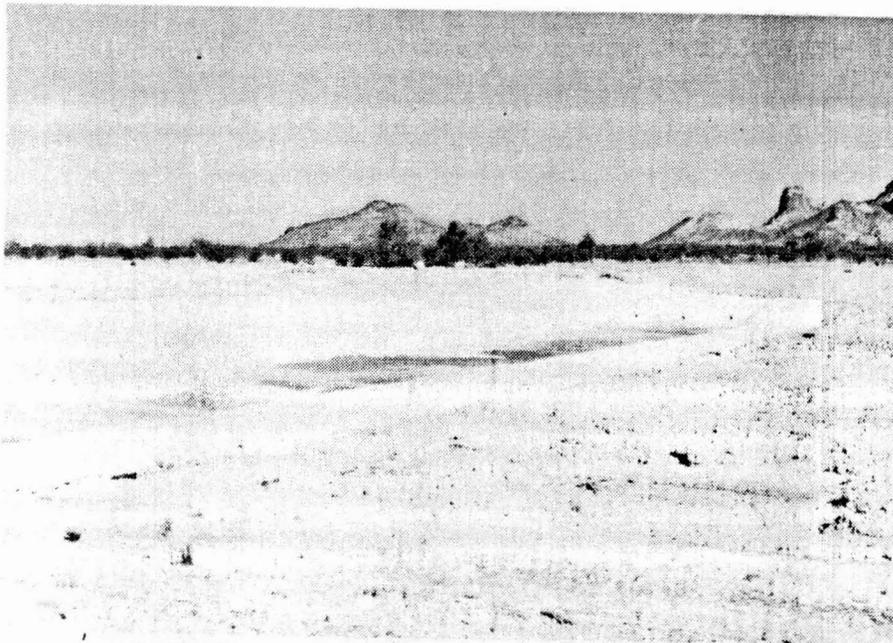
Photo No. 20

STATION 144+82 DROP #3
MINOR RILL EROSION

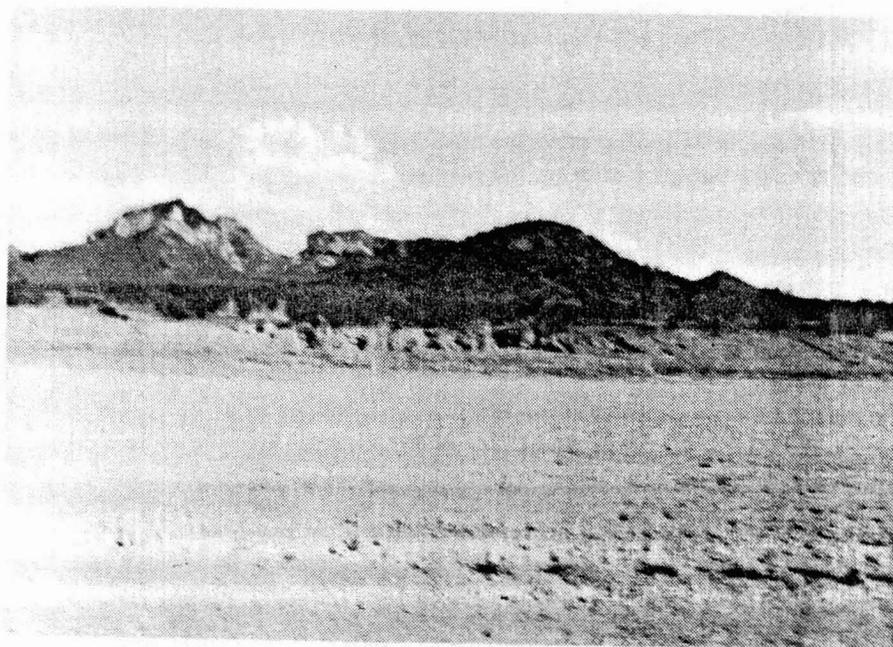
Photo No. 22

STATION 170+05 SIDE INLET #13
EROSION FROM OVERTOPPING
ON BOTH SIDES

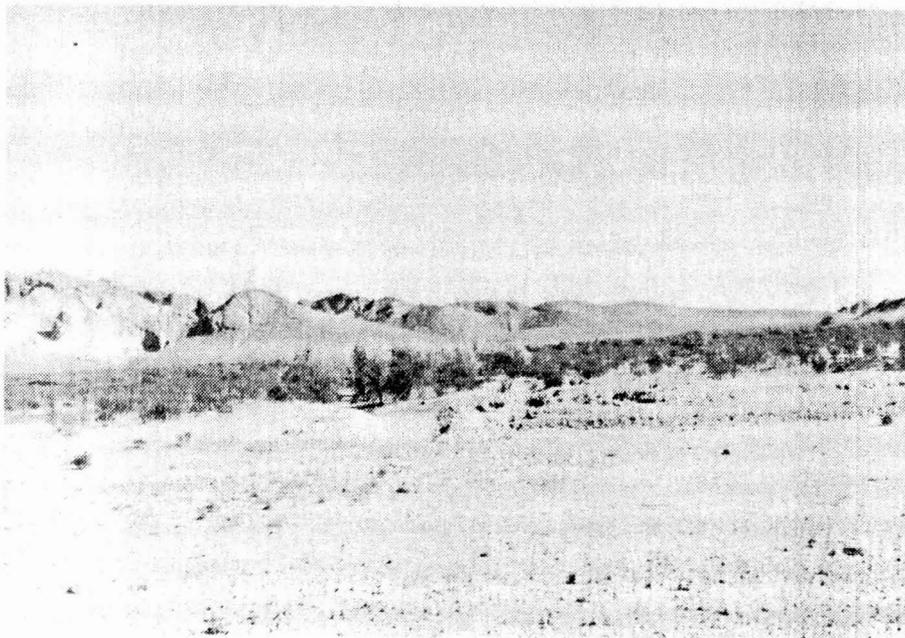
Photo No. 24

STATION 183+65 SIDE INLET #15
EROSION FROM OVERTOPPING ON
BOTH SIDES
