Saddleback Flood Retarding Structure Individual Structure Assessment Report

Prepared for
Flood Control District of Maricopa County
On-Call Phase I Assessment
FCD 2003C015
PCN 050.03.01
October 2005

**INDIVIDUAL STRUCTURE ASSESSMENT REPORT
for
SADDLEBACK FLOOD RETARDING STRUCTURE**

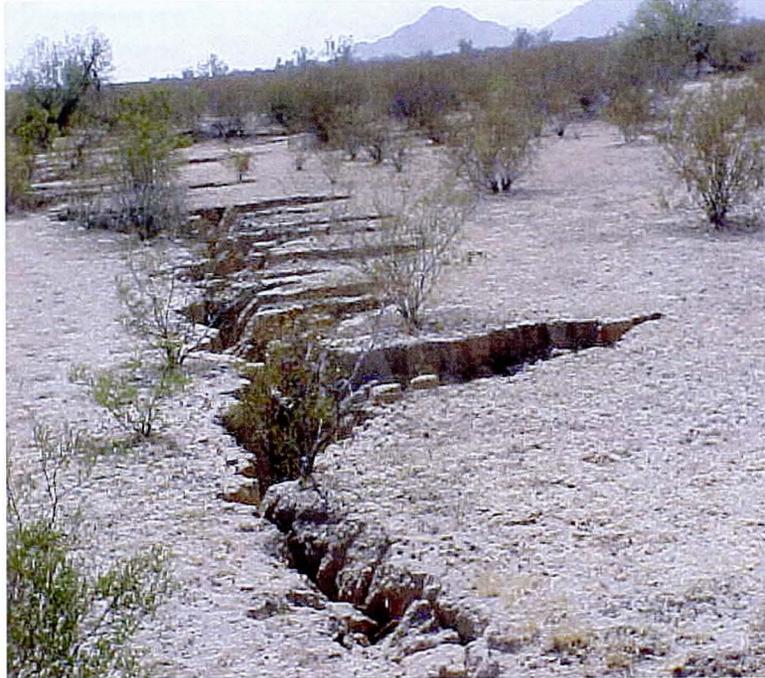
Photo 1: View of Rogers earth fissure with gully headcutting upslope along the fissure alignment.

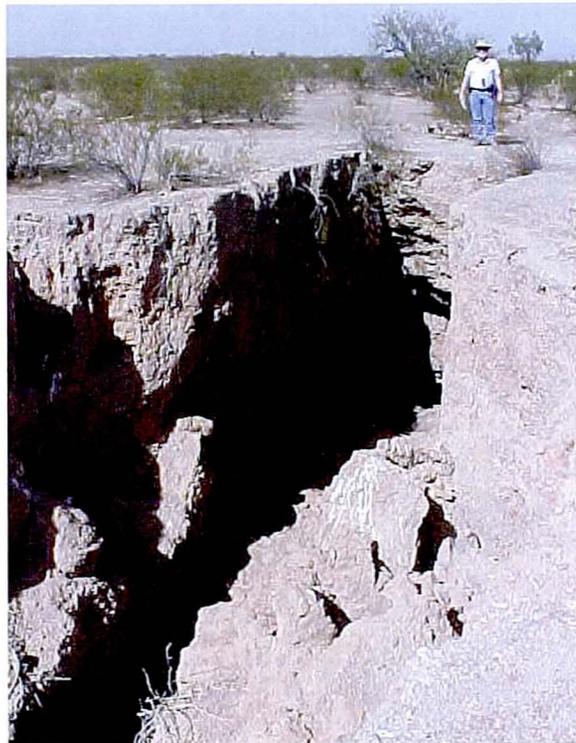
Photo 2: Well developed fissure gully along portion of Rogers earth fissure. Note slump blocks in bottom center of view generated from the tabular failure of the over-steepened fissure side slopes.

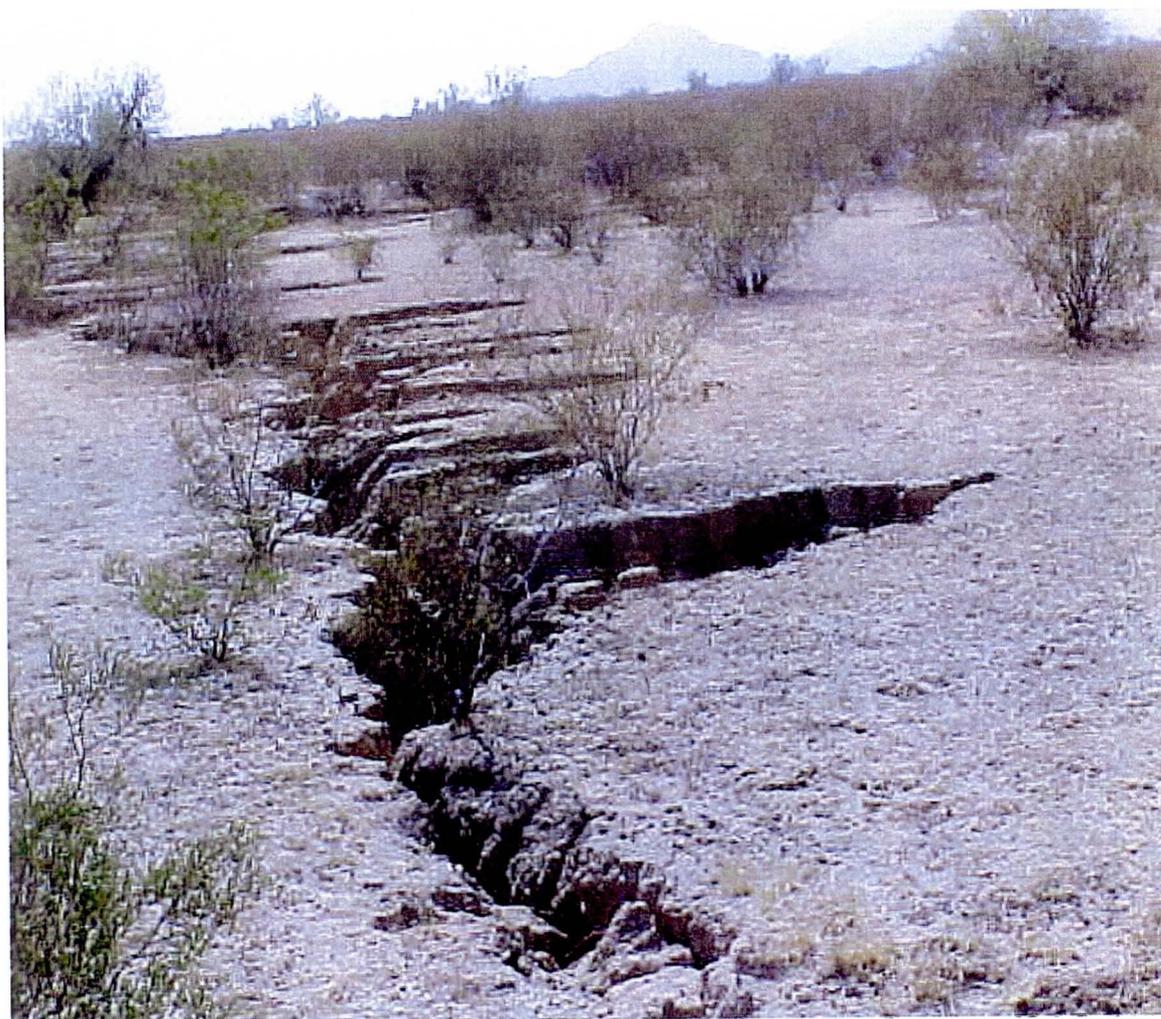
Photo 1: View of Rogers earth fissure with gully headcutting upslope along the fissure alignment.

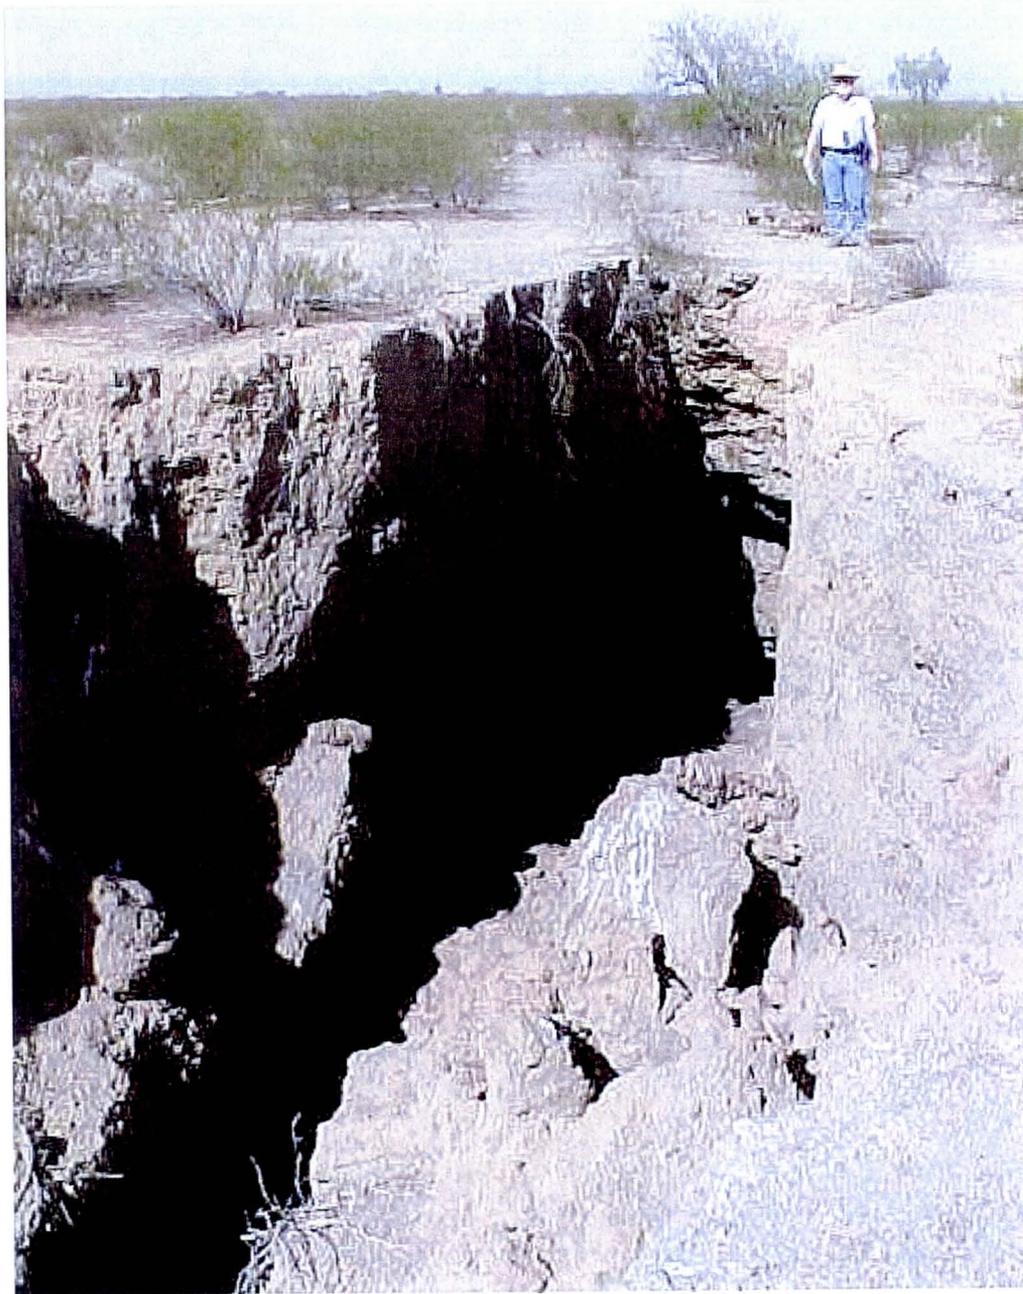
Photo 2: Well developed fissure gully along portion of Rogers earth fissure. Note slump blocks in bottom center of view generated from the tabular failure of the over-steepened fissure side slopes.

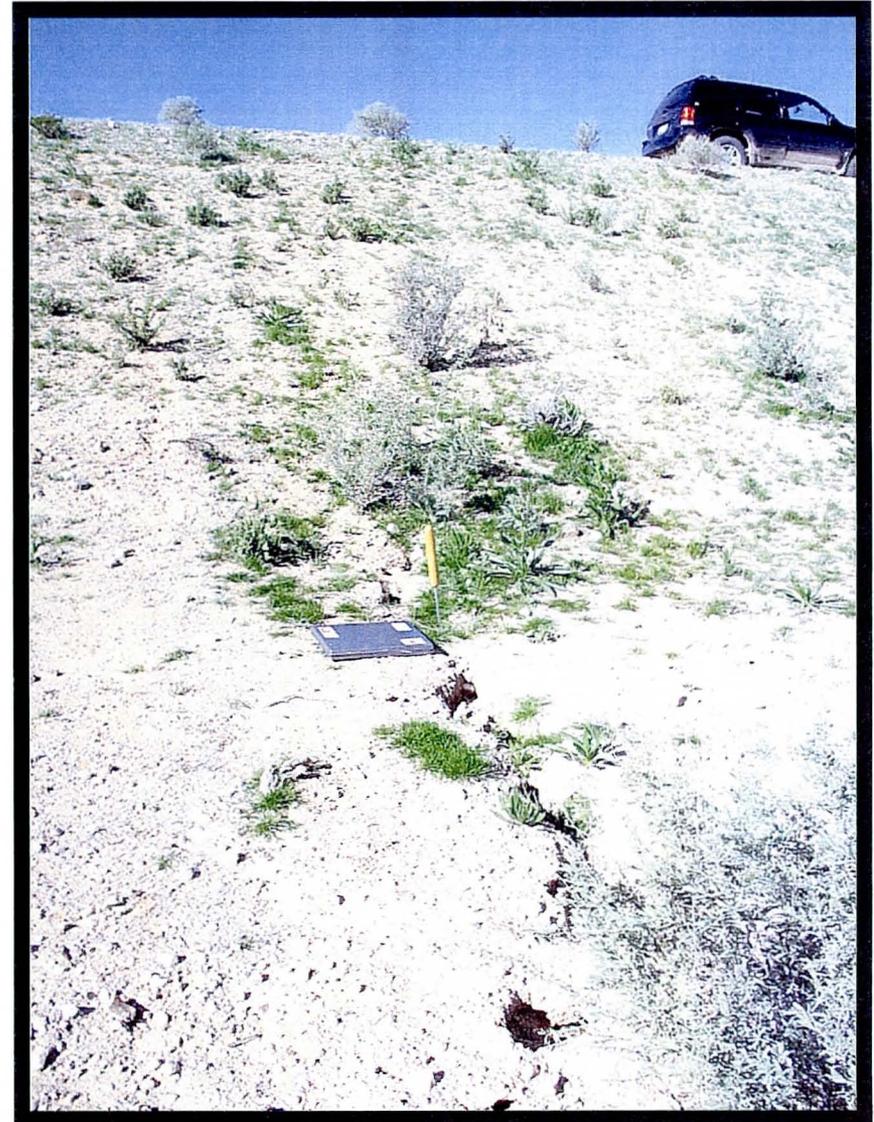
Photo 10 – Upstream Slope at Station 64+90: Crack or erosion at
the toe of the upstream slope, approximately 20-foot long, 6-
inches wide, inspection probe inserted approximately 2-feet.

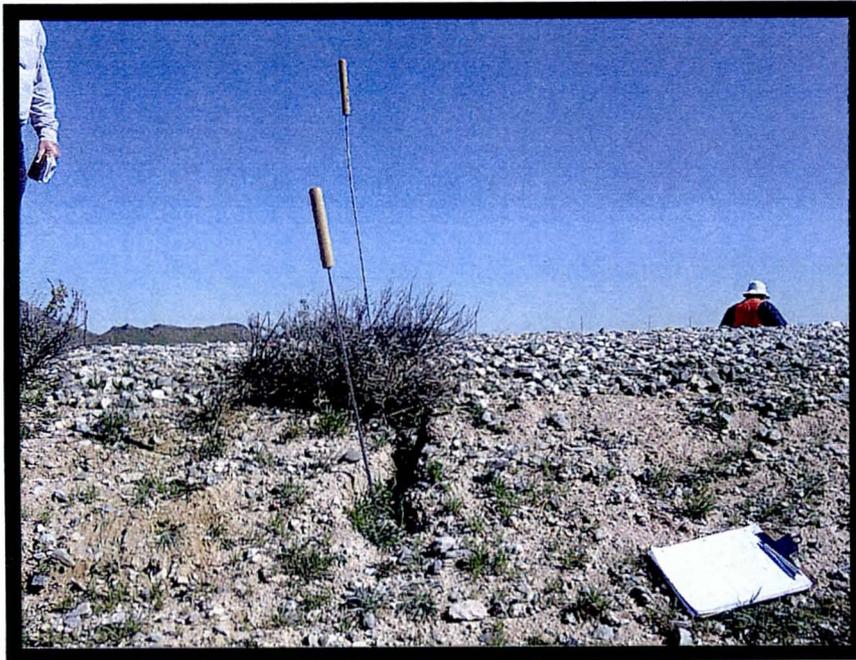
Photo 11 – Erosion rills that is possibly a transverse crack at Station 197+75: Old reports indicate a possible transverse crack at this location.

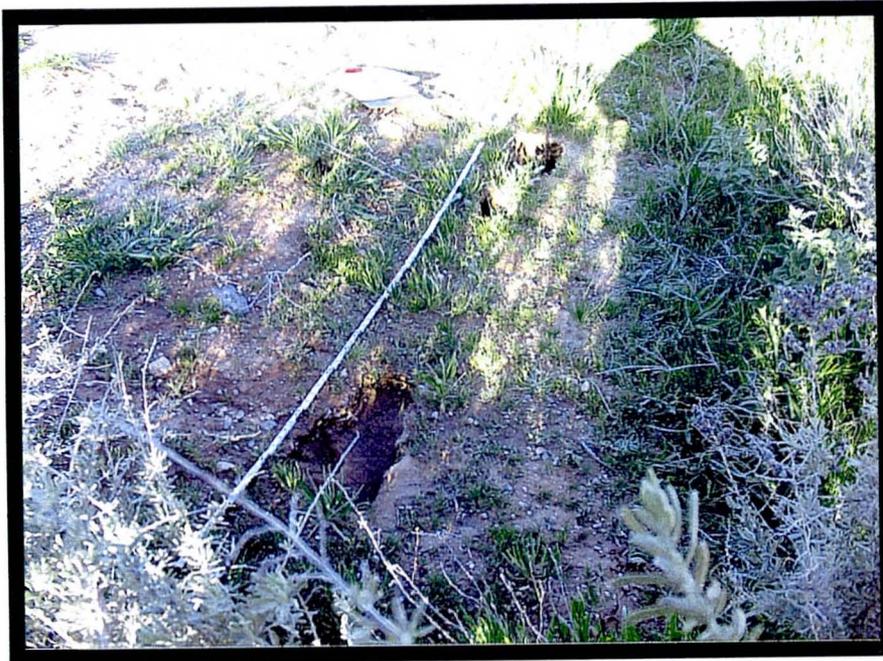
Photo 15 – Upstream Slope at Station 261+92: Longitudinal crack along downstream toe of low embankment section; ½-inch to 10 inches in maximum diameter; shows evidence of recent inflow.
