# Sunset Flood Retarding Structure Individual Structure Assessment

Prepared for  
Flood Control District of Maricopa County  
On-Call Phase I Assessment  
FCD 2003C015  
PCN 050.36.31  
June 2004

# *Sunset Flood Retarding Structure*

## *Individual Structure Assessment*

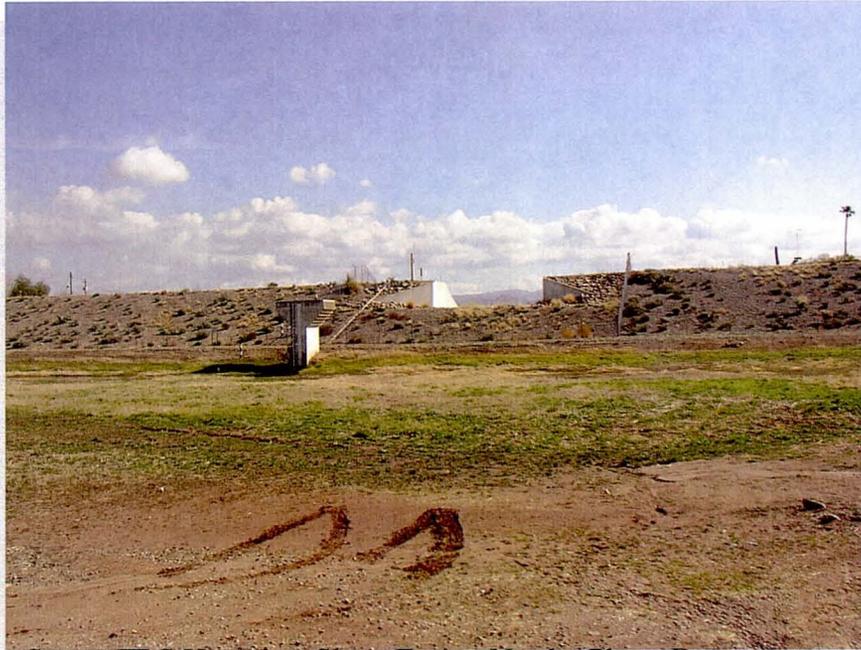
Sunset FRS Upstream Slope Facing North. Photo Date :  
2/25/04

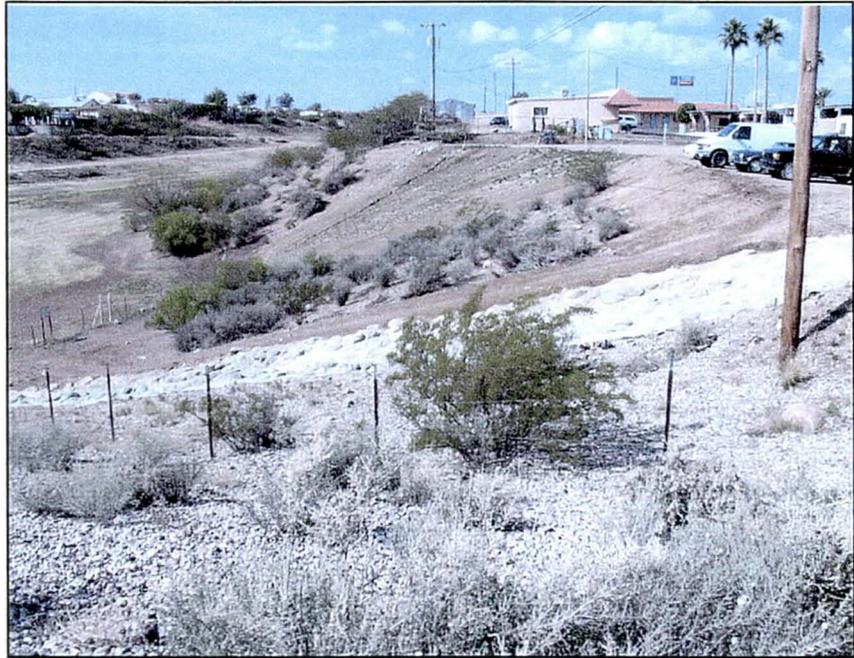
Photo 2: Right abutment upstream from dam. Fill area associated with the cutoff extended upstream to isolate large area of uncontrolled dumped fill from the left abutment. Commercial area parallel to U.S. Highway 60 in upper right of view.

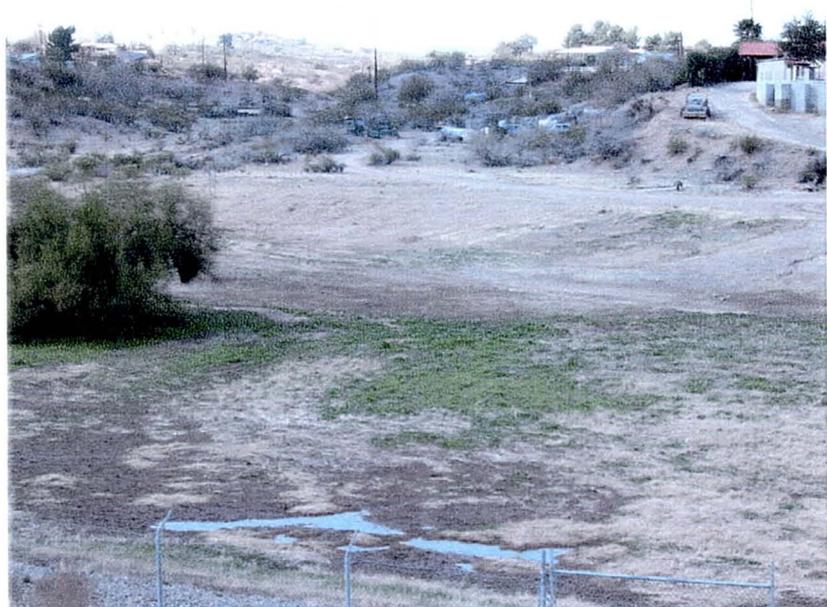
Photo 3: View looking upstream from Sunset FRS. Floodplain excavated for borrow material has modified the drainageway.

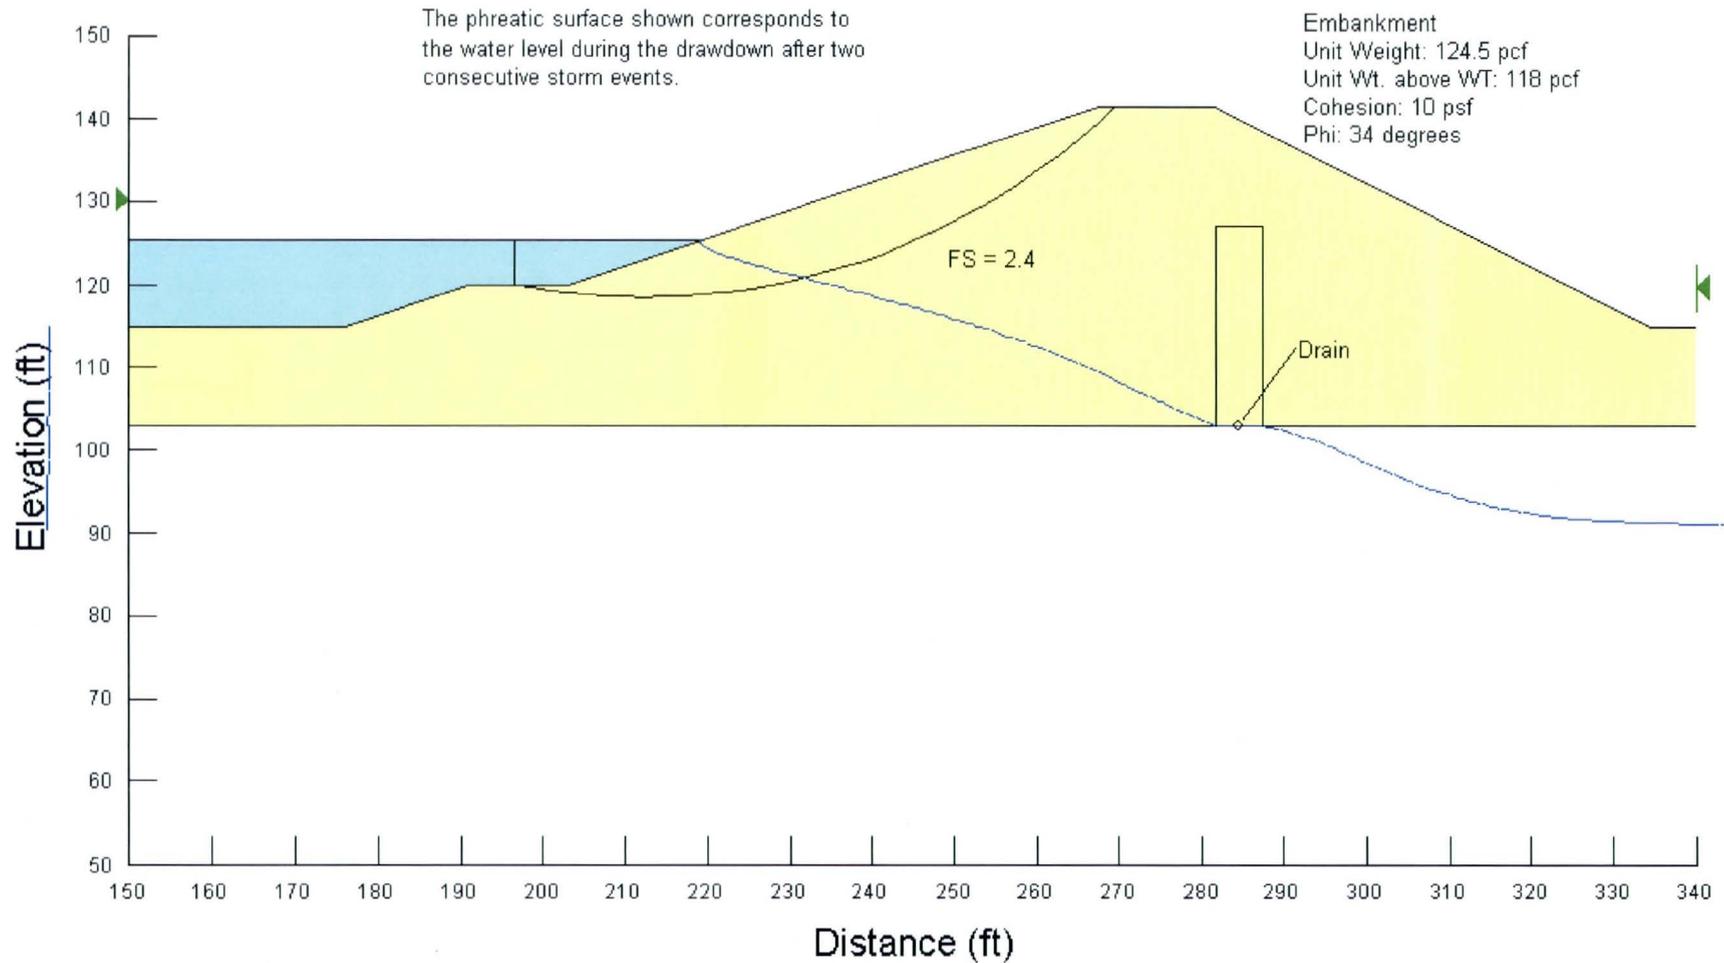
UPSTREAM STABILITY DURING DRAWDOWN AFTER TWO CONSECUTIVE EVENTS  
 SUNSET FLOOD RETARDING STRUCTURE  
 FLOOD CONTROL DISTRICT OF MARICOPA COUNTY

10. Upstream slope stability under steady seepage, partial pool: The original analysis evaluated upstream slope stability under steady seepage for the maximum pool elevation, resulting in a minimum factor of safety of 1.99. The ADWR criteria for partial pool conditions is intended for water retention dams, in which a steady state phreatic line may develop for intermediate pool elevations that result in a lower factor of safety than the steady state condition under maximum pool.

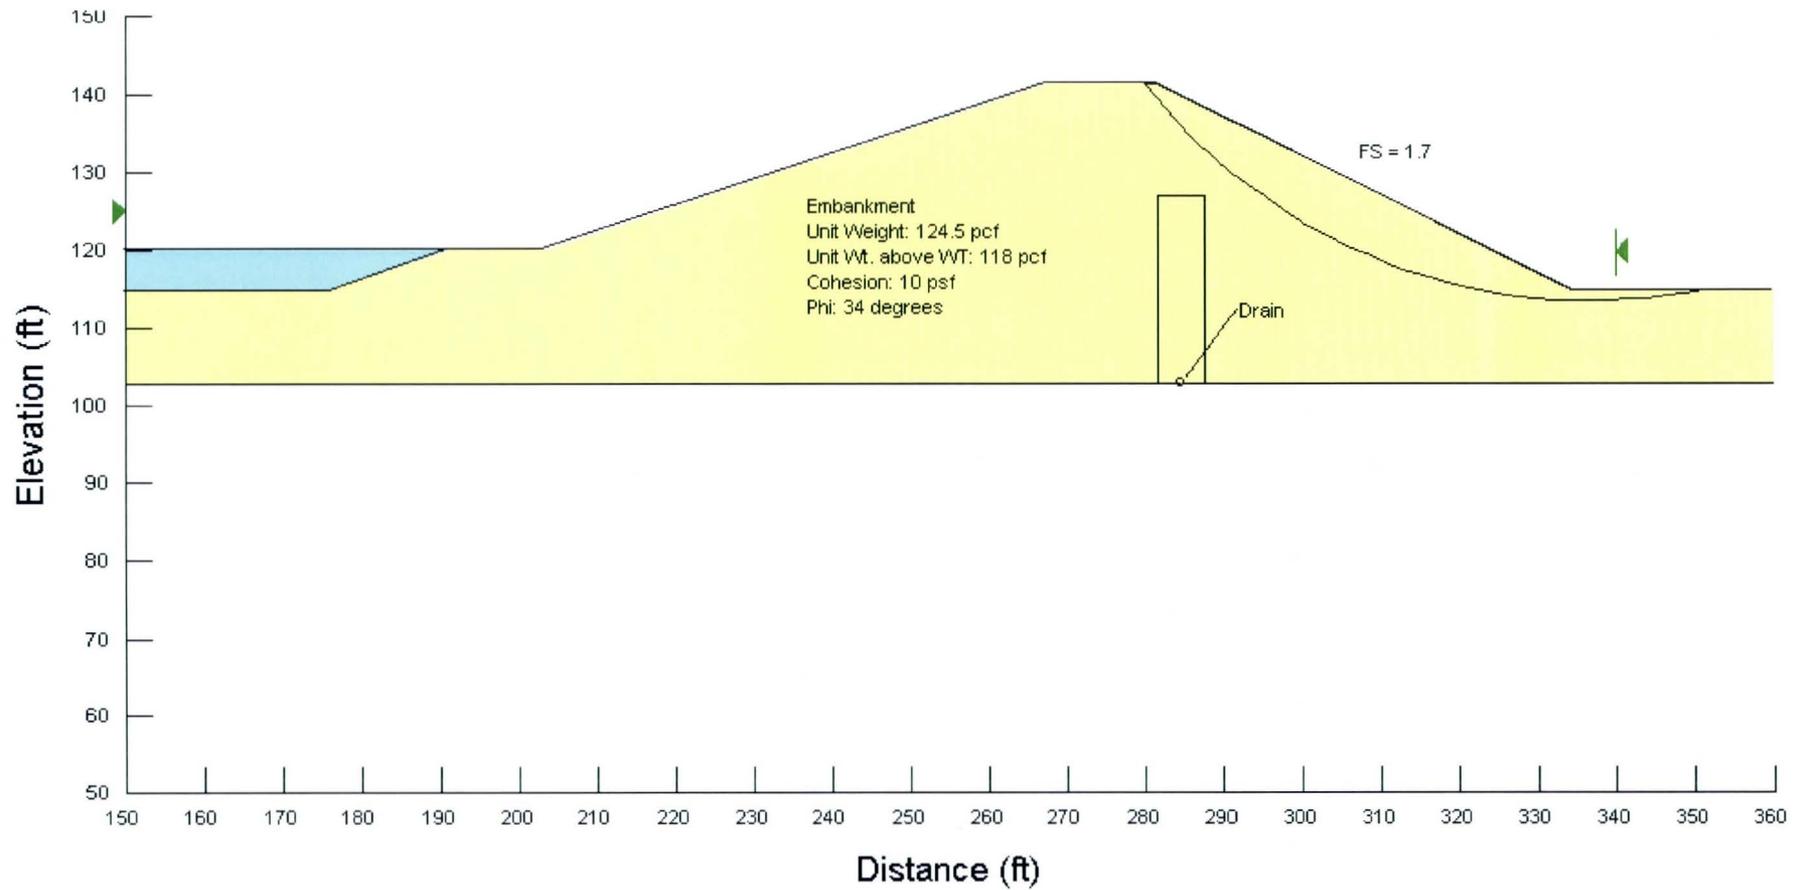
DOWNSTREAM STABILITY  
 SUNSET FLOOD RETARDING STRUCTURE  
 FLOOD CONTROL DISTRICT OF MARICOPA COUNTY

9. Downstream Slope Stability Under Steady Seepage: The original minimum factor of safety that was computed for the dry downstream slope (1.35) does not achieve the minimum criteria of 1.5. However, the KHA team does not consider the infinite slope analysis that was done in the original design as representative of a "critical" failure scenario. Preliminary analysis evaluated more substantial failure surfaces which resulted in a minimum factor of safety of 1.7.
