PHASE I INSPECTION REPORT NATIONAL DAM SAFETY PROGRAM

Prepared by: Arizona Water Commission
Supervision of Dam Safety
Phoenix, Arizona
For: Los Angeles District Corps of Engineers
Date: January 1979

Name of Dam: Sunnycove Dam (7-48)

Date of Inspection: June 5, 1978

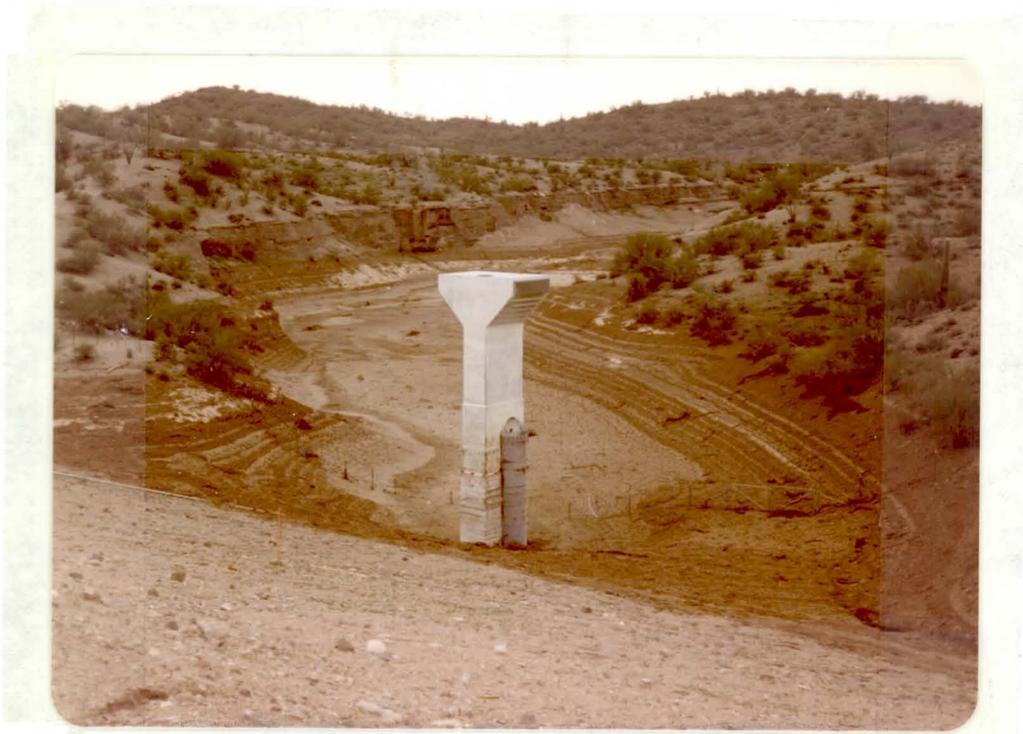
According to the Flood Control District, the gate mechanism was recently serviced and is believed to be in operable condition. The concrete of the intake structure on the outlet appeared to be in good condition. There is some silt accumulation around the base of the intake structure but not enough to affect operation of the low-level intake. The spillway has not operated yet and appeared virtually unchanged from its as-constructed condition. The Maricopa County Flood Control District is able to adequately perform all operation and maintenance required for the various flood control facilities including this dam that they own.

Photo 1 (October 22, 1976) - Outlet intake structure, upstream slope of dam and reservoir area.

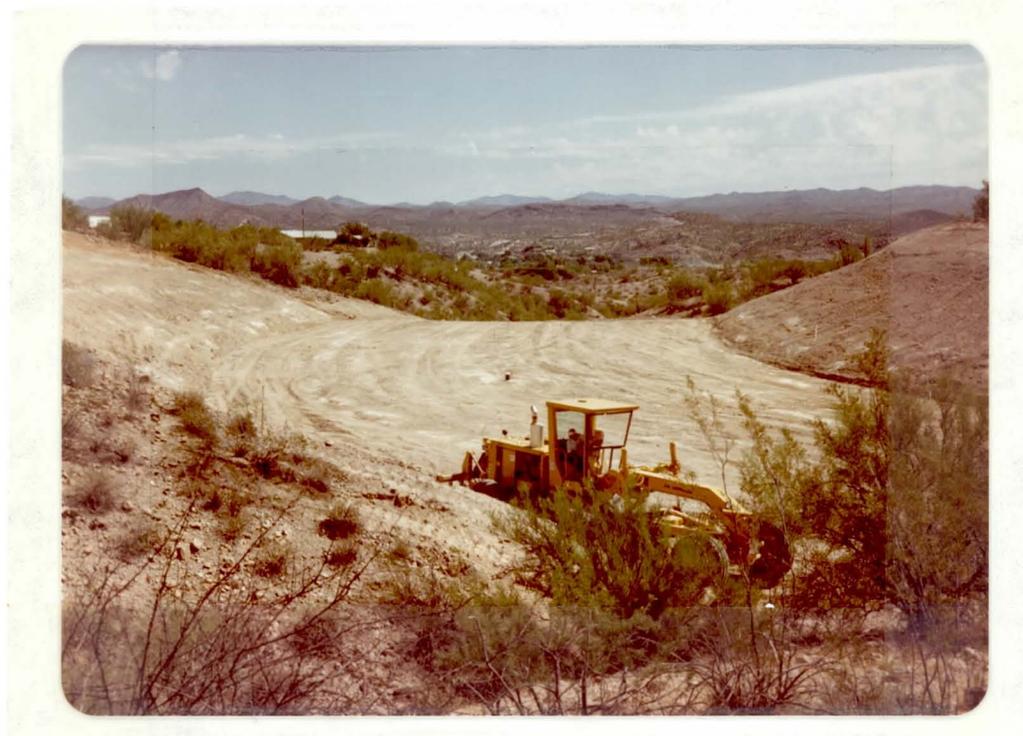
Photo 2 (August 19, 1976) - Emergency spillway. Looking downstream.

B. Recommendations: Construction quality control records presently not in the Commission files should be acquired for completion of the record. The present operational surveillance plan should be continued. Because the dam is unattended and because discharge from the emergency spillway could cause damage downstream, it might be well for the Flood Control District to consider the installation of a warning system to alert local emergency services people in time of extreme floods.

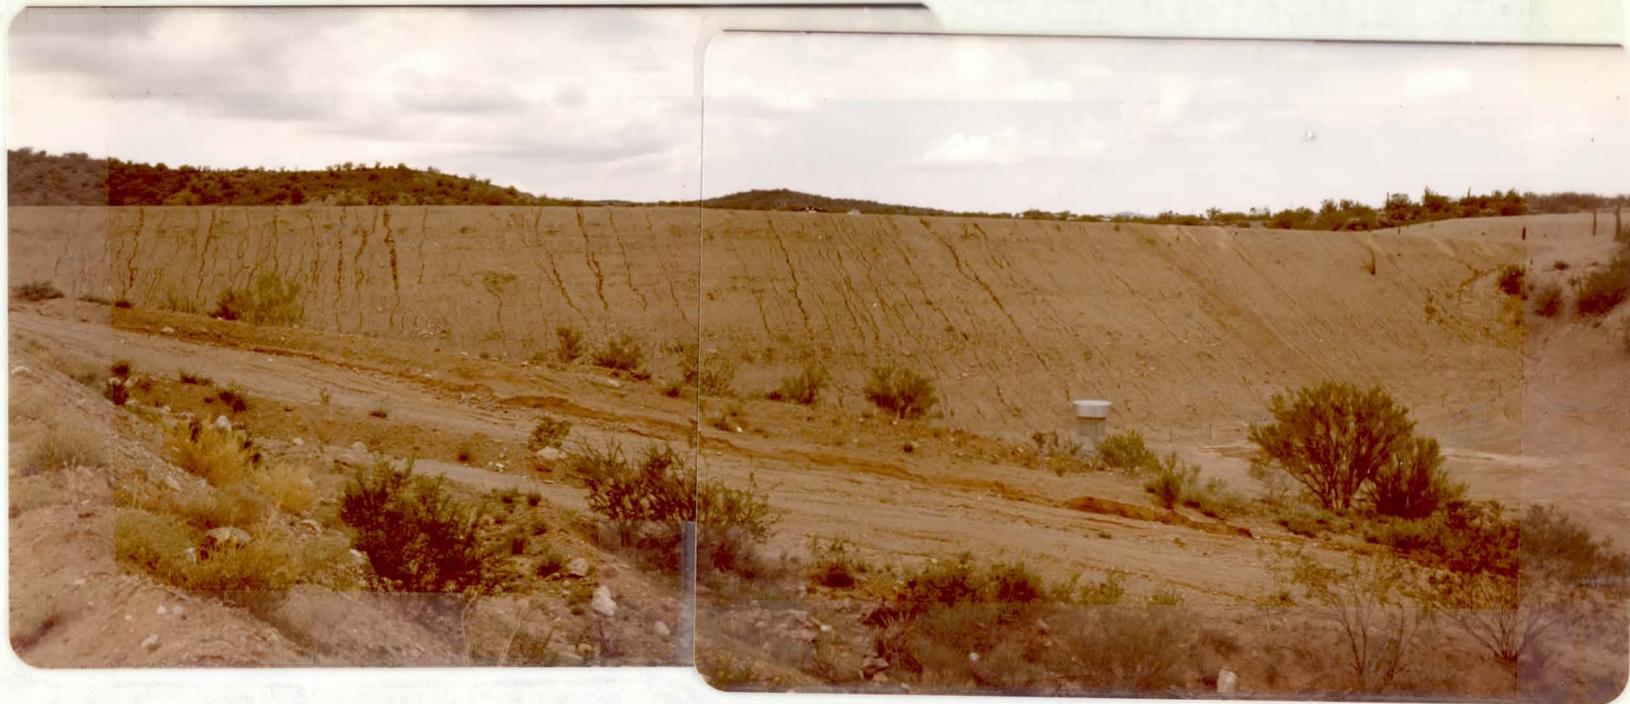
A. Inspections: The dam is inspected annually by Commission engineers. The dam was inspected in October 1976, April 1977 and June 1978. At the time of the most recent inspection engineers from the Commission inspected the dam with representatives of the Maricopa County Flood Control District, owner of the dam. There was evidence of about 20 feet of impoundment from recent floods in March 1978. At that time there was flow through the outlet works but none through the spillway. There was no evidence of seepage through the embankment or the foundation during or after this period of moderate storage. The crest and slopes of the embankment appeared to be in good condition with no visible signs of cracks or settlement. There are no surveillance monuments installed on this dam. There is moderate vegetation growth on the slopes but erosion gullies are developing along the slopes. They are not detrimental but

represent future maintenance work.

Photo 3 (October 22, 1976) - Downstream slope.
