**PHASE I
ENVIRONMENTAL SITE ASSESSMENT**

**NORTH OF WICKENBURG WAY
CASSANDRO WASH DAM PROJECT
PARCELS CWD-1 THROUGH CWD-14
WICKENBURG, ARIZONA**

January 21, 1994
WRA File AR390-2105

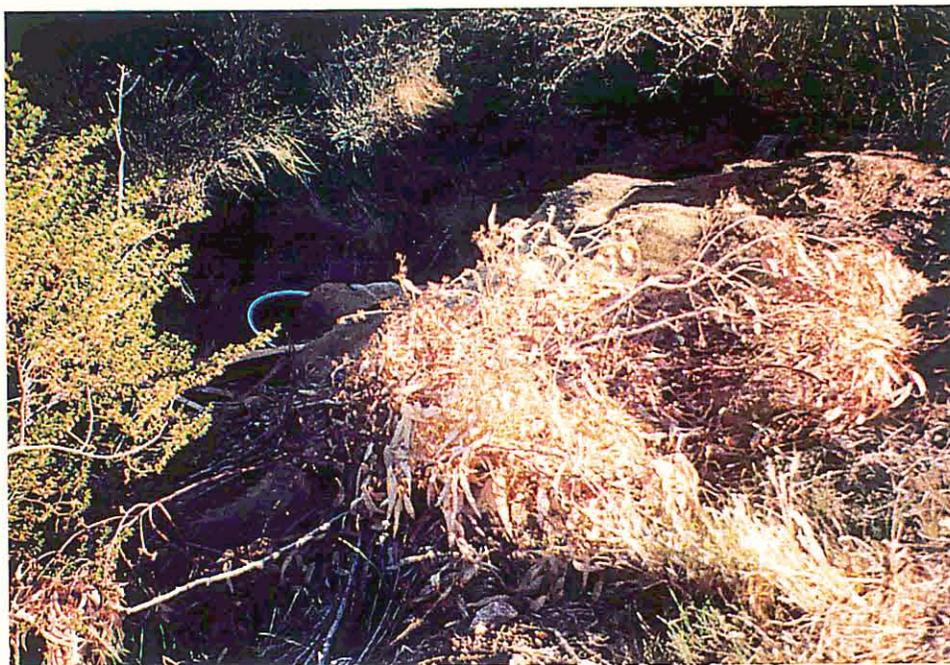
Photograph No. 1

CWD-1. Signage indicating the presence of an underground gas pipeline was observed near a small wash adjacent to a dirt road near the north edge of CWD-1. A trash pile was observed east of a single-family residence on CWD-1 in a small gully. The trash pile contained empty paint containers, three empty one-gallon plastic cans labelled paint thinner, a tire, scraps of carpet and carpet padding as well as empty quart oil containers. The bottom of the trash pile was not visible due to grass clippings and other landscaping debris obscuring the pile. No staining or odors were observed by CEC/WRA personnel in the trash pile. A pole mounted transformer was visible adjacent the residence to the east.

View of trash pile on east side of residence of CWD-1. View is looking east.

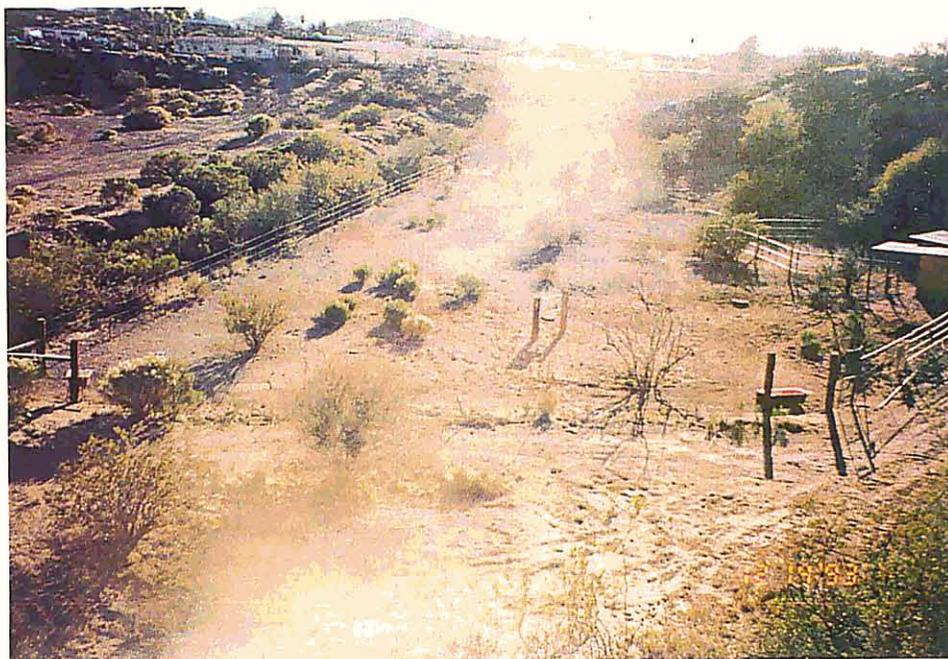
Photograph No. 2

A corral was observed on the southern portion of CWD-1 located on the north side of the wash. Water to the corral appears to be trucked in. Several hoses were observed leading from the residence on the hill to the corral.

View of corral on south portion of CWD-1.

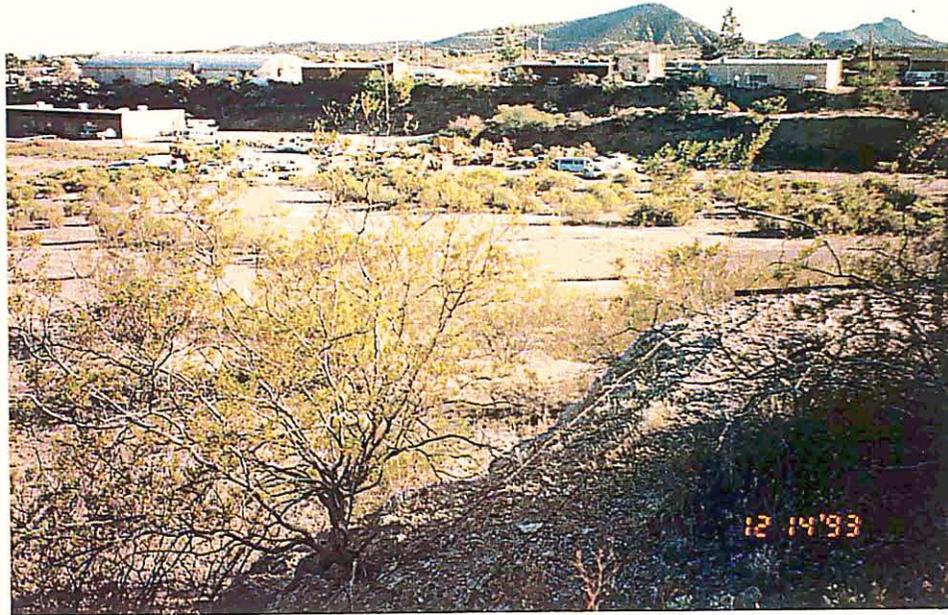
Photograph No. 3

View of subject property looking in southeasterly direction.

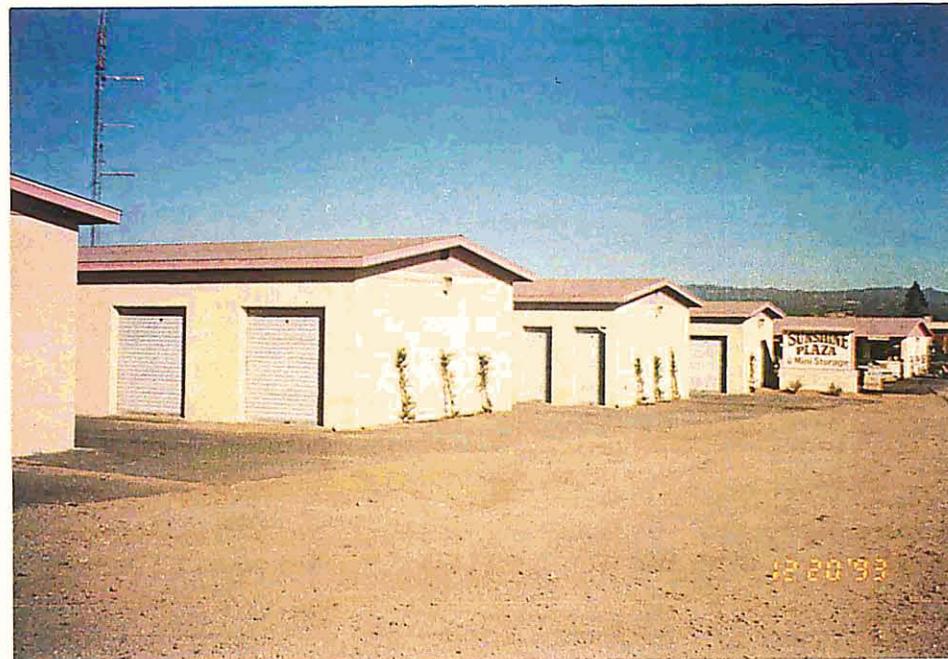
Photograph No. 4

View of Sunshine Place & Mini-Storage on CWD-2. View is looking northeast.

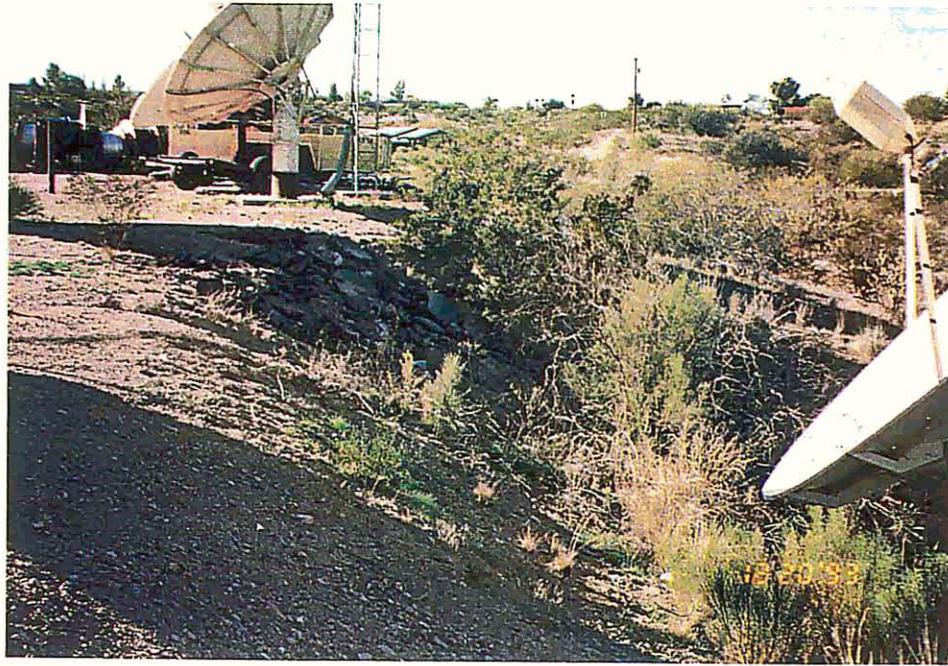
Photograph No. 5

View of satellite dishes and pile of dumped asphalt on north side of Cable America (CWD-2).

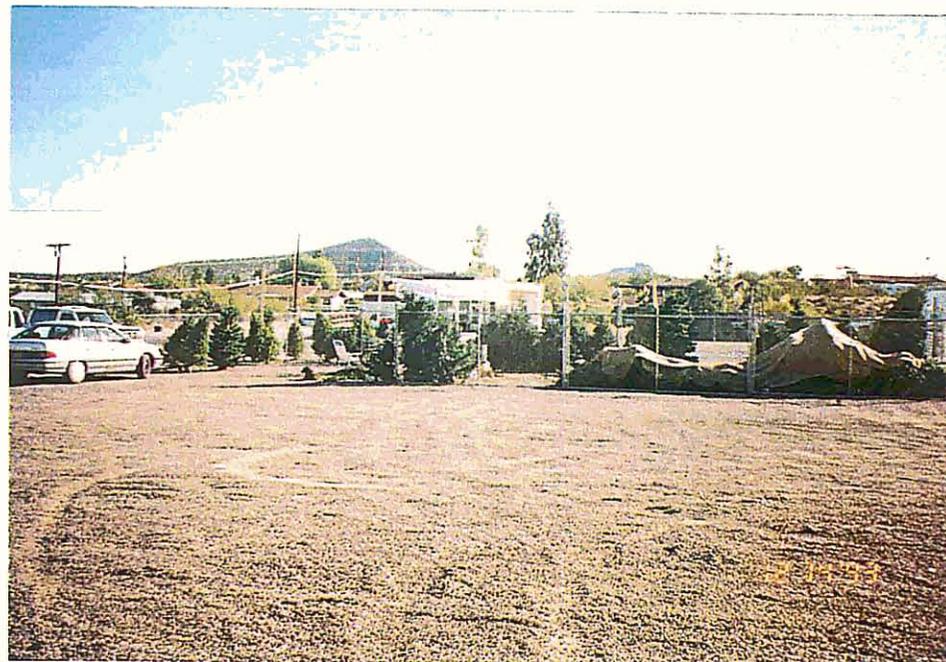
Photograph No. 6

CWD-3 is a vacant gravel lot. A Christmas tree lot was observed by CEC/WRA on the west side of the parcel during the December site visits. Four 12 foot pieces of metal pipe were observed near the edge where the property drops off towards Cassandro Wash. An empty 55-gallon drum which had tar stains

on the top was observed near the northern property boundary of CWD-3. The drum was marked "Fresh Trees" in white paint around the sides of the drum. No staining was observed on the ground around the drum.

View of Christmas tree lot on CWD-3 looking in southerly direction.

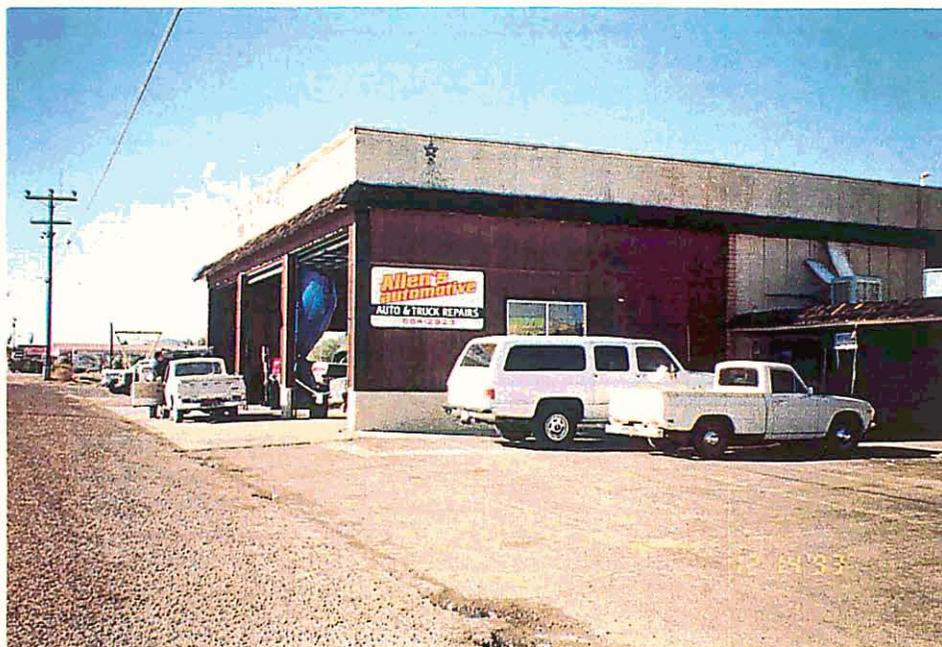
Photograph No. 7

View of Allen's Automotive on CWD-4 looking in northwest direction.
Note, 10,000 diesel UST slurred in-place under Chevrolet Suburban.

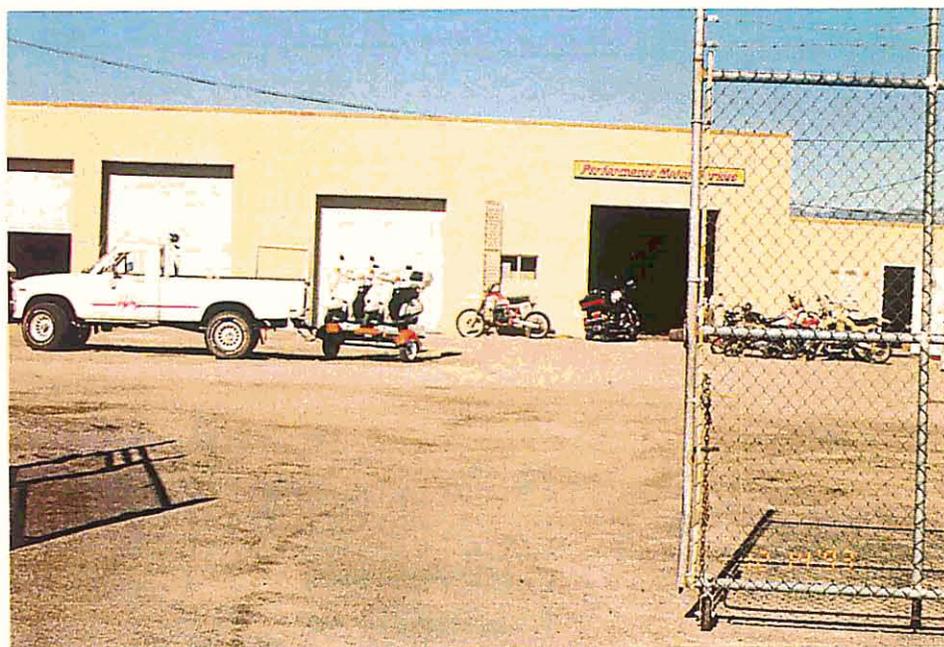
Photograph No. 8

A rectangular building located near the north edge of the bluff houses Performance Motor Service, a motorcycle repair facility. A dirt drive is located on the west side of Performance Motors. The dirt drive slopes down to the wash below. The area in front of Performance Motors is unpaved. No evidence of large scale staining was observed in the dirt area in front of the motorcycle repair shop.

View of Performance Motors (CWD-4) looking north.

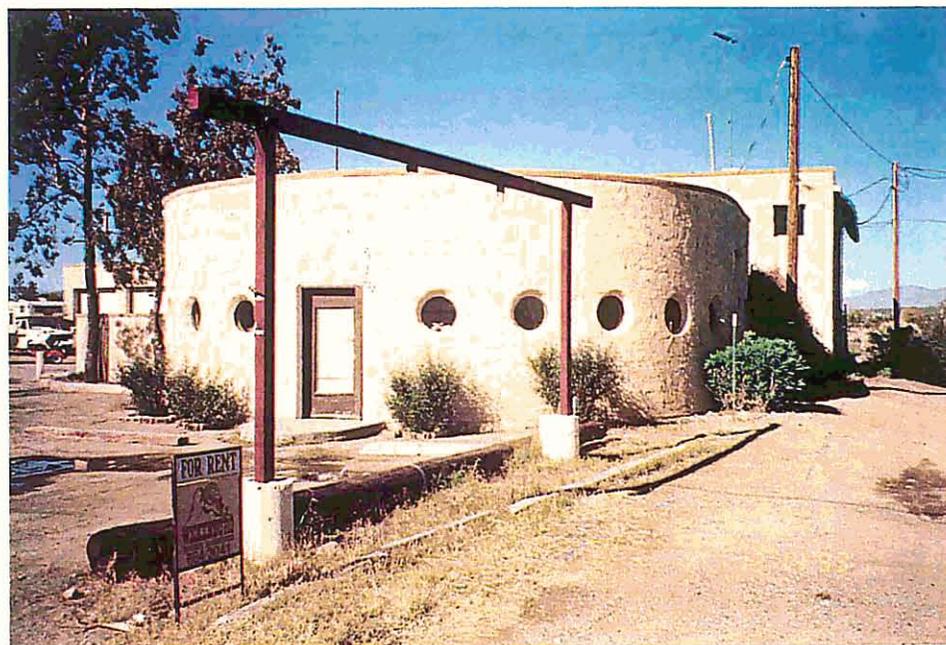
Photograph No. 9

View of vacant restaurant and two-story apartments on east side of CWD-4.
View is looking northwest.

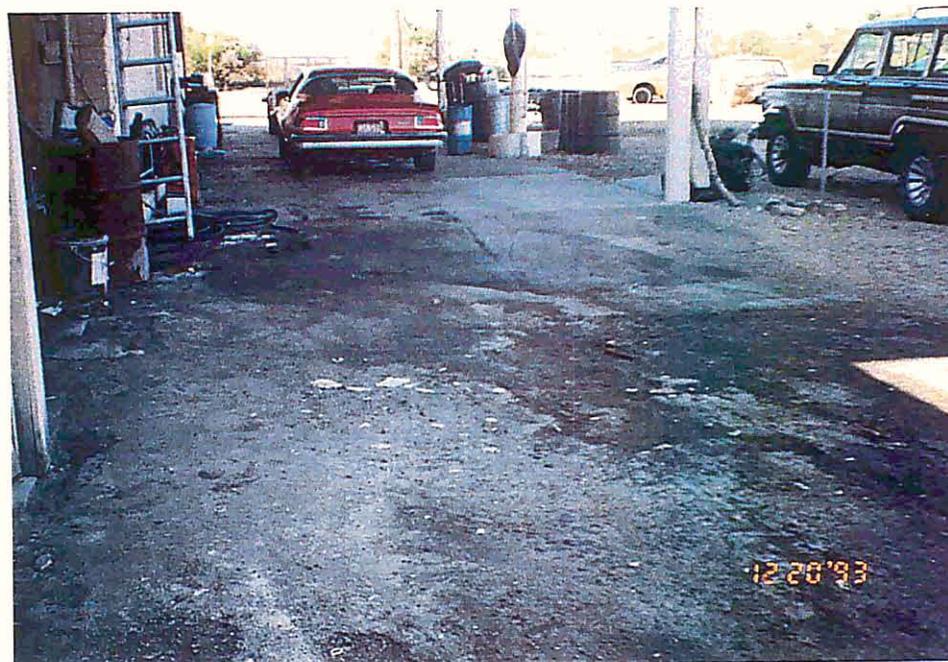
Photograph No. 10

Six 55-gallon drums of used motor oil and two flat pans of used motor oil were located on a concrete island under a canopy on the north side of Allen's Automotive. No petroleum product dispensers were observed. The area north of the canopy was unpaved and was heavily stained with what appeared to be motor oil.

View of oily soil staining on north side of Allen's Automotive looking west (CWD-4).

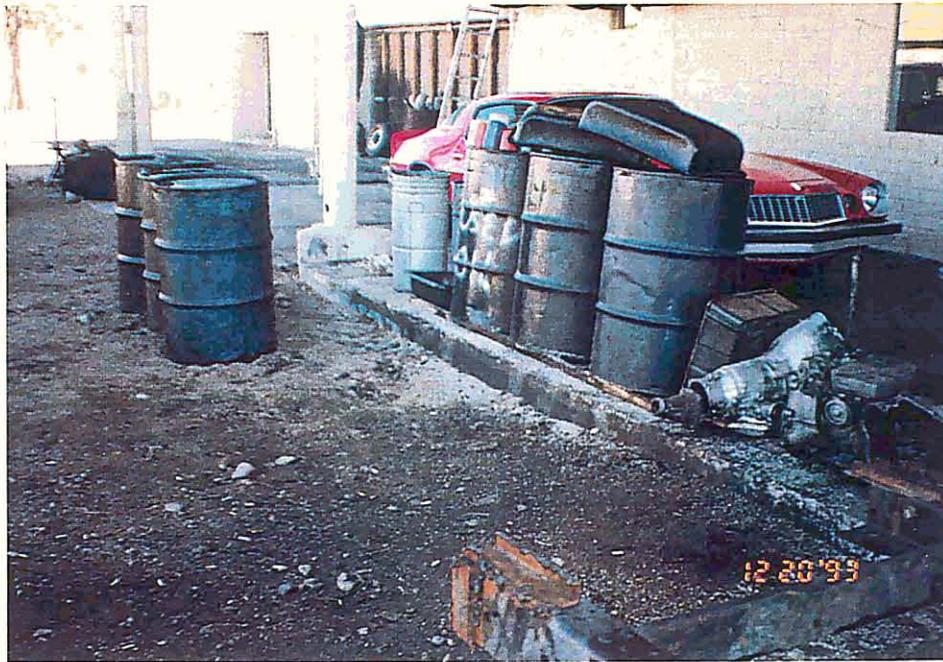
Photograph No. 11

View of former dispenser island on north side of Allen's Automotive
looking in southeasterly direction.

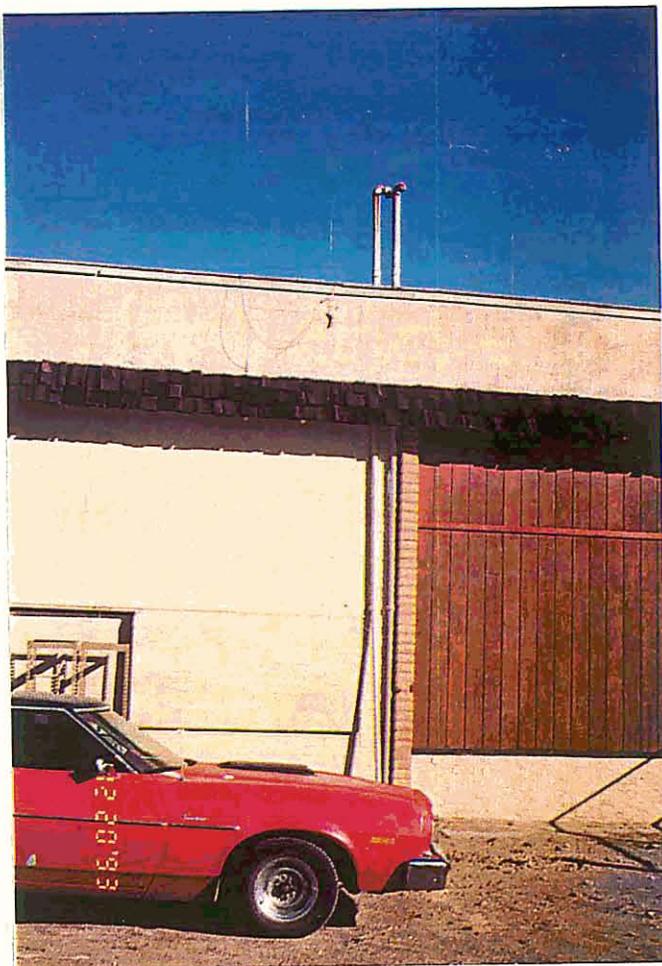
Photograph No. 12

View of vent pipes on west side of Allen's Automotive (CWD-4).

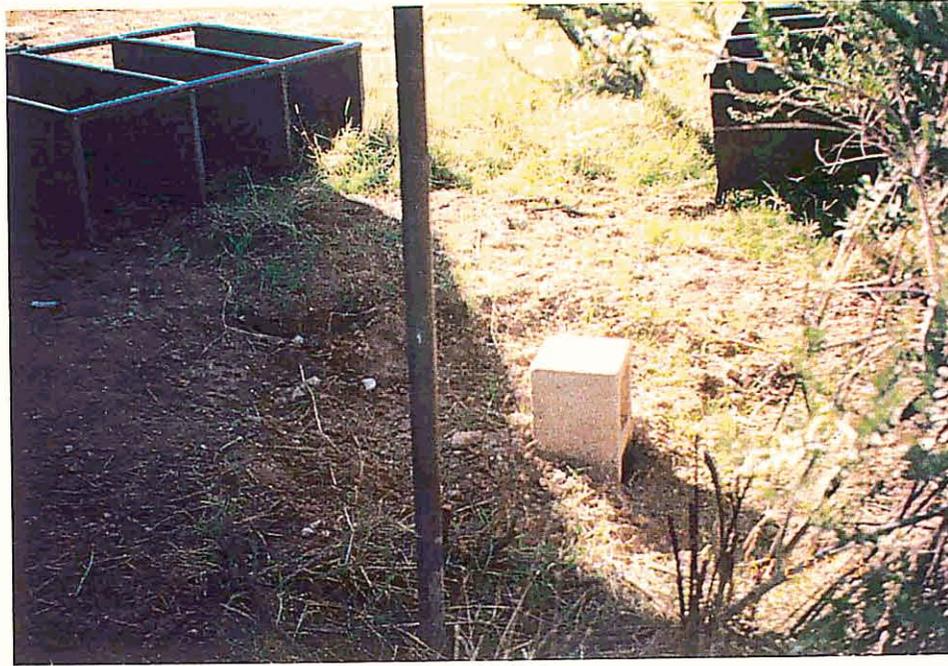
Photograph No. 13

A small depression was visible on the north side of the two-story vacant apartment building during the site visit. A concrete block was partially buried in the depressed area. The concrete block was removed from the depression and concrete was observed approximately six inches below the ground surface. No openings in the concrete or odors were detected by CEC/WRA personnel.

View of depression near northeast corner of CWD-4, north of two-story building.

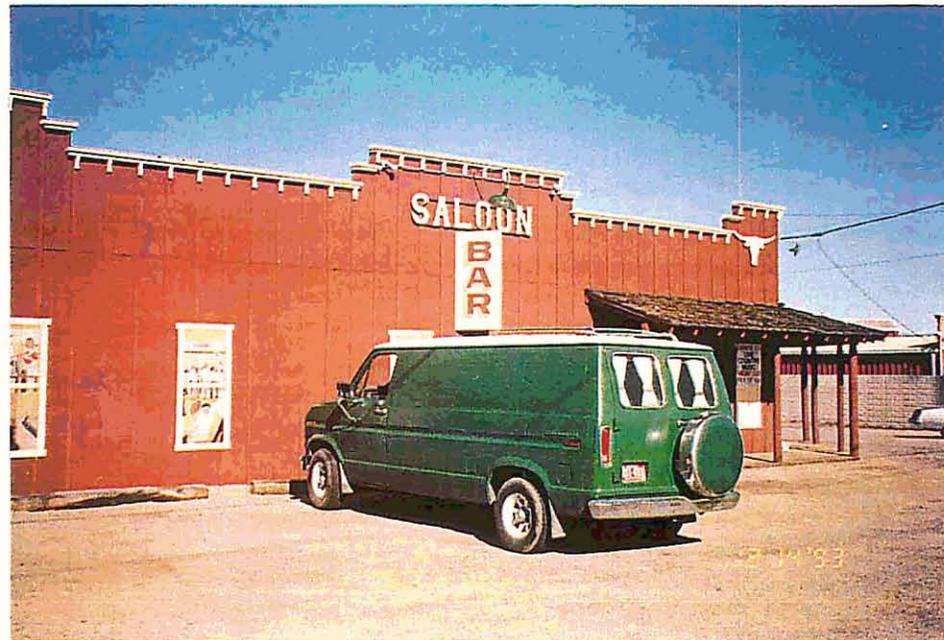
Photograph No. 14

CWD-5 is developed with the Rancher Bar. The parking lot surrounding the bar, consisted of both asphalt and gravel lot. A dumpster was observed near the northwest corner of this parcel. A pole-mounted transformer is located near the east fence line. A small amount of staining was observed on the transformer.

View of Rancher Bar located on CWD-5 looking north.

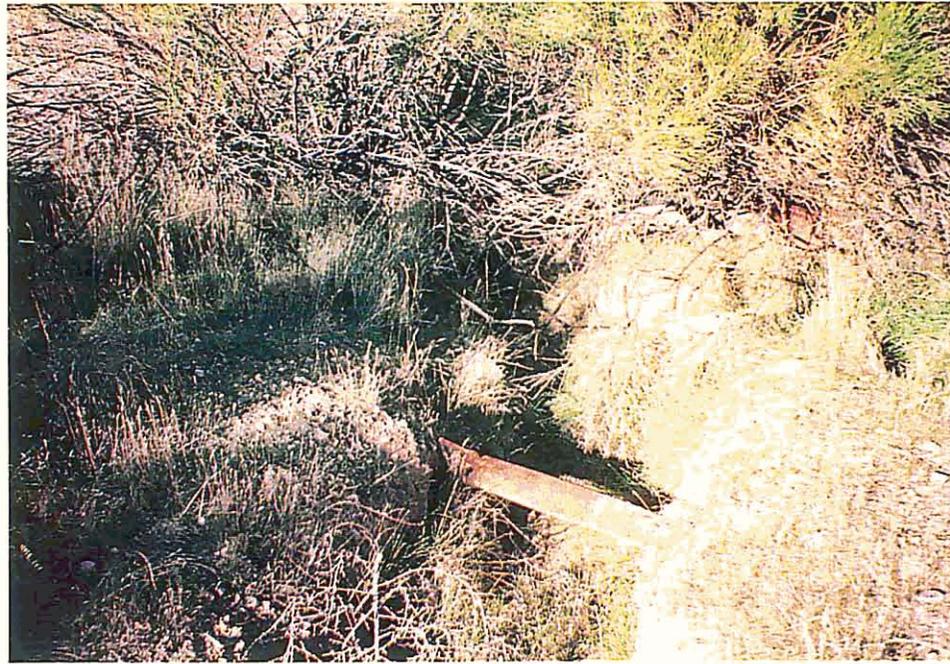
Photograph No. 15

West of the equipment yard is an area where approximately 40 vehicles and approximately 10 pieces of heavy equipment are located. A mounded area of dirt was observed on the site. The area which is oriented north and south contained buried tires, automobile parts and pieces of scrap metal.

View of mounded dirt and partially buried pipe on CWD-6.

used as fill material for the earthen flood control structure and will be in the pool area behind the dam, CEC/WRA recommends that the mounded area be excavated and examined for potential hazardous materials.

A knowledgeable person should be located on the site to characterize the debris piles prior to disposal. Any stained soil or potentially hazardous materials observed during excavation should be sampled for hazardous constituents at that time. The household and other non-hazardous debris should be removed from the site and properly disposed of according to applicable local, county or state regulations.

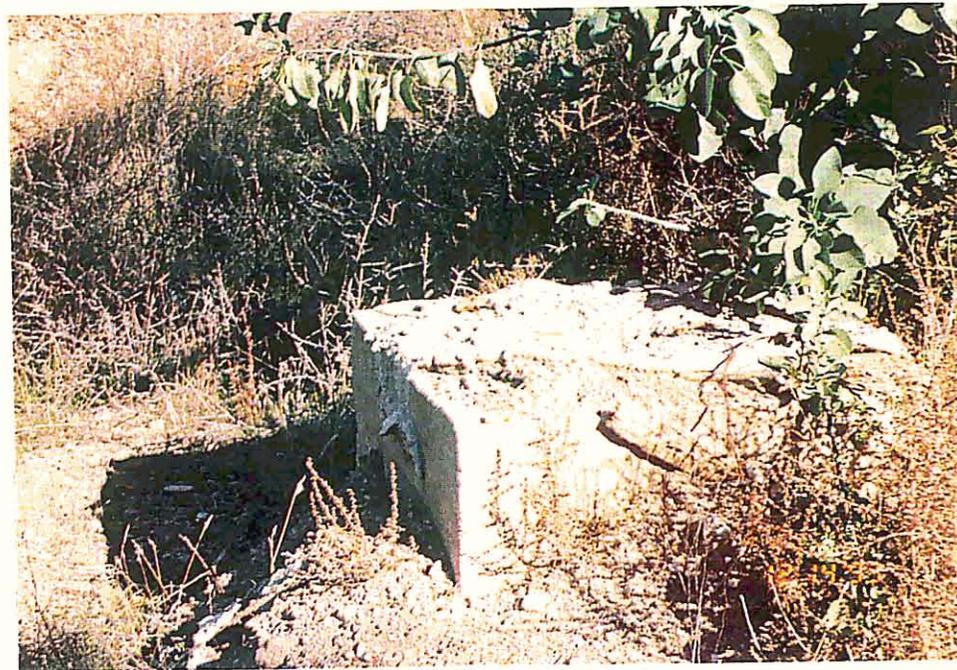
Photograph No. 16
View of concrete vault on CWD-6.

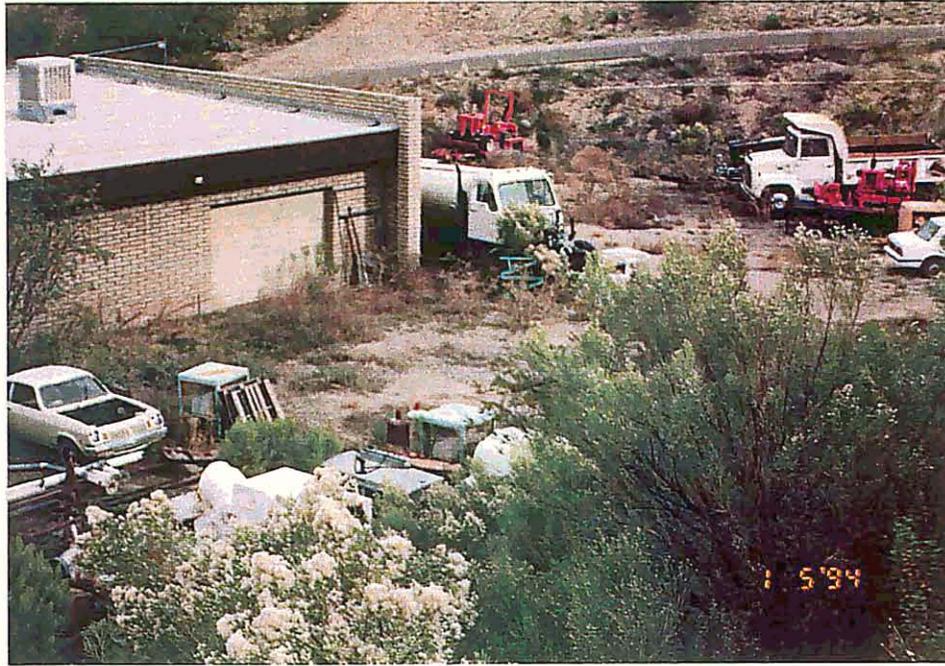
Photograph No. 17

View of equipment yard for former machine shop located on CWD-6.
View is looking northwest from top of hill.

Vehicles and Other Equipment. Numerous vehicles and heavy equipment and other miscellaneous equipment was observed on CWD-6. CEC/WRA recommends that the equipment and vehicles be removed from the site and the ground beneath the equipment be examined for staining. If evidence of soil contamination is discovered, CEC/WRA recommends that the stained soil be over-excavated and removed from the site and disposed of in an approved landfill. Confirmatory soil samples should be collected upon completion of over-excavation to assure total removal of contaminated soil. In addition, other trash and discarded items should be removed to a landfill prior to excavation of soils.

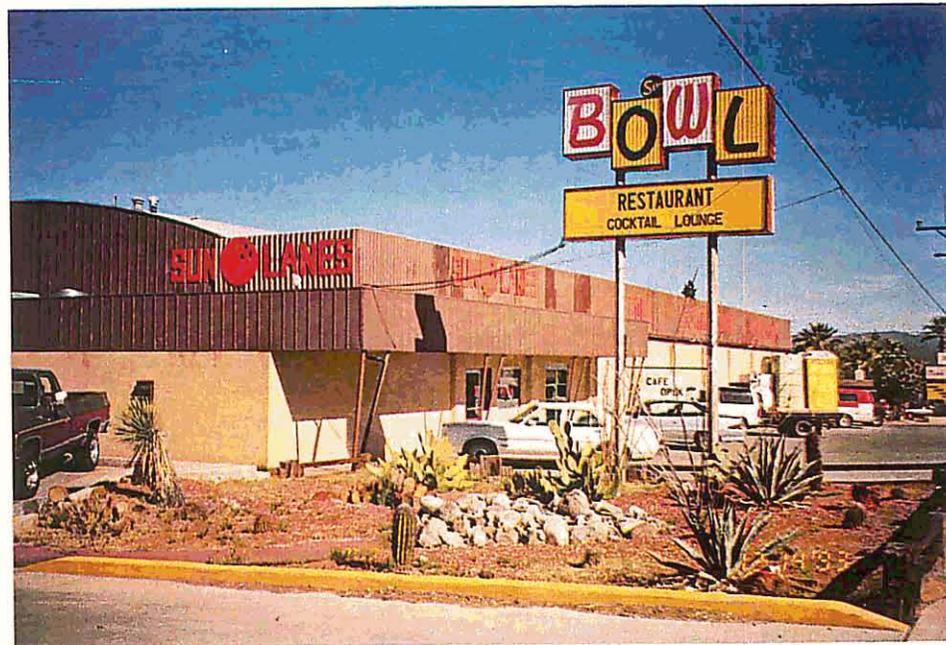
Photograph No. 18

View of Sun Lanes Bowl on CWD-7.

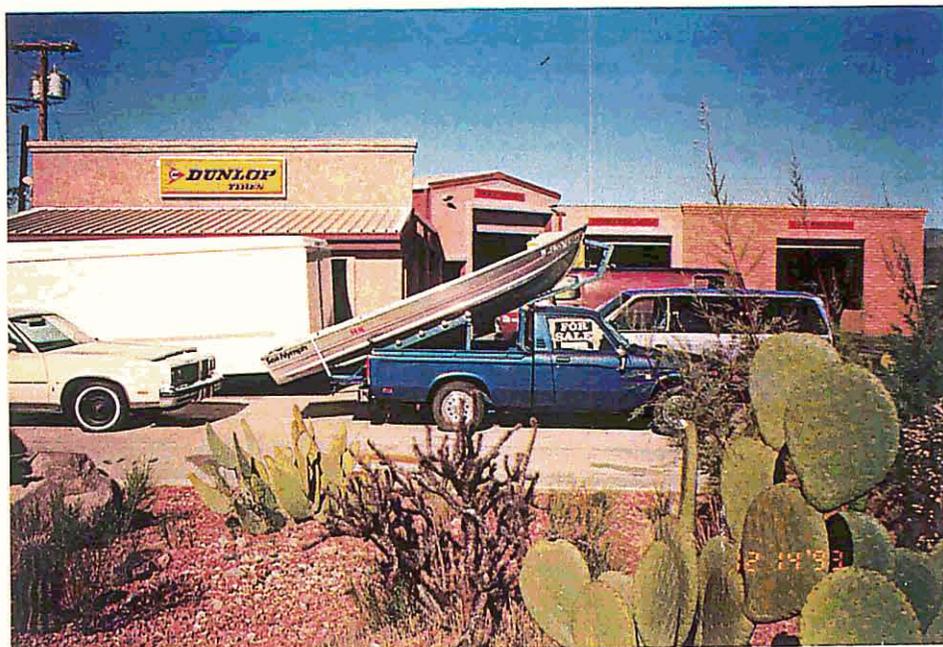
Photograph No. 19

View of Sun Tires Auto Center on west portion of CWD-7 looking north.

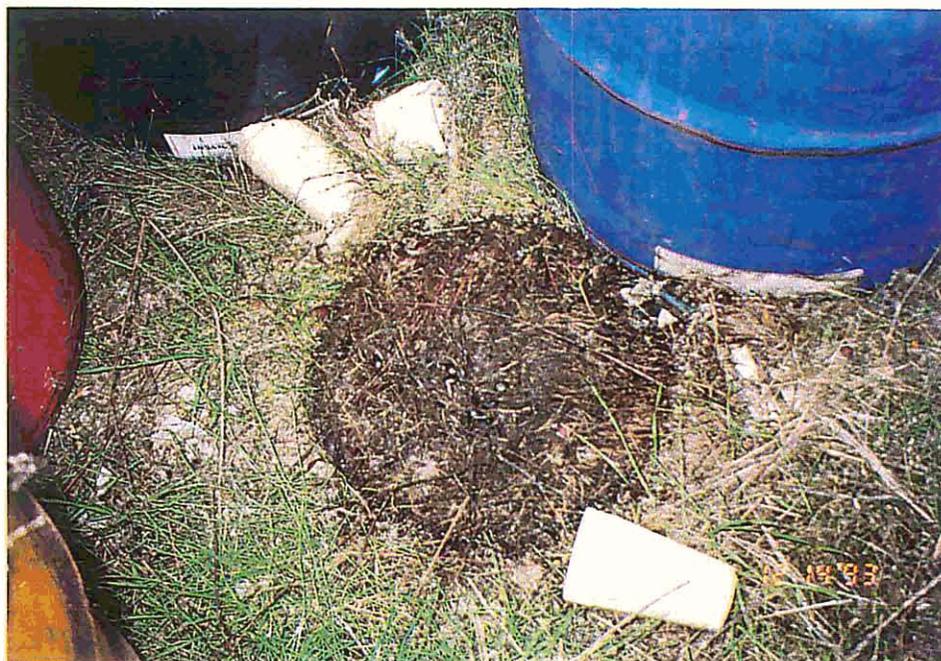
Photograph No. 20

Four empty 55-gallon drums were observed directly east of the dumpster. These drums were sitting directly on the dirt. In addition, a 20-gallon empty solvent drum labelled "360 Solvent" was observed upside down. CEC/WRA observed that the ground under the solvent drum was stained, damp and had a distinct solvent odor. Moisture was observed around the bung hole of the drum.

View of stained soil under 55-gallon drum of solvent on CWD-7.

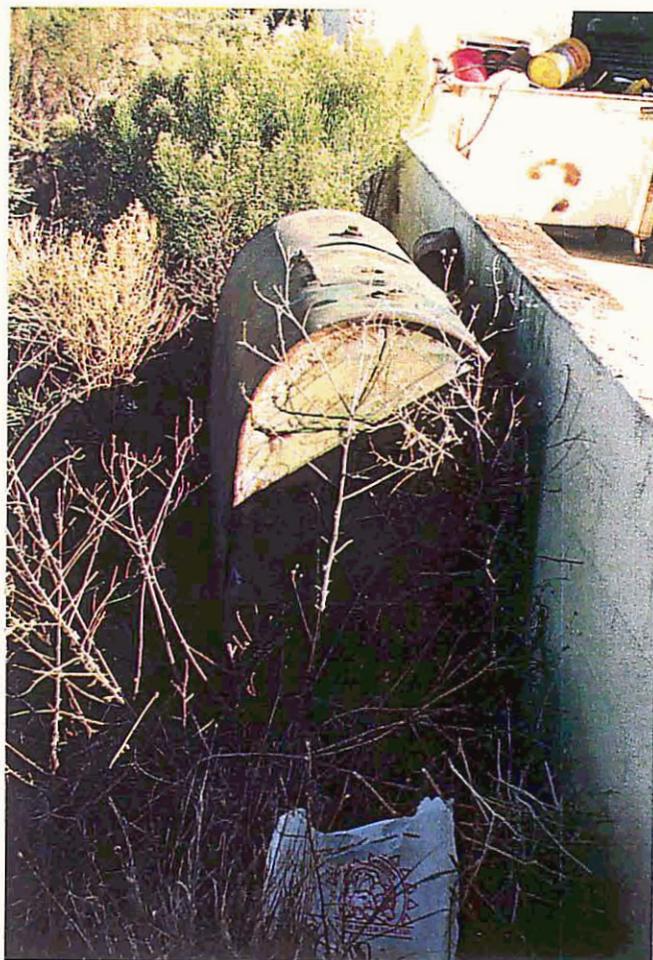
Photograph No. 21

View of used oil tank on north side of retaining wall on CWD-7.
Note dumpster in background. View is looking east.

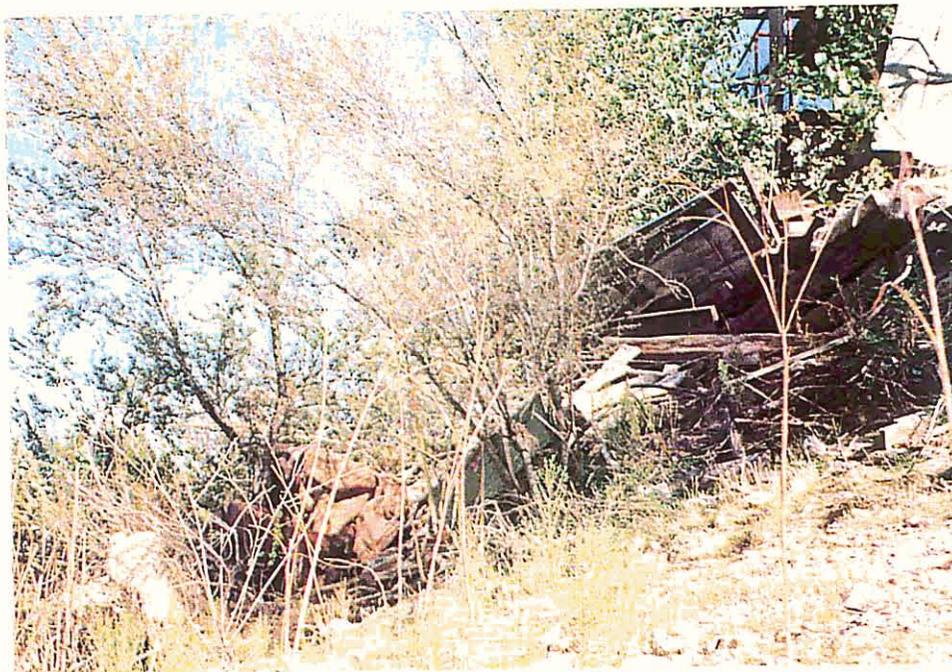
Photograph No. 22

CWD-9. North of the U.S. West building are two single-family residences. A hillside near the northwest corner of CWD-9 was littered with trash, wood, and the remains of a abandoned car. No evidence of hazardous materials was observed. A small shed was visible at the top of the hill and the materials appeared to have been placed against the hillside to control erosion and to stabilize the hill.

View of trash and debris on northwest corner of CWD-9.

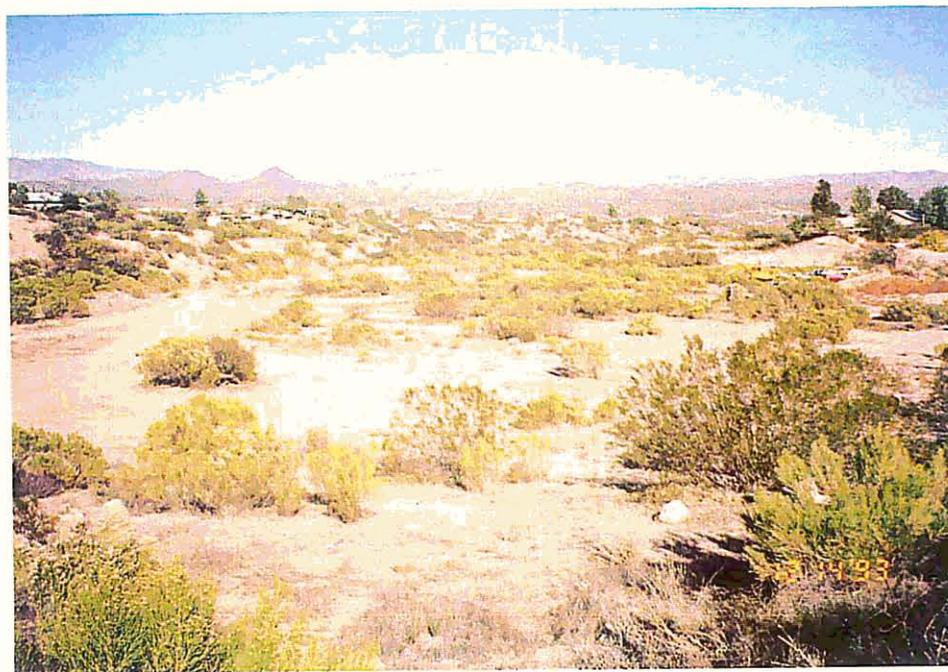
Photograph No. 23

View of Cassandro Wash looking in easterly direction.

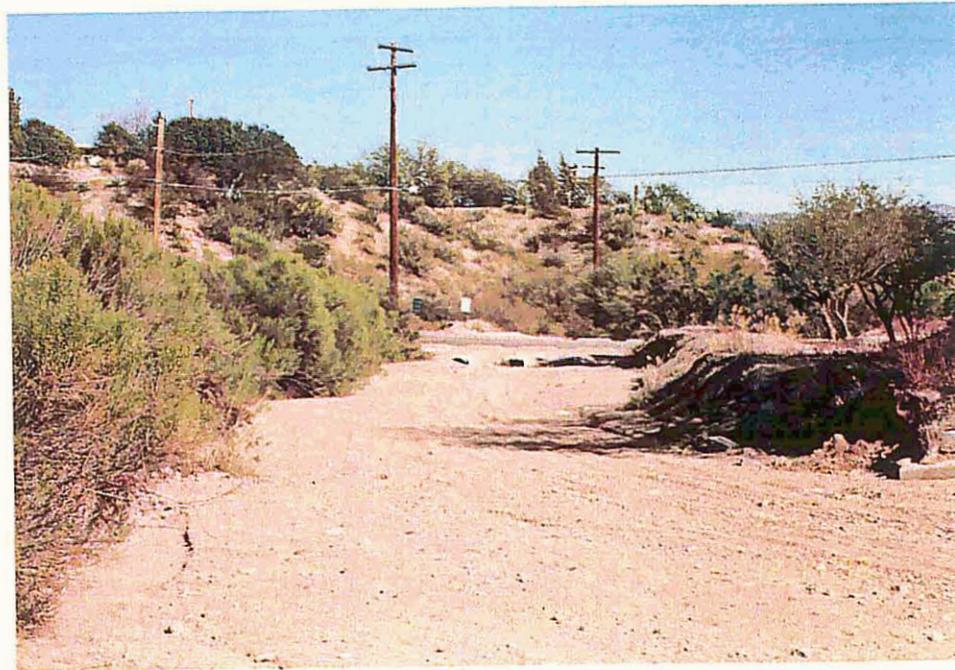
Photograph No. 24

View of Cassandro Wash near Mariposa Road looking in easterly direction.

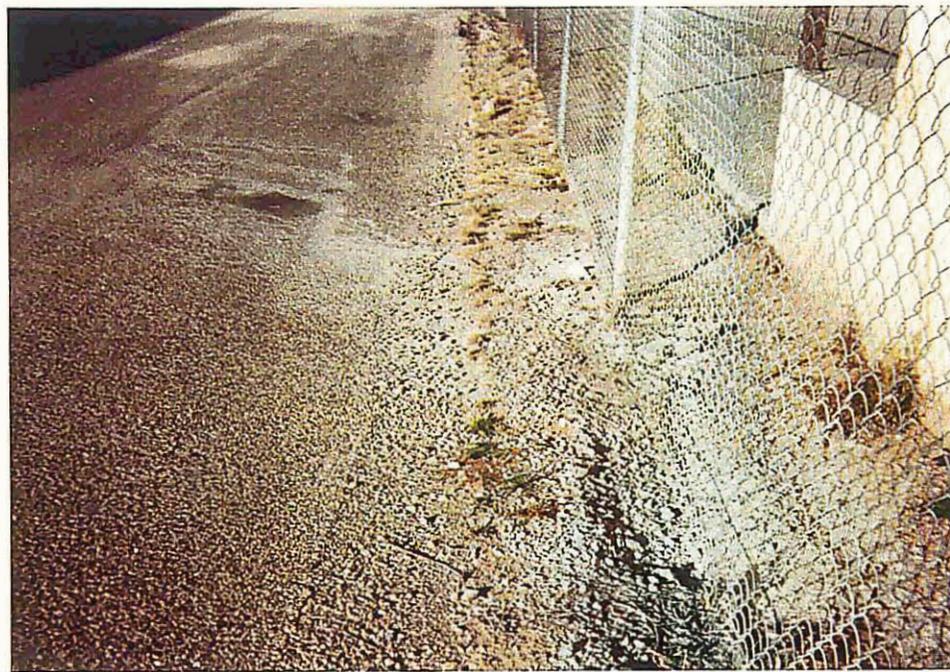
Photograph No. 25

of the freight dock building. A 55-gallon drum of paint thinner was observed adjacent to the building in the fenced area. CEC/WRA personnel observed an area of paint stained soil adjacent to the south side of the building during the site visit. An area of oil-stained soil, approximately five feet in diameter was observed on the west side of the building. Approximately 12 tires were observed adjacent to a barbed-wire fence west of the Freight Dock.

View of paint stain on south side of Freight Dock building.

Paint Building. The Freight Dock Building located near the north property boundary of CWD-6, appears to currently be used for painting. A 55-gallon drum of paint thinner was observed in a fenced area on the east side of the building. A area of staining was located east of the fenced area and on the south side of the building. CEC/WRA recommends that a shallow sub-surface soil sample be taken from the areas of paint-stained soil in order to analyze for selected hazardous substances.

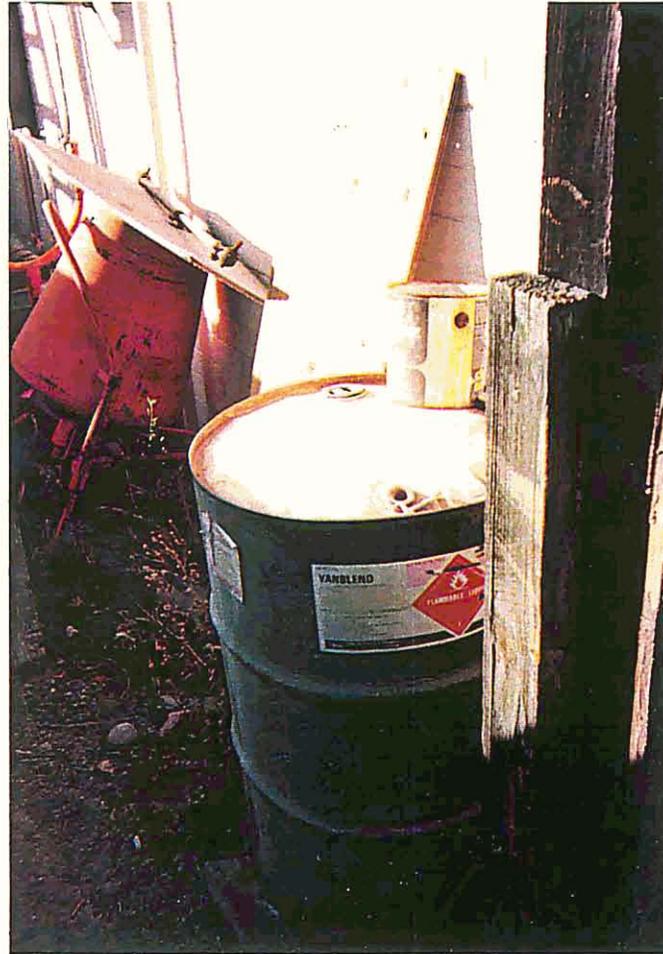
Photograph No. 26

View of 55-gallon drum of "Vanblend" on east side of Freight Dock.

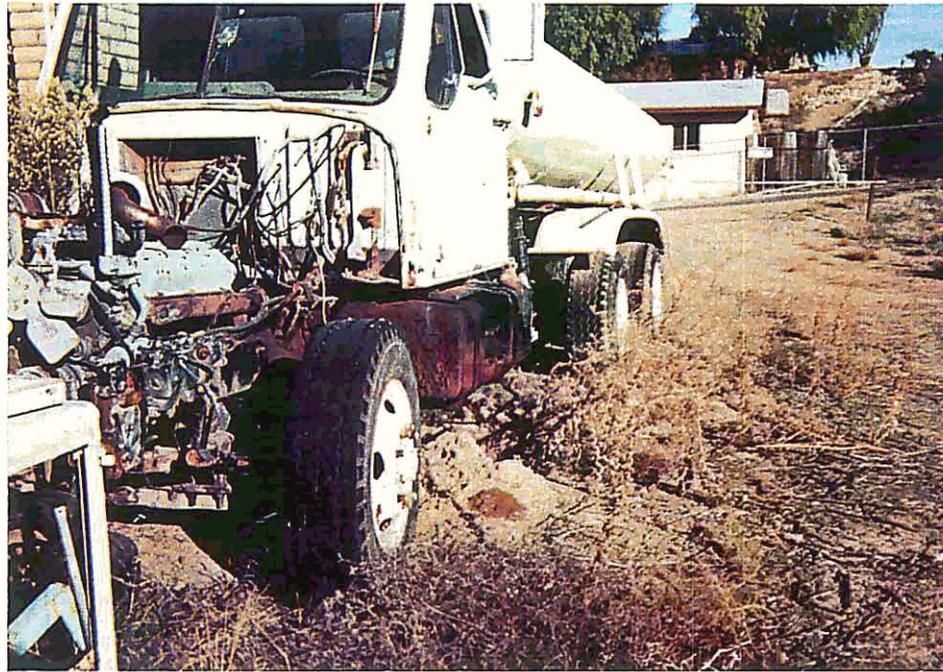
Photograph No. 27

View of stained soil under water truck on east side of warehouse building on CWD-6.

Petroleum-Stained Soil. A water truck was observed adjacent to the east side of the small warehouse building on CWD-6. Diesel fuel was observed leaking from the truck during a site visit. The soil beneath the truck was stained and a distinct diesel odor was detected. Although the staining appears to be limited in vertical and horizontal extent, CEC/WRA recommends that the stained soil be over-excavated and removed from the site and disposed of in an approved landfill. Confirmatory soil samples should be collected upon completion of over-excavation to assure total removal of contaminated soil.

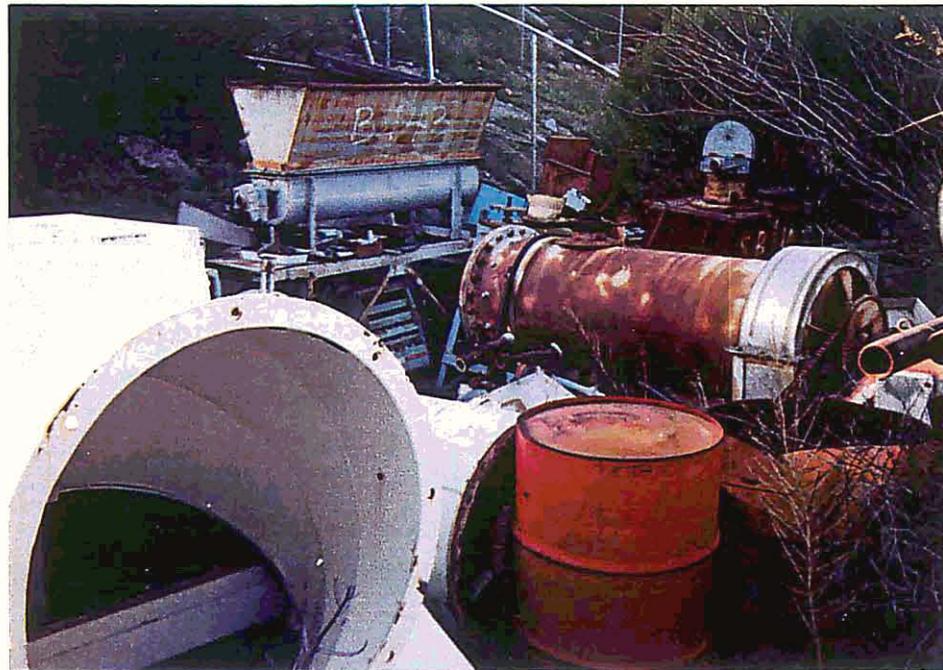
Photograph No. 28

View of equipment behind former machine shop on CWD-6. View is looking northwest.

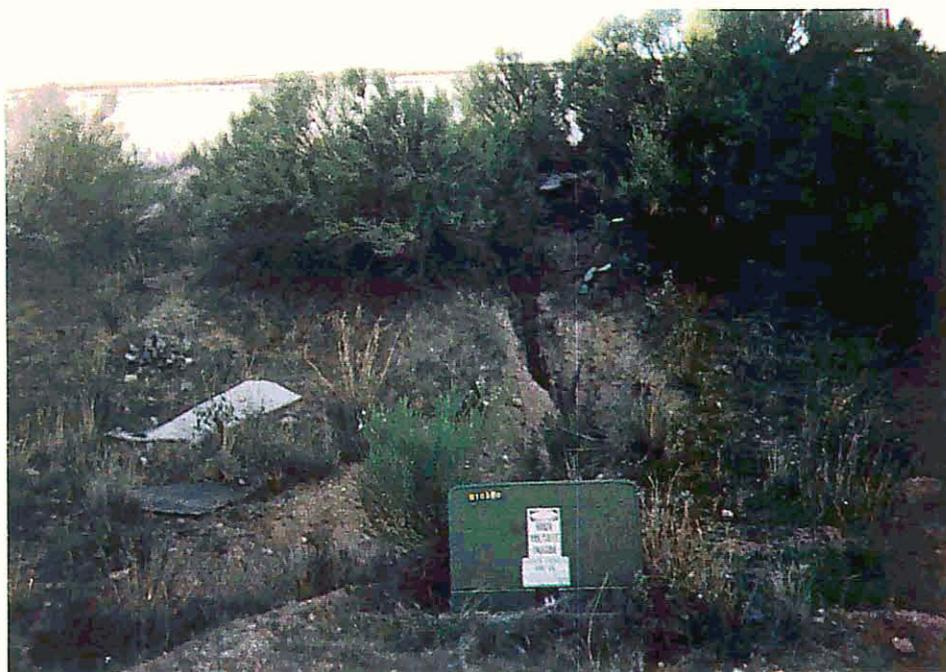
Photograph No. 29

View of pad-mounted transformer on CWD-6. View is looking south.

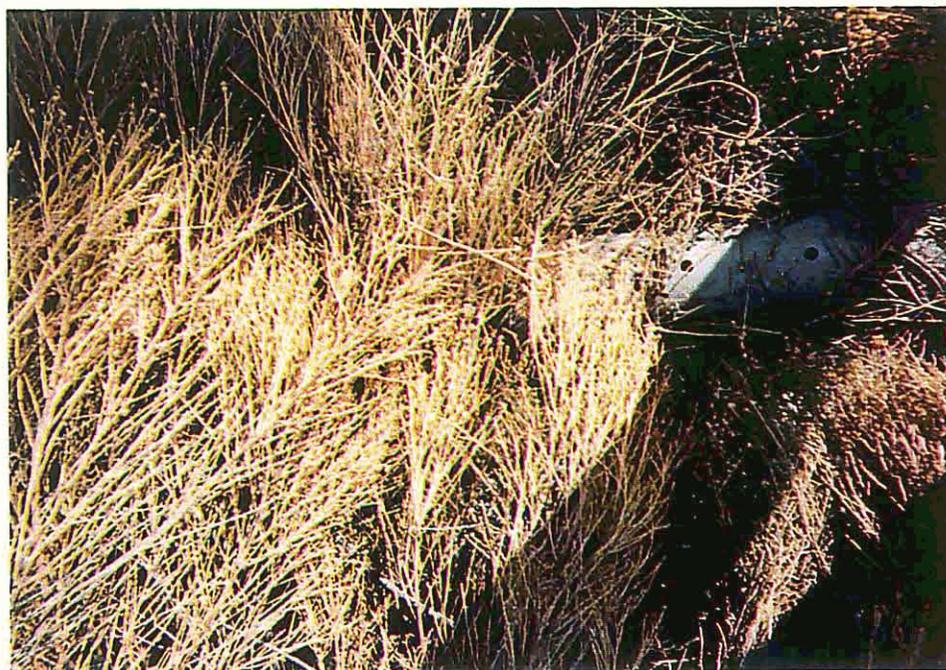
Photograph No. 30

No evidence of a septic tank was observed on CWD-6. An area of disturbed earth was located directly east of a Allis Chalmers track-hoe. Several small shrubs had been dug and laid on top of the ground. Several lengths of perforated PVC pipe approximately 4 inches in diameter were observed beneath the shrubs.

View of perforated pipe on CWD-6.
