**EXPLORATION TRENCHING FOR FURTHER
SITE CHARACTERIZATION
AT THE NEW RIVER CHANNEL
NEAR 88TH AVENUE AND THUNDERBIRD ROAD
IN MARICOPA COUNTY, ARIZONA**

March 4, 1994
CEC/WRA File AR390-2121

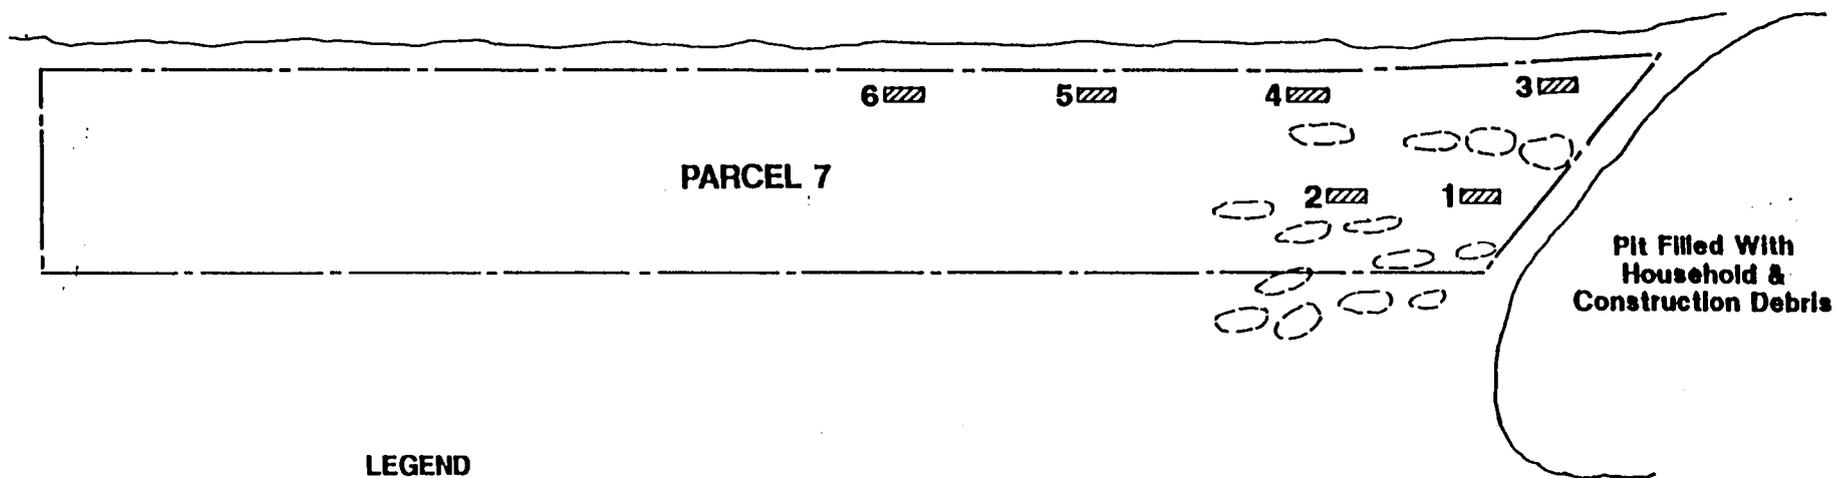
FIGURE 2

CEC/WRA personnel met with Mr. Dave Gardner, and personnel of G.E.C. Excavating Services on February 17, 1994 at the subject property. Six trenches were excavated by G.E.C. using a large track-hoe to allow for visual inspection of any potential debris. Trenches were excavated to depths ranging from 15 to 20 feet below ground surface. Excavation was halted at the District's direction when native material was penetrated to a depth of approximately three feet. The locations and dimensions of the trenches are shown in Figure 2.

There was no visual evidence of potential hazardous materials or construction debris in any of the six trenches excavated.

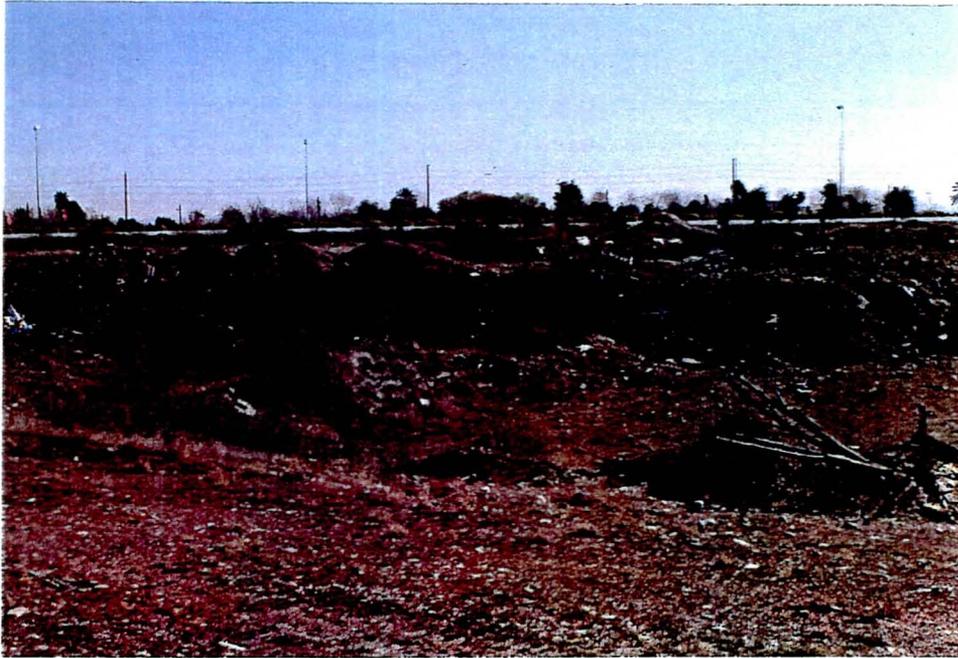
Photograph #1
View of depression adjacent to northern property boundary.

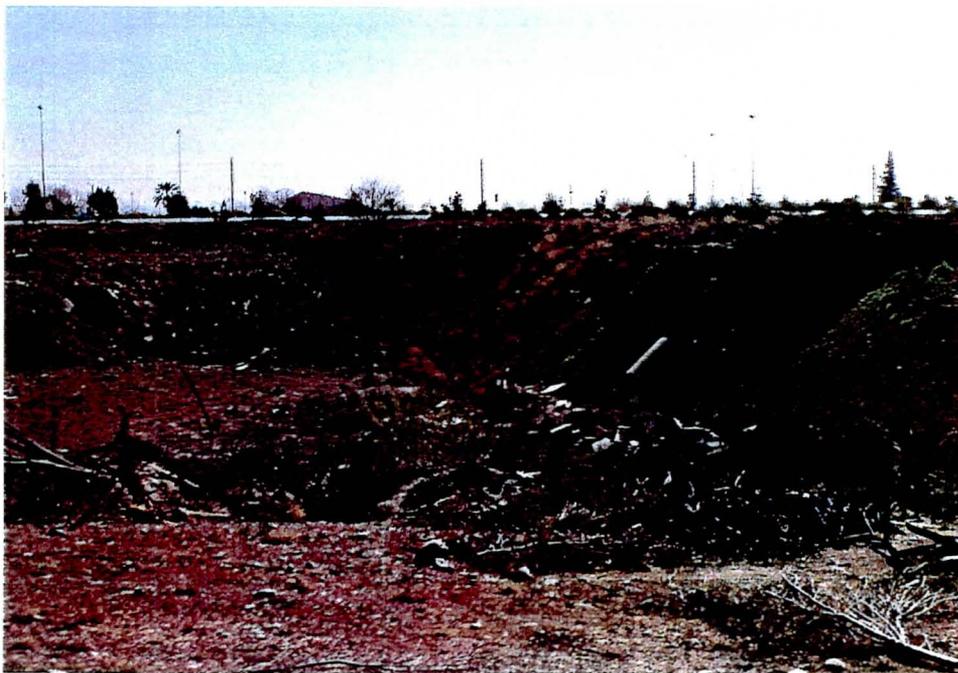
Photograph #2
View of northern property boundary.

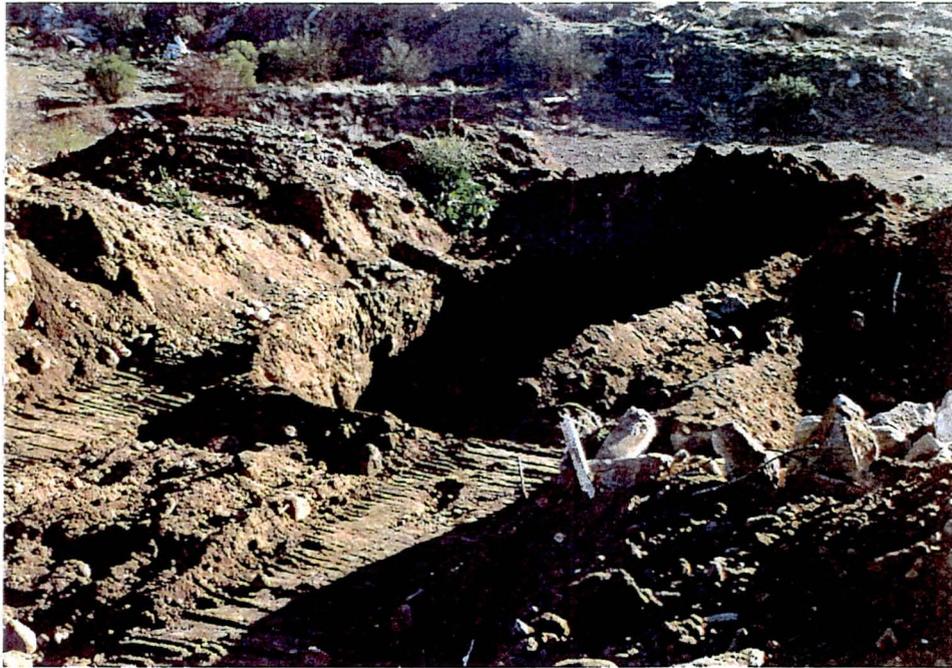
Photograph #3
View of excavation trench #1 and northern property boundary.

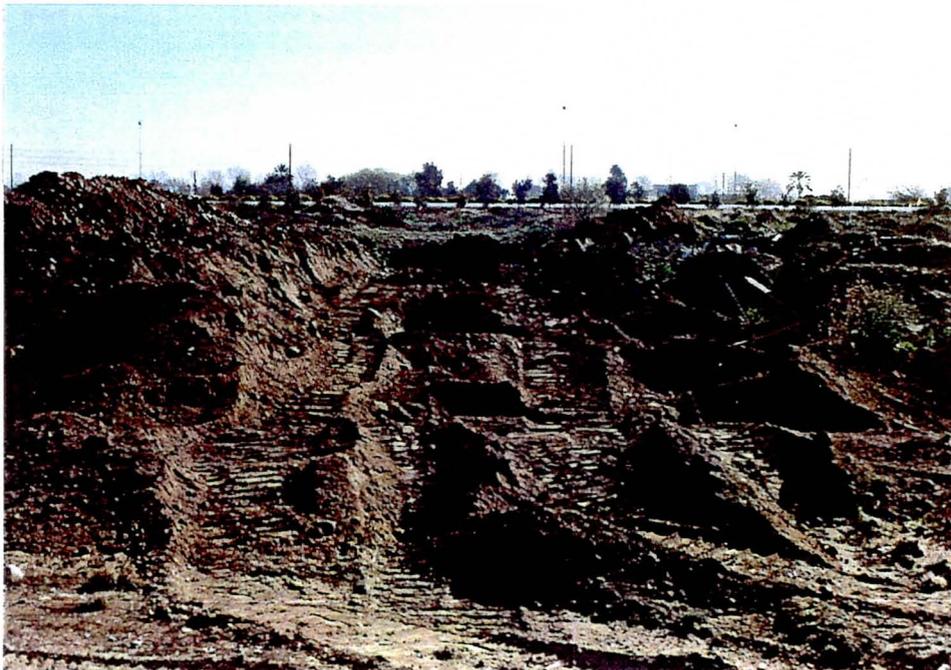
Photograph #4
View of excavation trenches 1 and 2.

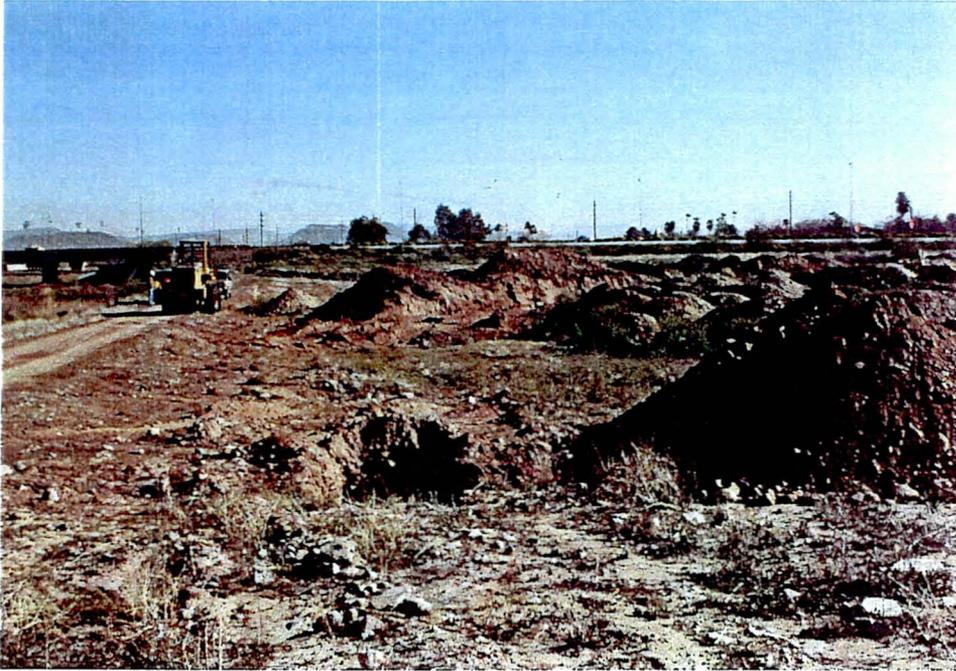
Photograph #5

View of excavation trenches 3 & 4, facing north along western property border.

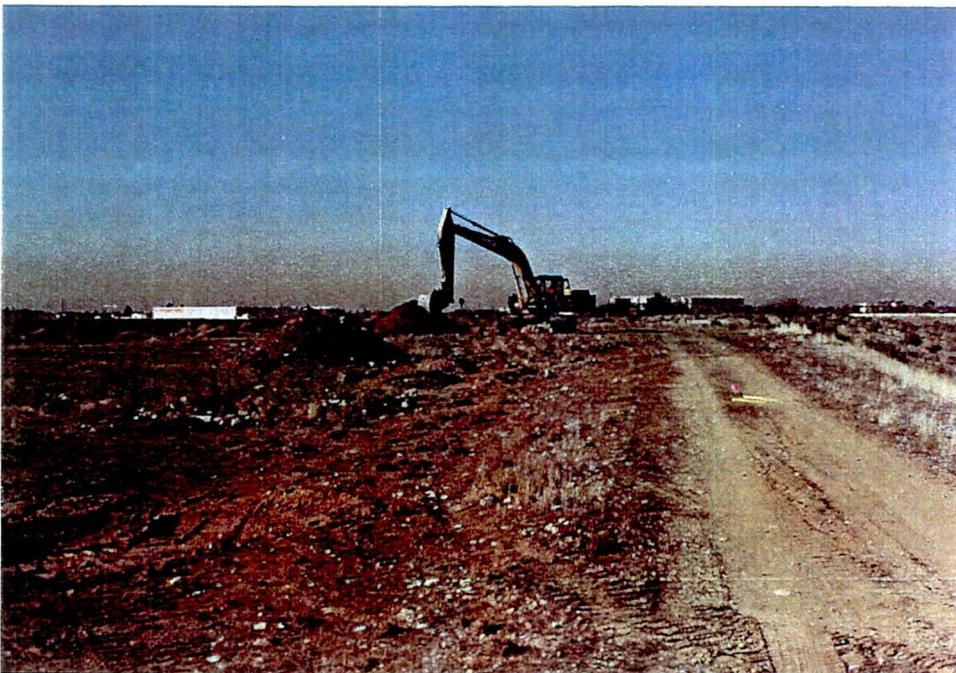
Photograph #6

View of excavation trenches 5 & 6, facing south along western property border.
