PHASE I ENVIRONMENTAL
SITE ASSESSMENT

SOUTHEAST MESA AREA DRAINAGE
MASTER PLAN
MARICOPA COUNTY, ARIZONA

WT JOB NO. 2188JK014.01

April 15, 1998

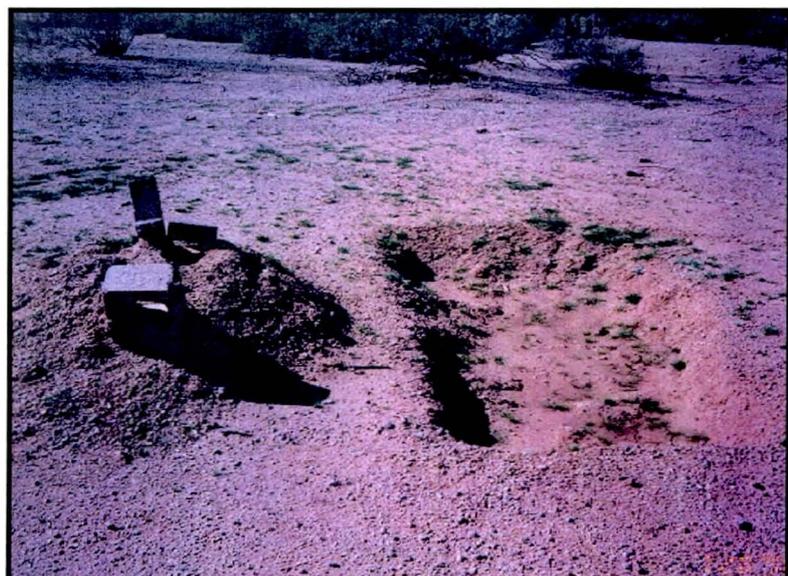
Picture No. 18

Basin 2 consisted of undeveloped native desert land and an abandoned residential structure (Appendix B, Pictures 11 through 17). WT observed no occupants or uses within the boundaries of this basin. A shallow excavation of unknown origin was observed on the Property (Appendix B, Picture 18).

Depressed Soil Area of Unknown Origin on Basin 2

- **Unknown Excavation** -- A shallow excavation of unknown origin was found on Basin 2. WT recommends excavating a test pit at this excavation to visually evaluate the subsurface. Make provisions for soil sampling and chemical analysis in the event that buried containers or other suspect media are uncovered.

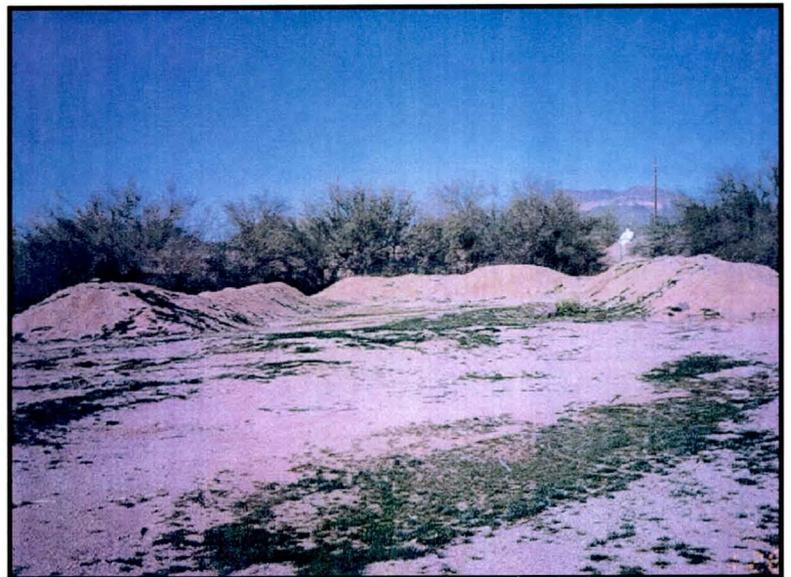
- **Soil Pile** -- A soil pile of unknown origin was seen on Basin 3. WT recommends sampling and chemically analyzing representative portions of these soil piles to evaluate for the presence of elevated constituents, including metals, petroleum hydrocarbons, poly-aromatic hydrocarbons, and volatile organics.

Picture No. 26
Soil Mound of Unknown Origin Within
Basin 3

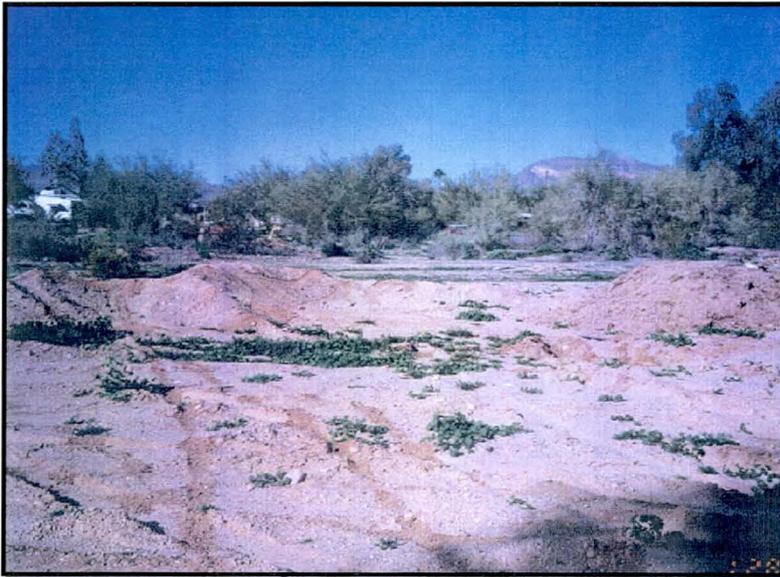
Picture No. 40

Soil Mounds of Unknown Origin on the West Portion of the Vacant Land - Basin 4

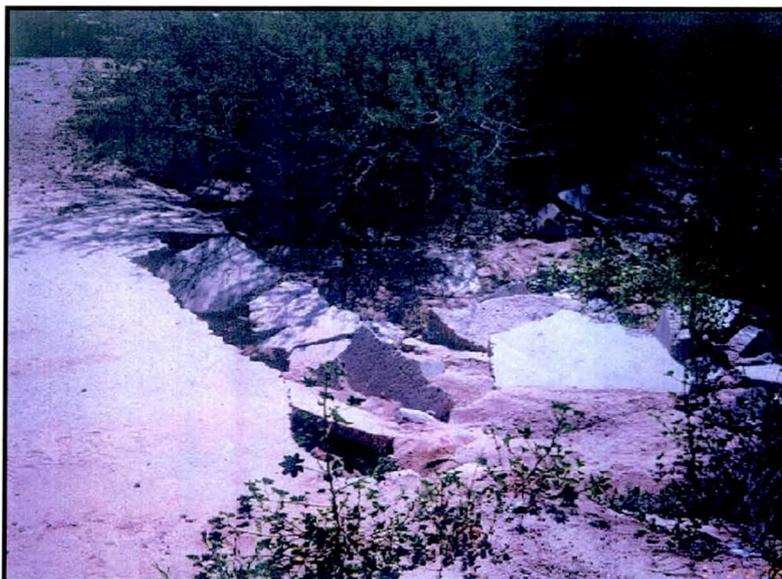
Picture No. 42

Eroded Concrete Crossing Wash on East Boundary of Basin 4

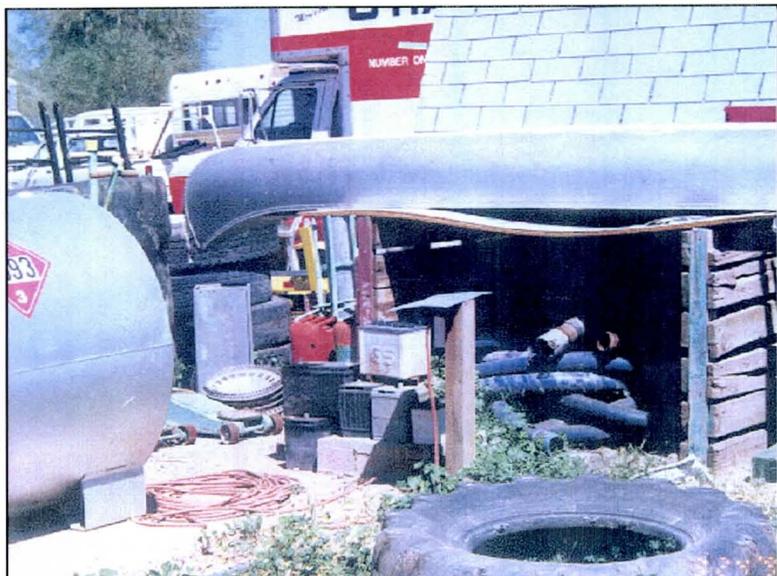
Picture No. 43
Old Batteries Stored on ICU Rental Lot
on Basin 4

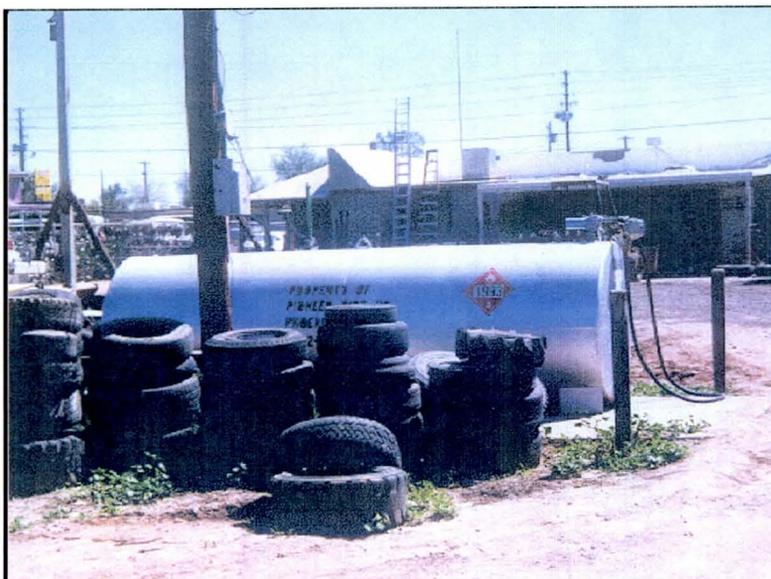
WT noted one above ground storage tank on Basin 4 on the north portion of ICU Rental. The tank appeared to be in good condition with no evidence of leakage. The tank was installed on a concrete pad, but did not have an enclosure, berm or other means of secondary containment.

Picture No. 44
Aboveground Storage Tank and Tires
on ICU Rental Lot on Basin 4

- **Above Ground Storage Tank** -- An above ground storage tank was observed on the ICU Rental lot. WT recommends removal of the tank and soil tests beneath the tank to assess for spillage.
- **Wash Rack** -- A wash rack used to clean equipment is operated on a parcel of land currently owned by ICU Rental. WT recommends sampling soil from this area to evaluate it for elevated levels of petroleum related compounds and cleaning materials.

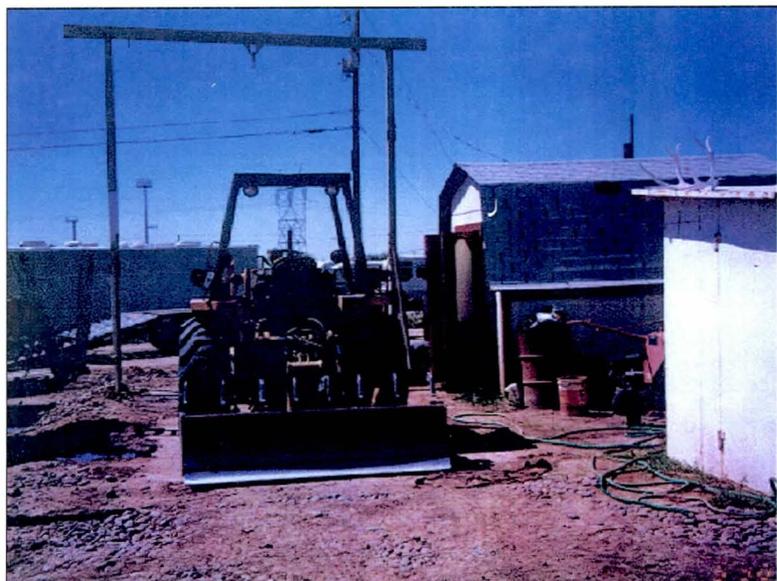
Picture No. 45
Equipment Washing Area on ICU
Rental Lot on Basin 4

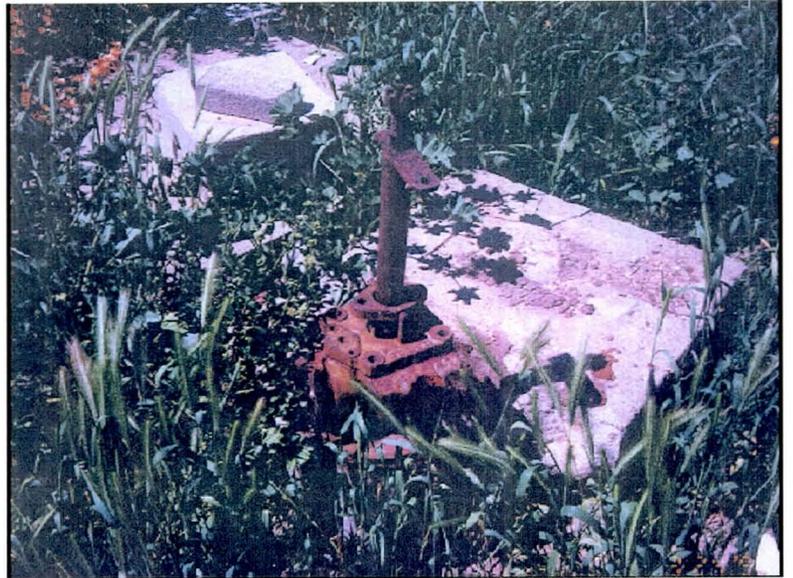
Picture No. 47

- **Old Well** -- An old well was observed on the north end of the Tire Store lot. The well appears not to have been used in some time, and WT recommends abandoning this well according to the requirements of the Arizona Department of Water Resources.

Groundwater Well No Longer Used on
Basin 4

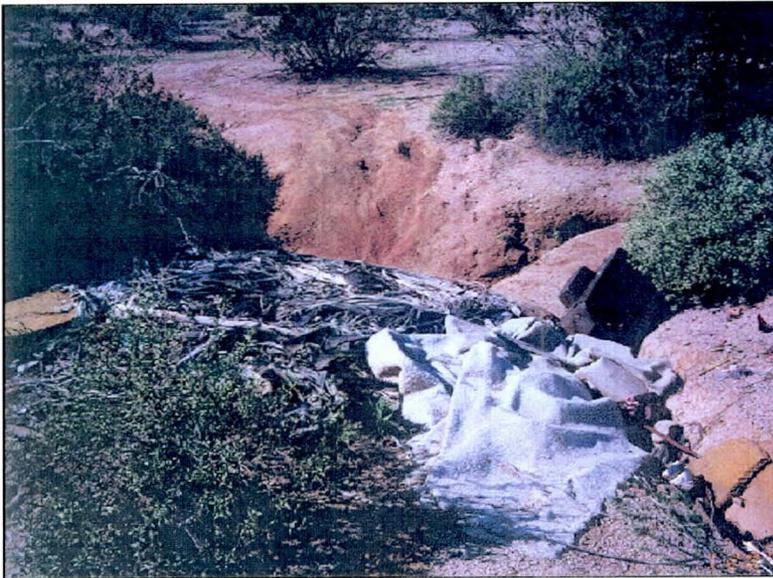
Picture No. 52

Several areas of construction, landscape and miscellaneous debris were observed on Basin 1 consisting of landscape trimmings, a television, foam, carpeting, paper waste, and cement pieces (Appendix B, Pictures 51 through 53). On Basin 2, WT observed the remains of a collapsed house near the south border and a few areas of general debris along the wash transversing Basin 2. The debris consisted of vegetation, wood scrap, foam, carpeting and lawn furniture (Appendix B, Picture 54 through 56). Basin 4 was observed with an area of construction debris on the vacant land near the southwest border of the Property, which consisted of broken concrete slabs and pipe sections, asphalt pavement and vegetation (Appendix B, Picture 57). Several areas of debris were also noted on the lot associated with the Tire Store consisting of scrap metal, scrap wood, vegetative debris, tires and old appliances (Appendix B, Pictures 58 through 60).

General Debris Within the Main Wash Across Basin 1. Debris Includes Landscape Trimmings, a Television, Foam, Carpeting and Cement Pieces

- **Solid Waste and Debris** -- Areas of solid waste and debris were seen on accessible areas of all four basins. No environmental indicators, or evidence of chemical containers, were seen at these debris piles. WT recommends removing this material to a solid waste disposal facility during grubbing and clearing activities.

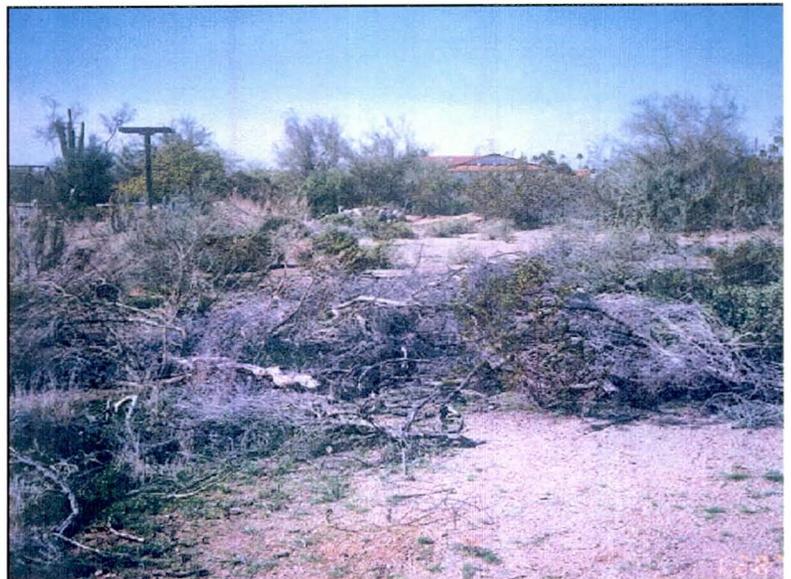
Picture No. 53

Dead Vegetation Along the Banks of the North Portion of the Wash on Basin 1. Material Could Have Accumulated During High Flows

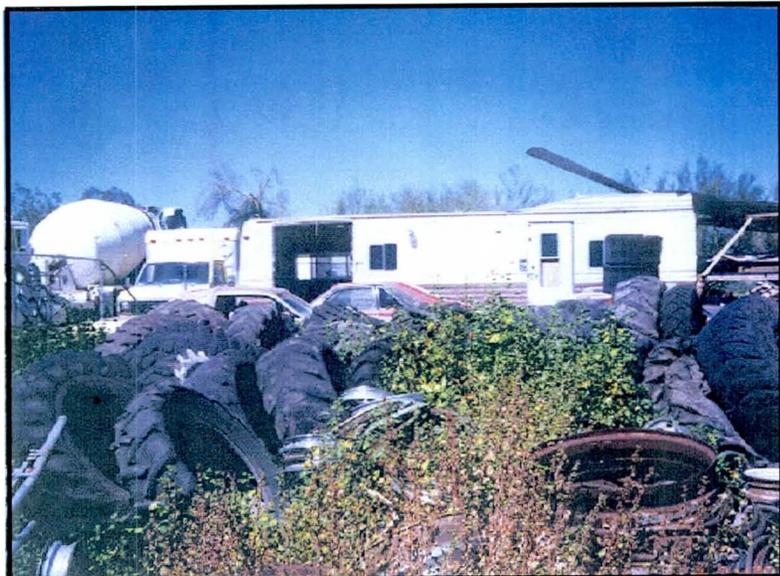
Picture No. 58

Debris Pile on Tire Store Lot Consisting of Tire, Scrap Metal, Vegetation Debris, Fence and Appliances

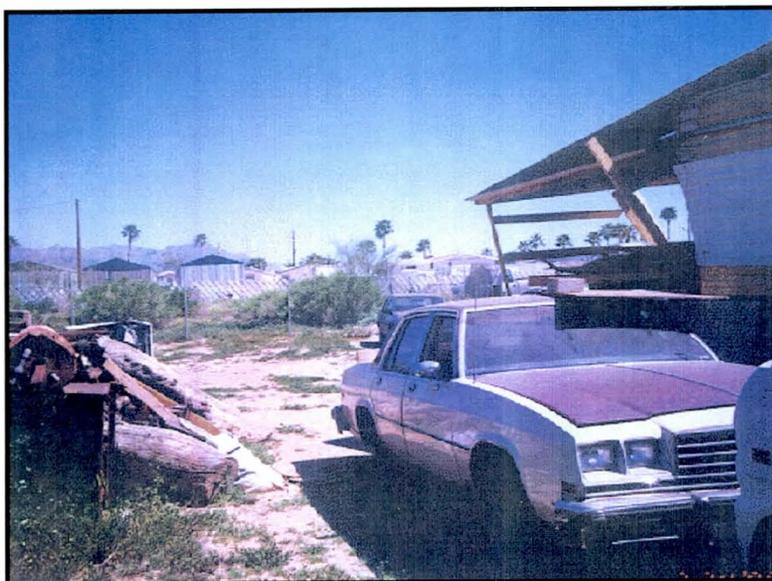
Picture No. 59

Debris Pile on Tire Store Lot Consisting of Scrap Wood, Scrap Metal and Appliances

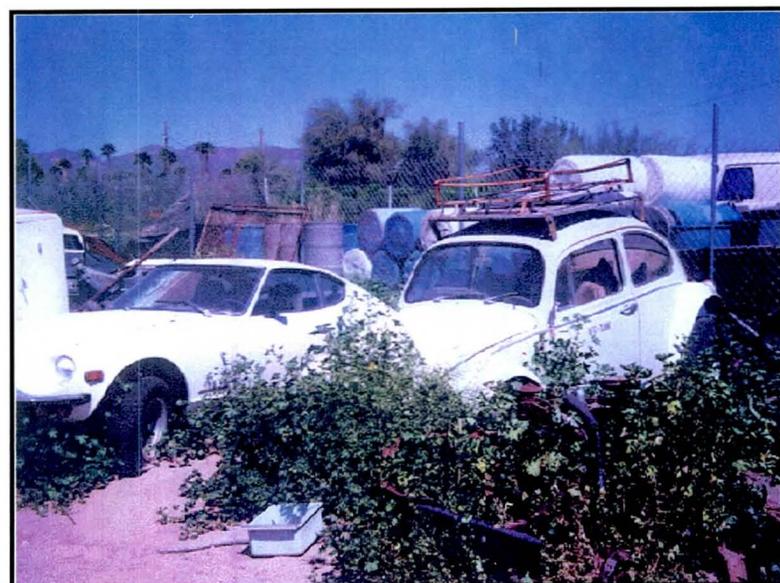
Picture No. 60

Debris Pile on Tire Store Lot Consisting of Scrap Wood and Car Parts
