**LAND SUBSIDENCE
& EARTH FISSURE INVESTIGATION - TASK 1**

**MARICOPA WATER DISTRICT PROPERTIES
NOS. 1, 2, AND 3 - 2,508 ACRES**

MARICOPA COUNTY, ARIZONA

August 5, 2002

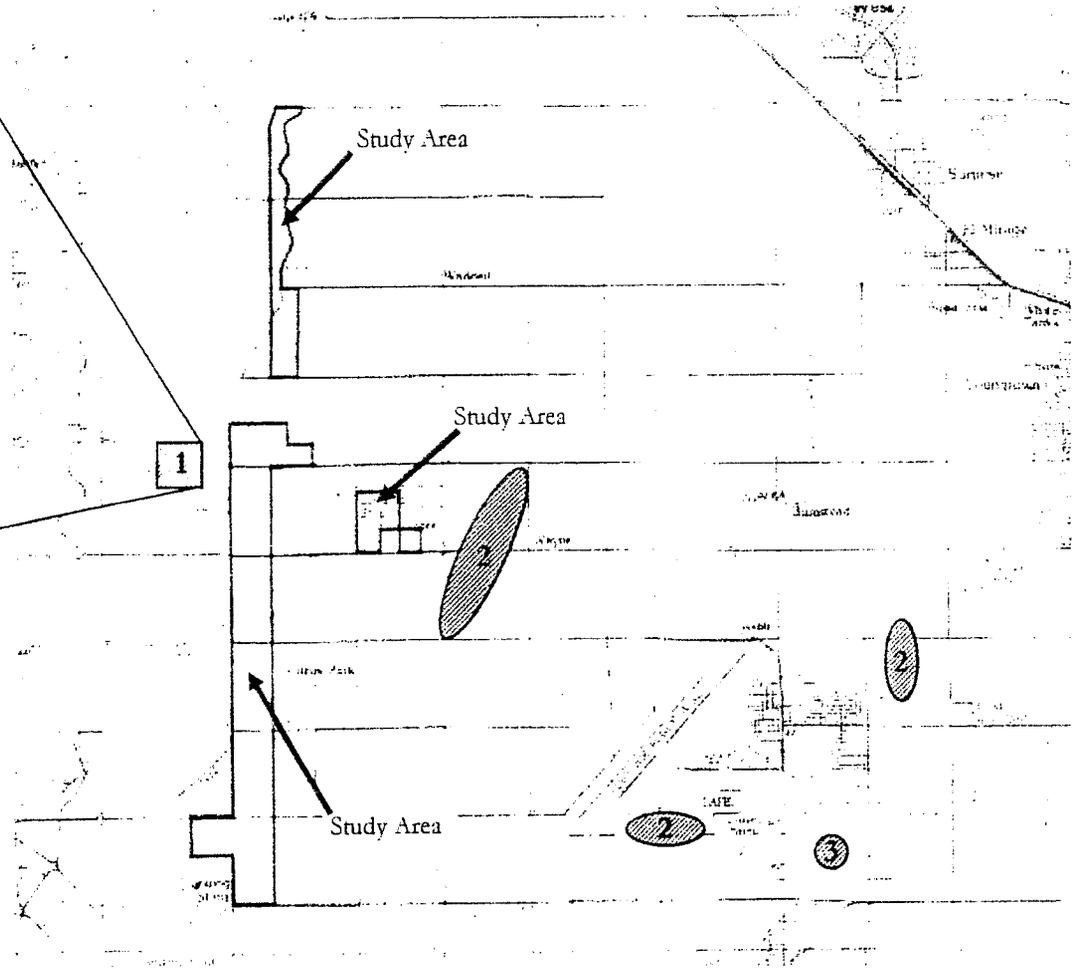
Figure 2
Earth Fissure Location Map

- 2.3 Based on the results of previous investigations by other researchers and by Geological Consultants for this project, there are known earth fissures located east and west of the subject site (Figure 2). None of these fissures project toward the subject development property.

Known earth fissures are fissures that have been documented by others or were verified during the field reconnaissance. Earth fissures have been documented in the vicinity of the MWD property (Figure 8). The fissures mapped adjacent to the east and west property boundary trend in a north/south direction. Projecting the potential future growth of these fissures, it does not appear that they will directly affect the MWD property. The earth fissures west of the property near McMicken dam are likely related to shallow bedrock (Fenne Knoll) in the area providing a hinge point for earth fissure formation. The earth fissures documented east of the property have likely developed around the margins of the Luke Salt Body (Figure 7).

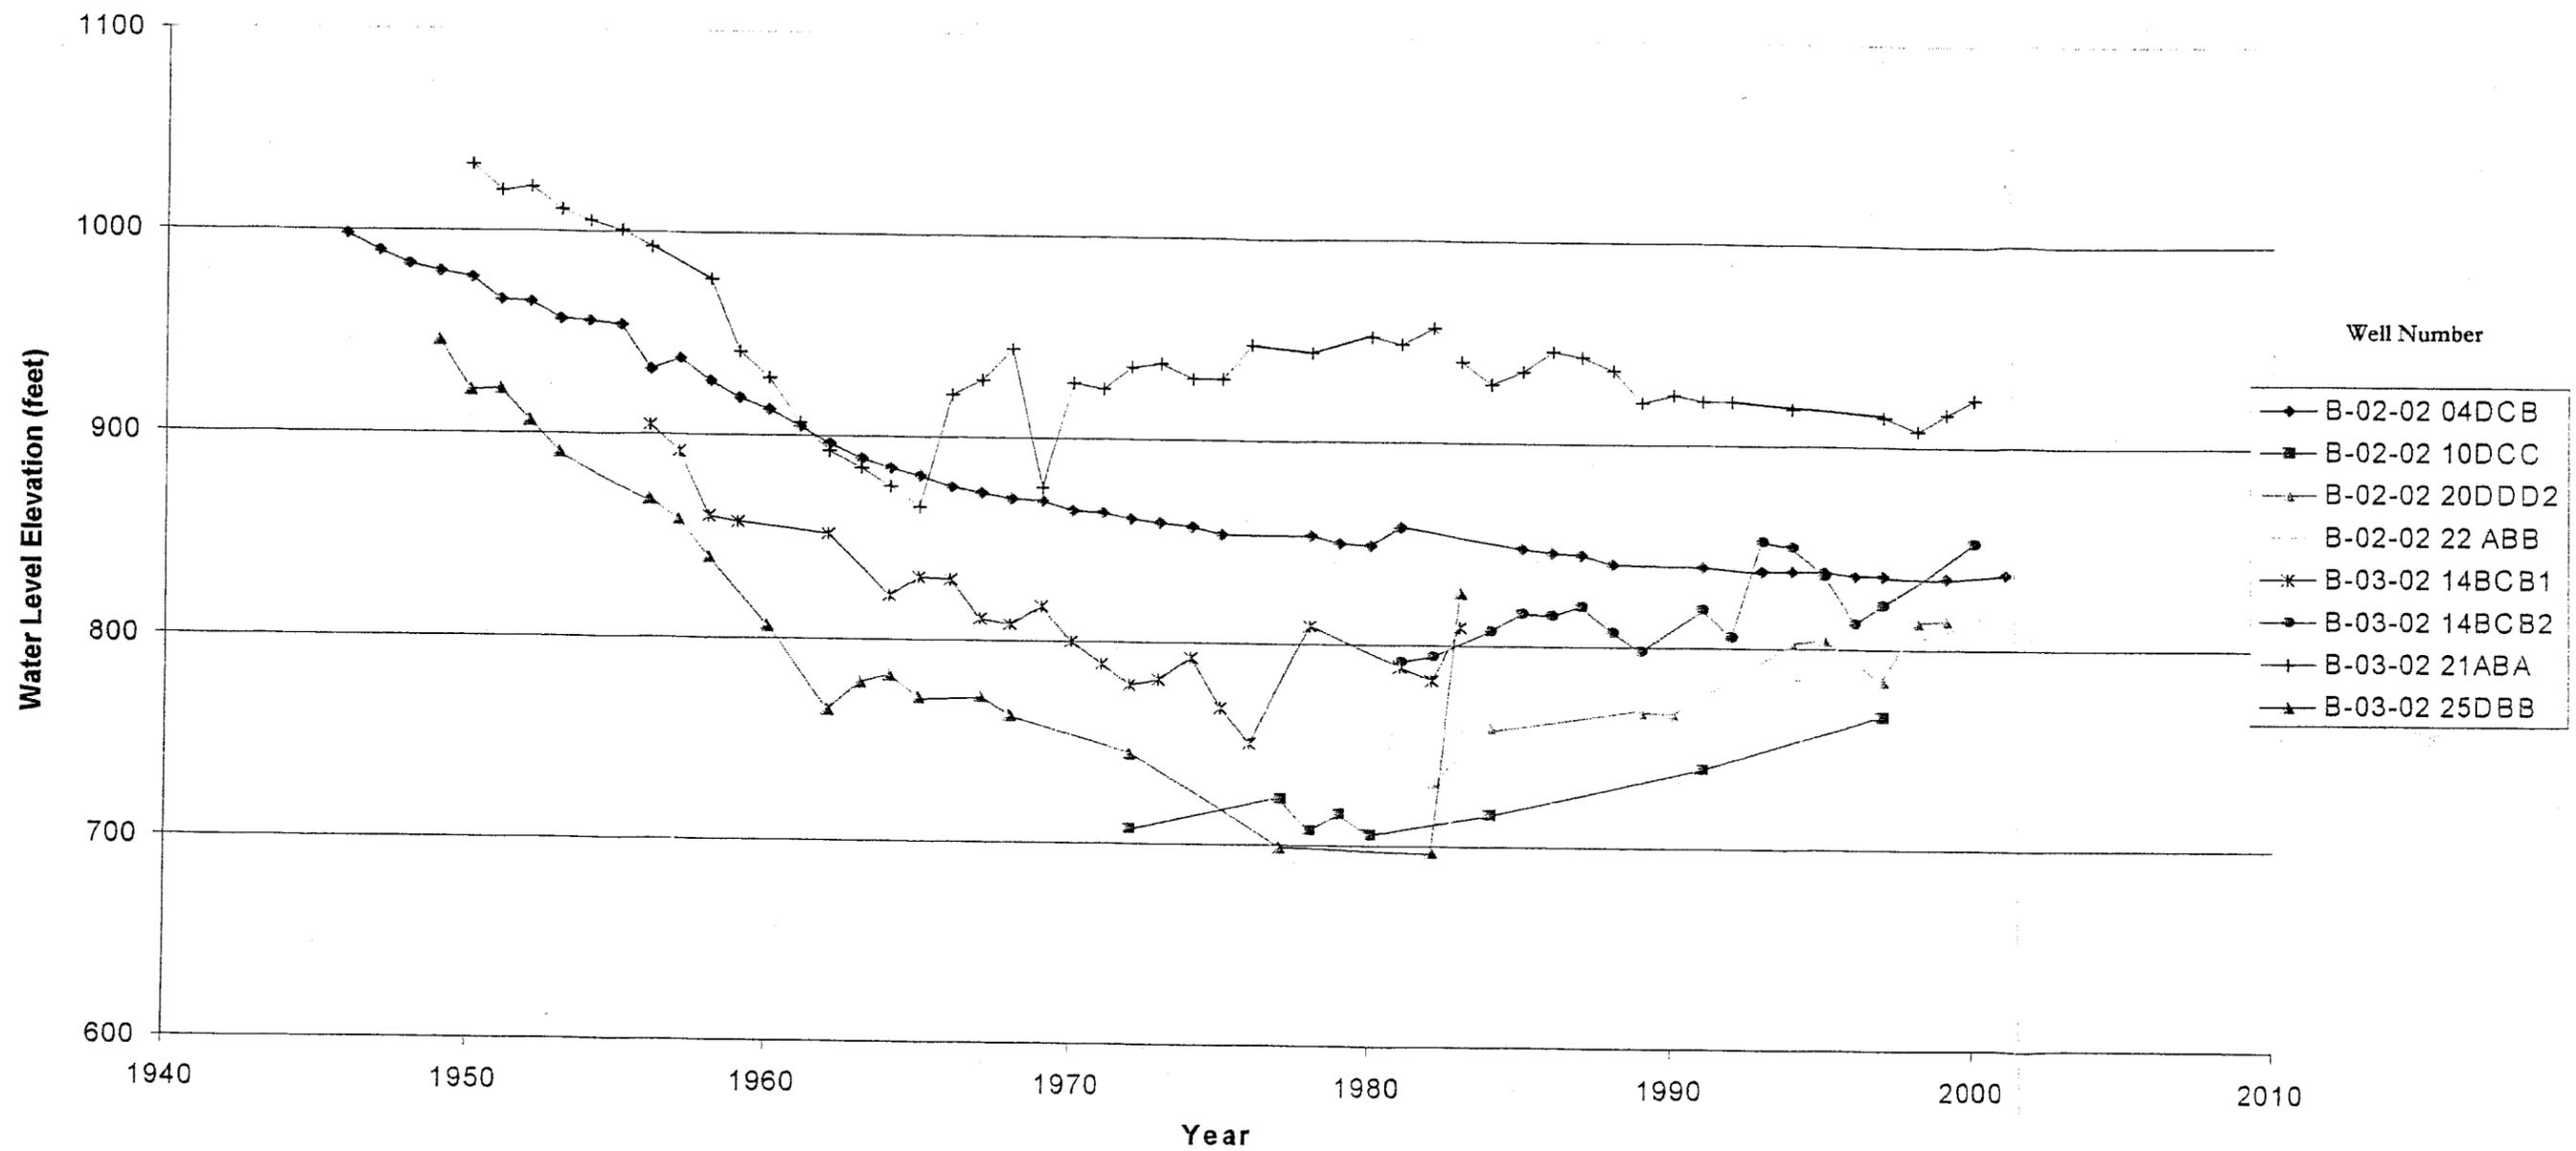
Figure 3
Water Level Hydrograph

Analysis of water level data (ADWR, 2002) from selected wells in the area indicates water levels have indeed dropped from 150 to 250 feet from the 1940's through the mid 1980's (Figure 3). Since the mid 1980's, water levels have at least leveled out, and in some cases have increased from 50 to 150 feet (Figure 3). The water levels for the area have not recovered to pre-pumping levels.

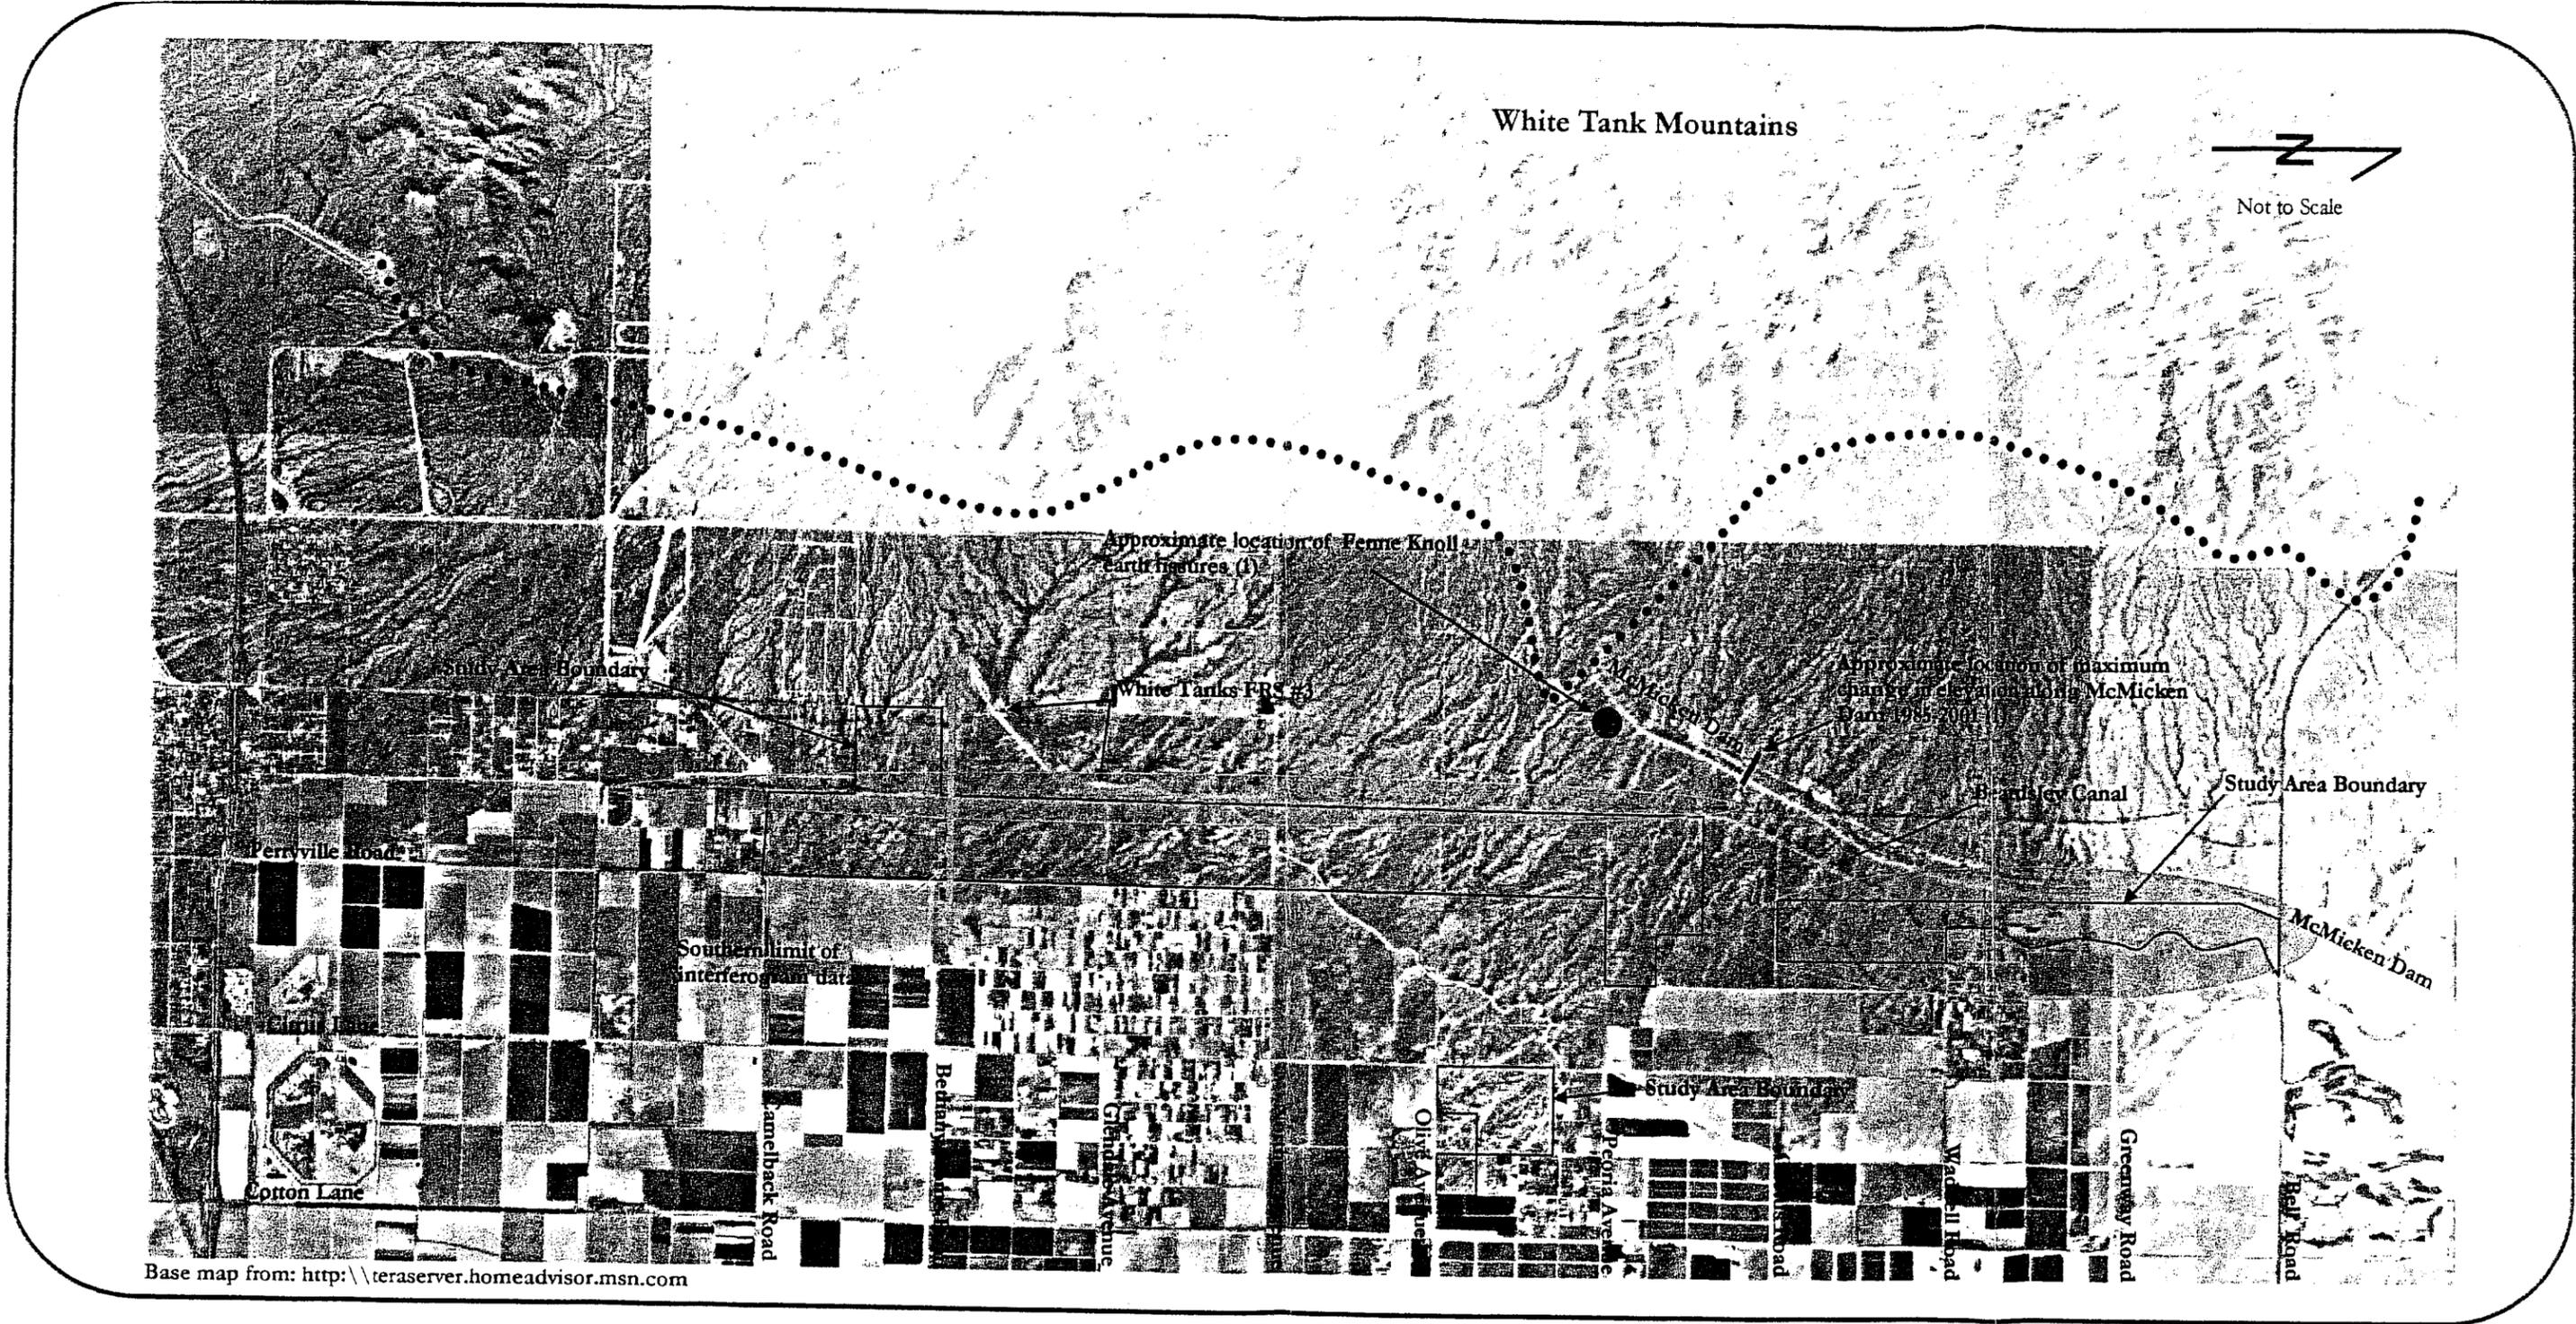
Figure 8
Compilation of Subsidence Related Ground Conditions

Land subsidence is well documented within the project area. An NGS level line using benchmarks located along the Beardsley canal was used to record subsidence from 1948 to 1981 (Table 1). Figure 7 shows an overall view of subsidence within the West Salt River Valley between 1957 and 1991 as compiled by Schumann (1995). And continued releveing along the crest of McMicken Dam recovered relatively significant changes in elevation along the crest of the dam between 1985 and 1991 (Table 2). Interpretation of Interferogram data indicated that changes in elevations occurred between 1996 and 2000 for portions of the northern portions of the study area (Figure 8).

A Flood Control District of Maricopa County (FCDMC) report (Staedicki, 1995), reported that subsidence measurements taken at White Tanks FRS #3 (Figure 8) showed an overall increase in ground elevation at the toe of the dam. No explanation was given for this finding.

Should water levels in this area, at some point in the future, reverse the current trend and start to decline, the earth fissure potential for this area should be revised to moderate. This would be due to continued subsidence and the presence of the interpreted "hinge" point located approximately under the Beardsley Canal (Figure 8).

Interpretation of gravity data indicates a possible hinge point for fissure development exists in this area. (1)
-
