To:	Flood Control District of Maricopa County  2801 West Durango Street Phoenix, Arizona	From:	Stantec Consulting Inc. Stephanie Gerlach, PE 8211 South 48 <sup>th</sup> street Phoenix, AZ
File:	Stantec # 181300034	Date:	April 24, 2009

### **RE: Gila River Bank Stabilization Pre-design Baseline Condition Summary**

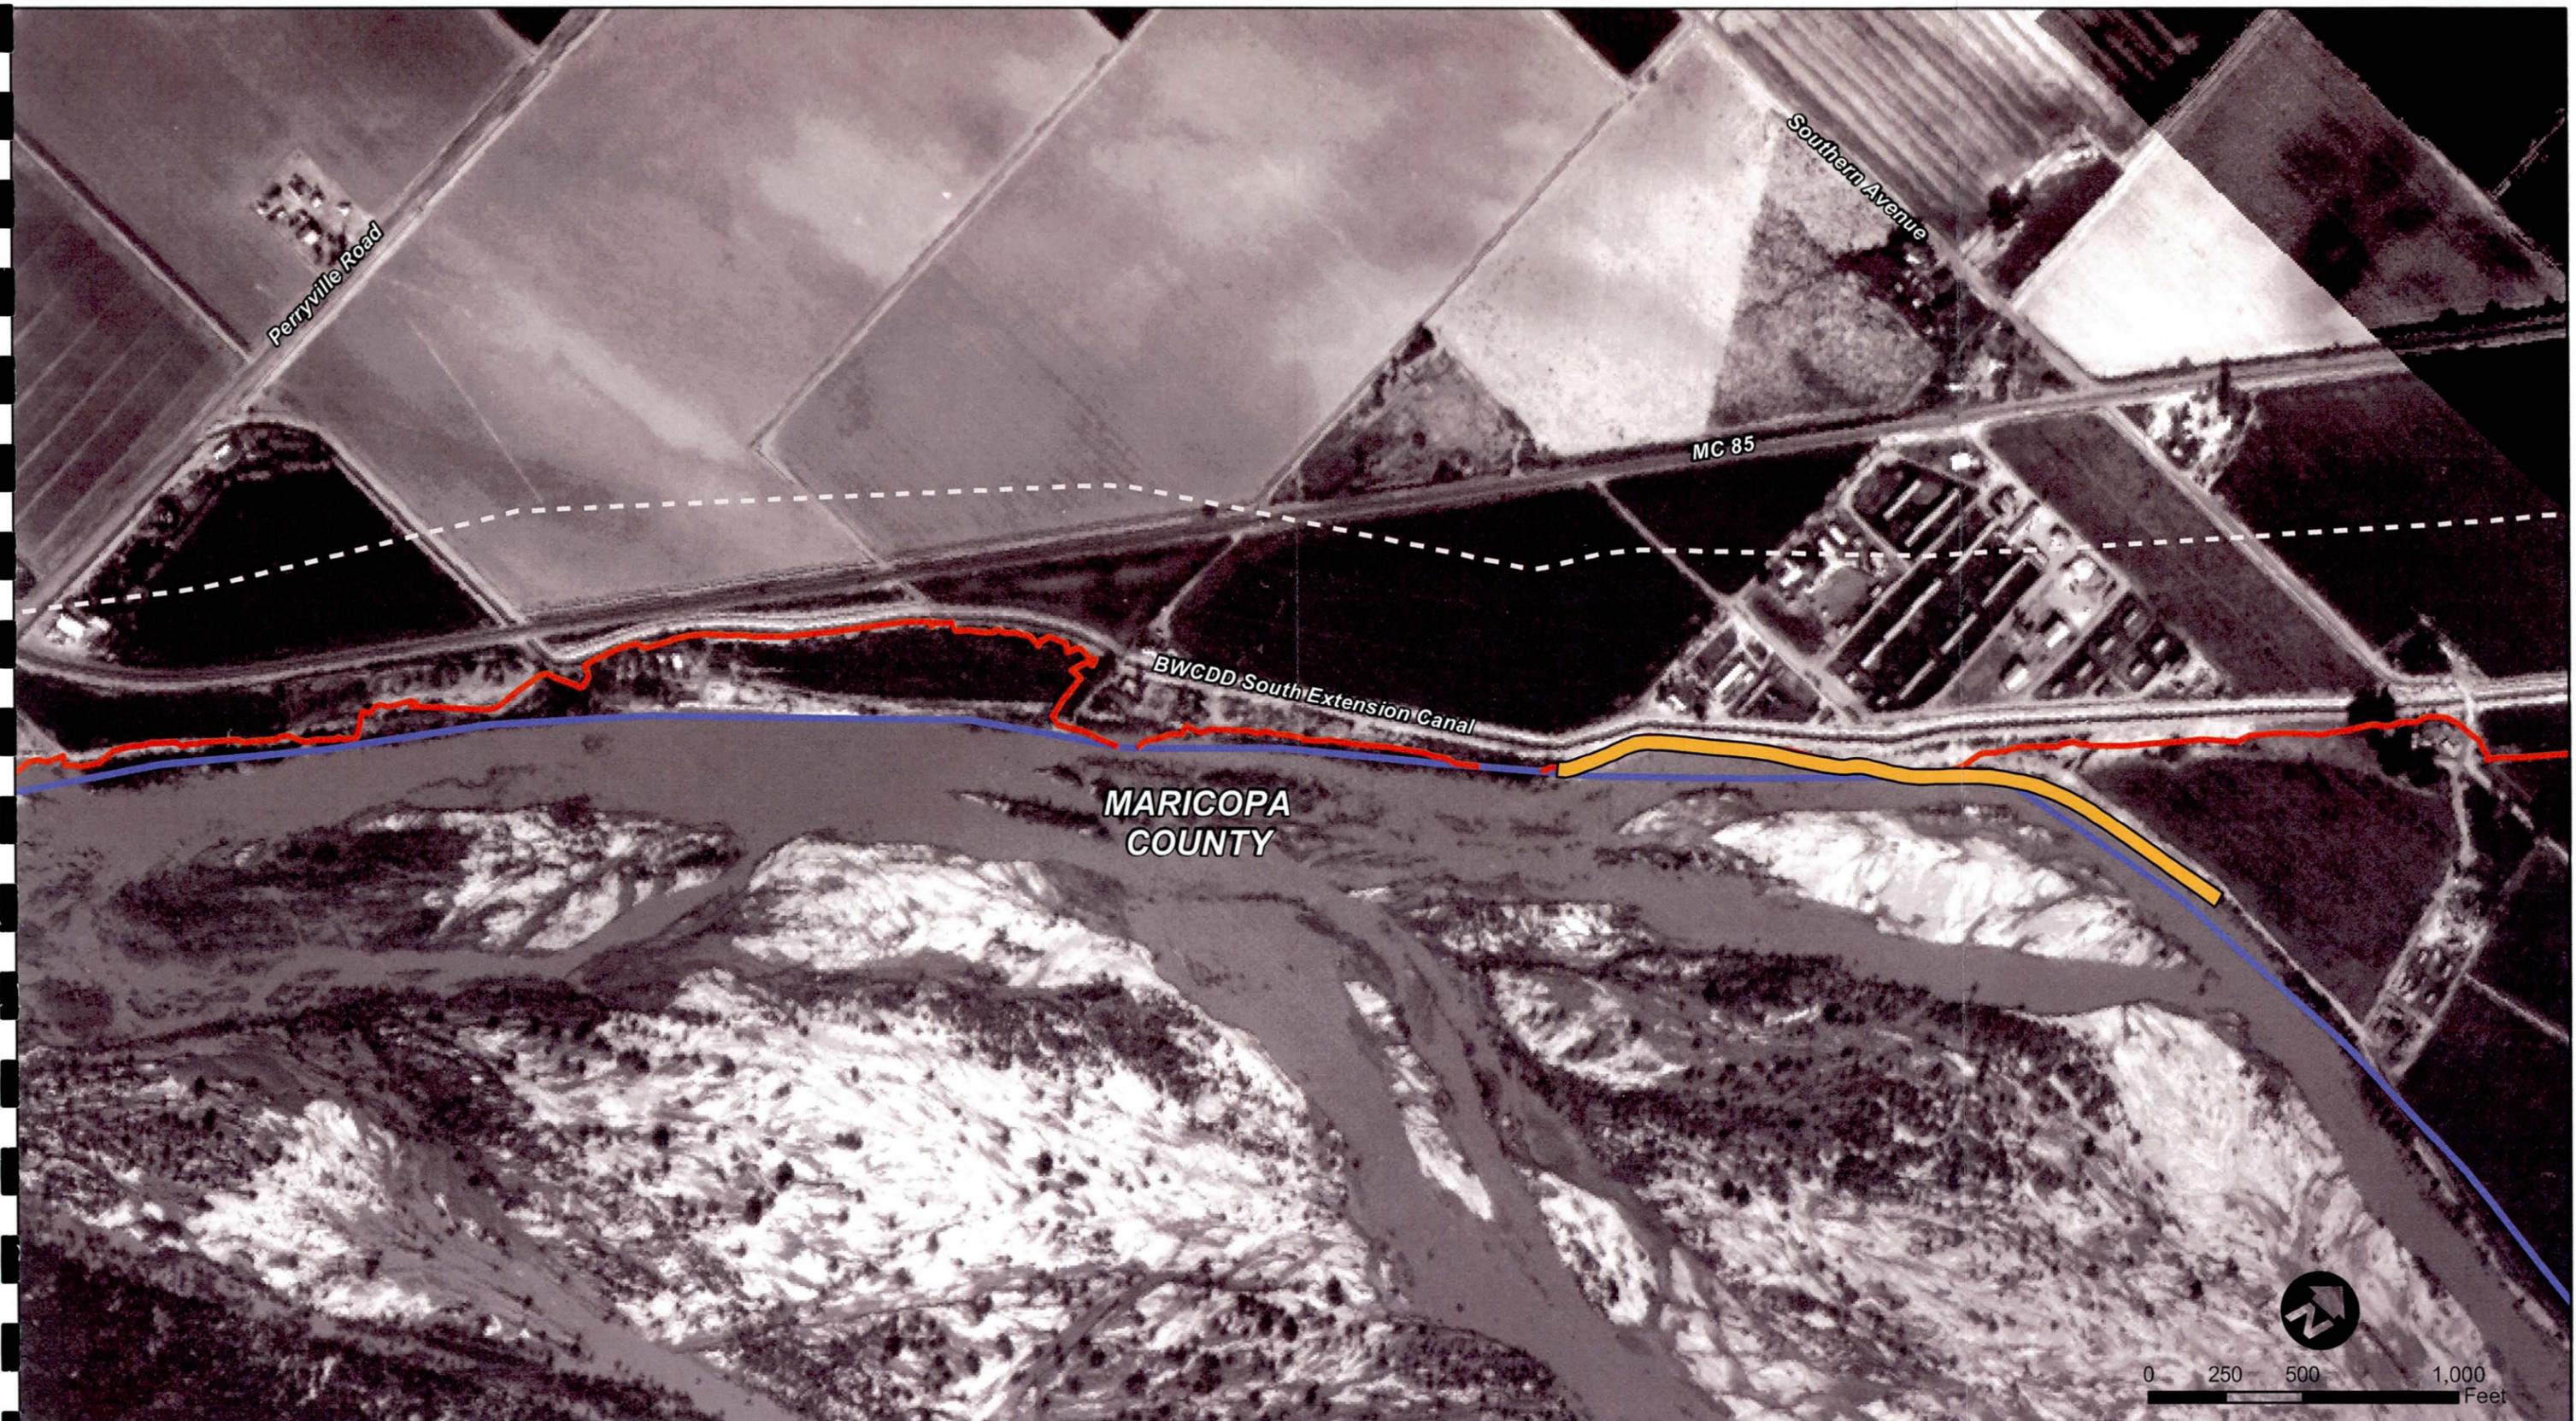
Figure No.  
**Figure 5**

During the 1993 flooding event the Perryville Bank Stabilization was damaged. An aerial photograph from the 1993 flooding event is shown on Figure 5. The records indicated that 1,600 cubic yards (cy) of riprap and 1,100 cy of fill was placed, but did not indicate where the damage occurred.

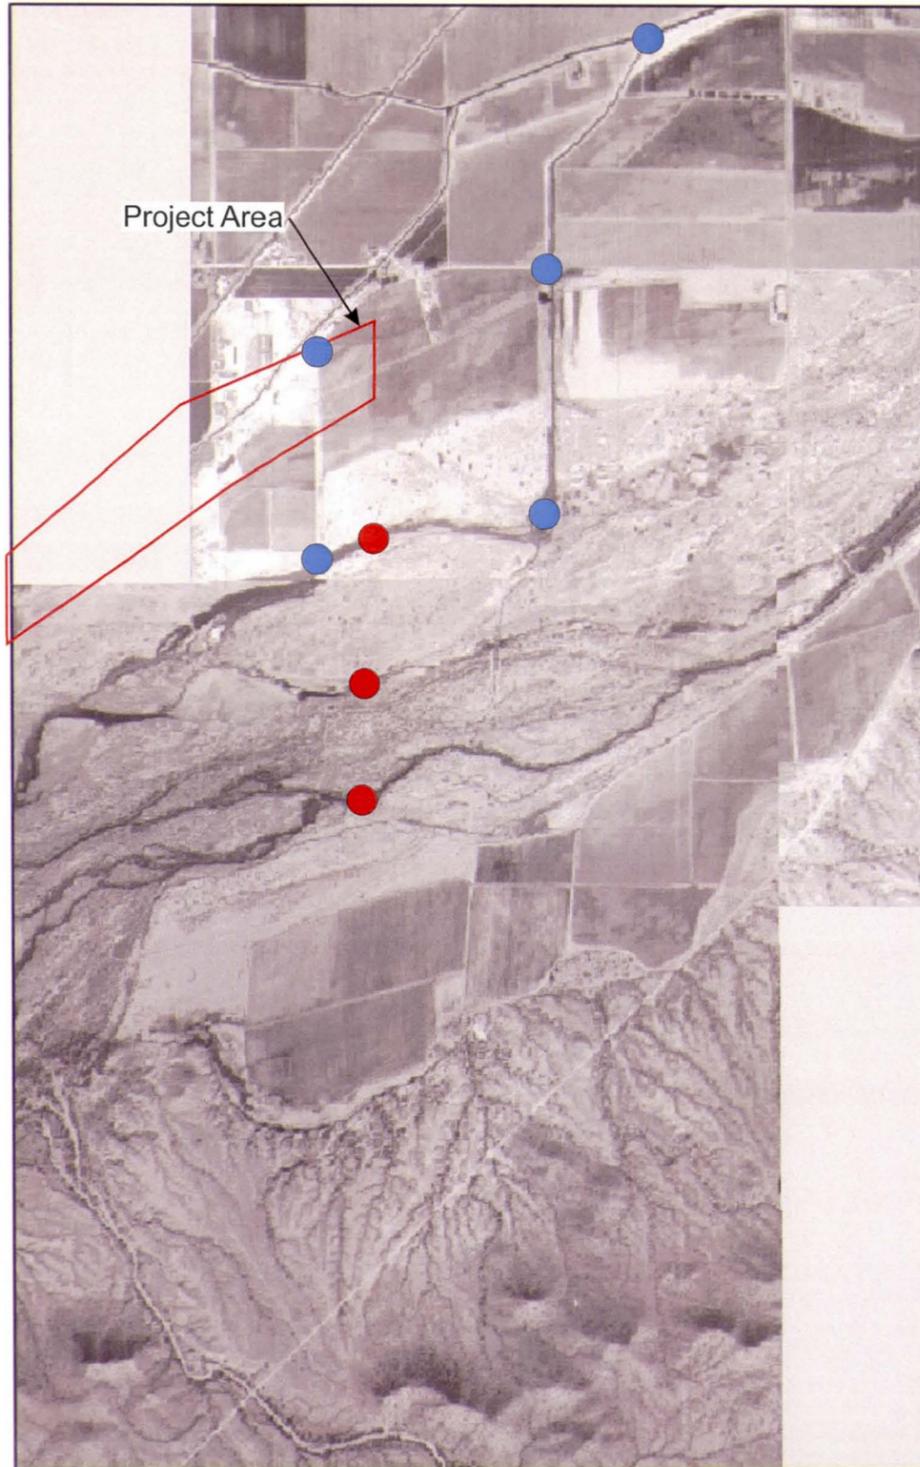
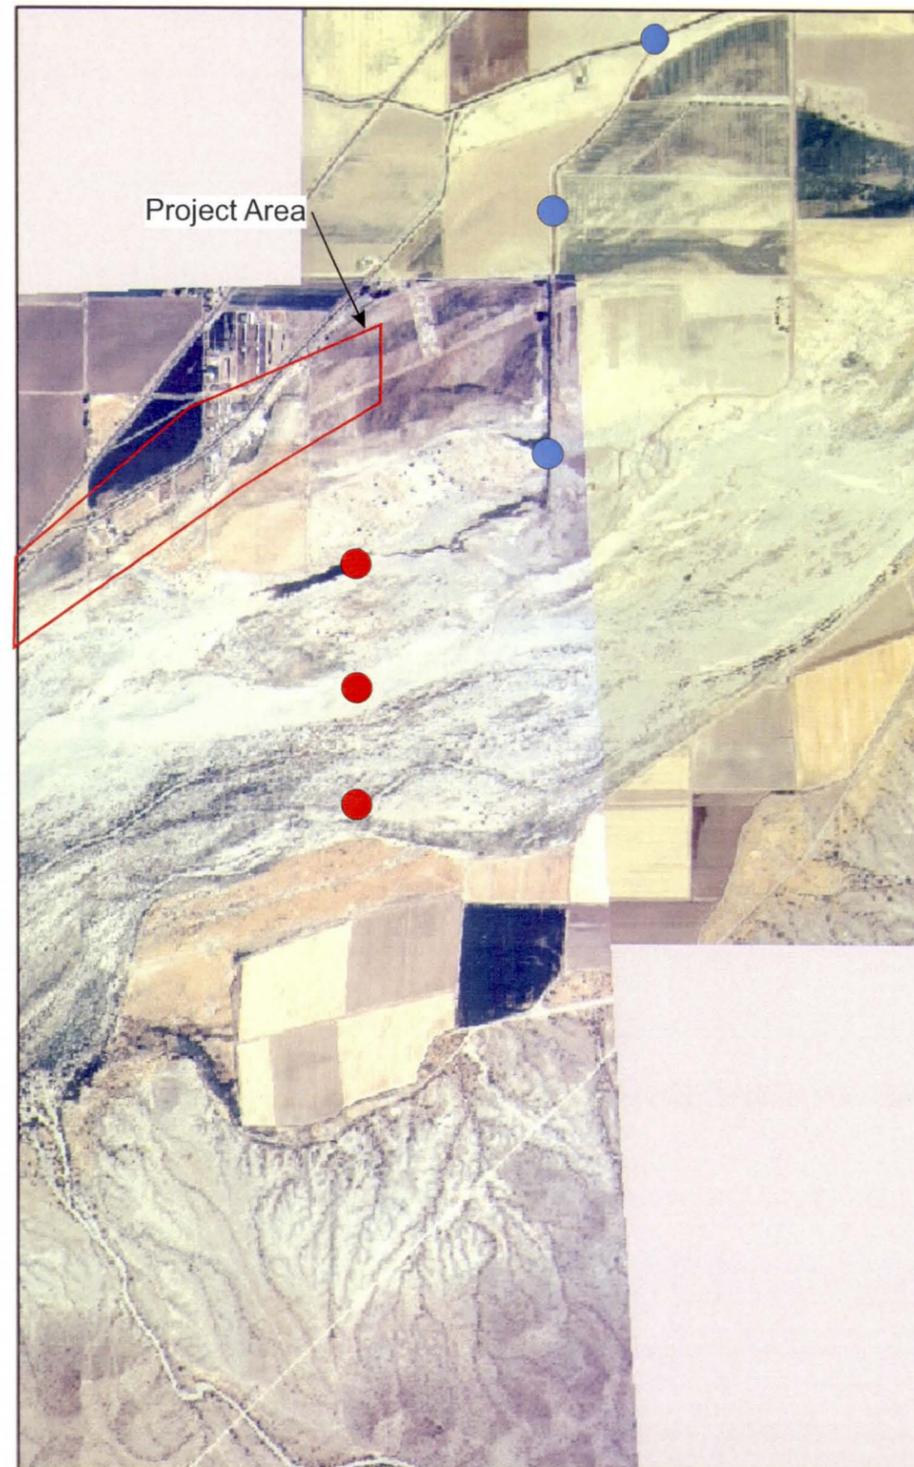
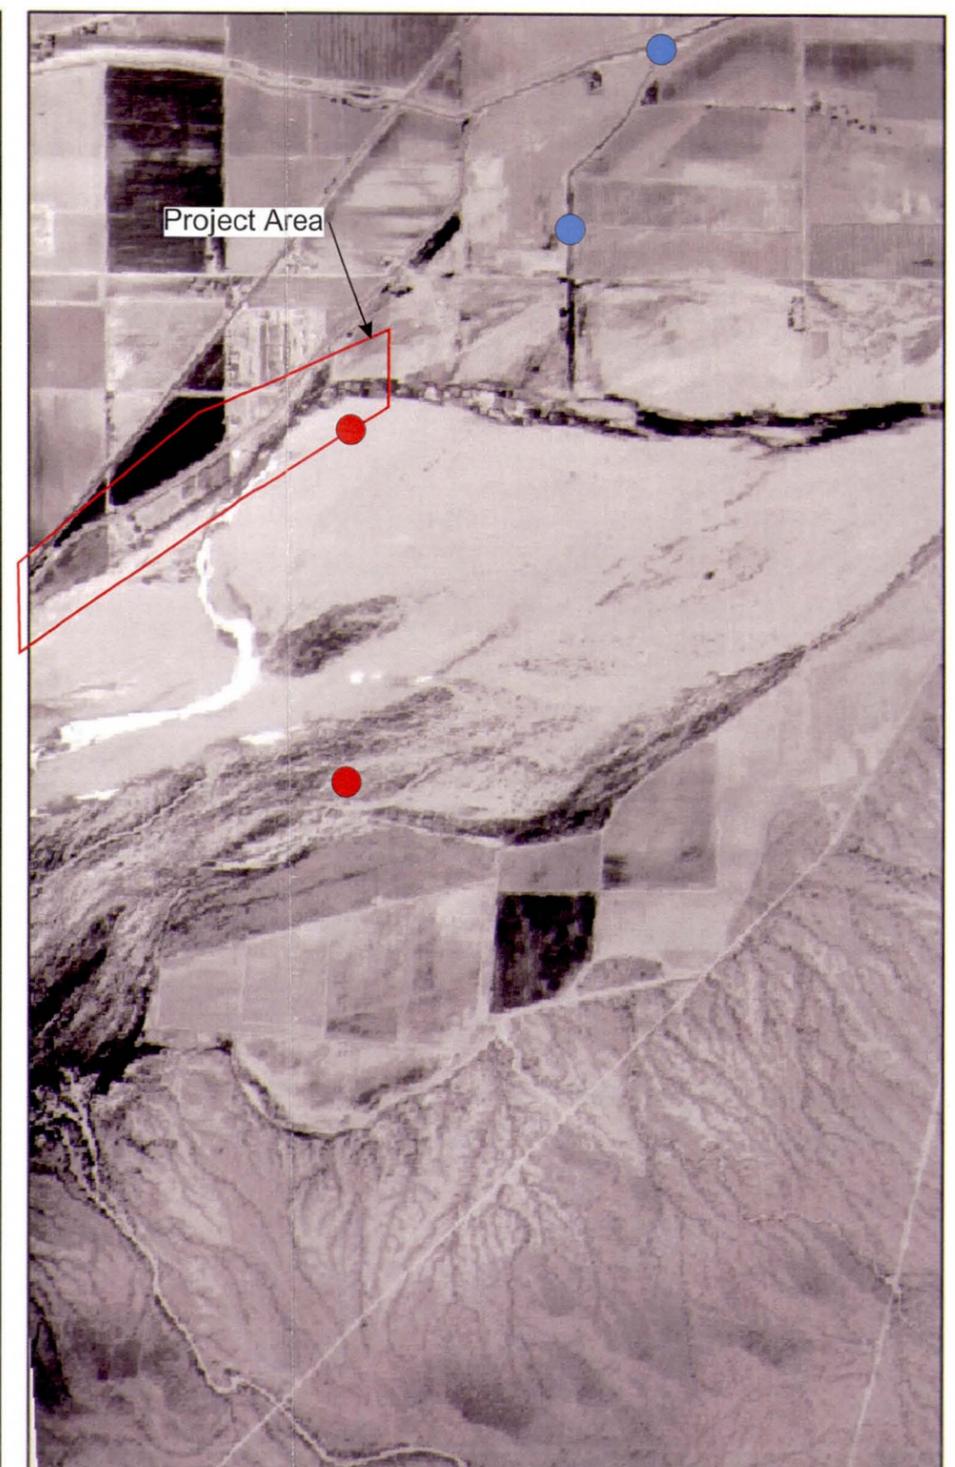
Observations made from the review of December 5, 1977 (Cooper Aerial), June 12 1978 (USBLM) and the May 13, 1979 (USDA) aerial photography that are different than the review of earlier aerial photography are:

- Channels appear to have laterally migrated to the north. The greatest evidence of lateral migration is depicted in the May 13, 1979 aerial photograph. The main channel has migrated from the center of the watercourse to the north bank.
- There is a significant loss of agricultural lands.
- A significant amount of vegetation has been removed from the channel.

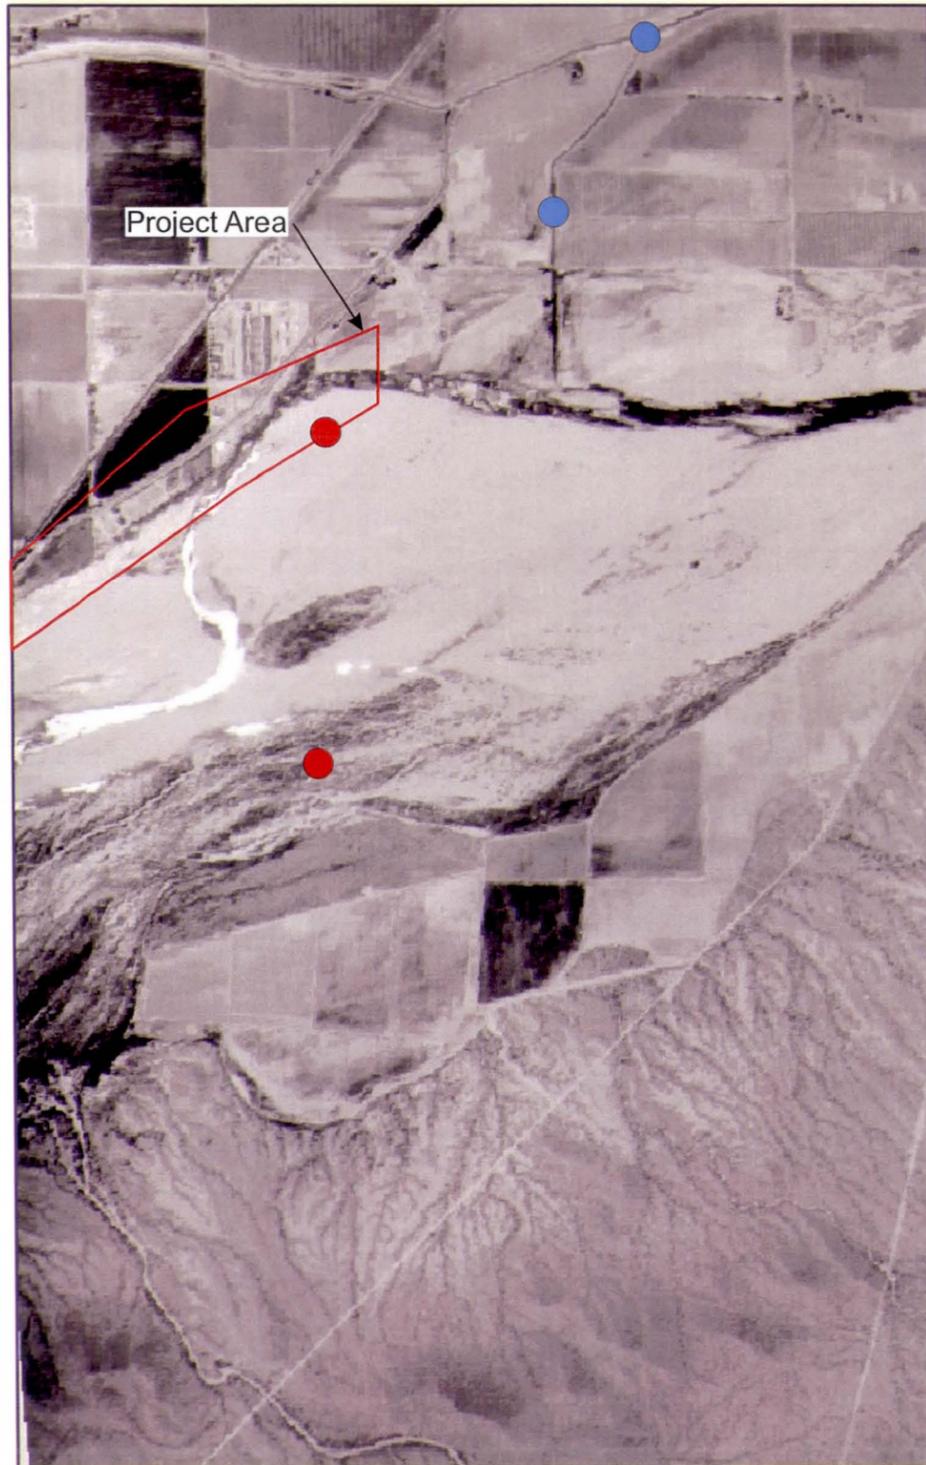
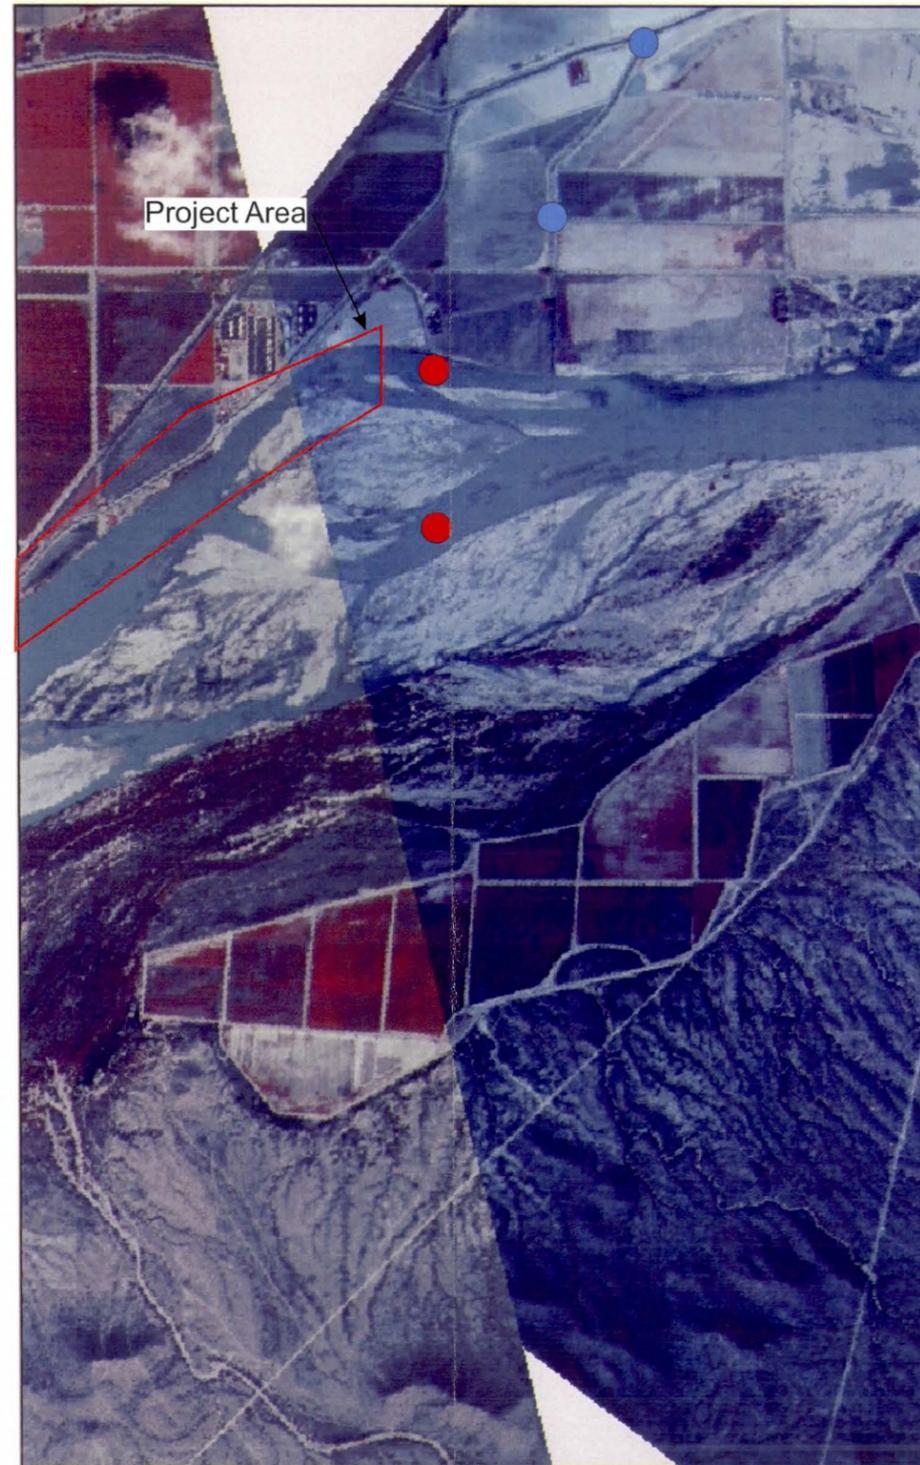
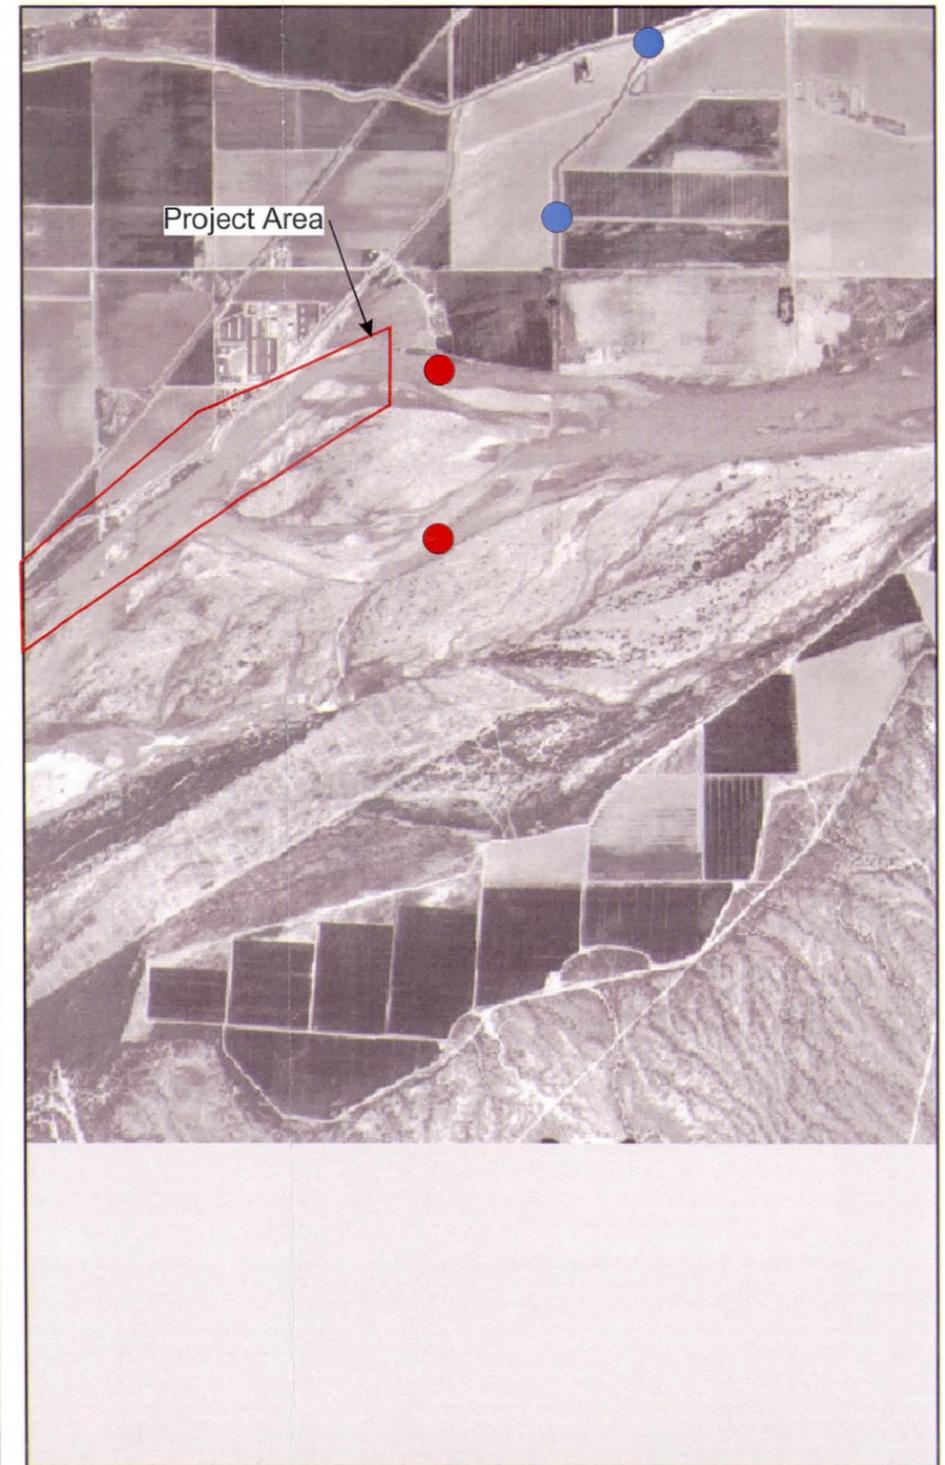
Observations made from the review of October 14, 1983 (USGS), March 22 1985 (Aerial Mapping Co.) aerial photography that are different than the review of earlier aerial photography are:

- Main channels appear to be predominately along the north bank and within the northern half of the watercourse.

Review of the Hydrologic Time Line presented in Figure 3 indicates that significant runoff events occurred in the time frame between the photograph dates. The maximum recorded runoff event occurred February 8<sup>th</sup> 1980.

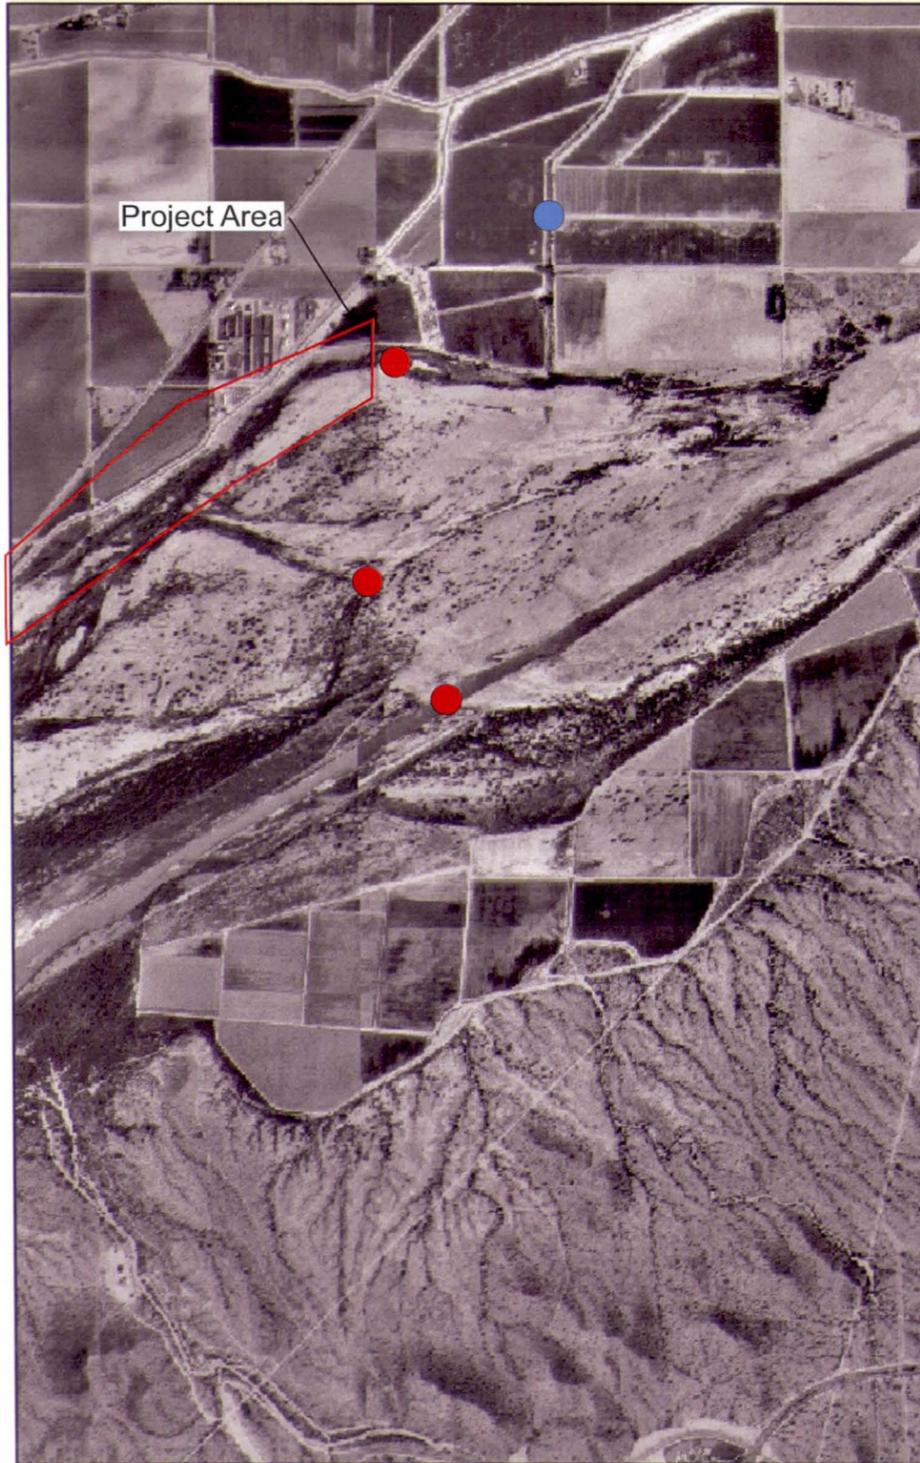
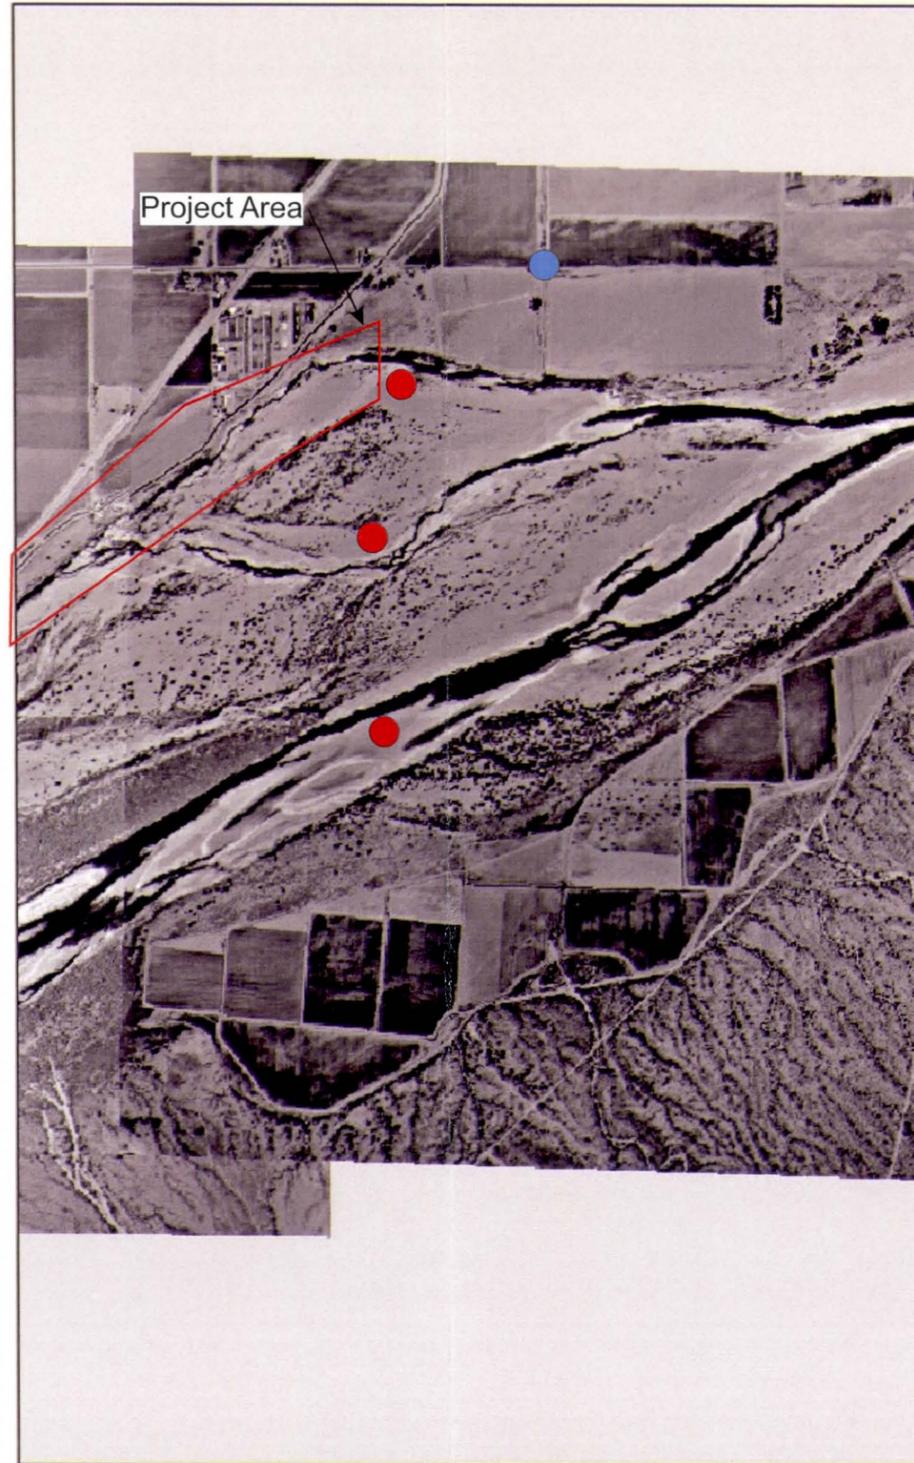
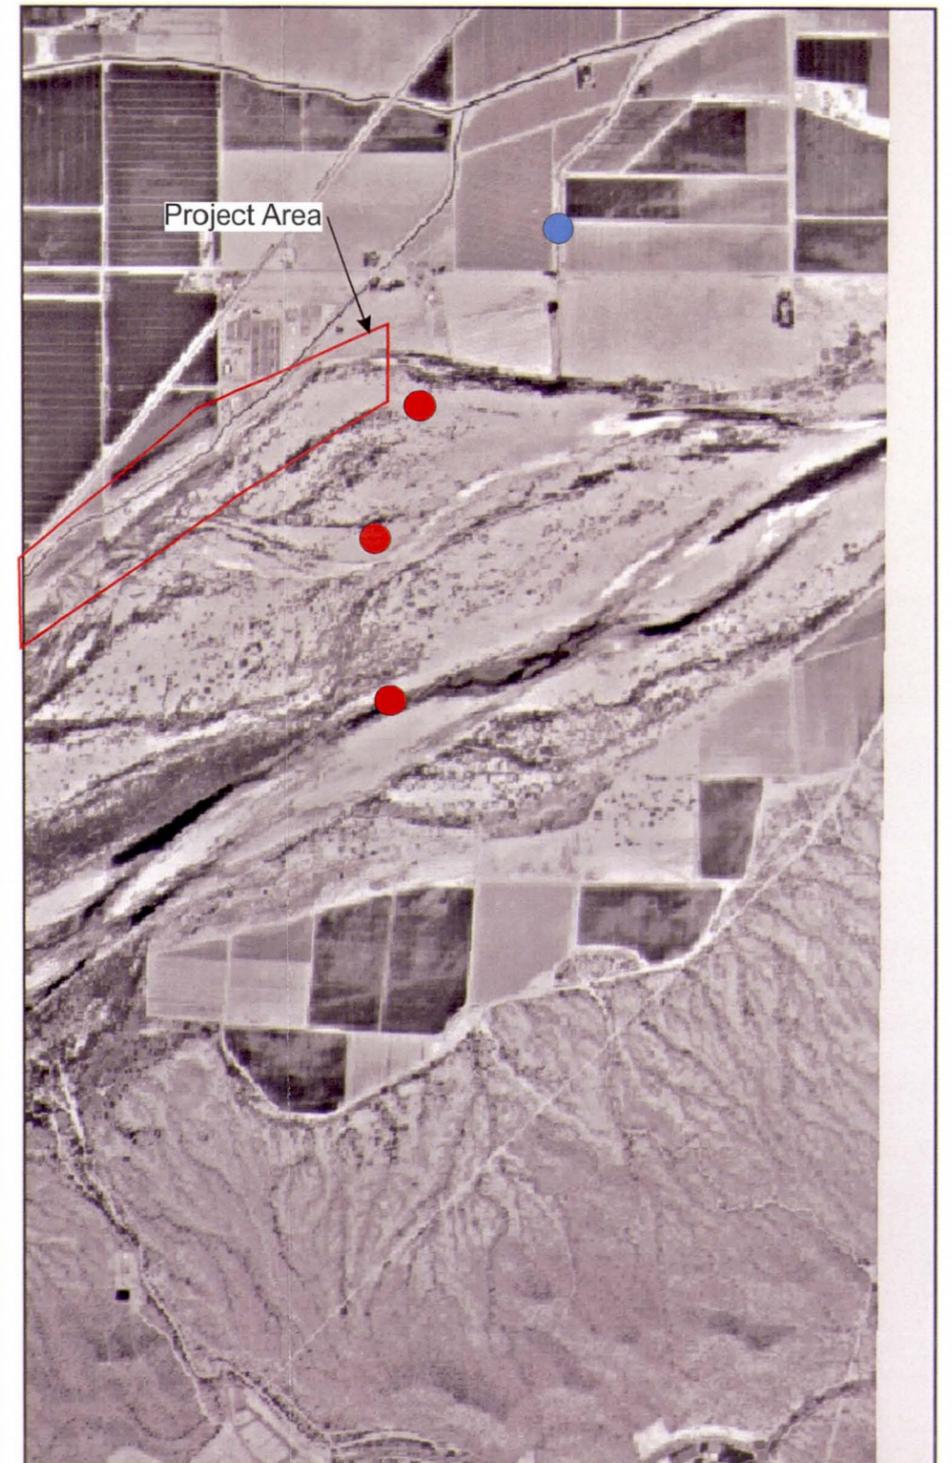
Observations made from the review of April 18 and September 6, 1992 (USGS DOQQ), June 26, July 1, 1993 (USGS) and April 30, 1997 (USGS NAPP) that are different than the review of earlier aerial photography are:

- There appears to be up to three defined channels (see red dot on aerial photograph)
- The channels appear to be clean of vegetation in the 1993 and 1997 aerial photography. The lack of vegetation is due to the 1993 runoff event.

During the 1993 runoff event additional bank protection material was placed on the bank protection constructed in 1983.
