Photo Dates: 1923-1993

Cave Creek Dam, Powerline, Rittenhouse, Vineyard Road Dam, Wittmann Wash, Wickenburg Areas various Washes

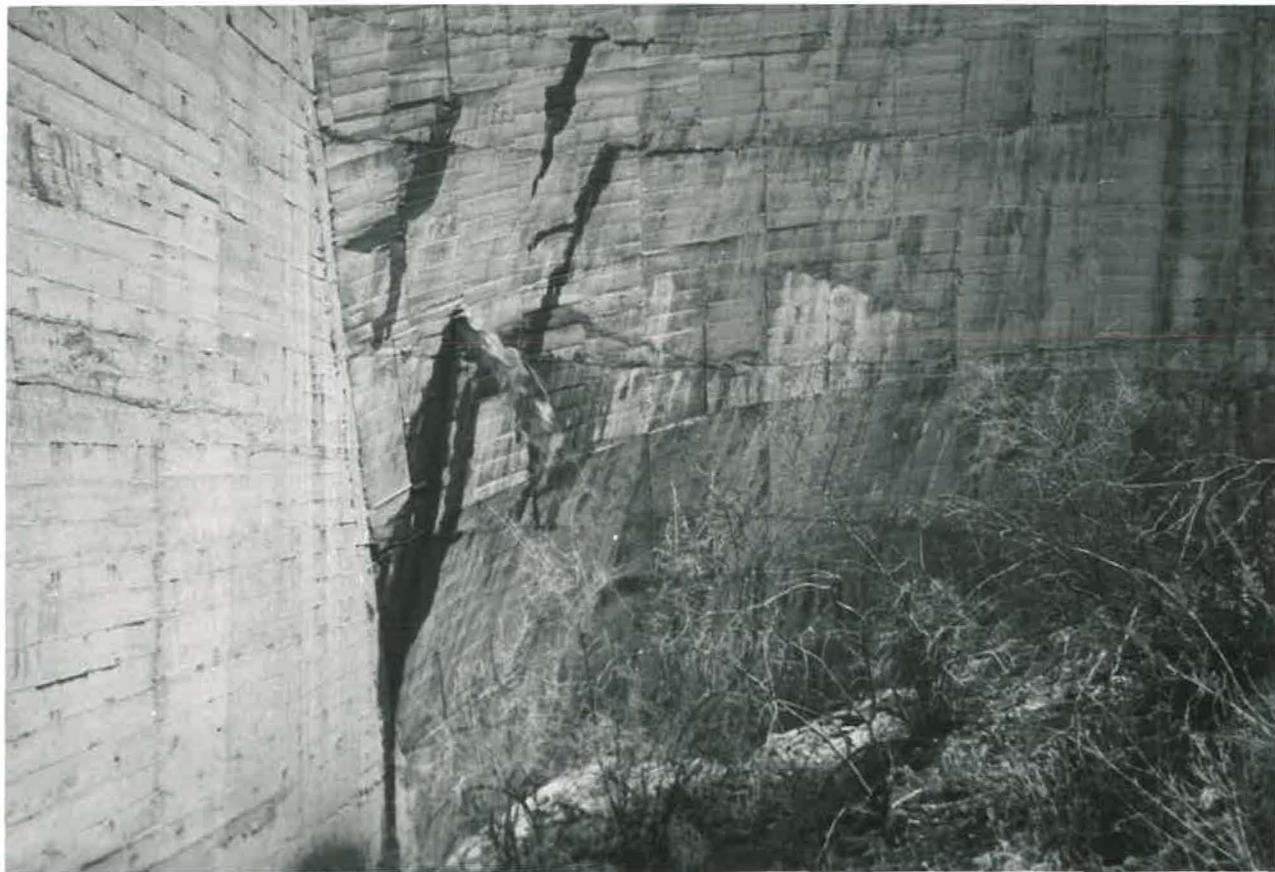
Cave Creek Dam  
A leak in it

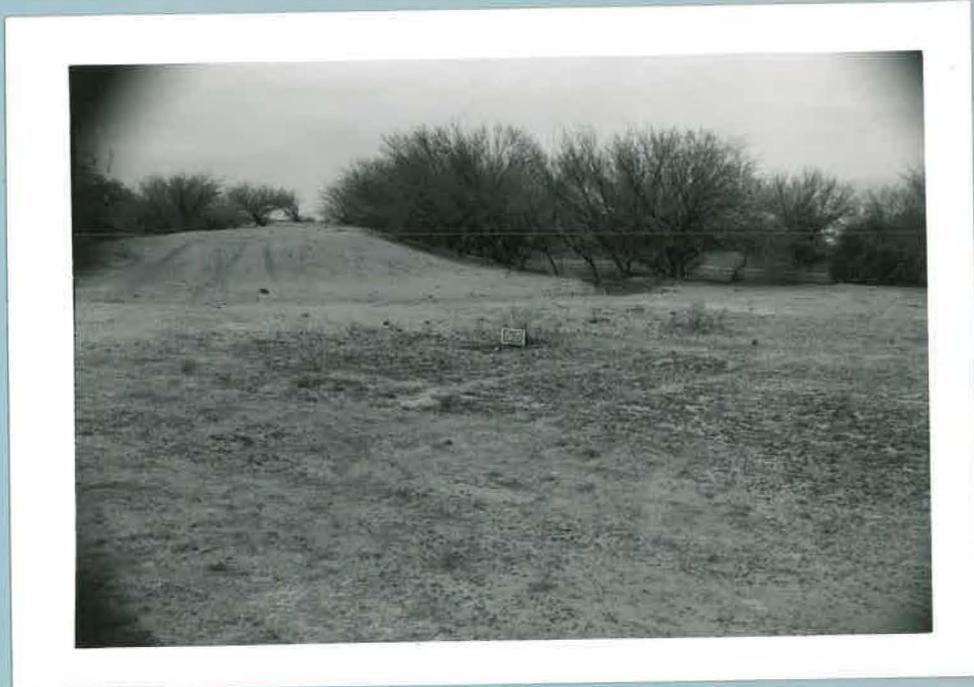
NW $\frac{1}{4}$  of Sec. 29, T1S, R8E  
(Phoenix T&T) SE end.  
Overflow occurs around this  
end. Small ditch dug around  
this end is only a few feet  
above present water level.

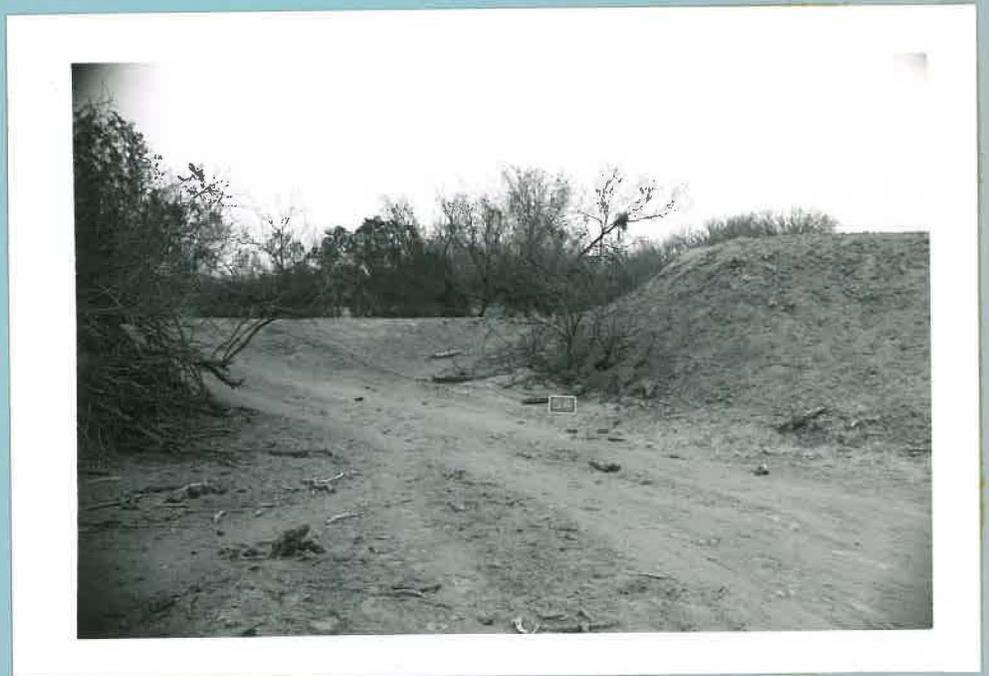
NW $\frac{1}{4}$  Sec. 30, T1S, R8E  
(M. Anderson) SE end.  
Overflows thru channel  
around this end. Channel  
is 7' below top of newly  
rebuilt dike.

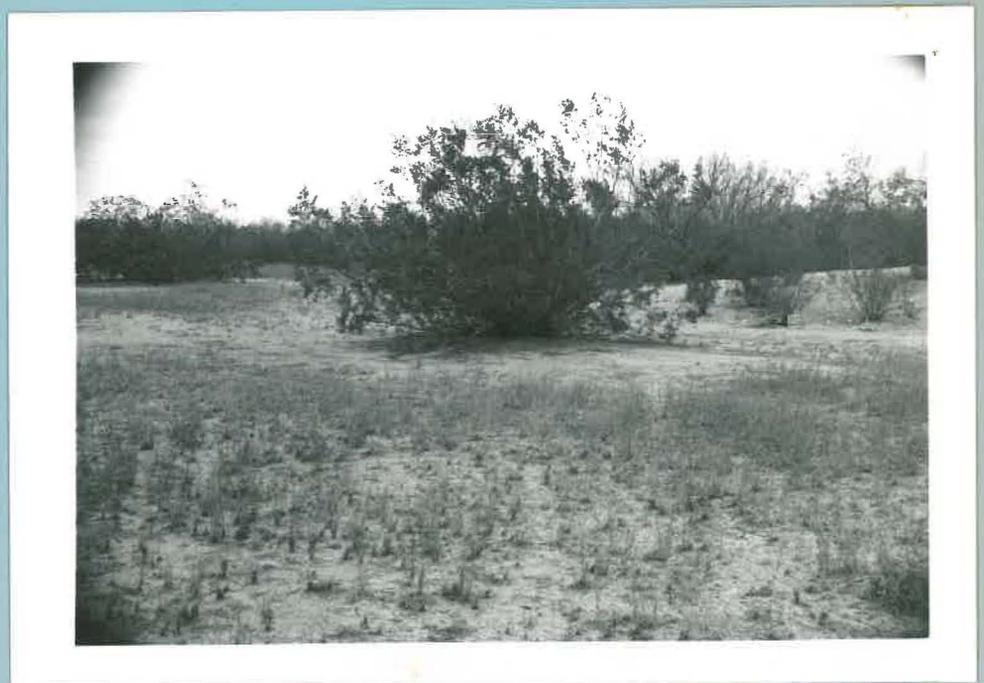
NE end. Can spill  
around this end, 4'  
lower than top of  
dam.

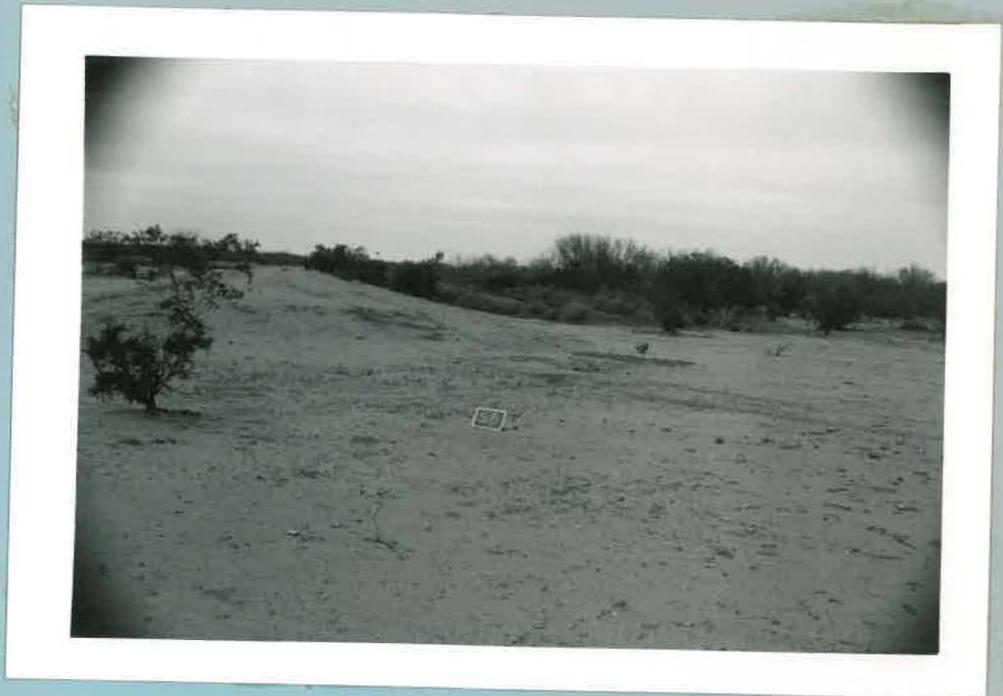
NE $\frac{1}{4}$  Sec 5, T2S R8E  
(Phoenix T&T) SE end  
Tank now dry due to  
break in center of dam.  
Flow has gone around  
this end 3' lower than  
top of dam.

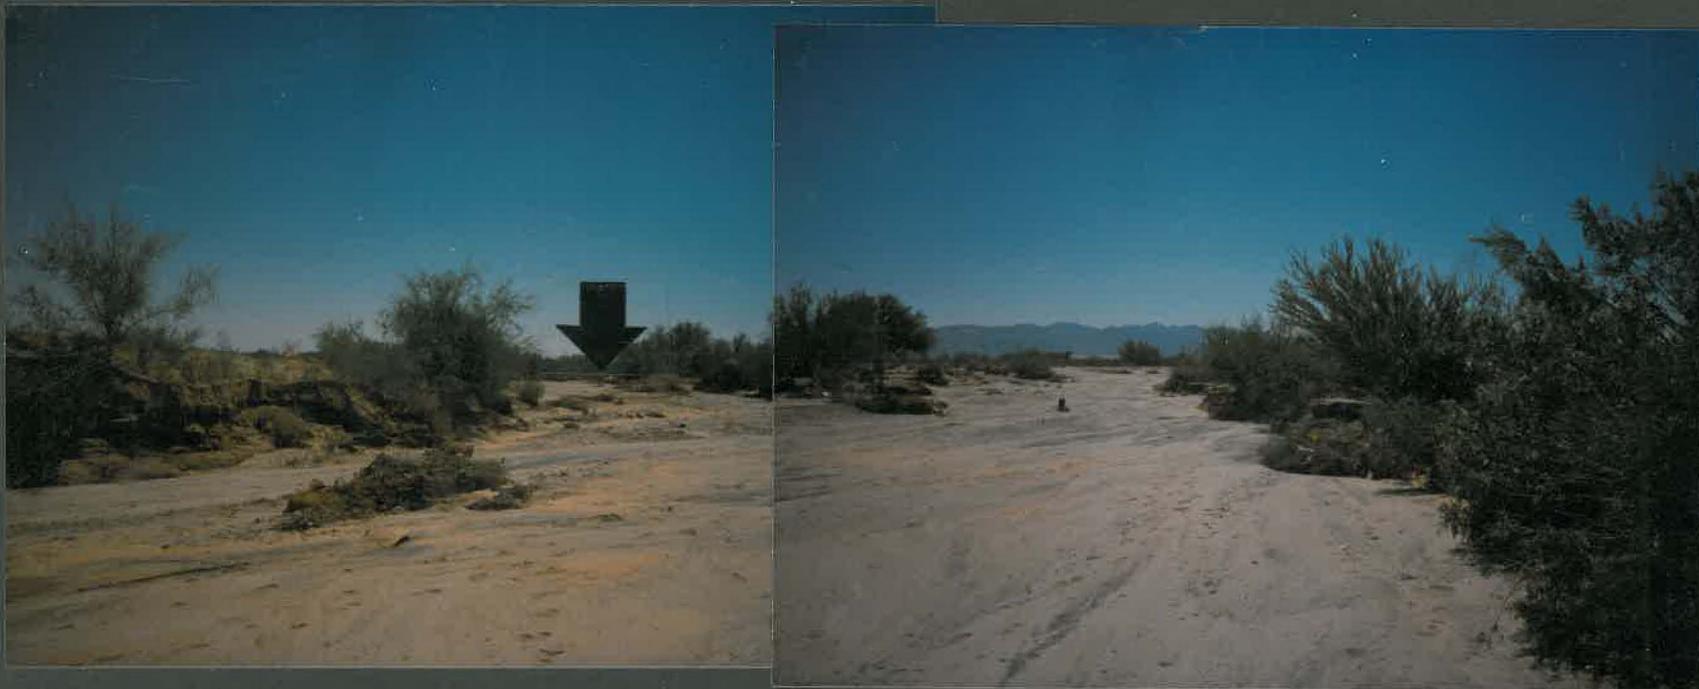
Looking down stream  
Main wash (arrow) filled with sediment  
Flows directed to the west

Labor Day Rains 9-3,5,-90  
photo date 9/7/90

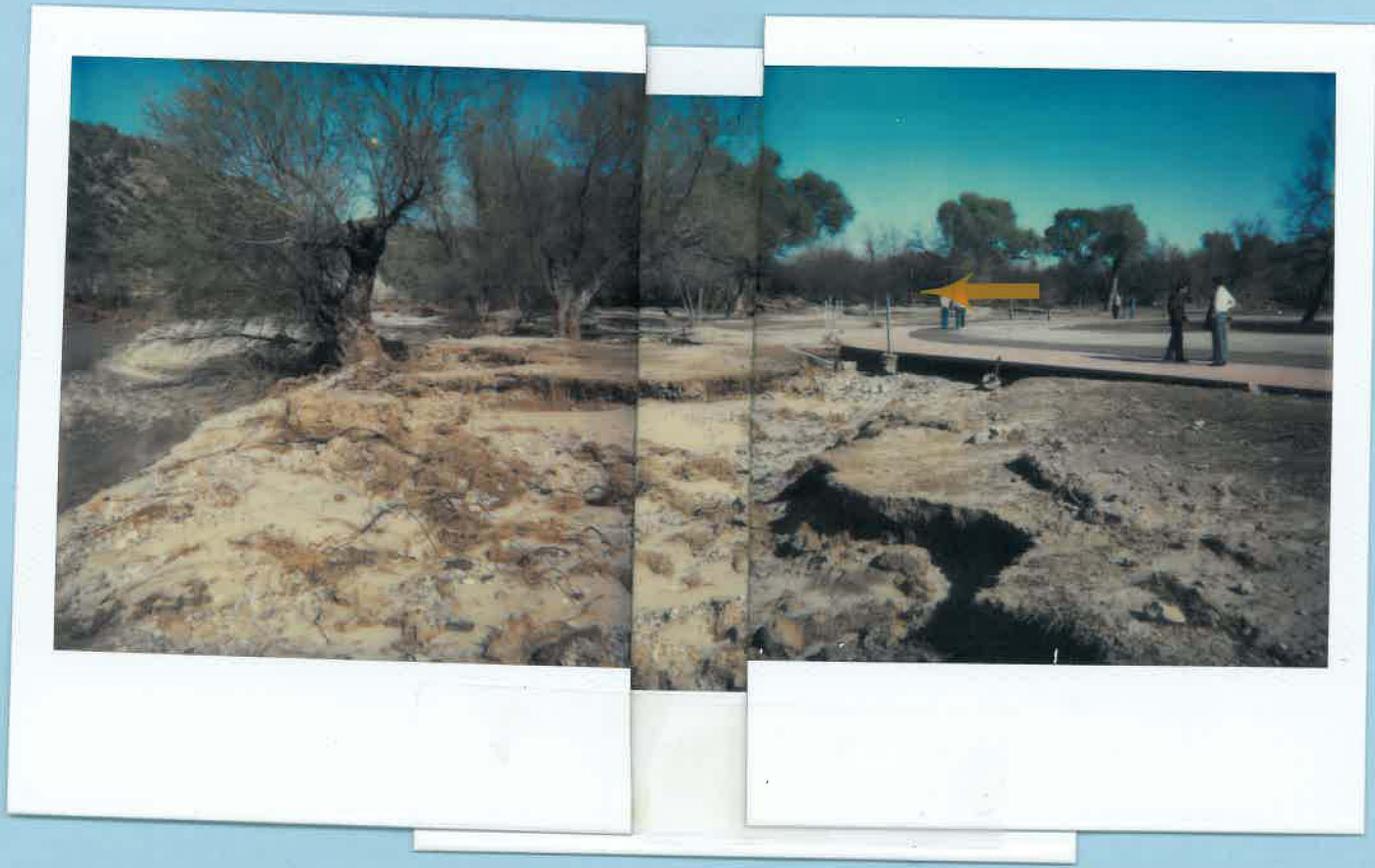
ADOT Rest Area along the Hassayampa R.  
Looking upstream  
A Arrow marks debris line 3/5/93
