JANUARY 1993 FLOOD PHOTOS

January 93 Flood Photos

Property,
Flood Control District of P
Please Return to
2801 W. Durango
Phoenix, AZ 85009

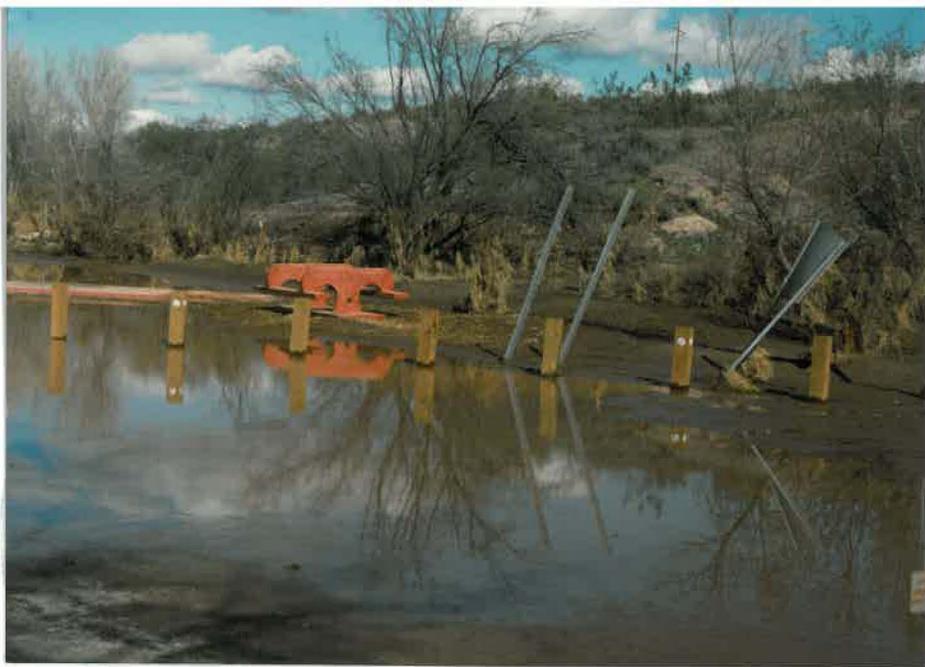
20-12

DAMAGE AT ADOT'S NEWLY CONSTRUCTED REST AREA WHICH IS SOUTH OF WICKENBURG ALONG U.S. HIGHWAY 60. THE REST AREA IS LOCATED BETWEEN THE HIGHWAY AND THE HASSAYAMPA RIVER. THIS DAMAGE OCCURED ON JANUARY 8, 1993. NOTICE THE OVERTURNED CONCRETE PICNIC BENCHES THAT WERE OVERTURNED AND THE MUD LEFT BEHIND.

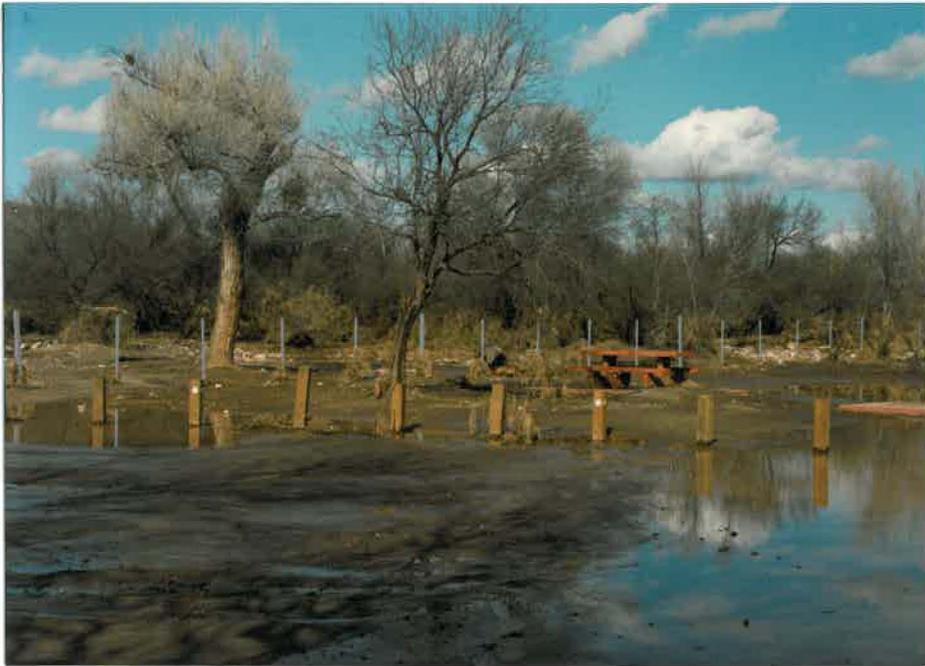
20-11

DAMAGE AT ADOT'S NEWLY CONSTRUCTED REST AREA WHICH IS SOUTH OF WICKENBURG ALONG U.S. HIGHWAY 60. THE REST AREA IS LOCATED BETWEEN THE HIGHWAY AND THE HASSAYAMPA RIVER. THIS DAMAGE OCCURED ON JANUARY 8, 1993. NOTICE THE SEDIMENT THAT WAS DEPOSITED OVER THE REST AREA.

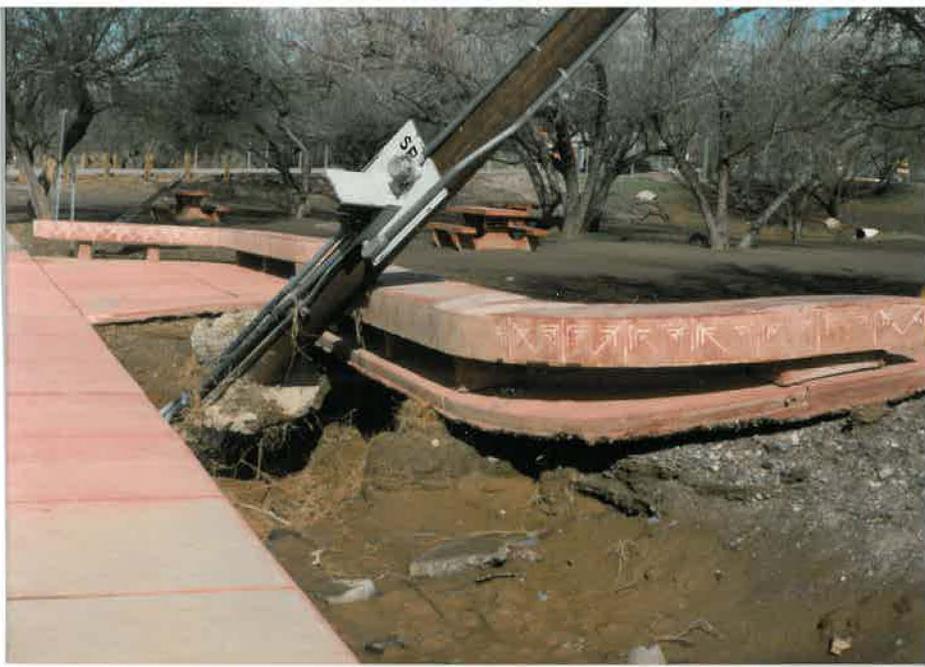
20-15

DAMAGE AT ADOT'S NEWLY CONSTRUCTED REST AREA WHICH IS SOUTH OF WICKENBURG ALONG U.S. HIGHWAY 60. THE REST AREA IS LOCATED BETWEEN THE HIGHWAY AND THE HASSAYAMPA RIVER. THIS DAMAGE OCCURED ON JANUARY 8, 1993. NOTICE THE SLABS OF SIDEWALK THAT WERE WASHED AWAY . ALSO, NOTICE THE SCOURING THAT TOOK PLACE AROUND THE LIGHT POLE FOUNDATION.

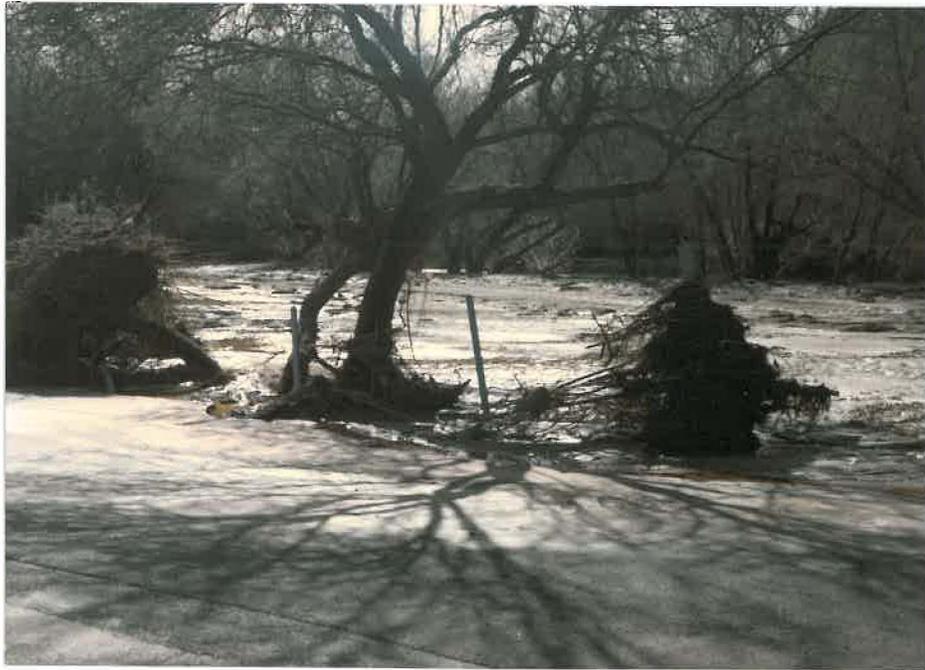
20-17

THIS PICTURE IS TAKEN FROM ADOT'S NEWLY CONSTRUCTED REST AREA LOOKING TOWARD THE HASSAYAMPA RIVER. THE REST AREA IS LOCATED SOUTH OF WICKENBURG ALONG U.S. HIGHWAY 60. NOTICE THE DEBRIS IN THE FENCE AND THE SIZE OF THE OVERTURNED TREE. THE FLOWS WERE ABOVE THE FENCE.

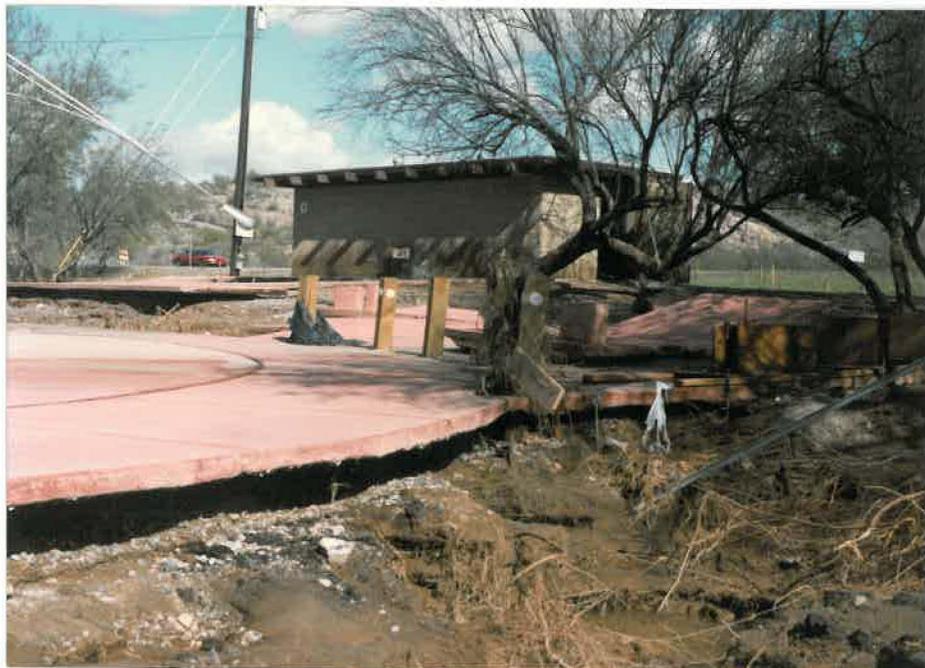
20-13

DAMAGE AT ADOT'S NEWLY CONSTRUCTED REST AREA WHICH IS SOUTH OF WICKENBURG ALONG U.S. HIGHWAY 60. THE REST AREA IS LOCATED BETWEEN THE HIGHWAY AND THE HASSAYAMPA RIVER. THIS DAMAGE OCCURED ON JANUARY 8, 1993. NOTICE THE SLABS OF SIDEWALK THAT WERE WASHED AWAY. ALSO, NOTICE THE SCOURING THAT TOOK PLACE AROUND THE SIDEWALKS AND DRIVEWAYS.

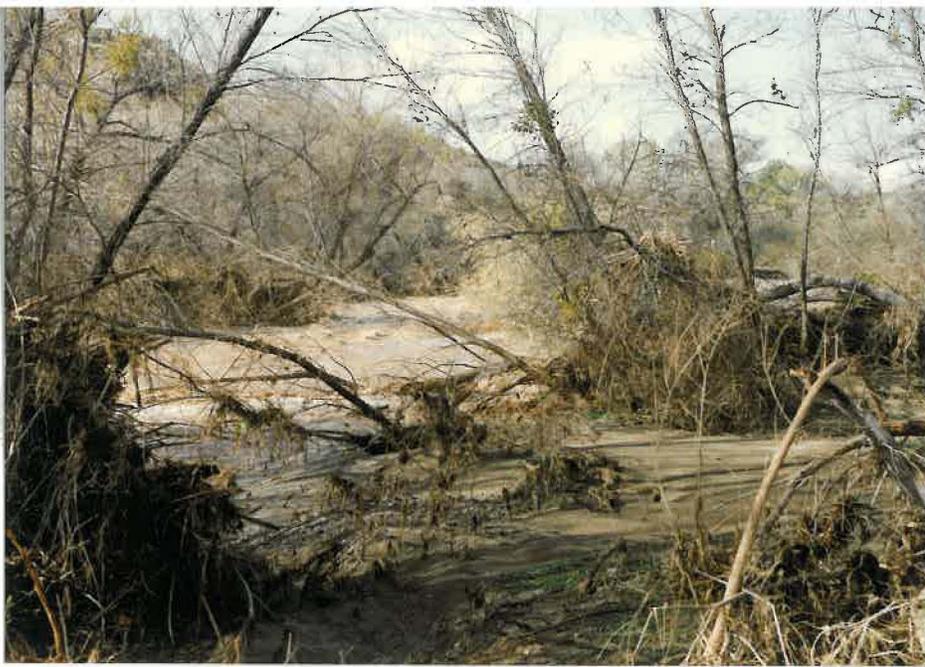
20-18

HASSAYAMPA RIVER UPSTREAM OF THE TRAILER PARK
THAT IS LOCATED SOUTH OF WICKENBURG AND
DOWNSTREAM OF THE WILDLIFE PRESERVE. NOTICE
ALL OF THE DEBRIS IN THE TREE BRANCHES AND
THE DESTRUCTION CAUSED TO SOME OF THE TREES.

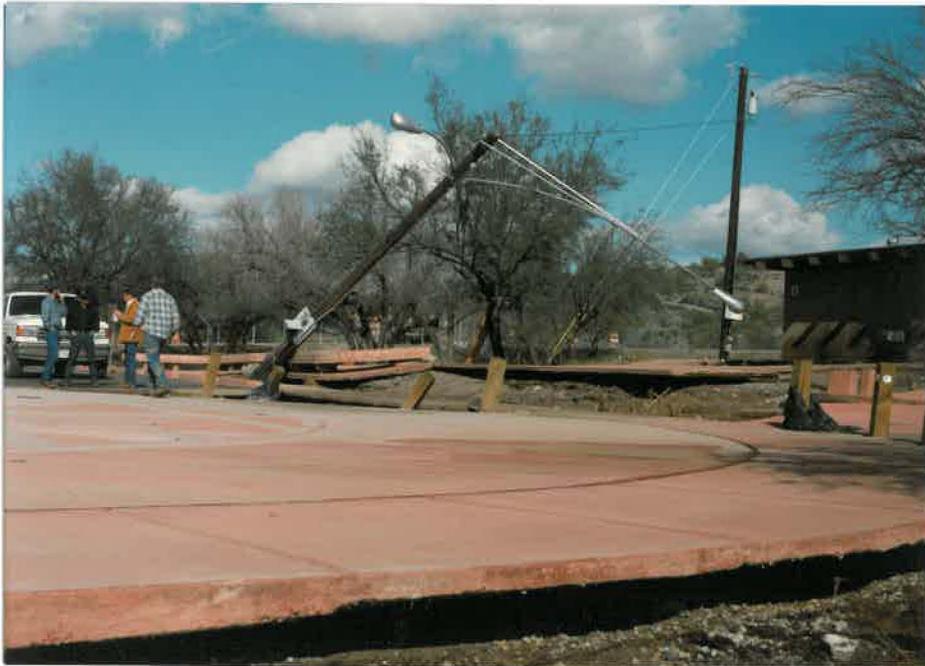
20-19

DAMAGE AT ADOT'S NEWLY CONSTRUCTED
REST AREA WHICH IS SOUTH OF WICKENBURG
ALONG U.S. HIGHWAY 60. THE REST AREA IS
LOCATED BETWEEN THE HIGHWAY AND THE
HASSAYAMPA RIVER. THIS DAMAGE OCCURED
ON JANUARY 8, 1993. NOTICE THE SLABS OF
SIDEWALK THAT WERE WASHED AWAY. ALSO,
NOTICE THE SCOURING THAT TOOK PLACE
AROUND THE SIDEWALKS AND DRIVEWAYS.

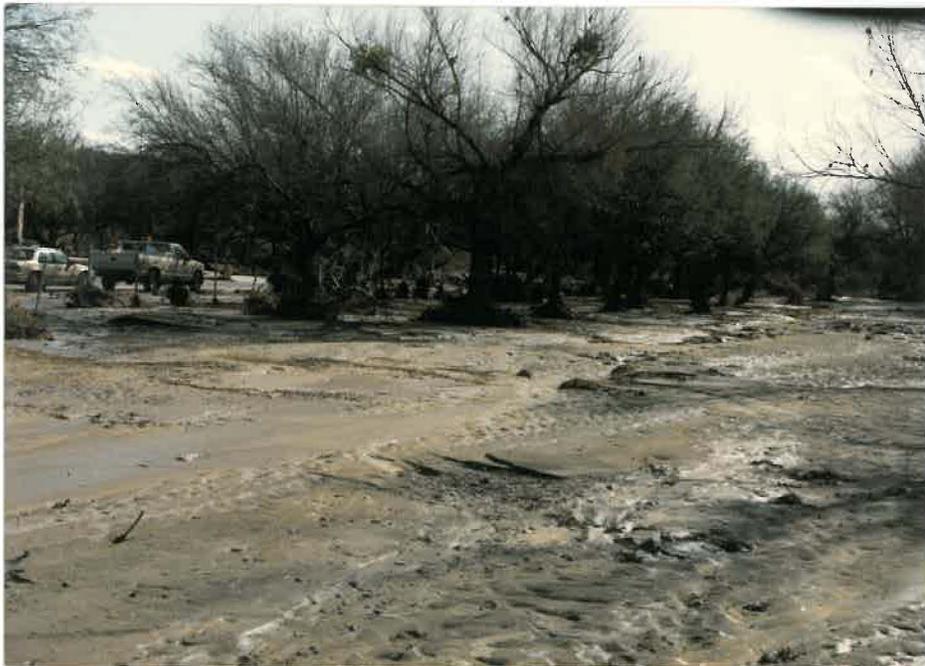
20-16

THIS PICTURE IS TAKEN FROM THE LOW FLOW
BANKS OF THE HASSAYAMPA FACING ADOT'S
NEWLY CONSTRUCTED REST AREA WHICH IS
SOUTH OF WICKENBURG ALONG U.S. HIGHWAY
60. THE REST AREA IS LOCATED BETWEEN THE
HIGHWAY AND THE HASSAYAMPA RIVER. THIS
FLOODING OCCURED ON JANUARY 8, 1993.
NOTICE ALL OF THE SEDIMENT CARRIED BY THE
FLOODWATERS.

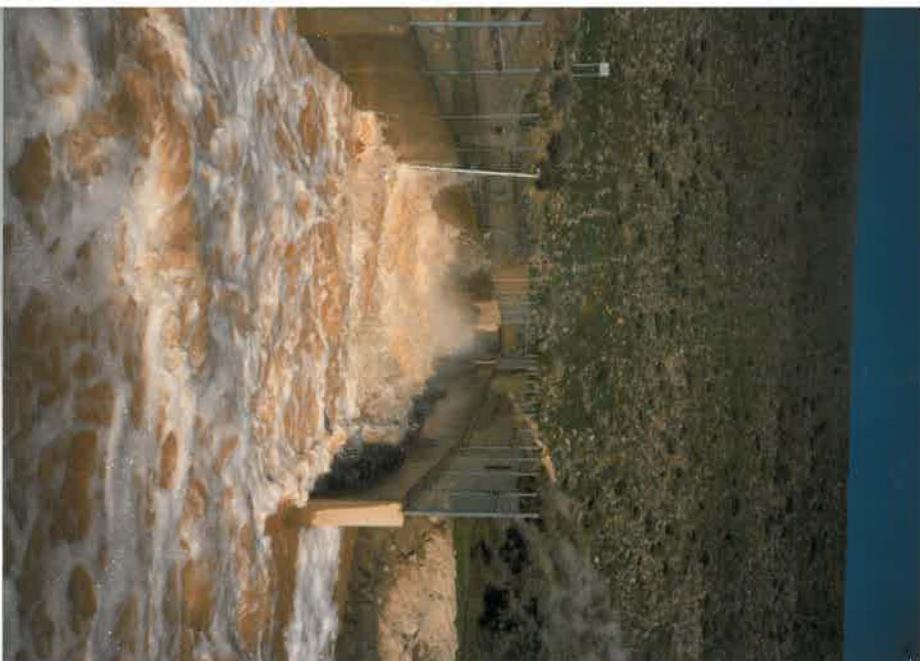
Skunk Creek wash xing at Pinnacle Peak Rd 01-22-93
435th Ave. Damages are shown on this picture.
