Historical Documentation of the Maricopa Drain

prepared for
**Flood Control District
of Maricopa County**

prepared by
URS Corporation

June 2001

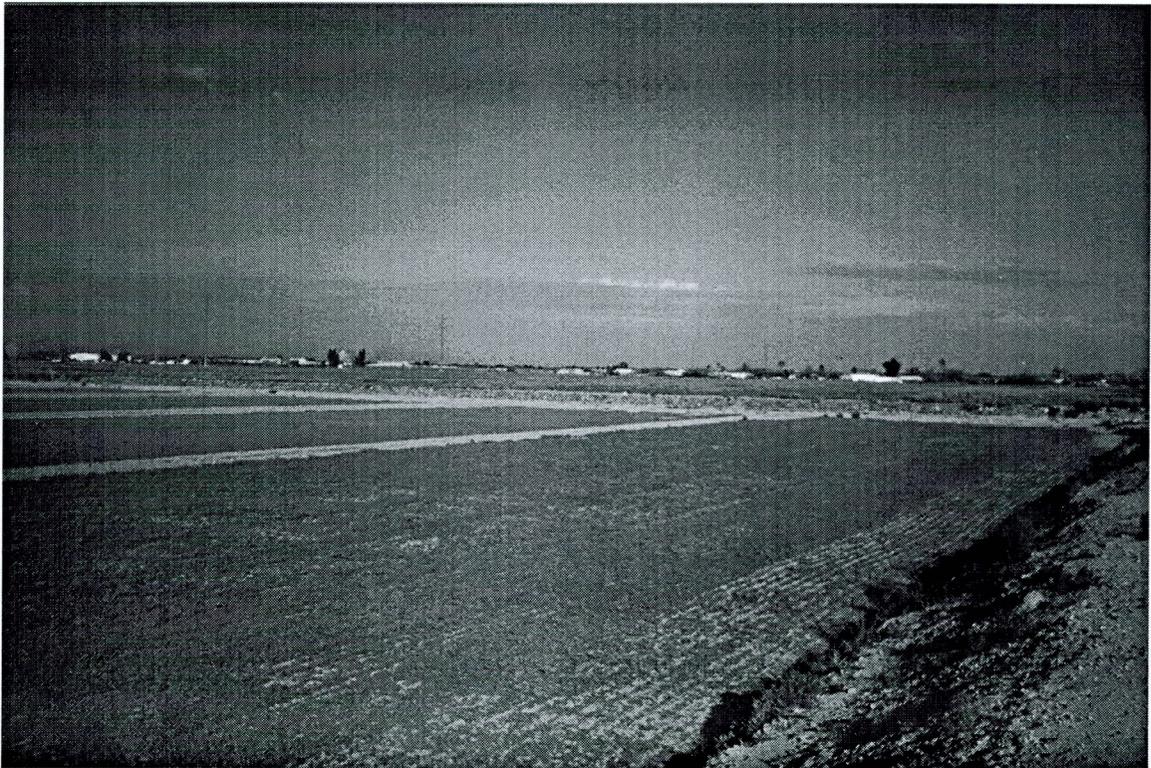
Photograph 7: Example of Field with Young Crop (view to the northeast) Note height of terraced on the right indicating substantial cuts and fills used to level land in this area.

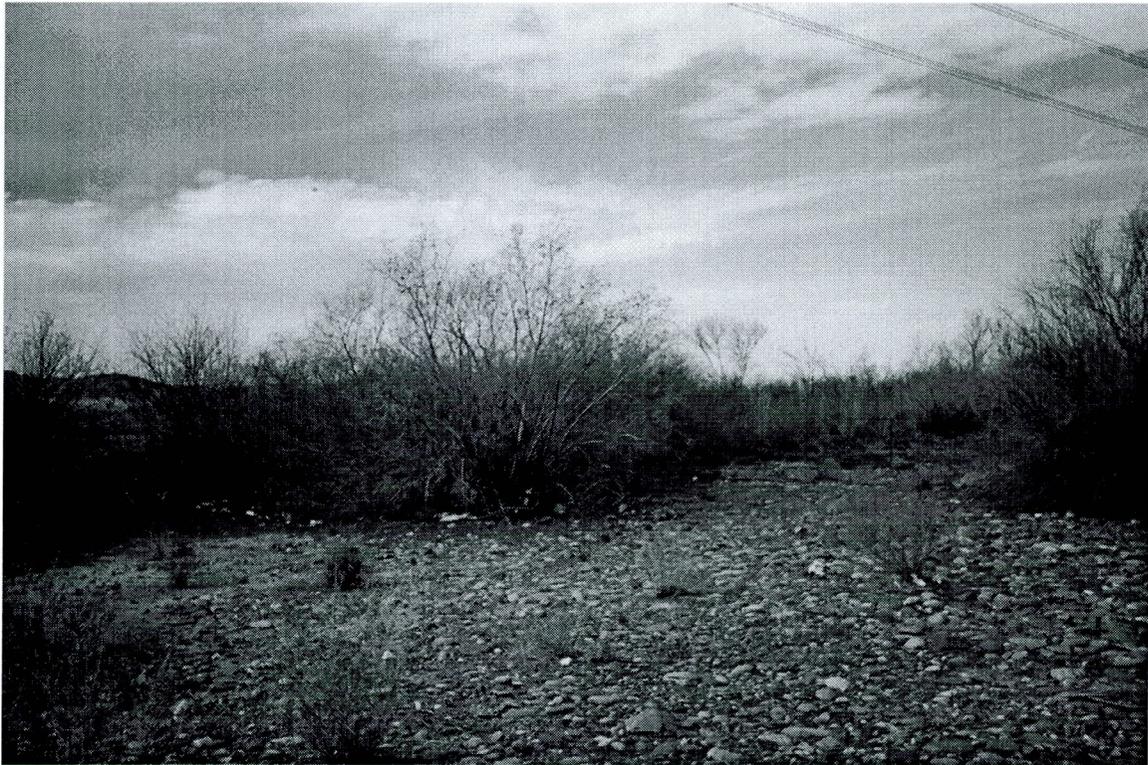
Photograph 8: Maricopa Drain Outfall Area in the Bed of the Salt River (view to the east)

vegetation was dense in places (Photograph 8). One parcel on the southern margin of the Salt River channel is a pasture with dense grass cover that made it impossible to intensively inspect.

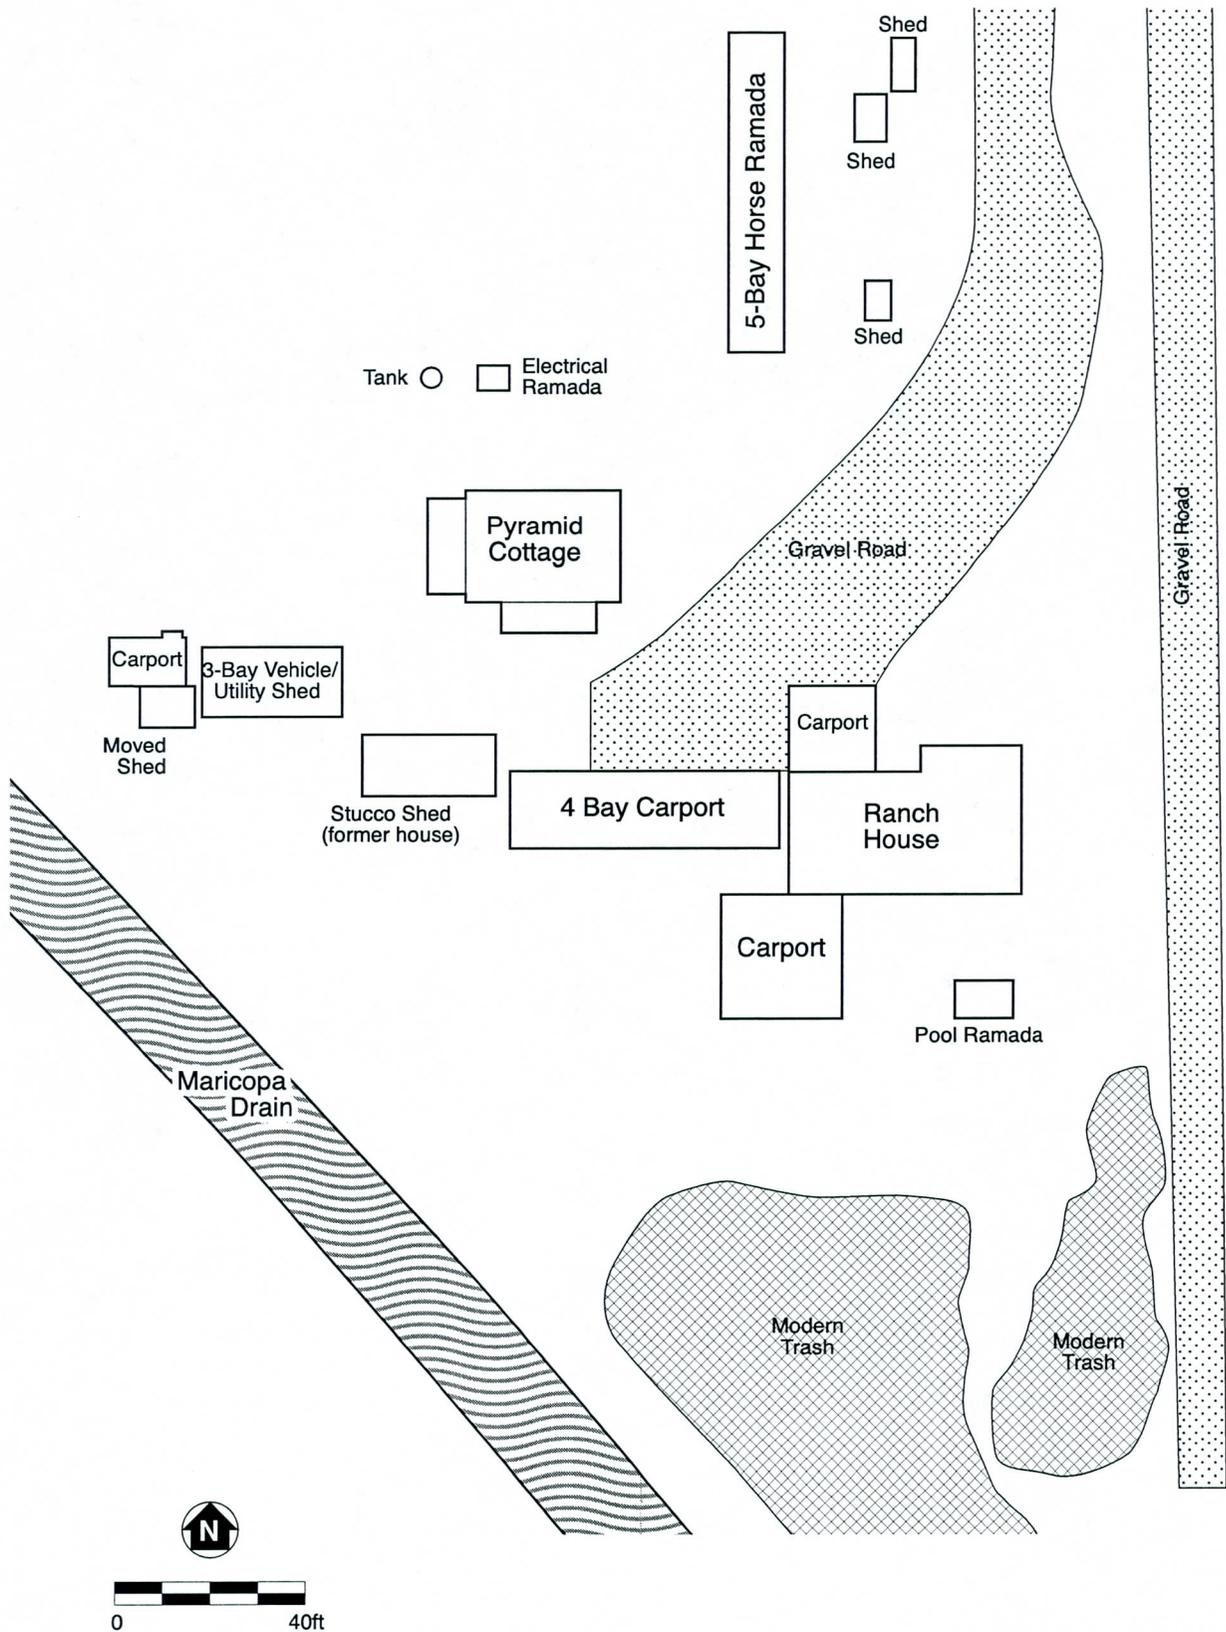
Map of the Webster Farmstead Figure 4

One of the houses and the storage shed are the only buildings of historic age. According to the Webster family, an old barn and shed previously located on the property have been demolished. The other residence is a ranch-style house constructed in the early 1970s. The vehicle storage shed is constructed of steel supports, horizontal wood siding, and the roof covering is standing seam metal. All of the covered parking areas are modern structures of steel supports with standing seam metal roofs and concrete slab foundations.

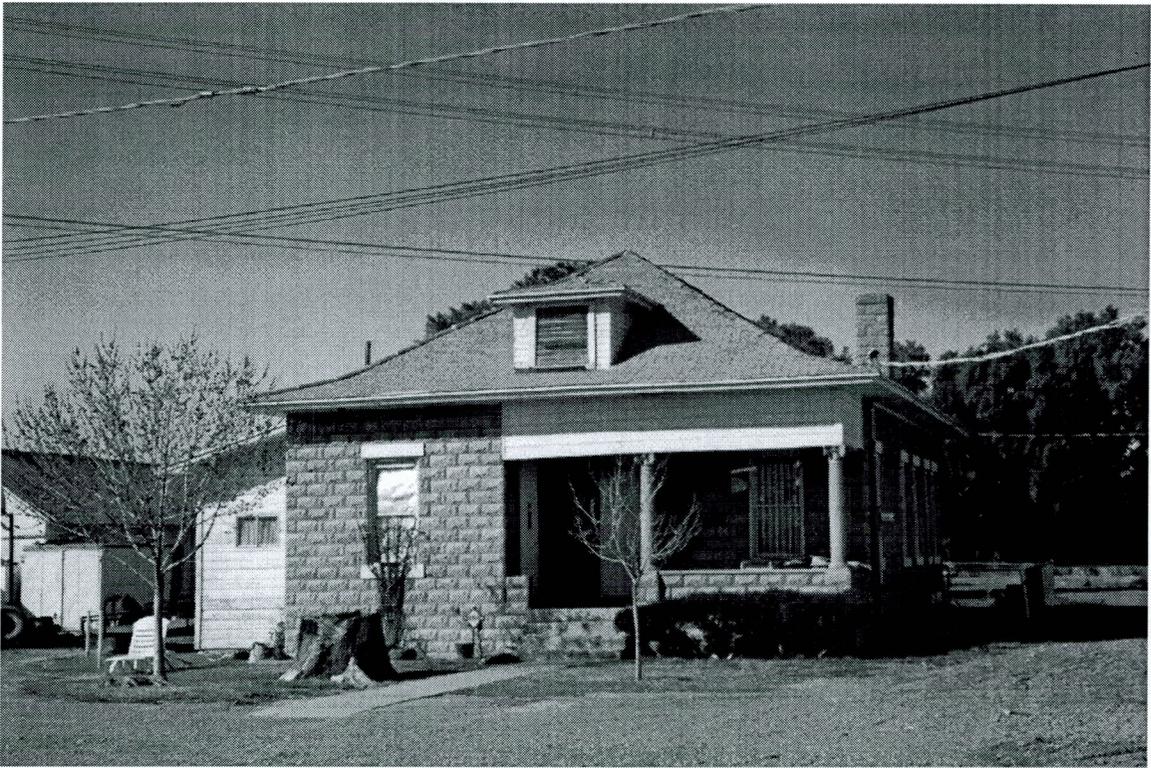
Photograph 9: Front Facade of the Webster House (view to the west-southwest)

The Webster House is a one-story building set on a concrete wall foundation, facing east (Photographs 9 and 10). The wall materials are rusticated concrete block and horizontal wood siding. Rusticated concrete blocks typically were made with easy-to-use concrete block-forming machines obtained through mail order catalogs. Residents of the adjacent Gila River Indian Community told the Websters that the concrete blocks for the house were cast on site, suggesting local Indians were hired to make the blocks (Jo Ellen Saenz, personal communication, 12 February 2001).

The Webster House has a belcast roof covered with asphalt composition shingles with clay tile along the ridgelines. The windows are double hung, 1 over 2-light and 1 over 1-light, wood frame windows with concrete lintels. One of the windows has a wrought iron grill covering. The recessed entry forms a porch, which is supported by two Ionic order concrete columns. Two single entries are located on the porch with concrete lintels. The main entrance has been covered with a metal security door and the original transom has been covered with decorative wood. The

other entry has been boarded over. There is a hipped roof dormer with a vent centered in the front roof. A rusticated concrete block interior chimney is located on the north elevation.

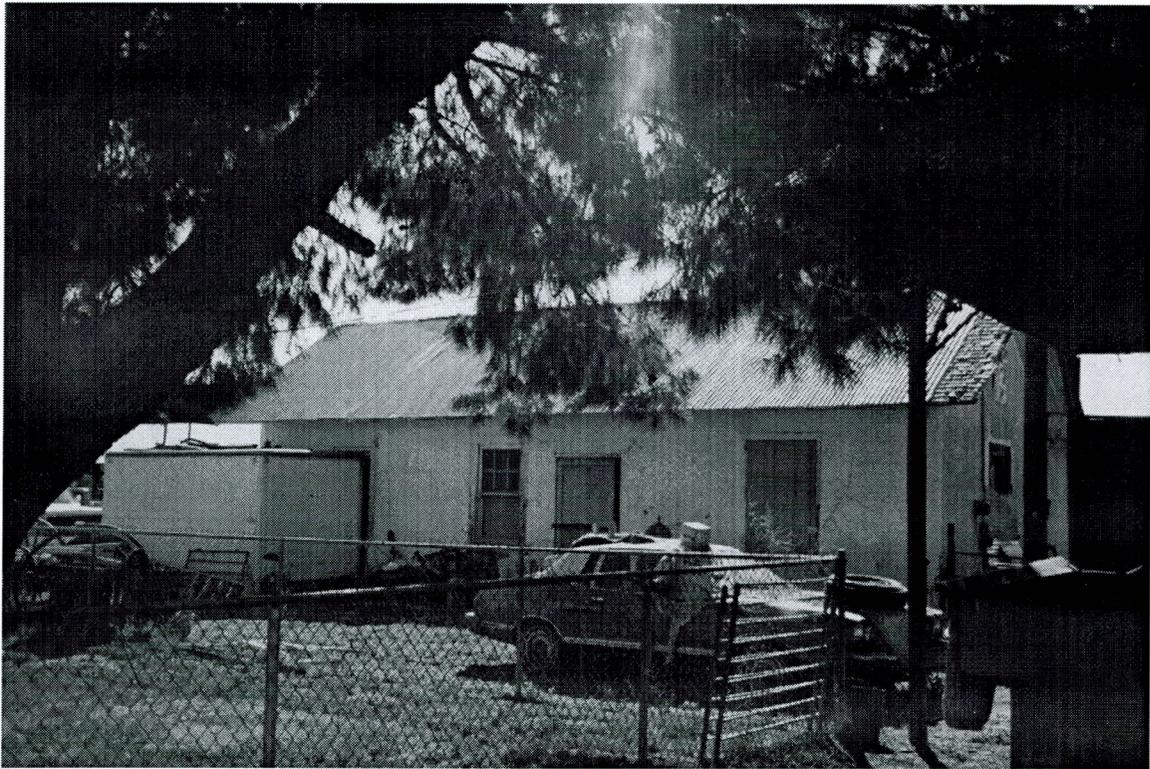
The building is a one-story structure of wood frame construction clad with concrete stucco over chicken wire (Photographs 11 and 12). Part of the building covered with horizontal wood siding appears to be an addition. The windows are double-hung, 6 over 2-light windows with wood sashes and surrounds. The roof is a side gable with a shed roof addition, both covered with standing seam metal over wood shingles. The building rests on a concrete foundation.

**Photograph 11: Front Facade of the Storage Shed, (former house) at the Webster Farmstead
(view to the southeast)**

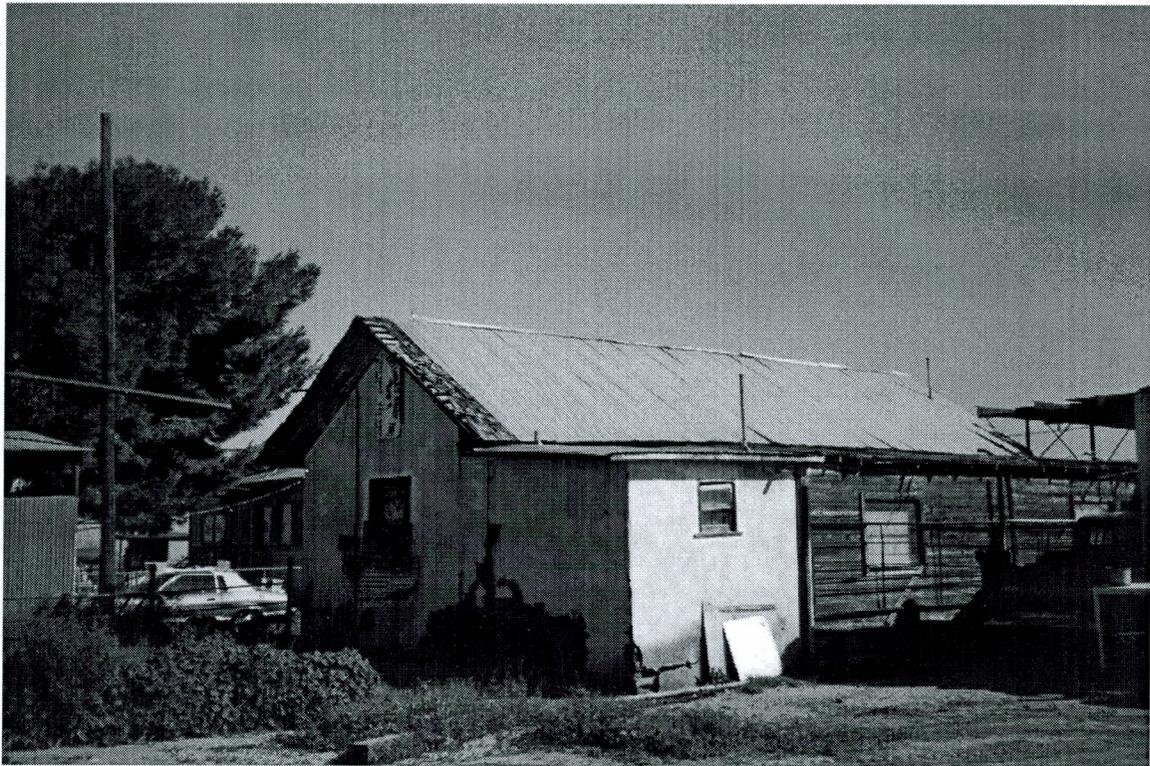
Photograph 12: Rear Elevation of the Storage Shed (view to the northeast)

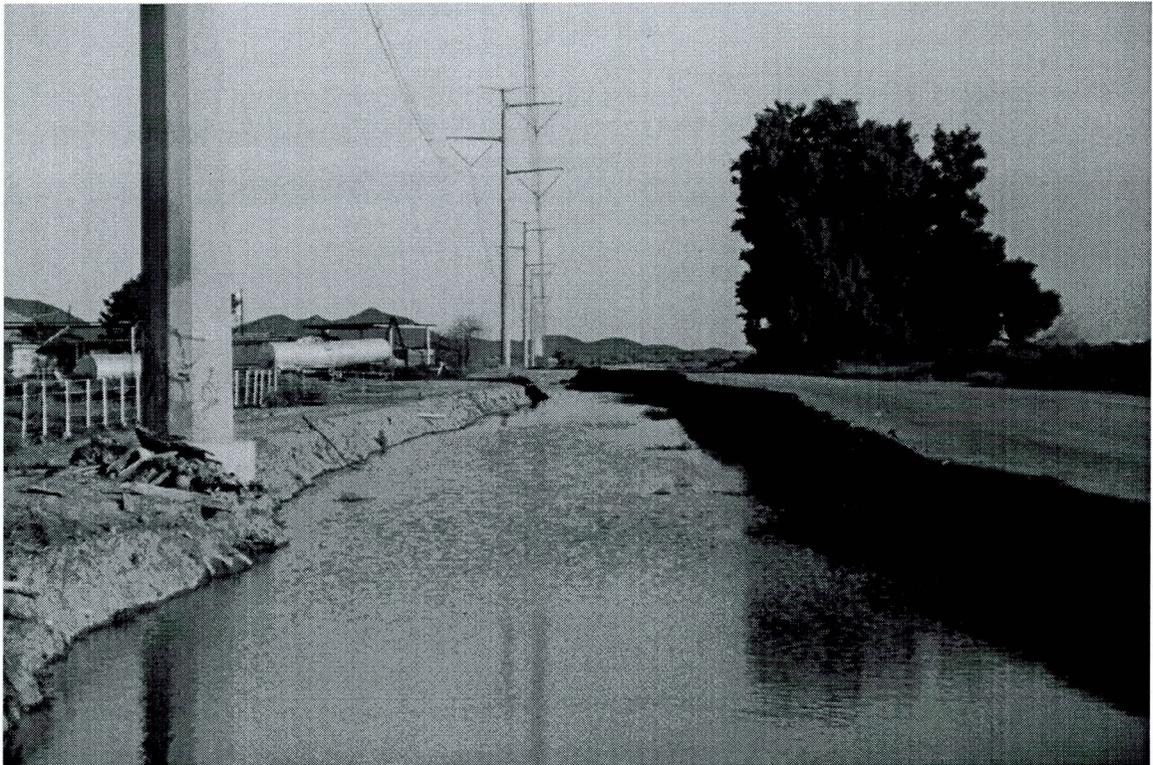
Field survey indicated that the Maricopa Drain remains an unlined, earthen channel (Photographs 13 and 14). The drain has been cleaned and maintained, more intensively since the 1970s than during its original half century of use, and a few modifications have been made over the years, such as adding a check structure in the 1980s. Review of the 7.5-minute USGS quadrangle and aerial photos provided by FCDMC identified a linear feature in the E1/2 of Section 33, T1N,

Photograph 14: Maricopa Drain Southwest of the Webster House (view to the southeast)
