# 500' SWATH/INTERSECTION DRAINAGE PLAN

ARIZONA CANAL DIVERSION CHANNEL  
AREA DRAINAGE MASTER STUDY

DRAINAGE INVENTORY & ANALYSIS

JULY 23, 1993

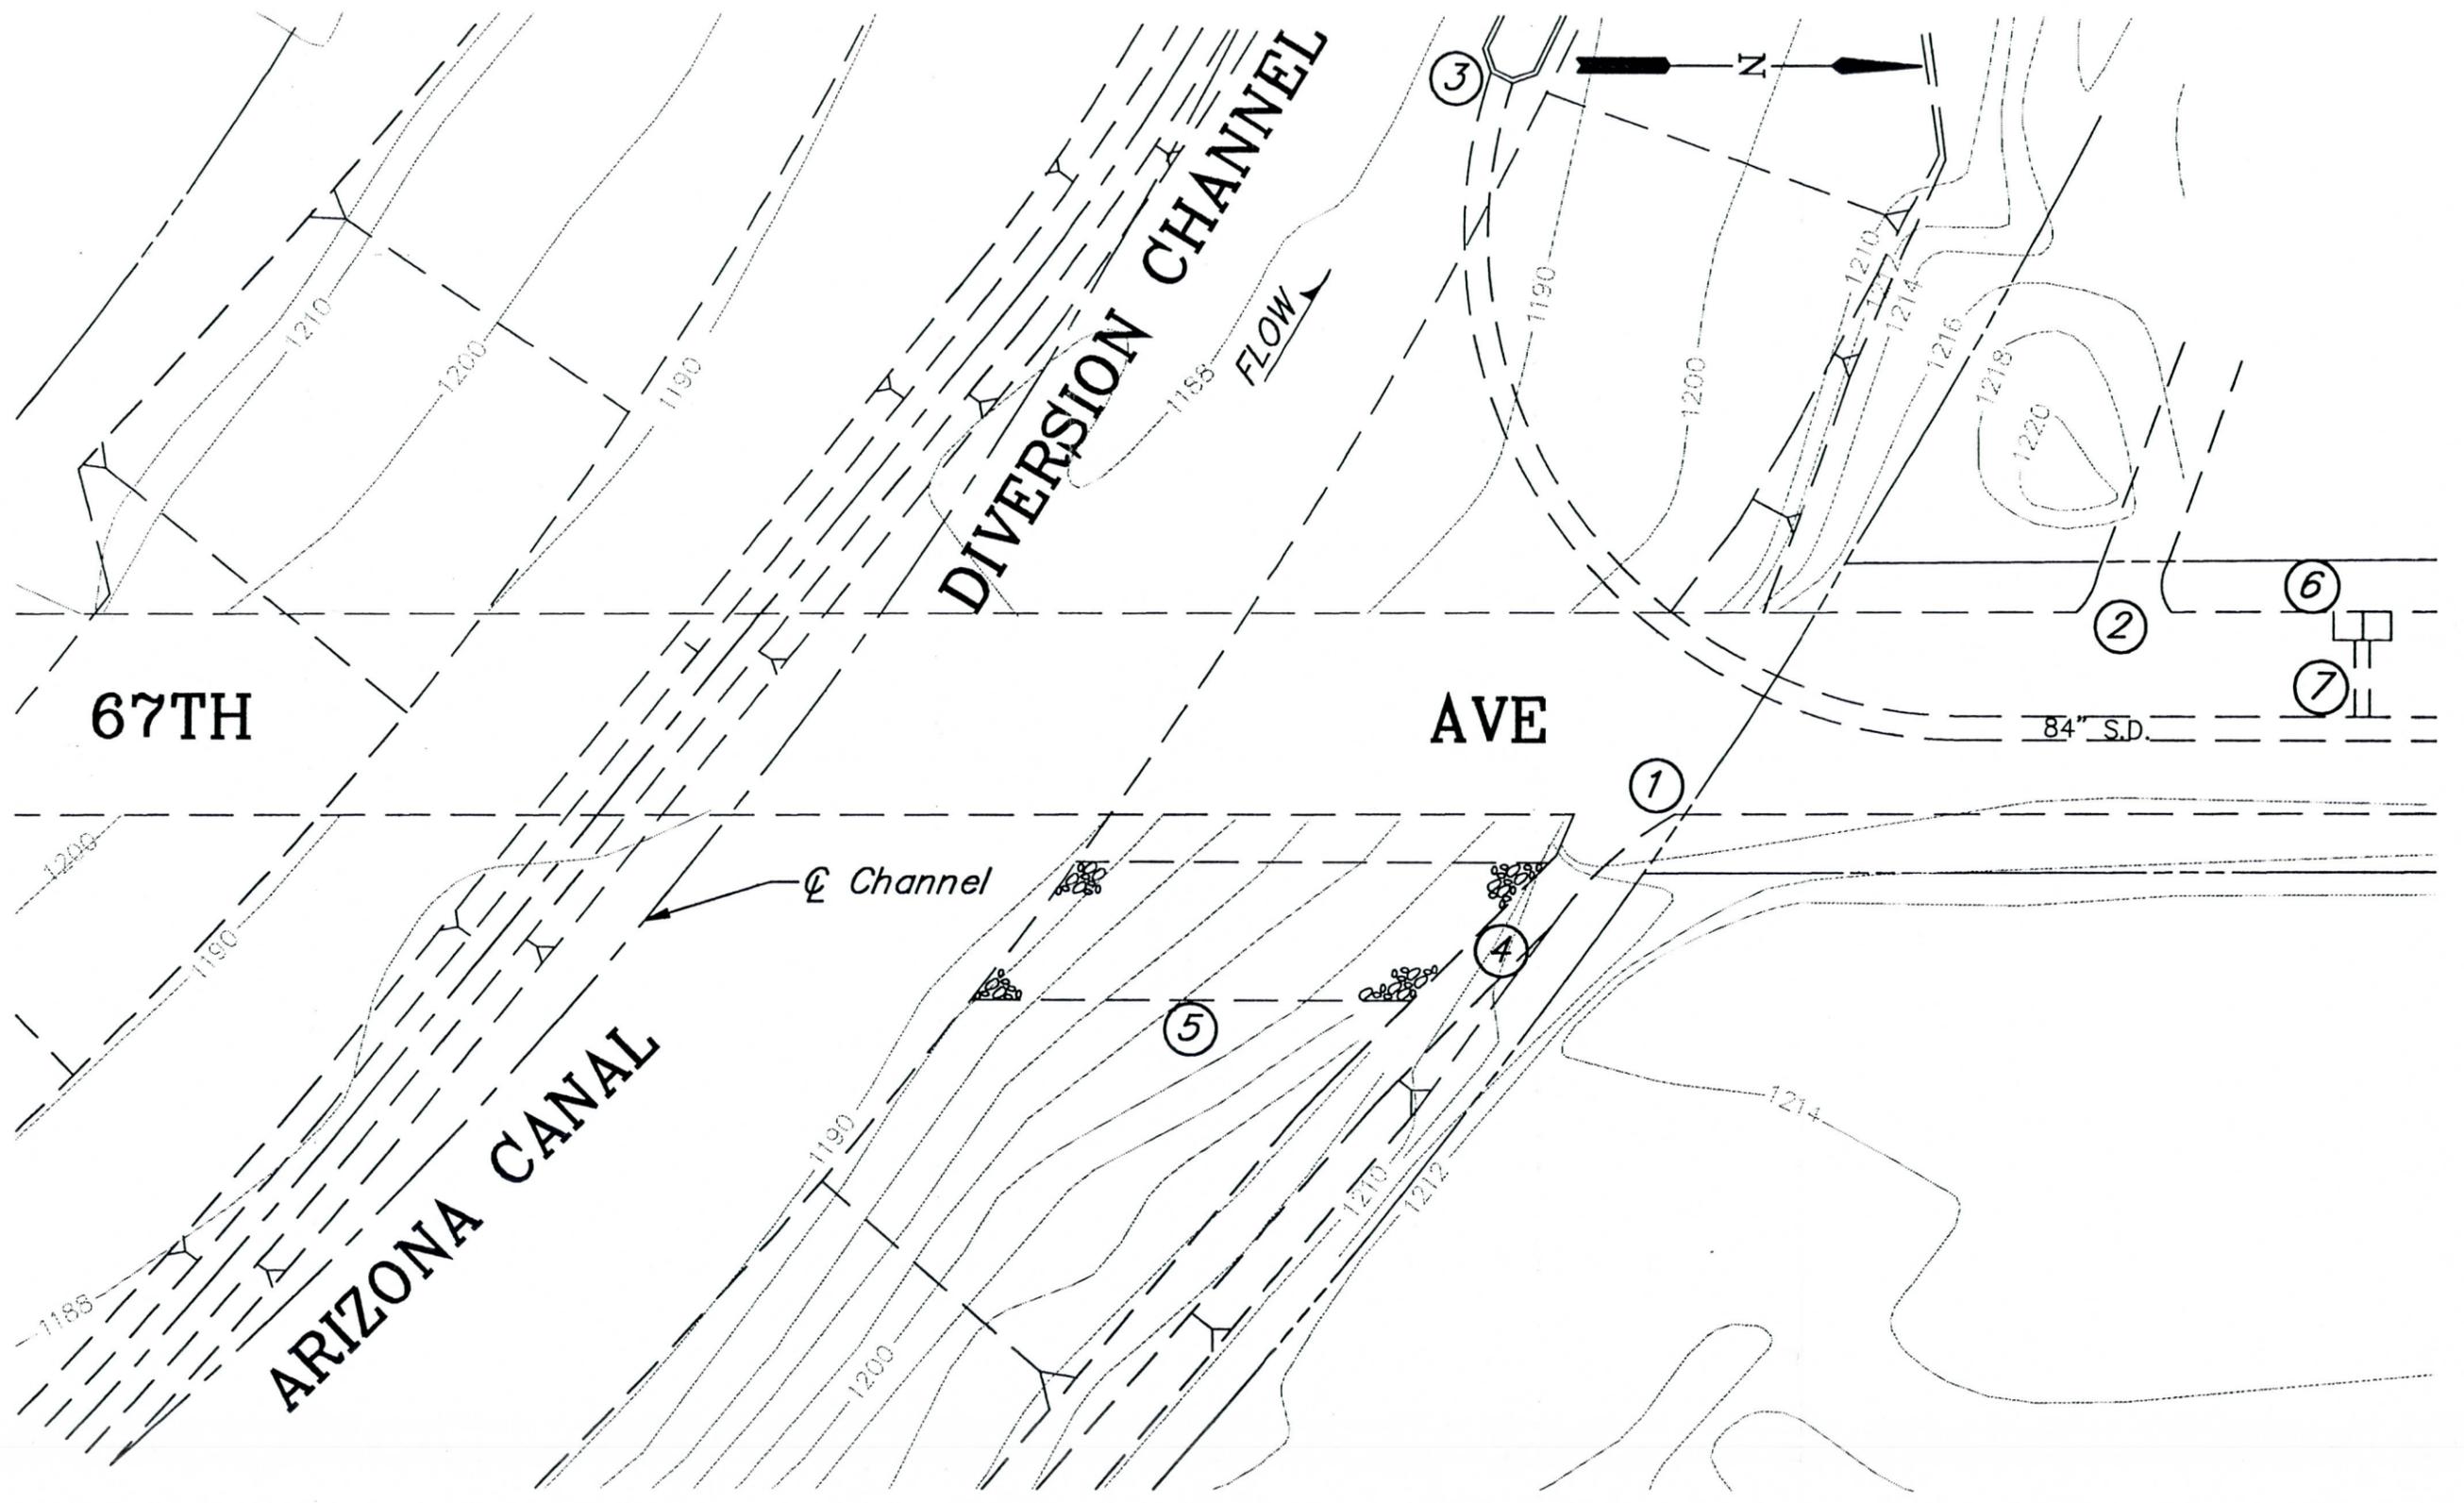
The intersection of 67th Avenue with the ACDC is located approximately a quarter mile south of 67th Avenue's intersection with Greenway Road. The concentration points for this analysis are located north from the ACDC centerline. Point 1 is 300 feet for the east side and Point 2 is 350 feet for the west side of 67th Avenue (See Exhibit 1).

The concentration points are impacted by storm water runoff from the north conveyed within 67th Avenue which consists of a crowned roadway section without curb and gutter. The existing roadway section conveys the storm water runoff to the ACDC outfall points within the shoulder areas of the roadway prism. The contributing watershed comprises mainly of low-density residential development.

Until this storm drain system is fully implemented, the majority of the storm water runoff will concentrate itself as surface runoff within the shoulder areas of 67th Avenue, as previously described. This runoff is then conveyed to the Concentration Points (Points 1 & 2) at the ACDC intersection with 67th Avenue. Concentration Point 1 conveys the storm water runoff from the 67th Avenue shoulder area down the ACDC concrete sidewalk (Point 4) to a grouted riprap spillway (Point 5). This system adequately conveys runoff to the ACDC except for the area where runoff is conveyed down the sidewalk (Point 4). The runoff cannot be confined within the limits of the sidewalk and therefore erodes the natural ground and landscaping that borders the sidewalk. This creates a continual maintenance problem.

The storm water runoff concentrated at Point 2 is conveyed into the ACDC via the conveyance described for concentration Point 1. Runoff contributing to Point 2 ponds until it overtops the roadway crown of 67th Avenue and is conveyed into the ACDC by the concrete sidewalk (Point 4) and the grouted riprap spillway (Point 5). This conveyance works well except for the fact that the storm water runoff from Point 2 is crossing 67th Avenue. In addition, for smaller runoff events or the tail end of larger storms, nuisance ponding will occur at Point 2 when headwaters can no longer overtop the 67th Avenue roadway crown.

To eliminate the erosion adjacent to the sidewalk (Point 4) for Concentration Point 1, the sidewalk would have to be expanded and bordered with monolithic curb on the north side. This would simulate a spillway containing the runoff within the sidewalk areas. To eliminate the ponding at Concentration Point 2 and to reduce the storm water runoff crossing 67th Avenue to Point 1, a double catch basin would have to be constructed at this low point (Point 6) and a connector pipe constructed to tie into the existing 84" storm drain (Point 7).

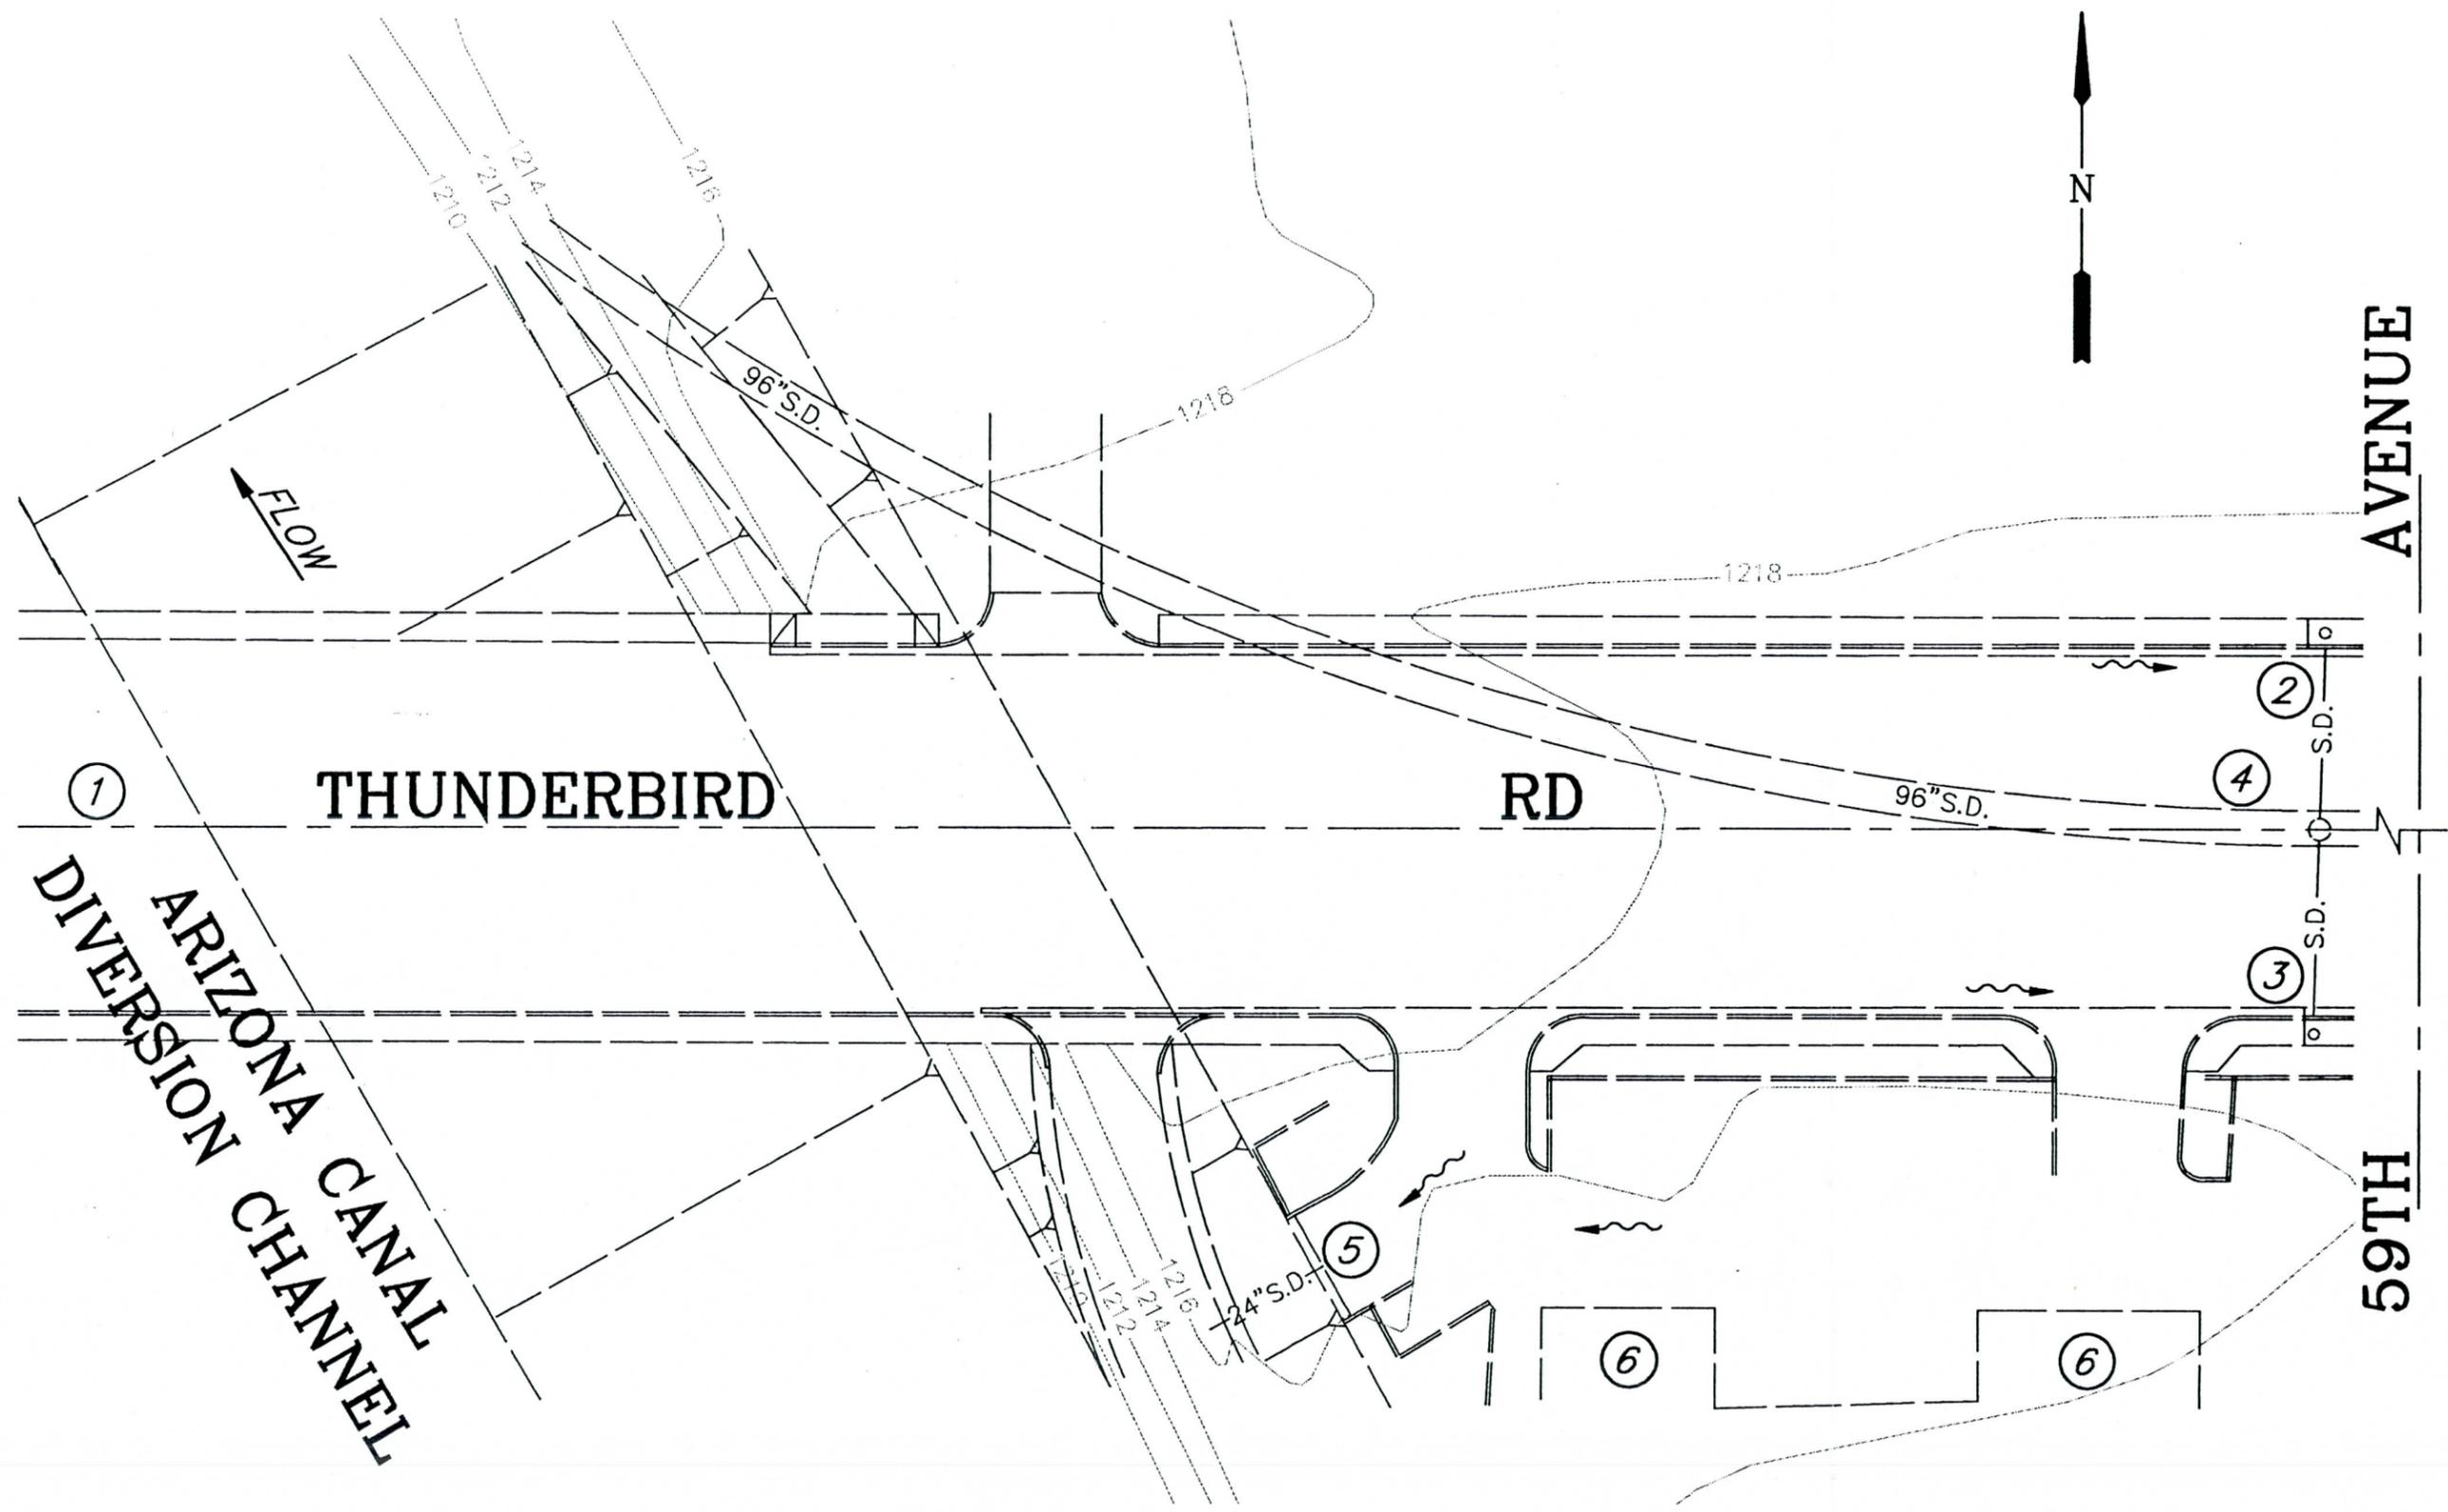
The intersection of Thunderbird Road with the ACDC is located west of Thunderbird Road's intersection with 59th Avenue (Point 1). The concentration point is the low point in Thunderbird Road located approximately 250 feet east of the ACDC. At this low point there are two existing curb-opening inlets (Points 2 & 3). These inlets are impacted by storm water runoff from the east conveyed in Thunderbird Road.

The storm water runoff conveyed in Thunderbird Road is intercepted by a storm drain system and conveyed into the ACDC via a 96" diameter storm drain pipe (Point 4). The intercepted runoff from the two curb-opening inlets in the sump condition (Points 2 & 3) are also conveyed into the ACDC via the Thunderbird Road storm drain pipe.

If the existing inlets are deluged by debris, their efficiency is reduced and the overflow storm water runoff is then conveyed into the ACDC by a spillway with a 24" diameter pipe culvert (Point 5). This combination spillway and pipe culvert is located at the southeast corner of the intersection of the ACDC with Thunderbird Road and functions both as an outlet for the adjacent commercial business (Point 6) and overflow spillway for Thunderbird Road.

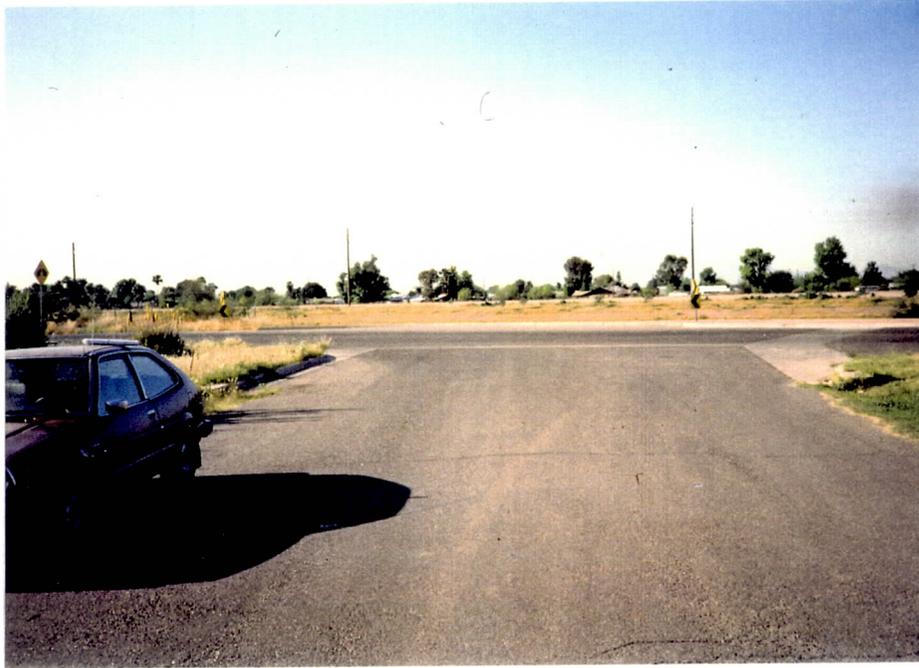
**Picture #1**

This analysis incorporates the intersection of Greenway Road with 70th and 71st Avenues. The existing condition illustrates storm water runoff flows from the east and the north to a concentration point in 70th Avenue north of its intersection with Greenway Road. At the concentration point there exists two 3.5-foot grate opening inlets (Points 1 & 2 - Picture #1) conveying storm water runoff via a 12-inch diameter pipe to the ACDC. These inlets and the surrounding subdivision are the concentration/low points for the contributing watershed.

Looking South @ the Intersection of Greenway Road with 70th Avenue.

There are two probable solutions to remedy this problem flooding location. The first solution is to construct a 2-foot wide transverse catch basin to extend between the existing catch basins at Points 1 & 2. The new transverse catch basins would be a vane grate inlet to maximize efficiency. For runoff from the north, swales bordering 70th Avenue would be constructed to channelize the water to the transverse catch basin between Points 1 and 2. With the new inlet and its increased hydraulic capacity, the 12-inch diameter connector pipe would be replaced with a 24-inch diameter connector pipe.

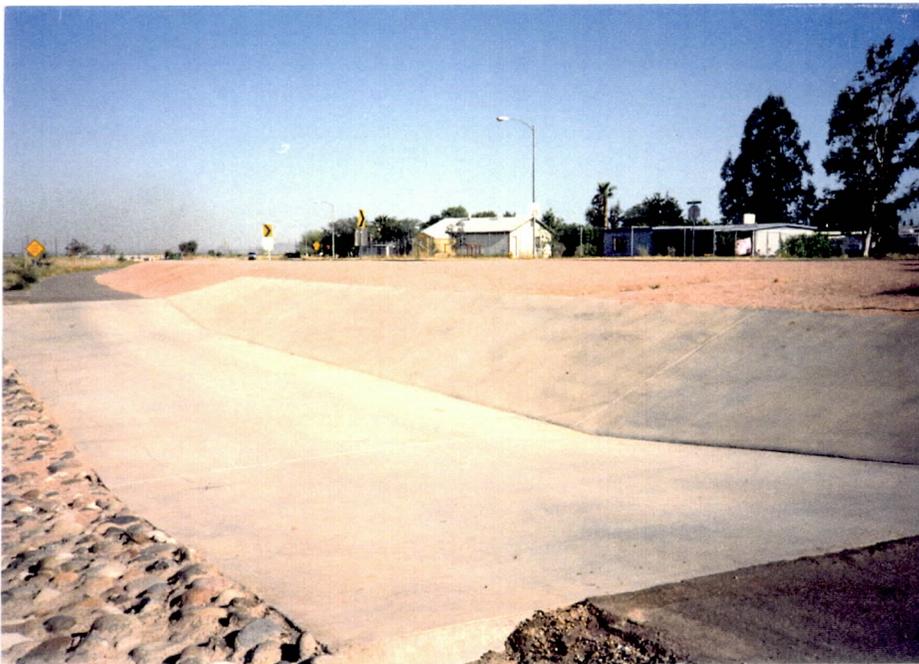
**Picture #2**

Looking West from the ACDC Maintenance Road at the Concrete Spillway Bordering the South Side of Greenway Road.

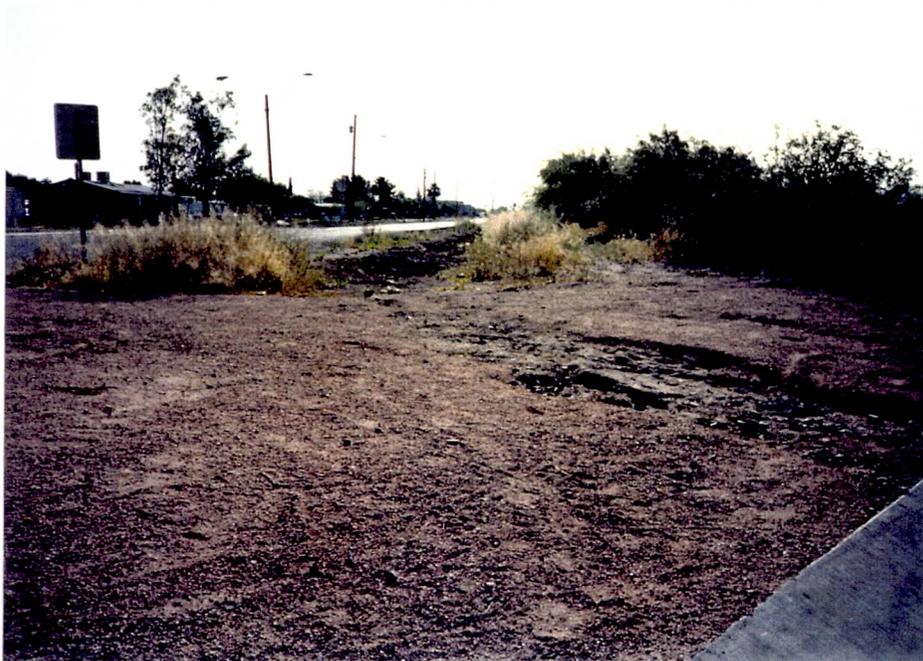
**Picture #3**

Looking East Along South Side of Greenway Road from the Concrete Spillway @ the Intersection of Greenway Road with 70th Avenue.

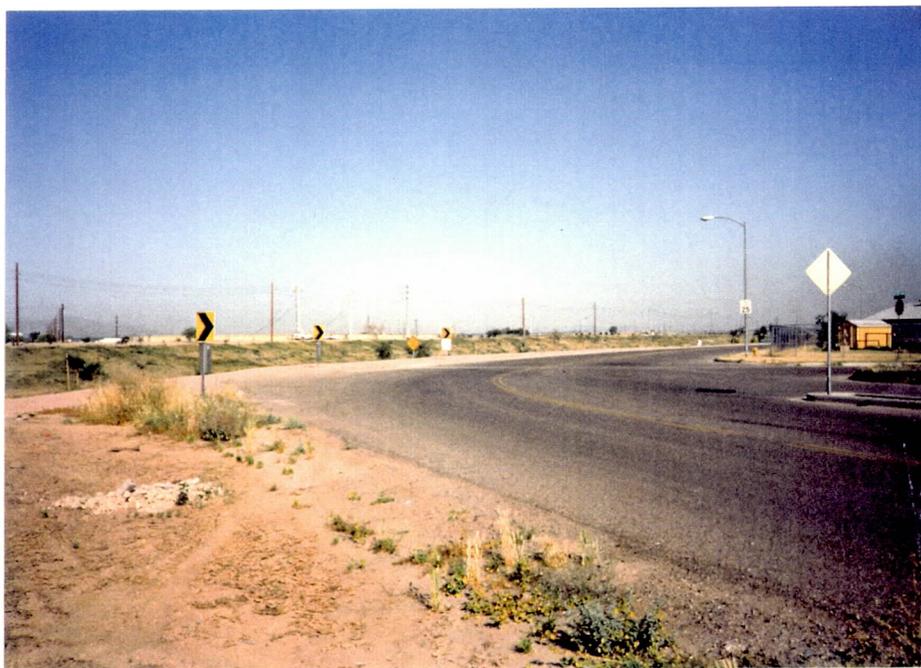
**Picture #4**

Looking West at the superelevation in the Intersection of Greenway Road with 70th Avenue.

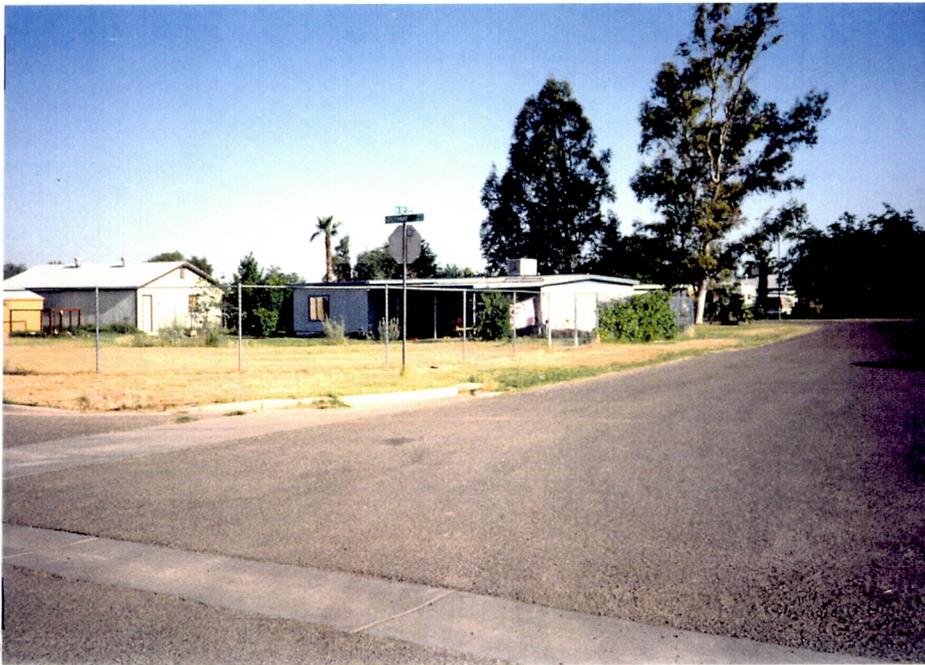
**Picture #5**

Looking Northwest @ the Northwest Corner of the Intersection of Greenway Road with 70th Avenue.

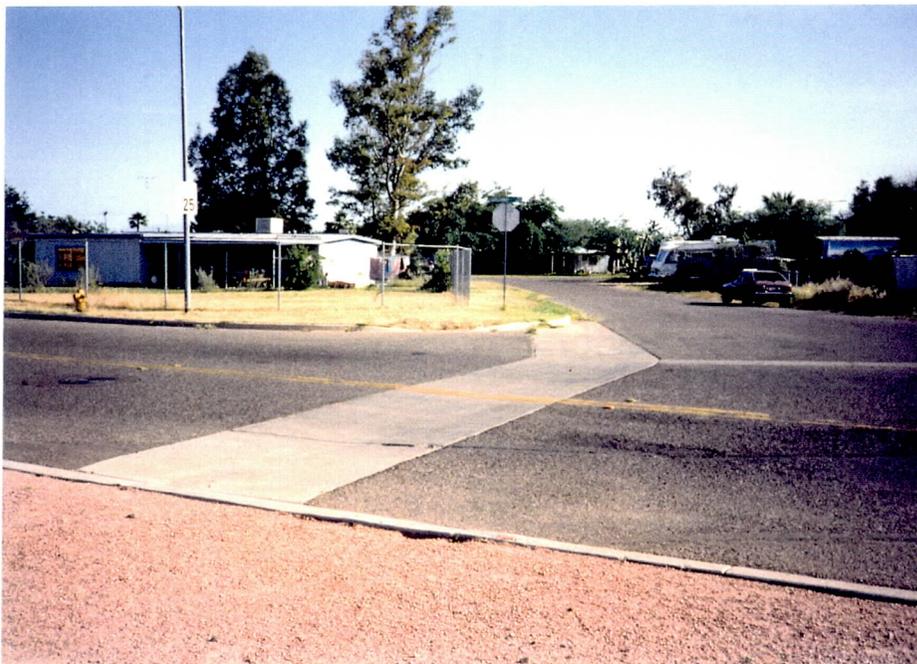
**Picture #6**

Looking North at the Intersection of Greenway Road with 70th Avenue.

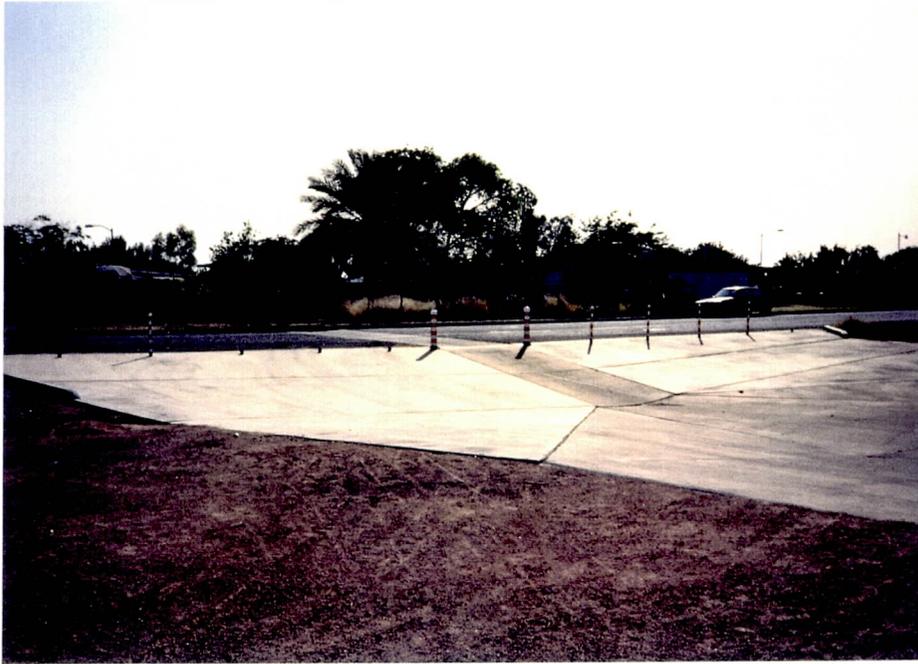
**Picture #7**

Looking Northeast @ the Superelevation and Concrete Spillway at the Intersection of 71st Avenue with Mary Jane Lane.

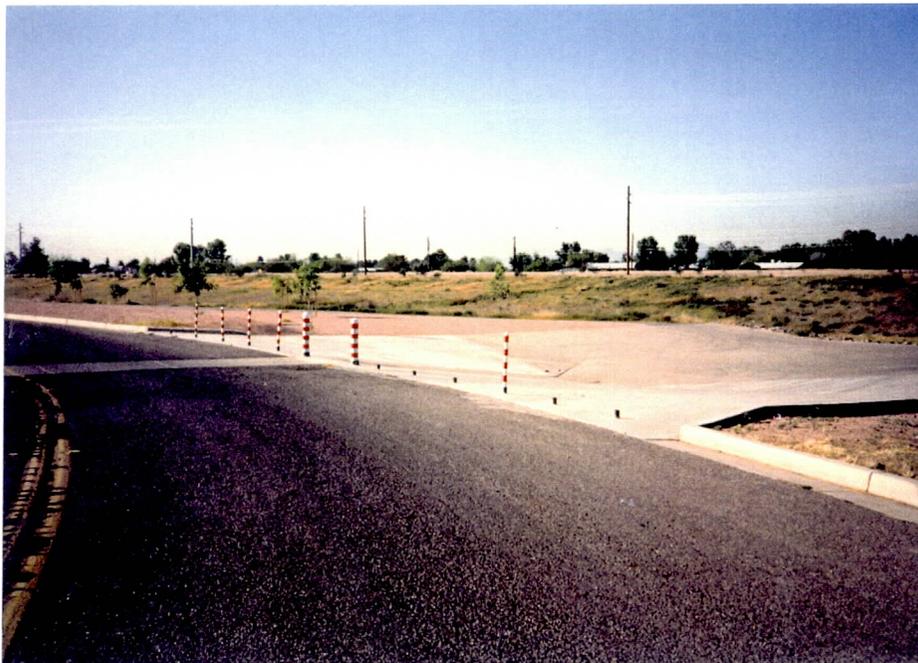
**Picture #8**

Looking South at the Concrete Spillway at the Intersection of 71st Avenue with Mary Jane Lane.

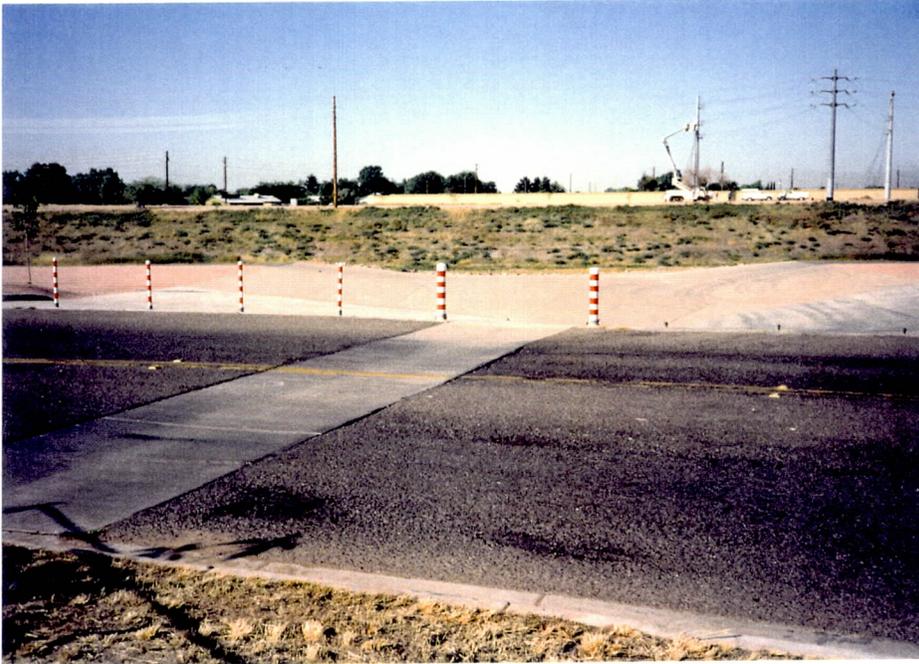
**Picture #9**

Looking Southwest at the Concrete Valley Gutter and Spillway at the Intersection of 71st Avenue with Mary Jane Lane.

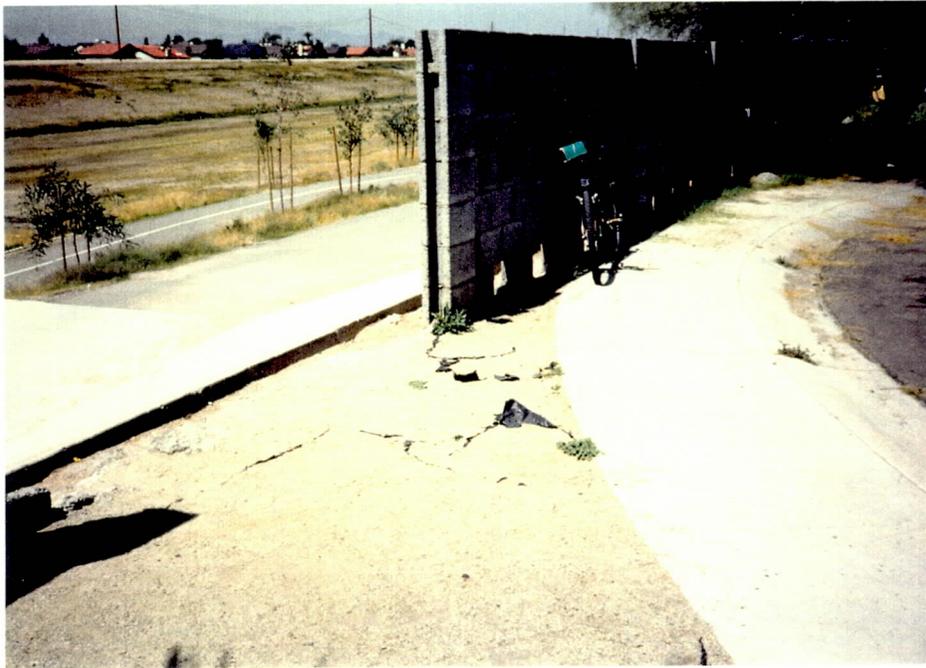
**Picture #10**

Looking West at the Opening in the CMU Wall at the End of the 64th Avenue Cul-De-Sac.

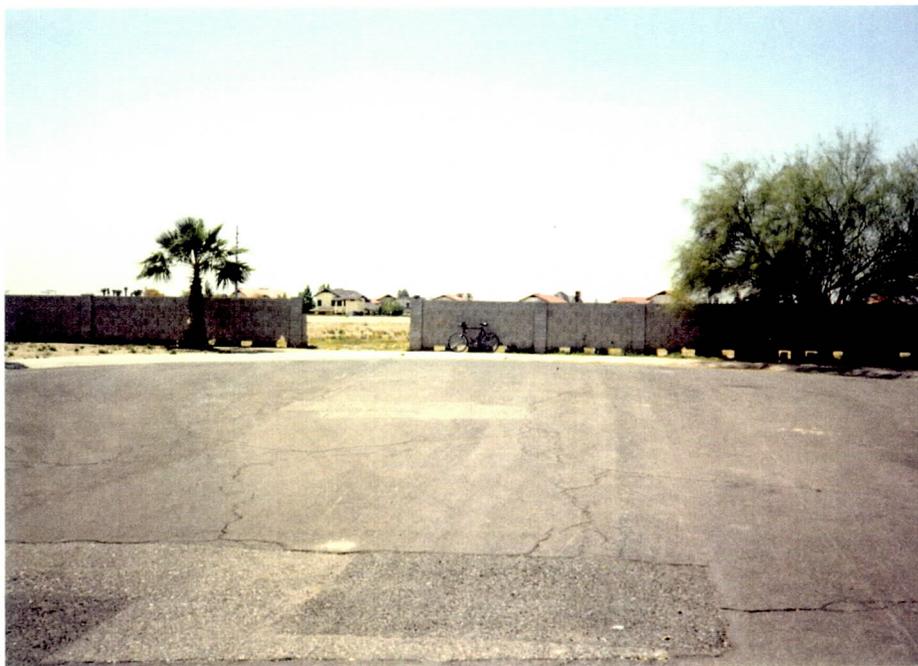
**Picture #11**

Looking South at the Opening in the CMU Wall at the End of the 64th Avenue Cul-De-Sac.

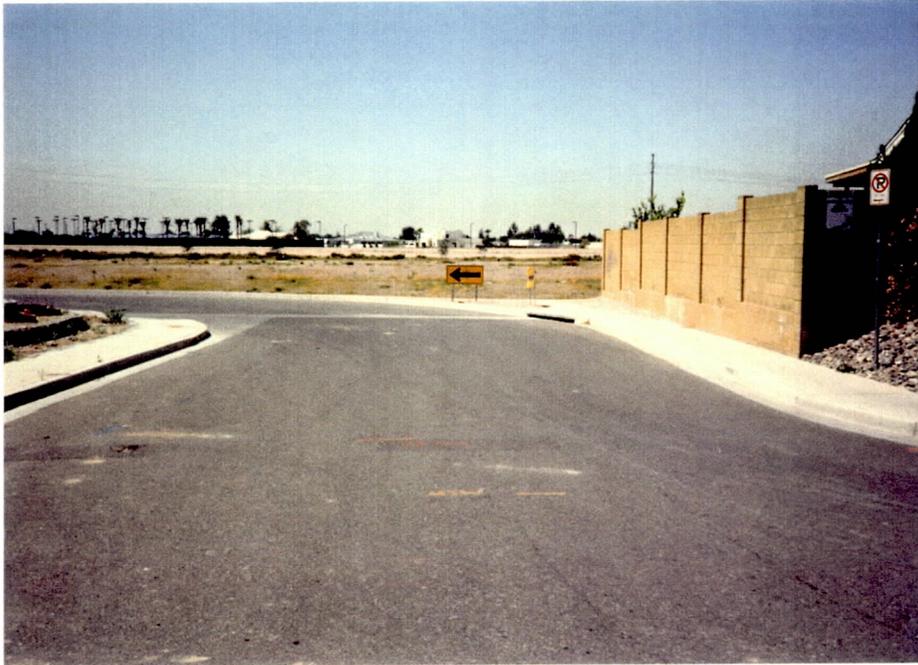
**Picture #12**

A series of inlets at the intersection of Acoma Drive with 62nd Avenue and within Acoma Drive itself, (Points 3 - 14 and Pictures #12 - 15), intercept storm water runoff and convey it to the ACDC via the previously discussed 36" diameter pipe. These curb opening inlets work satisfactorily under normal conditions, but their efficiencies are reduced when deluged with debris.

Looking Southwest at the End of Acoma Drive and its Intersection with Both the ACDC and Hearn Road.

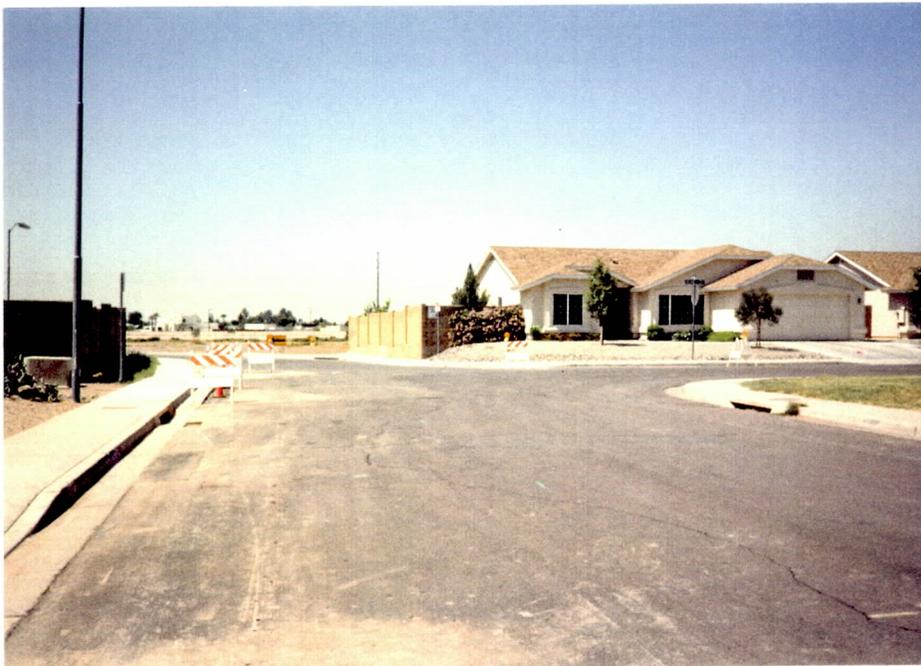
**Picture #13**

Looking Southwest at the End of Acoma Drive from resident described at "Point 15".

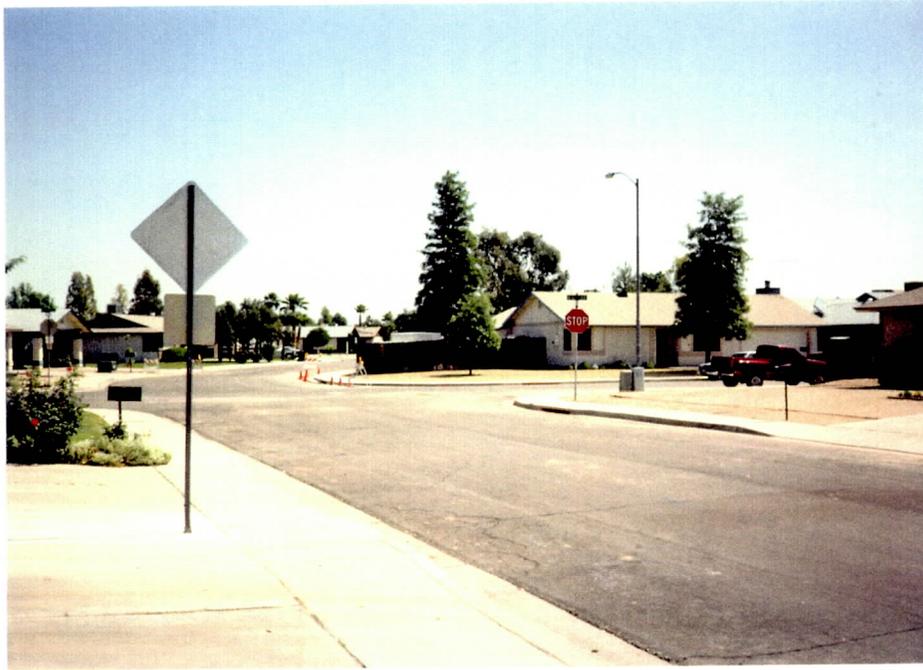
**Picture #14**

Looking Northeast at the Intersection of Acoma Drive with 62nd Avenue.

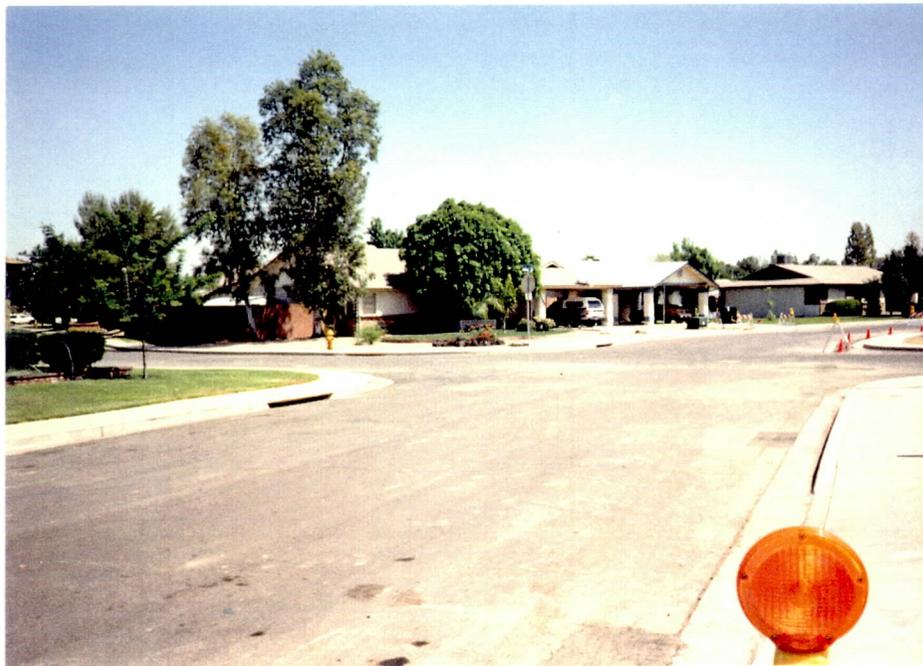
**Picture #15**

Looking Northeast at the Intersection of Acoma Drive with 62nd Avenue from resident described at "Point 15".

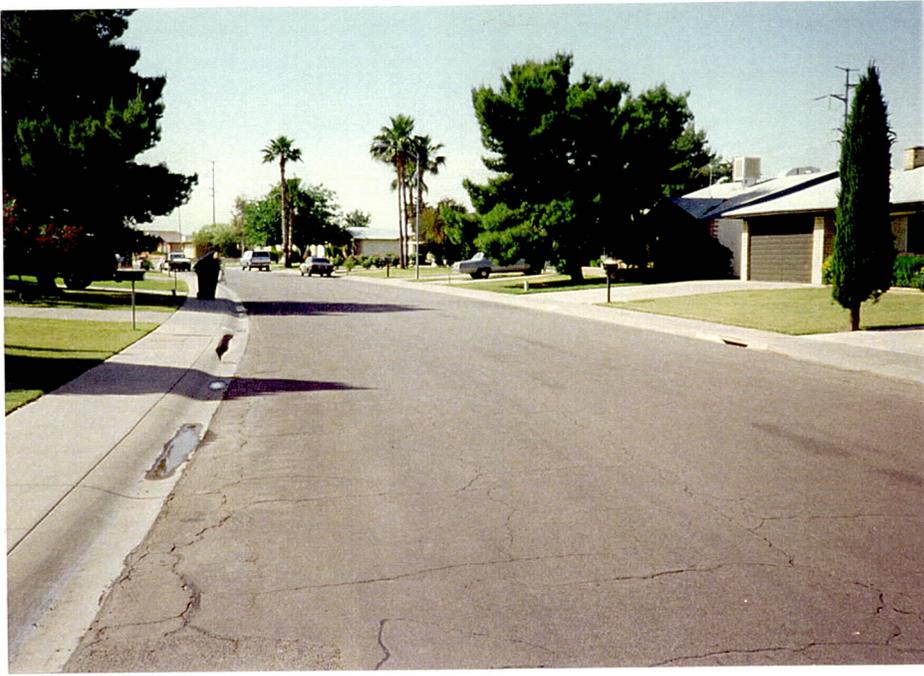
**Picture #16**

The two curb opening inlets are sufficient under normal conditions, but in the event the inlets are deluged with debris, their efficiencies are reduced and overflow storm water runoff occurs. Conditions of recent storms have promoted overflow storm water runoff from these inlets causing flooding within the roadway. The existing inlets (Points 2 & 3) are shown in Picture 16.

Looking South in 49th Drive at the Low Point described as "Points 2 & 3".

As illustrated in the analysis, the existing three foot curb opening inlets (Points 2 & 3) are adequate except in the event the inlets are deluged with debris. Therefore, it is recommended to remove these existing inlets and replace them with combination inlets that have increased capacity and reduced clogging potential. In addition, with the increase in efficiency of the catch basins it may be necessary to increase the existing 12" storm drain pipe to an 18" pipe.

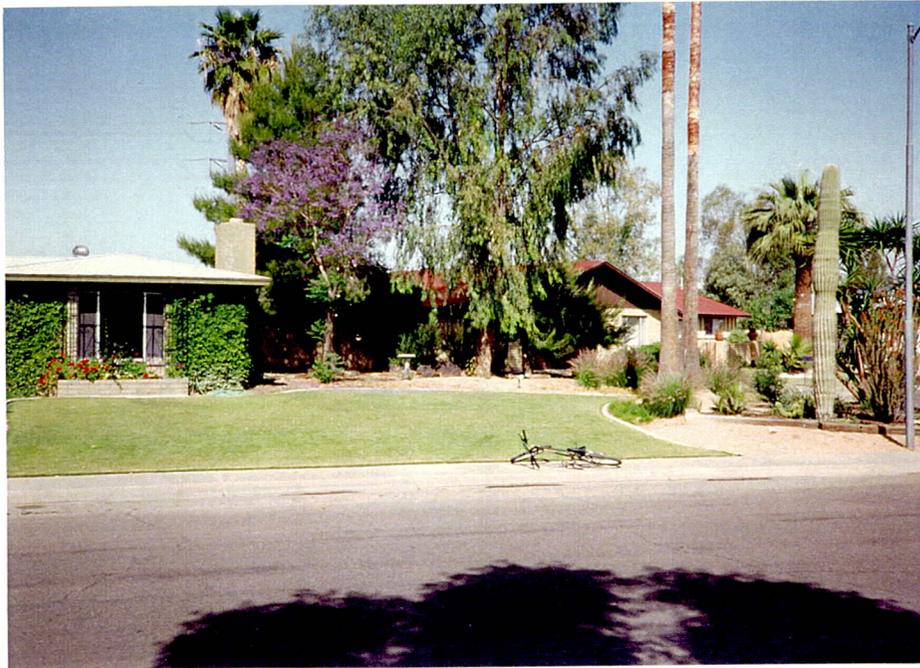
**Picture #17**

Looking West at Resident on West Side of 49th Drive described as "Point 5".

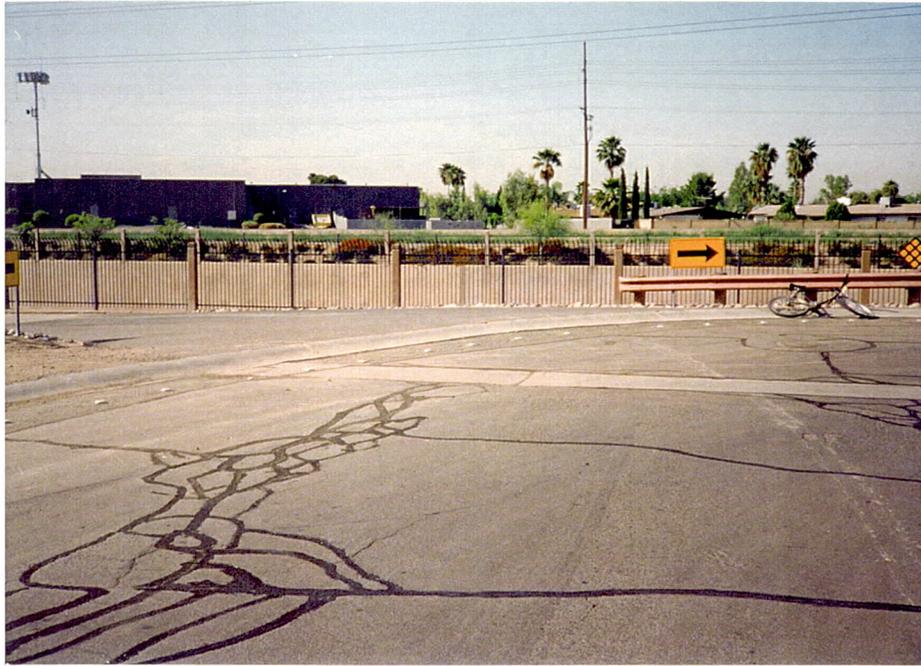
Picture #18

Looking South at the Southeast Corner of the Intersection of 46th Avenue with 44th Lane.

The solution to eliminate the potential for flooding is to remove the roll curb, replace it with ribbon curb and extend the access ramp to the ribbon curb. Essentially by extending the access ramp to the new ribbon curb, the new design would also function as a spillway. This design would eliminate the flooding potential by allowing the storm water runoff to naturally enter the channel. The design would also eliminate any erosion type maintenance by maintaining the runoff within the drainage improvements.

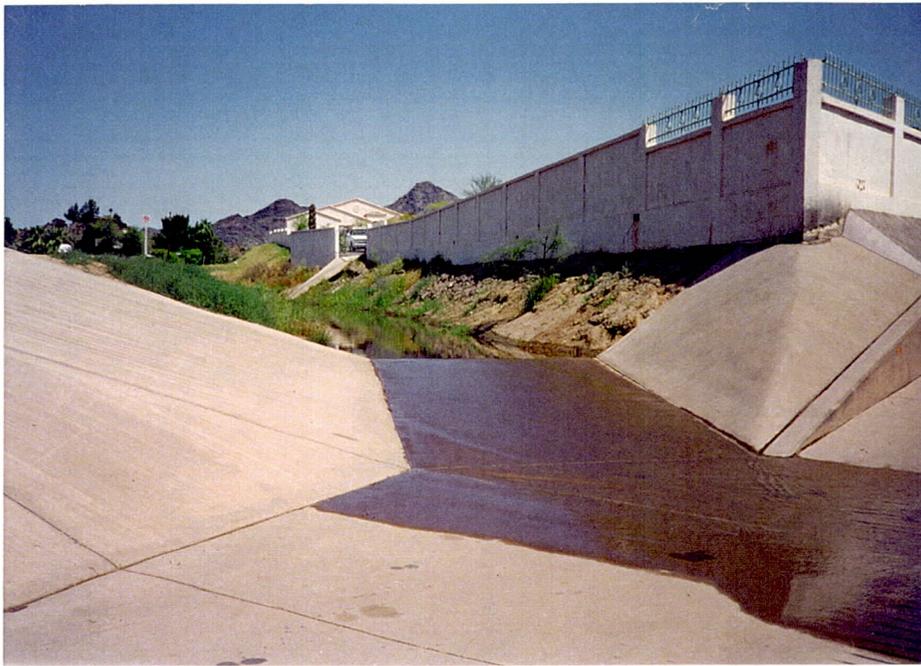
**Picture #19**

This analysis incorporates the intersection of the 10th Street Wash with the ACDC (Point 1) and the intersection of Griswold Road with 9th Street (Point 2). Existing drainage conditions illustrate that the intersection of 9th Street and Griswold Road (Point 2) is a concentration point for the contributing subdivision, specifically 9th Street. Upon construction of the ACDC, an extensive spillway was implemented at the 10th Street Wash outfall into the ACDC as shown in Picture 19. To construct the spillway, the northern bank (Point 3) of the 10th Street Wash was improved to provide a consistent channel section thereby improving the hydraulic performance of the wash. However, when the bank improvements were completed, the top of bank elevation was higher than the adjacent street elevations at the intersection of Griswold Avenue with 9th Street (Point 2). Picture 20 taken at the intersection of 9th Street with Griswold Road (Point 2) looking towards the ACDC and the 10th Street Wash outfall, vividly depicts the elevation differences between the top of bank and the intersection pavement elevations. An existing 18" diameter CMP inlet structure and pipe (Point 4) located at the end of Griswold Road intercepts and conveys the storm water runoff to the 10th Street Wash. However, if the inlet is deluged with debris, its efficiency is reduced and overflow runoff begins to pond.

Looking East at the 10th Street Wash Concrete Outfall Spillway into the ACDC.

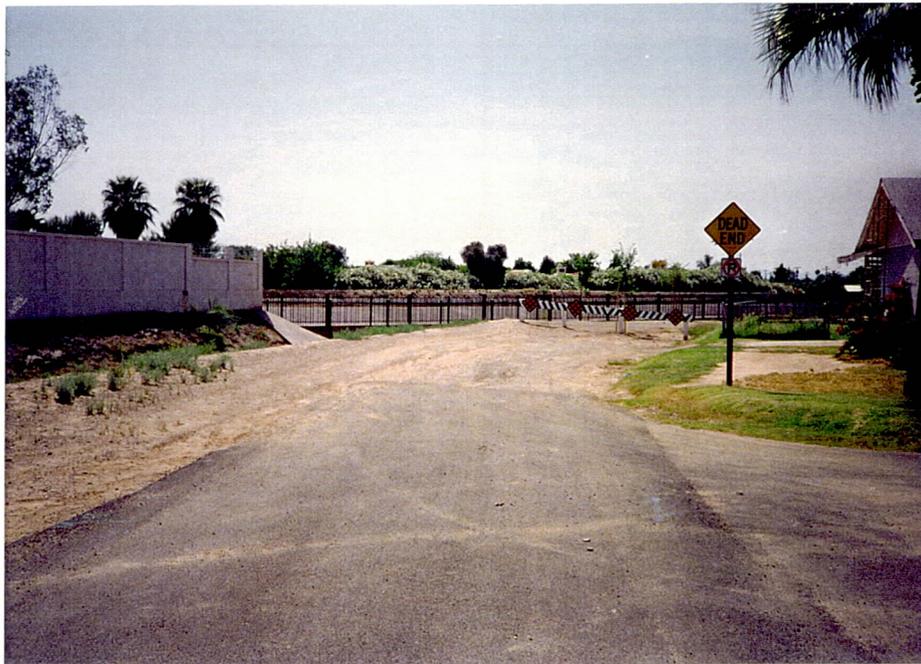
**Picture #20**

A homeowner adjacent to 9th Street (Point 5) discussed in an interview conducted on April 23, 1992, that during sizeable storm events the intersection of 9th Street and Griswold Road (Point 2) experiences significant flooding. The storm water runoff from the subdivision ponds in the intersection until at some point the runoff can overtop the earthen bank of the 10th Street Wash. This may cause flooding of the adjacent homes and significant scour of the 10th Street Wash channel banks.

Looking West at the 10th Street Wash Outfall into the ACDC and at the End of Griswold Road. Taken from the Intersection of Griswold Road with 9th Street.
