# 500' SWATH/INTERSECTION DRAINAGE PLAN

ARIZONA CANAL DIVERSION CHANNEL  
AREA DRAINAGE MASTER STUDY

DRAINAGE INVENTORY & ANALYSIS

JULY 23, 1993

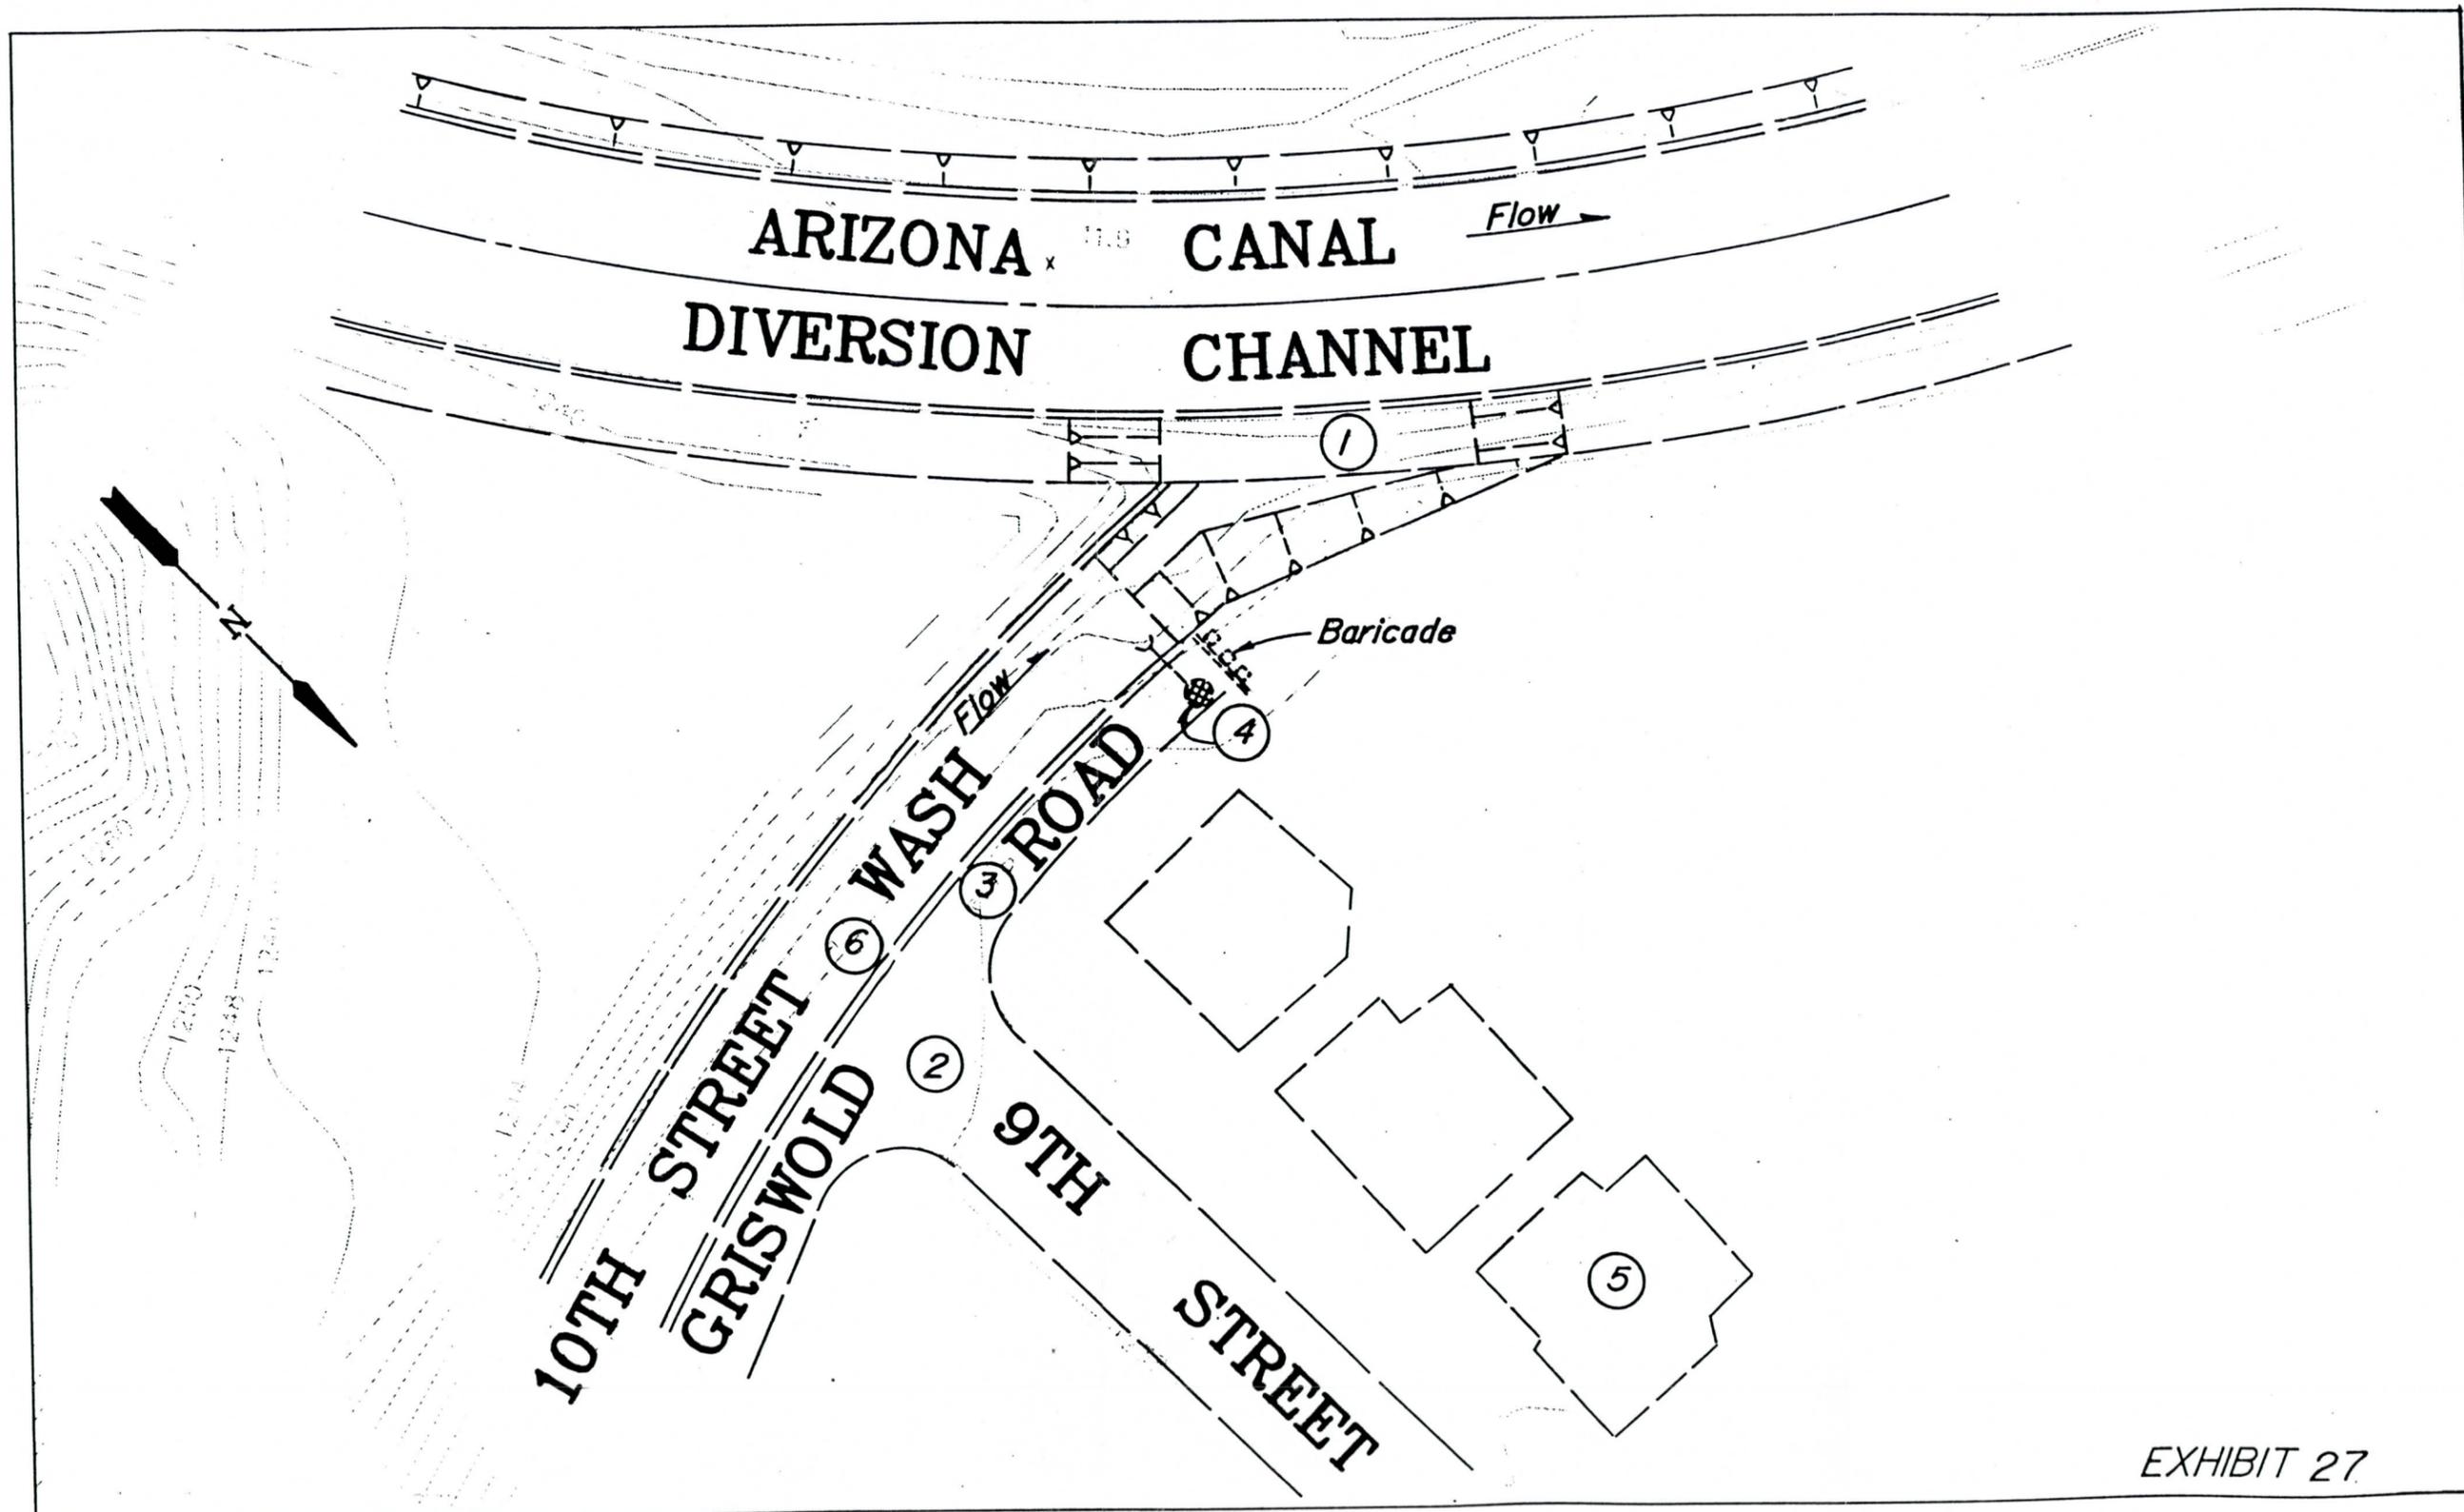
**Picture #20**

This analysis incorporates the intersection of the 10th Street Wash with the ACDC (Point 1) and the intersection of Griswold Road with 9th Street (Point 2). Existing drainage conditions illustrate that the intersection of 9th Street and Griswold Road (Point 2) is a concentration point for the contributing subdivision, specifically 9th Street. Upon construction of the ACDC, an extensive spillway was implemented at the 10th Street Wash outfall into the ACDC as shown in Picture 19. To construct the spillway, the northern bank (Point 3) of the 10th Street Wash was improved to provide a consistent channel section thereby improving the hydraulic performance of the wash. However, when the bank improvements were completed, the top of bank elevation was higher than the adjacent street elevations at the intersection of Griswold Avenue with 9th Street (Point 2). Picture 20 taken at the intersection of 9th Street with Griswold Road (Point 2) looking towards the ACDC and the 10th Street Wash outfall, vividly depicts the elevation differences between the top of bank and the intersection pavement elevations. An existing 18" diameter CMP inlet structure and pipe (Point 4) located at the end of Griswold Road intercepts and conveys the storm water runoff to the 10th Street Wash. However, if the inlet is deluged with debris, its efficiency is reduced and overflow runoff begins to pond.

Looking West at the 10th Street Wash Outfall into the ACDC and at the End of Griswold Road. Taken from the Intersection of Griswold Road with 9th Street.

There are two probable solutions to remedy this problem flooding. The first solution to resolve the potential flooding at the intersection of 9th Street with Griswold Road is to reverse the elevation differences between the intersection pavement and the 10th Street Wash top of bank. This entails a small area of pavement reconstruction shown in Picture #20 to provide a positive drain from the northwest curb return to the wash. In addition, to eliminate erosion of the wash bank, a concrete spillway from the roadway edge of pavement into the 10th Street Wash (Point 6) should also be constructed to utilize a controlled outfall point. The second solution would be to replace the existing inlet at Point 4 with a double area drain.
