**HISTORICAL RECORDS REVIEW  
MARICOPA COUNTY SHERIFF'S SHOOTING RANGE  
NEAR MCMICKEN DAM  
SURPRISE, ARIZONA  
CONTRACT FCD 2004C029  
WORK ASSIGNMENT NO. 3**

January 24, 2006  
Project No. 600996003

Subject: Historical Records Review  
Maricopa County Sheriff's Shooting Range  
Near McMicken Dam  
Contract FCD 2004C029  
Work Assignment No. 3

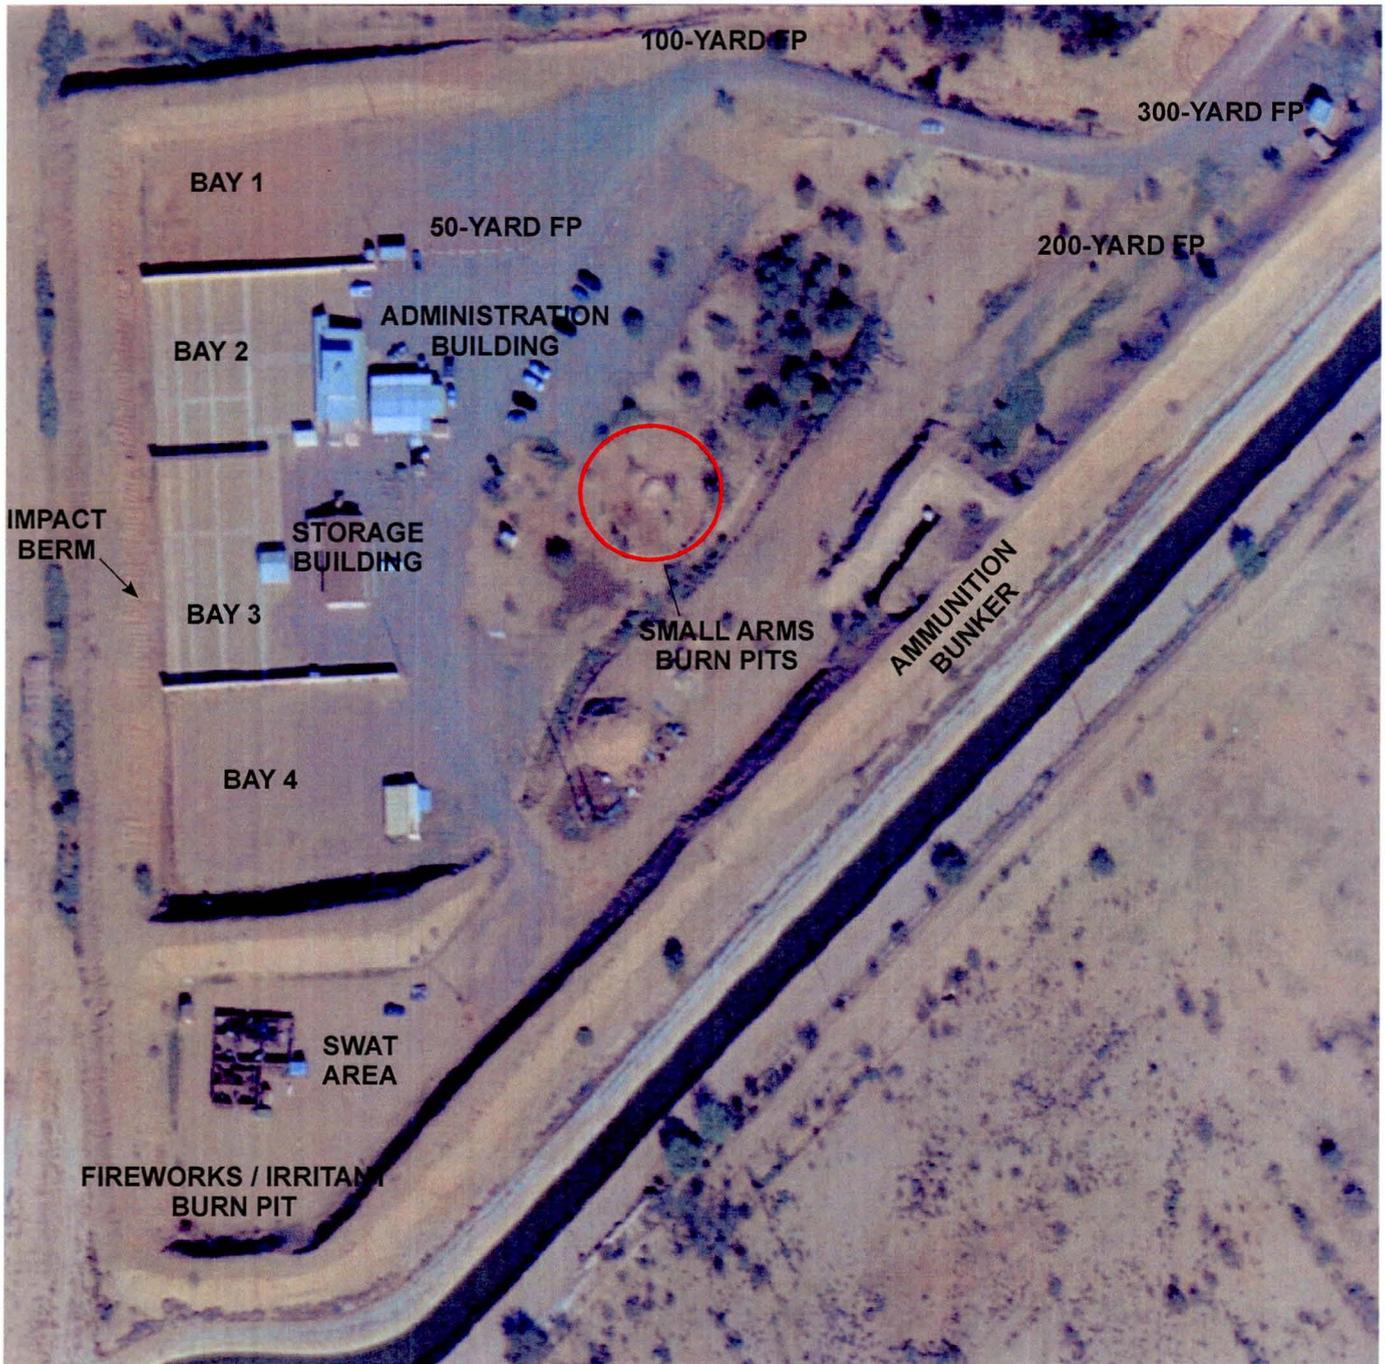
SITE LAYOUT MAP

The site contains several features of concern as noted in the site reconnaissance, the Phase I ESA, and during the interviews. The current shooting range configuration consists of five bays. Bay 1 is used as a rifle range, Bay 2, Bay 3, and Bay 4 are used for pistol and shotgun range training, and Bay 5 is used for SWAT training. In addition, there are open burning treatment units and an ammunition storage area. The layout of the areas of concern is presented in Figure 2. The detailed review of the use for each particular area of concern is included below.

Bay 1 is a rifle firing range located in the along the northern side of the Sheriff's Range complex. The bay is partially surrounded by impact berms constructed of earthen materials to the west and north, and a block wall separates Bay 1 from Bay 2 to the south. The impact berms form the western and northern boundary of the range. The target or impact area is in the western portion of the bay, in front of the impact berm.

Bay 1 contains firing positions at distances of 50, 100, 200, and 300 yards. Each firing position is reportedly a fixed location and no other firing points are procedurally used.

Bay 2 is used as a handgun range located in the western central portion of the Sheriff's Range complex, south of Bay 1 and adjacent on the east to the administration building. The bay is partially surrounded by impact berms constructed of earthen materials, and block walls to the north and south separate Bay 2 from Bays 1 and 3. The impact berms form the western boundary of the range. The target or impact area is in the western portion of the bay, in front of the impact berm. The floor of the bay is compacted stabilized soil, with concrete walkways.

Bay 3 is used as a handgun range located in the western central portion of the Sheriff's Range complex south of Bay 2, adjacent on the east to the storage building. The bay is partially surrounded to the west and south by impact berms constructed of earthen materials, and block walls to the north and south separate Bay 3 from Bays 2 and 4. The impact berms form the western boundary of the range. The target or impact area is in the western portion of the bay, in front of the impact berm. The floor of the bay is compacted stabilized soil, with concrete walkways.

Bay 4 is used as a shotgun range located in the western central portion of the Sheriff's Range complex south of Bay 3. The bay is partially surrounded on the north, south, and west by impact berms constructed of earthen materials. The impact berms form the western boundary of the range. The target or impact area is generally in the western portion of the bay, in front of the impact berm; however, targets may be placed randomly during practical shooting, with fire towards the impact berm. The floor of the bay is compacted soil.

The SWAT Area is located in the south-western portion of the Sheriff's Range complex south of Bay 4. The SWAT Area is partially surrounded by impact berms constructed of earthen materials on the west, north, and south sides. The impact berms form the western and southern boundary of the range.

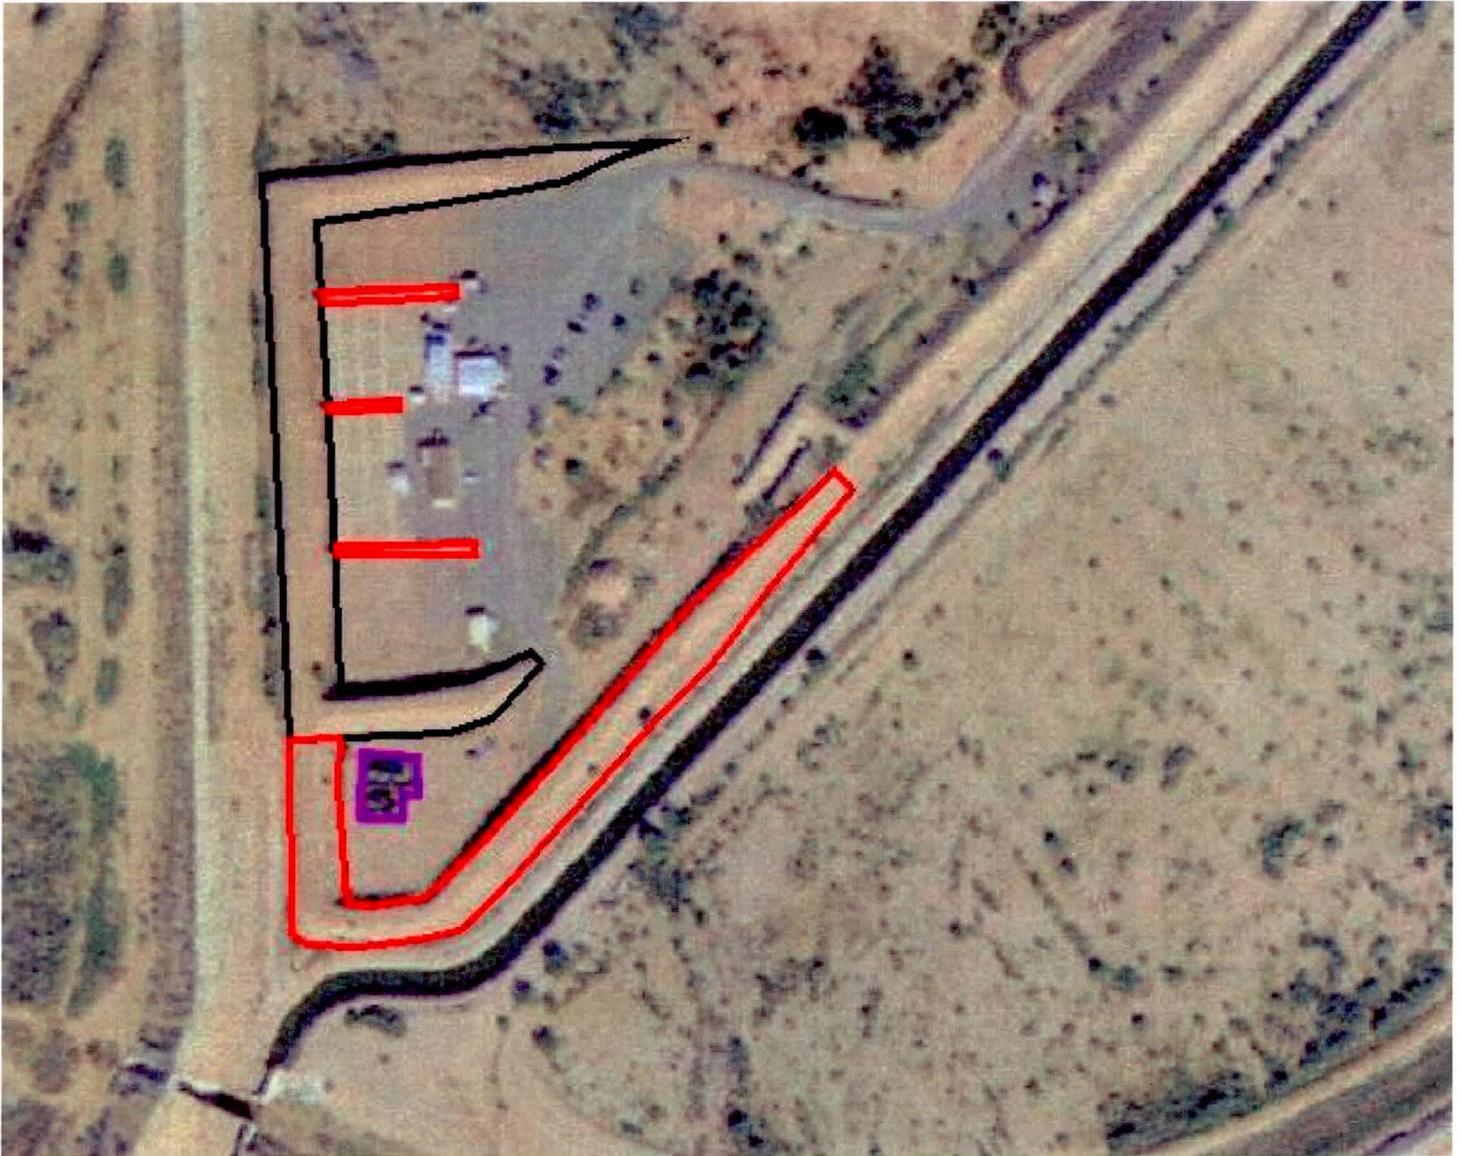
SITE PLAN AND  
VICINITY MAP

*1977* – The shooting range does not exist at this time. There are no surface disturbances noted aside from existing flood control structures. No area of stained soil were noted.

*1988 First Quarter* – The shooting range has been developed as a large C-shaped bay. This large open shooting range encompasses Bays 1 through 4. The SWAT Area has not been developed at this time. No areas of soil staining were noted.

*1994 Third Quarter* – Three lateral berms have been developed separating the individual bays from each other. The SWAT Area south of the original shooting range has also been developed.

*1995 Second Quarter* – Shooting range features are similar to present day features. Four shooting bays are located to the north and the SWAT Area to the south. The building structures in the SWAT Area have been constructed by this time.
