GRANITE REEF WASH

FLOOD DELINEATION STUDY

ESTIMATION OF MANNING'S N VALUE

FCD CONTRACT NO. 95-<sup>29</sup>~~05~~

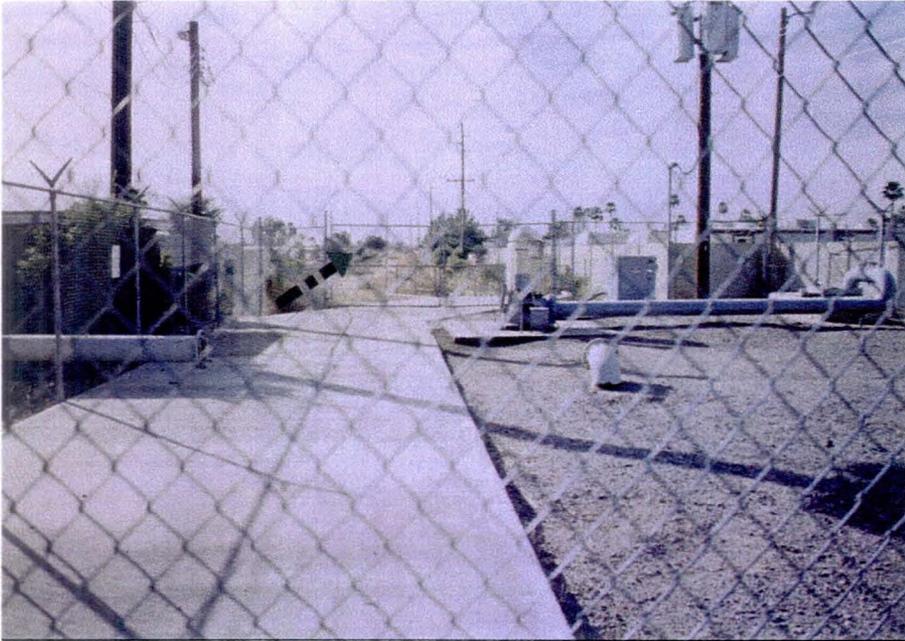
Picture No. 2

Water well at upstream end of reach

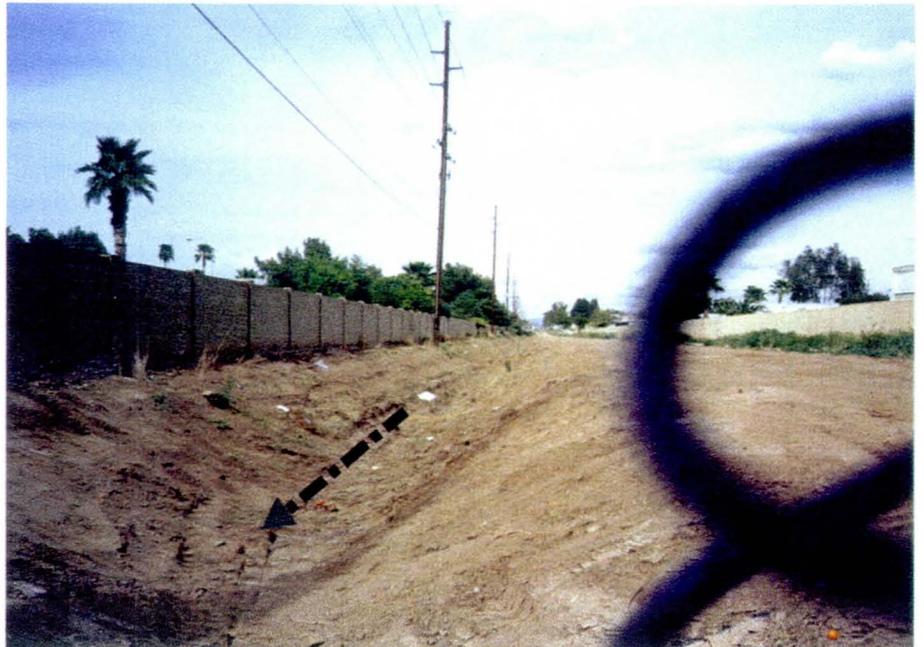
Picture No. 1

Upstream from McKellips Road

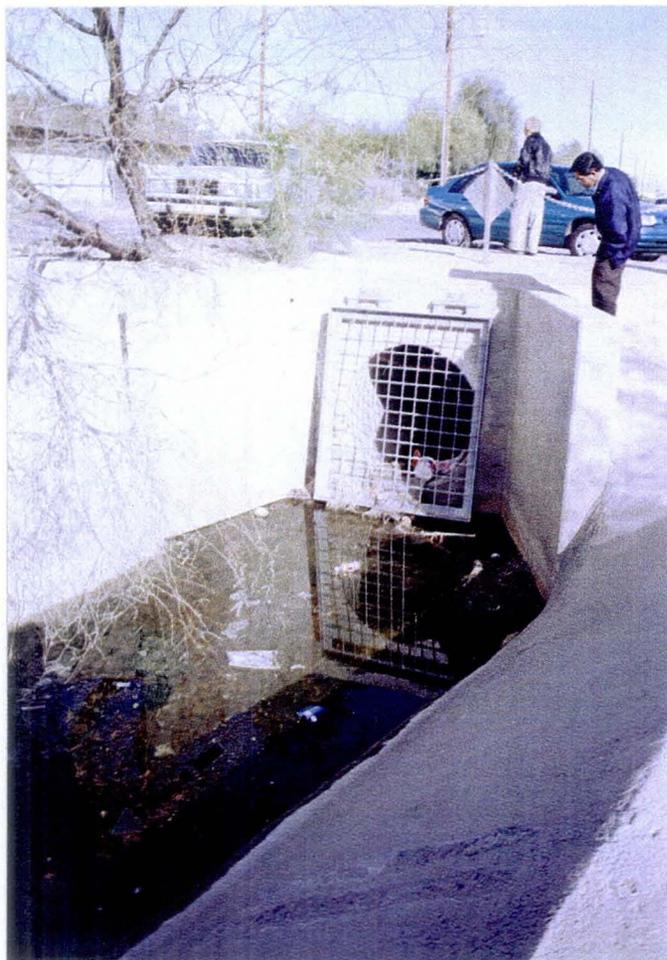
Picture No. 4  
Storm drain outlet

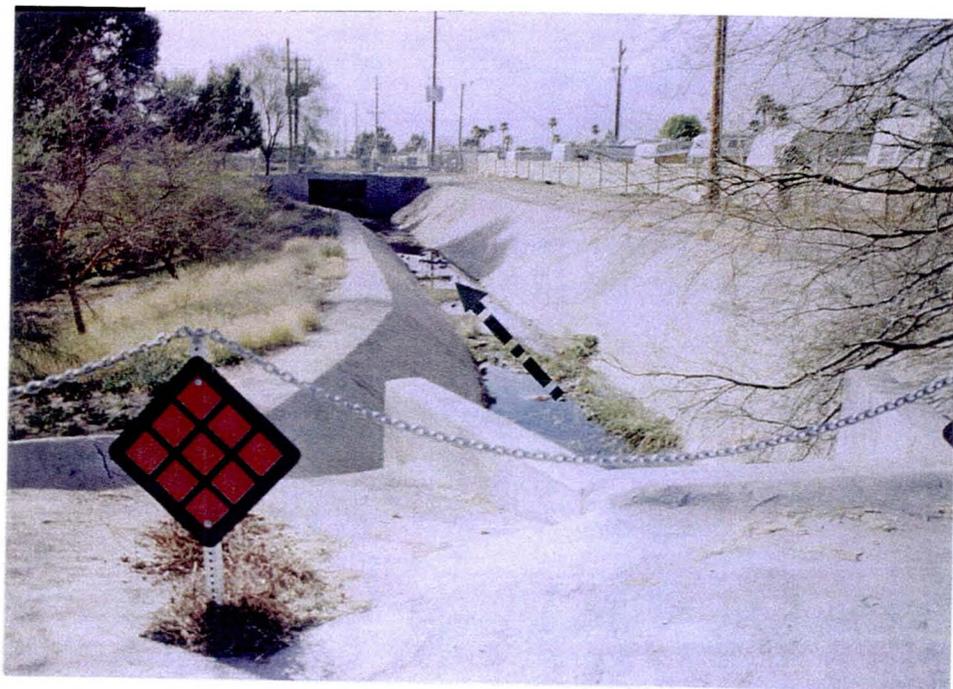
Picture No. 3  
Granite Reef Channel

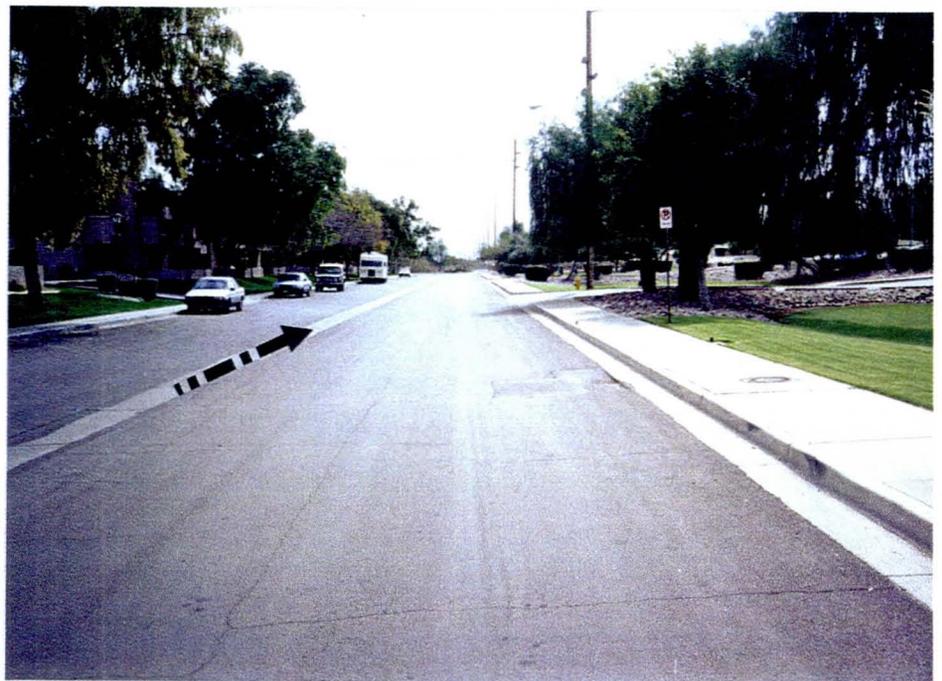
Picture No. 5  
Granite Reef Road

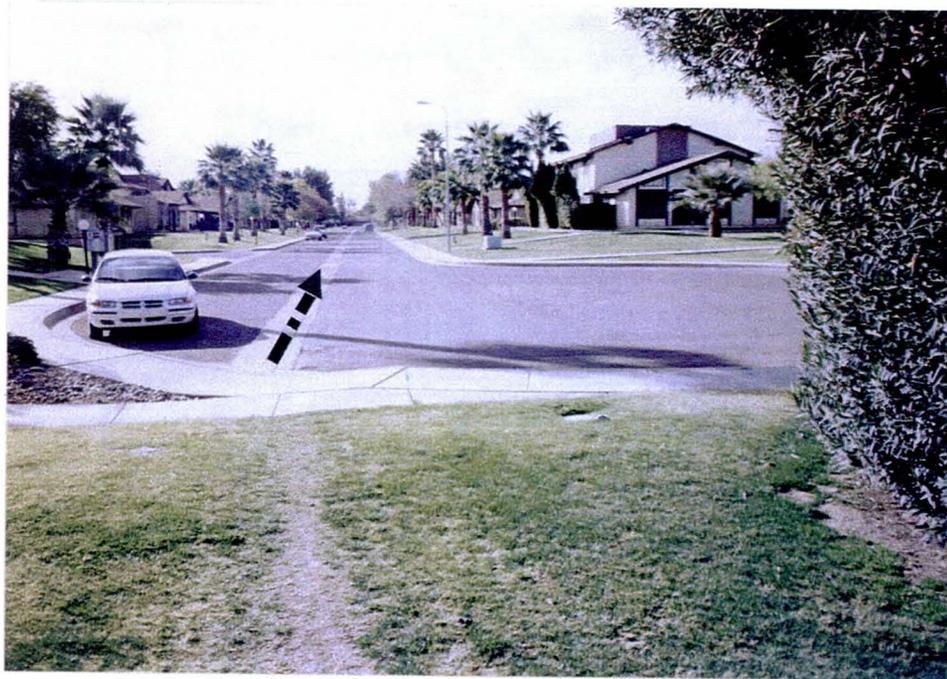
Picture No. 8

84TH Place

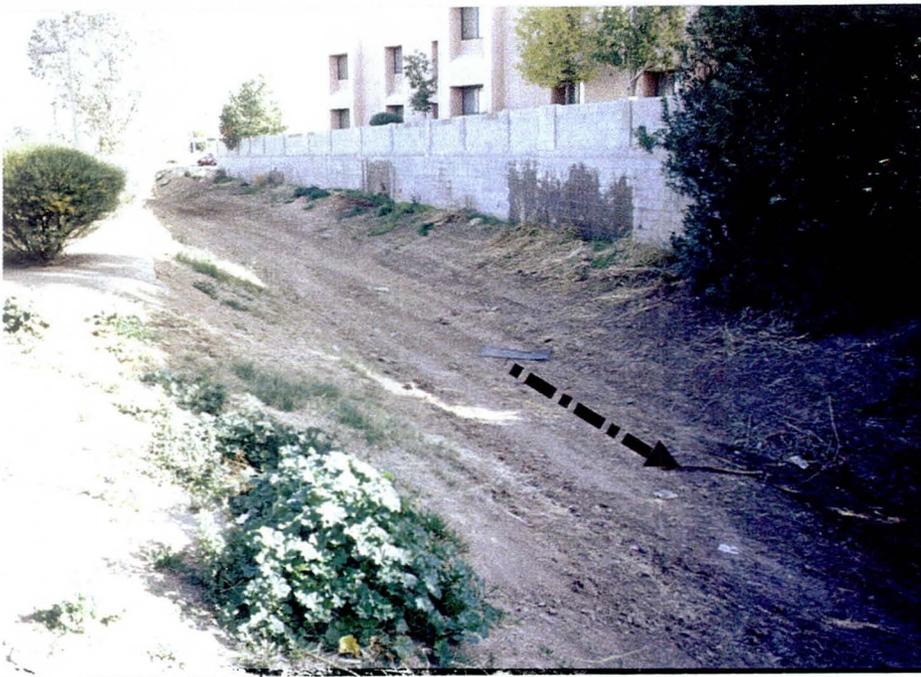
Picture No. 10  
Upstream end

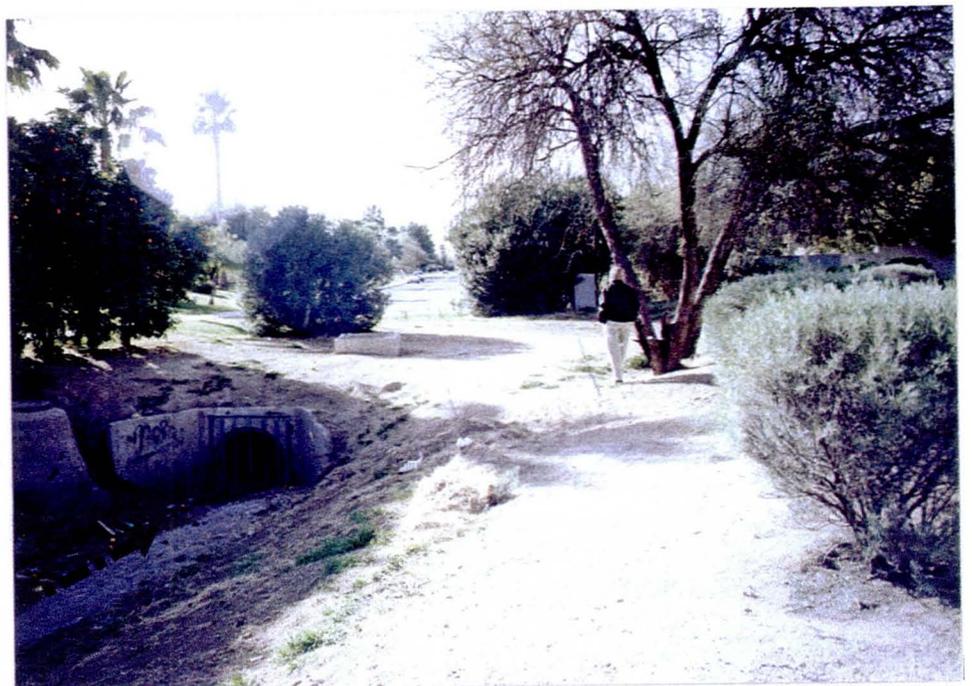
Picture No. 9  
Downstream end

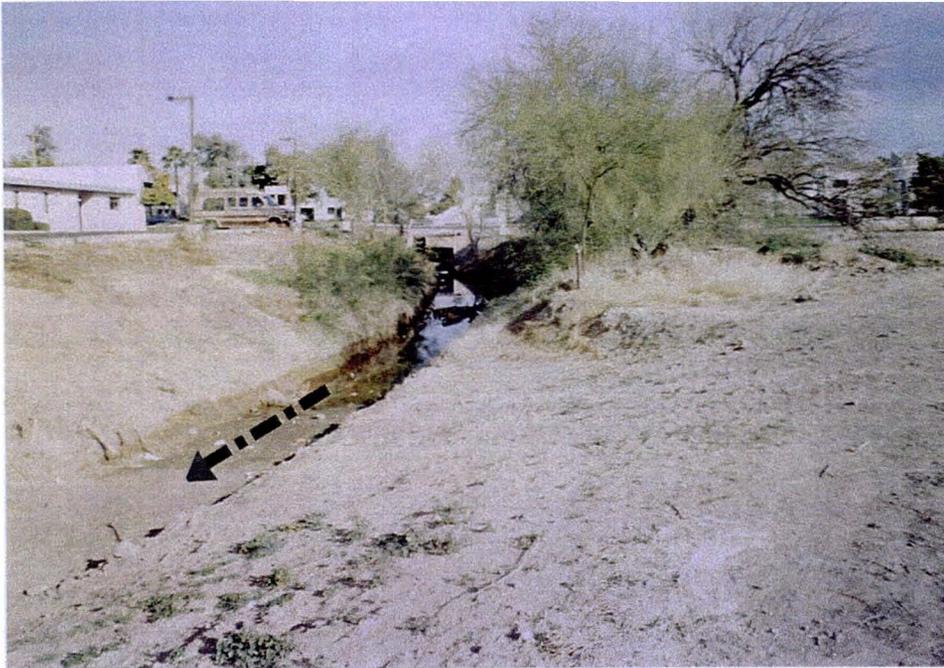
Picture No. 13  
Downstream from  
McDowell Road

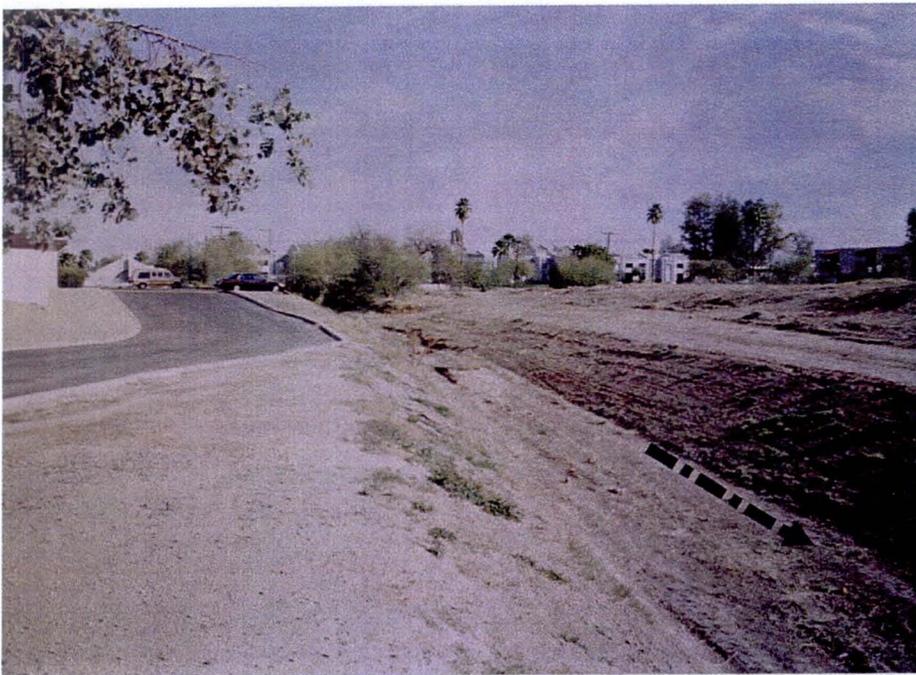
Picture No. 12  
Upstream end

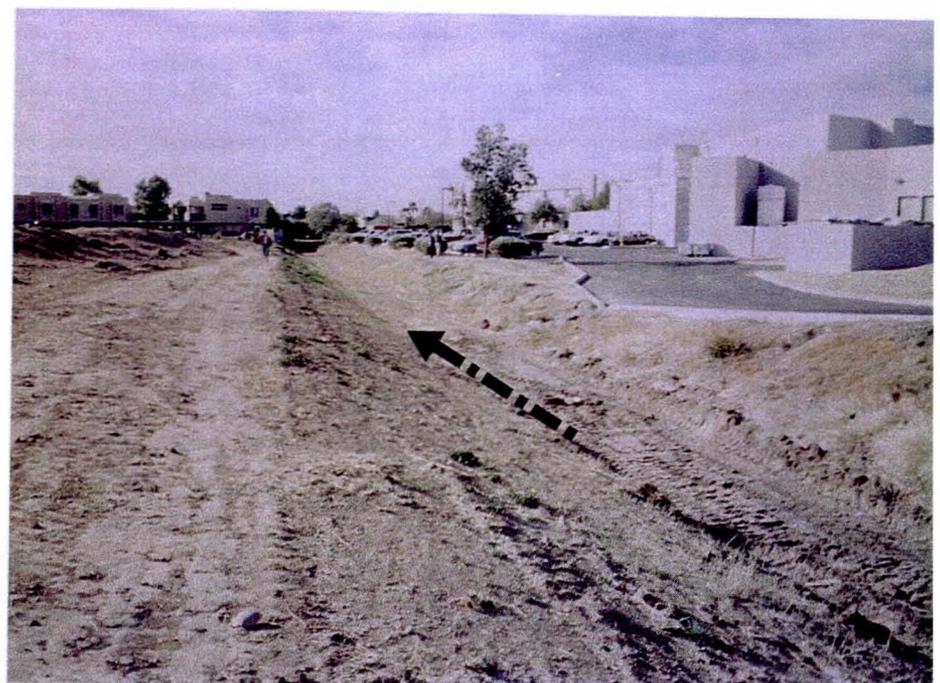
Picture No. 11  
Downstream end

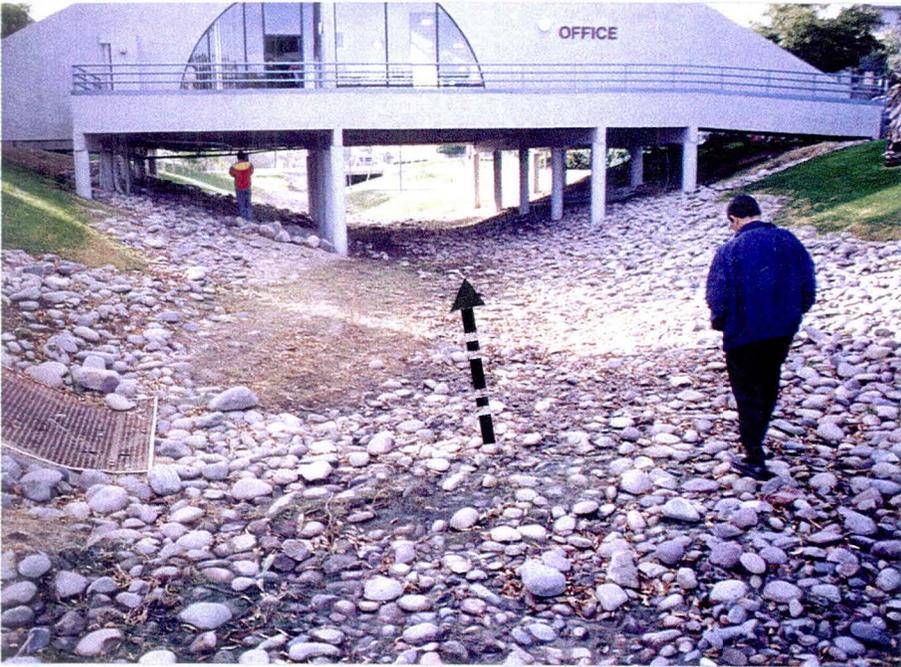
Picture No. 16  
Upstream looking south

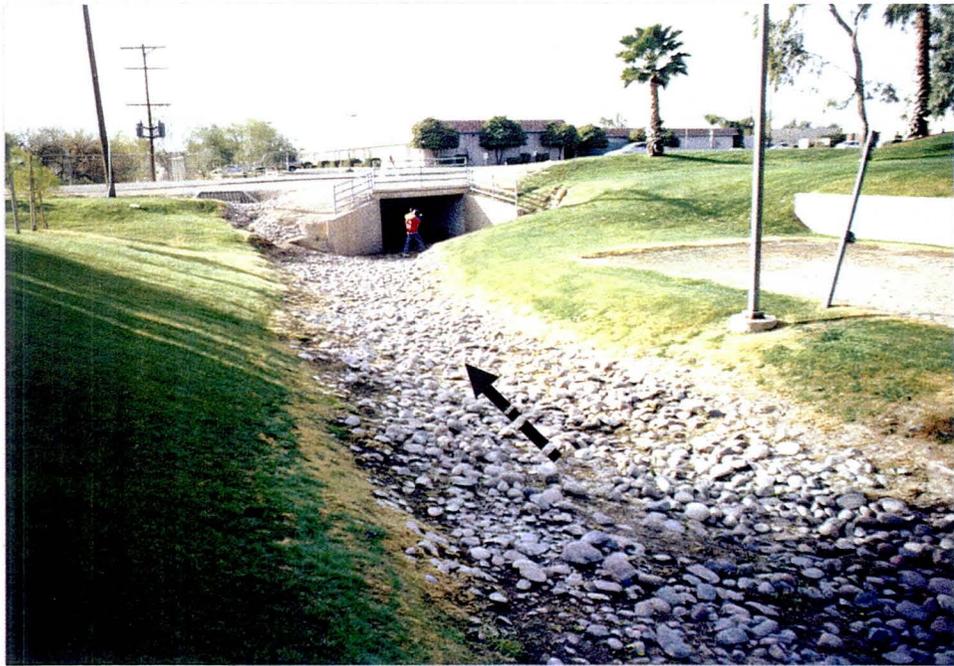
Picture No. 15  
Downstream end

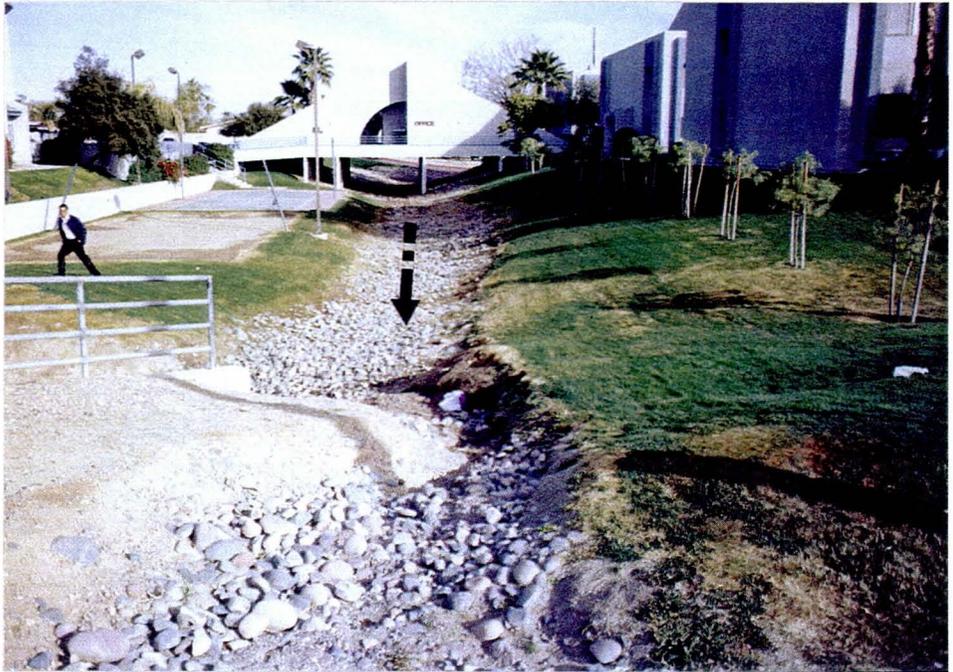
Picture No. 14  
From McDowell Road

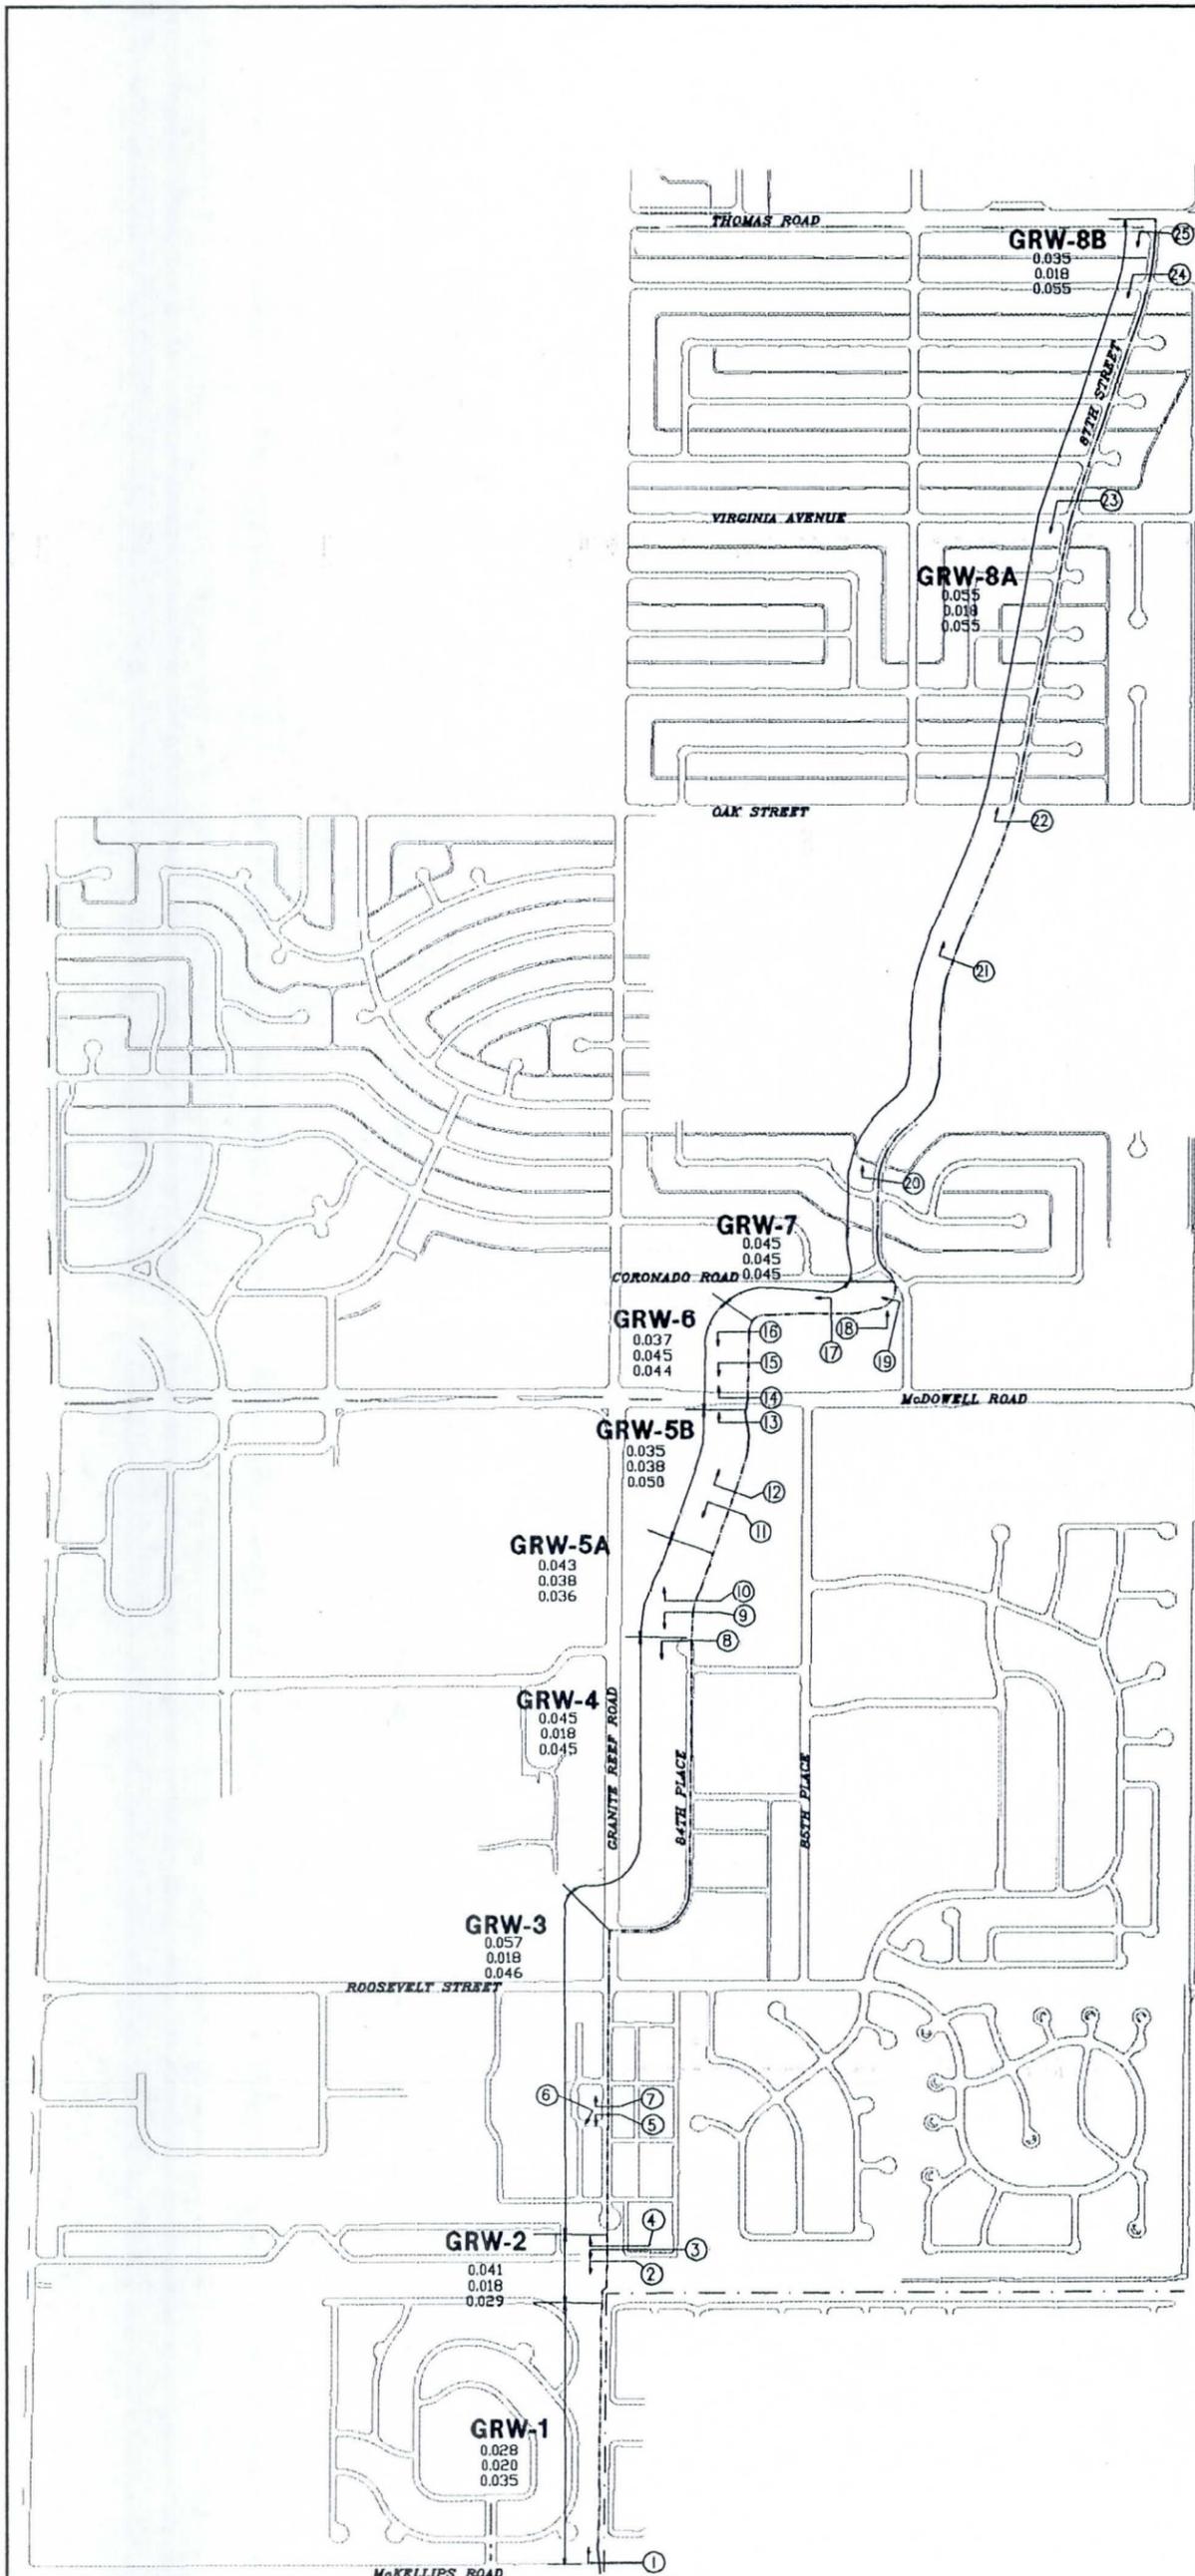
<b>FLOOD CONTROL DISTRICT OF MARICOPA COUNTY</b>			
PROJECT TITLE <b>FLOOD DELINEATION STUDY OF GRANITE REEF WASH F.C.D. CONTRACT NO. 95-05</b>			
DESIGNED BY HAA	DRAWN BY DRP	CHECKED BY SEK	DATE 2/23/96
REVISION 11/14/96			
<b>EXHIBIT 1 MANNING'S n VALUE MAP</b>

The limits, location of photographs and n values for each reach are shown on Exhibit 1 entitled, "Manning's n Value Map". In calculating the n Value, the following factors were considered:

REACH LABEL	<b>GRW3</b>
LEFT (EAST) OVERBANK n-VALUE	0.057
MAIN CHANNEL n-VALUE	0.018
RIGHT (WEST) OVERBANK n-VALUE	0.046
PHOTO LOCATION AND DIRECTION	⑤ →
HYDRAULIC BASE LINE	— — — — —

Each reach was identified with the aid of 1" = 100' aerial photographs. The discerning characteristics were channel size, vegetation density, bed materials and development encroachment. Each reach was photographed during the field reconnaissance at a representative and accessible location. The photography locations are summarized on Exhibit 1.
