Padelford Wash F.D.S. -- Inactive Fan Documentation

PADEFORD WASH FLOODPLAIN DELINEATION STUDY

"INACTIVE FAN" DOCUMENTATION

Subject: Padelford Wash Floodplain Delineation Study
Transmitting Alluvial-Fan-Evaluation Documentation

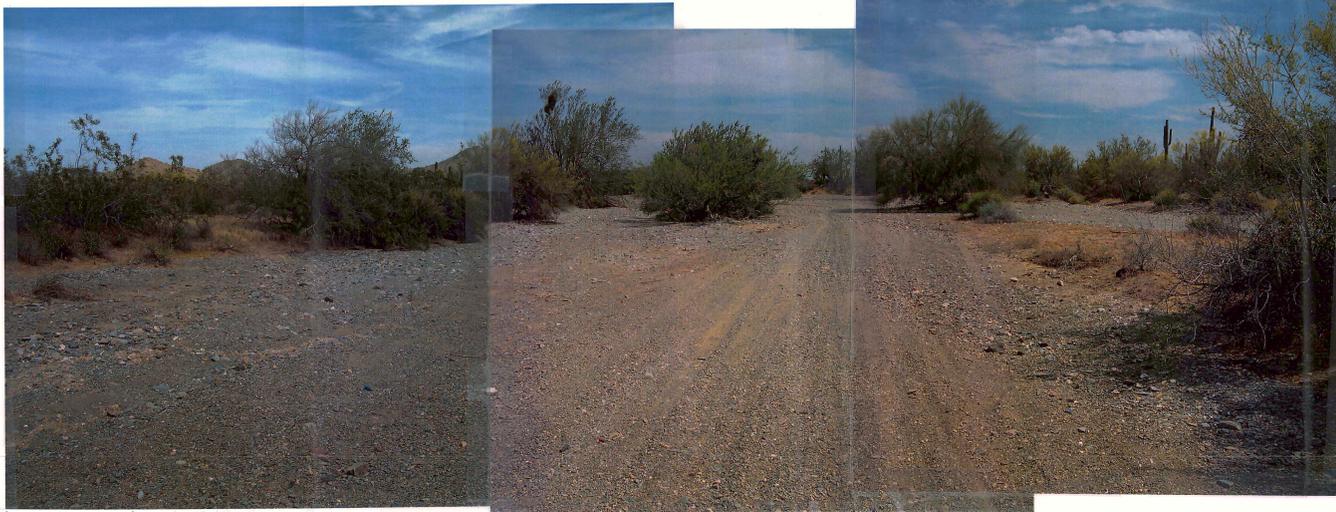
FIGURE 4
LOCATION 4
LOOKING SOUTH

Figures 4 through 7, of Sheets 2 and 3 of 4, were taken further downstream, and exhibit streambed character and overbank character similar to those of the upstream photos.

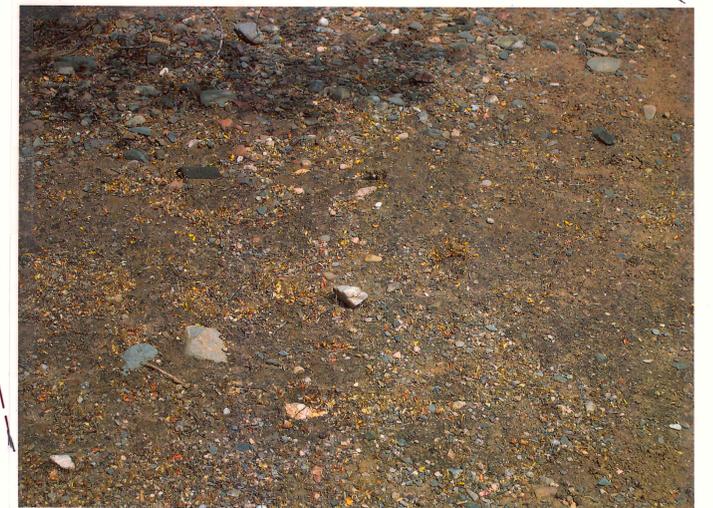
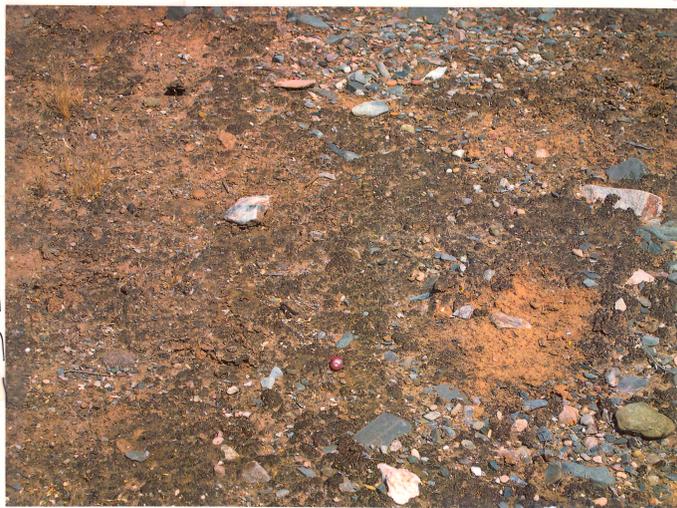
FIGURE 5-A
LOCATION 5
LOOKING SOUTH

FIGURE 5-C
LOCATION 5
LOOKING SOUTH

FIGURE 5-B
CLOSE-UP
OF FIG. 5-A

FIGURE 5-D
CLOSE-UP
OF FIG. 5-C

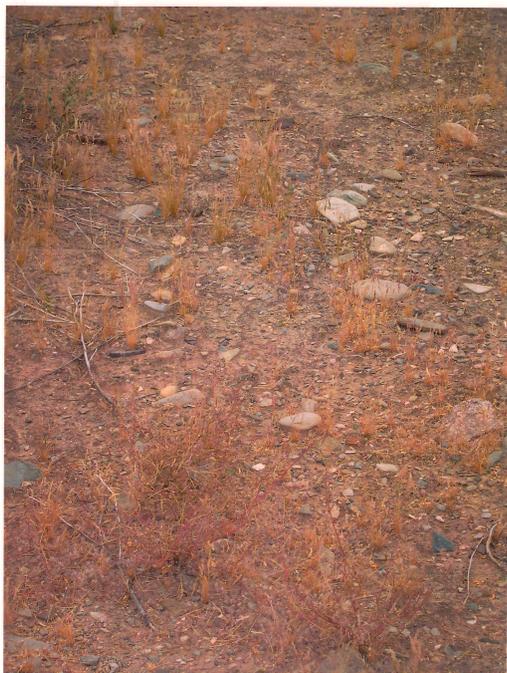
The next group of ground photos, taken even farther downstream, are Figures 8 through 13, on Sheets 3 and 4 of 4. At these locations, the flow splits are farther apart, and the overbank areas are much larger. The panoramic view of Figure 11 shows that the flow splits are more incised than the upstream areas, but the same sort of smooth, uniform, gravelly streambeds occur, as well as the rounded stream-banks.

FIGURE 8-A
LOCATION 8
LOOKING SOUTH

FIGURE 8-B
CLOSE-UP
OF FIG. 8-A

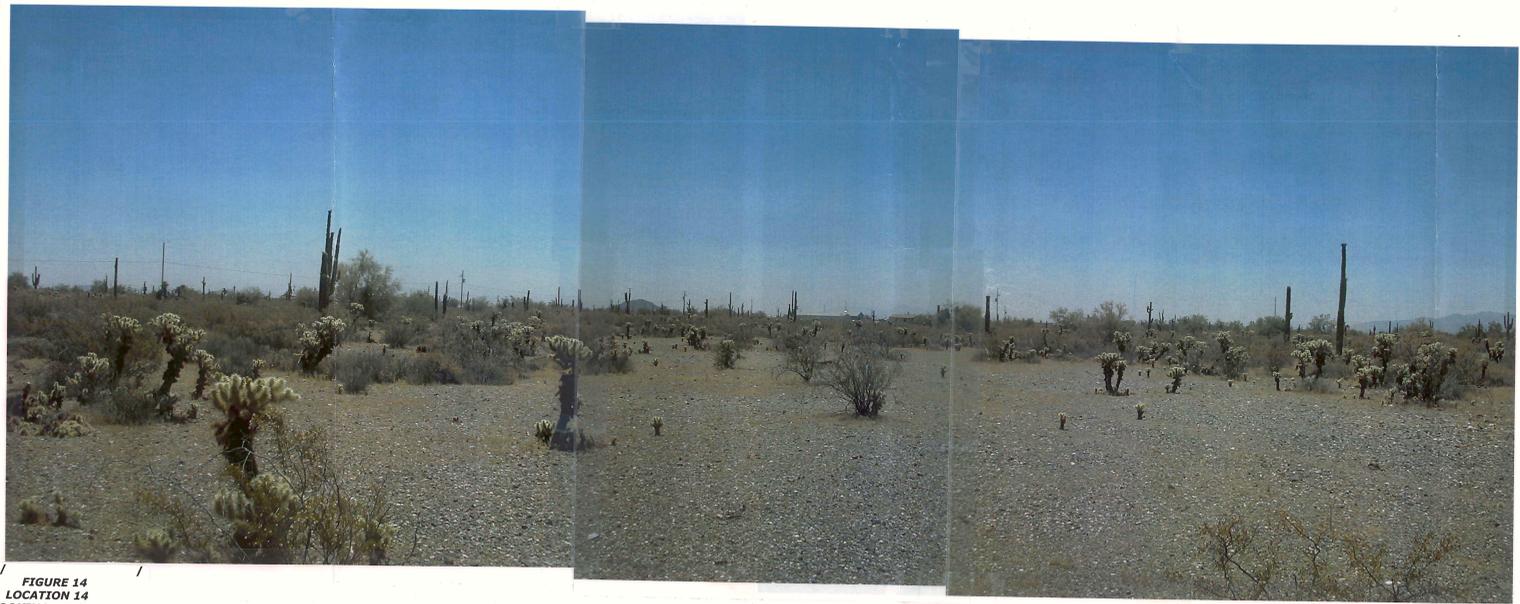
FIGURE 14
LOCATION 14
LOOKING SOUTH

Figure 14 shows some well-developed desert pavement in a typical overbank area farther downstream. Desert pavement surfaces exhibit a concentration of pebbles and cobbles, due to the removal of the fine grained material by wind or sheet flow, and due to the lack of alluvial deposition by flooding events.
