**Iona Wash Flood Insurance Study  
Field Reconnaissance Report**

**Flood Control District  
of  
Maricopa County**

December 1992

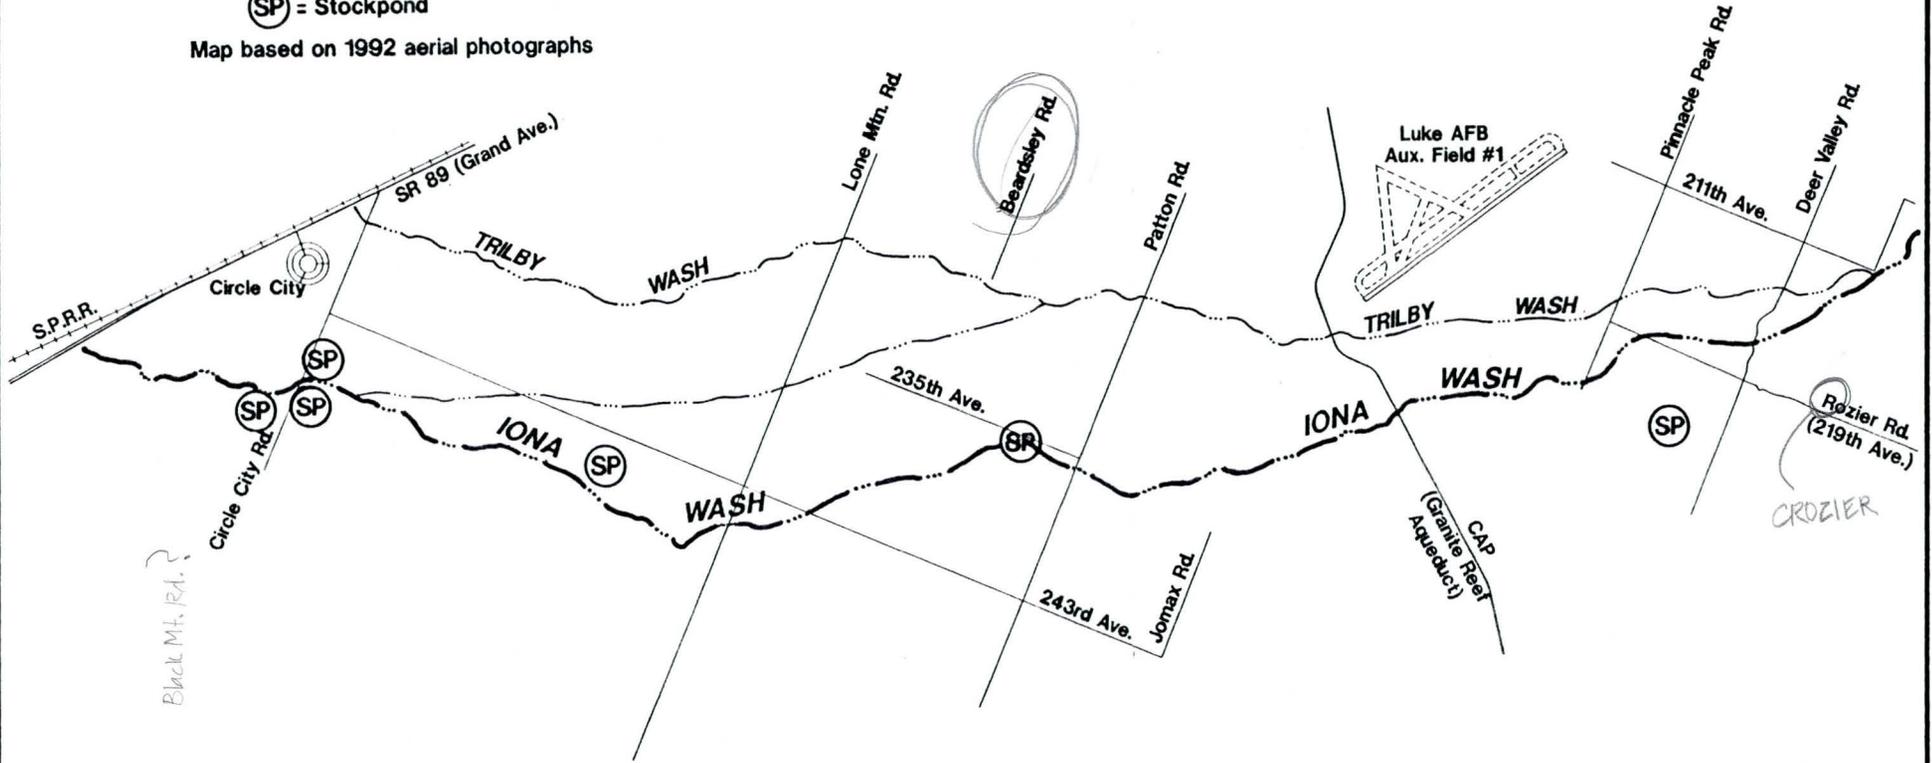
**FIGURE 1  
LOCATION MAP**

The Iona Wash study area extends approximately 12 river miles from the confluence with Trilby Wash in T.4N., R3W., Section 25 to State Route 89 (Grand Avenue) in T.6N., R.3W., Section 29 as shown in Figure 1. Iona Wash includes reaches of channelized and ~~distributary flow~~, as well as portions of ~~unconfined sheet flow~~.  
*see p 3*

**Levees and Stockponds.** There several abandoned stockponds and levees in the study area (Figure 1). All but one of the stockponds are off-channel features, not directly connected to the main channel of Iona Wash. The single in-channel stockpond is located in reach 3, which is a sheet flow area. The off-channel stockponds are generally located along tributary channels upstream of the tributary confluence with Iona Wash. Man-made diversions may direct runoff from Iona Wash into the ponds. Levees were constructed in conjunction with the stockpond diversions in reaches 2 and 6. It is unlikely that these levees or the stockponds will meet FEMA criteria.

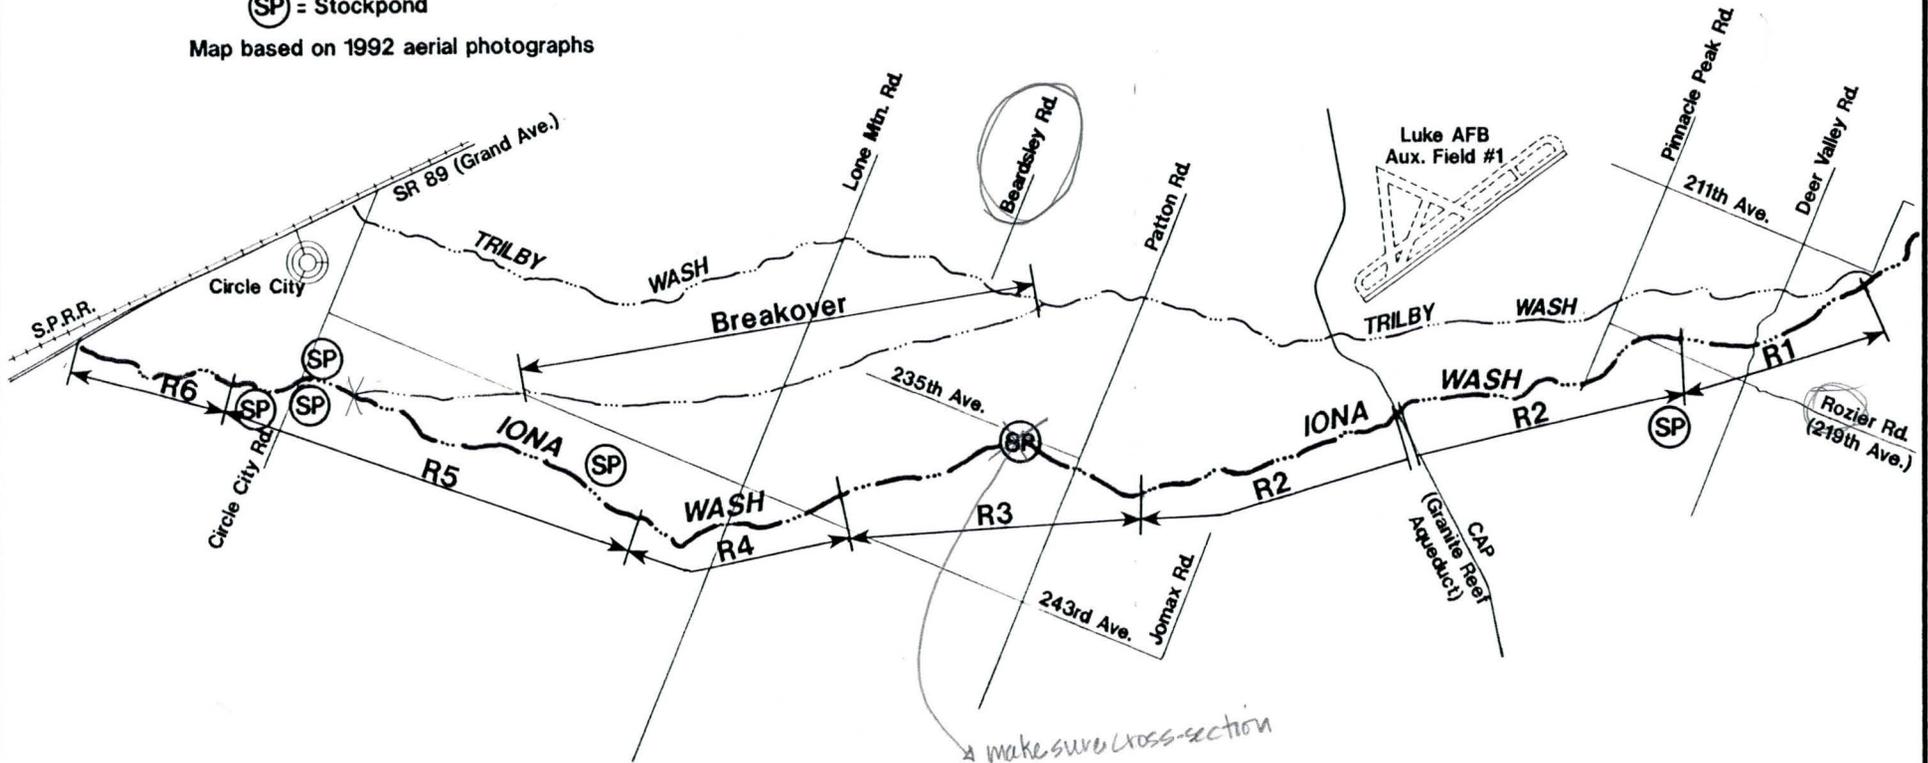
**FIGURE 2**  
**REACH DESIGNATIONS**

*Reach Definition.* Within the study area, Iona Wash can be divided into six reaches of distinct geomorphic and hydraulic characteristics (Figure 2). These six reaches are described in Table 1. An additional reach, which conveys breakover flow from Iona Wash to Trilby Wash, will be used for floodplain modeling. The six reaches include three basic channel types: (1) reaches with wide, well-defined channels, and limited riparian vegetation near the banks (reaches 2, 4, and 6), (2) braided reaches with narrow, less well defined channels and extensive riparian zones (reaches 1 and 5), and (3) poorly defined ~~sheet flow~~ areas with minor channel conveyance (reach 3 and the breakover reach).  
*see p 3*

Reach	Reach Limits	Description
1	Trilby Wash to Crozier Rd.	Braided w/ Dense Riparian Veg'n
2	Reach 1 to 237th Ave.	Channelized w/ Riparian Veg'n
3	Reach 2 to Beardley Rd.	Sheet Flow, Unconfined
4	Reach 3 to 1/2 mi. N of Lone Mtn Rd	Channelized w/ Riparian Veg'n
5	Reach 4 to 1 mi. S of Rt. 89	Braided, Very Poorly Defined
6	Reach 5 to Rt. 89	Channelized, wide channels
Breakover	Iona Wash to Trilby Wash	Sheet Flow to Braided

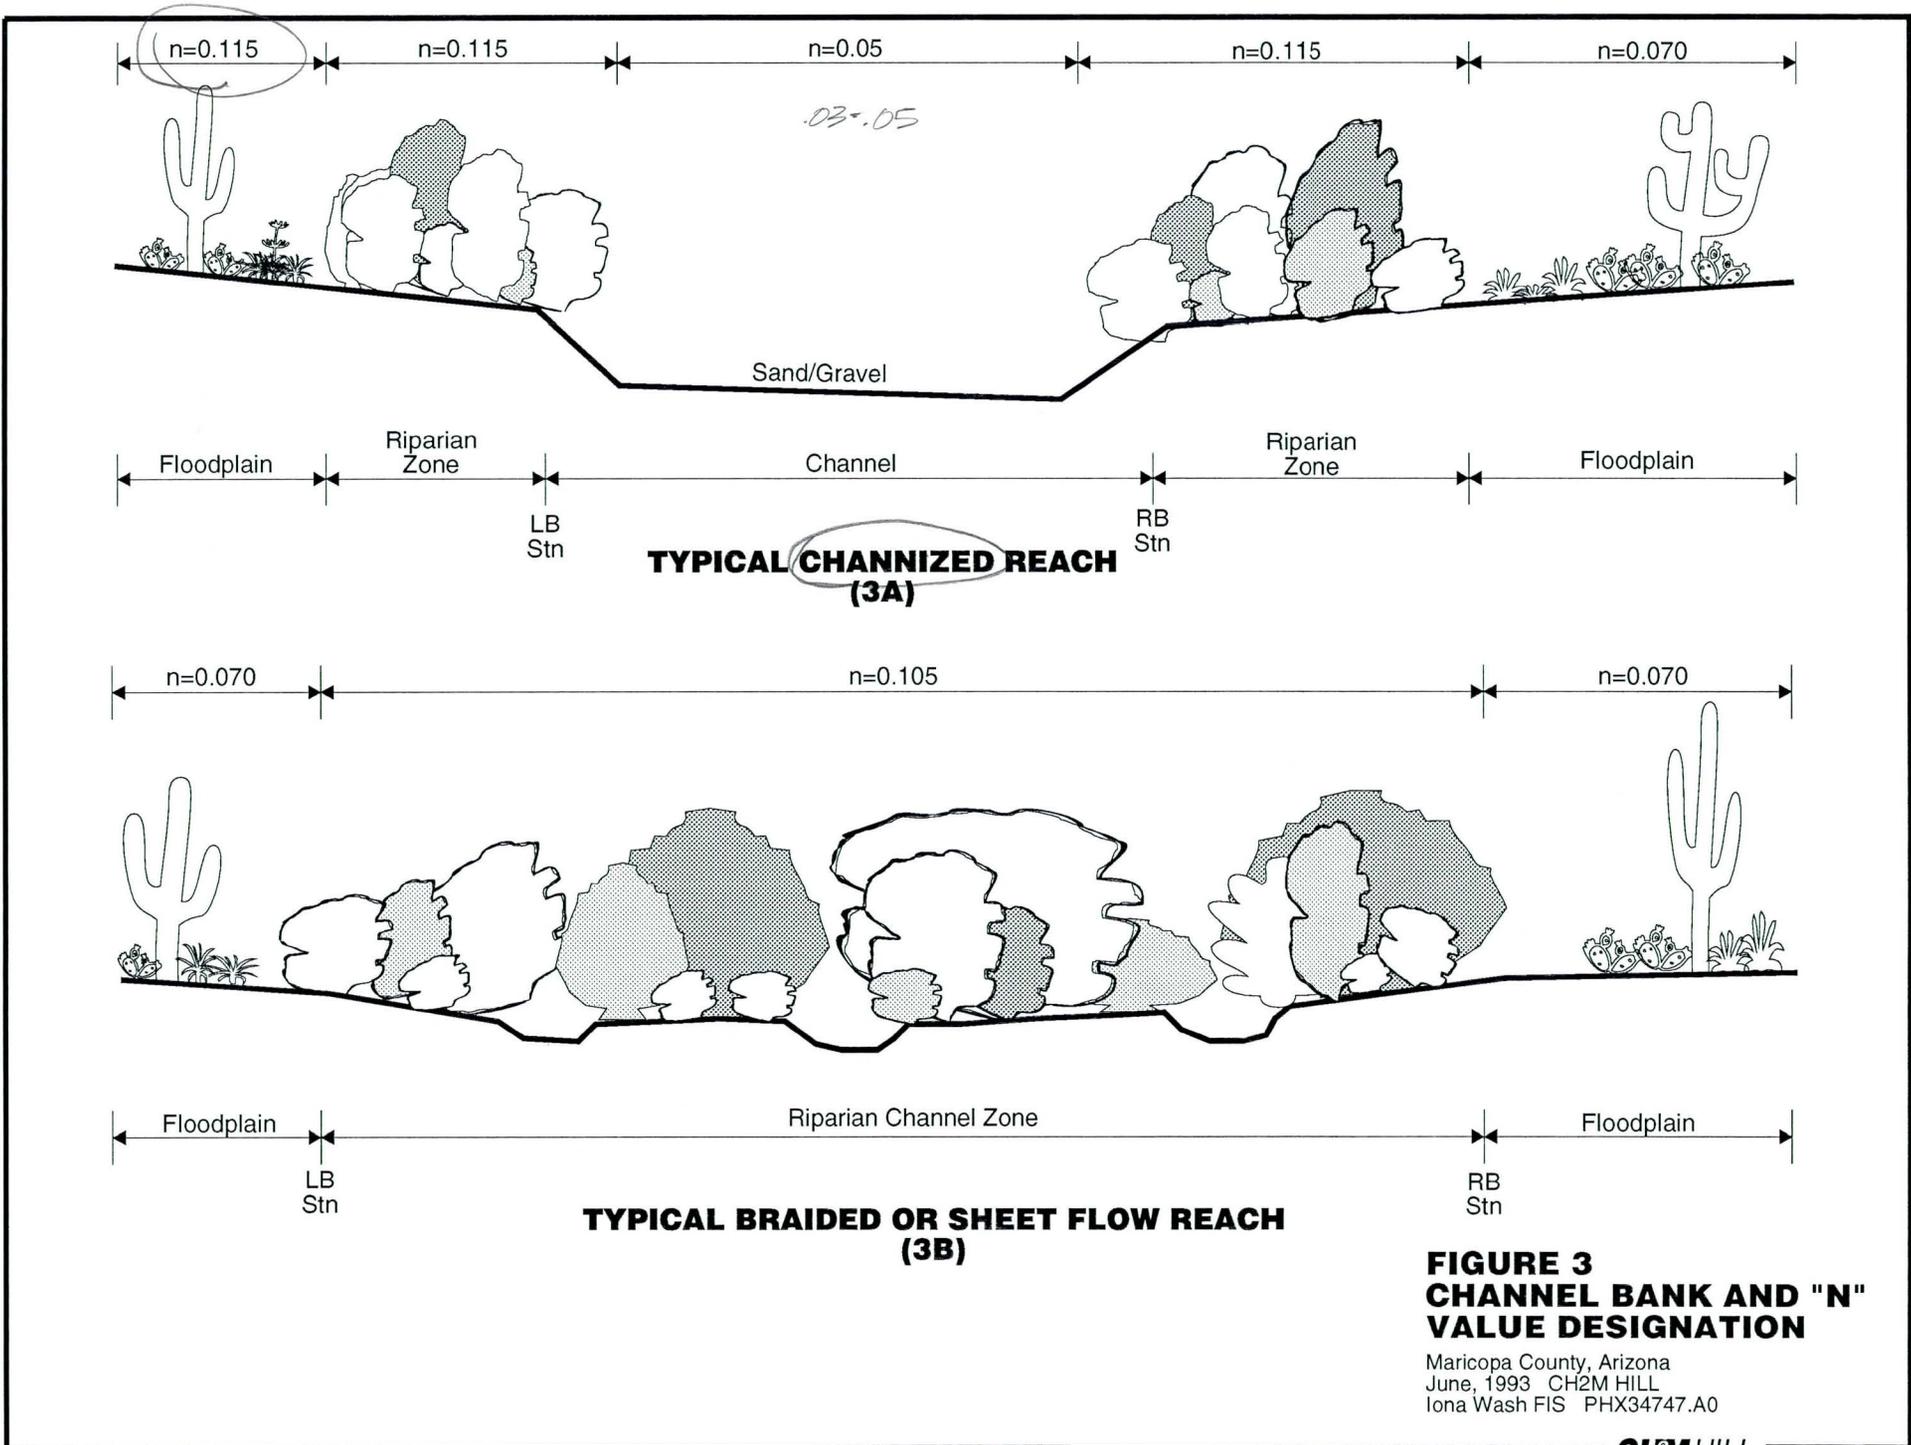
**FIGURE 3  
 CHANNEL BANK AND "N"  
 VALUE DESIGNATION**

*Channel Conditions.* For this report, two definitions of "channels" will be used, as illustrated in Figure 3. For well-defined reaches the standard definition of a channel, the wash bottom and bank slope, applies. For braided and sheet flow reaches, the term "channel" includes the wash bottom and the surrounding riparian zone. This broader definition will be used for several reasons. First, a single flow path cannot be easily identified in the field or on phototopography due to the presence of multiple channels, the a tree canopy which hides channels, and the inaccessibility of most of the wash. Including riparian zone makes identifying the channels using aerial photography possible. Second, the channel and riparian zone are better characterized by a single composite "n" value. Third, this broader definition will facilitate floodway mapping.

*Channel Bank Stations.* Channel bank stations for hydraulic modeling will be defined in two ways<sup>1</sup>. First, for wide, well-defined channelized reaches, bank stations will be defined at top of the bank slope adjacent to the margins of the sandy channel bottom. Using this first definition, separate "n" values can be selected for the channel characteristics, the riparian zone, the floodplain. For braided and sheet flow areas with limited conveyance in channels, the channel bank stations will be defined at the margins of the riparian zone. A composite "n" value will be used to estimate roughness in the braided channel area.

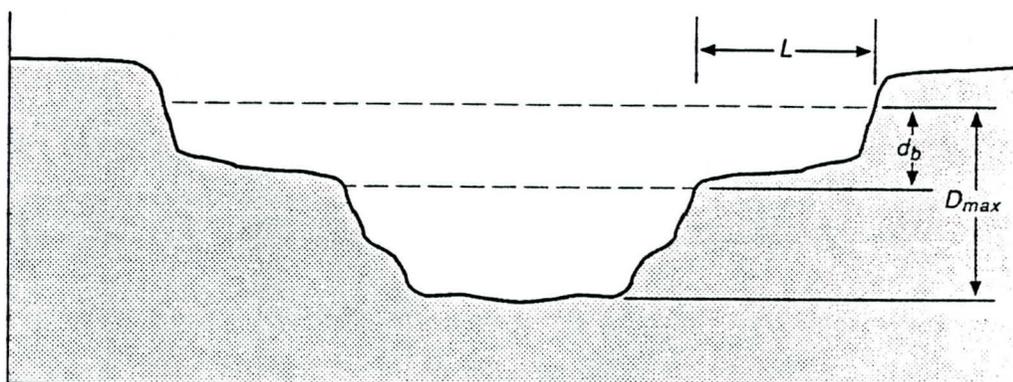
Figure 2.--Subdivision criteria commonly used for streams in Maricopa County, Arizona.

Subdivide if  $D_{max}$  is greater than or equal to  $2d_b$

Subdivide if  $D_{max}$  is approximately equal to  $2d_b$   
and if  $L/d_b$  is equal to or greater than 5

$L$  = width of flood plain

$d_b$  = depth of flow on flood plain, in feet

$D_{max}$  = maximum depth of flow in cross section,  
in feet

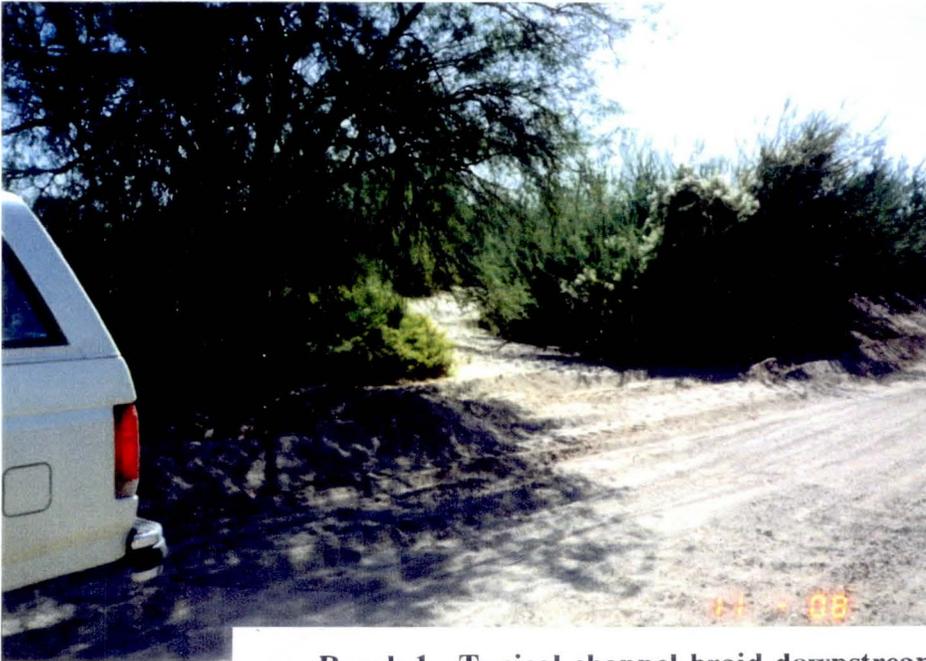
**Reach 1. Typical channel braid downstream of Crozier Road.**  
 Base  $n$  value = 0.022; Composite  $n$  including riparian  
 vegetation = 0.105.

\*  
 1/2 Would like to see  
 channel  $n =$   
 overbank  $n =$   
 on these pictures.  
 Base  $n$  & composite are  
 confusing.

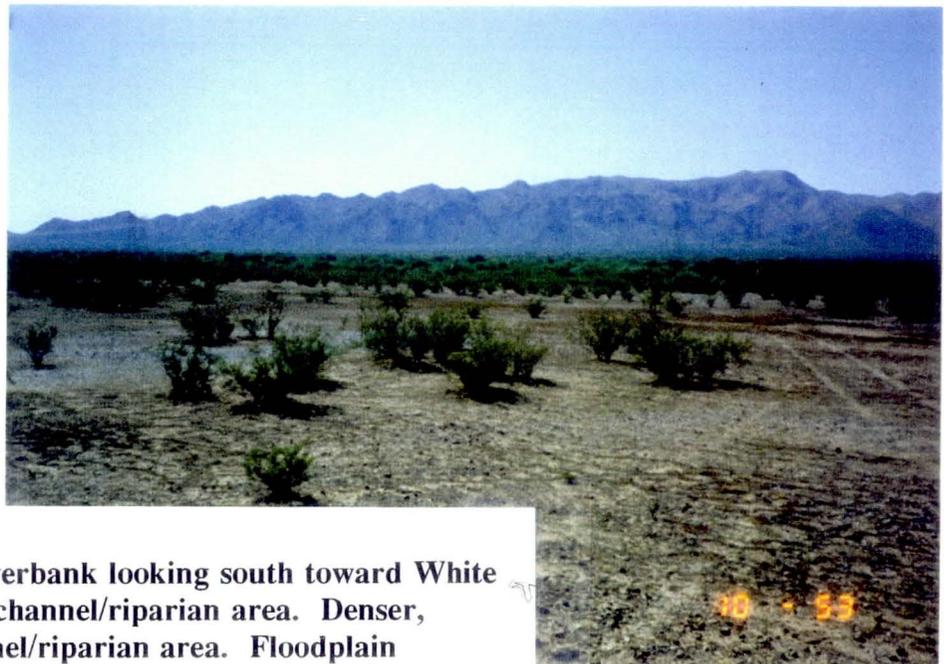
**Reach 1. View of left overbank looking south toward White  
 Tank Mountains across channel/riparian area. Denser,  
 taller vegetation is channel/riparian area. Floodplain  
 $n$  value = 0.070.** *seems a little high based on this picture.*

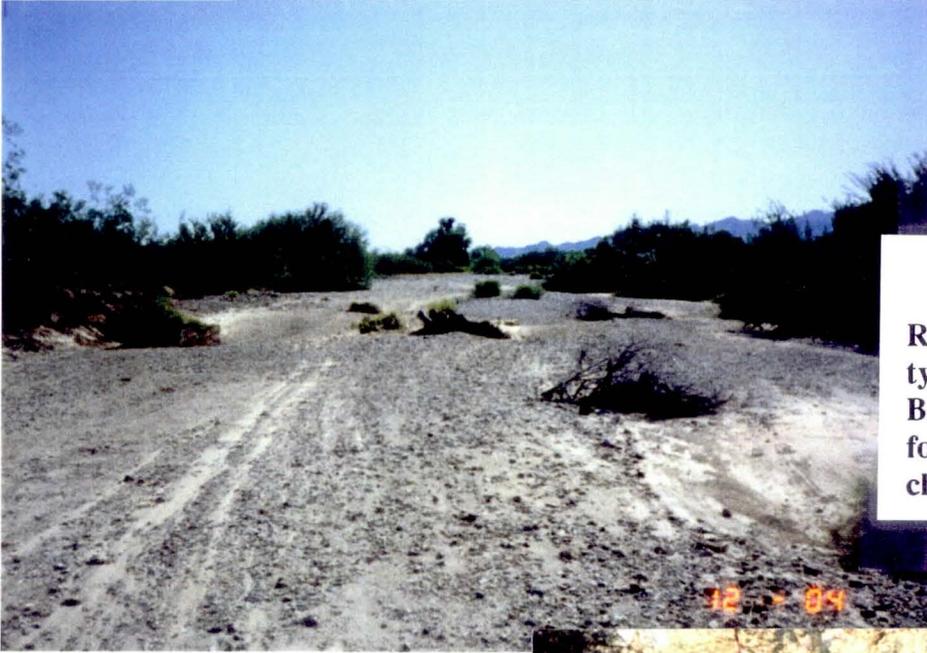
Reach 2. Looking upstream at typical channel in Reach 2. Base n value = .026. N value for riparian zone adjacent to channel = 0.115.

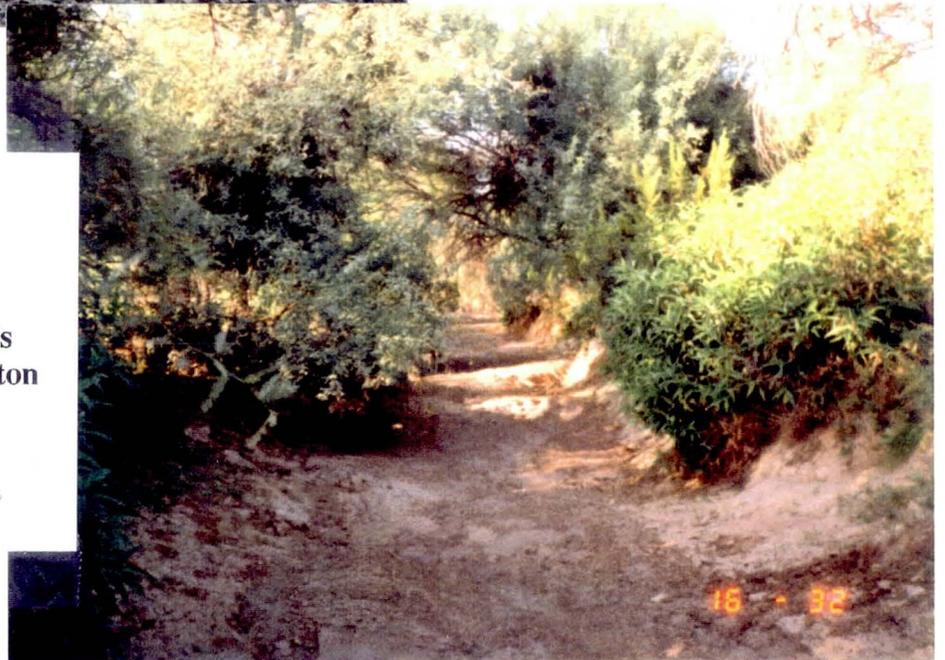
Reach 3. View of typical channel in braided flow area in Reach 3. Channel shown is one of many upstream of Patton Road. Base n value = 0.022. Composite n value includes riparian vegetation.

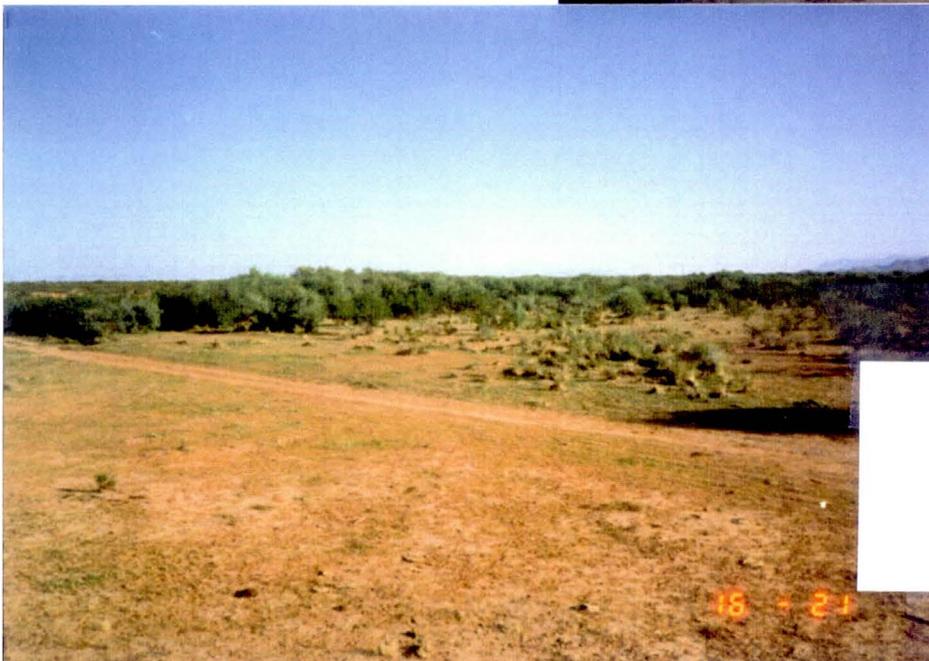
Reach 3. Right overbank in heavily grazed part of Reach 3. Dense vegetation lines channel.

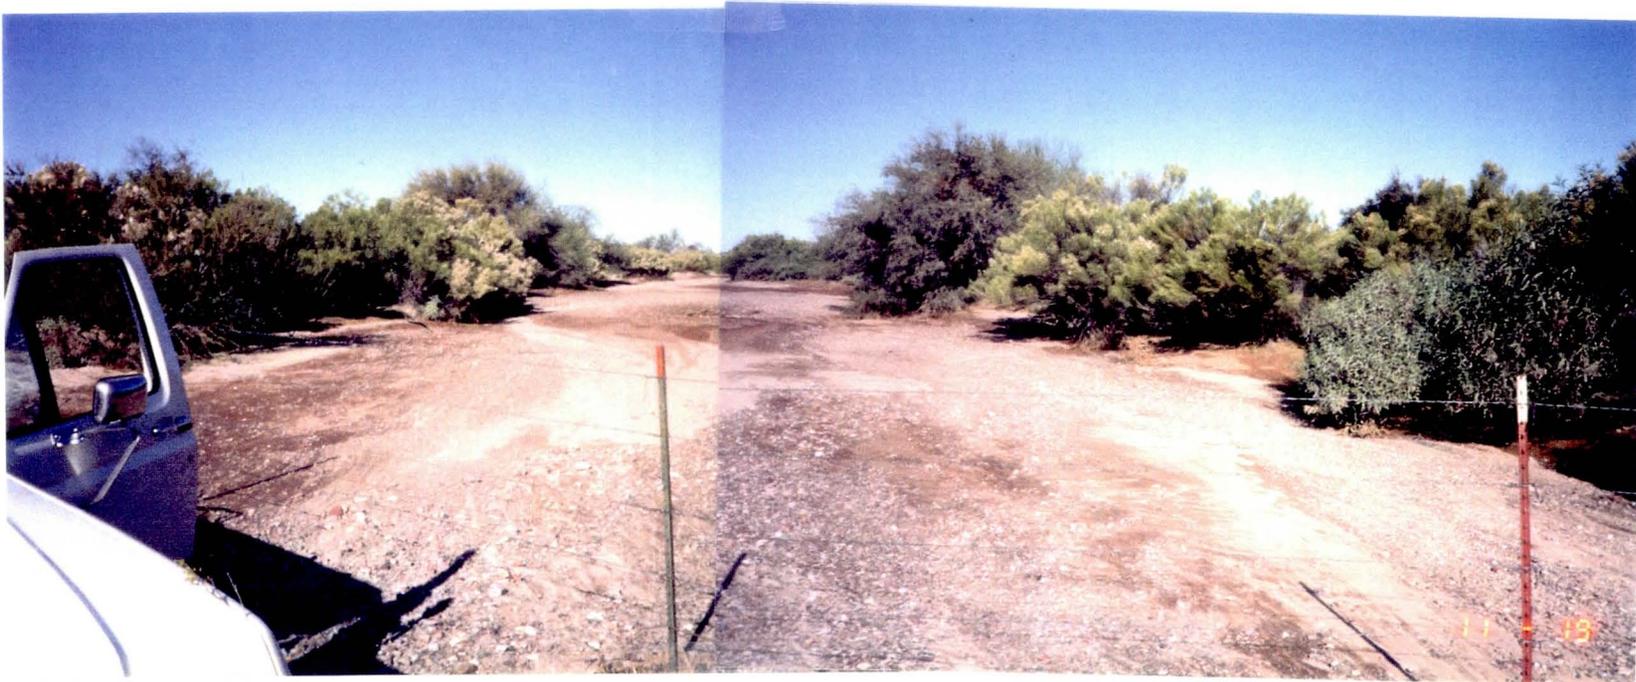
Reach 4. Looking upstream at defined channel in Reach 4. Base  $n$  value = 0.028.  $N$  value for riparian zone adjacent to channel = 0.115. View from Lone Mountain Road.

*depending  
on depth of flow.*

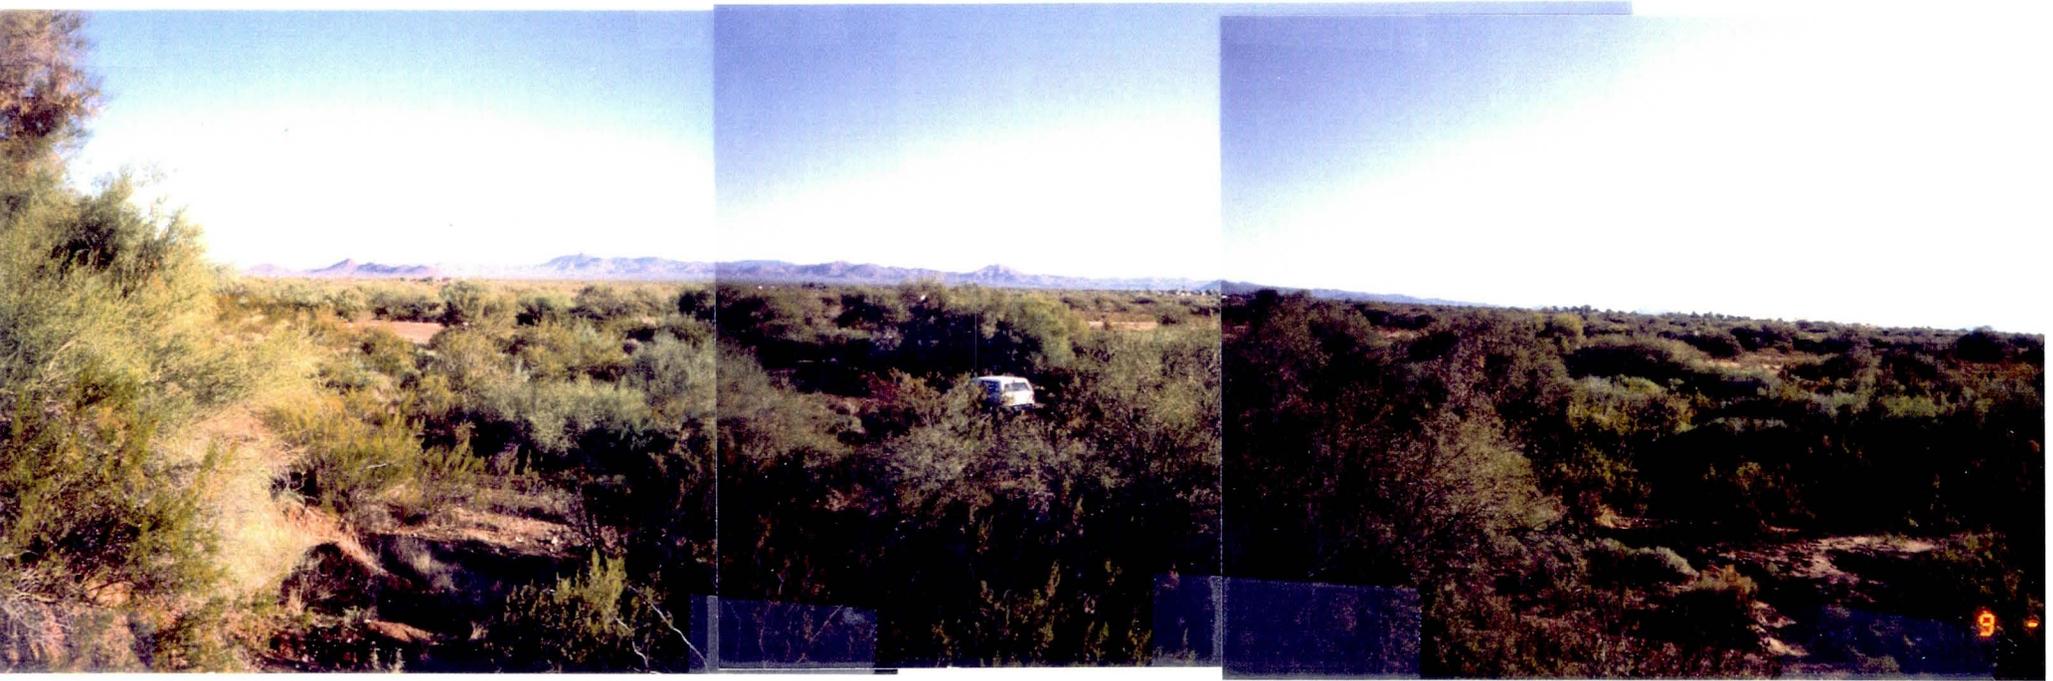
Reach 5. Looking north from stockpond embankment across braided flow area in Reach 5. Base n value = 0.022; composite n value including riparian vegetation = 0.095. Truck is parked between several active flow paths. Hieroglyphic Mountains in distance.

*just from this picture -  
it would seem this  
reach should have  
higher vegetation adjustment?  
than reaches 1 & 2??*

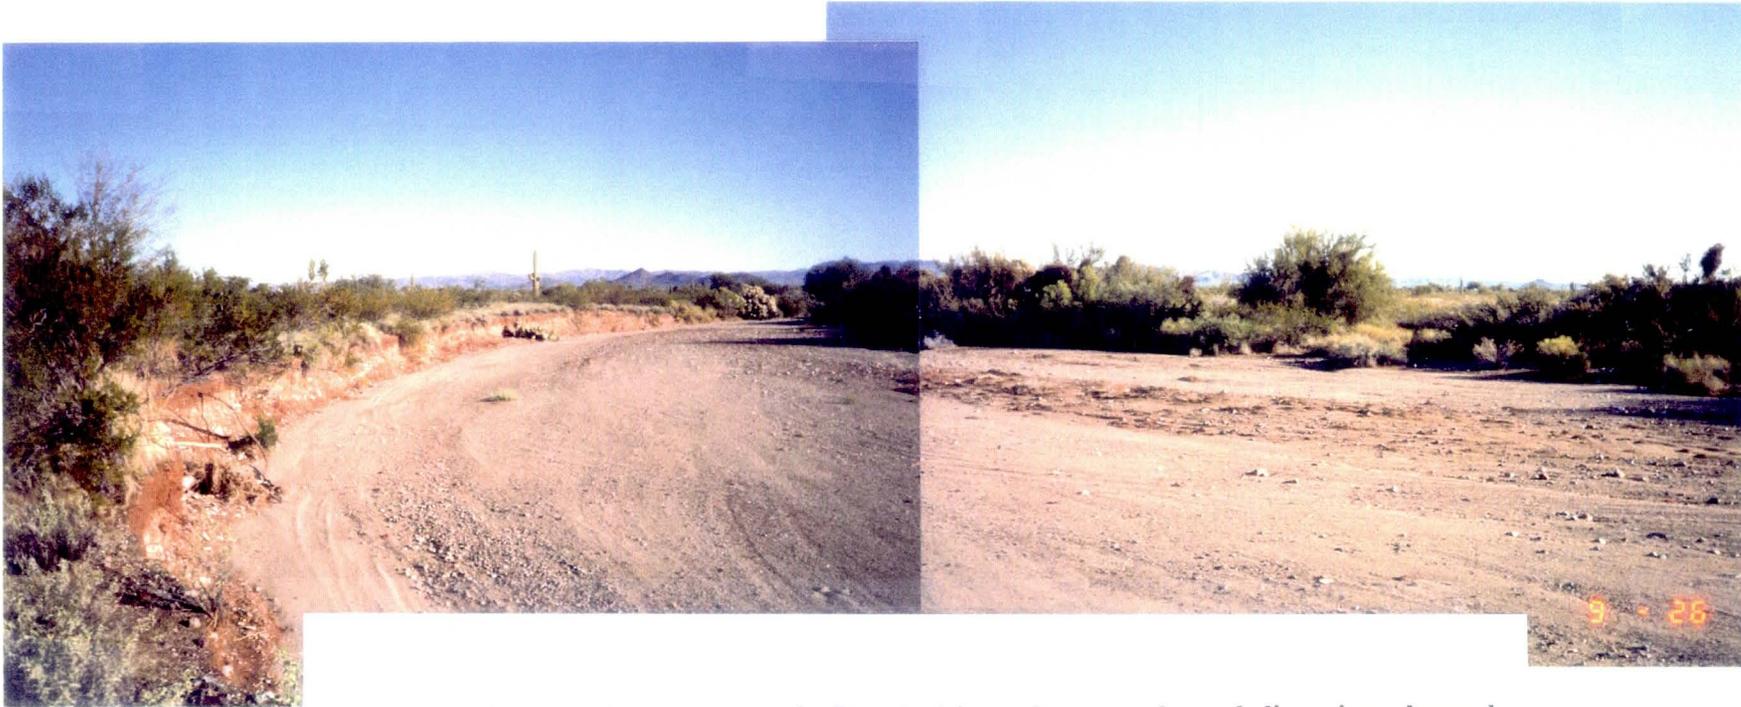
Reach 6. View looking upstream in Reach 6 just above stockpond diversion channel.  
Base n value = 0.028.

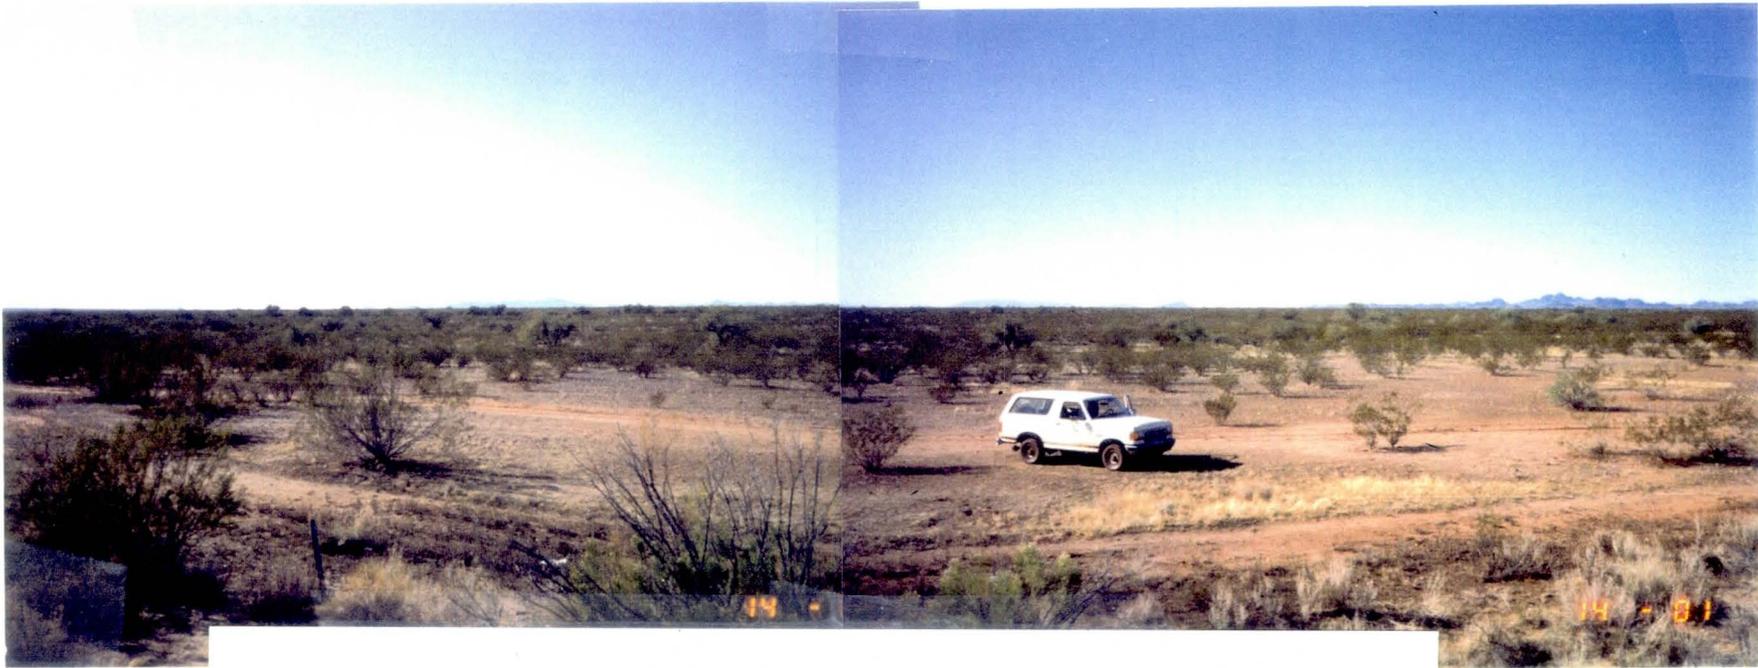
Typical floodplain with creosote bursage vegetative community with a heavily grazed low grass understory. Floodplain n value of 0.070 applies to all overbank areas in study area except riparian zones. View looking north from CAP levee in left overbank in Reach 2.

This picture → .030 - .050 ??

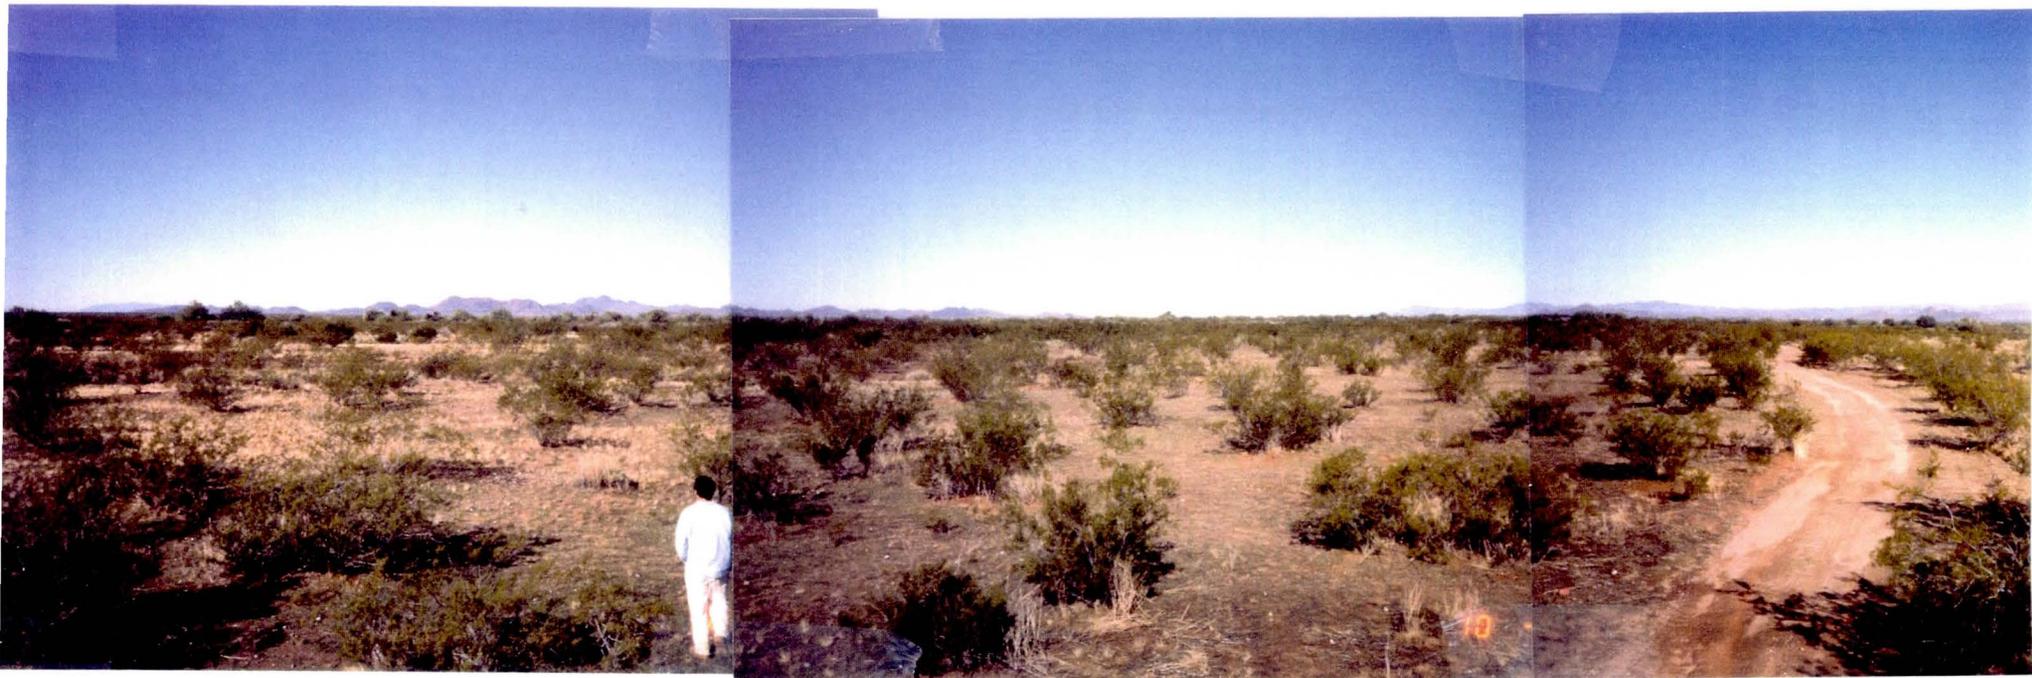
**Typical floodplain with creosote bursage vegetative community and heavily grazed low grass. Floodplain n value of 0.070 applies to all overbank areas in study areas except riparian zones. View looking south toward White Tank Mountains in right overbank in Reach 5.**

*depending on depth of flow - !!  
could also be .04-.05.*
